Delft screw injection pile tests factual report

Delft Screw Injection Pile Tests

Factual Report

24th November 2024

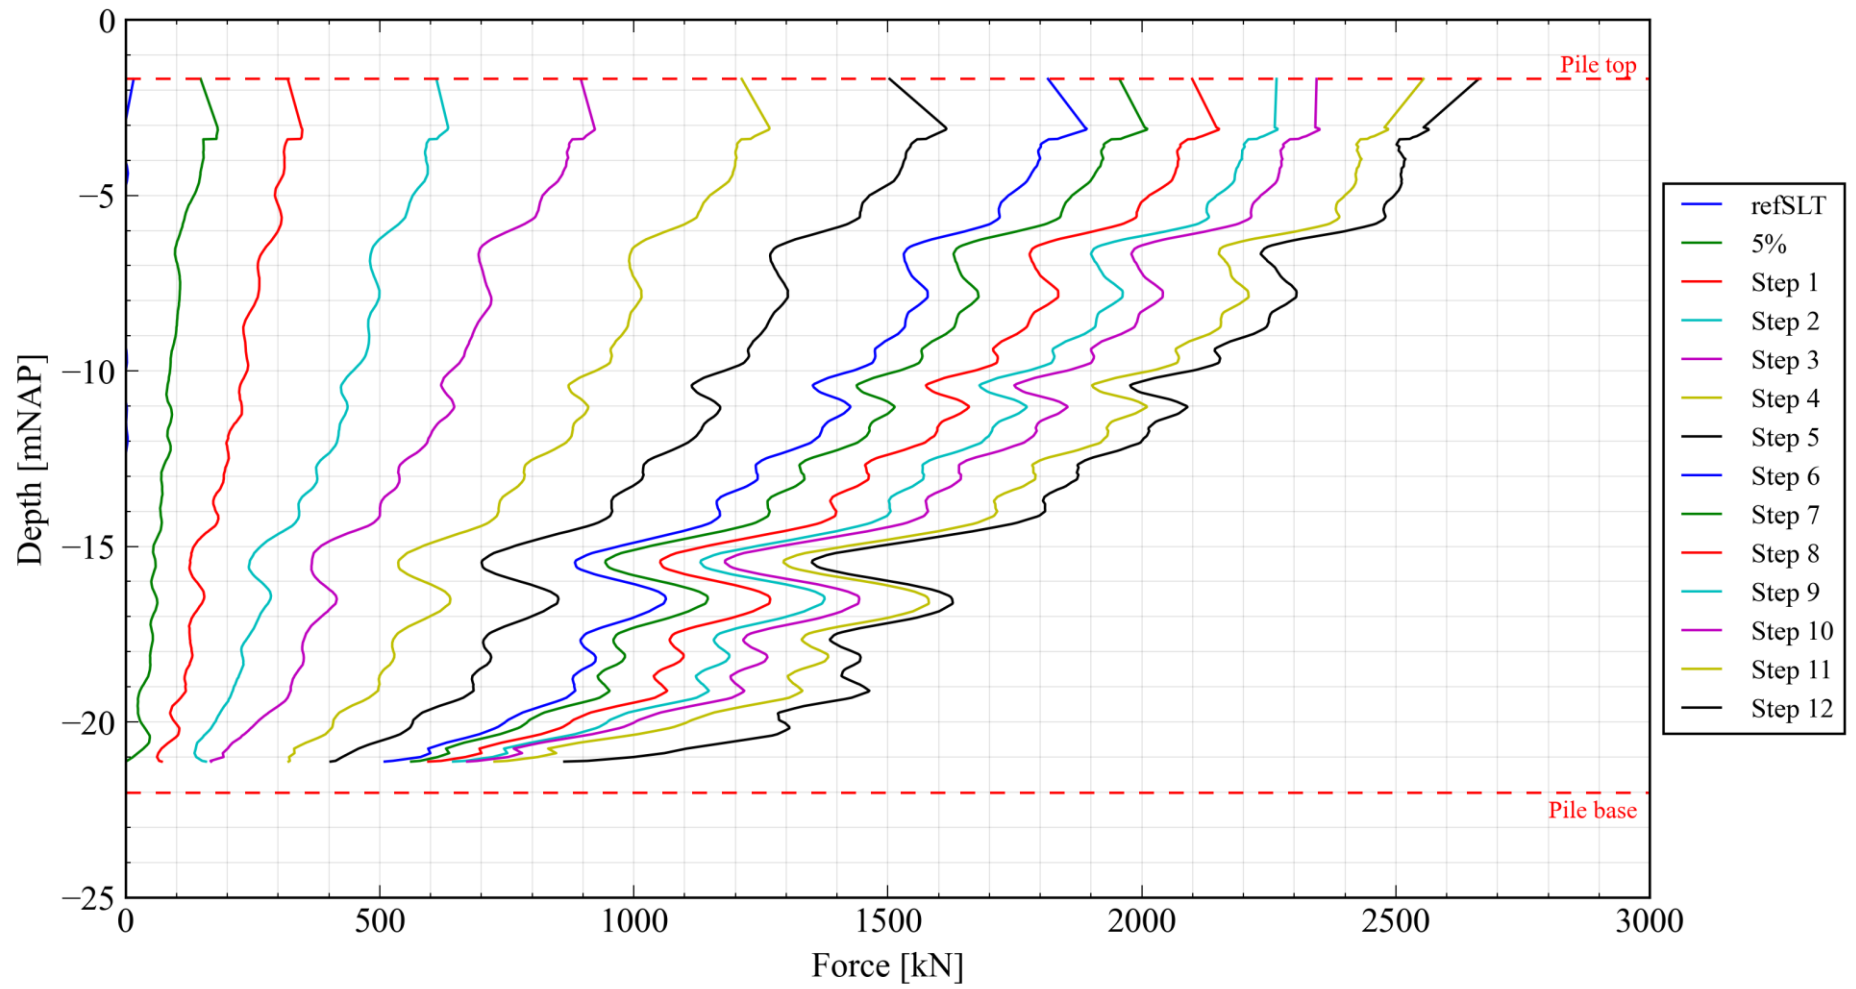
Figure 5.27: Normal force measurements in pile F1 at the end of each load step, including the load measured by the load cell. For more details on strain-to-force conversion, see Section 6.1

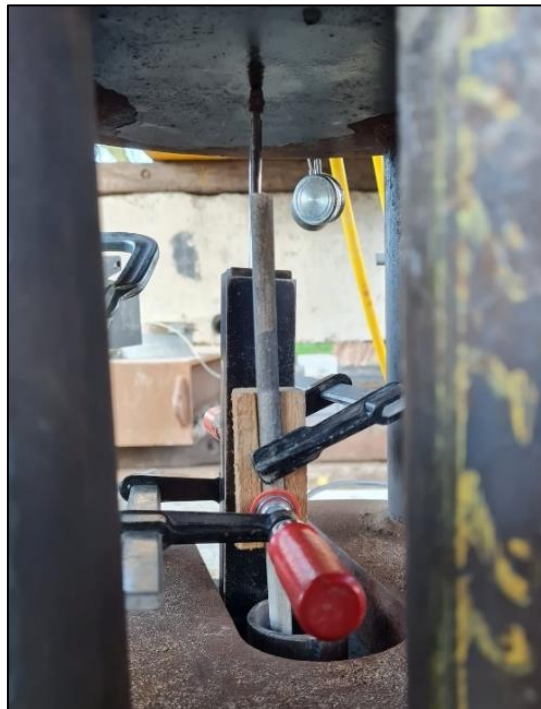
Figure 5.28: Placement of the telltale potentiometer for pile T2. The platen is touching the top side of the transition piece

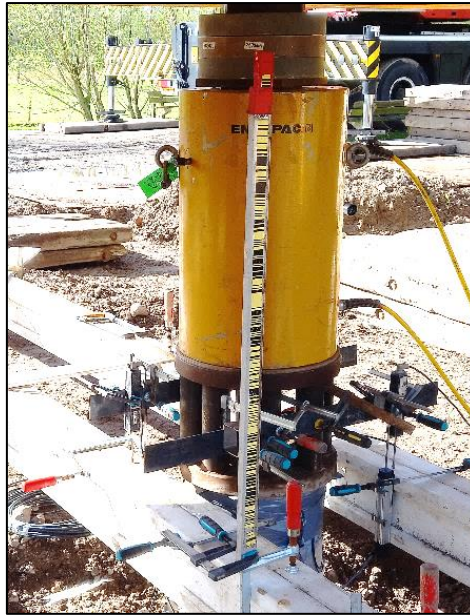
Figure 5.29: Northern-western side of pile T2, with additional potentiometers on the south-eastern side (left) and north-western sides (right)

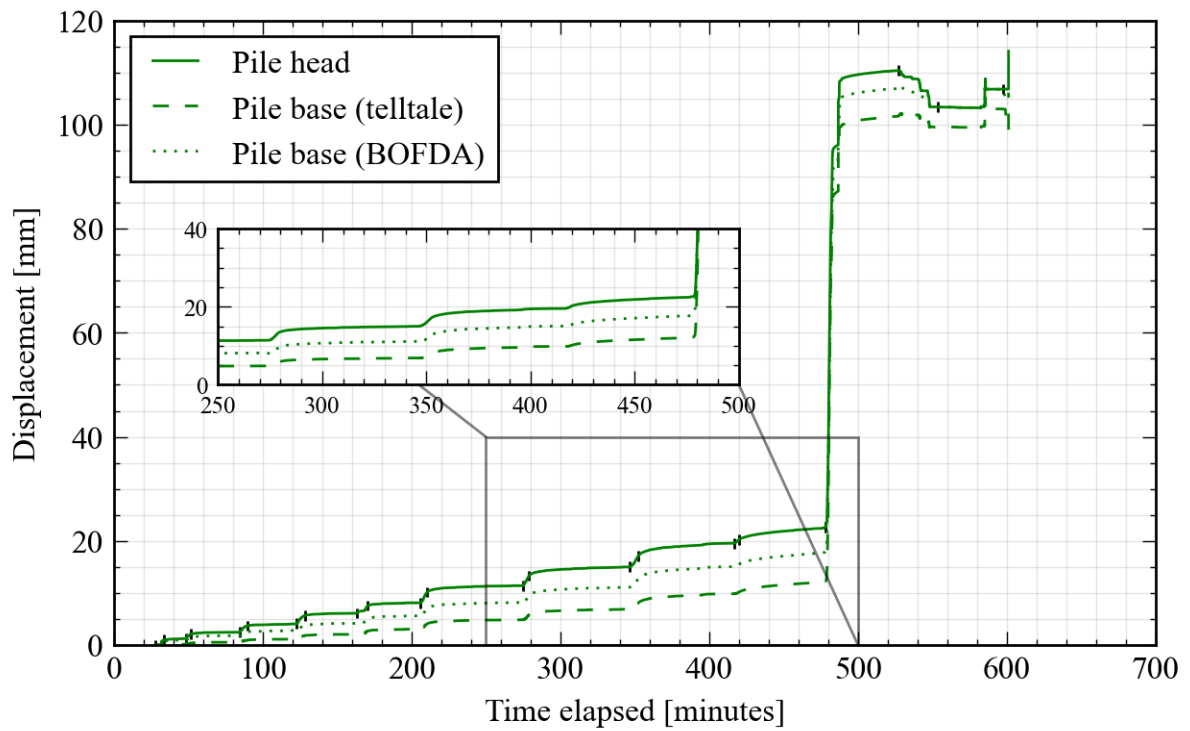
Figure 5.31: Plot of settlement measured at the pile head against the time elapsed for T2

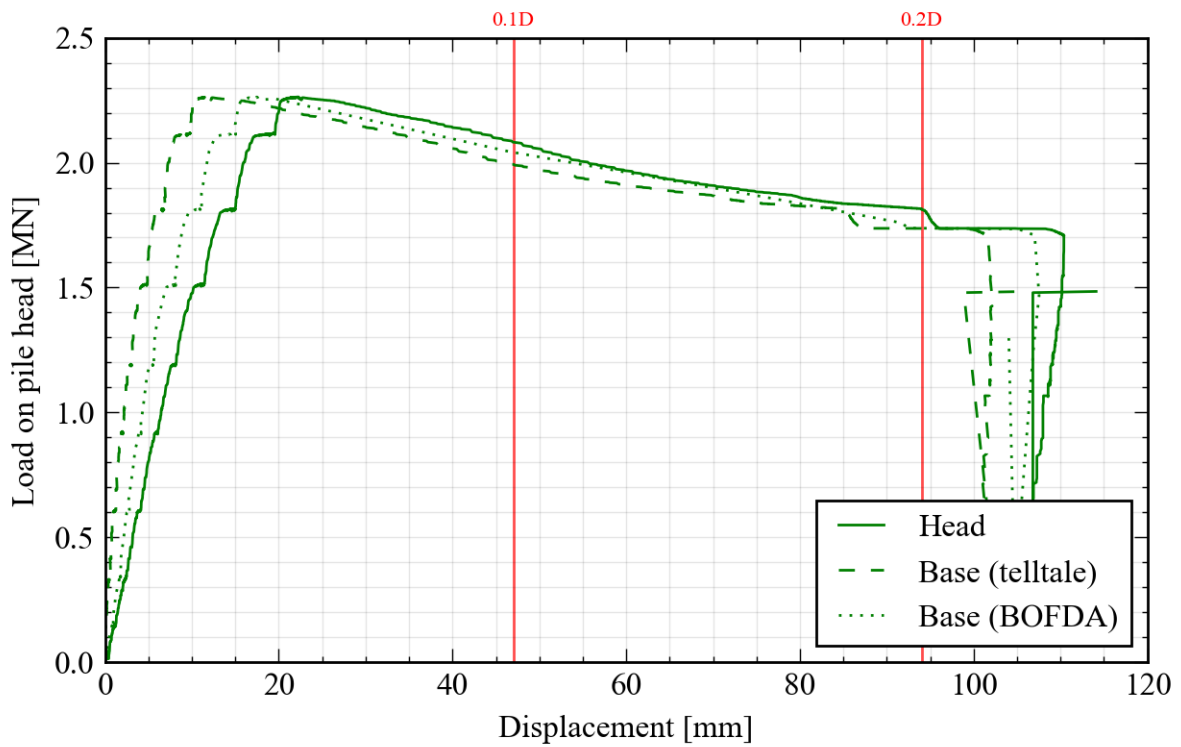
Figure 5.35: Plot of load versus settlement at pile head for T2

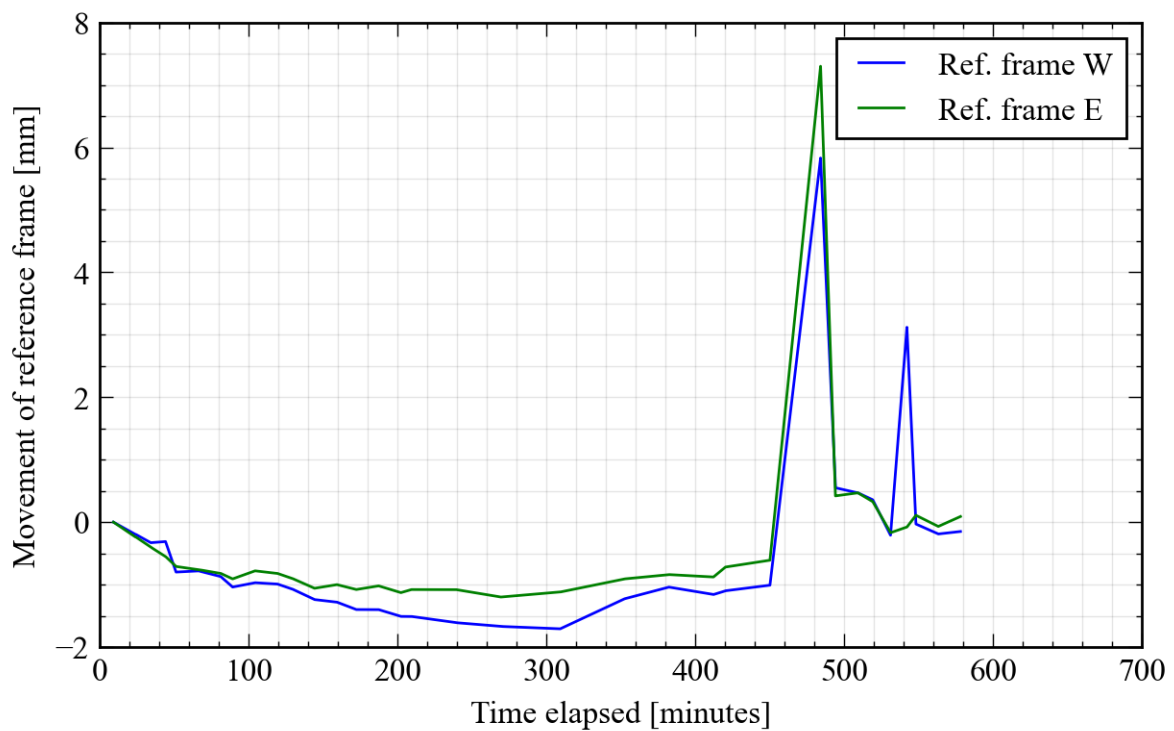
Figure 5.39: Measurements of the reference frame during the test on pile T2. The abrupt peak in the measurements corresponds to the sudden failure of the pile during Step 8

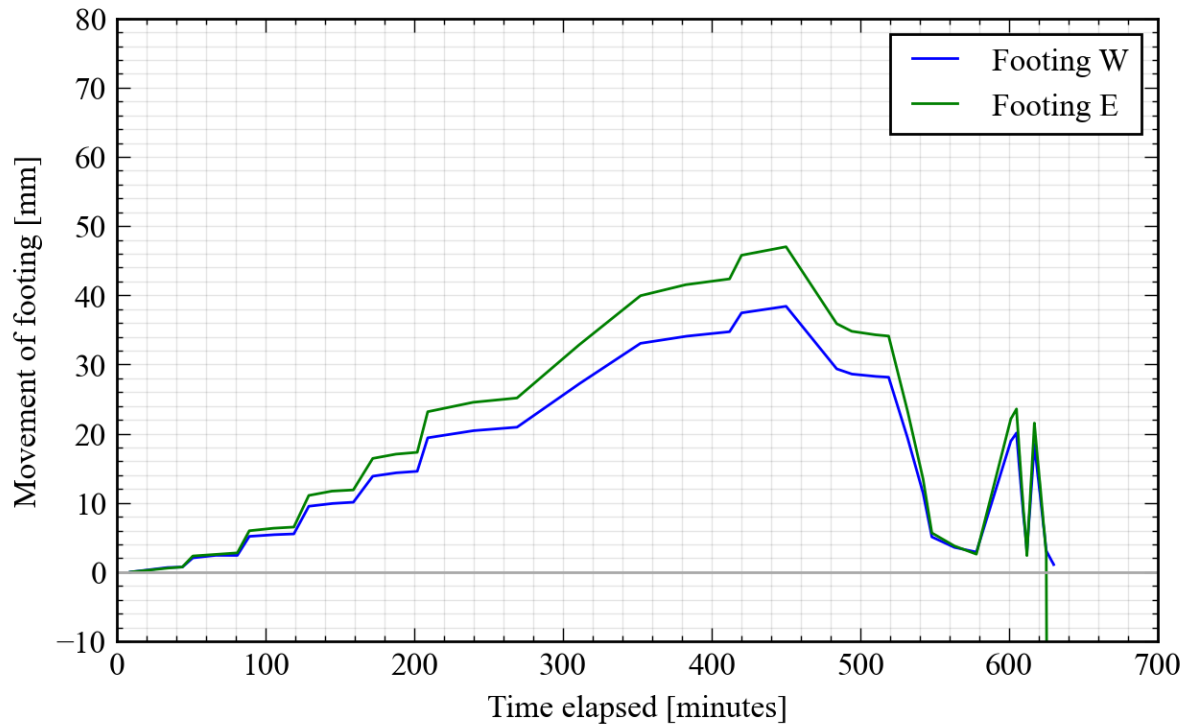
Figure 5.40: Measurements of the test frame footings during the test on pile T2. Positive sign indicates upward movement

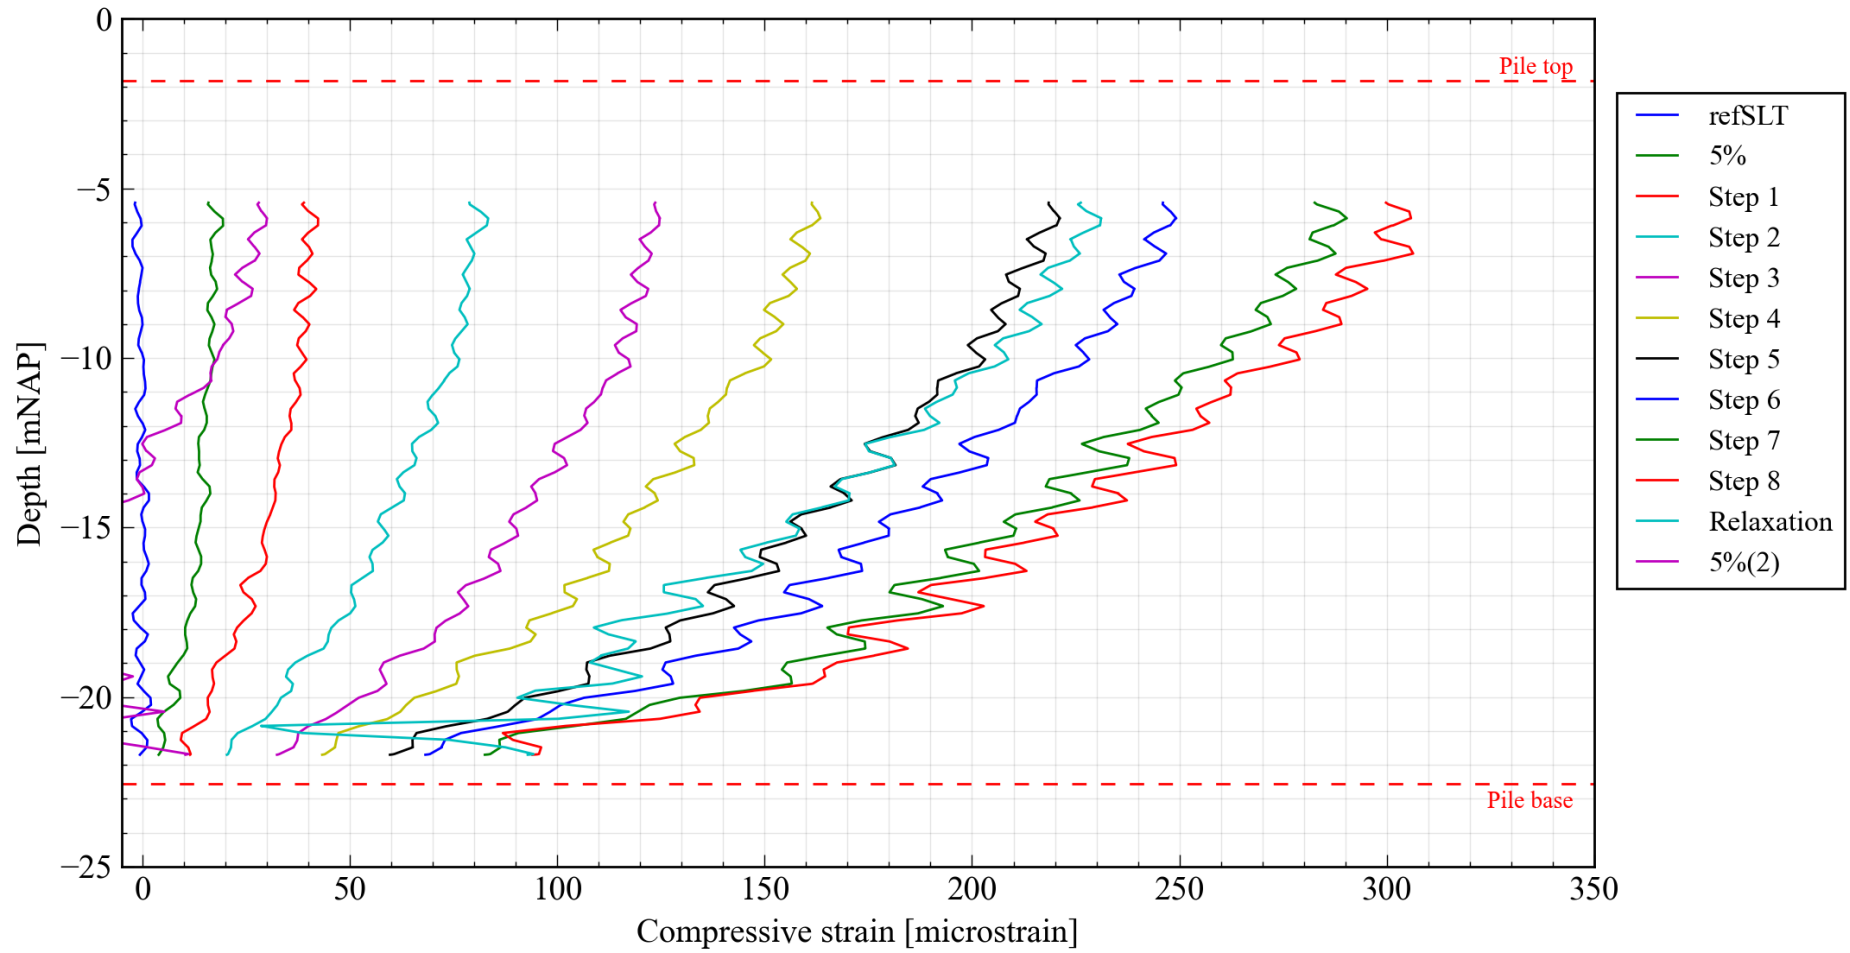
Figure 5.41: Strain measurements in pile T2 over the course of the load test. Noisy strain readings are evident in the lower sand layer (NAP -17m onwards) at the end of the Relaxation load step

Based on the interpretation of the load distributions (**Figure 5.41**, Section 6.2), it was later found that structural failure in the grout shell in the lower sand layer, manifesting in a loss of load transfer to the lower sand layer during subsequent reloading cycles.

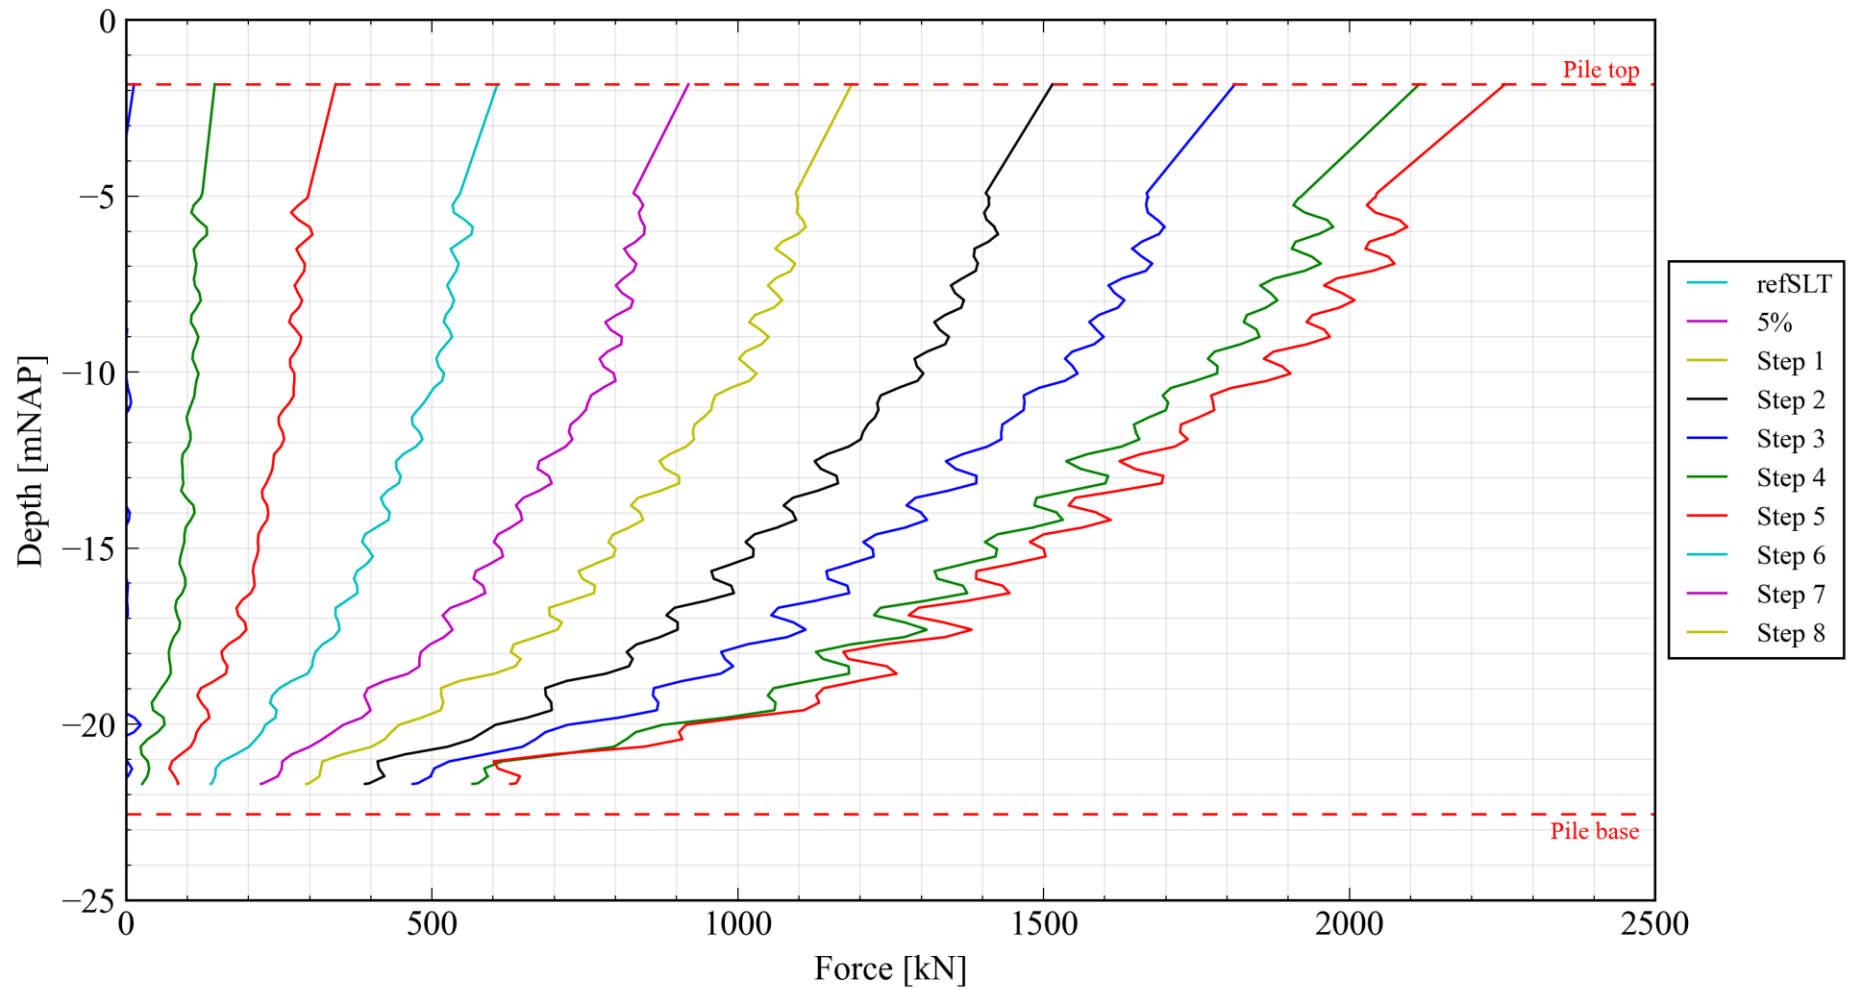
Figure 5.42: Normal force measurements in pile T2 at the end of each load step, including the load measured by the load cell. For more details on strain-to-force conversion, see Section 6.1

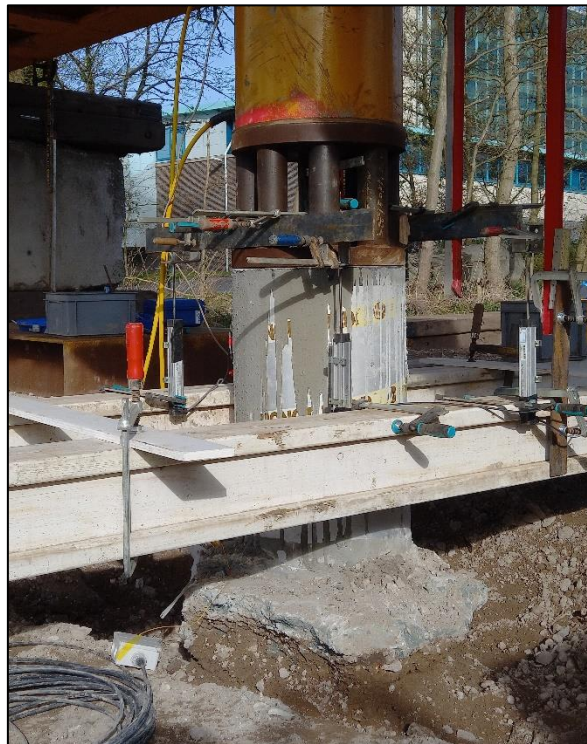
Figure 5.43: Pile F2 prior to testing. Note the grout shell at the base of the pile cap

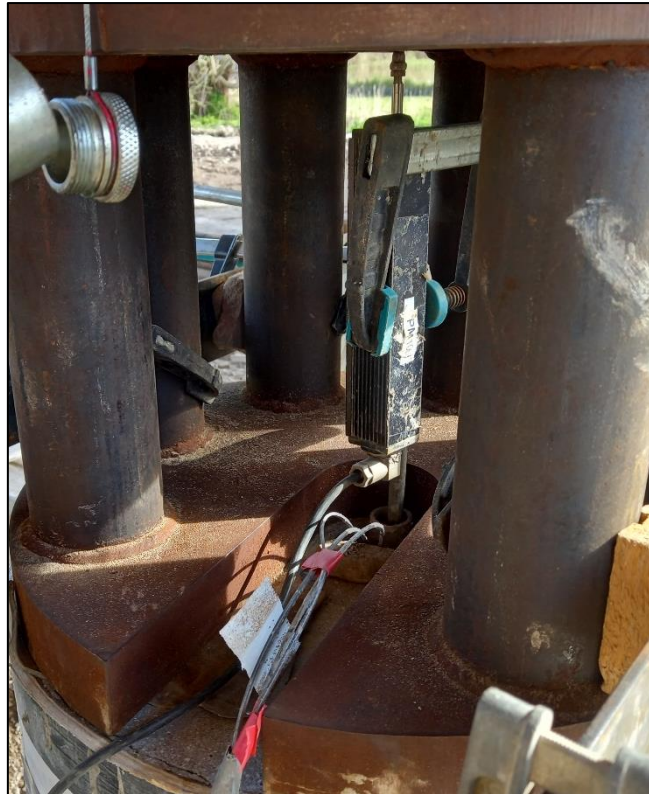
Figure 5.44: Placement of the telltale PM for pile F2. The platen is touching the top side of the transition piece

Similar to the test on pile T2, the telltale potentiometer was placed upside-down with the tip placed underneath the topside of the transition piece (**Figure 5.28**). This was due to the lack of space for the platen on the upper surface of the pile head.

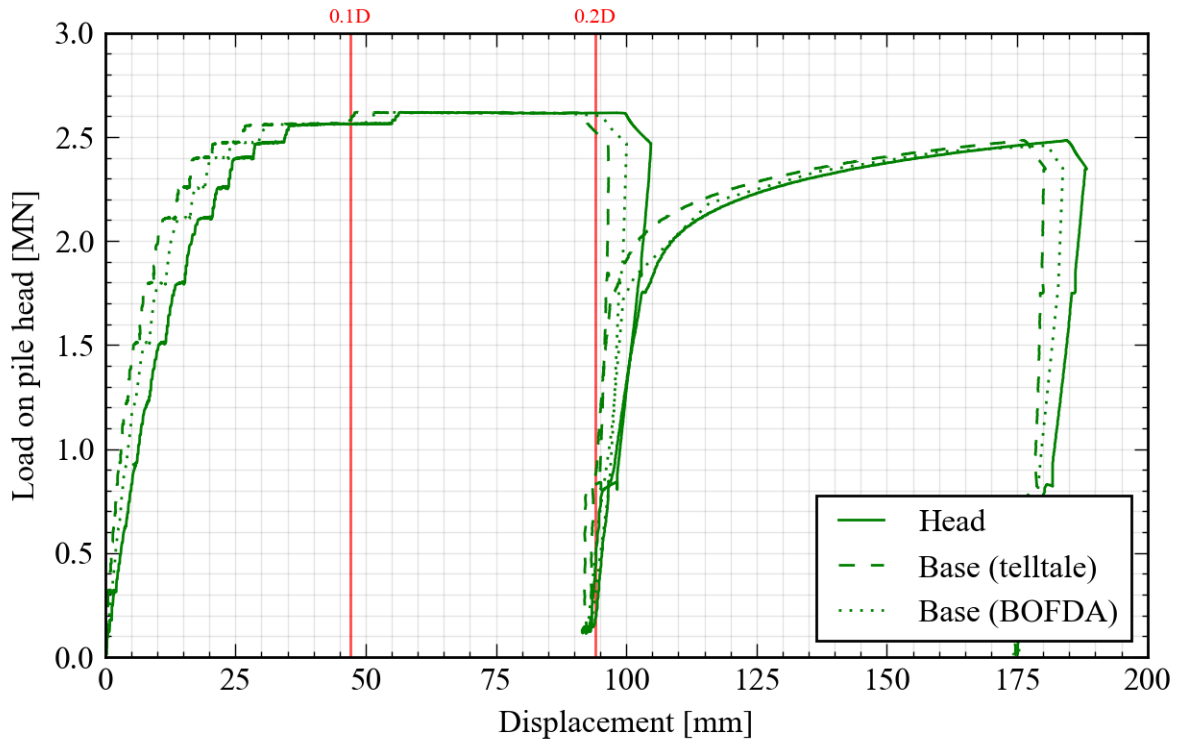
Figure 5.49: Plot of load versus displacement at pile head for F2

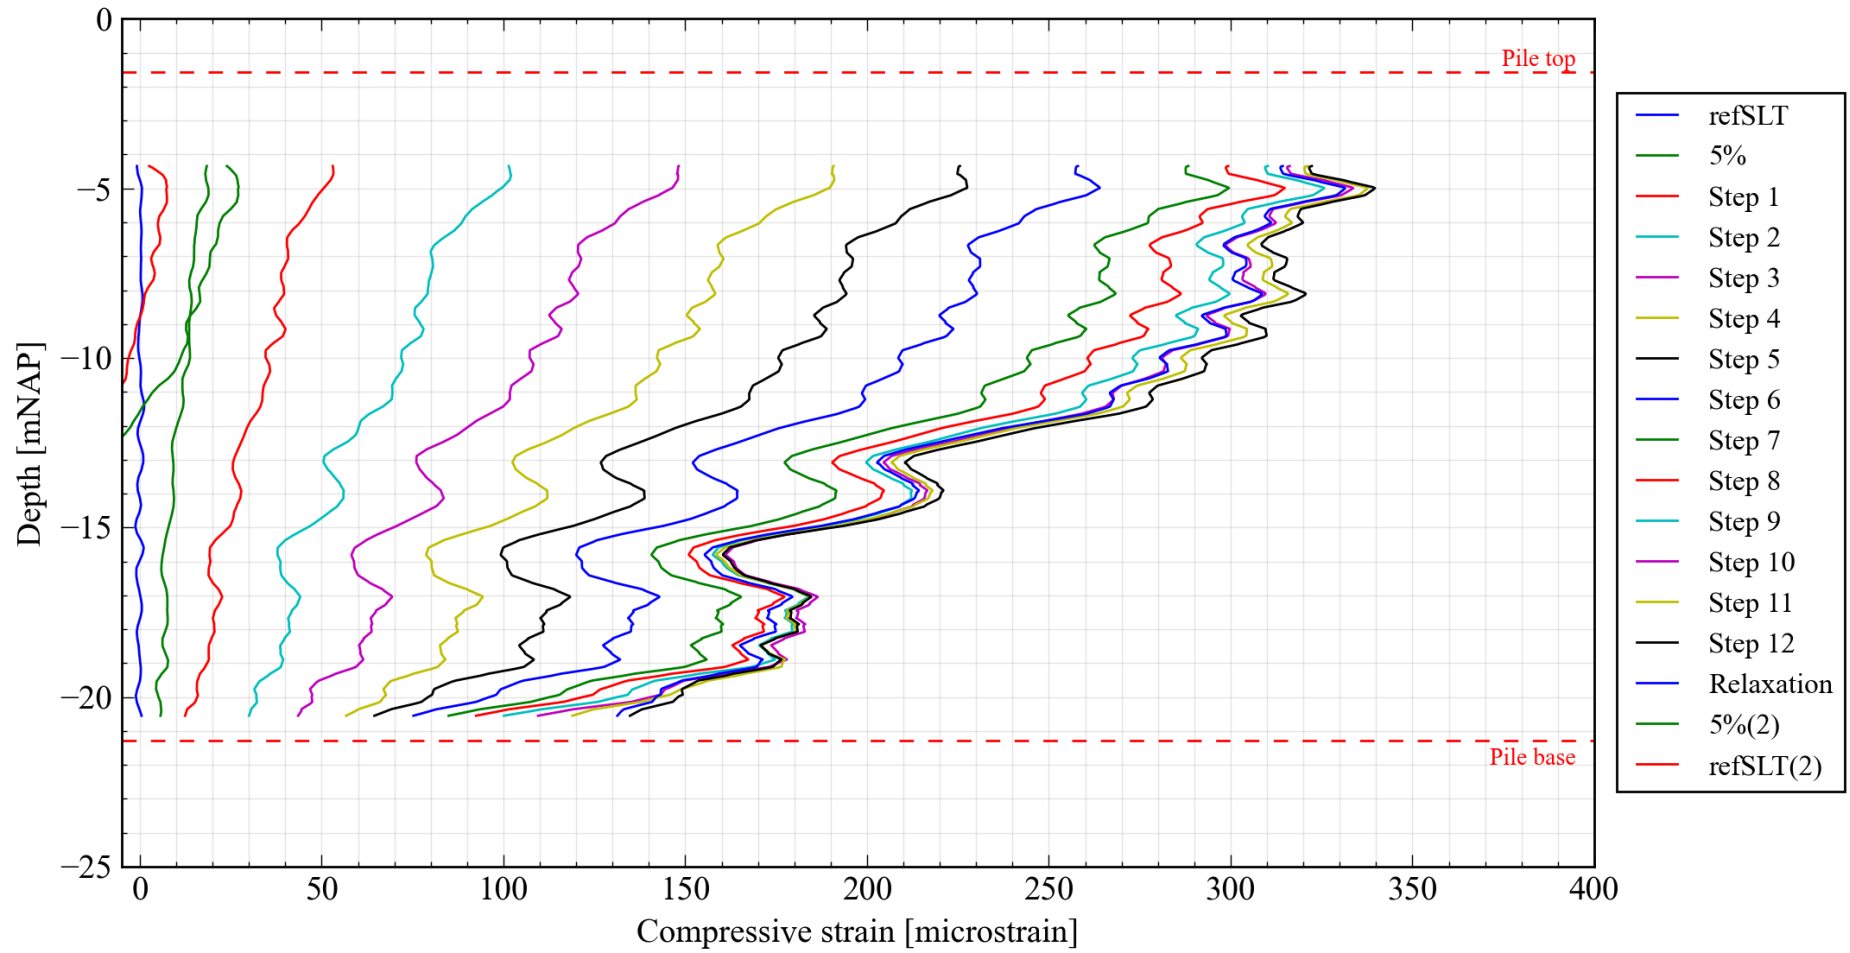
Figure 5.55: Strain measurements in pile F2 over the course of the load test

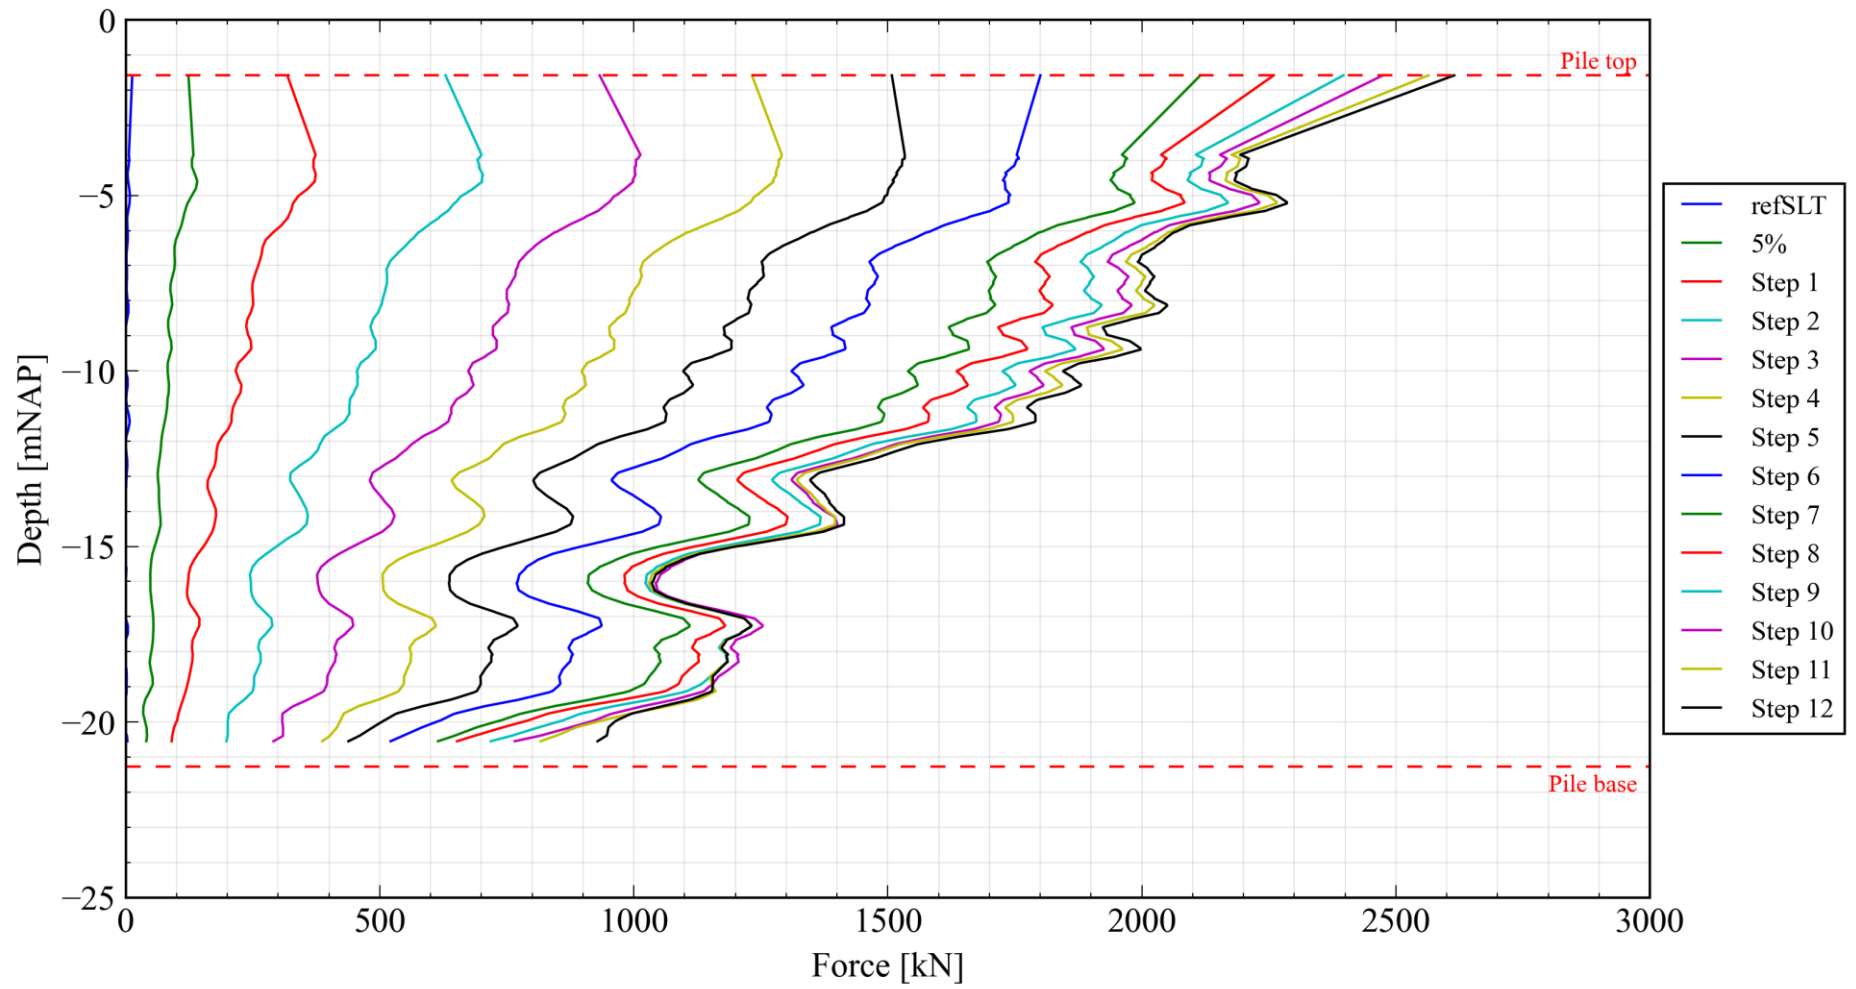
Figure 5.56: Normal force measurements in pile F2 at the end of each load step, including the load measured by the load cell. For more details on strain-to-force conversion, see Section 6.1

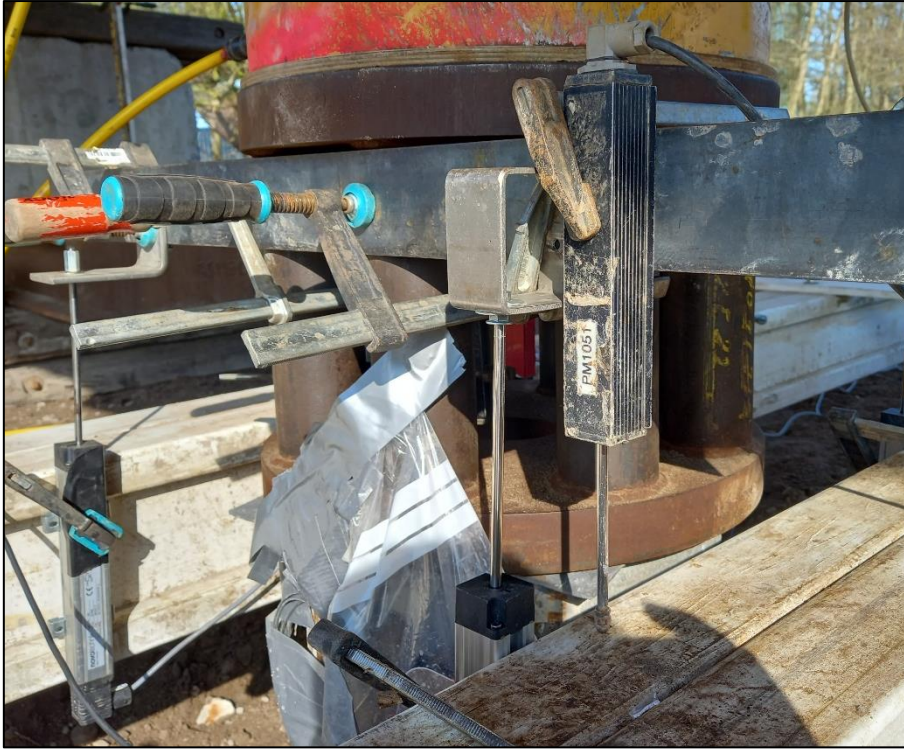
Figure 5.57: Back-up sensor PM_SE(2)

Prior to load testing, it was realised that internal issues relating to PM_SE was leading to noisy measurements. An additional sensor PM_SE(2) was placed as a back-up to this sensor (**Figure 5.57**). Furthermore, all potentiometers with the exception of PM_SE(2) were not automatically logging until midway through step 1. Manual readings of these potentiometers were recorded every five minutes as per testing protocol.

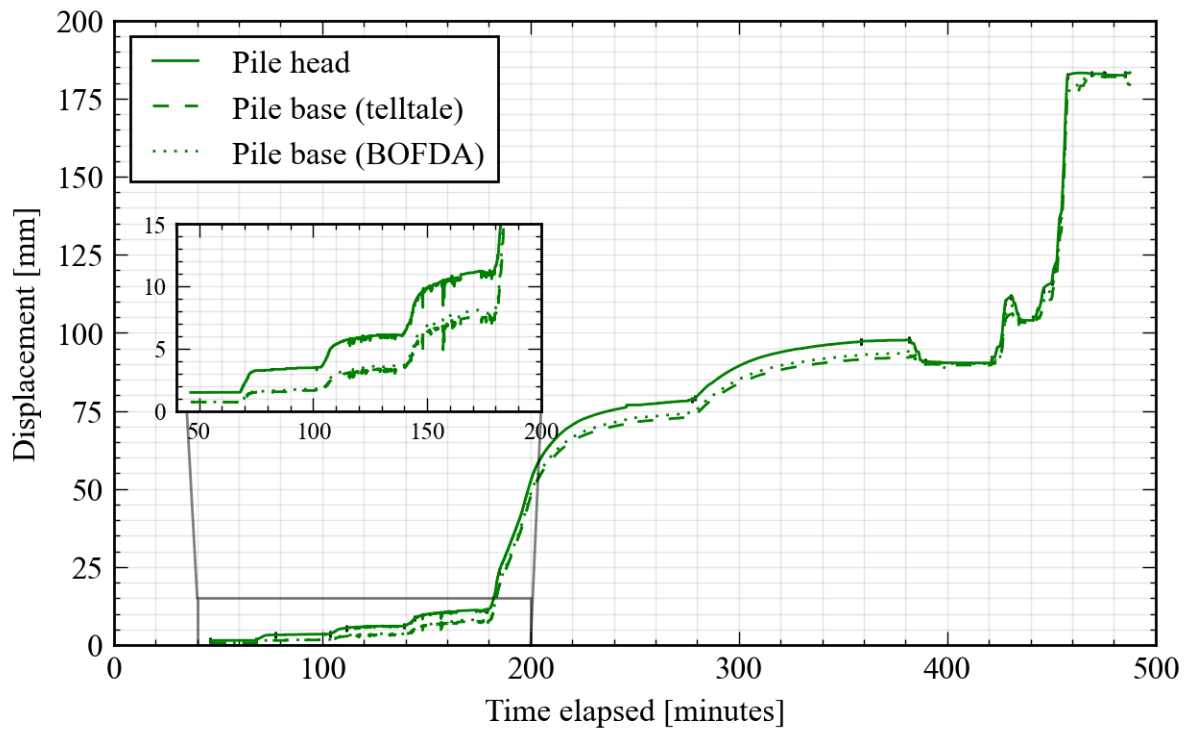
Figure 5.59: Plot of settlement measured at the pile head against the time elapsed for T3

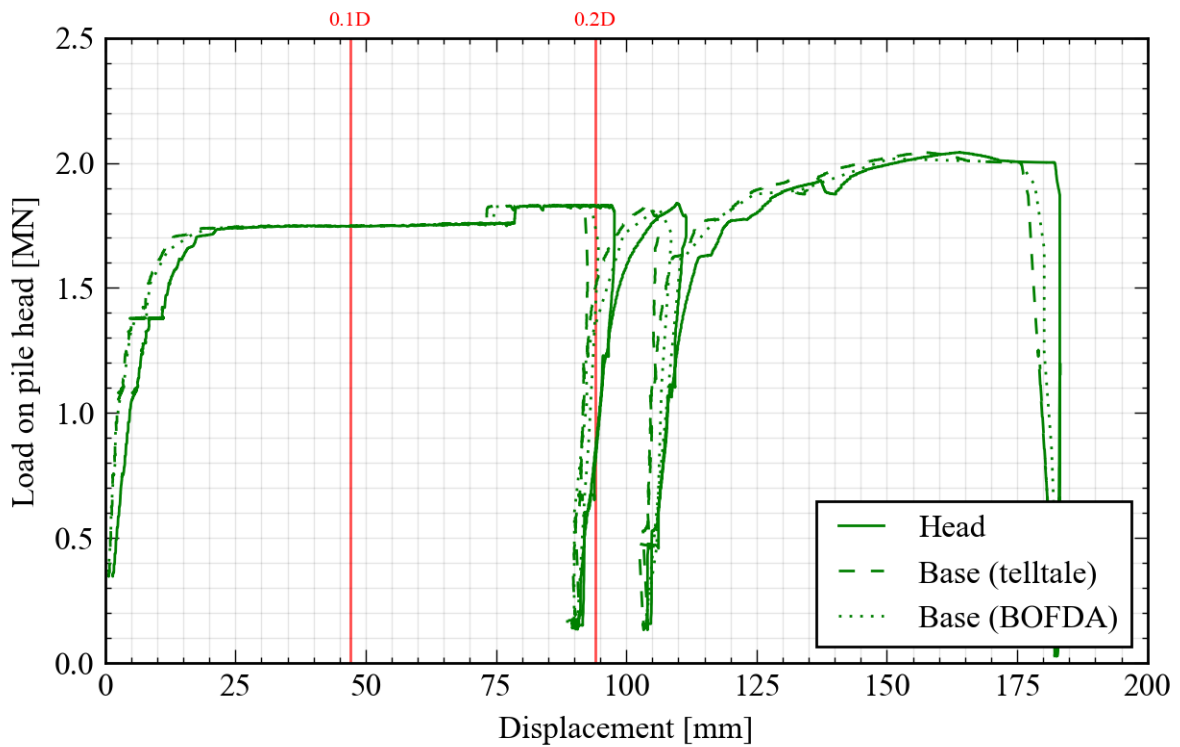
Figure 5.63: Plot of load versus displacement for T3

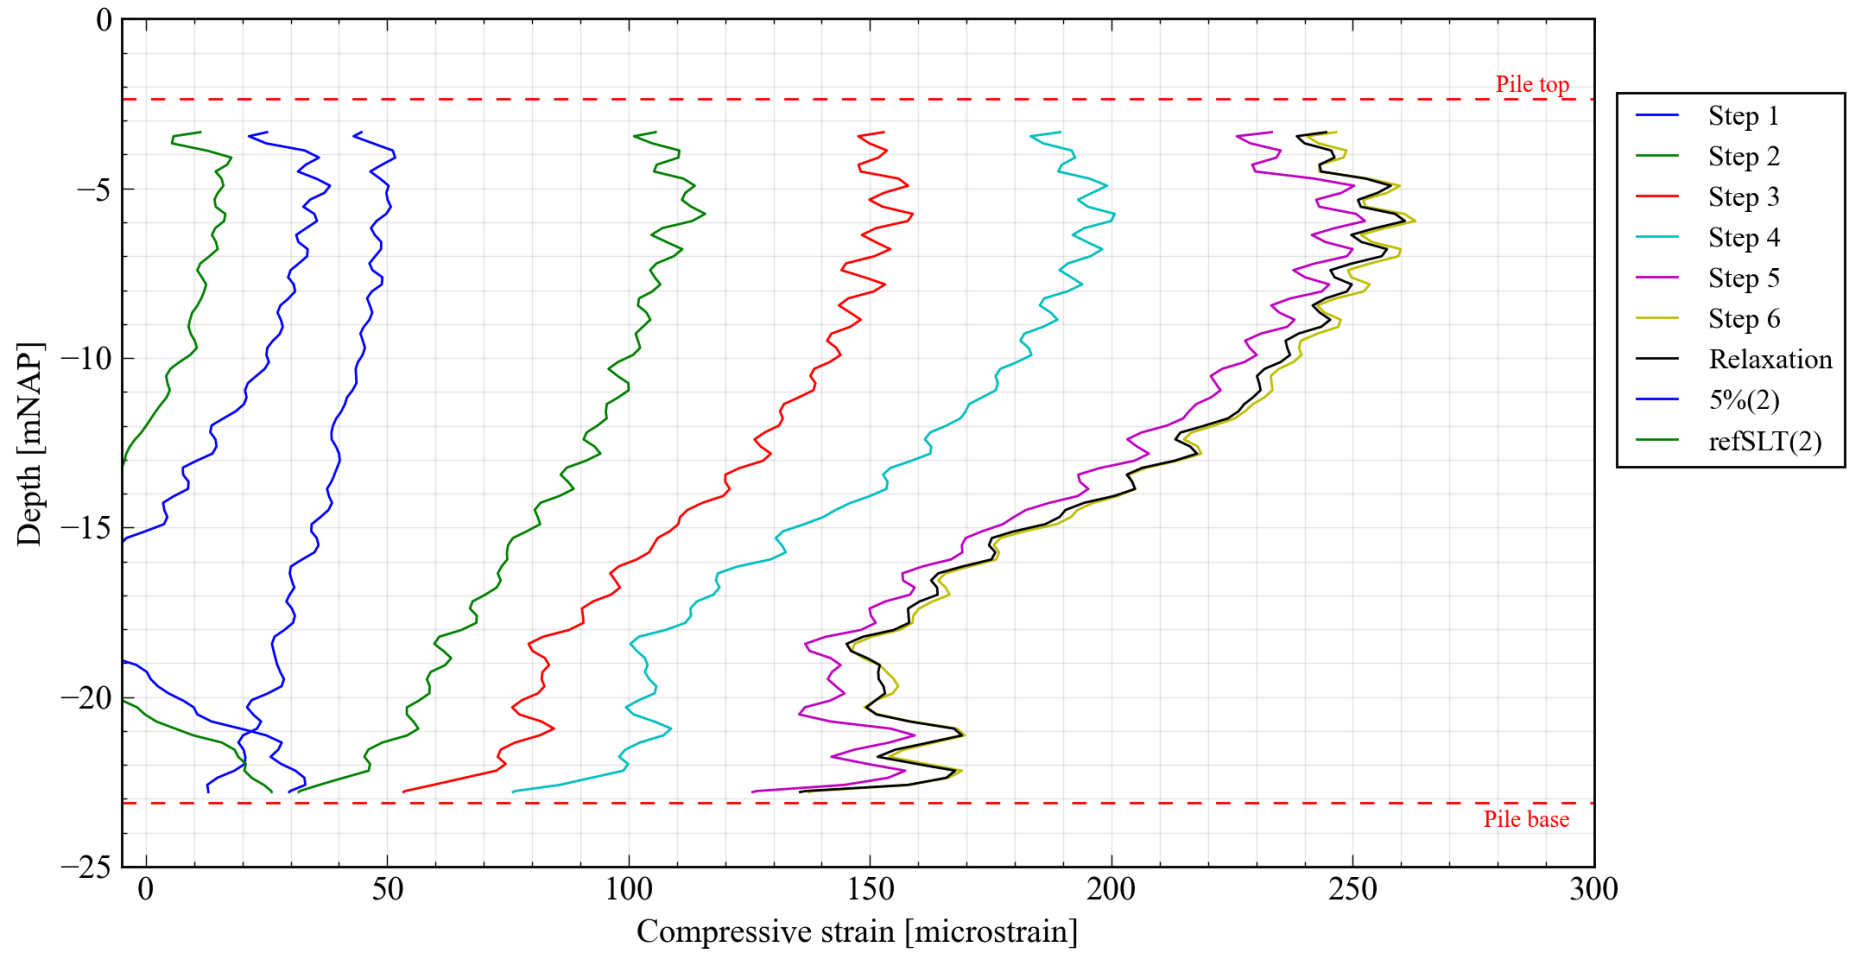
Figure 5.69: Strain measurements in pile T3 over the course of the load test

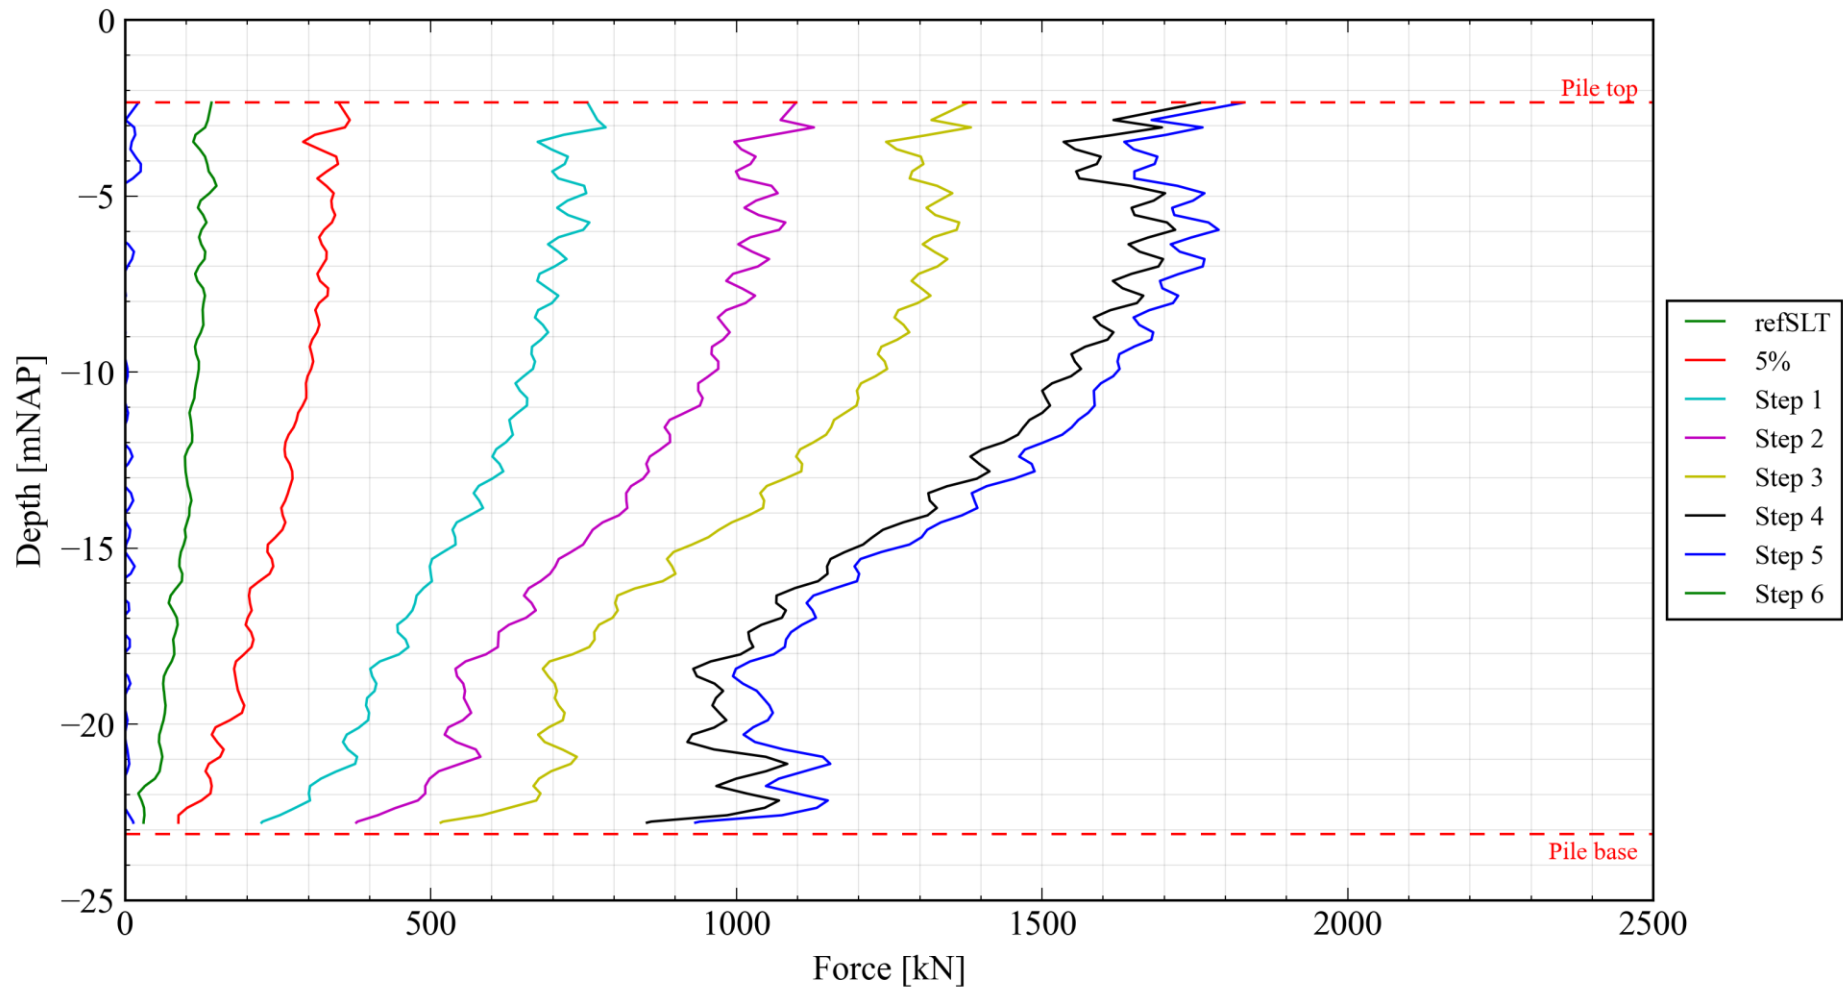
Figure 5.70: Normal force measurements in pile T3 at the end of each load step, including the load measured by the load cell. For more details on strain-to-force conversion, see Section 6.1

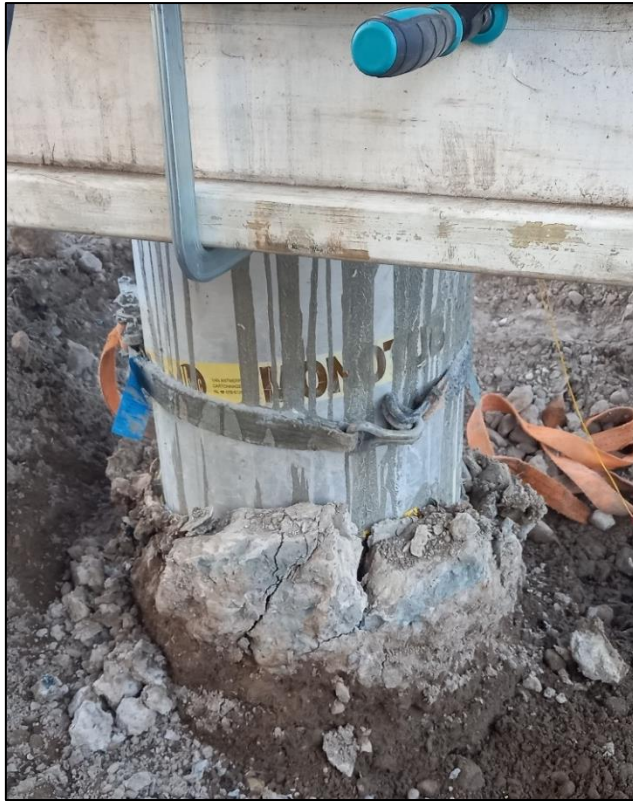
Figure 5.71: Cracked grout at pile head

At the end of the main test, during the relaxation period, cracking in the grout at the pile head was observed. This grout was readily removable.

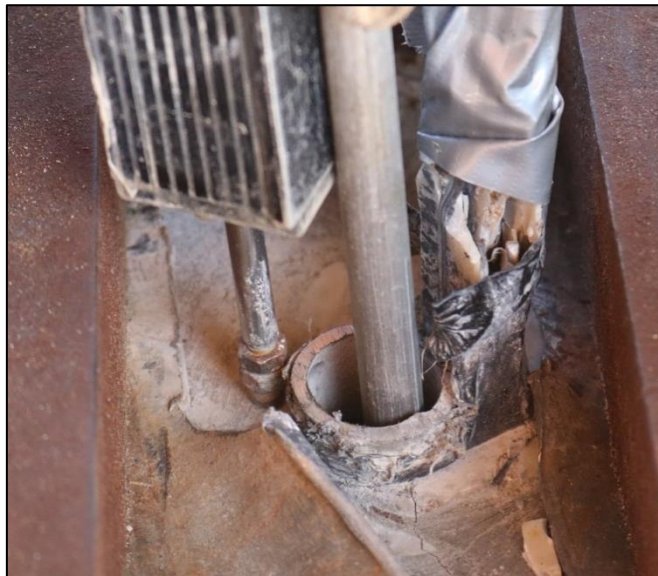
Figure 5.72: Sharp bending in the FO cable of pile F3, leading to loss in light intensity and reduction in measurement quality
