Delft screw injection pile tests factual report

Delft Screw Injection Pile Tests

Factual Report

24th November 2024

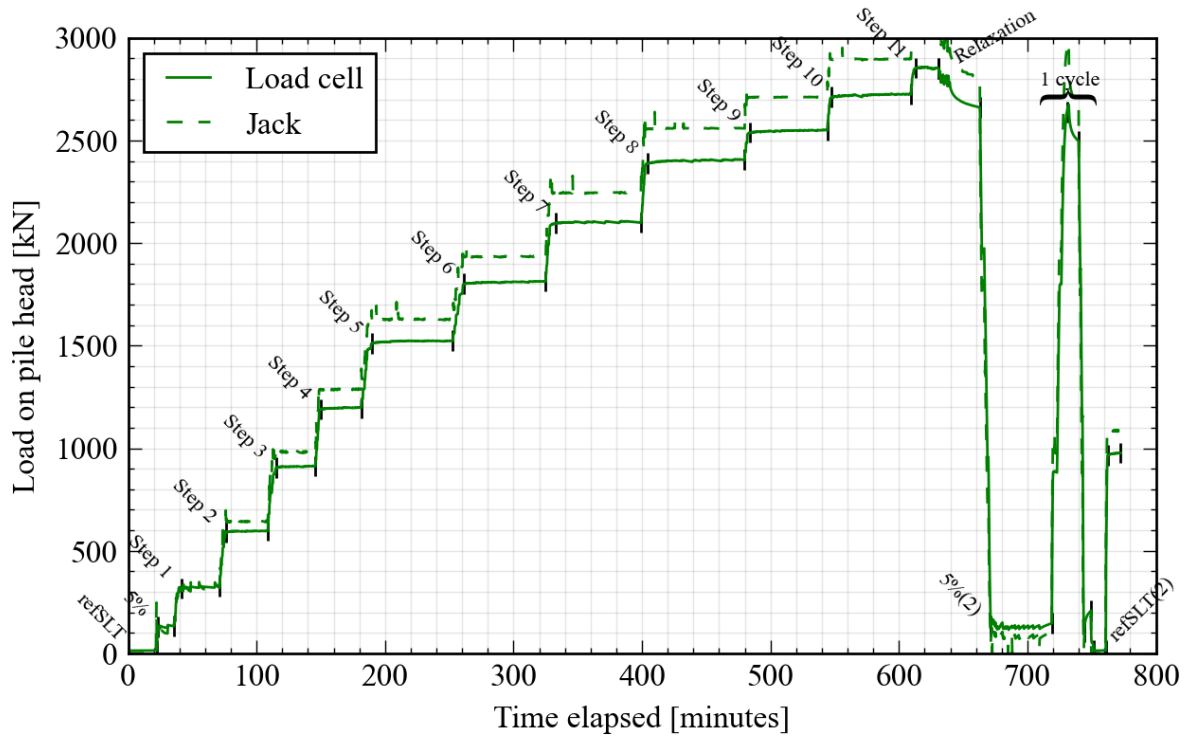
Figure 5.73: Plot of load exerted on pile head against the time elapsed for F3

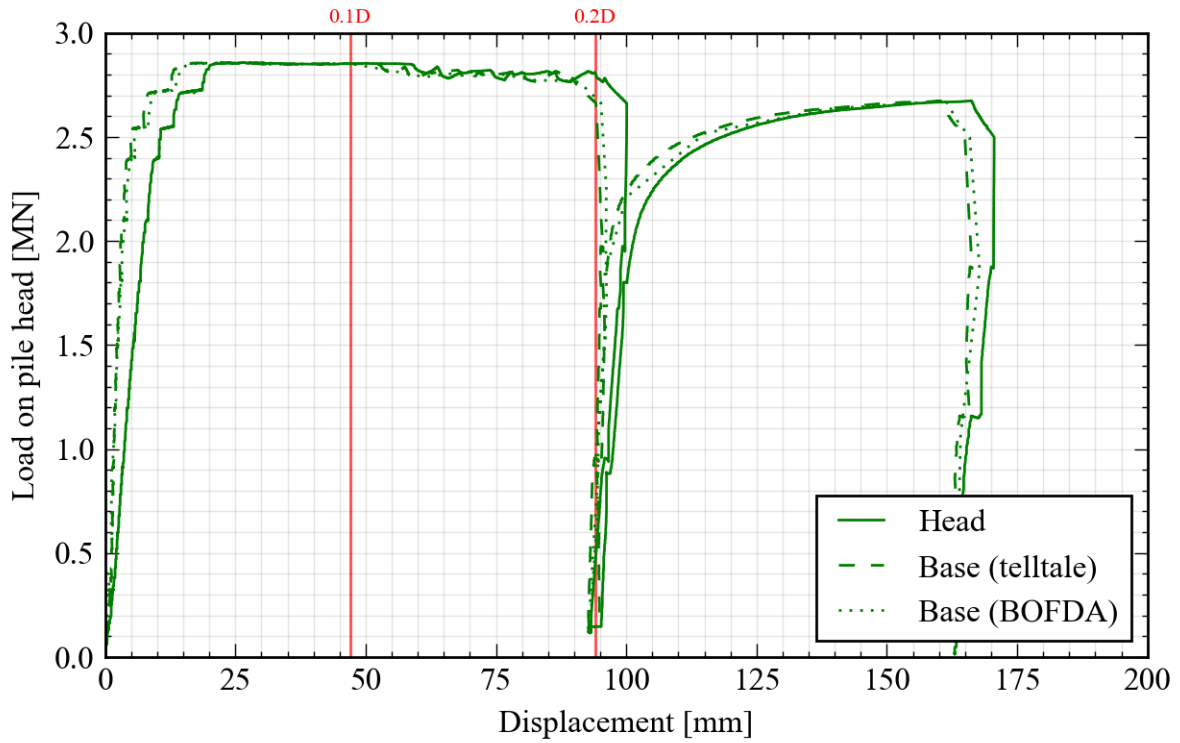
Figure 5.77: Plot of load versus displacement at pile head for F3

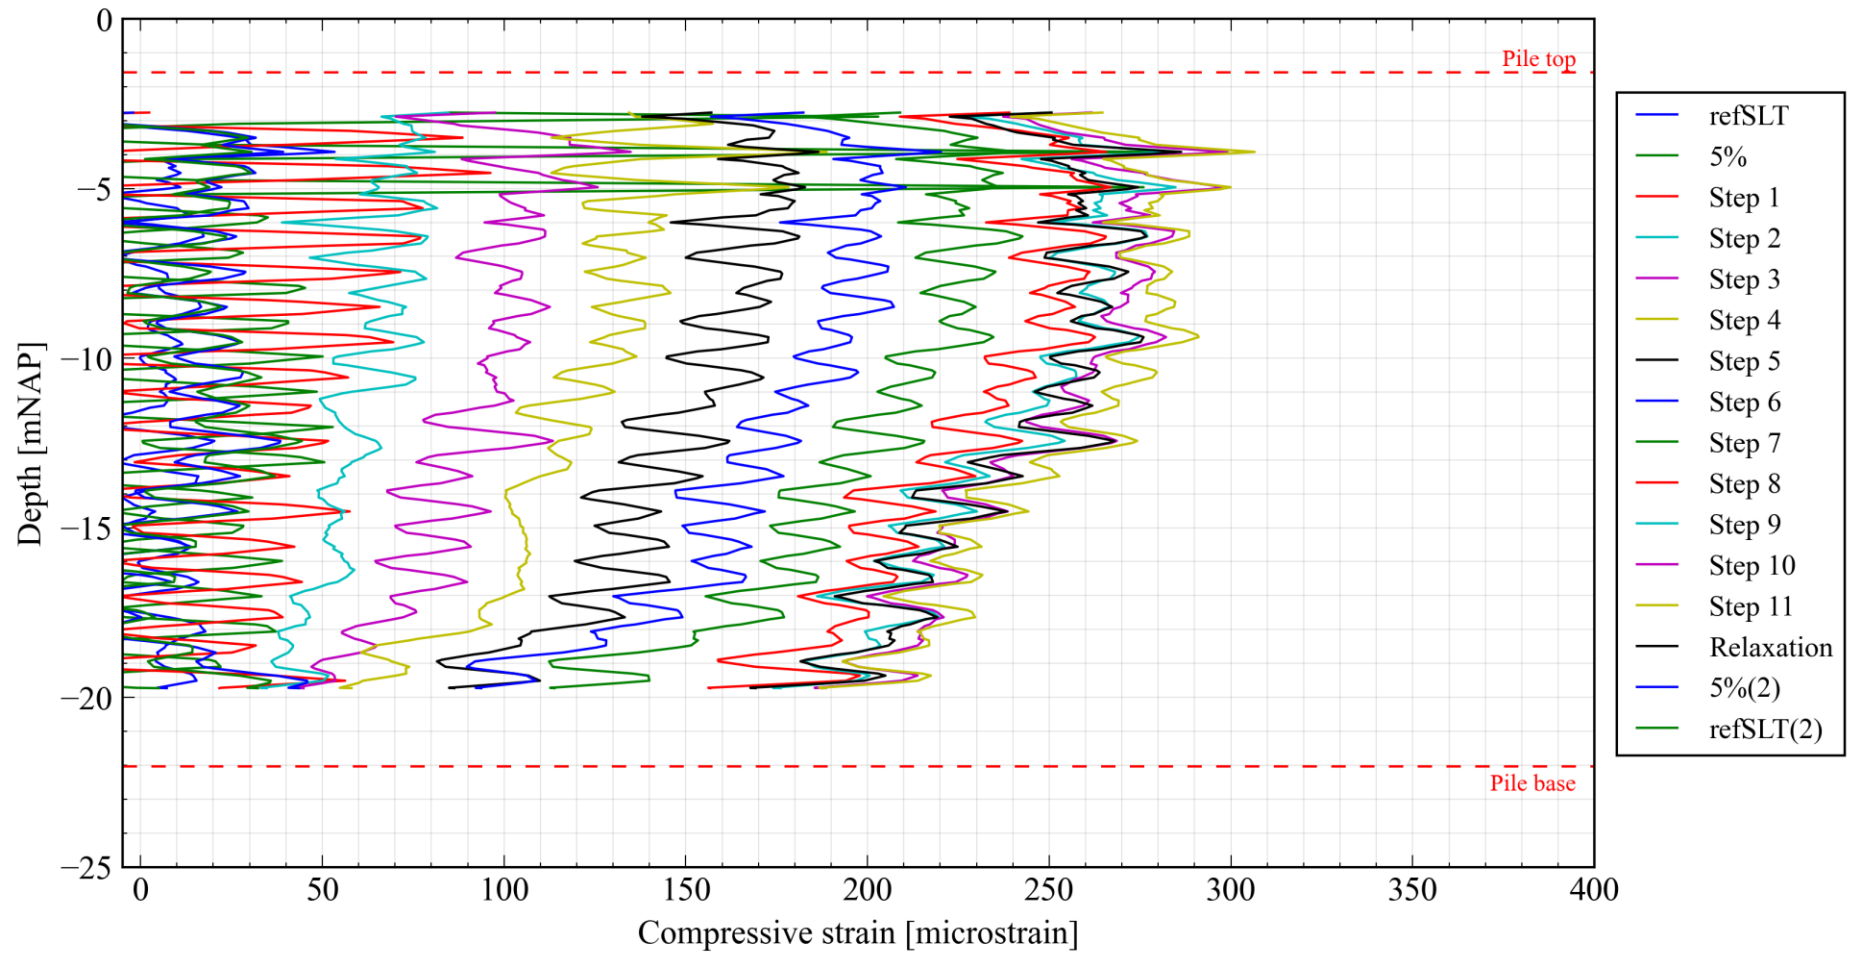
Figure 5.83: Strain measurements in pile F3 over the course of the load test (rolling average applied)

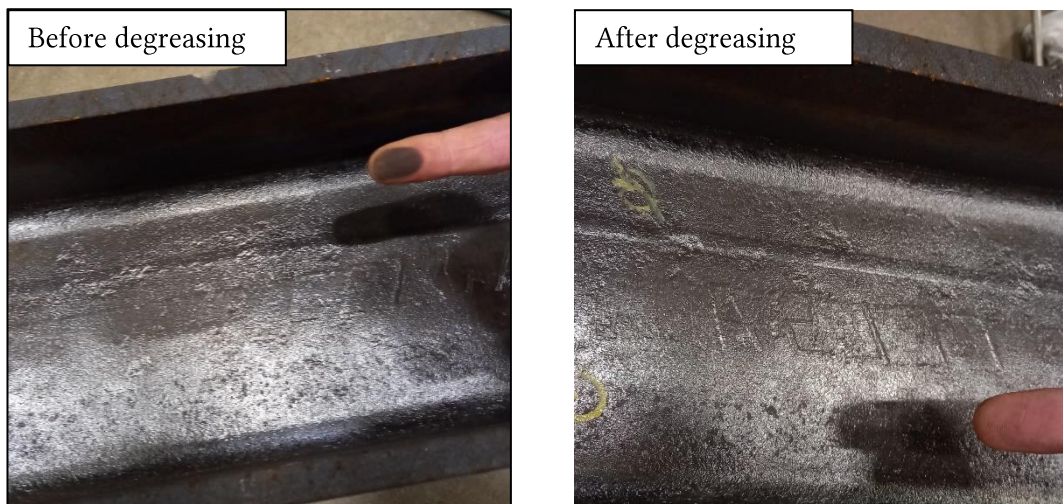
Figure 7.1: Simple finger swab of the steel reinforcing before and after degreasing and cleaning

Both the SI pile reinforcement and SIc piles were instrumented indoors in a temperature-controlled environment on the premises of Deltares. For most test sites, procuring such a site is generally quite difficult or expensive. However the benefit of an indoor environment cannot be understated. Even within the Deltares warehouse, some rusting was observed on the steel when this was left overnight, albeit to a very small degree. In outdoor environments, the extent of steel corrosion will inevitably be much greater and so repeated scouring of the steel will need to be performed to remove this. Morning dew or rain will also significantly reduce the adherence of the glue, so maintaining a dry environment on-site is crucial and at the same time challenging.

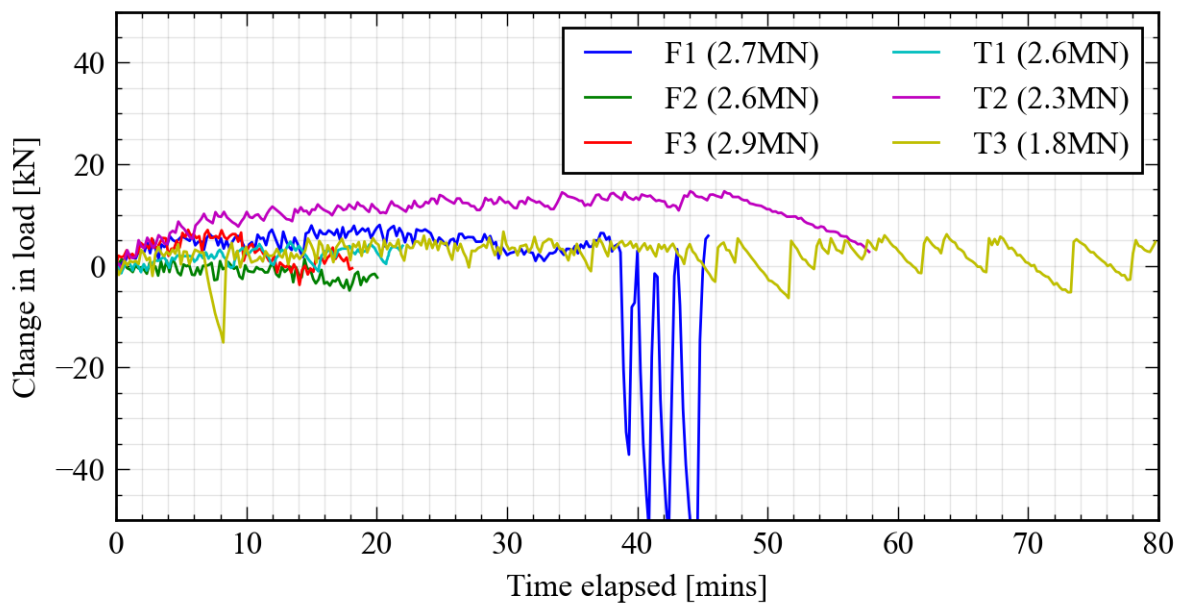
Figure 7.3: Comparison of the change in applied load at the final load step prior to failure

With the exception of the latter stages of pile F1, the load steps have been executed within the 1% margin of error prescribed by NPR 7201 (**Figure 7.3**). This is primarily a concern at load steps close to failure.

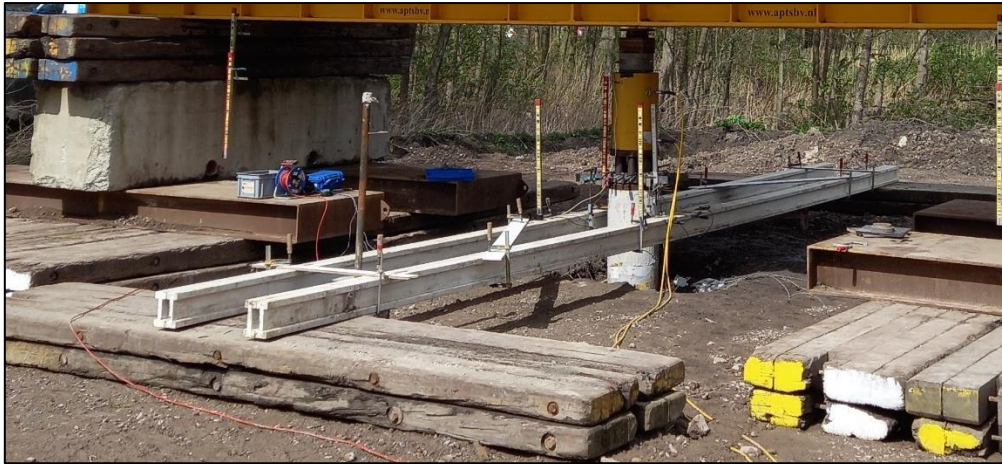
Figure 7.5: Reference frame, resting on dragline mats, each 5.5m away from the pile

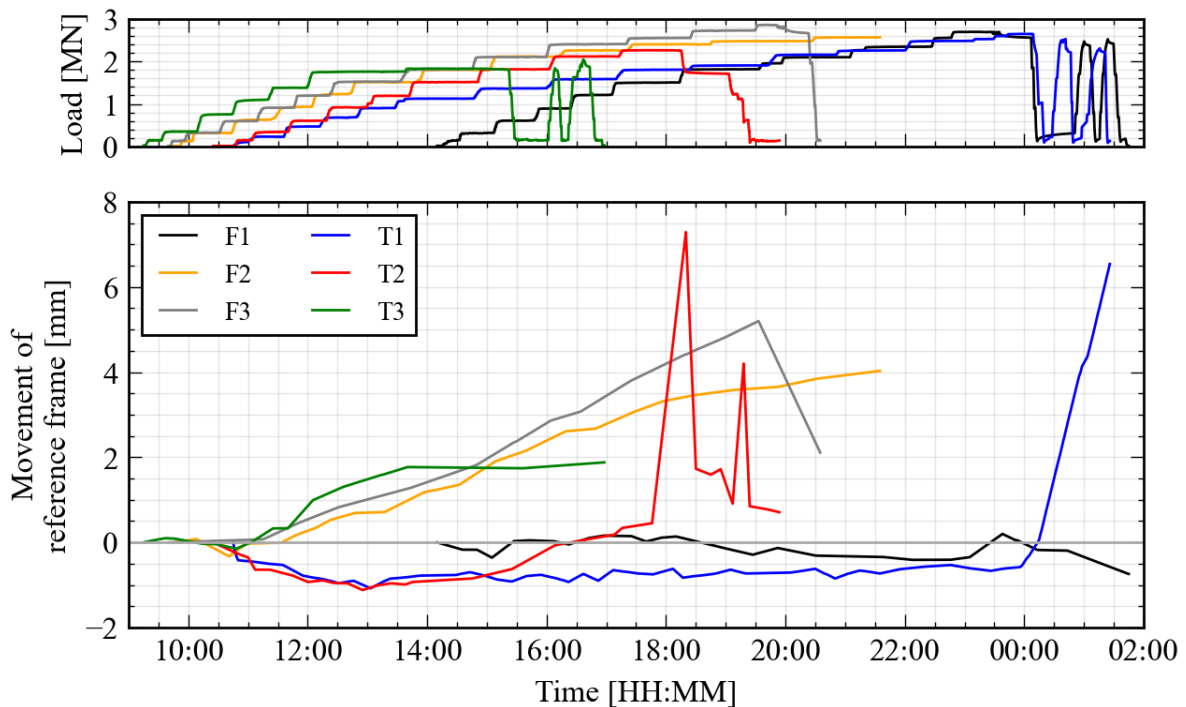
Figure 7.6: Movement of the western reference frame across all piles, compensated by relative movement between the levelling stations and the reference point

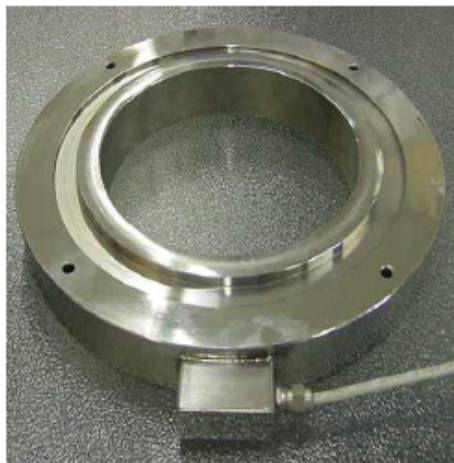
D.1 Calibration Sheet: Load Cell

Dati Tecnici	Specifications	
Portate	Capacity	300 + 2500 kN
Sensibilità nominale	Nominal Sensivity	2,0 mV/V +/- 0,1 %
Coeff. Temperatura di zero	Zero temperature coeff.	± 0,005 %F.S /°C
Coeff. Temperatura di F.S.	Span temperature coeff.	± 0,005 %F.S /°C
Errore combinato	Combined error	± 0,10 % F.S.
Ripetibilità	Repeatability	± 0,02 % F.S.
Creep a pieno carico (20')	Nominal load creep (20')	± 0,03 % F.S.
Resistenza di Ingresso	Input resistance	700 ± 20 Ohm
Resistenza di uscita	Output resistance	700 ± 5 Ohm
Isolamento	Insulation	>5000 M Ohm
Alimentazione elettrica	Electrical excitation	2 + 15 Vcc/ca
Compensazione in temp.	Compensated temp. Range	-10 + +50°C
Temp. di funzionamento	Operating temp. Range	-20 + +70°C
Sovraccarico ammesso	Safe overload	150 % F.S.
Sovraccarico di rottura	Ultimate overload	>300 % F.S.
Freccia massima a carico	Deflection at rated capacity	0,4 mm
Grado di Protezione	Protection degree	IP 67

Materiale	Material	Acciaio Inox
Funzionamento	Working	Flessione

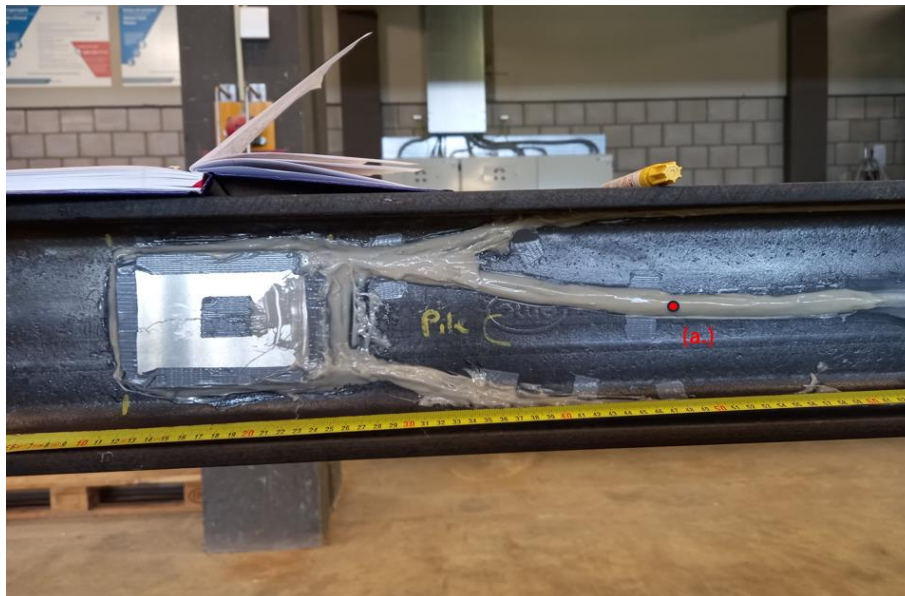
Figure E.1: Base of the H-beam reinforcing of an SI pile. Each fibre optic cable runs to the connection box where a fusion splice connects one optical fibre in the cable to the other optical fibre in the same cable. The Point (a.) is referred to as the “last gluing point” and is last reasonable axial strain measurement before the cable bends into the connection box

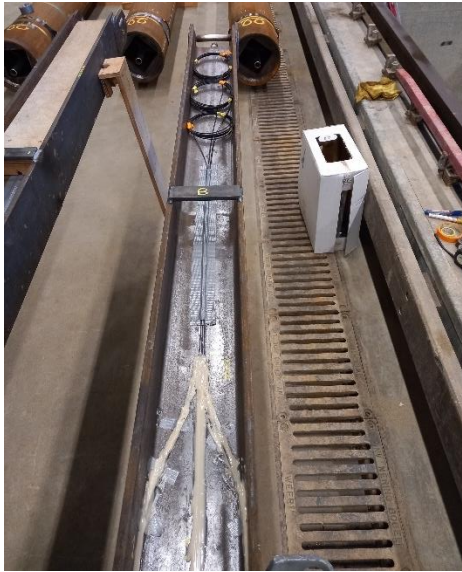
Figure E.2: Head of the H-beam reinforcing of an SI pile. The reinforcing of the SI piles had a free length of 1-2m, part of which was cut off after installation. As a result, the highest glued point of the fibre optic cables was set conservatively.

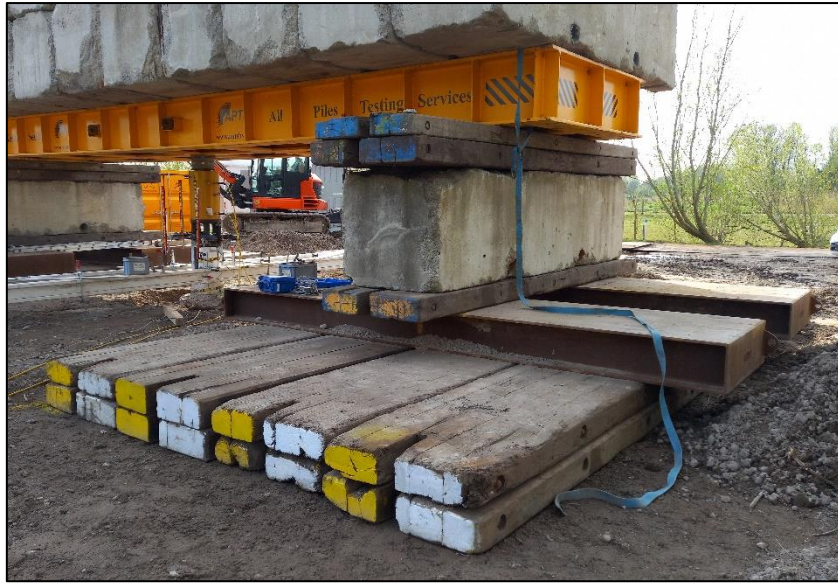
Figure E.5: Footing configuration for each test. The number of dragline mats between the concrete block and the frame was changed from test to test to ensure enough height above surface level was provided
