To detect anomalies in diaphragm walls

PROEFSCHRIFT

Rodriaan SPRUIT

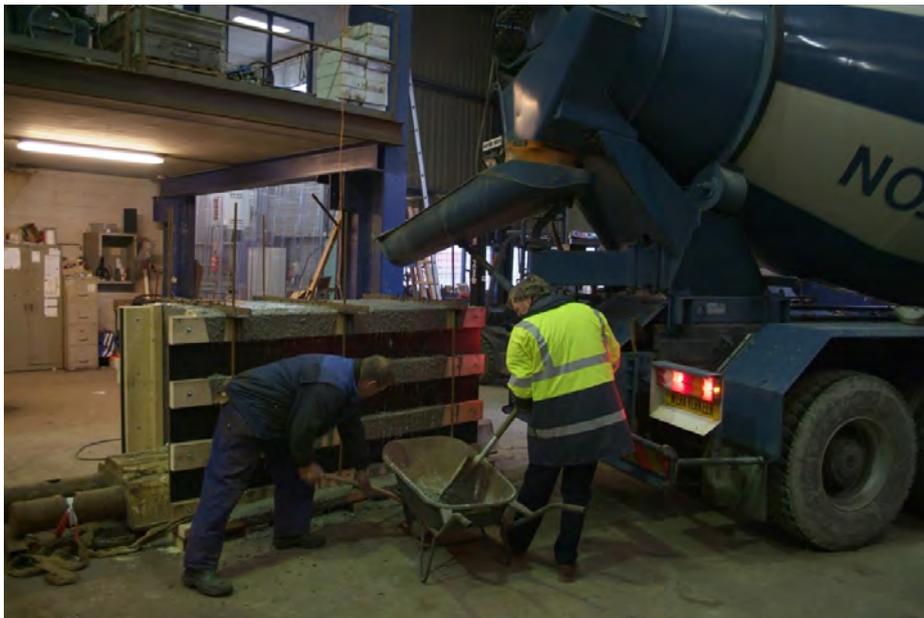
The aim of these blocks was to detect, a bentonite anomaly included at the casting joint between the two sections of each test block.

Figure 2: Test block casting

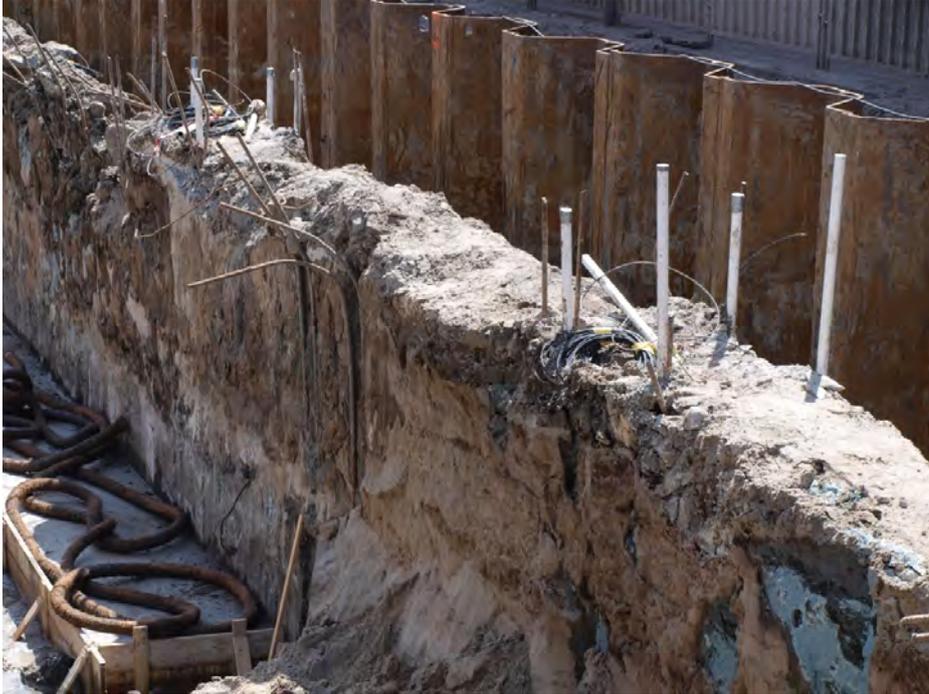
Figure 4: Top of diaphragm wall just before demolishing top meters, note the CSL tubes

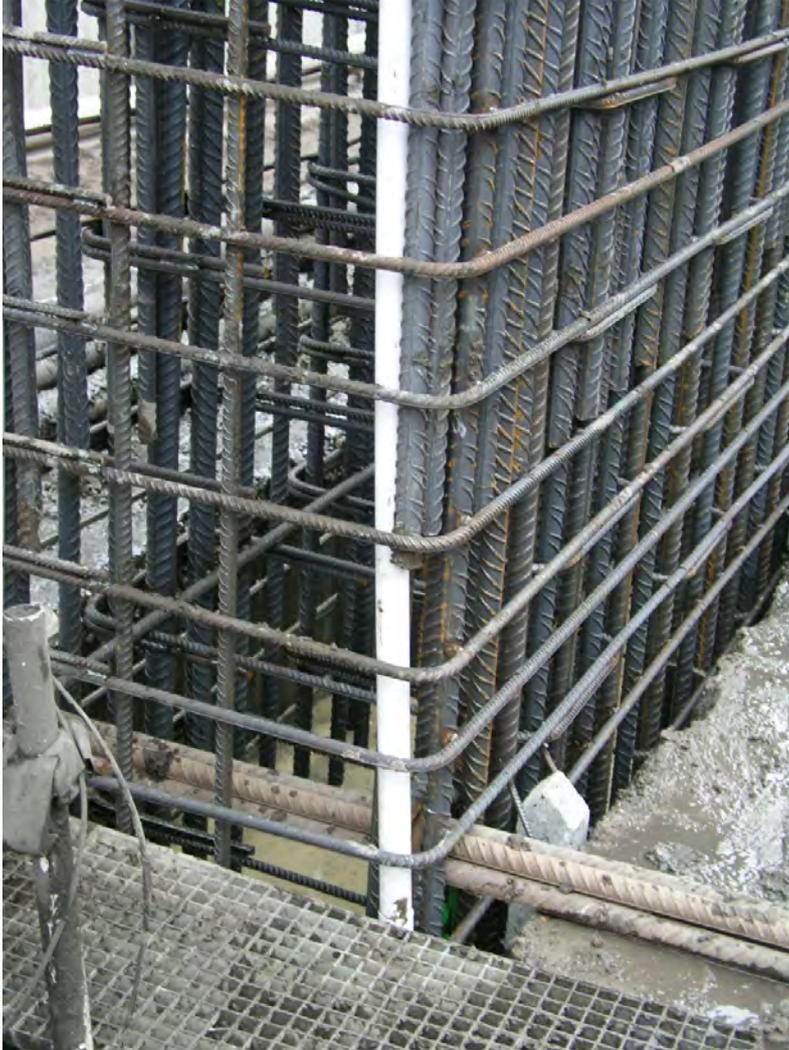
Figure 5: Rebar cage with PVC tubes at connecting height of two sections

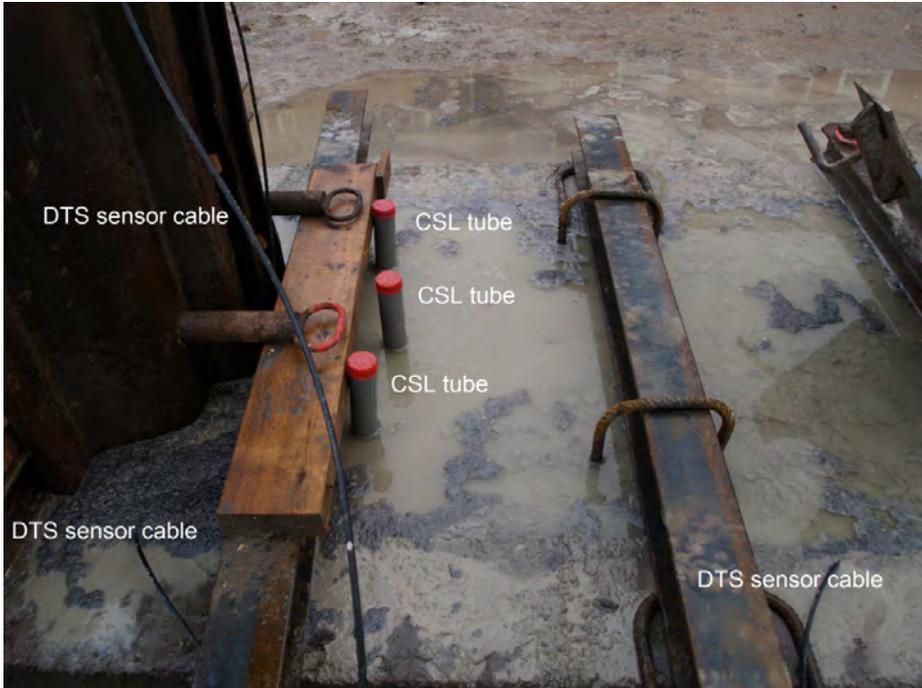
Figure 6: Panel after concrete casting, showing the CSL tubes and the DTS sensors

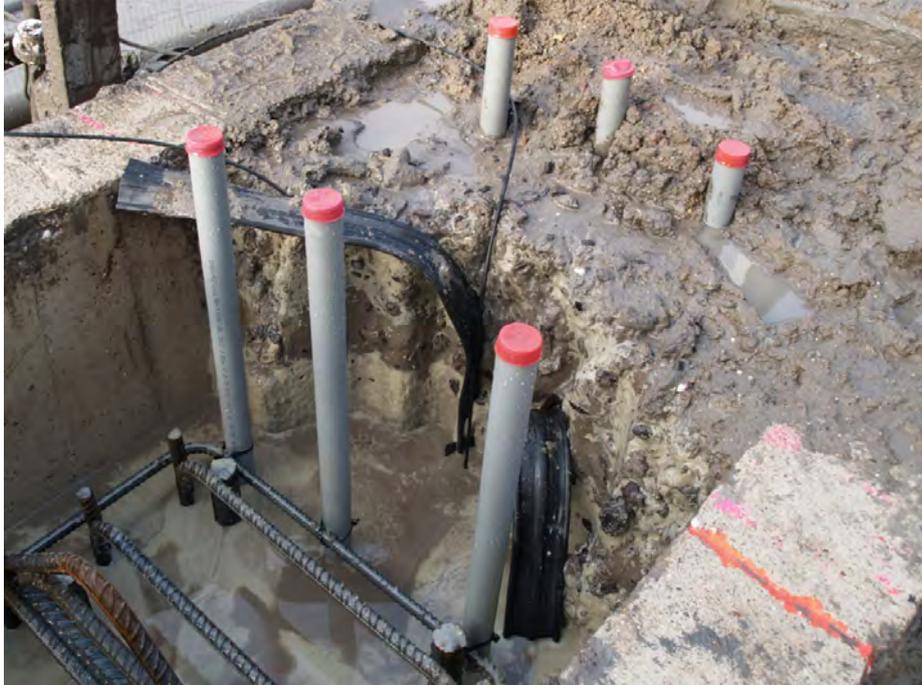
Figure 7: Joint between a cast panel and an excavated panel, just before concrete casting (showing a total of 6 CSL tubes)

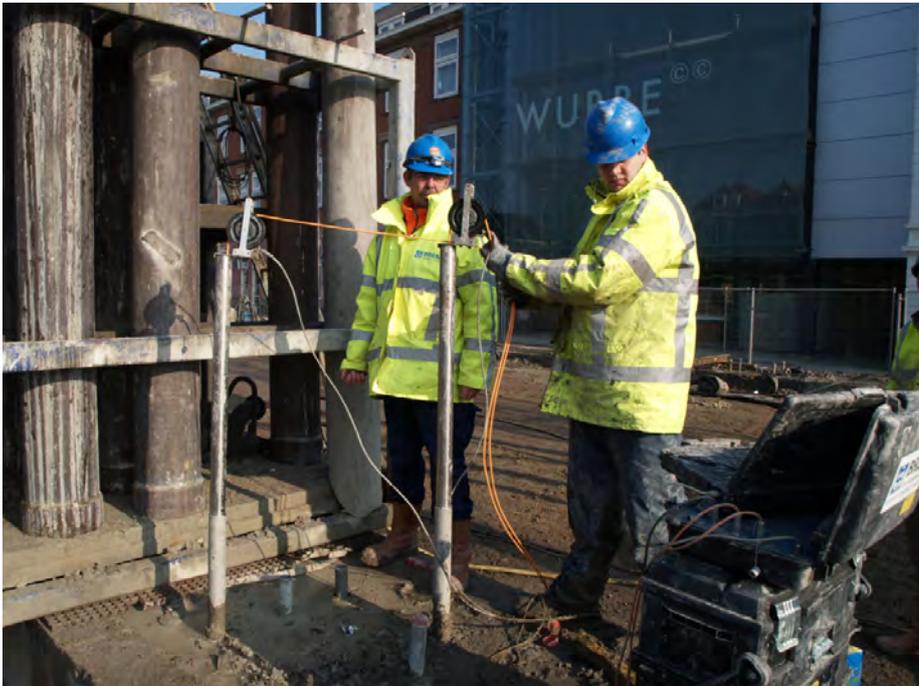
Figure 8: CSL testing (Brem Funderingsexpertise BV) at 'Spoorzone' Delft

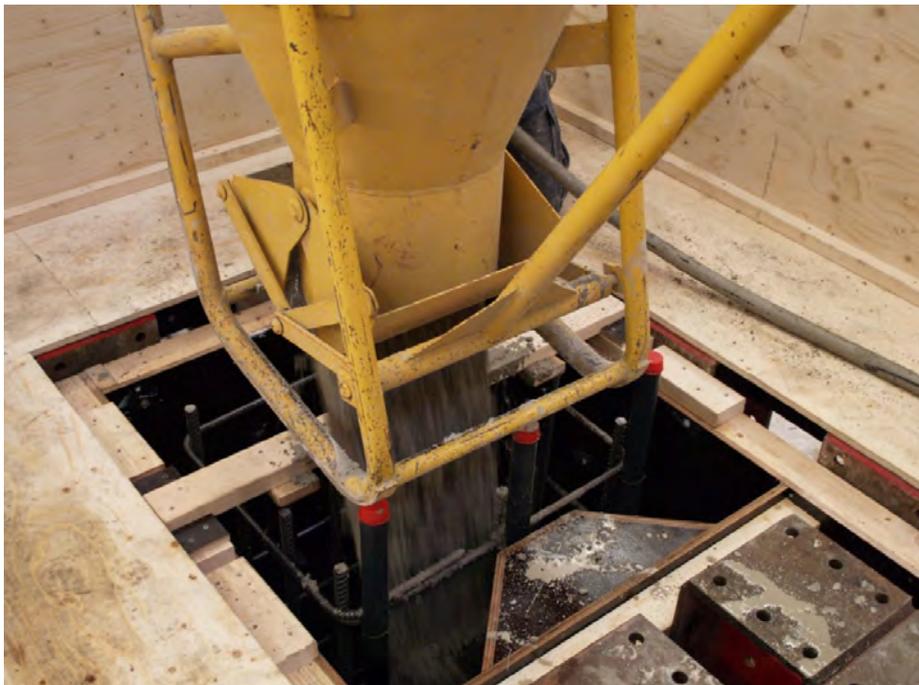
Figure 9: Concrete casting of the one of the test objects

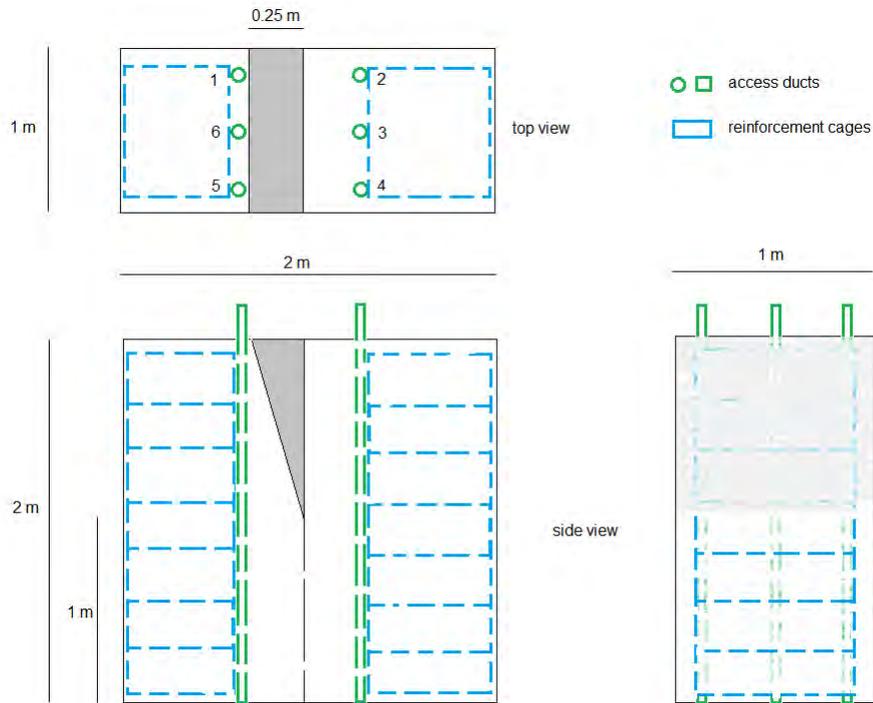
Figure 12: Test block 1 with flat joint profile

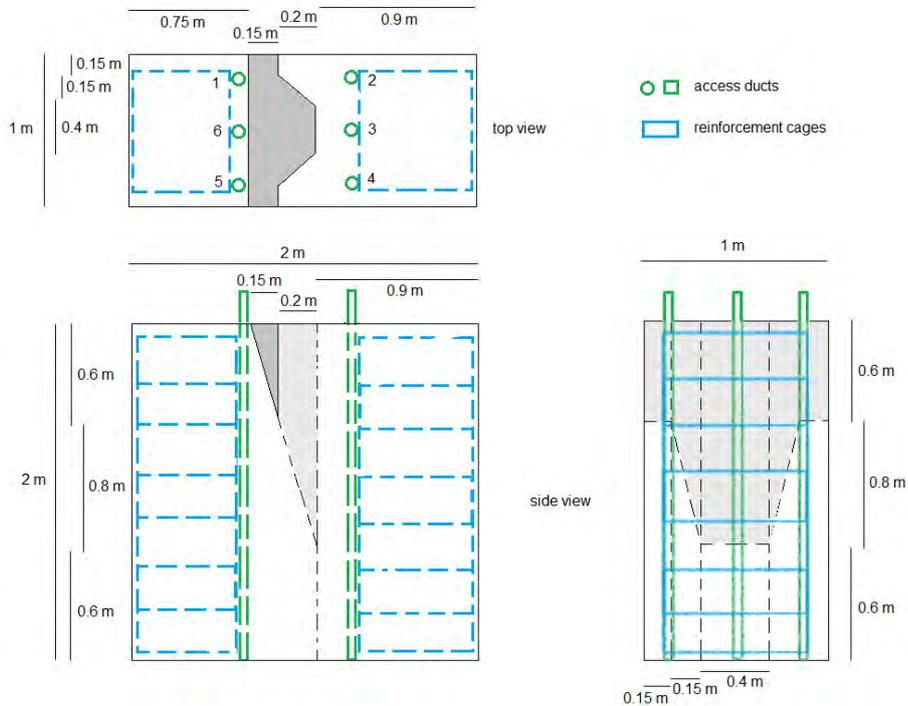
Figure 13: Test block 2 with trapezoidal shaped joint profile (dark grey: outcropping anomaly, light grey: anomaly only inside the test block)

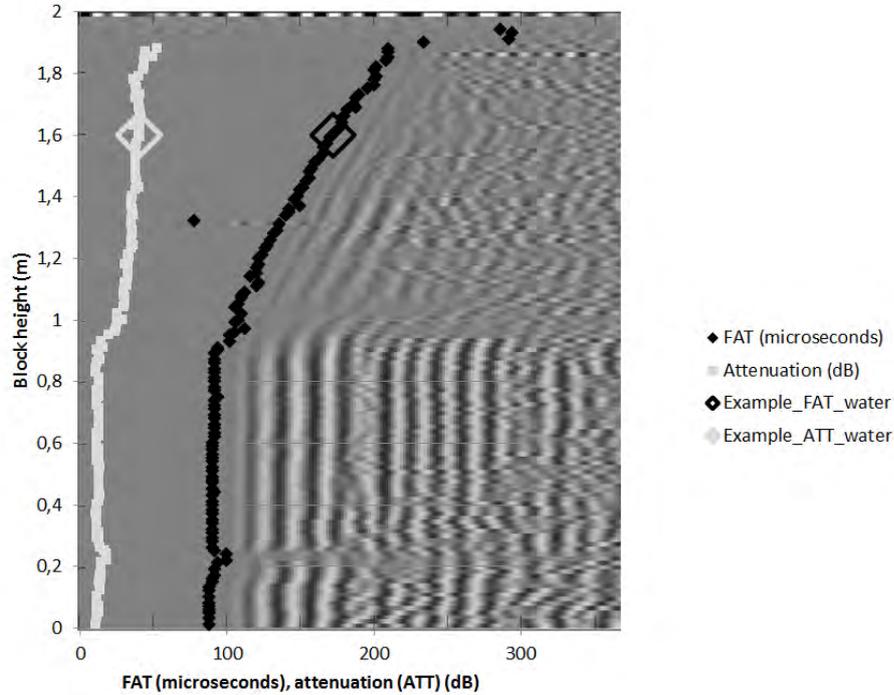
Figure 14: CSL results for an anomaly filled with water

The lower halves of Figure 14 to Figure 17 show the part of the test block without anomaly. Both FAT and attenuation are almost constant.

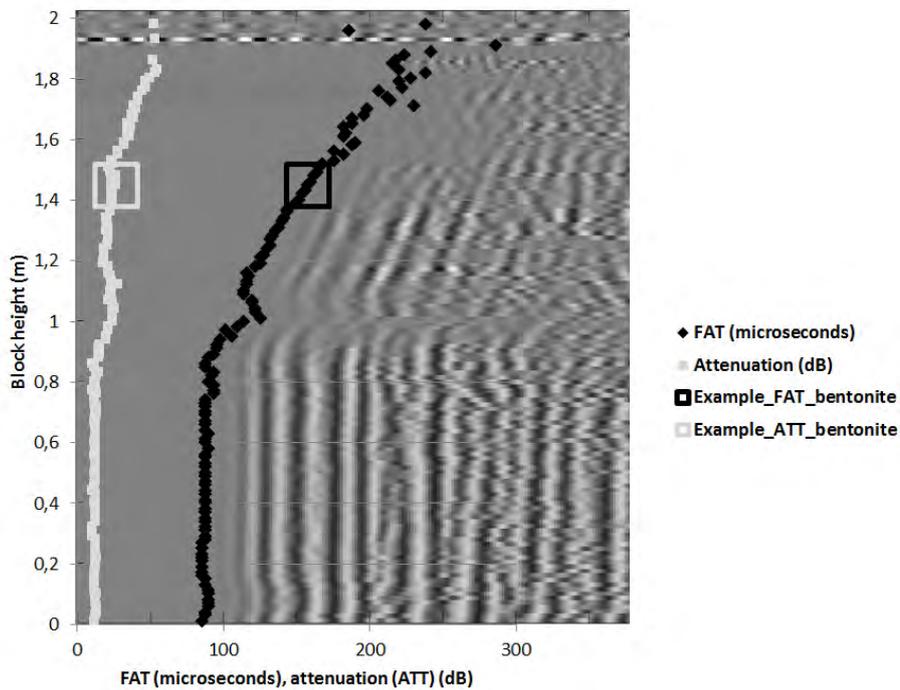
Figure 15: CSL results for an anomaly filled with bentonite

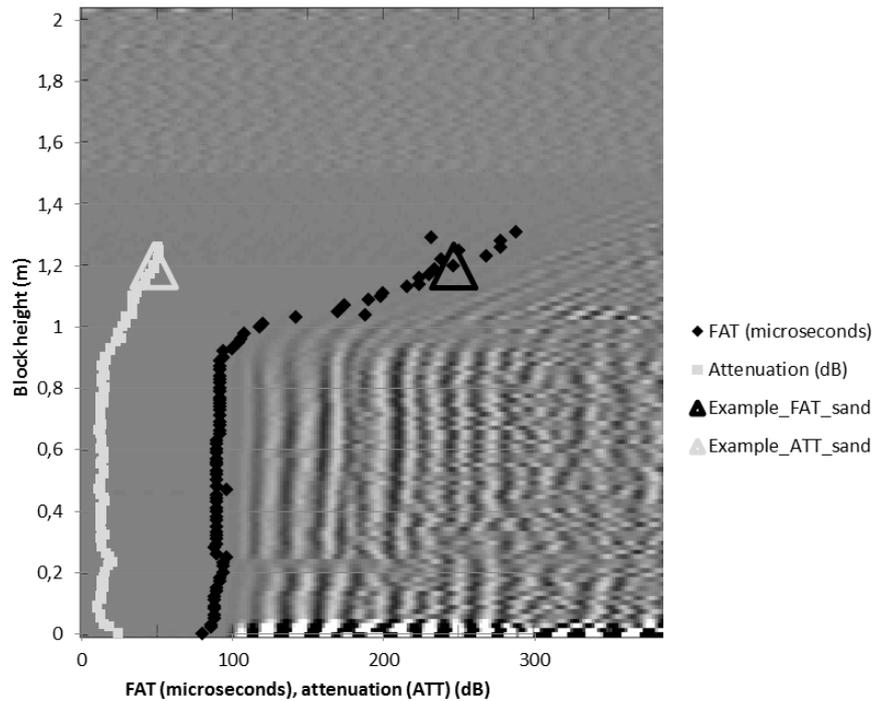
Figure 16: CSL results for an anomaly filled with saturated sand

Figure 16 and Figure 17 show that the signal passing through the anomaly filled with saturated sand (Figure 16) or saturated gravel (Figure 17) deteriorates quickly with increasing anomaly width. Fat and attenuation can only be determined up to an anomaly width of about 0.15 m.

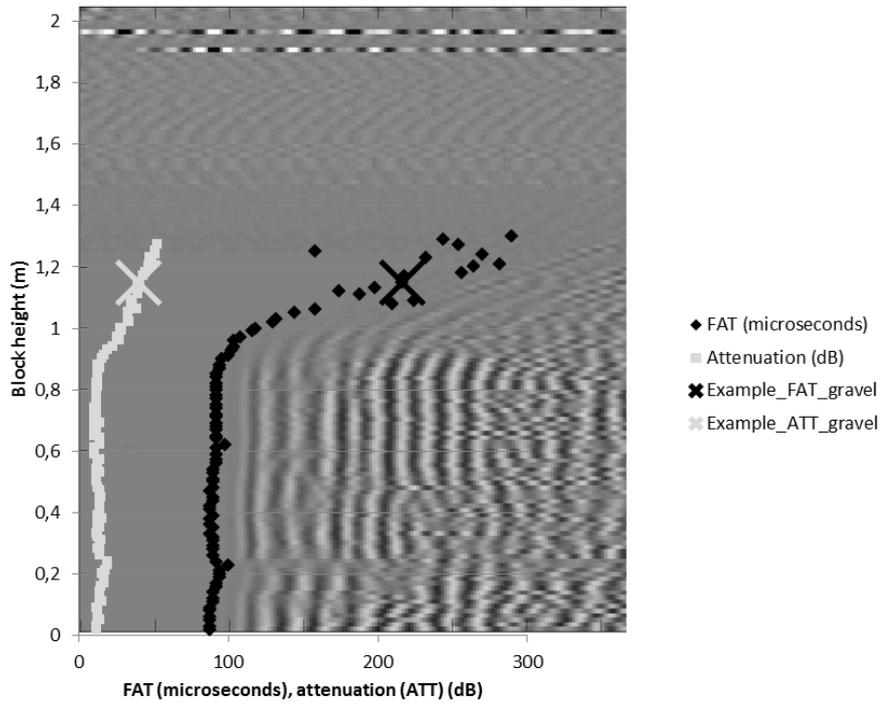
Figure 17: CSL results for an anomaly filled with saturated gravel.

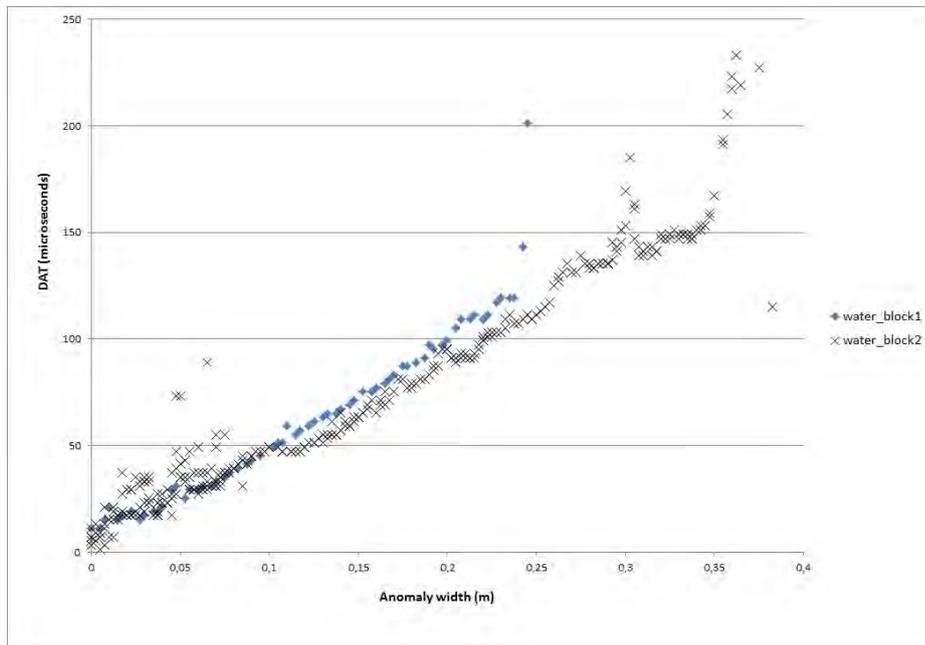
Figure 19: DAT for anomaly filled with water, comparison between blocks 1 and 2, for both blocks the measurements from tube 3 to tube 6 were used

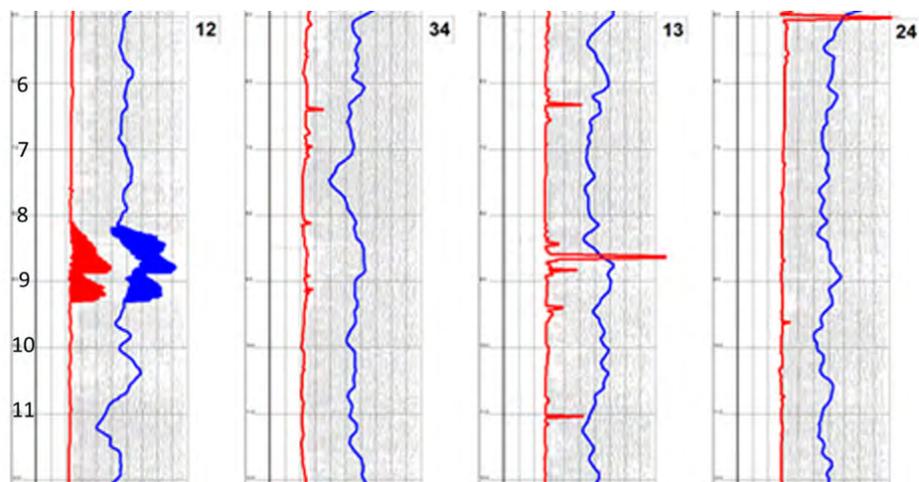
In one of the joints in Rotterdam an anomaly was detected. Figure 23 shows that the anomaly extends only in part of the cross section. The anomaly shows up in trace 1-2 but not in traces 3-4 and 2-4. In the diagonal trace 1-3 a slight distortion is noticeable.

Figure 23: Four CSL results of the same joint showing an anomaly partly affecting the depth from 8.25 to 9.25 m below top level. FAT in red, Attenuation in bleu (x-scale ticks: respectively 100 microseconds, 6 dB)

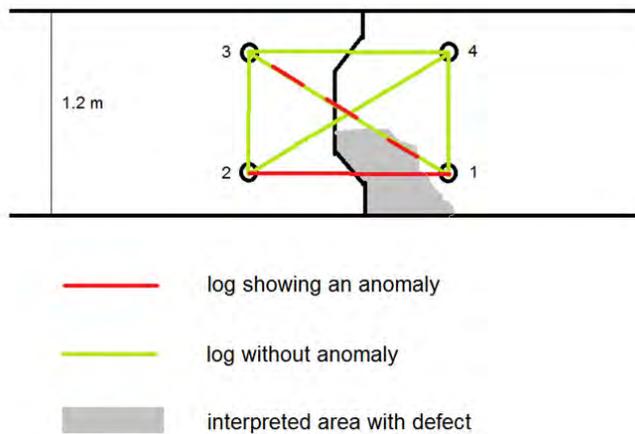
Based upon preliminary lab tests this anomaly was interpreted as a bentonite intrusion of approximately $0.3 * 1 * 0.5 \text{ m}^3$ (width * height * thickness) as depicted in Figure 24. Because the anomaly did not extend through the complete cross-section of the diaphragm wall and the soil at the depth of the anomaly consisted of stiff clay with low risk of leakage, no repair works were carried out before excavation of the building pit took place.

Figure 24: Interpretation of anomaly affected cross section (between 8.25 m and 9.25 m below top level)

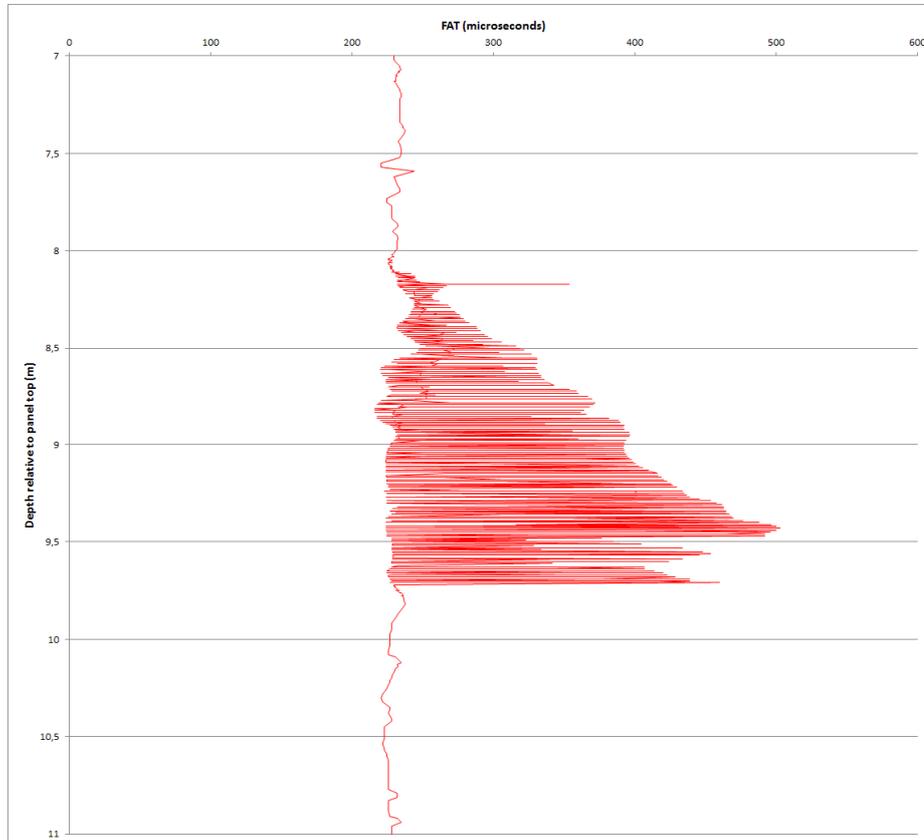
After the excavation, the anomaly showed up on the expected location and consisted of a gravel pocket or low grade concrete with slightly larger horizontal dimensions than interpreted from the measurements. Re-examination of the original test results without filtering showed a very irregular shape of the first arrival interpretation, showing either a FAT close to the average FAT of that joint, or an extra-long FAT, see Figure 25. This more or less 'double staged' behavior of the FAT could be explained by the partly concrete / partly granular nature of the anomaly.

Figure 25: Zoomed part of scan 1-2 with anomaly

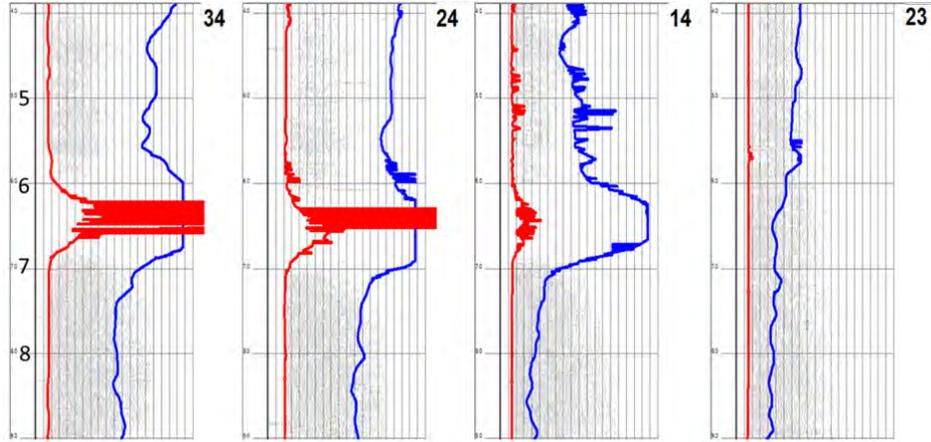
One of the tested joints in Delft showed almost absent signal over a height of 1 m (from 6 to 7 m below surface level) in 5 out of 6 logs (Figure 26). Log 34, perpendicular through the joint and log 24, diagonally through the joint, both show a clear defect between 6 m and 7 m from the top of the panel. Logs 12 and 13 are not shown but are similar to respectively 34 and 24. Log 14 (parallel to the joint) shows that the left panel (Figure 27) is even affected as far as the rebar cage onto which the access tubes are installed. The only log showing no defect is 23, parallel to the joint in the right panel.

Figure 26: CSL results showing an anomaly from 6 to 7 m below reference level. FAT in red, Attenuation in bleu (x-scale ticks: 100 microseconds, 3 dB)

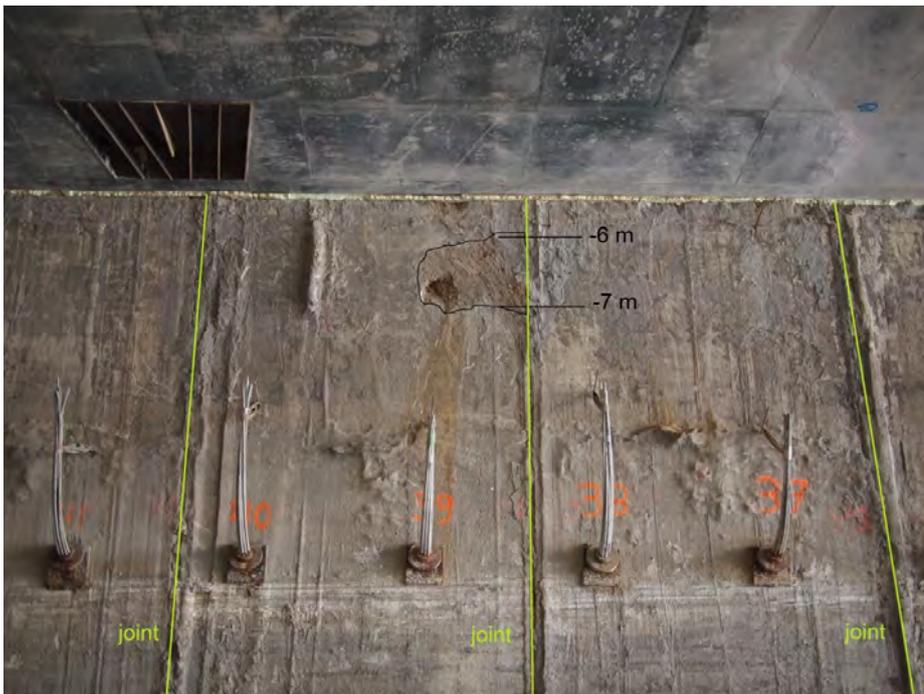
Figure 28: Location of the sand inclusion in the Delft field case relative to the joints and panels

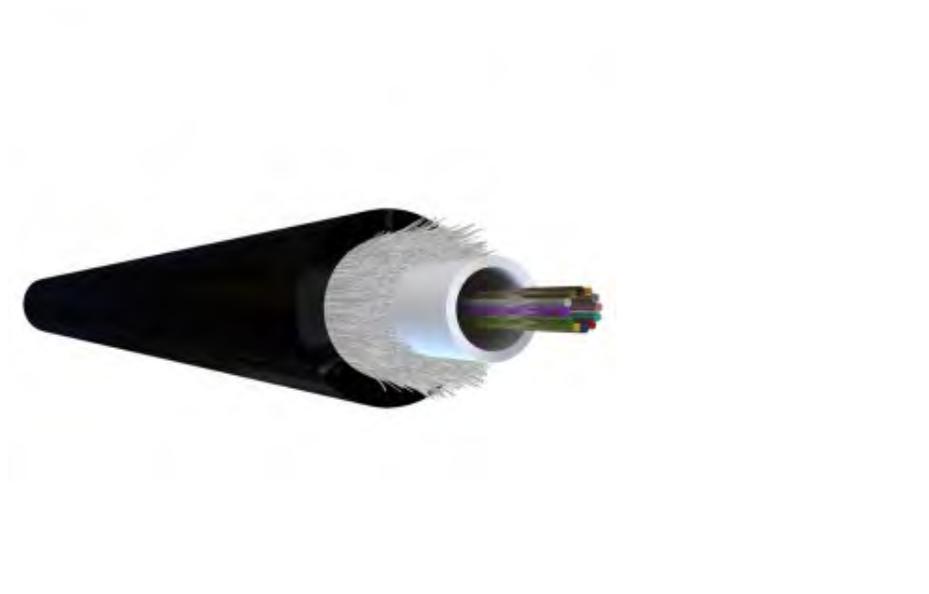
Figure 30: Cross section of the ACE-TKF CTC 8xMM cable

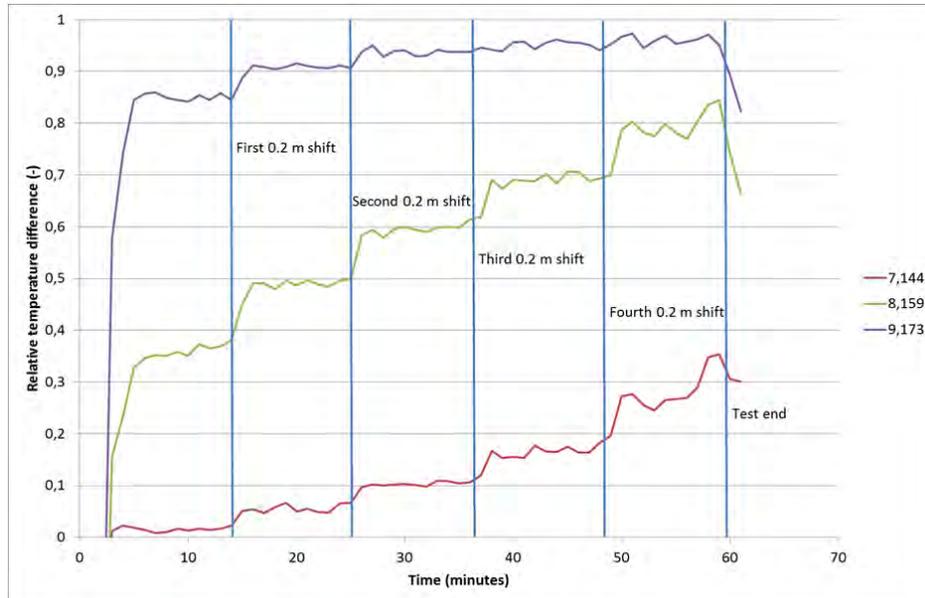
Figure 33: Relative temperature difference for 3 measurement positions (in meters relative to the DTS device) in the linear sensor near the transition zone during the response curve test

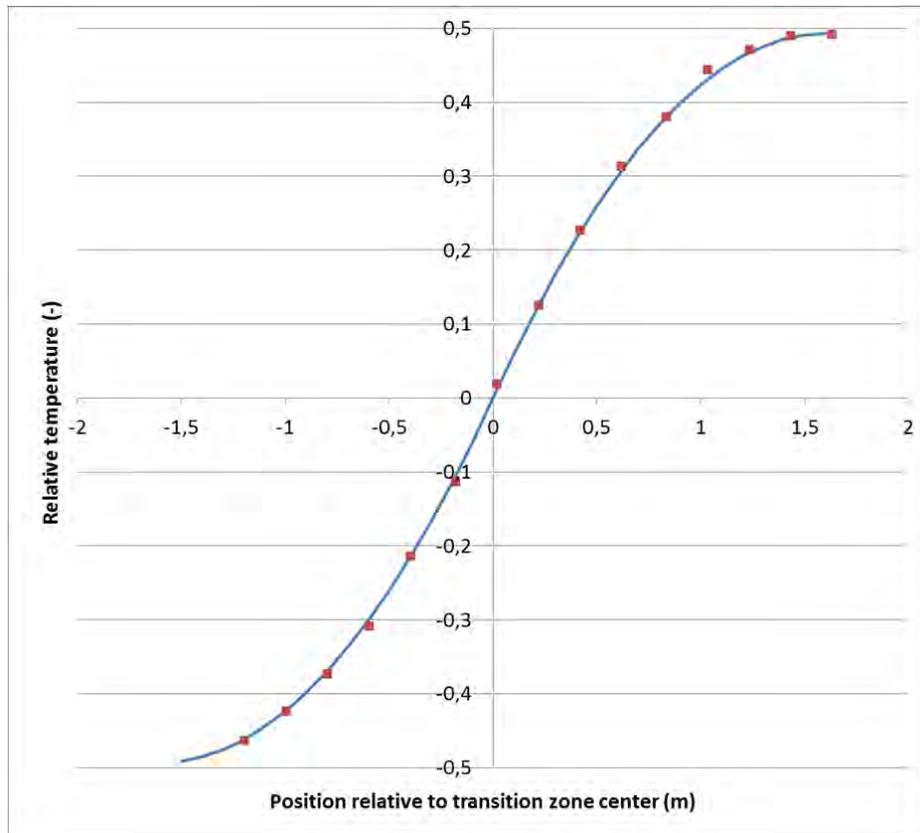
The average of each set of ten temperature readings has been used to determine Figure 34. After the fourth shift, it seems that no equilibrium has been reached at measurement position 7.144 m. However, this does not show in Figure 34, confirming that 10 minutes is a well-chosen interpolation period.

Figure 34: Response curve for Sensornet Oryx DTS and single ended ACE-TKF CTC 8xMM fiber based upon ten averaged recordings with acquisition time of 1 minute (model as line and measurements as dots)

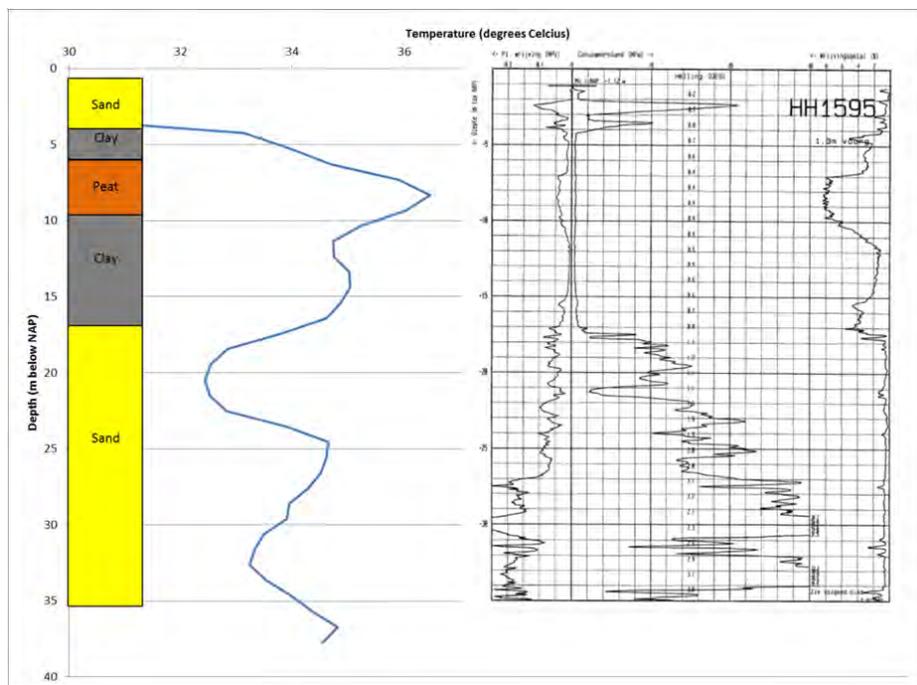
Figure 36: Peak temperature profile from concrete curing with CPT and boring

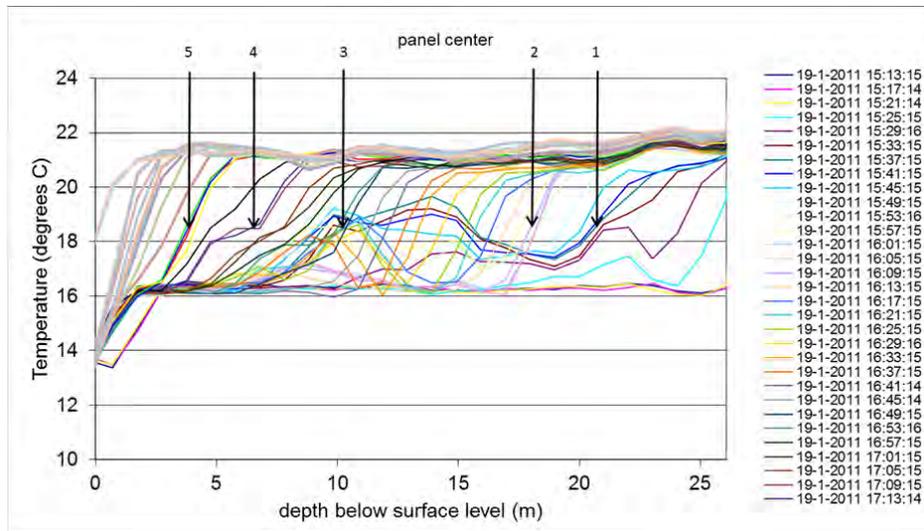
Figure 37: Subsequent temperature profiles in the center of the panel during concrete casting, arrows indicating overlapping temperature profiles of subsequent measurements

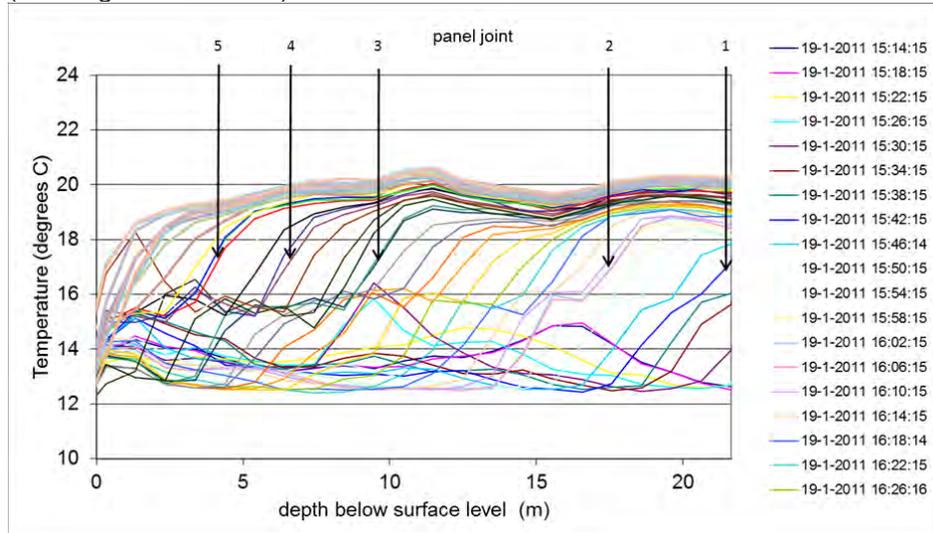
Figure 38: Subsequent temperature profiles in the joint area during concrete casting, arrows indicating overlapping temperature profiles of subsequent measurements

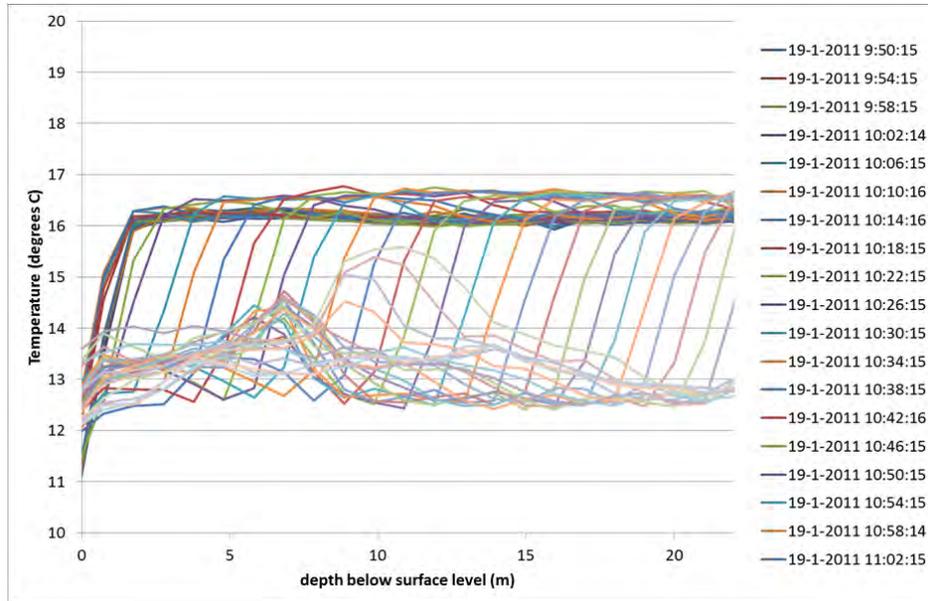
Figure 39: Subsequent temperature profiles in the joint area during slurry refreshing

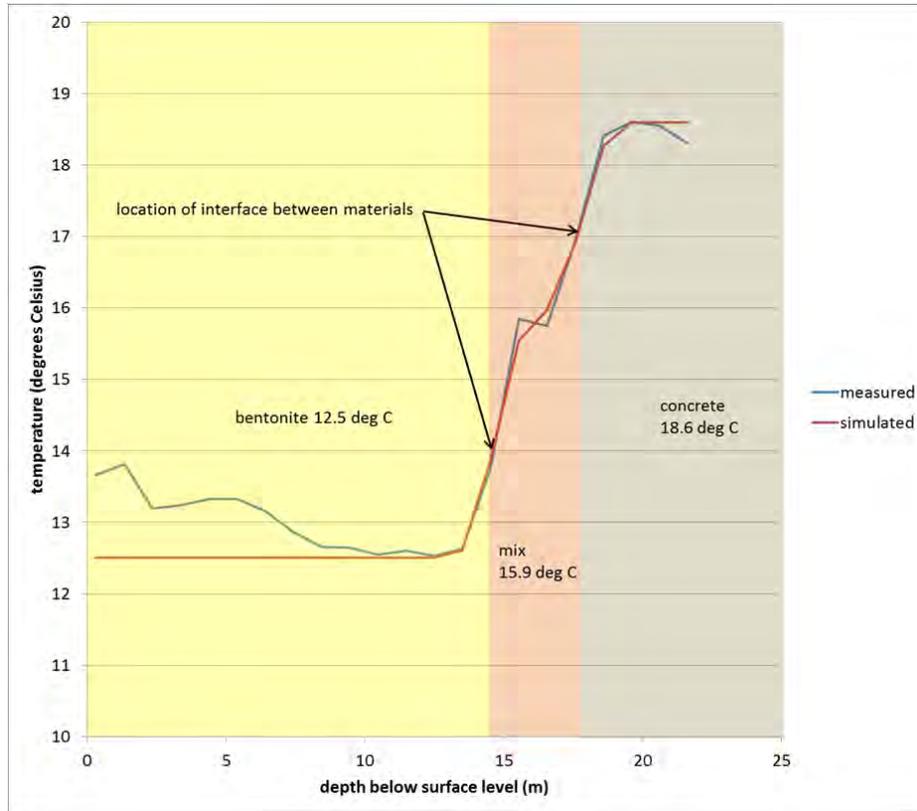
Figure 40: Measured and simulated temperature profiles in the joint at 19-1-2011 15:58:15. Correlation between measured and simulated graphs = 0.999 from 10.5 to 20.5 m below surface level

Using simulation of the temperature response based upon the device characteristics and the known temperatures of the media, the accuracy of determining the level of an interface can be significantly improved (see Figure 40 and Figure 47).

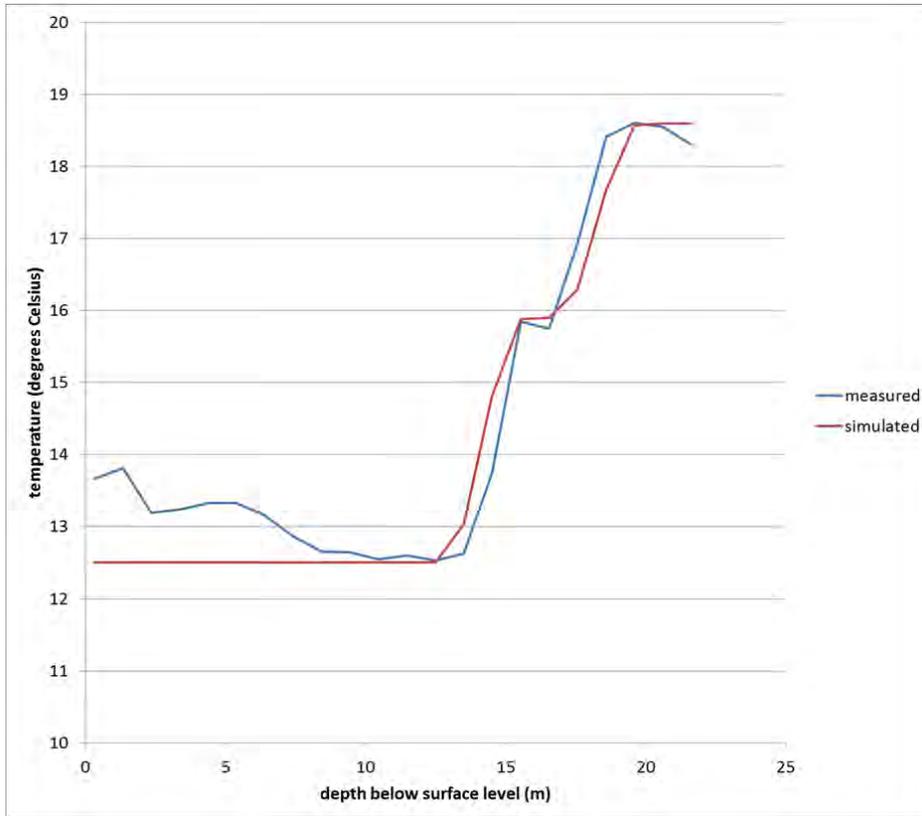
Figure 41: Measured and simulated temperature profiles in the joint at 19-1-2011 15:58:15, upper interface 0.5 m too high, lower interface 0.5 m too low. Correlation between measured and simulated graphs = 0.984 from 10.5 to 20.5 m below surface level

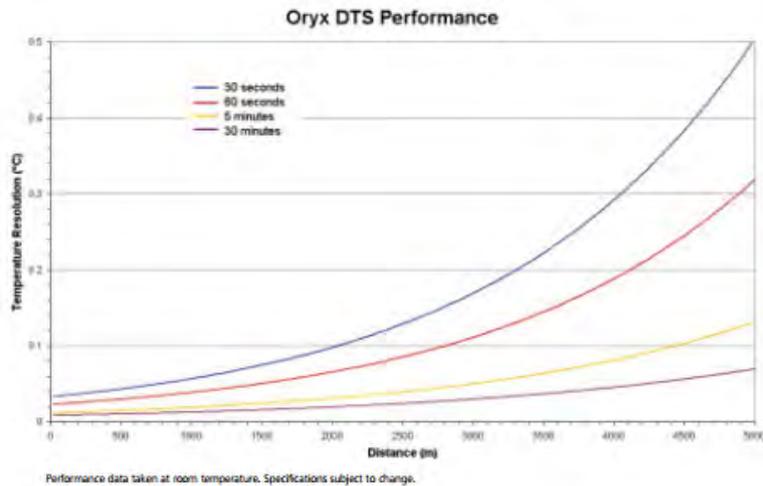
Figure 42: Temperature resolution depending on sensor length (Sensornet 2012)

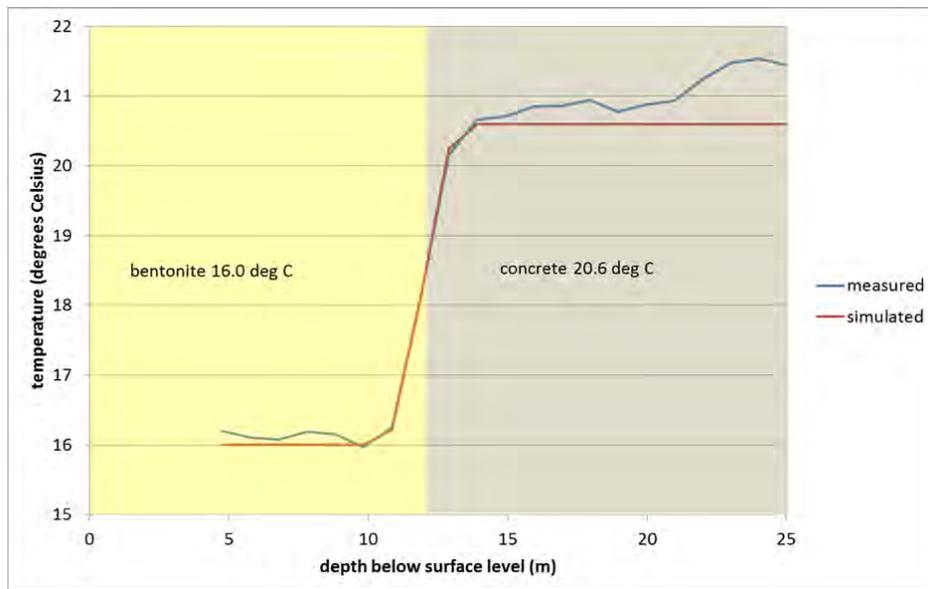
Figure 43: Measured and simulated temperature profiles in the center of the panel

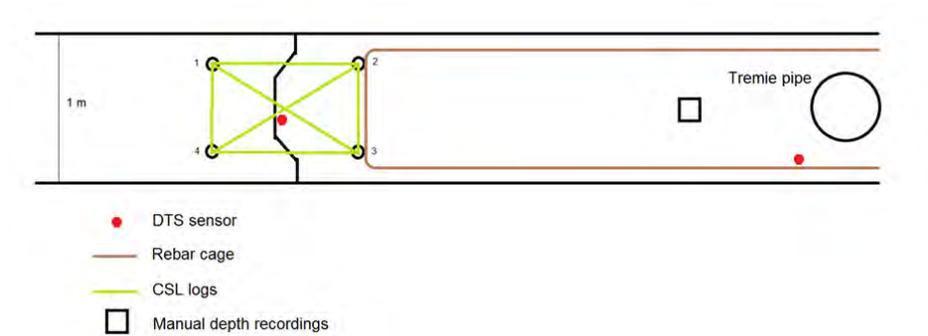
Figure 44: Position of CSL logs, manual depth recordings and DTS sensors in the panel

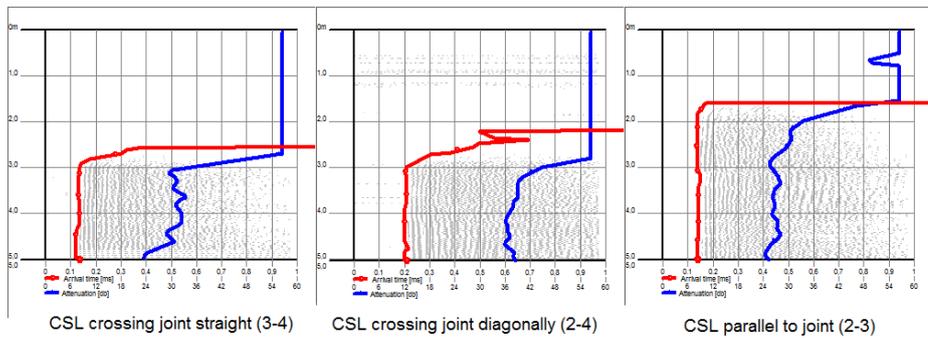
Figure 45: CSL logs, loss of signal indicating poor concrete

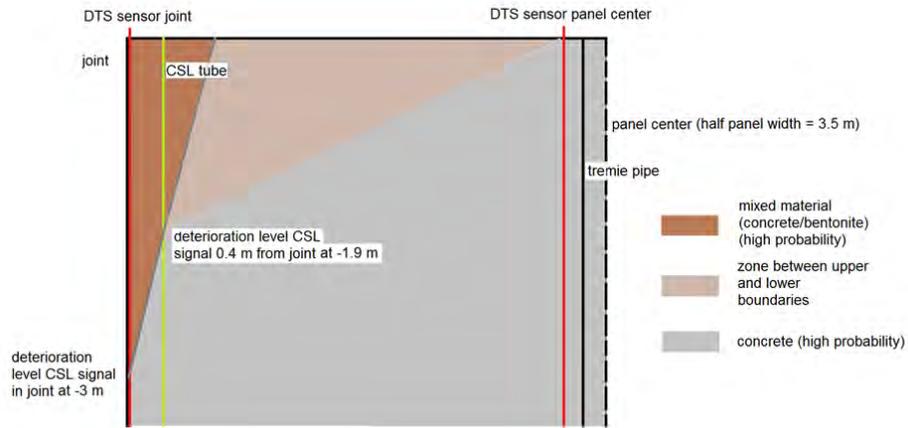
Figure 46: Interpretation of CSL and DTS concrete levels (side view of panel)

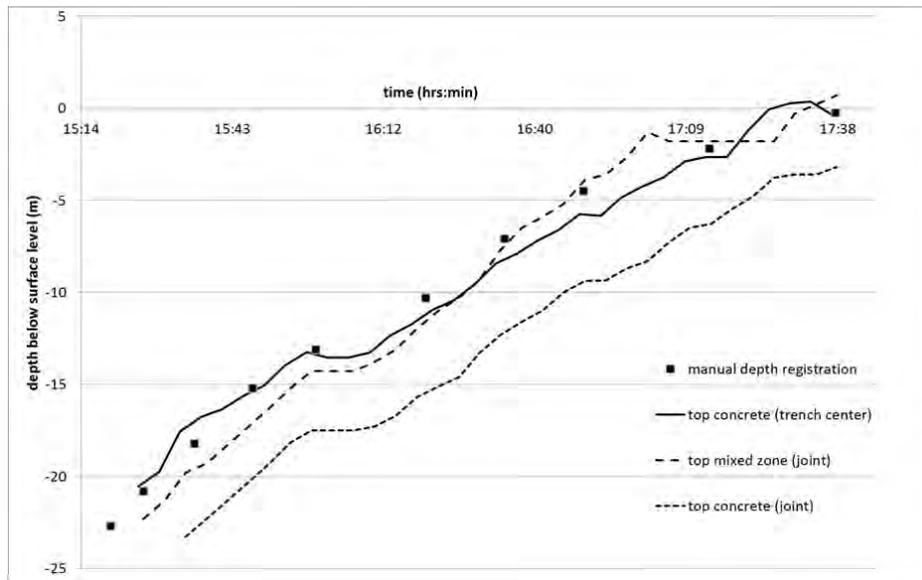
Figure 47: Concrete levels recorded in the center and joint of a panel

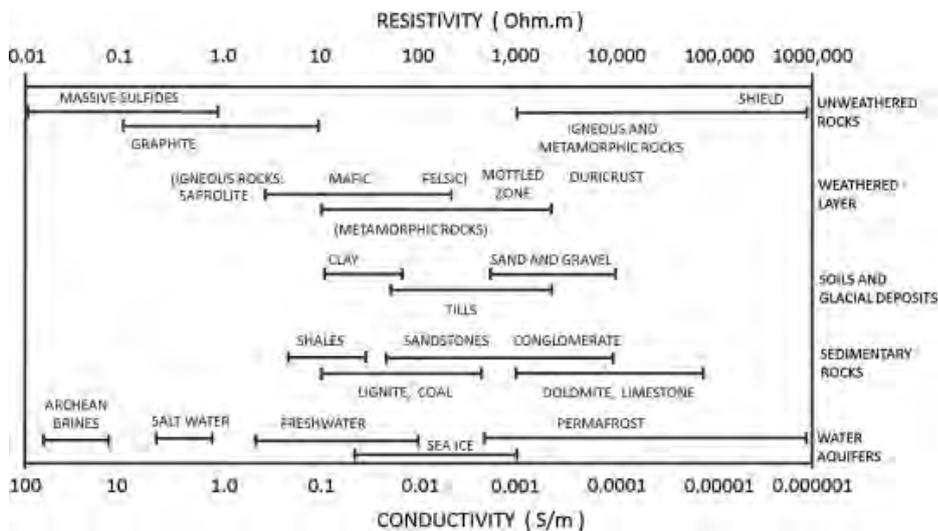
Figure 48: Indication of resistivity properties (Gunn et al. 2014)

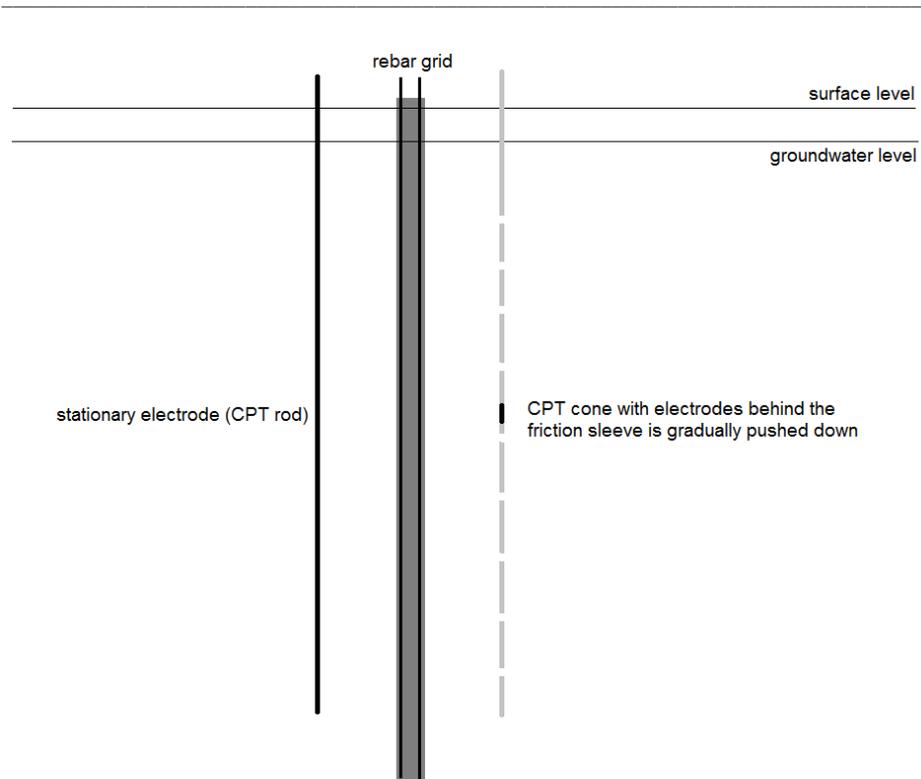
Figure 49: Schematic cross-section of the field test (not to scale)

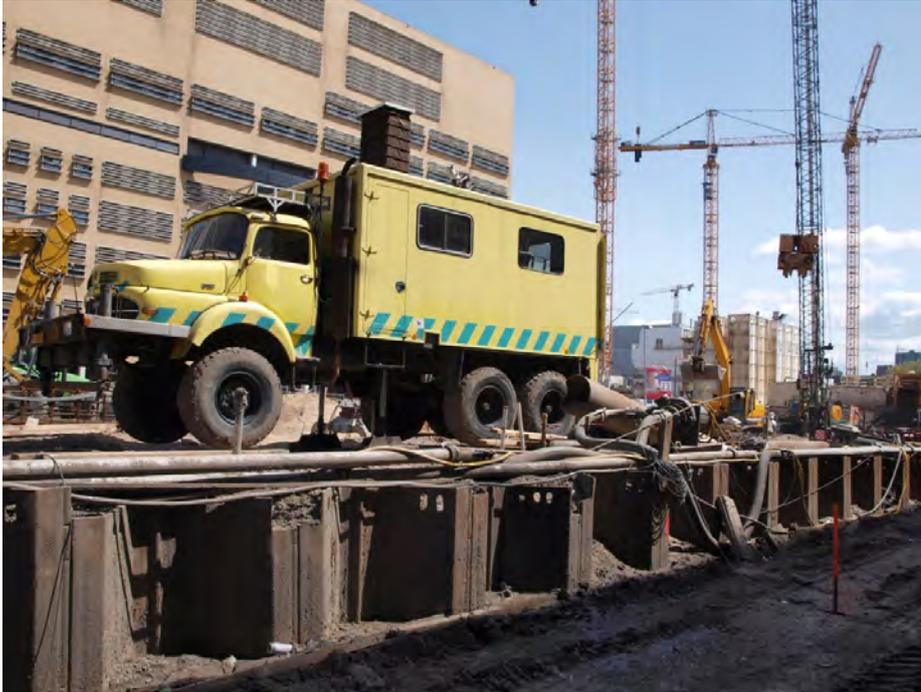
Figure 50: CPT truck during resistivity measurements
