To detect anomalies in diaphragm walls

PROEFSCHRIFT

Rodriaan SPRUIT

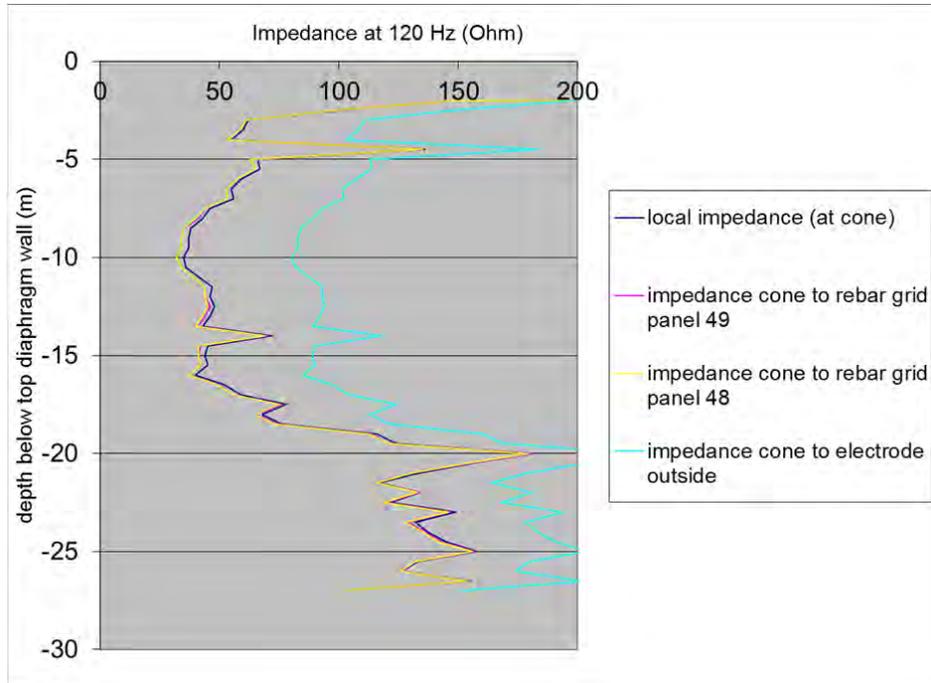
Figure 51: Impedance at 120 Hz

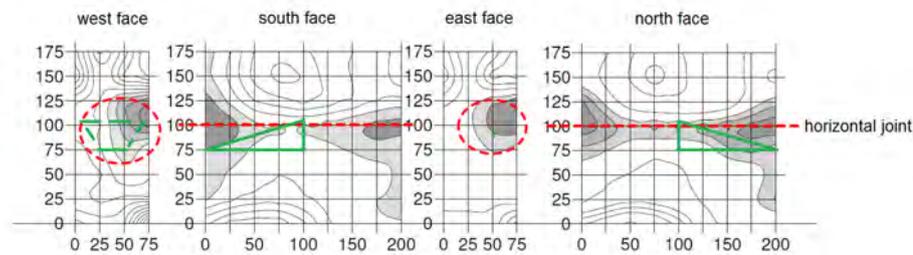
Figure 53: Measurement results (dimensionless)

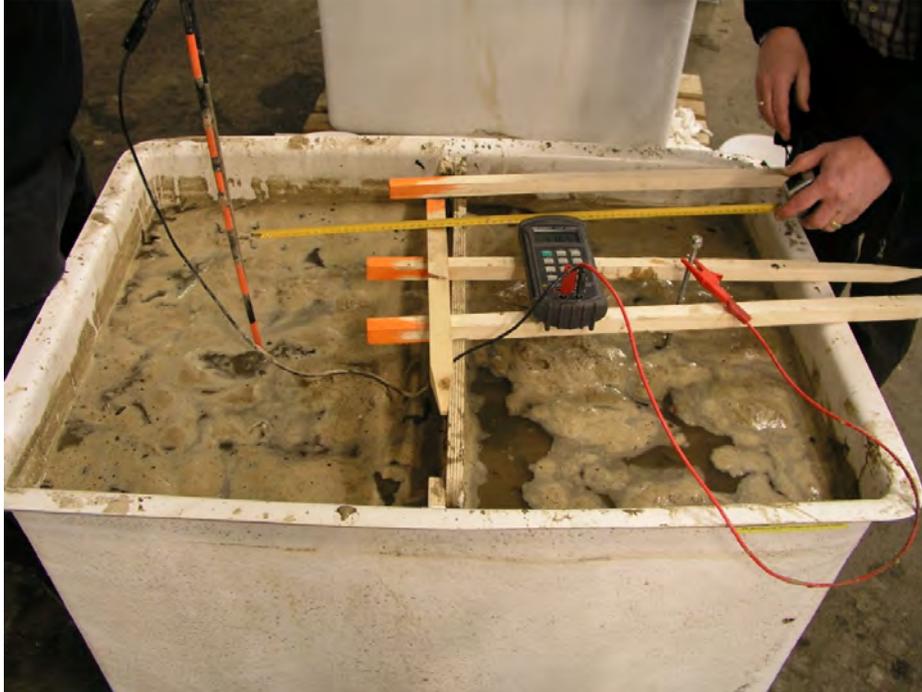
Figure 54: Test container with wooden barrier, water and sand

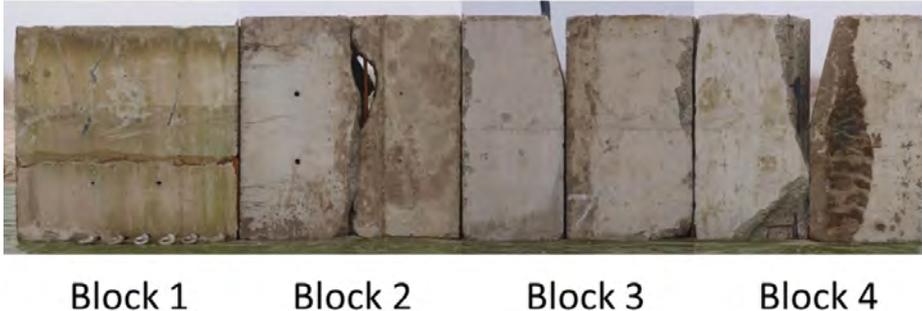
Figure 55: Test wall (side view), dimensions: height=2 m, length=8 m, width=1 m.

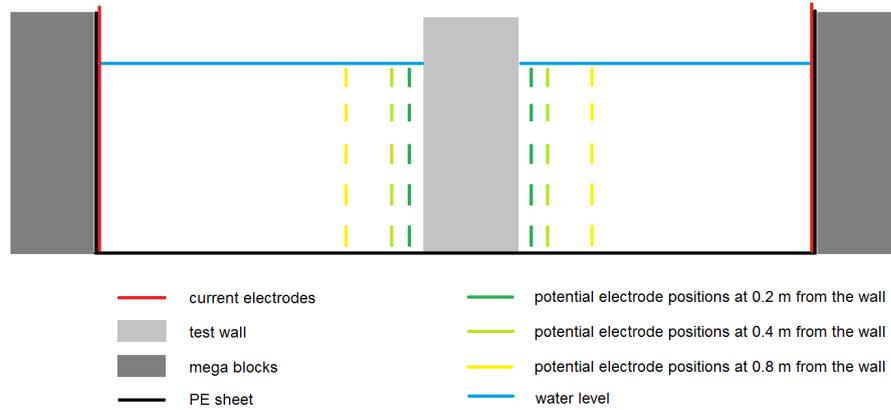
Figure 56: Cross-section of the test setup

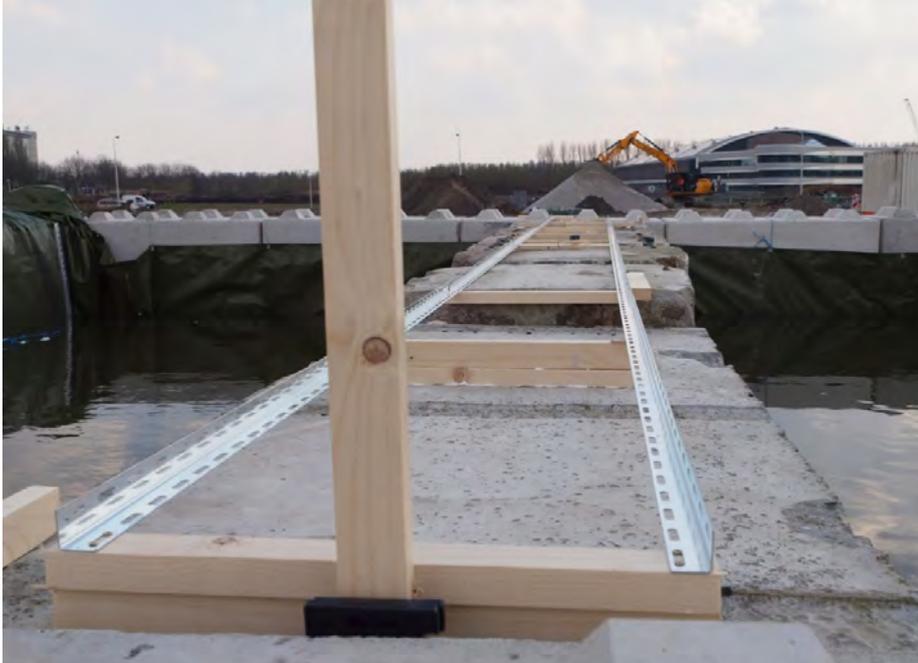
Figure 57: Top of test wall with track for positioning the potential electrodes

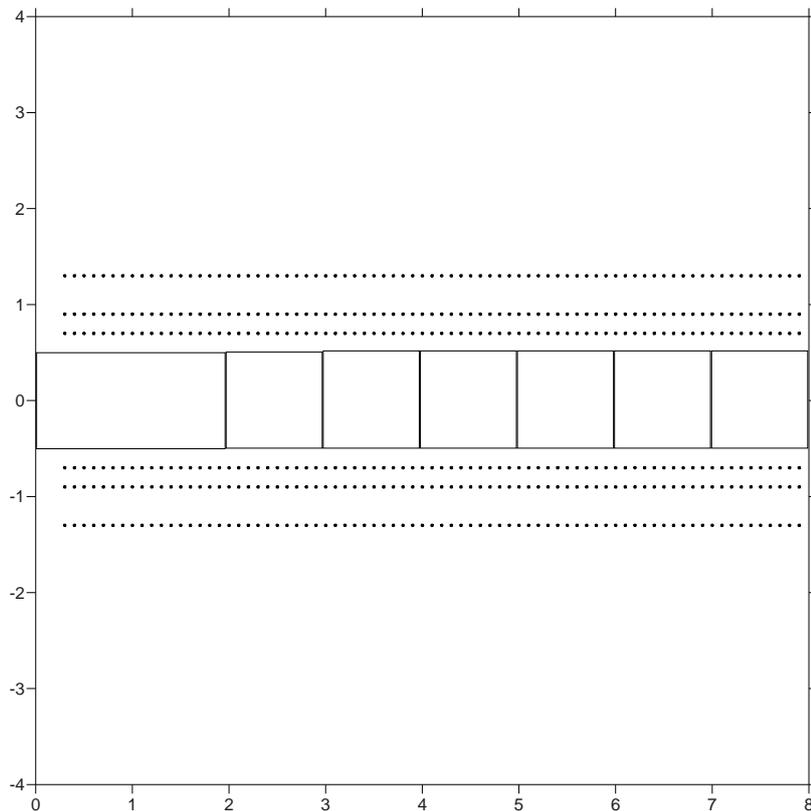
Figure 58: Top view of test wall with electrode positions (dots) for measuring the potential at 0.2, 0.4 and 0.8 m distance to the test wall, horizontal dimensions (m)

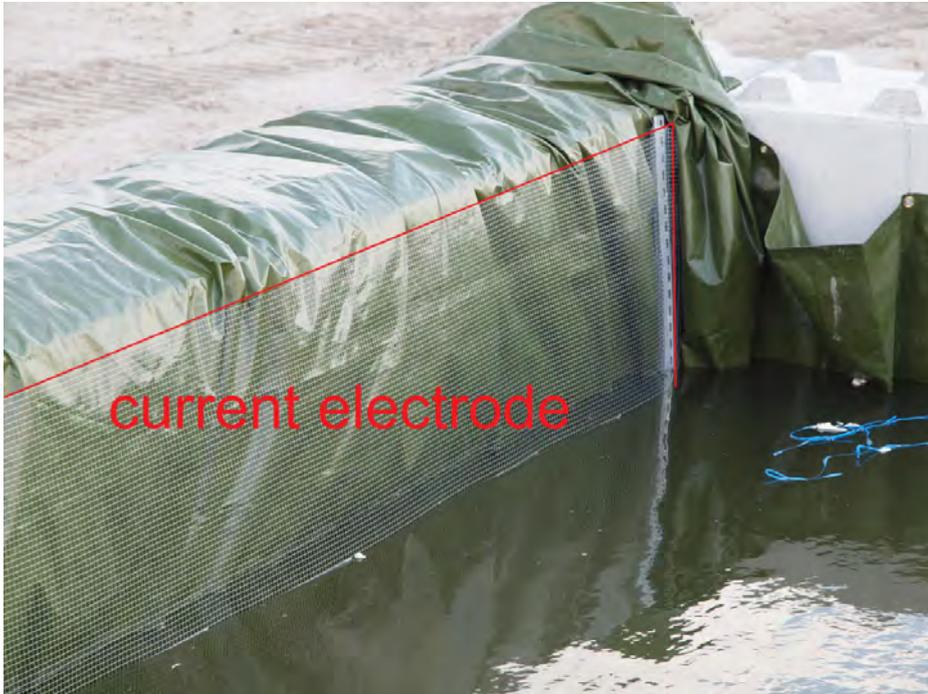
Figure 59: Current electrode grid

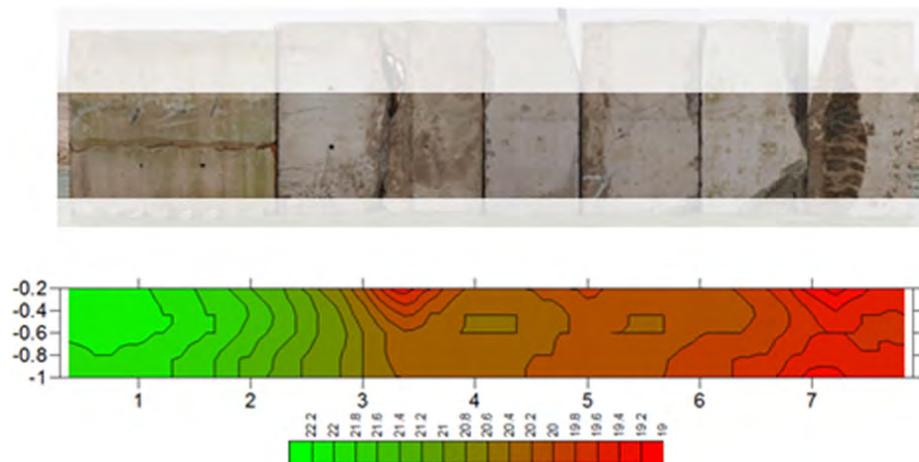
Figure 61: Apparent resistivity (Ohm) results for potential electrodes 0.2 m distance to the test wall

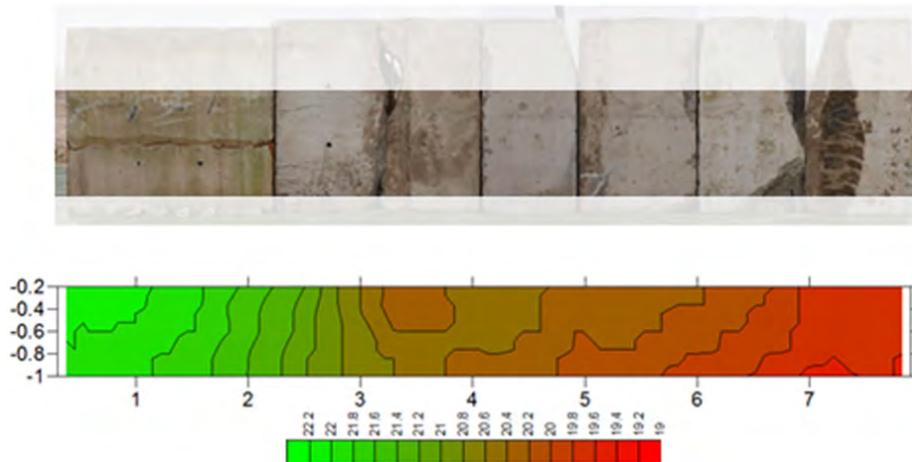
Figure 62: Apparent resistivity (Ohm) results for potential electrodes 0.4 m distance to the test wall

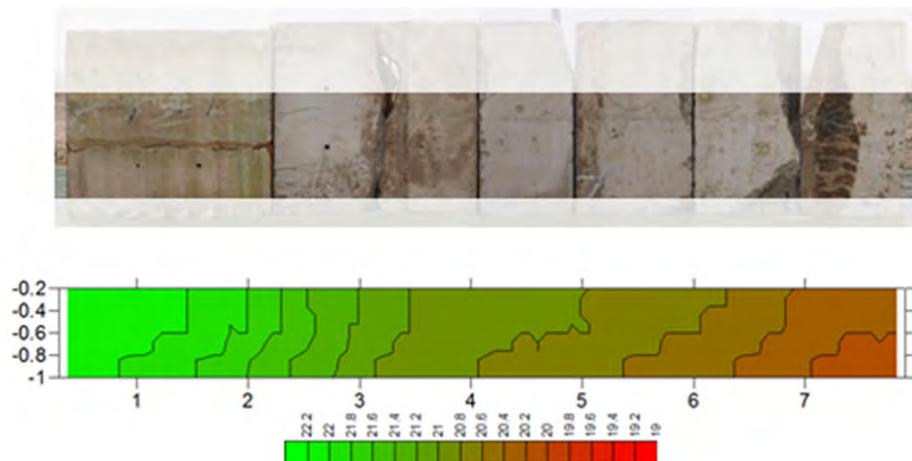
Figure 63: Apparent resistivity (Ohm) results for potential electrodes 0.8 m distance to the test wall

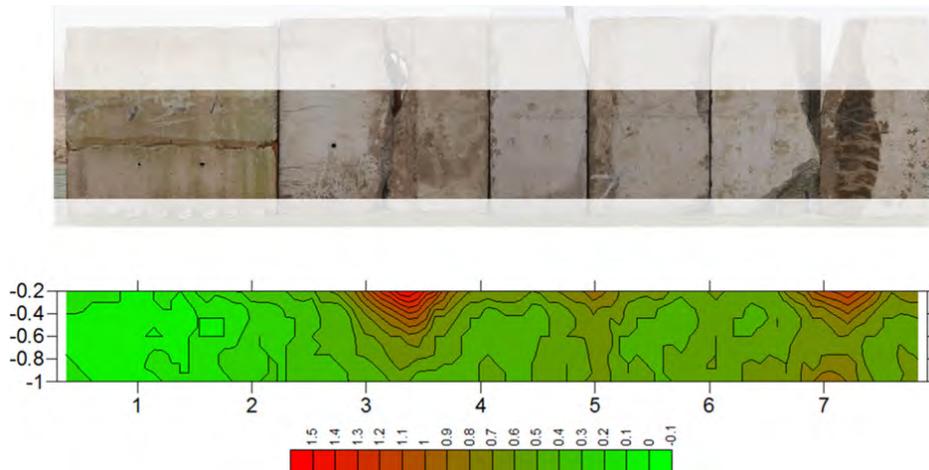
Figure 64: Apparent resistivity (Ohm) results for potential electrodes 0.2 m distance to the test wall, corrected with the results at 0.8 m distance.

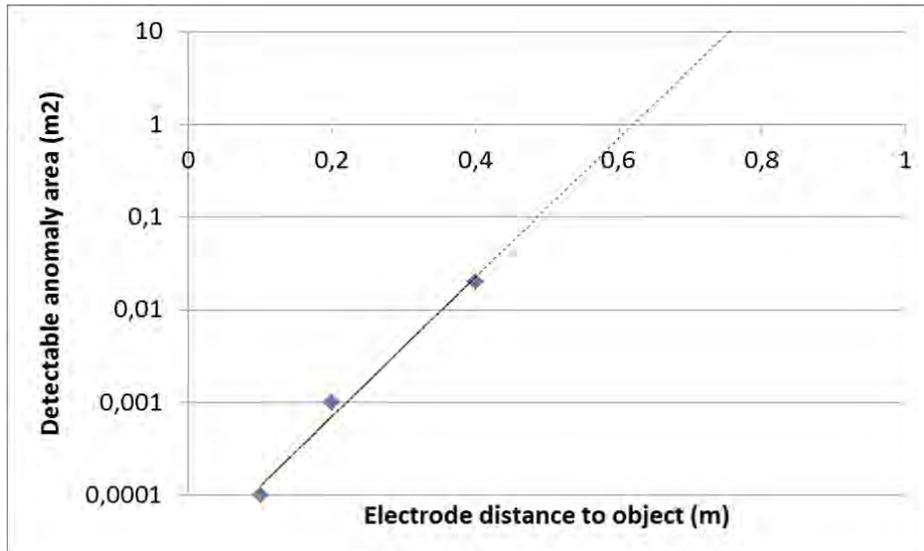
Figure 66: Detectable anomaly size and electrode distance to the test object

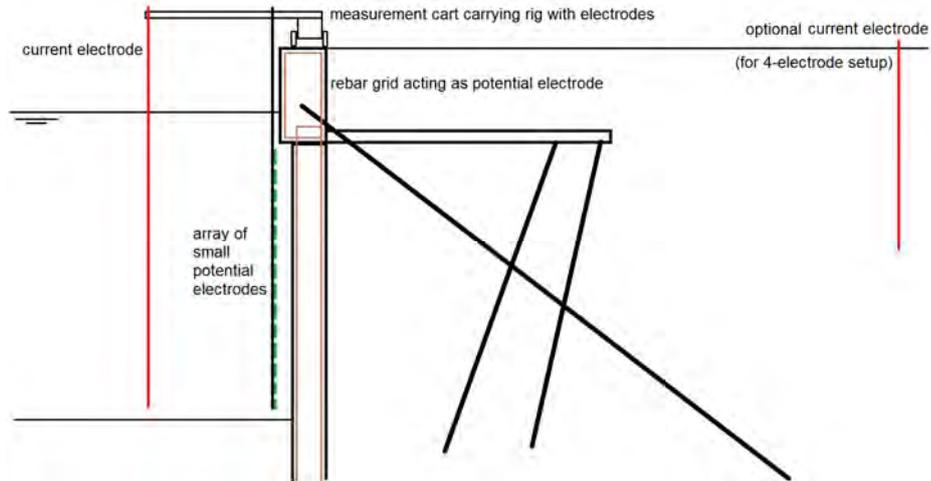
Figure 74: Suggested 3-electrode measurement setup (with optional 4th electrode) for concrete quality check quay walls

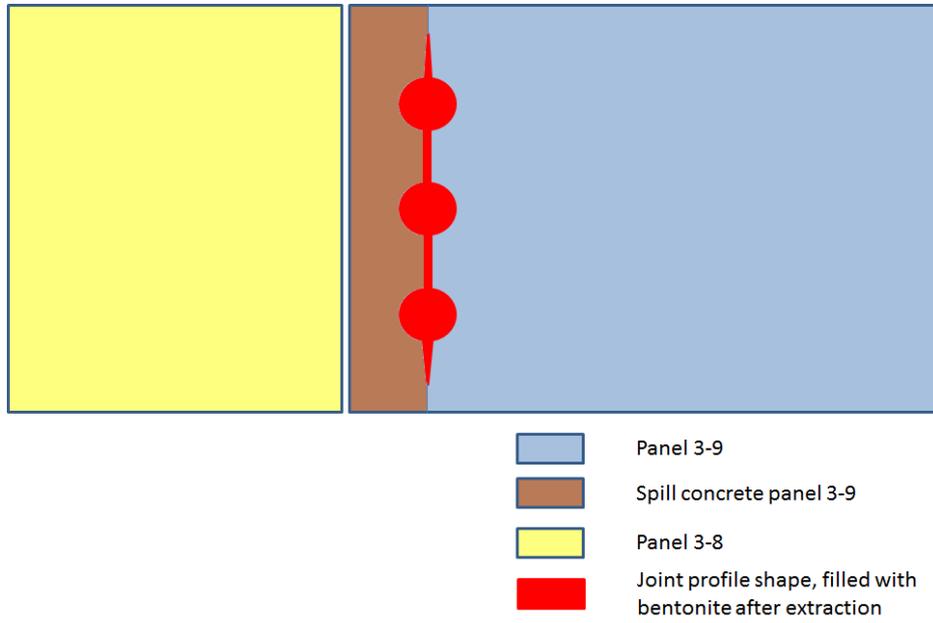
Figure 76: Interpretation of the anomaly (top view/cross section), panel 3-8 was excavated after 3-9.

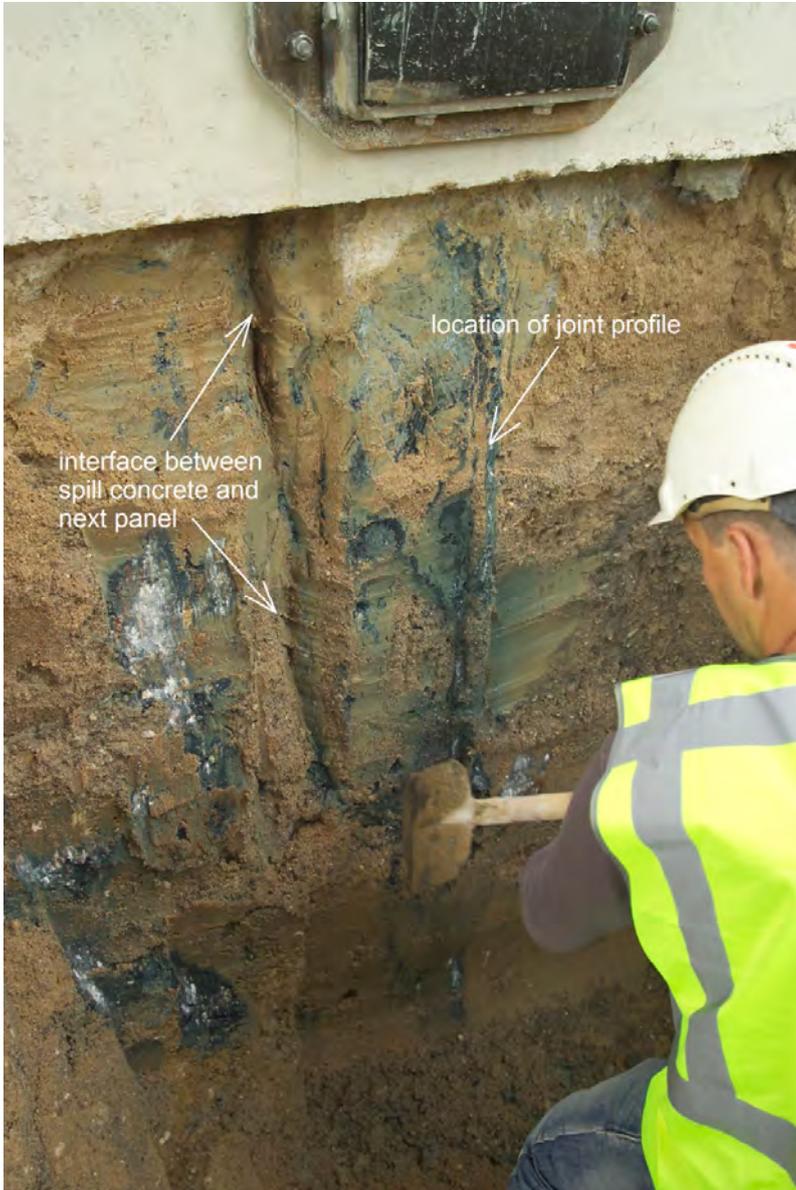
Figure 77: Picture showing the intended joint and the accidental extra joint due to non-removed spill concrete

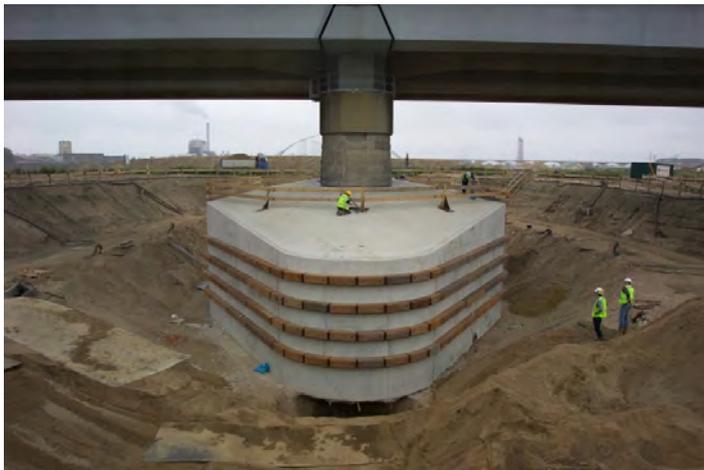
Figure 79: Result before excavation of the channel

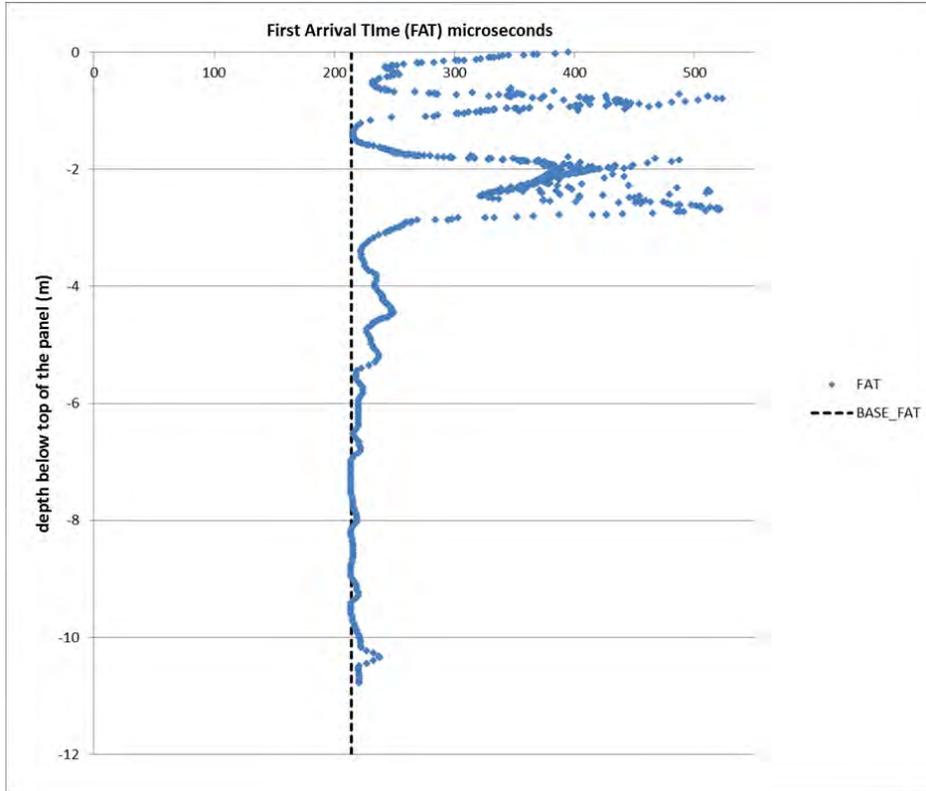
Figure 80: Determining the base-FAT to which the DAT is determined (crossing 1-3)

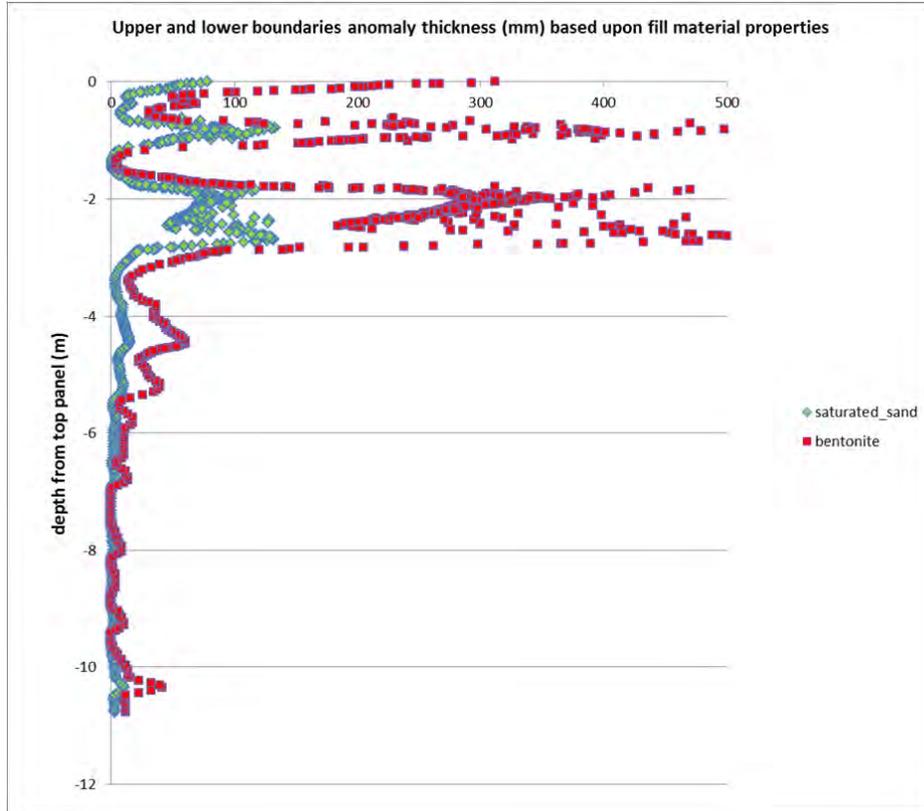
Figure 81: Anomaly thickness based upon DAT (1-3)

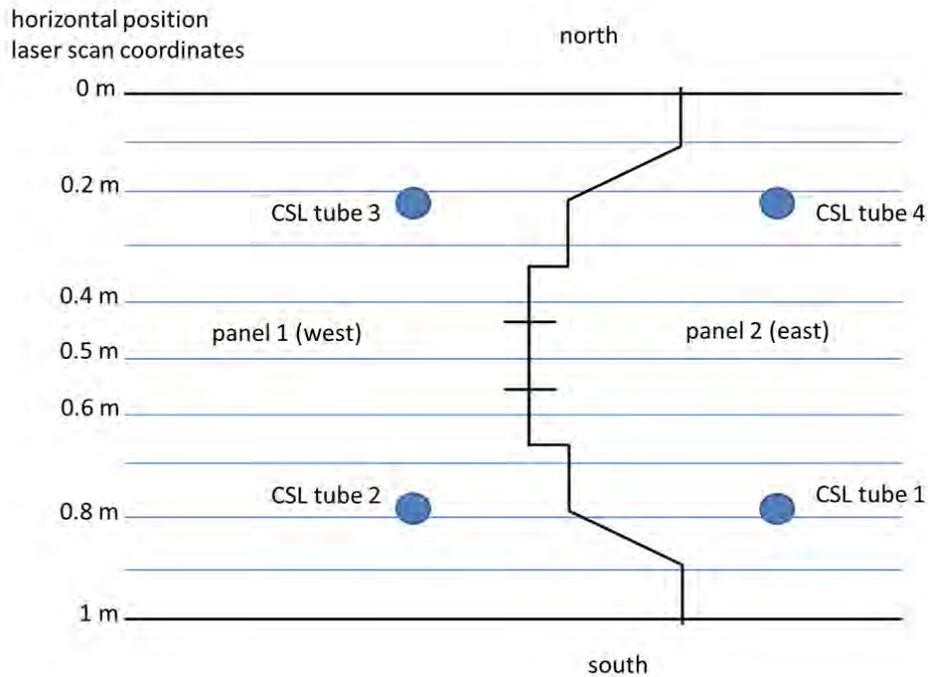
Figure 82: Schematic top view of the test panels

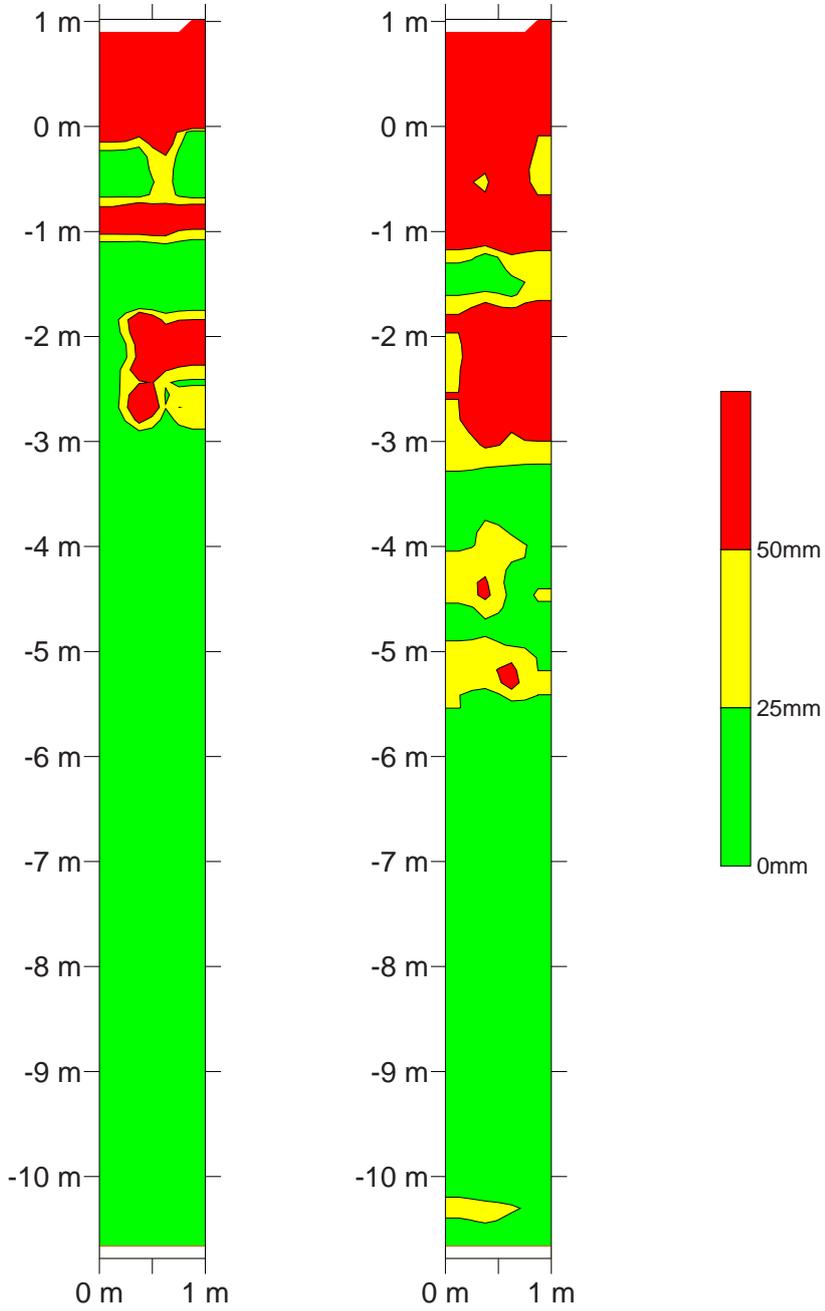
Figure 83: Interpreted anomaly thickness (mm) in the joint, assuming saturated sand fill (left) or Bentonite fill (right)

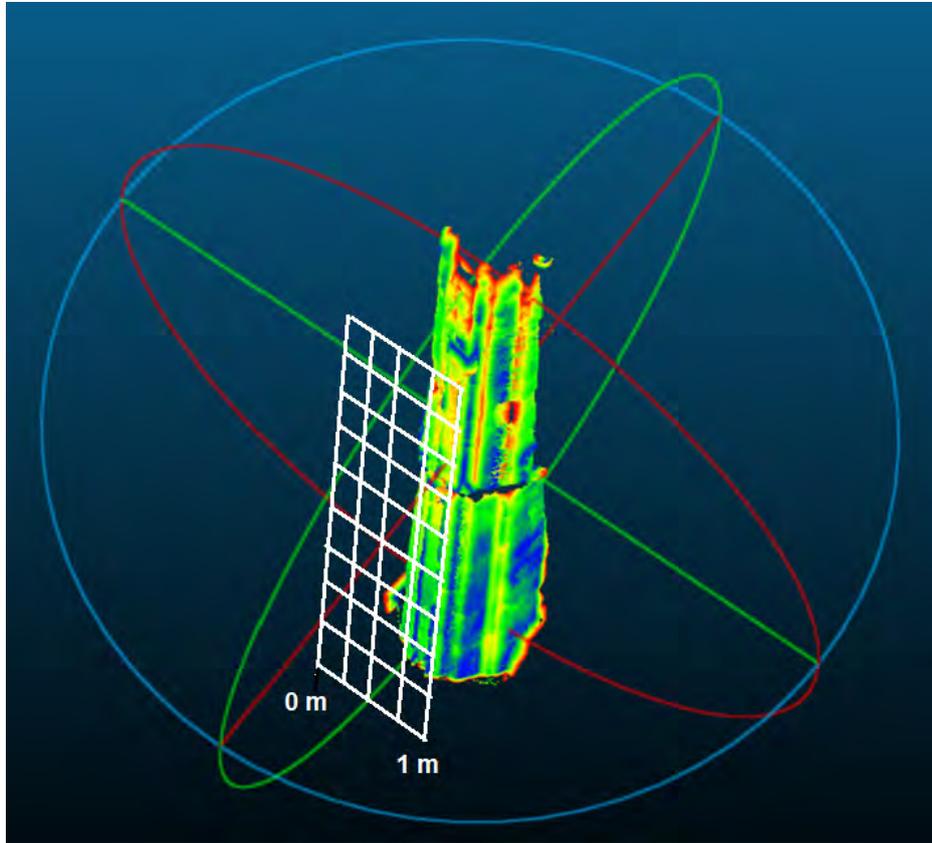
Figure 84: 3D model from laser scan data, with a sketch of the reference grid (in white)

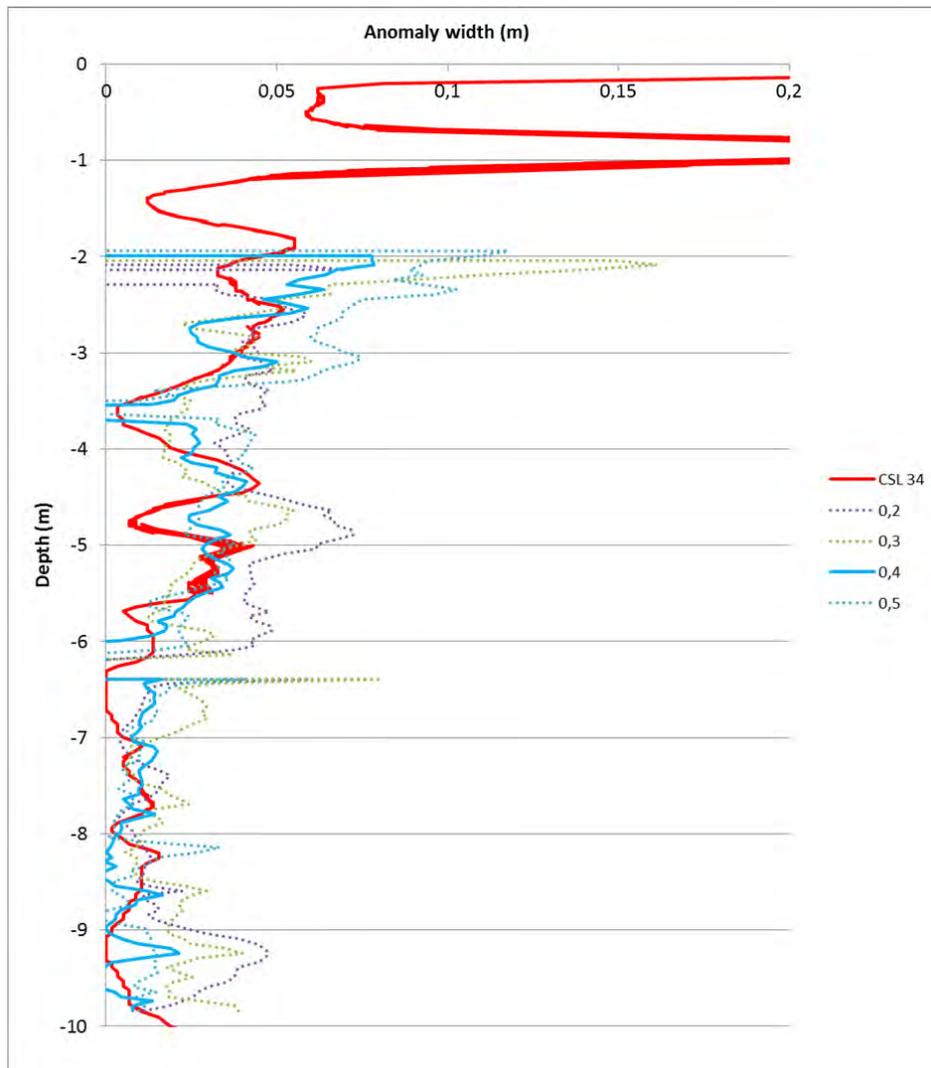
Figure 85: CSL interpretation assuming bentonite in the anomaly for scan line 3-4, compared with four scan lines from the 3D laser scan

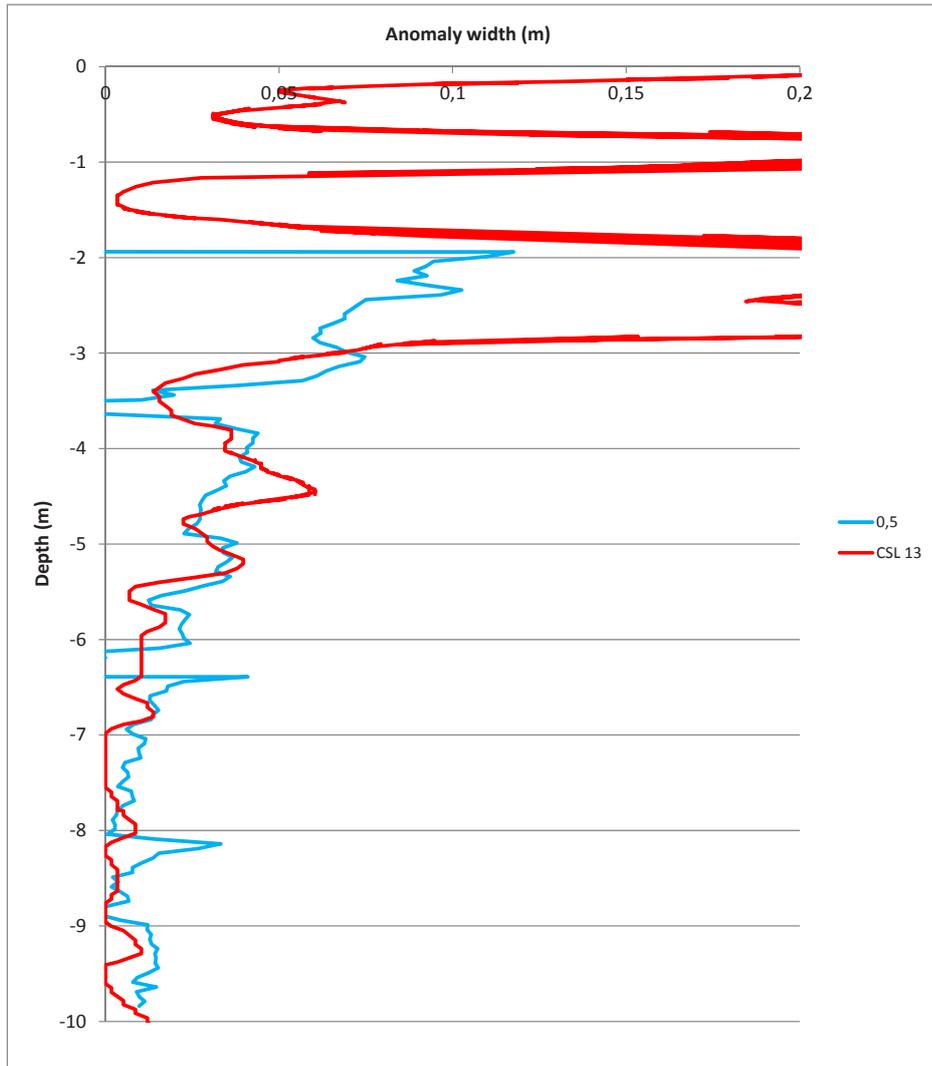
Figure 86: Example comparison of interpreted CSL results assuming a bentonite anomaly with 3D laser scan anomaly dimensions

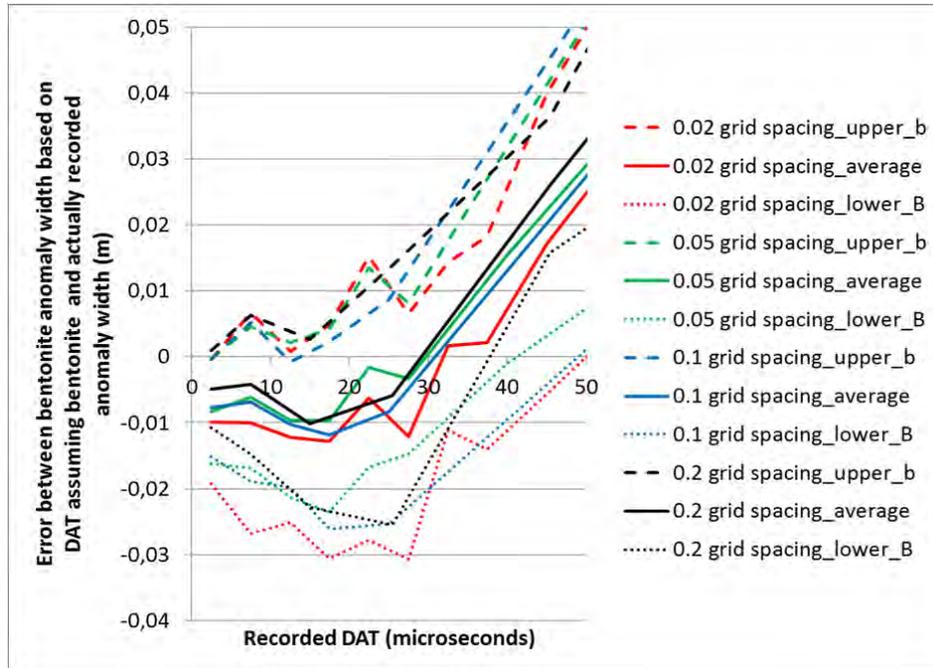
Figure 91: Error distribution as a function of DAT (up to 50 microseconds) and laser scan grid spacing. Upper and lower boundaries are set to average + and – the standard deviation.

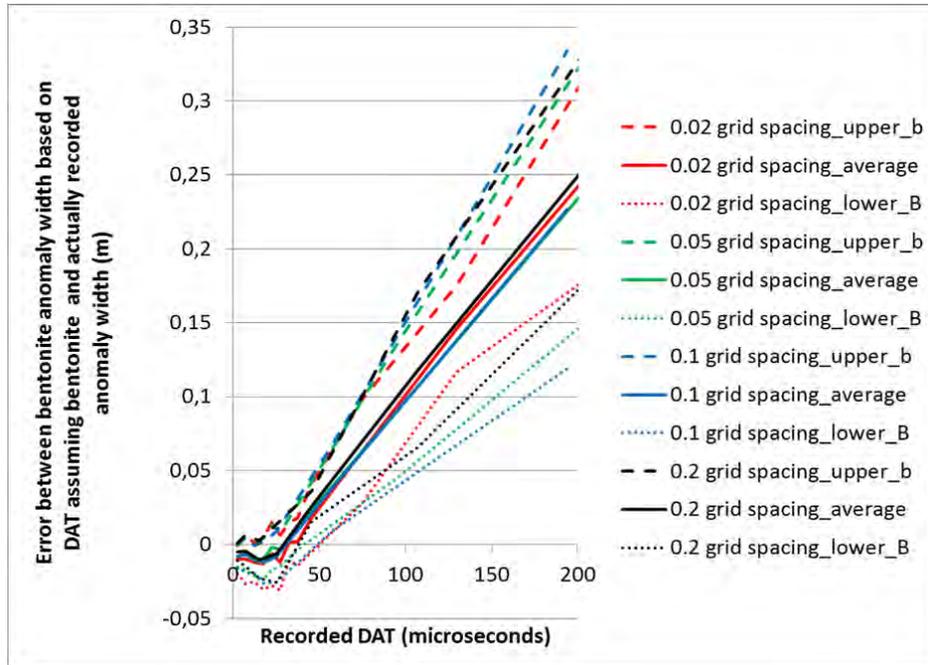
Figure 92: Error distribution as a function of DAT (up to 200 microseconds) and laser scan grid spacing. Upper and lower boundaries are set to average + and – the standard deviation.

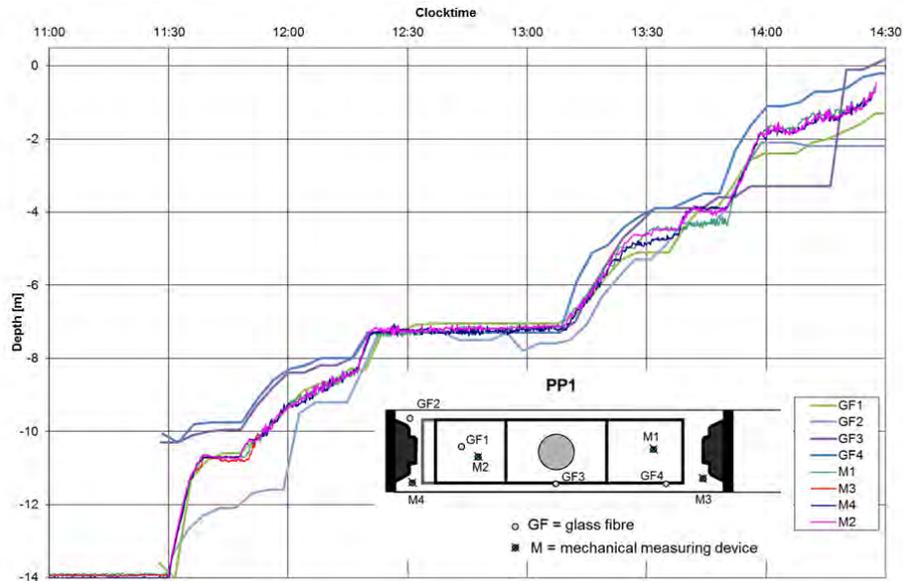
Figure 93: concrete casting progress recorded with DTS and mechanical loggers in panel 1

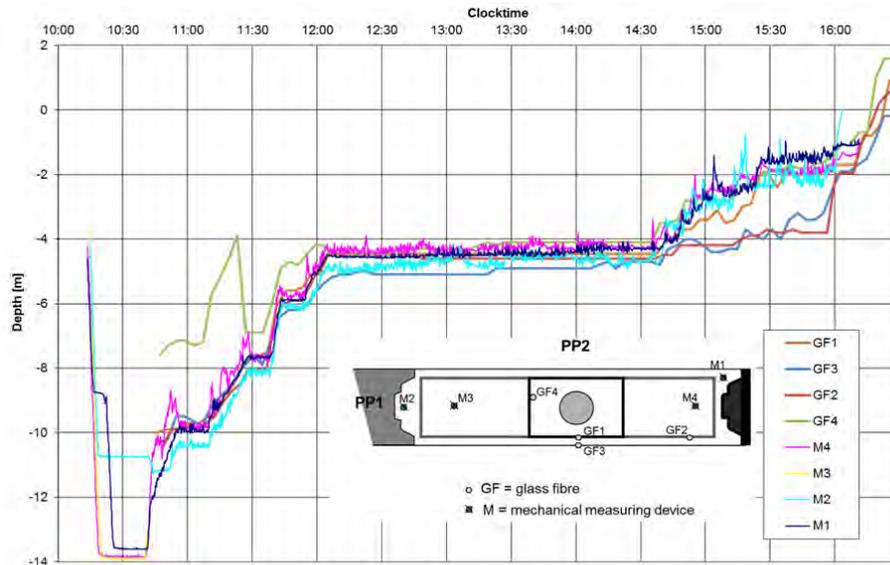
Figure 94: concrete casting progress recorded with DTS in panel 2

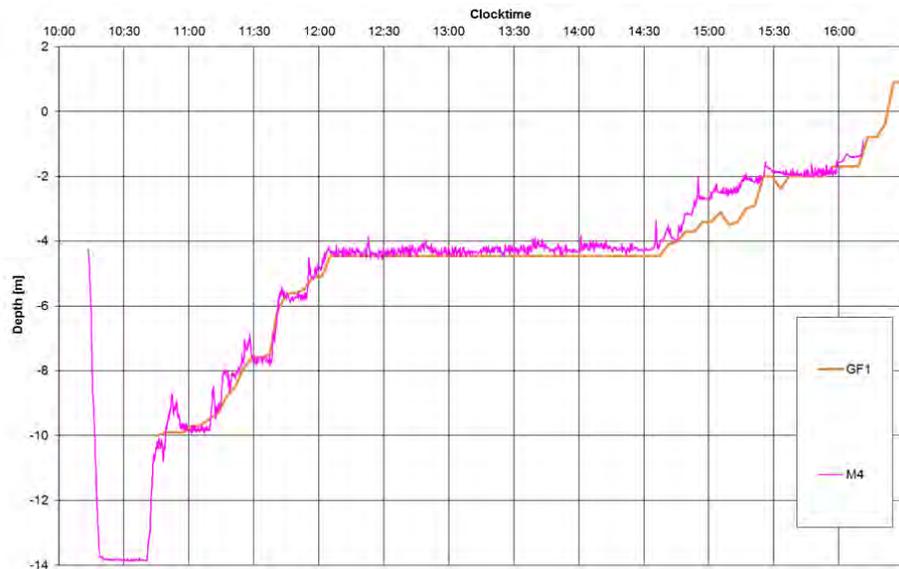
Figure 95: Comparison concrete level from automated mechanical logger (M4) and DTS based concrete level (GF1)

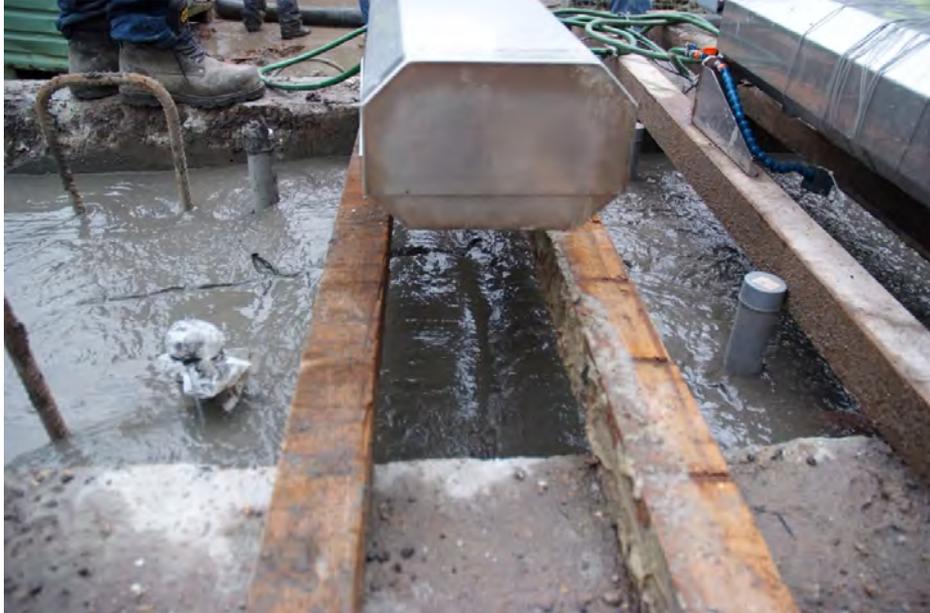
Figure 96: Automated mechanical loggers at work

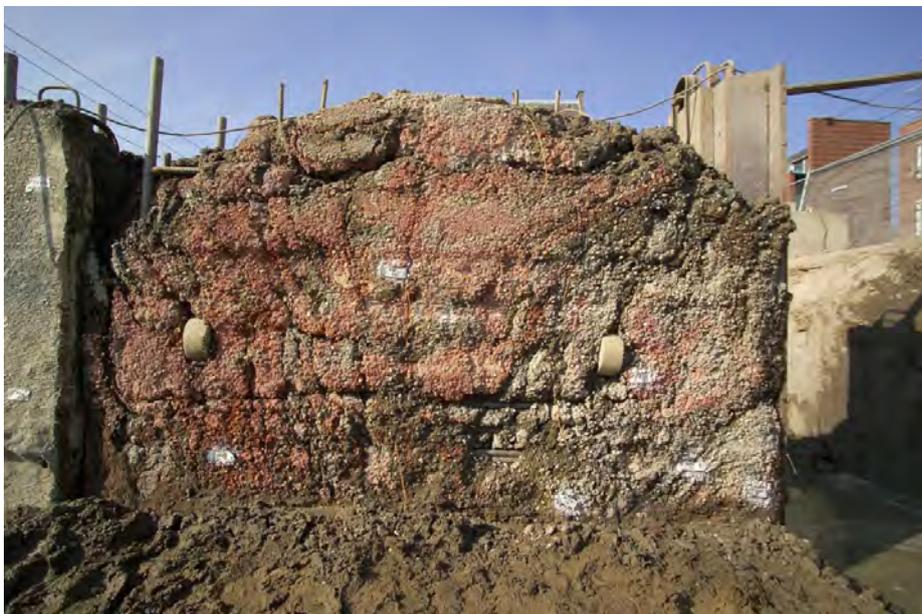
Figure 97: Side view of the south face of panel 2 (worst parameters), the western panel 1 is just visible on the left and shows much better concrete

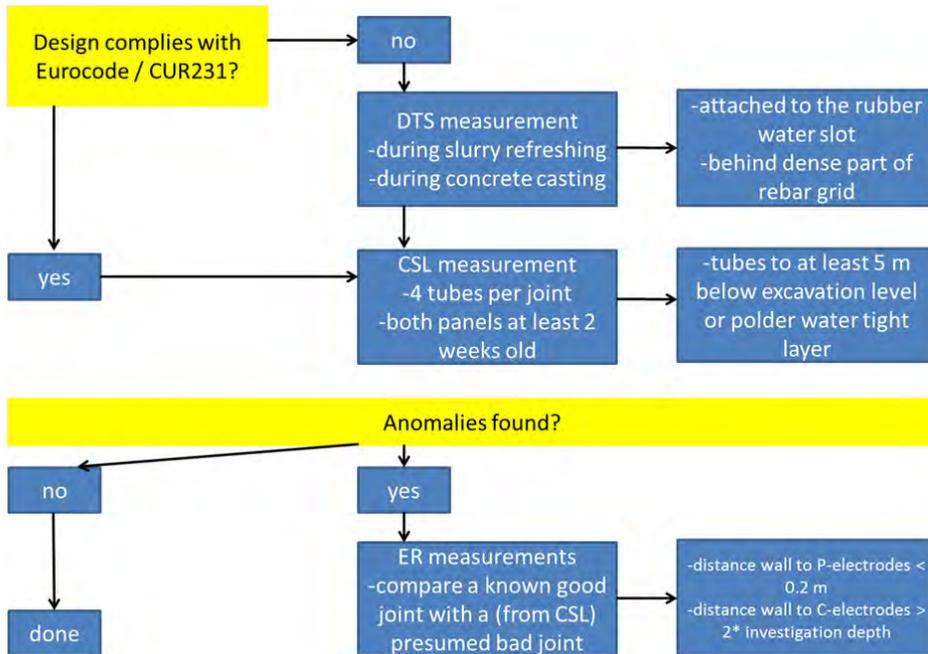
Figure 98: Decision scheme for D-wall testing
