## Experimental and Numerical Assessment of Historical Steel-Concrete Composite Bridge Decks Without Mechanical Connectors

Building for the Future: Durable, Sustainable, Resilient

**Abstract.** In old Dutch inner cities like Amsterdam a large number of steel-concrete bridge decks built between 1880 and 1960 remain in service nowadays and currently need assessment of their bearing capacity. A significant number of these decks were designed without any mechanical connectors like shear studs in the interface between concrete and steel. Moreover, the concrete decks were designed with only shrinkage reinforcement in both directions on the top layer of concrete. No additional transverse reinforcement was placed that can ensure proper (re)distribution of loads after cracking. In order to study the bearing capacity of this deck typology, two specimens of an existing bridge were taken to the Stevin Lab of TU Delft and tested until failure. In this work, the experimental results of both tests are presented. Then, finite element models including nonlinear behaviour of the materials and the interface are presented and compared with the experimental observations. Experimental results show tha

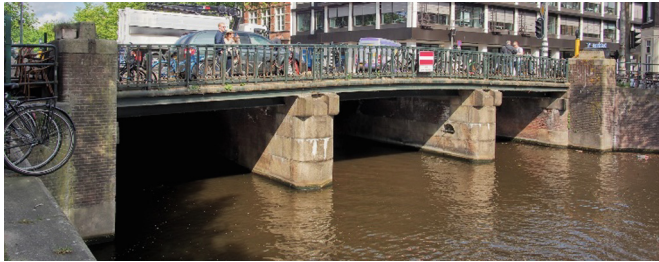
**Fig. 1.** Picture Bridge 70 Vijzelstraat, Amsterdam. Picture adapted from Google.

A particular type of bridges that has brought attention lately is the steel-concrete-composite slab deck. These bridges were designed and built between 1880 and 1960, and around 150 are still in operation in Amsterdam [1]. These bridges are multi-span bridges, and the cross-section of the deck is composed of partially encased steel beams, see Fig. 1 and Fig. 2.

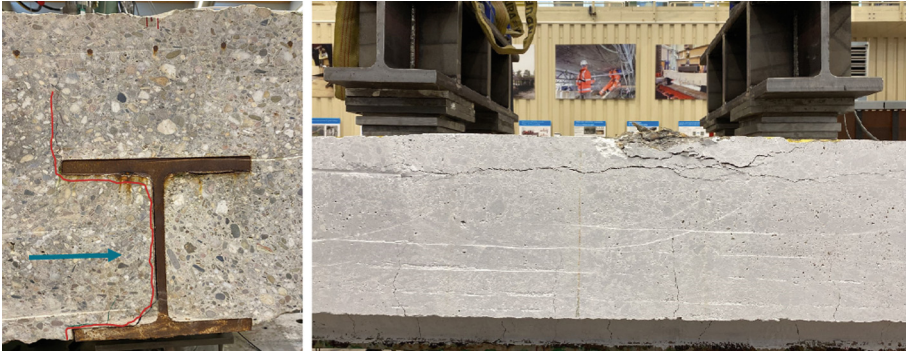
**Fig. 7.** Observed Failures. Left: Specimen LB1. Right: Specimen LB3

Specimen LB1 failed in a brittle manner after the development of plastic deformations in the steel beams. Interface failure occurred suddenly on one of the outer beams. This happened jointly with an increase of the transverse displacement between the outer and centre beams. Moreover, longitudinal cracks were observed between the beams. That also explains the increase of transverse displacements. In Fig. 7-left shows how the crack reached the end of the specimen at failure.

In the case of LB3, the specimen failed in a ductile manner exhibiting progressive concrete crushing on the top layer of concrete, see Fig. 7-right.

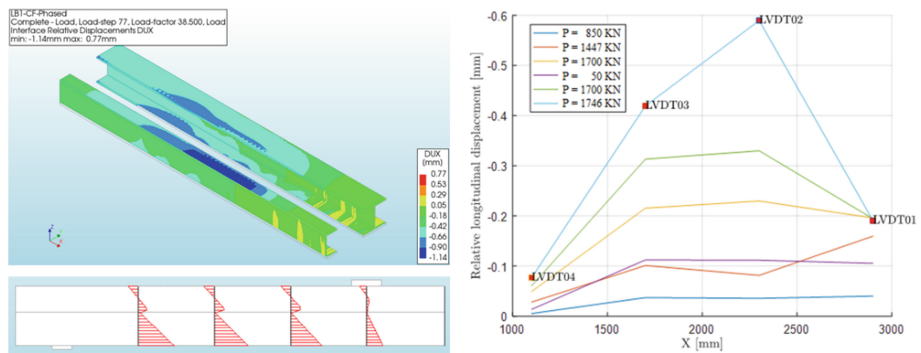
**Fig. 12.** Interface Behavior LB1 - Top Left: Longitudinal Interface slip. Bottom Left: Relative displacement profile at central beam. Right: Slip measurements at different locations

Another source of difference between both specimens was the interface behaviour. In LB3 minor slips were observed during the test and on the numerical models. LB1 exhibited interface activity at early stages of the test, see Fig. 12-right.

During testing of LB1 the interface slip was distributed longitudinally but without reaching the element ends. Full propagation of the interface failure occurred at ultimate stage and on one of the outer beams, contrary to the expectation of interface failure at the more loaded centre beam.

The overall interface behaviour was well captured by the numerical model. In Fig. 12 shows that partial interaction was simulated. A more accurate quantification of the interface behaviour requires the precise estimation of the interface parameters.
