## Bridge Clogging in Belgium and Germany During the 2021 Floods

Water Resources Research

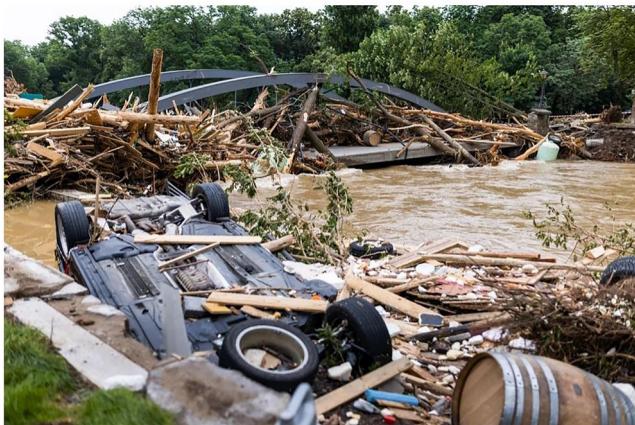
**Figure 1.** A debris accumulation in Bad Neuenahr-Ahrweiler, Germany (bridge 16 in the database by Erpicum, Poppema, Burghardt, Benet, Klopries, et al. (2024)). Trees, vehicles, tanks and other objects are present in front and on top of the bridge, with debris interlocking with the bridge superstructure. Photo by Philipp von Ditfurth (Jannaschk, 2021).

this floating debris would often be blocked at bridges, creating debris accumulations (see e.g. Figure 1) reducing the conveying capacity of an already overloaded water infrastructure.

A multitude of different objects and materials was present in the debris accumulations, as visible in photos of accumulations (e.g., Figures 1 and 5). Detailed analysis of the type and volume of objects in the accumulations showed that on average about half of the material was natural wood (trees), in both Belgium and Germany (Figures 6a and 6b). The other half of the debris mixture was of anthropogenic origin, often in the form of anthropogenic wood (construction wood, cut and without bark) or building rubble (parts of roofs, insulation material, etc.) from upstream buildings damaged by the flood. In Germany, a substantial fraction of the debris also consisted of vehicles: cars and caravans. These were not present on the photos of Belgian accumulations, probably because campsites or parking areas were not located directly along the river or not flooded as severely. Other debris types present are tanks and containers (shipping containers, water tanks, petroleum tanks of heating systems, etc.), household items (furniture, electrical appliances) and industrial items (large equipment from factories along the river).

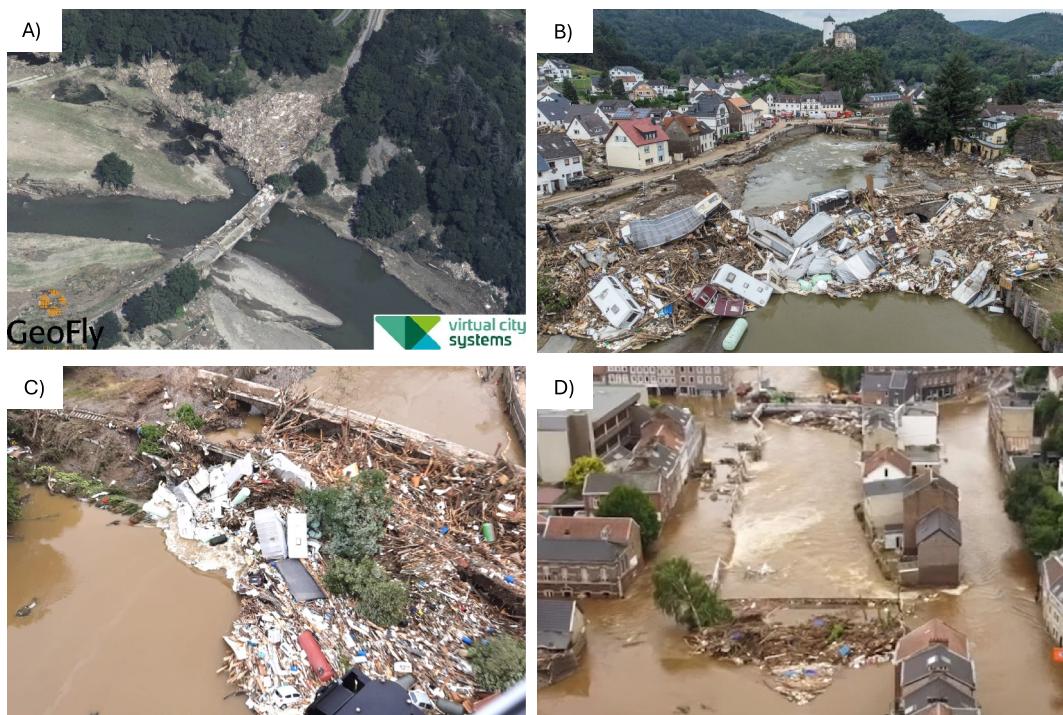
**Figure 5.** Examples of clogged bridges in the database. (a) Pützfeld, Germany (bridge ID 63 in the database by Erpicum, Poppema, Burghardt, Benet, Kloppries, et al. (2024)). Photo based on an aerial survey after the flood event by GeoFly GmbH and provided by Virtual City Systems. (b) Kreuzberg, Germany (bridge ID 62, after the flood). Source: Baumert (2024). (c) Altenahr, Germany (bridge ID 55 and 56, after the flood). Photo by Polizei Thüringen (2021). (d) Pepinster, Belgium (foreground: bridge ID 59; background: bridge ID 60, during the flood) Credit: Vedia. The flow direction is from left to right and foreground to background.
