What can we learn from a photographed B-17 “Flying Fortress” in-flight structural failure?

Reengineering history: What can we learn from a photographed B-17 “Flying Fortress” in-flight structural failure?

Delft University of Technology, Faculty of Aerospace Engineering, Delft, 2629HS, The Netherlands

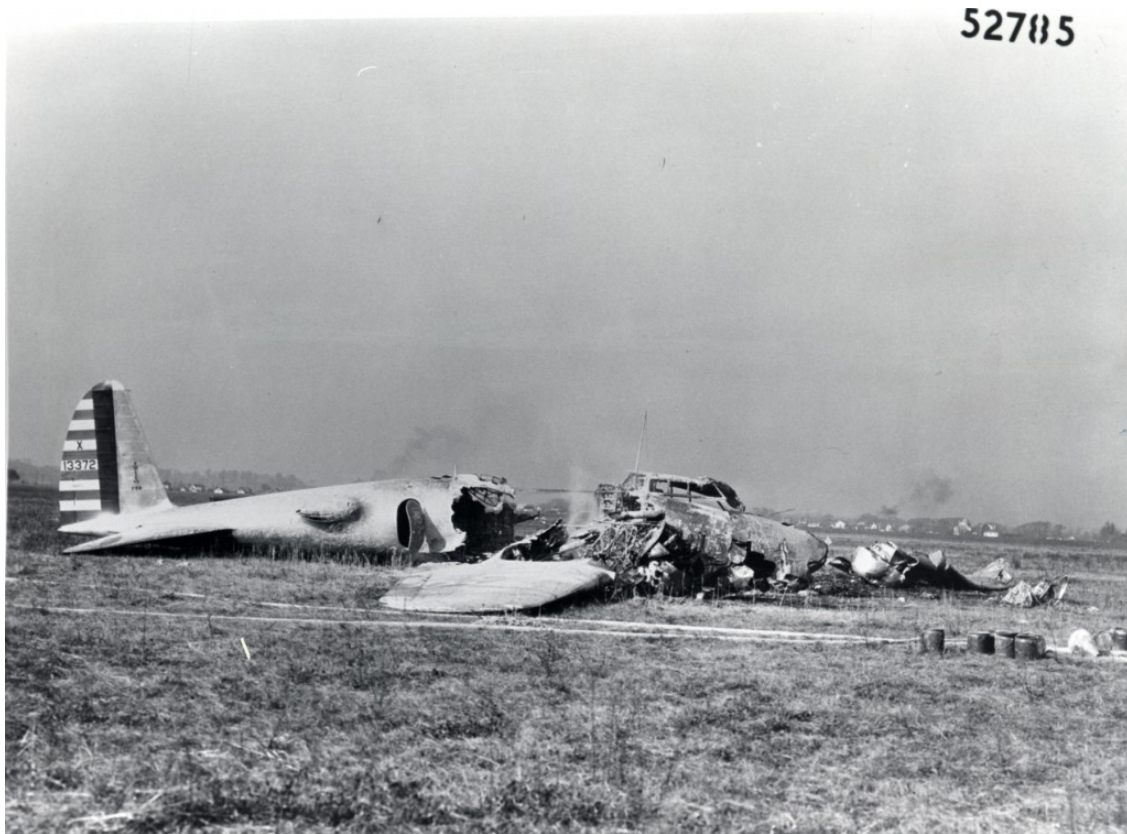
On October 30th, 1935, during evaluation exercises for the USAAC, the 299 crashed shortly after take-off (Fig. 1). The gust locks were left engaged and this oversight resulted in the aircraft entering a steep climb and stall immediately after take-off. The official investigation into the cause of the crash was concluded in December as pilot error and the Model 299 was absolved of having any defect contributing to the crash [3].

Fig. 1 Side view Model 299 after the crash during evaluation exercise [4].

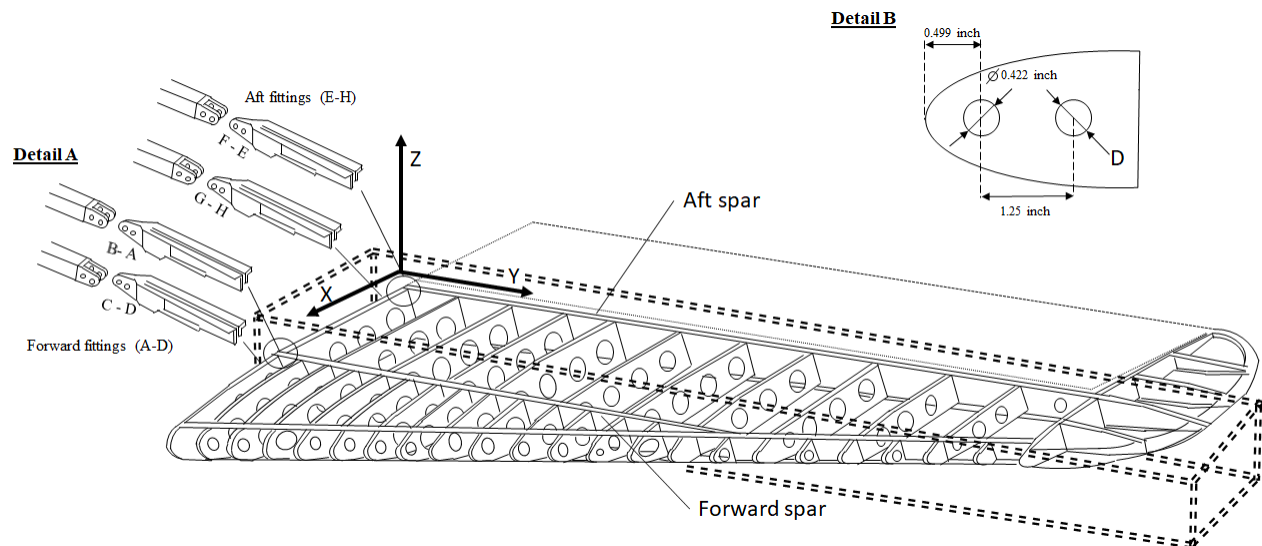
The B-17 horizontal stabilizer Fig. 2 has an area of 250.6 sq. ft. and is set at 0° relative to longitudinal axis. The front spar extends 19.167 feet to within 8 feet of tip end. The longer rear spar extends to the tip joining point. From the point where the front spar stops to the end of the tip, the leading edge and rear spar take over as the torsion-carrying structure. The two I-type spar beams have hydro-pressed webs with at the end a steel male attachment fitting. These end fittings can be joined with a steel taper pin onto bulkhead section 8 and 9 of the rear fuselage which has a female type fitting. The stabilizer has a NACA 0012 symmetrical profile which allows the stabilizer to be interchangeable on the left and right hand side. The flying characteristics of the B-17 were good as it was designed as a bomber flying long missions. The B-17 was not designed for spins and steep dives care must be taken to recover the aircraft [8]. A limit load factor of 3 is given for a design gross weight of 48,726 pounds [9].

Fig. 2 Horizontal stabilizer assembly B-17 with fittings (Detail A) and lug measurements (Detail B).

The two-spar horizontal stabilizer consists of a center structural box section with two outer sections, the leading edge section and aft elevator section. The aft spar serves as the connection point for the elevator. The leading edge consists of the ribs shaping the nose which are connected to the forward spar and the skin. It is assumed no major structural load can be carried by leading edge because it is designed for much lower loads than the bomb exerts during impact and thus would fail immediately. The elevator is a separate element connected by two hinges and a torsion bar for elevator and trim control. Similar to the nose section the elevator is considered to be able to carry a bomb impact load and would fail immediately. As such this approach uses a symmetrical structural box section consisting out of the forward and aft spar to assess the forces and moment at the stabilizer root to fuselage connection. As a result, the bomb impact location (X and Y-direction) which is a model input should be within the wing box outline shown in Fig. 2. This is supported by close examination of Fig. 4a.

The horizontal stabilizer is in principle designed to withstand the lift force and is connected to the fuselage by two terminal fittings on each spar. Each terminal fitting consists of a male and female lug system with two holes for a taper pin Fig. 2 detail A. The fittings have lug holes which are individually designated from A-H. Using the wing box dimensions the reaction forces F_x , F_Y and F_z of each individual lug hole can be calculated following the aerodynamic (A) and bomb load (B) inputs.

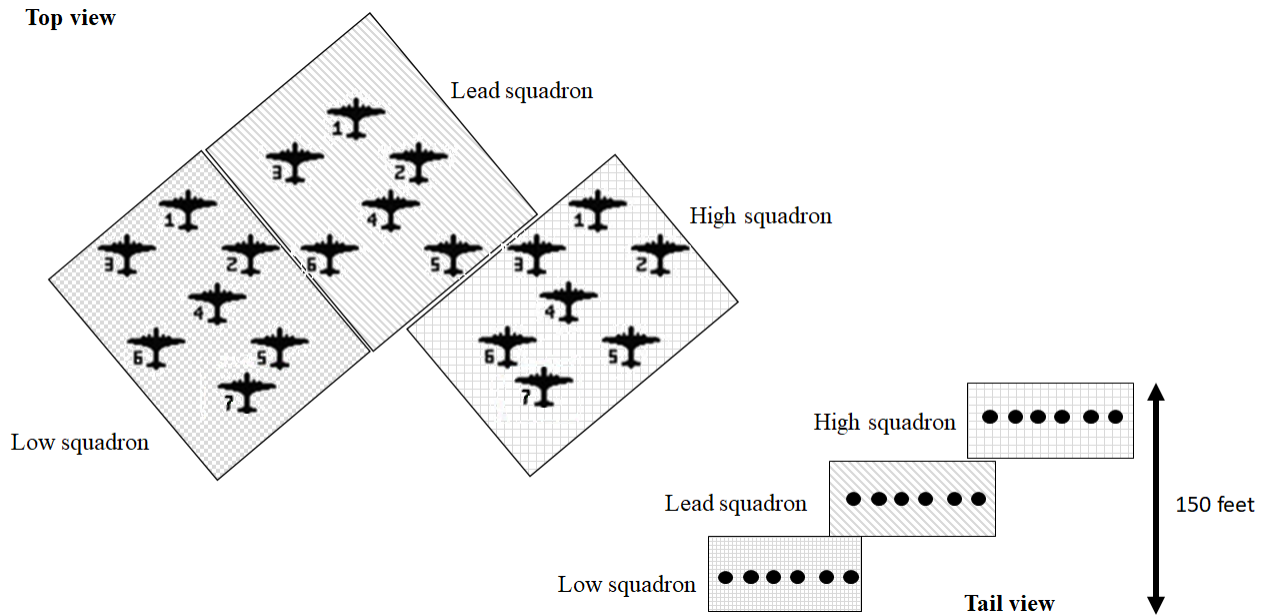
In January 1944 the box formation was adopted as general practice and was used for missions. The box formation was tuned to best use the B-17 armament and defend the formation. The formation also needed to be close together to give a better bomb pattern and minimize the time over heavy flak defenses and anti-aircraft guns which could only fire on a few number of the units at the time. The three squadrons element flew in a box of 160 feet wide by 150 feet high, the distance was close and staying in formation was essential Fig 3.

Fig. 3 "Box formation" flown by the B-17s with aircraft position numbers.

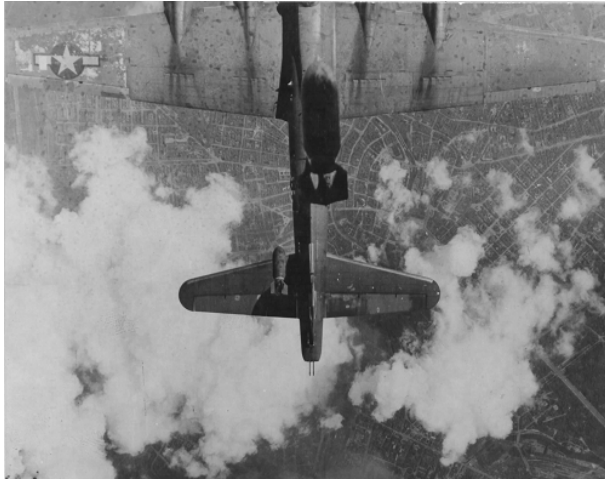
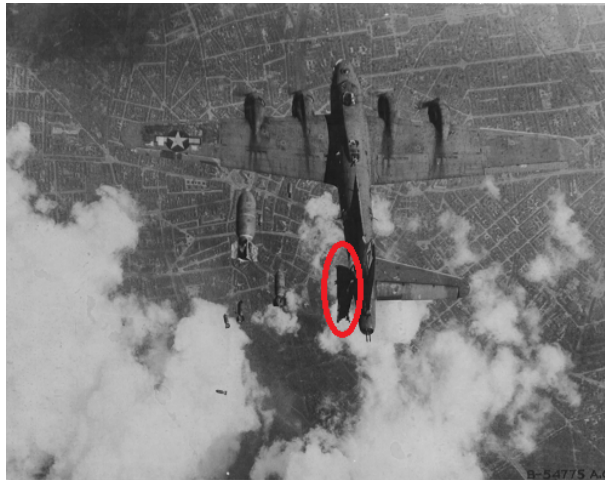
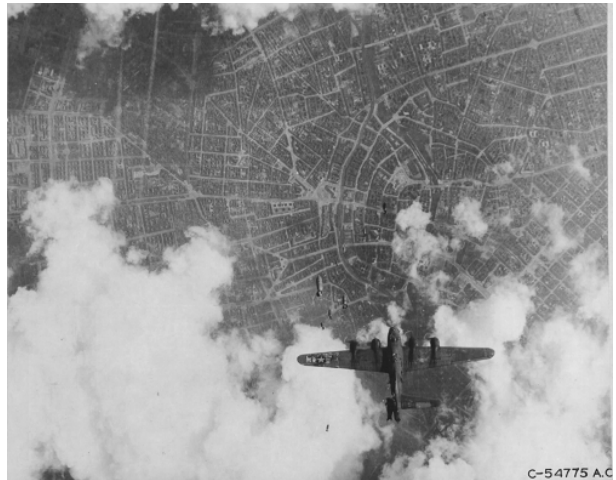
(a) Photograph showing stabilizer before bomb impact.

(b) Photograph 1 showing stabilizer after bomb impact.

(c) Photograph 2 showing stabilizer after bomb impact.

(d) Photograph 3 showing stabilizer after bomb impact.

Fig. 4 Photographs (a)-(d) showing the B-17G "Miss Donna Mae II" left horizontal stabilizer hit by bomb [17].

After reviewing the photographs in Fig. 4 three main scenarios were developed which could explain the stabilizer failure. The first scenario will look at the possibility of an explosion of the bomb when it hit the stabilizer. The second and third scenario will look at the failure caused by bomb impact, where the distinction is made between a partial and a full separation of the horizontal stabilizer.

The second scenario that will be looked at is a full separation of the left stabilizer due to the bomb impact. This scenario has been suggested by several sources including the MACR[18] report and the original photograph descriptions Fig. 4. Following this scenario and given the time interval between the photographs it would be likely to observe the separated stabilizer falling down. Examining the three post impact photographs Fig. 4b, 4c, and 4d no debris can be observed. Evaluating this information Scenario B – full separation of the left stabilizer by impact is possible but given photographic evidence unlikely.

Two other model input variables are the X and Y-coordinate of the bomb impact point on the stabilizer. Using Fig. 4a an estimate of the bomb impact location can be determined using scaled distances. Figure 4a is a top view of the B-17, where the Bomb c.g. is at 1/3 from the nose. Assuming no lateral movement occurred before impact the impact

location is determined to be approximately 35 inches (Y-direction) from the fuselage-stabilizer root connection. This result will be used to evaluate the model outcomes for the photographed stabilizer impact event.

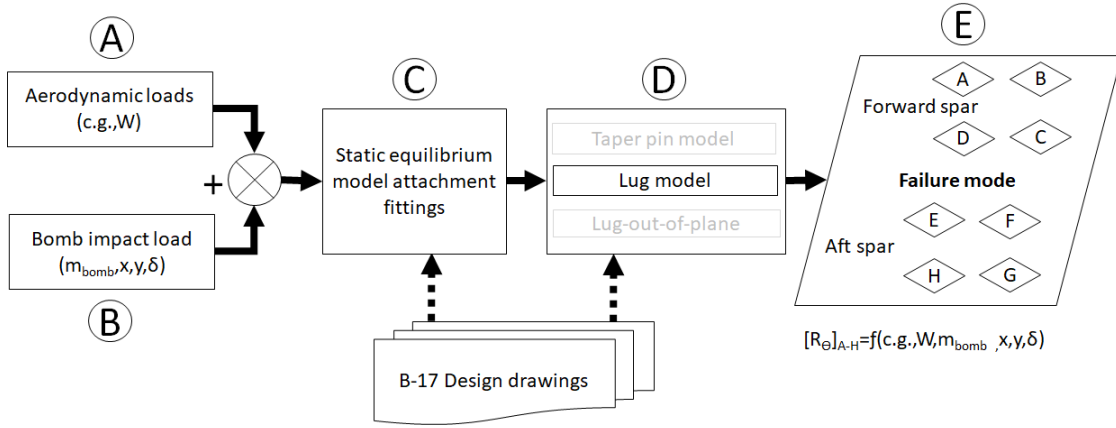
Fig. 5 Structural modeling approach diagram.

Figure 5 shows the model setup with the inputs consisting out of the estimated aerodynamic loads (A) and the force resulting from the bomb impacting the stabilizer (B). The stabilizer static equilibrium model for the connection points (C) represents the mechanical characteristics of the stabilizer connection points to the main fuselage. In the failure model (D) the taper pin, lug and male fitting connection base maximum forces are calculated. The analytical model was created using B-17 design drawings and component specifications [23]. Given model inputs an assessment of possible failure mode(s) (E) can be evaluated. A more detailed description of the modeling approach is provided in the next sections.

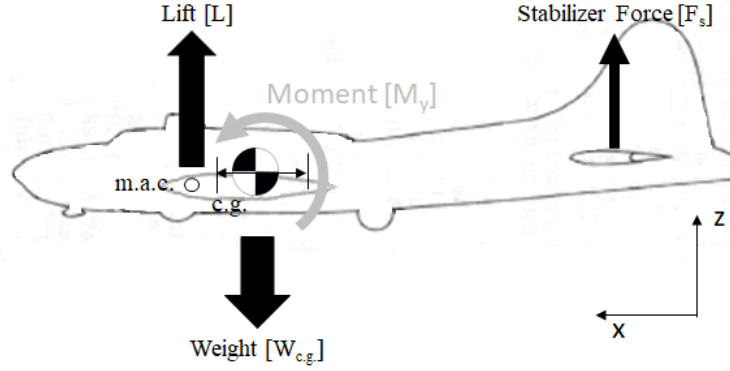
For a balanced flight condition, the external forces and moments acting in the vertical plane on an aircraft can be determined using the simplified scheme depicted in Fig. 6. The B-17 aircraft can be simplified to a fuselage, main wing and stabilizer. The aircraft weight ($W_{c.g.}$), lift (L) and the stabilizer force ($F_{stabilizer}$) are assumed to be aligned in the Z-direction. A balancing calculation can be executed to determine the stabilizer vertical force or lift. Using the aircraft weight and balance data the center of gravity (c.g.) and mean aerodynamic chord (mac) are described [24]. As the B-17s' center of gravity and weight range are known the load balancing calculation Eq. (1) and Eq. (2) yields the stabilizer vertical force for its full operational flight range. The balancing calculation output is the total stabilizer force or vertical force created by the stabilizer during flight.

Fig. 6 The vertical forces and moment for the B-17 weight and balancing calculation

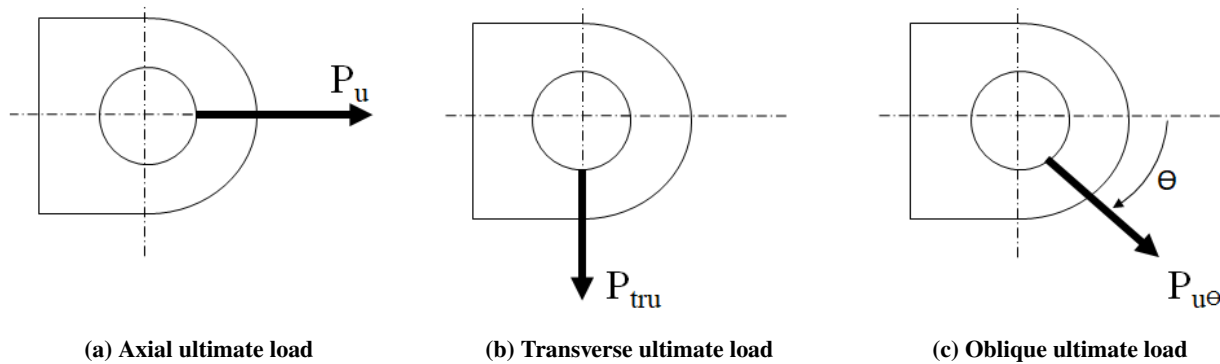
Fig. 7 Lug loading.

The maximum load able to be carried by the lug connection can be calculated using standard calculation methods [26–28]. Three different load cases can be distinguished an axial, transverse and an oblique load failure Fig. 7. For axial load failure three failure modes can be distinguished, a net section failure which can be described by Eq. (8), a shear-out or bearing failure which can be calculated by Eq. (9).

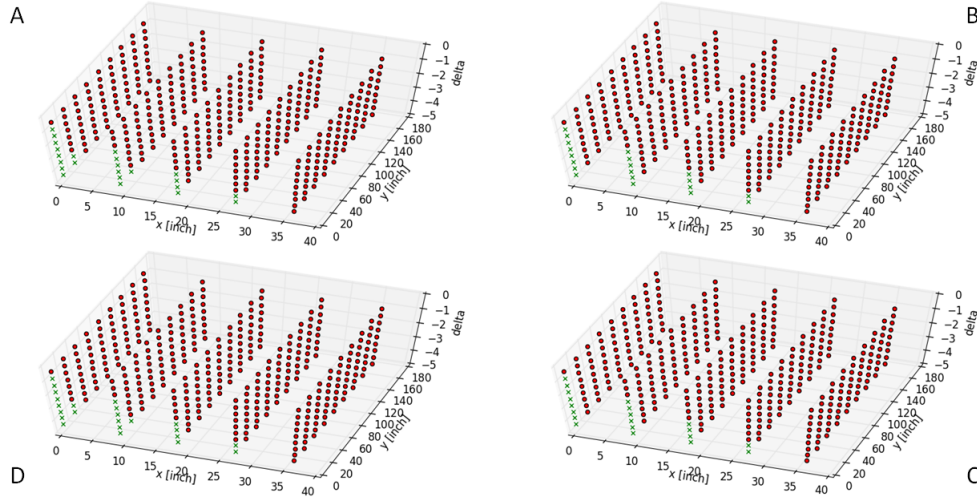
Fig. 8 Oblique load failure for lug element A-B-C-D ($m_{bomb} = 1000lb$, $F_s=2000N$).

As can be seen from the Fig. 8 and 9 where $m_{bomb} = 1000lb$ a small area exists where the oblique lug load is not exceeded, this is near the root at large δ values. Reducing the bomb mass to $m_{bomb} = 100lb$ shows an increase in area where the lug load is within the R_θ threshold as shown in Fig. 10 and Fig. 11. This is also the case when the bomb is dropped at $y = 35$ inches, the estimated impact location from Fig. 4c. In this case however the calculated resultant F_x for fitting D and E are beyond the established normal load threshold for impact distance $\delta = 0.5$ and a failure would still occur.

The model results show that in most cases a $m_{bomb} = 1000lb$ would separate the stabilizer as shown in Fig. 8 and 9. This finding is not entirely consistent with the photographs of the event Fig. 4. By reducing the bomb mass to $m_{bomb} = 100lb$ the same study was performed. What one concludes from 10 and 11 is a relatively narrow range of impact locations exist where R_θ is above the threshold and the stabilizer would separate. A reverse outcome compare to

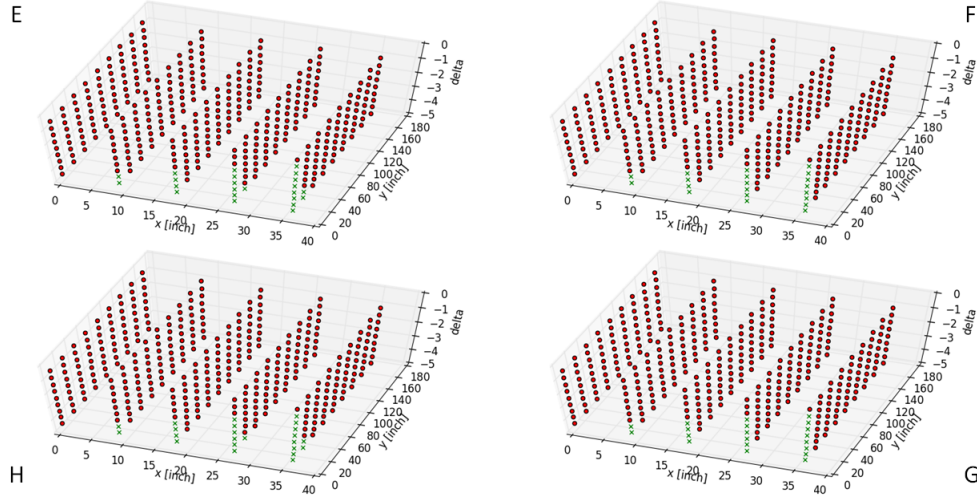
Fig. 9 Oblique load failure for lug element E-F-G-H ($m_{bomb} = 1000lb$, $F_s=2000N$)).

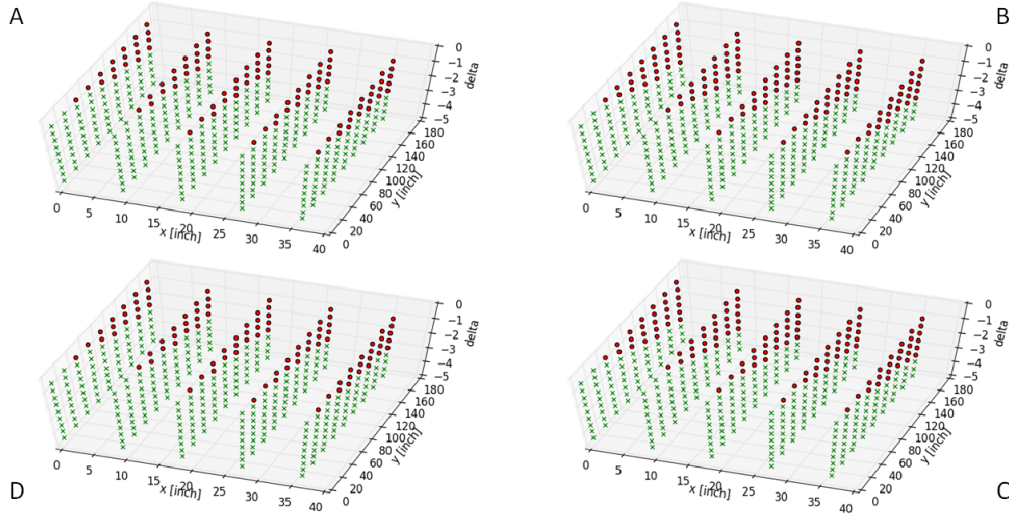
Fig. 10 Oblique load failure for lug elements A-B-C-D ($m_{bomb} = 100lb$, $F_s=2000N$)).

$m_{bomb} = 1000lb$, which shows that m_{bomb} mass influences the lug failure mode. Similar to Fig. 12 where the bomb mass m_{bomb} was simulated to vary the study outcome shows a small area where the stabilizer would not shear off. However this calculation shows the result of the forward spar when the bomb impacts the aft spar. This is an ideal case which is not consistent with Fig. 4a where it was estimated that the bomb impact was at $y=35$ inches between the forward and aft spar. Figure 8 and Fig. 9 clearly show that in that case the R_θ threshold was exceeded. Thus for the vast majority of cases it is expected that the stabilizer would separate.

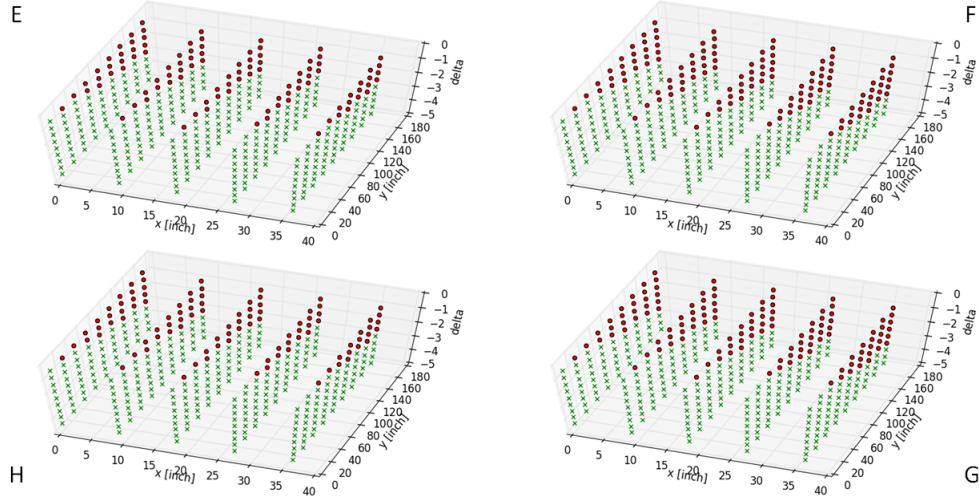
Fig. 11 Oblique load failure for lug element E-F-G-H ($m_{bomb} = 100lb$, $F_s=2000N$).

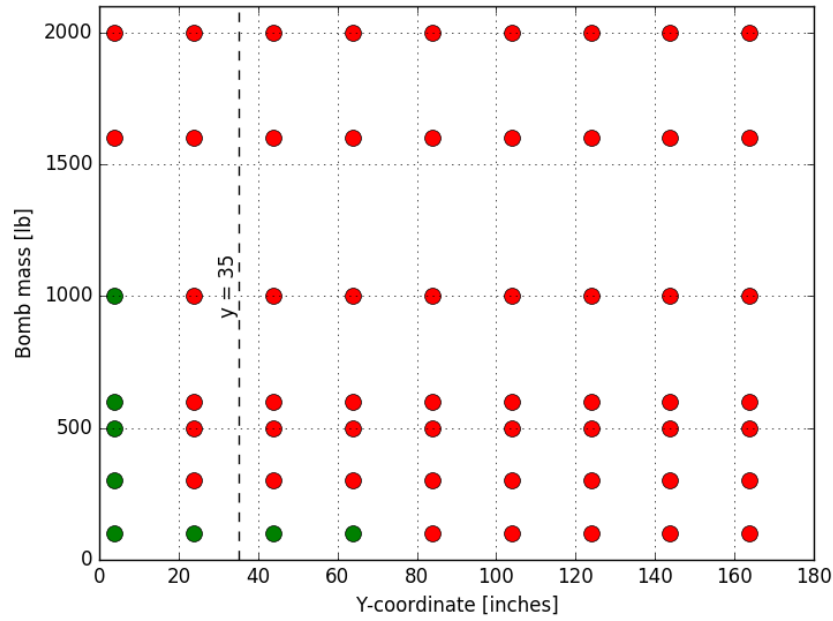
Assuming a bomb impact location on the forward spar $x = 36$ inch, an impact distance $\delta = 1$ and varying the bomb masses m_{bomb} which can be carried by the B-17 will result in Fig. 12. It can be concluded that a small area will not result in failure of the horizontal stabilizer and the lug load is within the R_θ threshold. What should be noted is that in this case the R_θ threshold is not exceeded for a $m_{bomb} = 1000lb$ when the bomb impacts the aft spar ($x = 0$).

Fig. 12 Forward spar with varying bomb mass m_{bomb} and y-coordinates ($F_s = 2000N$, $\delta = 1$, $x=0$).
