Characterisation and Application of Bio-Inspired Hybrid Composite Sensors for Detecting Barely Visible Damage under Out-of-Plane Loadings

Tabatabaeian, Ali; Mohammadi, Reza; Harrison, Philip; Fotouhi, Mohammad

Sensors

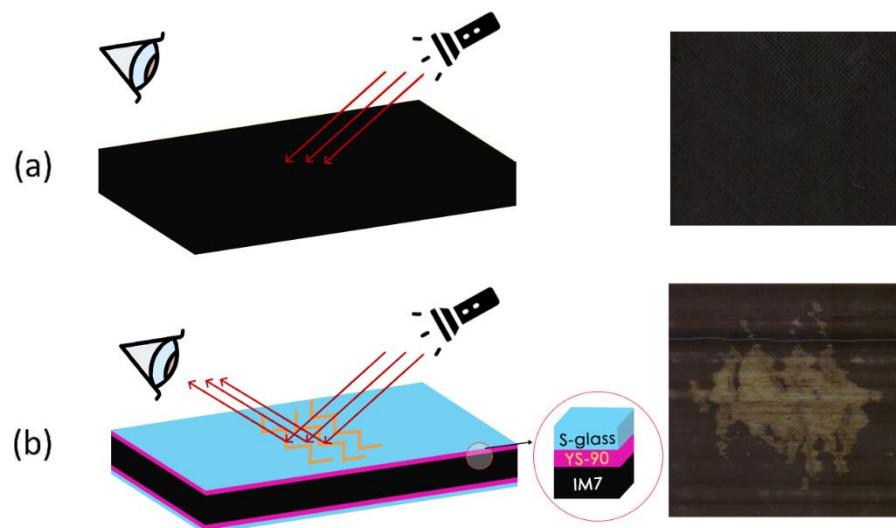
Figure 1. Schematic of (a) a reference specimen and (b) a sensor-integrated specimen, showcasing the sensor's working principle and configuration (left). The images on the right show the post-low-velocity impact surface of the specimens, highlighting the mechanochromic function in the sensor-integrated sample.

visible colour change occurs when subjected to strains surpassing a predefined threshold. As the sensor is applied onto the surface of the structure, it experiences similar strains as the underlying material. It comprises a carbon sensing layer and an outermost glass layer. As shown in Figure 1, a reference specimen (without a sensor) absorbs the light after being subjected to an impact load, indicating a dark appearance. In the *sensor* specimen, on the other hand, after the impact, when the strain goes beyond the failure strain of the carbon sensing ply, the carbon ply develops multiple fractures, reflecting the light from the damaged glass/carbon interface around the fractures in the carbon layer, making the damage visible.

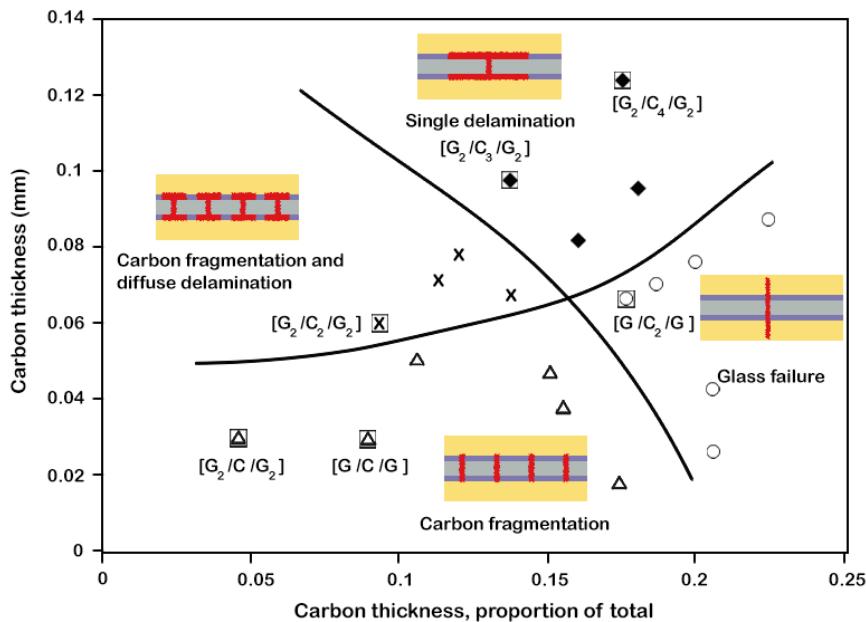
Figure 2. Categorisation of different damage modes as a function of absolute and relative thickness of carbon layers (reprinted with permission from Ref [23]).

The sensor can be integrated by either co-curing or retrofitting by bonding onto finished parts. Depending on the curing temperature of the sensor and substrate prepreg materials, the co-curing itself can also be done through either a one-step or a two-step curing procedure. By co-curing, the sensor acts as a structural sensing layer, while by retrofitting, it acts as a discrete sensor on the structure. It should be noted that the thickness of the sensing material must be thin enough to exhibit failure with fragmentation and dispersed delamination. This was studied in detail in work by Jalalvand et al. [23], where a damage mode map was developed using numerical damage analysis of hybrid glass/carbon composites with different thicknesses of the carbon layer (see Figure 2).

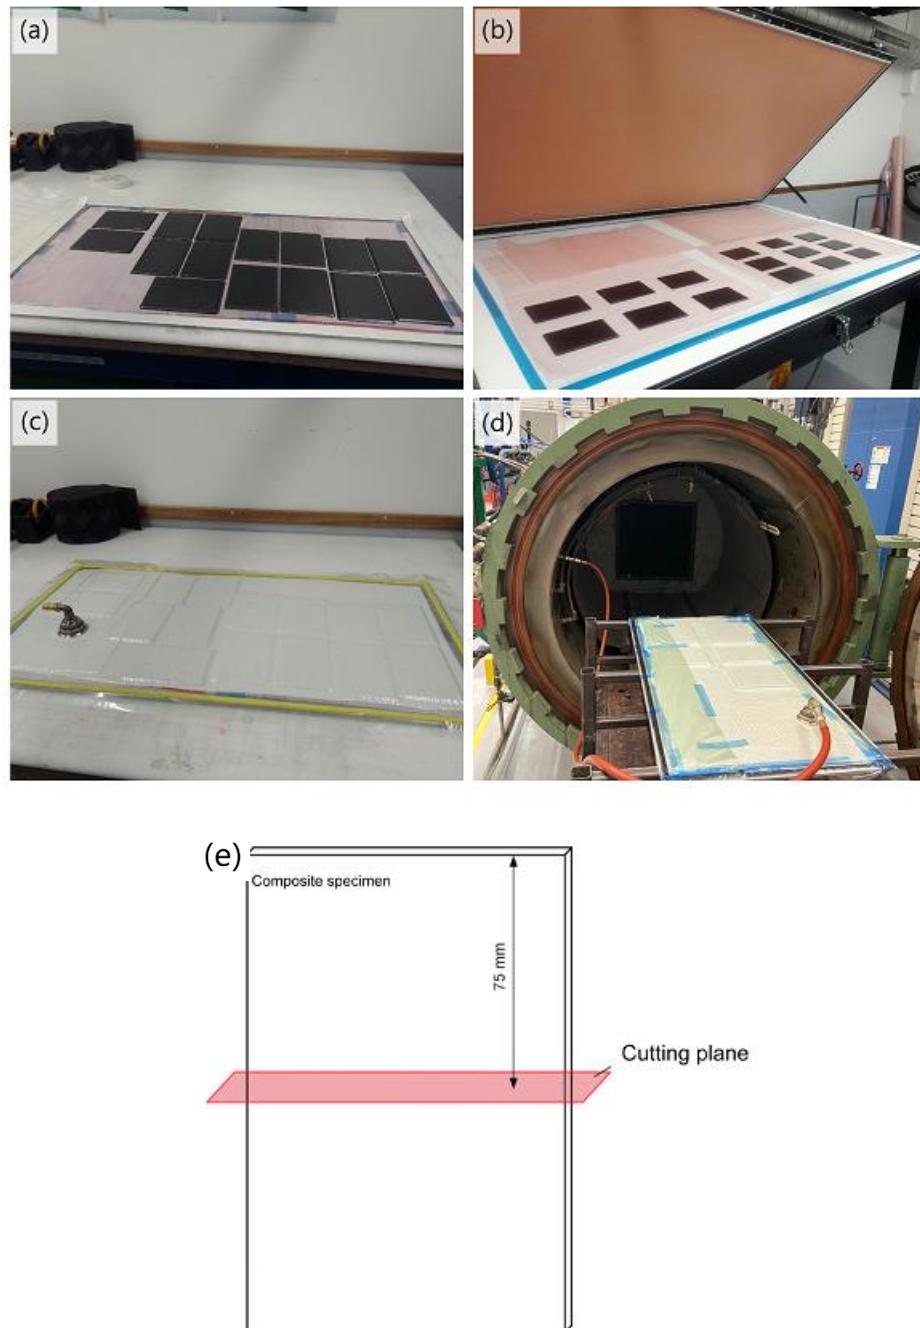
Figure 3. Manufacturing process: (a) cutting the prepgs into standard specimen size and stacking the layers, (b) applying pressure after stacking every four layers to ensure there is no air or bubbles, (c) completing the vacuum-bag lay-up, (d) curing at autoclave under desired temperature and pressure, (e) cutting plane for examining the cross-section of the impacted specimen.

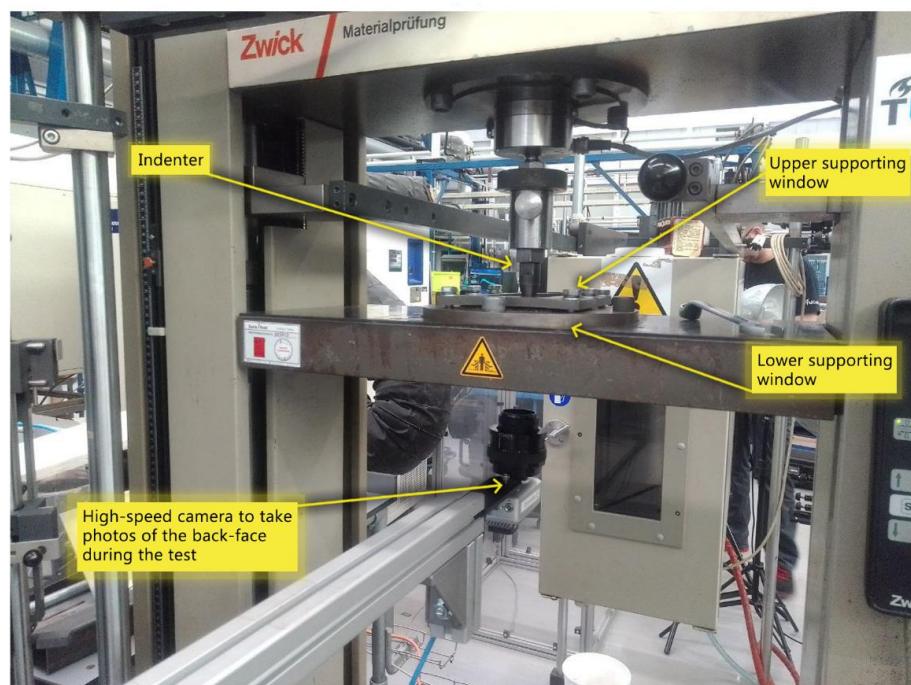
Figure 4. Indentation test setup.

The out-of-plane indentations were applied vertically on the front surfaces of the specimens at a constant indentation rate of 2 mm/min using a steel hemispherical indenter with a diameter of 16 mm, in accordance with the ASTM D7136-07 standard for drop weight impact damage resistance on FRP composites, ensuring the indentation test results match drop weight impact testing as closely as possible. The dynamic and rate effects of the laminate were considered to be minimal at this loading rate [21]. The specimen was positioned centrally over a 75 mm × 125 mm supporting window and was clamped in position, ensuring that the clamping base and the specimen were central to the indenter. Experiments were continued until a significant drop in force was observed, and the force did not continue to rise after the drop. This is the termination load drop, marked by an audible cracking sound. All tests (indentation and impact) were performed at room temperature. As shown in Figure 4, and a camera was placed beneath the supporting window to capture the initiation and propagation of the damage as well as sensor activation. The camera was set to take a photo every one second, collecting an image-based dataset during the whole test time.

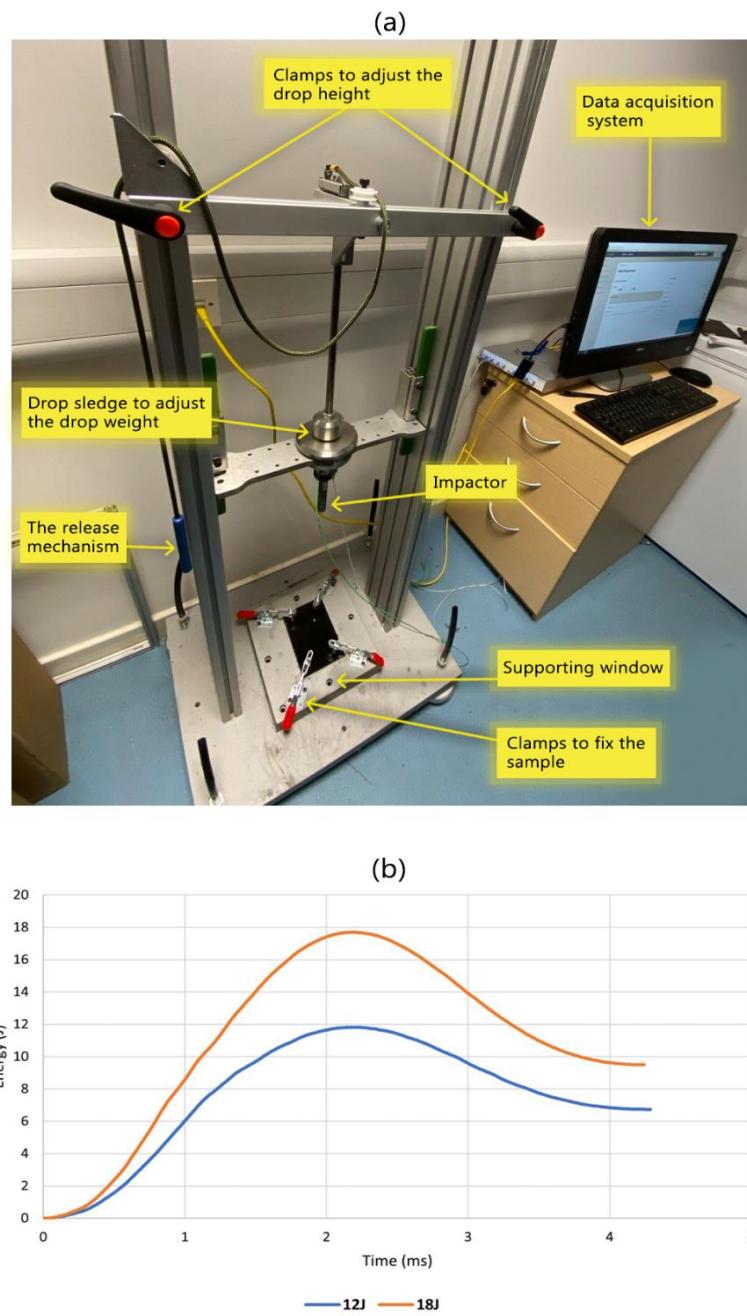
Figure 5. Impact test setup: (a) different parts of the custom-designed drop tower apparatus; (b) calculated impact energy at 12J and 18J impact tests from force–time results. Peak values are seen to match the corresponding test energy, demonstrating an effective setup.

Based on the indentation results, three impact energy levels were considered (12J, 18J, and 27J) and carried out according to the ASTM D7136 standard [21]. The drop mass was chosen to ensure the lowest drop energy of 12J would not require a drop height of less than 300 mm, ensuring test standards were met. As a result, the drop mass was recorded to be 3.94 kg, including all components on the dropping sledge (see Figure 5a). A Kistler

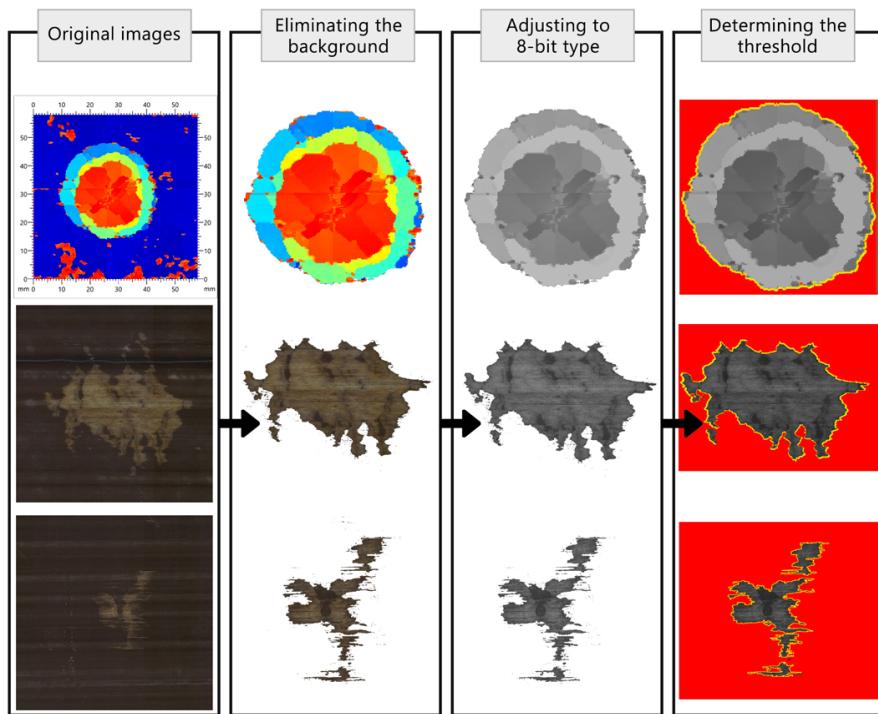
Figure 6. The image processing method to measure the C-scanned area and sensor-activated areas.

Following the collection of image-based data from the front face, back face, and C-scan of the samples impacted at various energies, image processing was performed using ImageJ software to measure the sensor-activated area on the surface as well as the C-scanned area. This analysis aimed to establish a correlation between surface and internal damage. The image processing procedure involved utilising Adobe Photoshop software (version 25.6) to eliminate the background, followed by adjusting the image type to 8-bit using ImageJ software. Subsequently, the threshold was determined, and the area was measured using the Region of Interest manager toolbox. This process is illustrated in Figure 6.

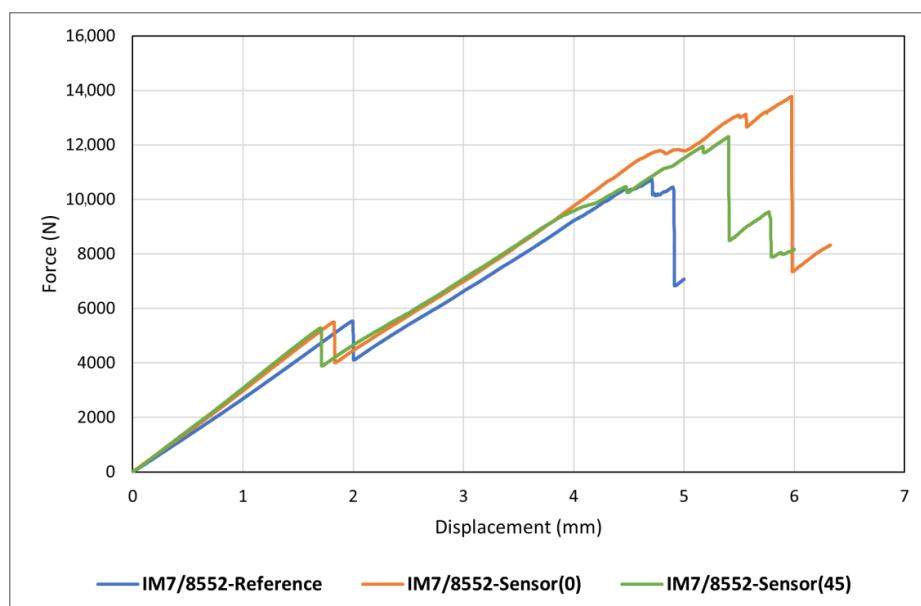
Figure 7. Static indentation results of all tested samples.

Figure 7 shows the results of *reference* and *sensor* samples tested under static indentation loading. It is seen that all curves follow the same general pattern (global behaviour), featuring a linear behaviour until a noticeable load drop, followed by a non-linear behaviour with a lower slope that reaches a second, more significant load drop, and then multiple smaller drops. This pattern has also been seen in static indentation testing of quasi-isotropic CFRPs by other researchers [16,19,21,31,32]. The graphs presented in this figure show the high repeatability and accuracy of both the test setup and the obtained results.

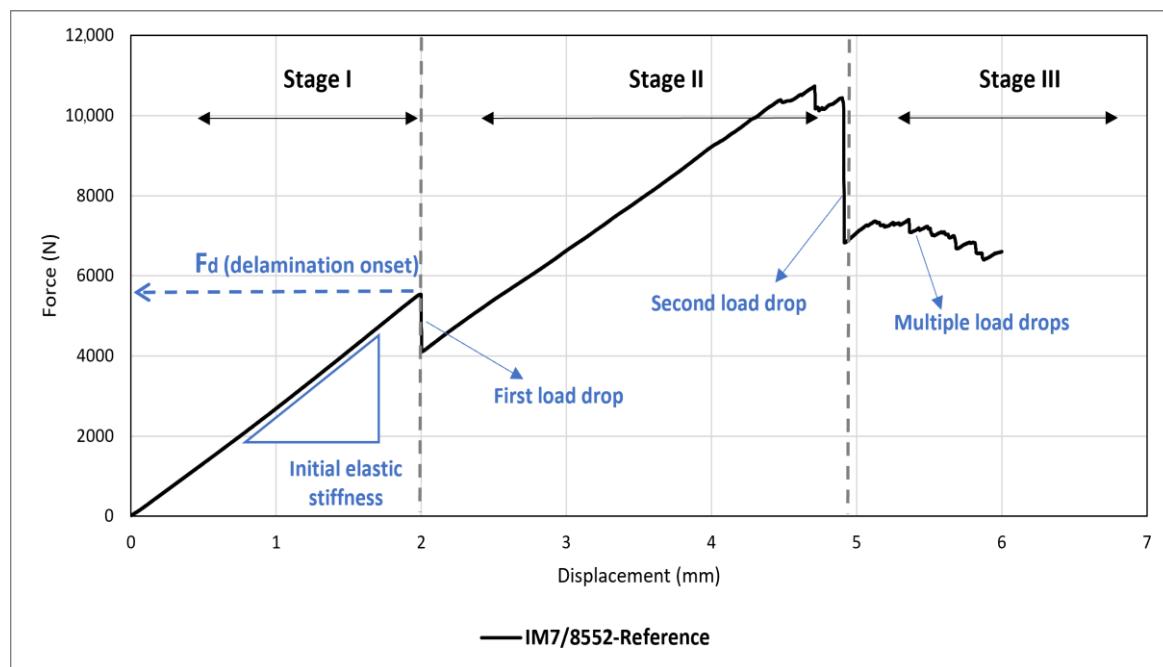
Figure 8. Different stages of damage initiation and propagation in a laminated quasi-isotropic CFRP composite under quasi-static indentation.

To further investigate global behaviour, the results of the first sample (IM7/8552-Reference) is chosen and shown in Figure 8. Three primary stages are evident from this figure. The first stage starts from the beginning of the test until a load drop occurs at displacement and force of approximately 2 mm and 6000 N, respectively. This initial phase represents the elastic region, characterised by a linear load–displacement response. The primary damage mechanism in this stage is matrix cracking, with the load drop marking the onset of delamination [21,33]. This delamination onset was distinctly identifiable during testing by an audible sound. The associated critical load at this point is shown by F_d , which is of great interest in this work. After the first load drop, a nearly linear response is seen until a second significant drop occurs at displacement and force of approximately 5 mm and 10,000 N, indicating more severe damage in the form of fibre failure. Alongside the load drop, this type of damage was identifiable by a distinct sound during testing. The minor load drops in the second stage, between the first and second significant load drops, are mainly associated with delamination propagation. Furthermore, the magnitude of the second load drop surpasses that of the first, indicating more severe damage to the specimen (see Table 2). Generally, damage in CFRPs is not visible until this point, and it only becomes visible on the surface after fibre failure happens. The third stage, initiated after the second load drop, signifies that the sample has incurred significant damage and cannot withstand further loading. Consequently, multiple small drops occur until the sample undergoes complete failure. Given that the objective of this research is to develop sensors capable of enhancing visual inspection of BVID, the emphasis will be on the first two stages. Accordingly, all subsequent low-velocity impact tests are designed to induce damage within these two regions.

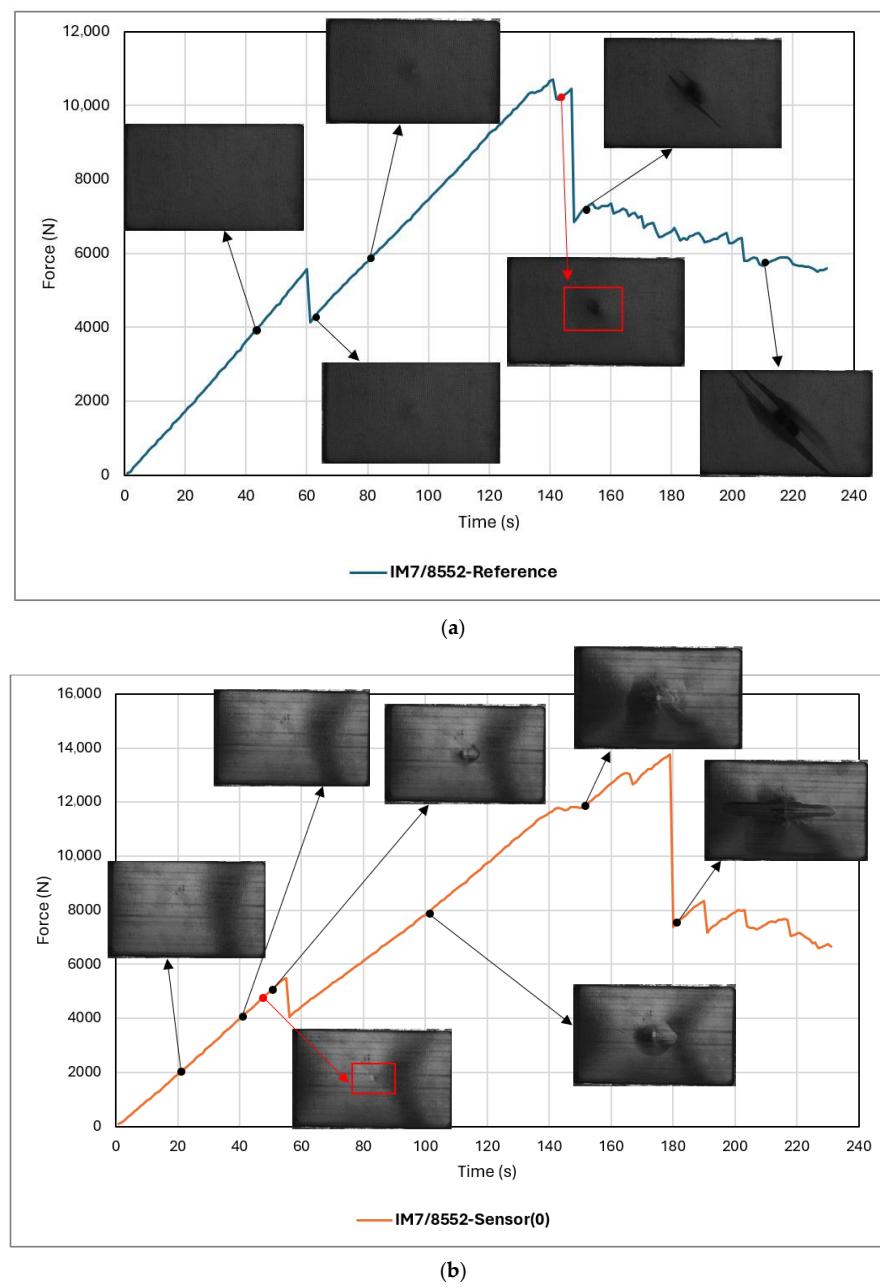
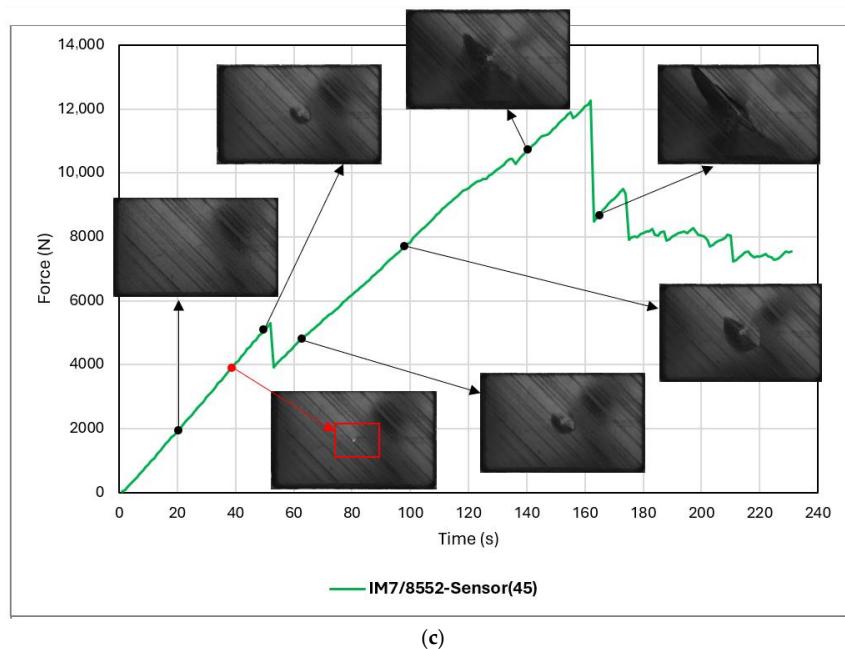
Figure 9. Visual inspection and sensor activation during static indentation experiment: (a) IM7/8552-Reference, (b) IM7/8552-Sensor(0), (c) IM7/8552-Sensor(45).

In Figure 9b,c the sensor on the back face activates before the first load drop, with the activated area expanding as the force increases. Upon analysing images captured during the indentation test of *sensor* samples, it was observed that the visible damage pattern on the surface enlarges up to a certain point, that is, where delamination has already happened, but fibre failure is yet to occur. However, beyond this point, the activated area exhibits minimal change despite increasing force. This suggests that in terms of detecting damage “levels” (rather than damage “existence”), the sensor is well suited for identifying low-energy damage types such as matrix cracks and delamination. This is evidenced by the lack of significant alterations in the appearance of the samples (size and shape of damage pattern) beyond a certain force threshold. Nonetheless, the sensor can also be utilised for “visualising” and “detecting” higher-energy damage types. Furthermore, a comparison between Figure 9b,c reveals sensor activation at a lower force for the sample with a sensing layer orientation of 45°. This suggests that the activation force threshold could be influenced by altering the fibre direction of the sensing layer.

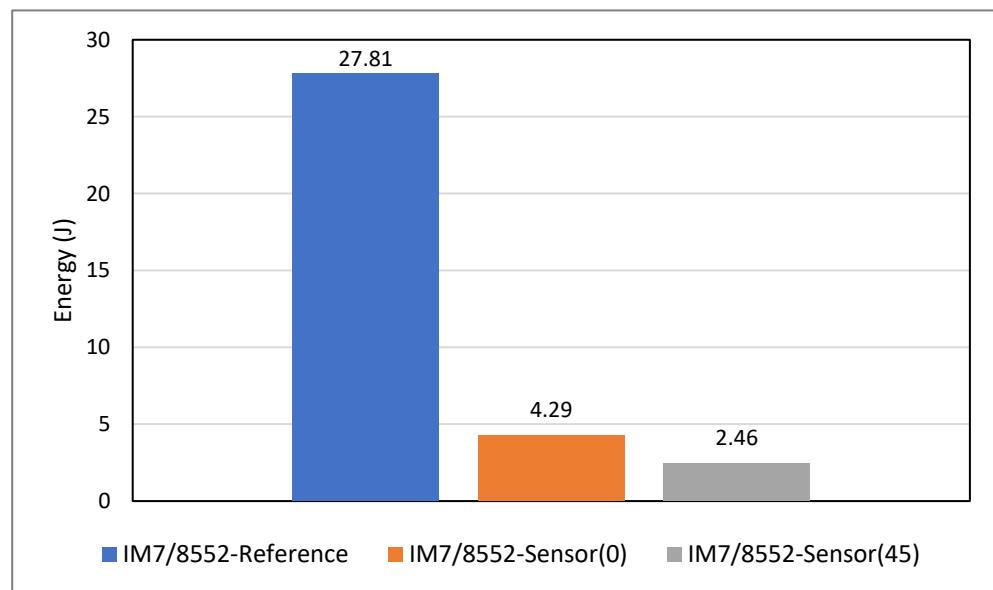
Figure 10. Threshold energies for visually detectable damage.

Figure 10 represents a comparison of threshold energies for detecting damage across all tested samples, highlighting the performance of the sensor in visualising damage on the back face at very low energies. It is observed that while damage on the back face of the IM7/8552-Reference sample is not visible until over 27J, it becomes visible in *sensor* samples at energies as low as less than 5J.

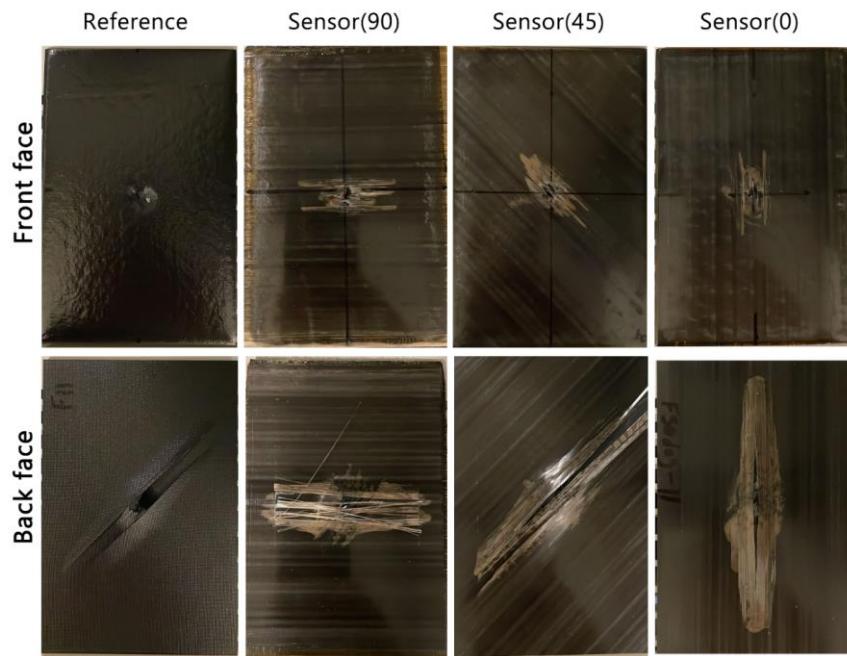
Figure 11. Post-experiment visual inspection.

The post-experiment inspection images are displayed in Figure 11. Note that in addition to the samples discussed previously, this figure includes visual inspection images of an IM7/8552-Sensor(90) sample. This test was conducted initially, and its force–displacement graph was not included in the preceding sections. Its purpose here is to illustrate a comparison of visual damage patterns at various degrees.

Various modes of composite failure are observed in these samples, stemming from indentation tests continuing until significant load drops are observed. Noticeable damage is evident on the front face of the *reference* sample. A recessed area is evident, where the indenter made contact with the specimen. Additionally, a series of small, stepped lines indicate cracks propagating in the upper carbon layer. On the back face, there is significant evidence of damage, particularly fibre failure at the centre of the image directly under the indenter, running parallel to the fibre direction. On the front face of *sensor* samples,

light-coloured patches parallel to the sensor fibre direction indicate sensor activation. On the back faces, the significant light patch directly under the contact area of the indenter demonstrates good sensor activation. Above and below the activated patches, the sensor activation appears striped; this indicates the strain due to the tension on the back face has exceeded the strain to failure of the carbon sensing layer. This result was seen when sensor-integrated specimens were tested in tension by Czél and Wisnom [13]. Overall, the visual damage pattern is larger on the back face than the front face. The findings here suggest that incorporating sensors can lead to notable improvements in visual inspection by revealing visible damage patterns on both the top and back surfaces. Additionally, it enhances the load-bearing capacity, offering flexibility in design to meet the specific requirements of each application. This adaptability can be achieved by adjusting sensor-related parameters, such as the fibre orientation of the sensing layer, to suit desired outcomes.

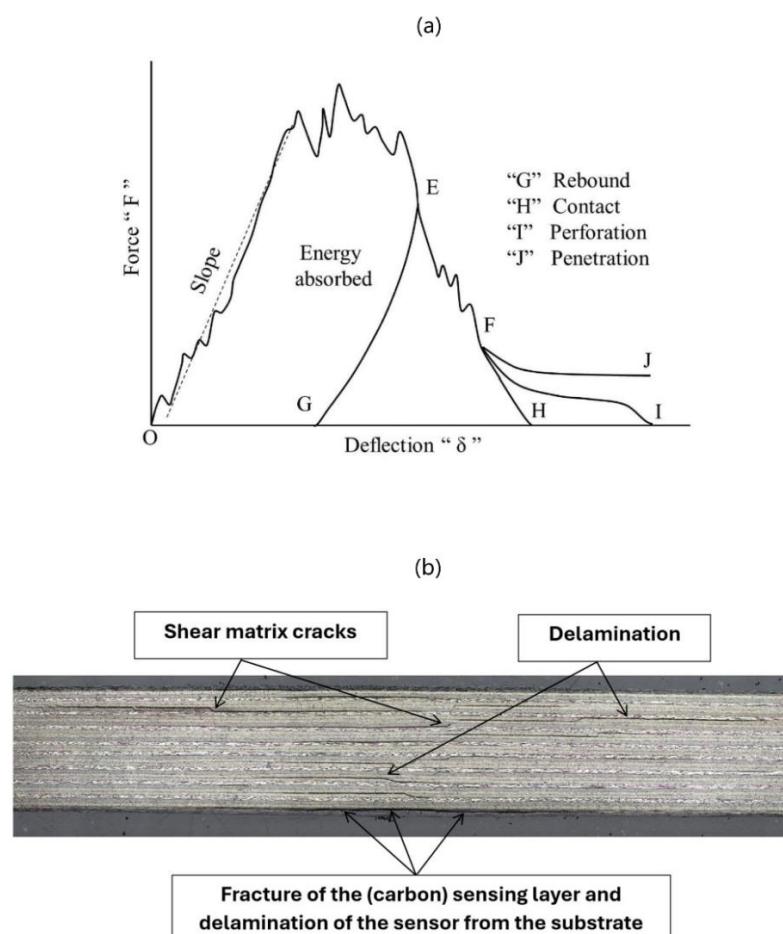
Figure 12. (a) Different damage scenarios with respect to permanent deflection (indentation) [38]. (b) The microscopy image depicts impact-induced damage at 12J, captured from the cross-section of the *sensor* specimen, demonstrating internal damage mechanisms, such as shear matrix cracks and delamination. Additionally, the fracture of the carbon sensing layer and delamination of the sensor from the substrate are evident, both at the point of impact on the front and back faces.

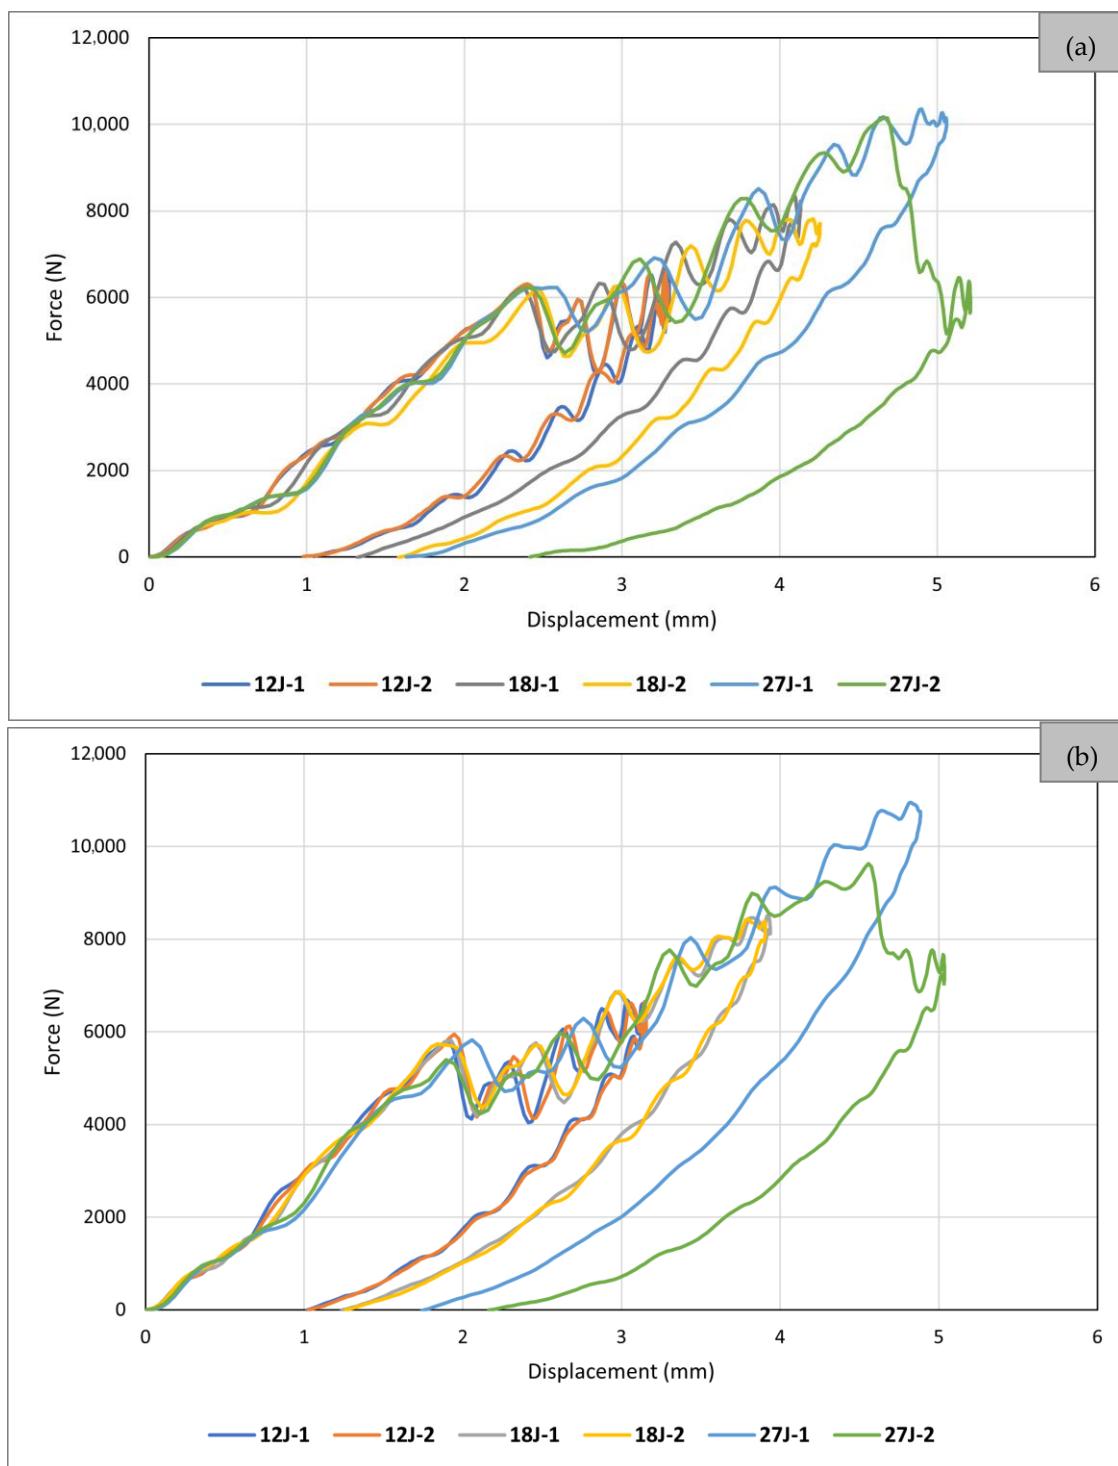
Figure 13. Low-velocity impact test results: (a) reference; (b) sensor.

The results of all impact tests are shown in Figure 13. It indicates that at impact energies of 12J and 18J, both *reference* and *sensor* samples exhibit excellent repeatability, as evidenced by the close alignment of the graphs. However, some discrepancies arise at the impact energy of 27J, particularly noticeable when approaching the maximum force and displacement. Notably, this trend persists in both *reference* and *sensor* samples at the 27J energy level. This can be attributed to two potential factors. Firstly, the influence of boundary conditions may become more pronounced as the impact energy increases.

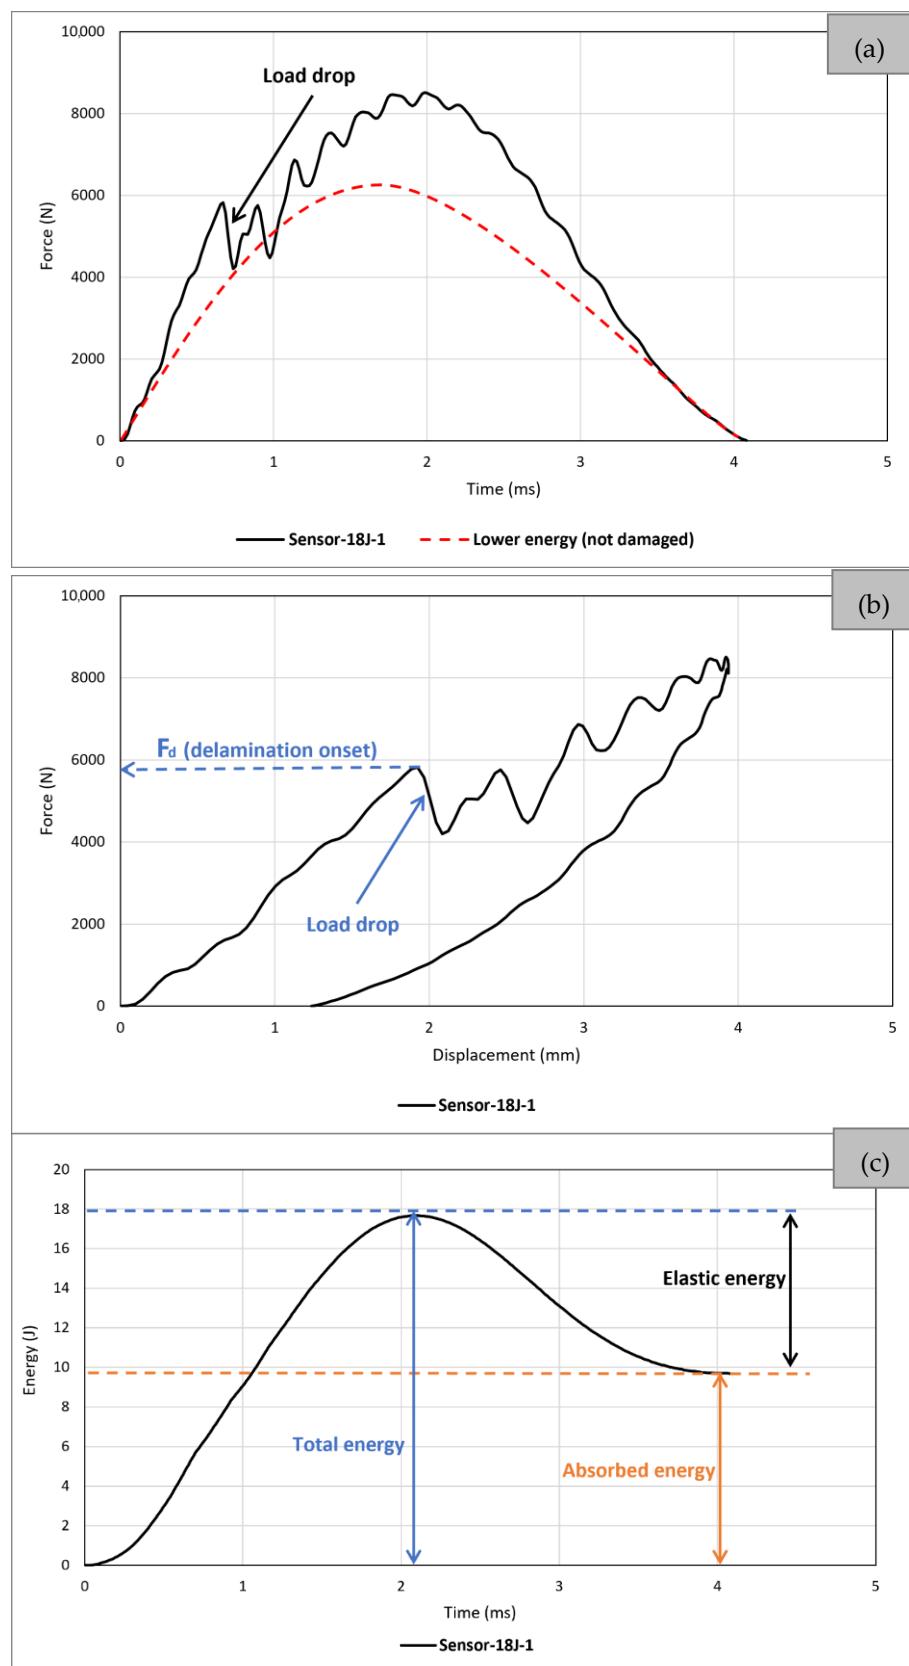
Figure 14. Typical low-velocity impact test results: (a) force–time, (b) force–displacement, (c) energy–time.

To comprehensively analyse the global behaviour of a CFRP under the impact, the force–time, force–displacement, and absorbed energy–time graphs of the *sensor* sample (18J-1) are depicted in Figure 14. In Figure 14a, the force–time results, directly recorded and obtained from the data acquisition system during the impact test, are illustrated. The graph can be divided into two distinct phases. The first half commences with the initial contact between the impactor and the specimen and extends until the velocity of the impactor reaches zero, indicating the point at which the impactor is about to rebound. Notably, a significant load drop associated with delamination is observable during this phase. A red

graph corresponding to a hypothetical lower impact energy that does not cause any damage is also included, demonstrating no significant drop in load. The second half portrays the rebound process, concluding at the moment when the impactor completely separates from the sample. As damage is primarily incurred during the first half, multiple drops are evident in the graph, while the second half displays a smoother and less fluctuating trend. Figure 14b illustrates the force–displacement history, calculated from the force–time results. The graph exhibits an initial almost linear response from 0 to nearly 6000 N. Minor load drops in this region may be attributed to matrix cracking. Then, a sudden drop in load is observed, signifying the onset of delamination. Subsequently, intermittent minor drops occur until reaching a maximum force of slightly over 8000 N. Following this, once the impactor has fully transferred its energy to the specimen, there occurs a redirection of elastic energy stored within the specimen back to the impactor, inducing a rebound phenomenon. This transition is graphically represented by a gradual reduction in both force and deformation. The plot of the unloading curve passes under the loading section of the plot; this encloses an area that corresponds to the total absorbed impact energy. This energy is absorbed through both the dynamic response of the specimen and through damage mechanisms. The change in gradient and the enclosed area indicate that damage has occurred for this impact energy. Nevertheless, the enclosed nature of the graph means that there is no penetration or structural failure [38], which supports findings from both indentation and visual inspection. Figure 14c shows the energy–time history that can be divided into two parts: (a) elastic energy and (b) absorbed energy. The curve exhibits a progressive increase during loading, reaches a peak, decreases during unloading, and ultimately levels off at a constant value. The latter signifies the total energy permanently absorbed through damage mechanisms by the composite specimen at the end of the impact event. The peak of the curve corresponds to the respective impact energy (18J here).

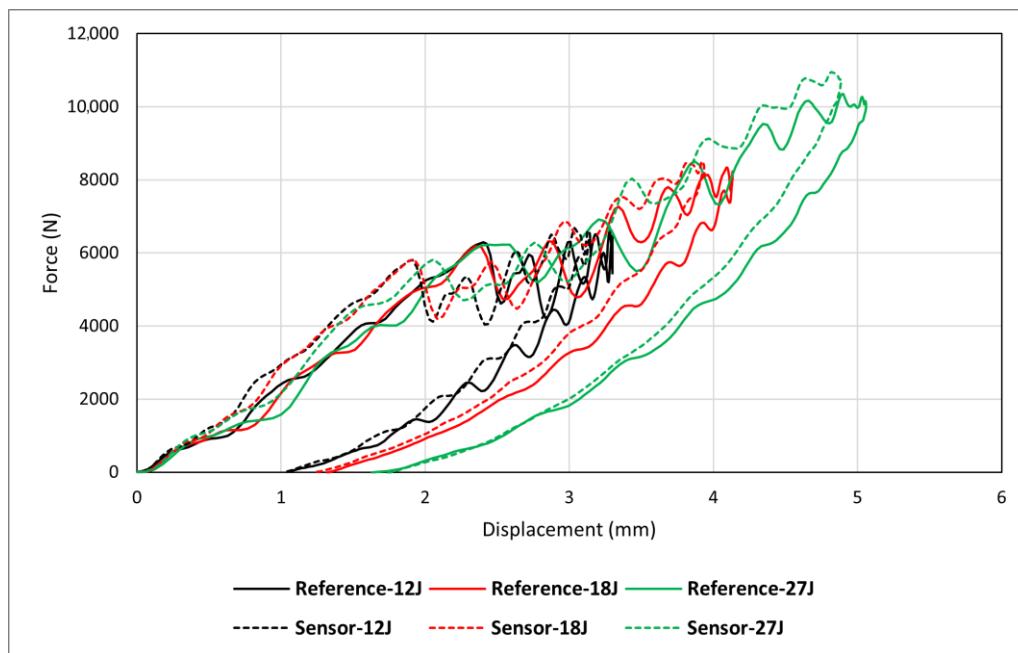
Figure 15. Influence of adding sensors at different impact energies.

The assessment of composite materials' impact resistance typically involves examining aspects such as impact energy absorption, resistance to damage (specifically, the extent of damage following a non-penetrating impact), and tolerance to damage (residual properties after non-penetrating impact) [46]. This research focuses on energy absorption and resistance to damage. Accordingly, it is essential to understand the influence of sensor incorporation on the mechanical properties of the substrate structure and minimise this effect to achieve a reliable self-sensing system. Figure 15 compares two groups of samples, *reference* and *sensor*, at three different impact energies, and important information obtained from the graph is presented in Table 3. The results demonstrate a higher maximum force at a relatively lower maximum displacement for *sensor* samples compared to *reference* ones, meaning that adding sensors slightly increased the rigidity and structural stiffness. Considering the maximum force, for example, the results suggest that adding sensors could increase the maximum force by approximately 1% at 12J energy, 2% at 18J energy, and 6% at 27J energy, indicating that the effect of adding sensors on impact behaviour appears to be more significant at higher impact energies. Overall, no significant difference can be seen between the two types of specimens, indicating the addition of sensors has little influence on the maximum force generated by the specimen, though it does slightly increase the energy absorption, suggesting the sensor may slightly enhance impact resistance in terms of the energy absorption capacity (see Figure 16). The post-impact visual inspection revealed that these drop energies had activated the sensor, meaning that energy was absorbed by damage within the sensing layer, which could be a possible reason for the increased energy absorption in *sensor* specimens. Overall, results suggest that within the BVID range, the sensor does not change mechanical properties significantly while improving the load-bearing capabilities (energy absorption) of the entire structure. This aligns well with the indentation test results.

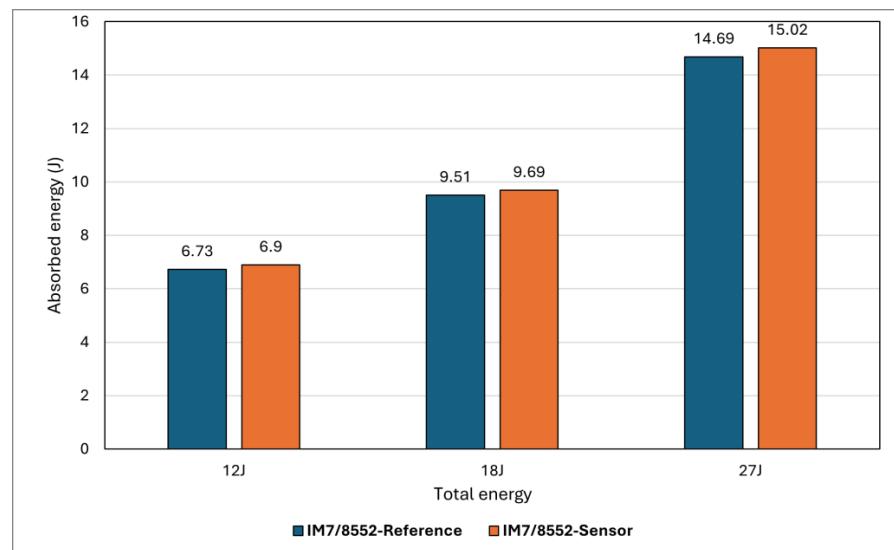
Figure 16. Comparison of the absorbed energy in all samples at various impact energies.

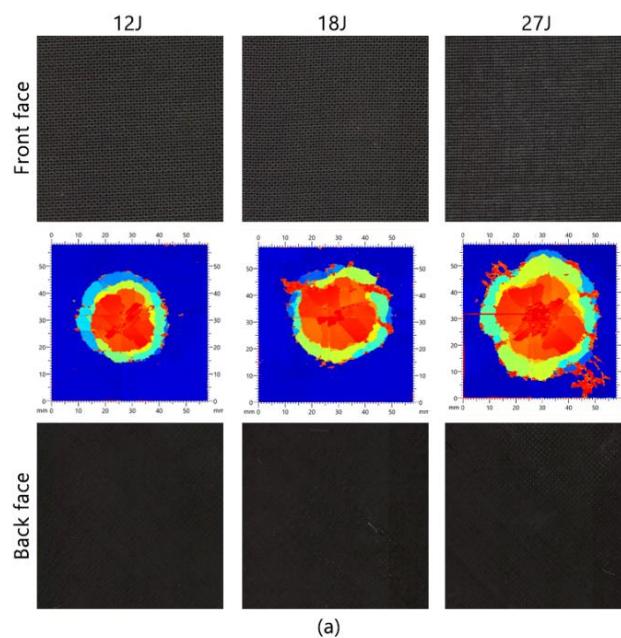
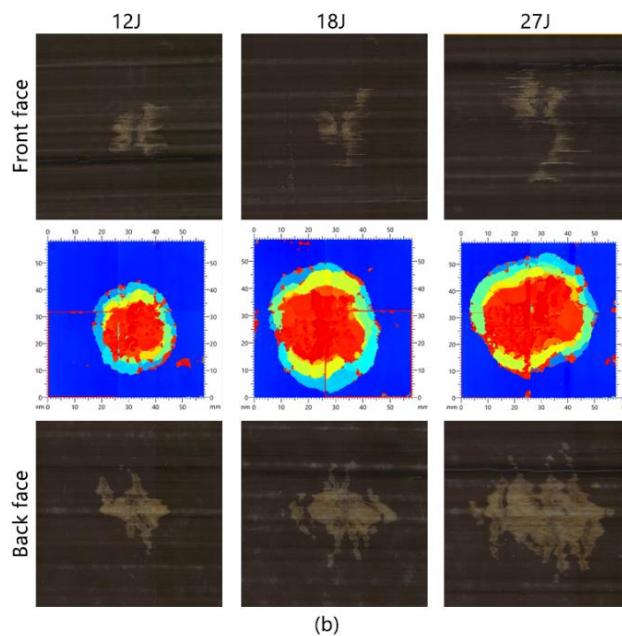
Figure 17. Ultrasonic C-scan and visual inspection results: (a) reference; (b) sensor.

No visible signs of impact damage on the back face are apparent in any of the three energies investigated in the *reference* samples. However, upon closer scrutiny of the 27J sample, a subtle indentation is discernible in the region directly affected by the impactor on the front face, suggesting internal damage within the specimen, indicative of BVID. This becomes more apparent upon physical examination. Ultrasonic examination, on the other hand, reveals evidence of internal delamination damage across all three energy levels, with the extent of damage increasing proportionally with energy input (see Figure 17a). In contrast to the *reference* samples, the visual inspection results of the *sensor* samples clearly reveal damage on both the top and back faces. This indicates that the sensor was triggered at all three energy levels, with the visual damage proportionately increasing as energy levels rose. Notably, the visual damage pattern on the back face differs from that on the front face due to different damage modes. On the back face, a discernible light patch suggests sensor activation due to tensile strain from the impact loading. Within this region, a darker speckled area indicates fibre fracture within the sensing layer, while a larger, lighter area signifies delamination of the glass layer from the carbon sensing layer. The front face displays less pronounced sensor activation, though it still exhibits a discernible activated area. With increased energy, the activated area expands more prominently in a

direction perpendicular to the fibre direction. Additionally, short white lines surrounding the impacted area, aligned parallel to the sensor fibre direction, indicate matrix damage within the sensing layer. This is particularly noticeable in the case of 27J energy (see Figure 17b). For the scale, all images in this figure cover a dimension of 50 mm × 50 mm.

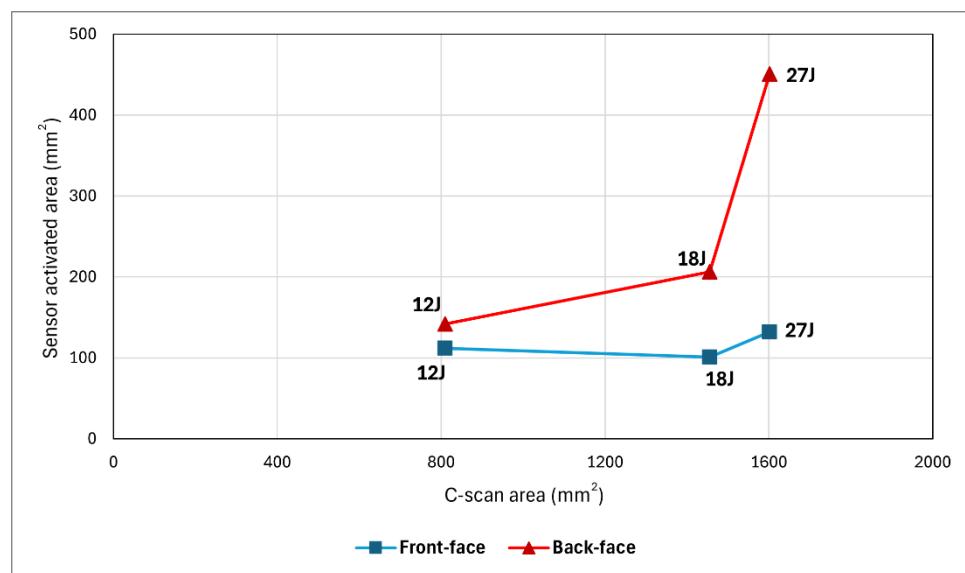
Figure 18. Comparison of the surface visible damage area and C-scan damage area at three impact energies.

Figure 18 compares the size of the visual damage area on the surface and the size of the C-scanned damage area for the *sensor* samples at the three impact energies. It is evident that as the impact energy increases, both the C-scanned and sensor-activated areas on the surface also increase. However, there is an exception with the activated area on the front face of the 18J sample. Note that the values on the vertical axis of this graph represent the activated area size, which is smaller for the front face at 18J compared to 12J due to its inconsistent elongated length but relatively shorter width, unlike the 12J sample, which covers a consistently smaller area. Nevertheless, the visible damage in the 18J sample is still more significant than in the 12J sample. Overall, this graph suggests that the activated damaged area on the surface can serve as an estimate of the severity of internal damage.
