Characterisation and Application of Bio-Inspired Hybrid Composite Sensors for Detecting Barely Visible Damage under Out-of-Plane Loadings

Tabatabaeian, Ali; Mohammadi, Reza; Harrison, Philip; Fotouhi, Mohammad

Sensors

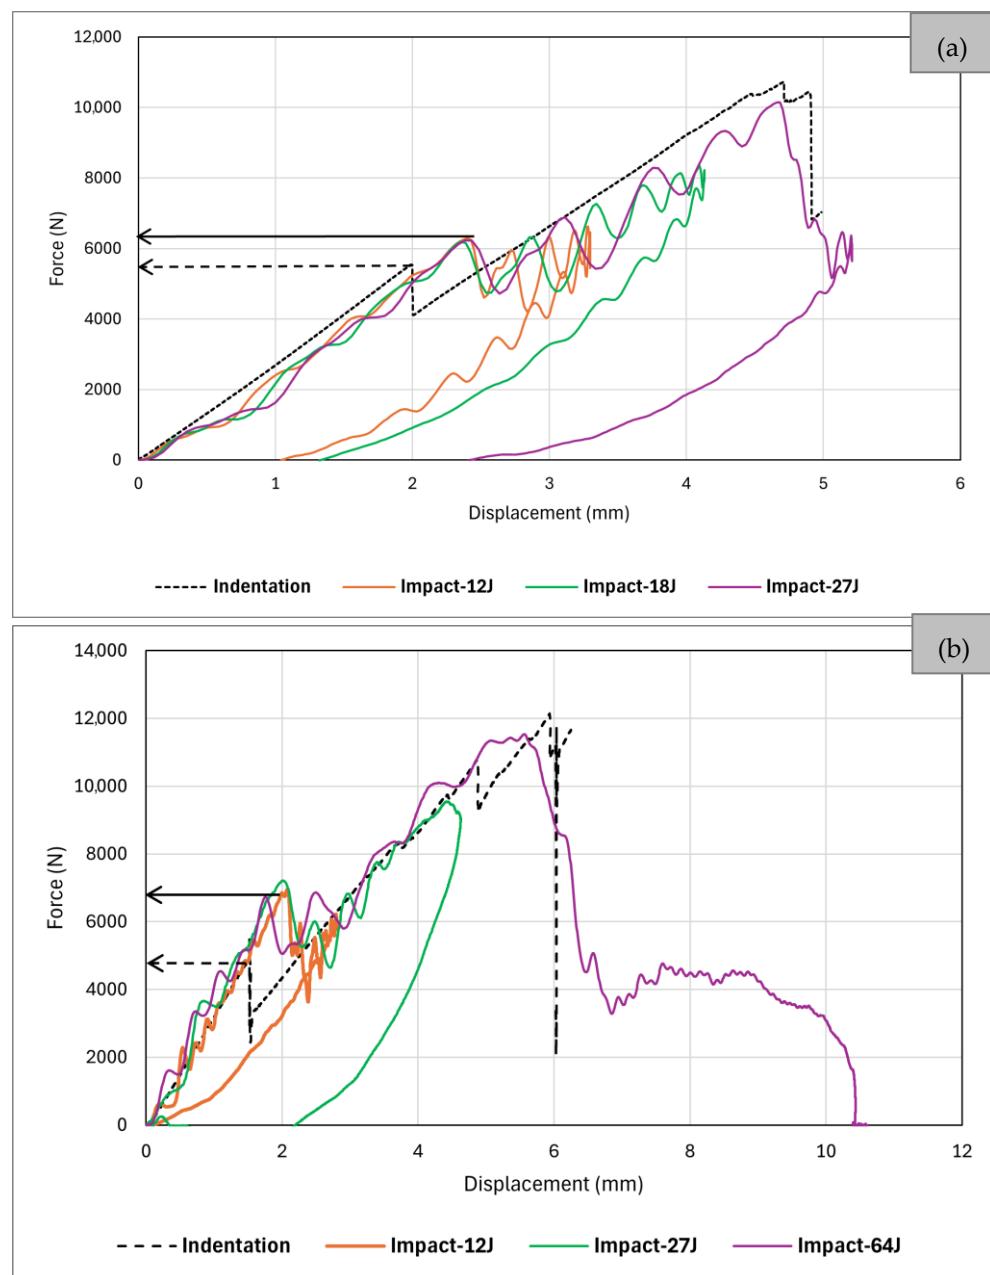
Figure 19. Comparison of indentation and impact response: (a) IM7/8552 samples of this research (*reference samples*); (b) T800/MTM49-3 samples of work by Fotouhi et al. [16].

Given the dynamic nature and short duration of low-velocity impact tests, analysing the progression and development of degradation mechanisms within a structure during such tests proves challenging and can mainly occur post-test completion. Consequently, researchers have redirected their attention to the static indentation test, which has demonstrated similar overall behaviour and resulting damage states compared to low-velocity impact tests [27–29,33,39–45]. The static indentation test offers the advantage of pausing the test at different stages, allowing for the observation of damage evolution. Nonetheless, it is crucial to thoroughly examine the similarities and disparities between these two tests to gain a deeper understanding of their correlation and the potential for substituting a low-velocity impact test with a quasi-static indentation test. Figure 19a compares force-displacement curves for the indentation and impact tests of this research. Note that the curve labelled “27J” in Figure 19a corresponds to the “27J-2” curve depicted in Figure 13a.

Both Figures 3 and 19a,b demonstrate a high level of similarity in the initial stiffness of the load–displacement curves obtained from the static and dynamic tests. This observation indicates that both displacement and force measurements obtained from static indentation and impact tests are precise. Therefore, the higher dynamic critical load observed in impact tests may not be due to misinterpretation or measurement errors. The disparity is believed to reflect the influence of loading rate on alterations in material intrinsic properties. Consequently, the increase in the critical load in the impact test is more likely a consequence of the strain rate dependence of the mode II critical strain energy release rate.

The critical load corresponding to fibre failure (second significant drop) in the indentation test closely mirrors that of impact tests in Figure 19a,b. In Figure 19a, this load drop for both indentation and impact tests occurs at a force and displacement of approximately 10,000 N and 5 mm, respectively, while in Figure 19b, these values are 12,000 N and 6 mm, respectively. The calculated absorbed energy values from the area under the

force–displacement curve of the indentation tests for both figures were slightly higher than 27J. Thus, an impact energy of 27J or higher was anticipated to result in fibre failure. Notably, the impact energy of 27J in Figure 19a has caused this damage, indicated by a recognisable drop, while in Figure 19b, the impact energy of 64J has led to fibre failure and perforation, evidenced by a force–displacement graph similar to scenario “I” in Figure 12a. When examining the trends of second load drops, it is apparent that the values associated with these drops consistently align between the indentation and impact tests. This observation suggests that forces linked to fibre failure also appears to exhibit similarities between the two tests. Overall, the comparative study presented in this section, along with the findings from the literature, confirm that static indentation properly represents the barely visible damage induced in impact tests of quasi-isotropic laminates, offering a controlled, reliable, and repeatable loading setup, as well as stable damage growth [22,29,39].
