# ***HURRICANE OPAL***

### **STRUCTURAL DAMAGE AND BEACH AND DUNE EROSION ALONG THE PANHANDLE COAST OF FLORIDA**

**DECEMBER 1995**

**BUREAU OF BEACHES AND COASTAL SYSTEMS  
DIVISION OF ENVIRONMENTAL RESOURCE PERMITTING  
DEPARTMENT OF ENVIRONMENTAL PROTECTION**

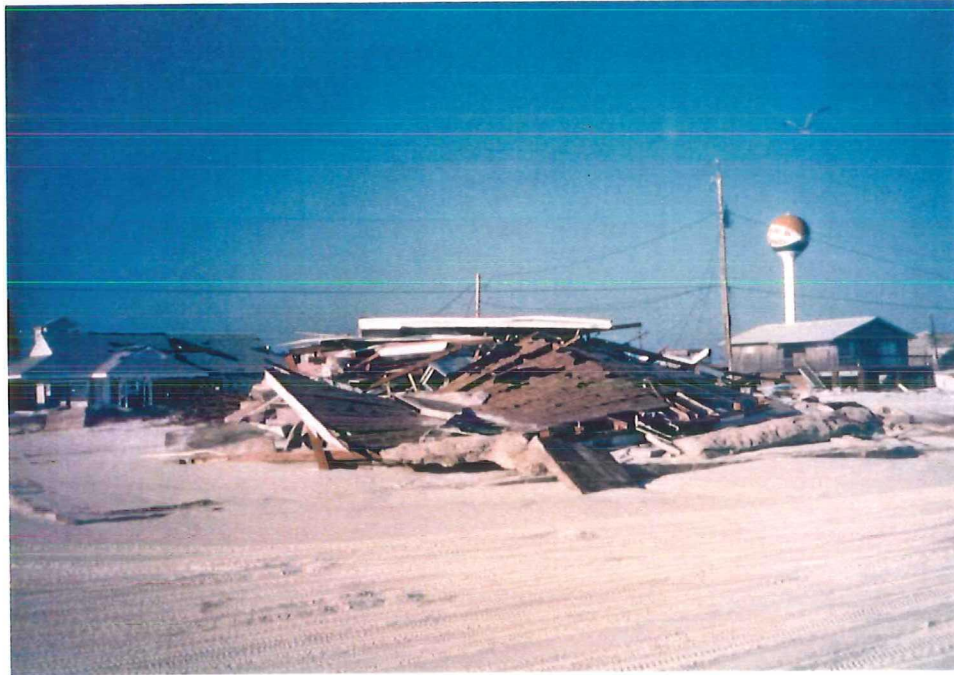
**Escambia County - Pensacola Beach**

The post-storm photographs on the following pages are representative of the types of damages experienced by structures from Opal.

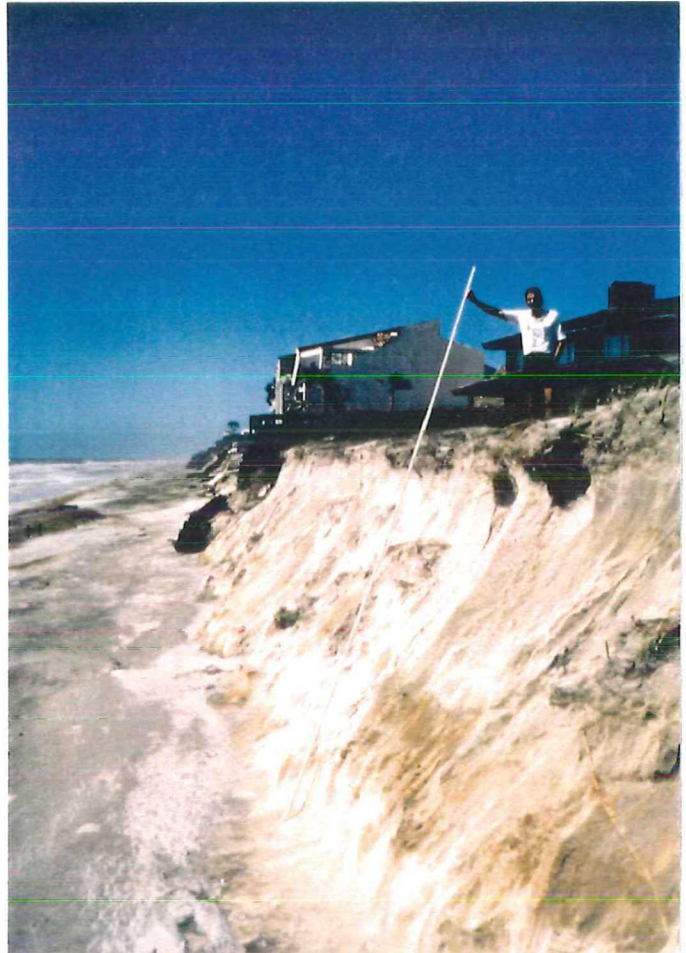
**To Right: View of critically eroded dune in Walton County following impact of Hurricane Opal.**

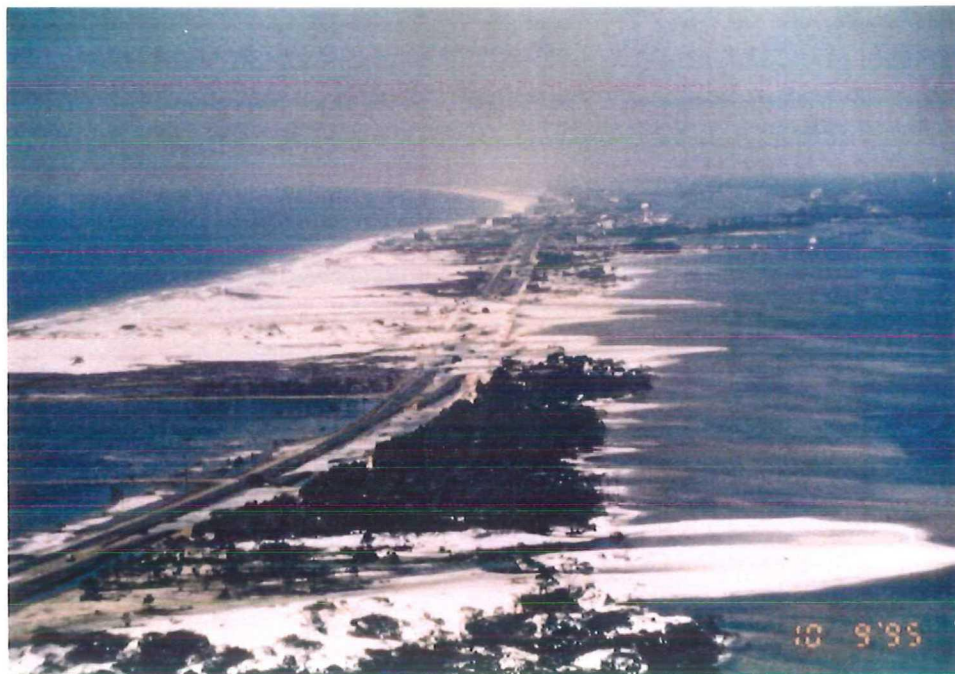
**Below: View of extensive overwash in Okaloosa County just east of Ft. Walton Beach (looking to west); typical of overwash throughout the west Panhandle counties following Hurricane Opal.**

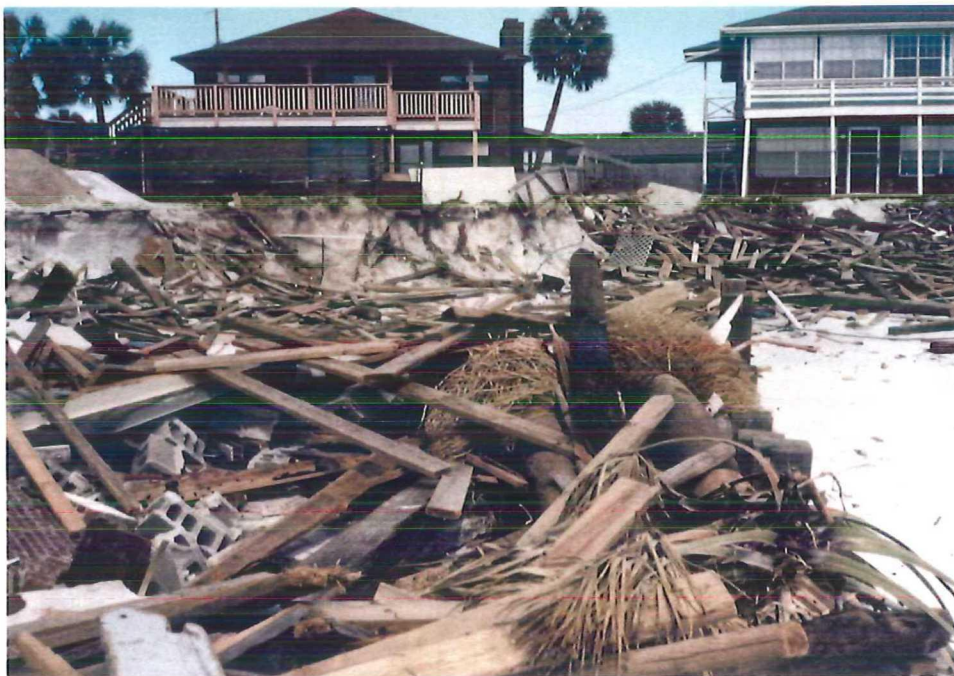
Sand and debris removal - The structural damage from Opal's storm surge, breaking waves, and wind coupled with beach and dune erosion and overwash produced a widespread and potentially dangerous situation in terms of debris distribution and burial. Excessive debris along roadways created immediate access problems after the storm, but was also carried both in offshore and overland directions by storm surge and wave forces. A photo below depicts storm debris in the aftermath cleanup period.

**Storm Debris in Bay County Following Hurricane Opal**

It should be noted that the bulk of the debris was generated from the damage or destruction of non-conforming unpermitted structures.

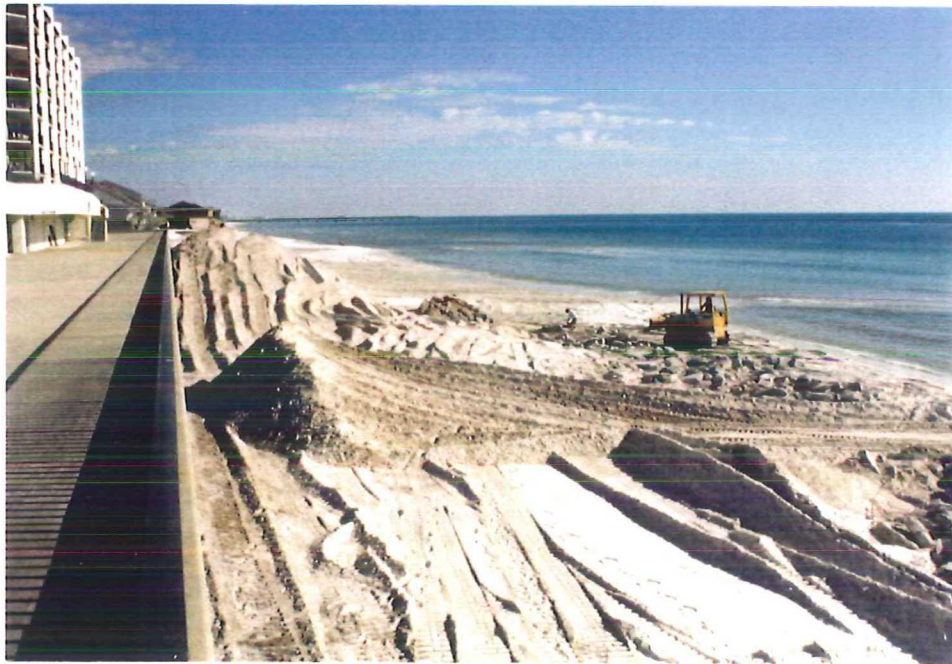
**Beach scraping** - Topographic losses from beach and dune erosion left many structures without soil support beneath their foundation and loss of a storm-protective dune buffer seaward of them. In order to facilitate and accelerate the beach and dune recovery process, a proliferation of beach scraping activity was undertaken by private citizens and local governments in certain areas. Beach scraping consists of excavating sand material from the lower beach berm area just upland of the mean low water line and placing it in upper beach areas or at the base of the dune system. Natural processes tend to replace the excavated sand thus accelerating the recovery process. A depiction of beach scraping being conducted following Opal is shown in the photo below.

**Beach Scraping Activity Following Hurricane Opal**

Guidelines were established by the Bureau to control the extent and methods of scraping and reduce potential for adverse impacts. Beach scraping activities that

transpired in the weeks following the storm included excavation which significantly exceeded these guidelines endangering the beach and upland areas such that general authorizations for scraping were halted and only carefully controlled activities permitted by the Department. An analysis of the effects of the beach scraping on the post-storm recovery processes will be included in the post-Opal recovery study currently being conducted by the Bureau.
