**Traditional wooden foundation piles in Amsterdam and Venice
Techniques for the assessment of their state of conservation**

Pagella, Giorgio; Urso, Tiziana; Mirra, Michele; Naldini, Silvia; van de Kuilen, Jan-Willem

Wood Material Science and Engineering

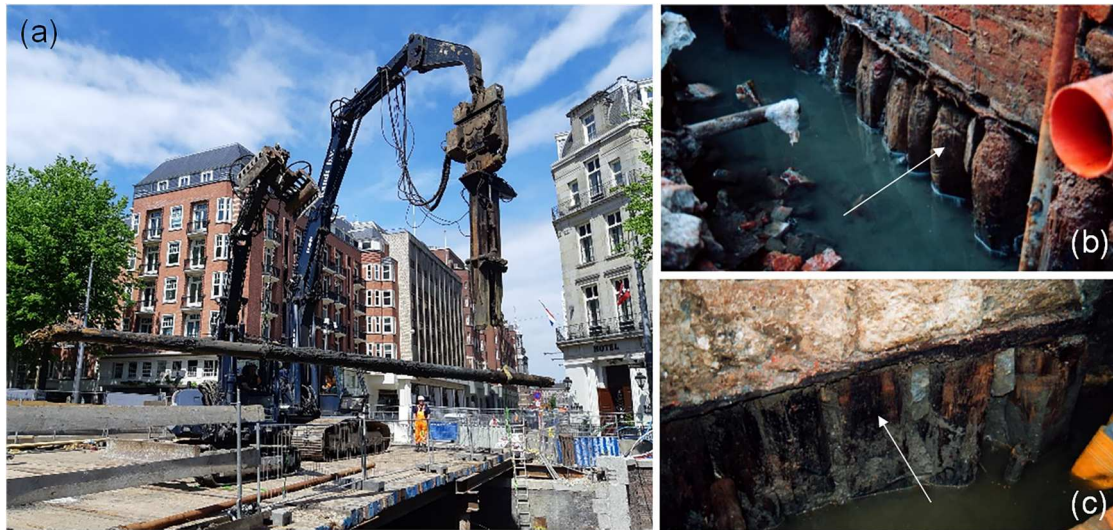
Figure 1. (a) Wooden foundation pile retrieved from the historical foundation of a bridge in the centre of Amsterdam; (b) foundation piles in Venice, visible after lowering the water level of the canal; (c) rough-hewn piles (rectangle shaped) in a foundation in Venice.

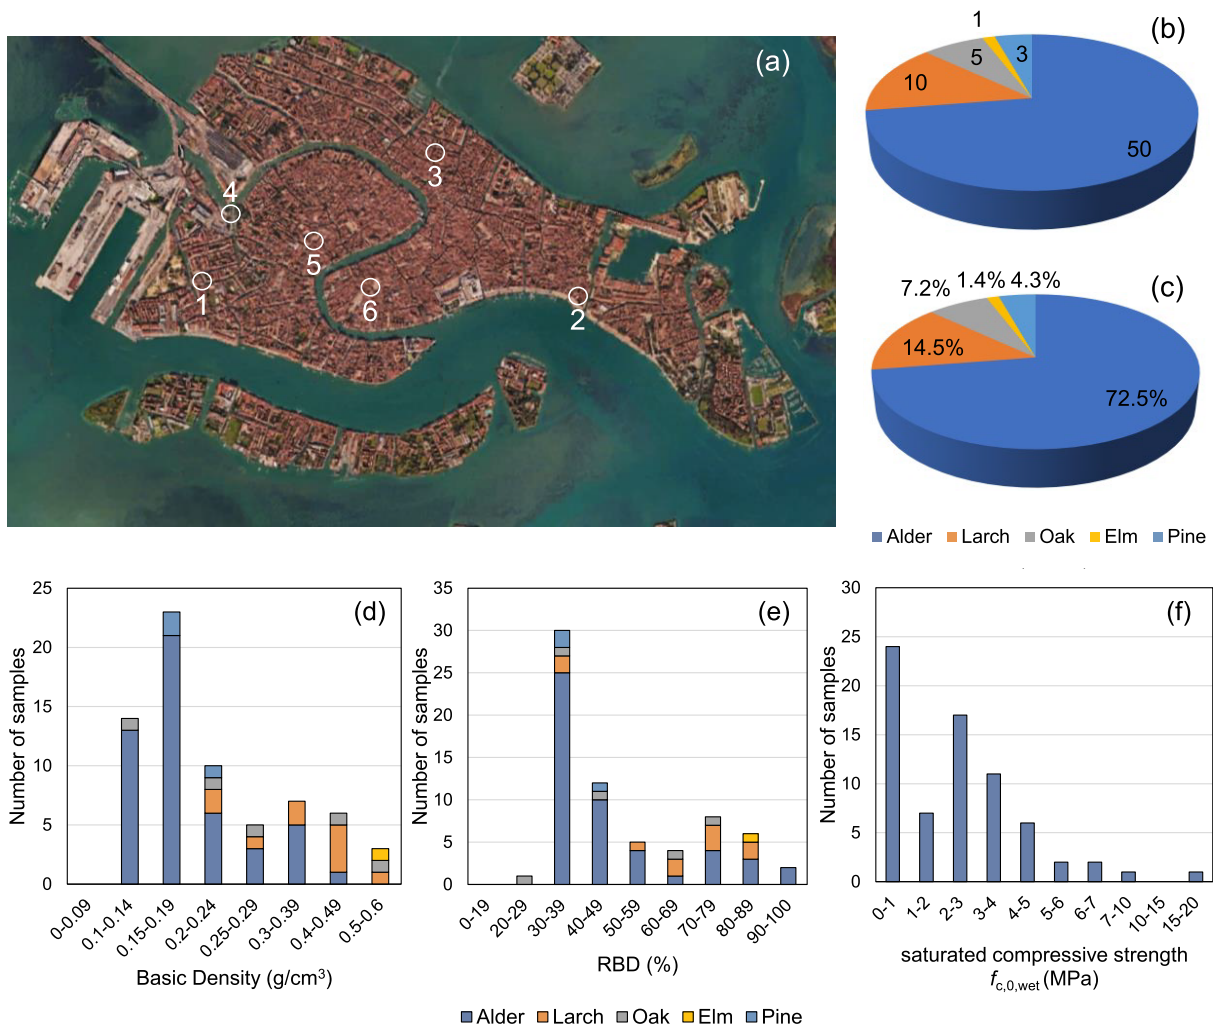
Figure 4. Sample collection: (a) map of Venice with historical sites: (a1) Church of Santa Maria Maggiore, (a2) Rio Ca' di Dio & San Martino, (a3) Rio Acque Dolci, (a4) Santa Chiara, Belfry of (a5) Frari, and (a6) Santo Stefano. Wood species distribution for all 69 wooden piles sampled: (b) per number of samples, (c) percentage of wood species. Distribution of samples based on: (d) basic density, (e) residual basic density (RBD), and (f) distribution of saturated compressive strength ($f_{c,0,wet}$) for all the wood species of wooden foundation piles in Venice.

BD and RBD of all the samples are presented in Figure 4d and e, respectively. The majority of the samples exhibited BD ranging from 0.1 to 0.25 g/cm³ and RBD between 30% and 50%, indicating significant levels of decay with extensive destruction of the wood tissue. The samples examined across all studies in Venice were collected from various positions along the piles. Overall, the results revealed a relatively uniform level of decay along the length of the piles. The outcomes of the compression tests conducted under saturated conditions are shown in Figure 4f. These tests included 65 samples measuring 20 × 20 × 35 mm³ from Santa Maria

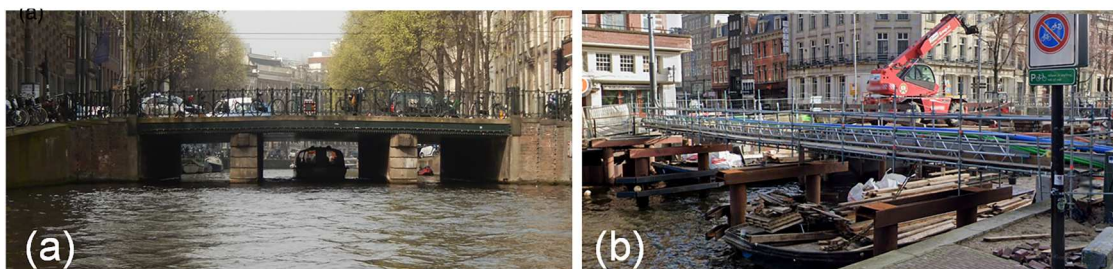
Figure 5. Bridges where the piles samples were collected: (a) Bridge 30 and (b) Bridge 41 (b) in the historic city centre of Amsterdam.

The materials comprised 55 spruce (*Picea abies*) and 5 fir (*Abies alba*) wooden foundation piles, which were part of the foundation system of the piers of two bridges (called bridge 30 and 41) in the city of Amsterdam that were planned to be demolished and reconstructed (Figure 5). The retrieved full-

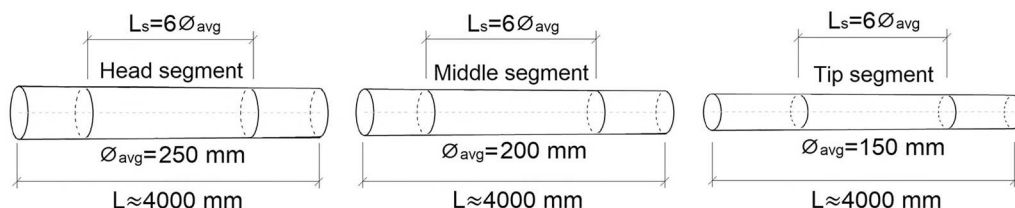
**Figure 6.** Cutting scheme and subdivision of the full-scale pile into head, middle and tip segments.

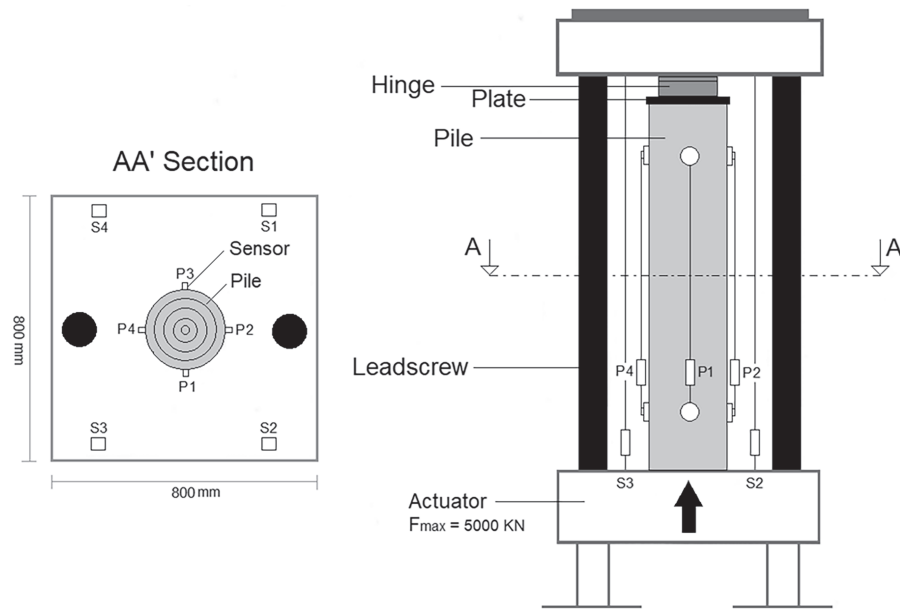
Name	Description	Sensor Type	Stroke (mm)
Actuator	Vertical actuator. Max force 5000 kN.	Hydraulic actuator	+/- 100
S_1, S_2, S_3, S_4	Vertical displacement between top and bottom steel plates of the compression machine	Linear potentiometers	+/-50
P_1, P_2, P_3, P_4	Deformation of the wooden pile measured on each side of the pile. The sensors span 2/3 of the length of the pile.	Linear potentiometers	+/-20

Figure 7. Compression test for a wooden pile segment tested at TU Delft and data measurements details.

Compression tests were performed to determine the short-term wet compressive strength ($f_{c,0,wet}$) of the pile segments in direction parallel to the grain in submerged conditions. To this end, a displacement-controlled test setup was used, where the pile segments were subjected to an axial load in direction parallel to the grain according to the EN 14251 standard (2003), as in Pagella *et al.* (2022a, 2022b). A hinge, mounted on a steel plate, was placed on top of the specimen to have a uniformly distributed compression load on the pile. Four linear potentiometers were screwed to the segment to measure its deformation, along its lateral surface, at 90° from each other, and with a variable length equal to $2/3$ of the length of the specimen (Figure 7). The tests were conducted at a displacement rate of 0.02 mm/s until the peak load was reached. After the peak load (reached at approximately 5 min according to the EN 408 standard 2012) the test continued

at a higher speed until cracks were visible, and to show the post-peak behaviour of the pile (EN 14251, CEN 2003). Then, $f_{c,0,wet}$ was derived from the ratio between the maximum force reached in compression and the average cross-sectional area of each specimen.

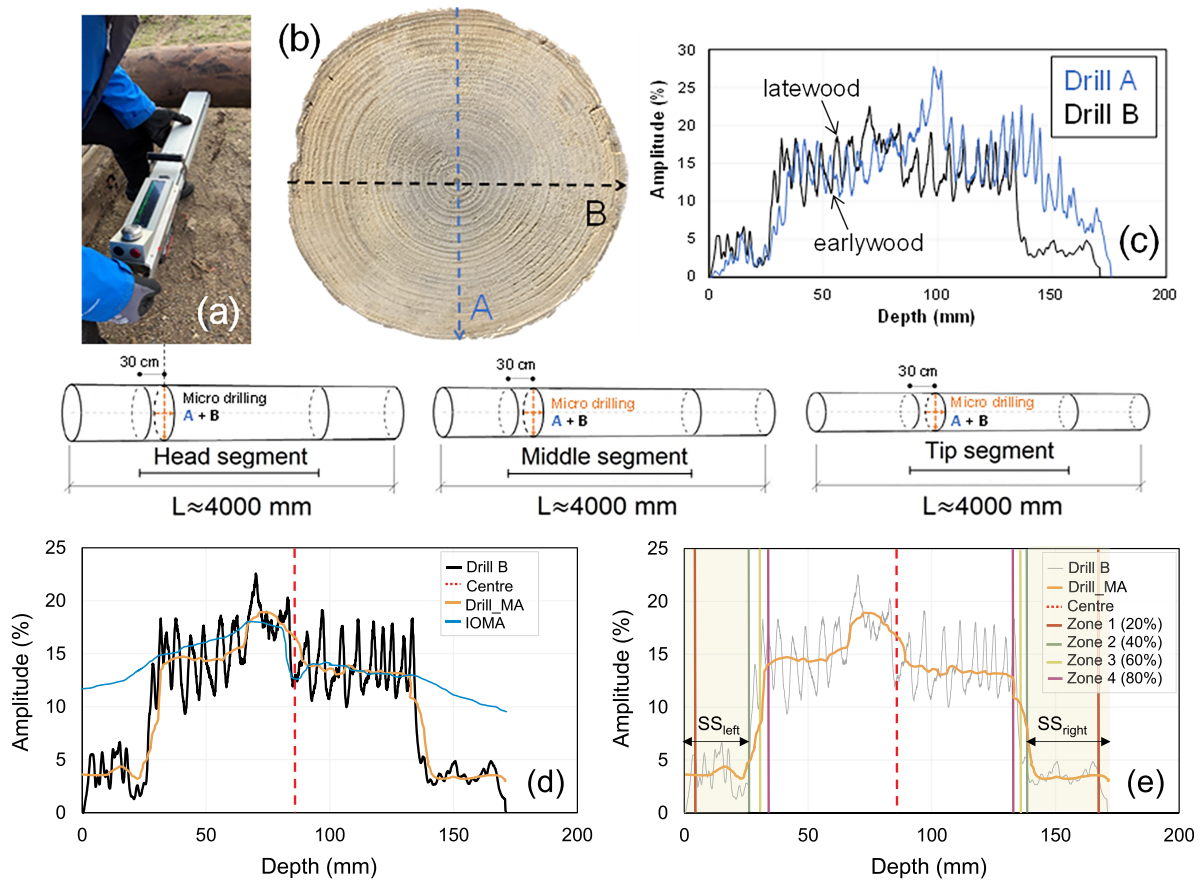
Figure 8. Test procedure: (a) micro-drilling measurements on a wooden pile, (b) drill A and B performed 30 cm from the head of the pile segment, (c) micro-drilling signal plotted as resistance (% of the maximum output engine power) vs distance (mm), (d) example of the analysis of the drilling signal (Drill B) with drilling moving average (Drill_MA) and IOMA from which the zones are calculated, and (e) 4 zones and soft shell (SS_{left} and SS_{right}) associated to zone 1 + 2.

A TU Delft-developed algorithm analyses micro-drilling signals A and B (Figure 8(c)), to assess degraded portions of historical pile cross-sections. The calibration and validation of the approach are described in Ravenshorst *et al.* (2024), and Pagella *et al.* (2024d). The algorithm utilizes Moving Average and Incremental Outwards Moving Average (IOMA) of the drilling signal to identify specific zones based on signal amplitude differences, assuming the centre of the pile is sound wood (Figure 8(d)). Four zones (z1-z4) are determined on each side of the signal, representing different 20% (z1), 40% (z2), 60% (z3) and 80% (z4) of maximum IOMA values on each side. The soft shell, indicative of degradation, is calculated as the sum of zones 1 and 2 (Ravenshorst *et al.* 2024). The total soft shell of a decayed cross-section is averaged from measurements on both sides, aiding in determining the remaining sound cross-sectional area (Figure 8(e)). Subsequently, the total soft shell of a decayed cross section was calculated as the average of the 4 lengths of the soft shell (SS), corresponding to left and right sides of micro-drilling signal A + B. From this, the average length of the soft shell (a_{SS}) was calculated with

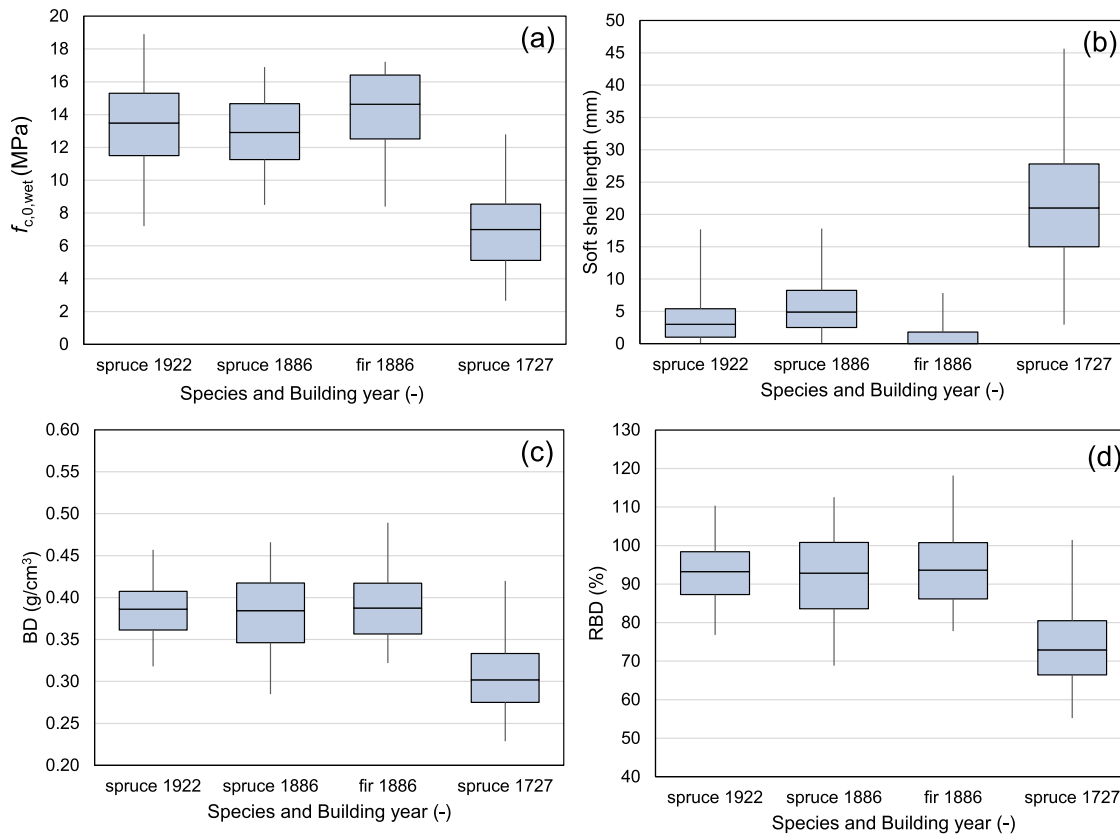
Figure 9. Box plots for (a) $f_{c,0,wet}$, (b) soft shell length, (c) BD, and (d) RBD of spruce and fir pile segments divided in 3 building years (1922, 1886, 1727).

The results of large-scale mechanical testing are presented in Figure 9, including a total of 201 pile segments extracted from 60 full-length spruce and fir piles. No significant difference in the mechanical properties was found between spruce and fir from building years 1886 and 1922, after carrying out a statistical analysis (two-sample t-test, one-tailed) two different groups (e.g. representing two different building years) to determine whether the mean value of one group was significantly greater or less than the other. However, the results are not included in this paper due to length constraints.

1727. The average values of BD (Figure 9(c)) and RBD (Figure 9(d)) of piles from 1727 were also lower, confirming the presence of decay. The micro-drilling analysis conducted on head, middle-part, and tip of the pile segments, and supported by the TU Delft-developed algorithm (Pagella *et al.* 2024b), highlighted that the spruce pile segments from 1727 had a rather constant soft shell along the length of the pile. The soft shell was also measured in piles from 1922/1886, but on average limited to 5 mm. Finally, fir pile segments from 1886 exhibited minimal bacterial decay. This may be attributed to the inherently higher resistance of fir to decay (Klaassen *et al.* 2005, Mirra *et al.* 2024), the limited number of tested fir piles, or the fact that they exclusively dated back to 1886.

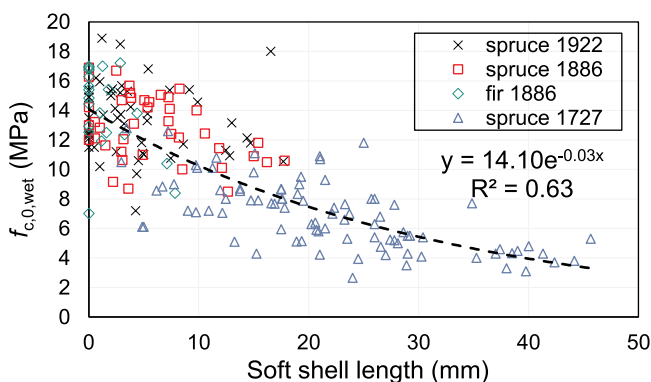
Figure 10. Relationship between $f_{c,0,wet}$ and the length of the soft shell of all the historic spruce and fir segments in Amsterdam.

The remaining short-term compressive strength was well correlated with the soft shell length, as shown in Figure 10, especially for piles from 1727, which exhibited a larger soft shell length, spanning from ca. 10 to 45 mm. The relationship between remaining compressive strength and soft shell of the piles can be implemented in future research, to build damage accumulation models taking into account the effect of decay over time on the strength properties of wood (Van de Kuilen 2007, Pagella *et al.* 2024d). This gives the possibility to have a direct estimation of the remaining short-term compressive strength from in-situ underwater micro-drilling of the piles.

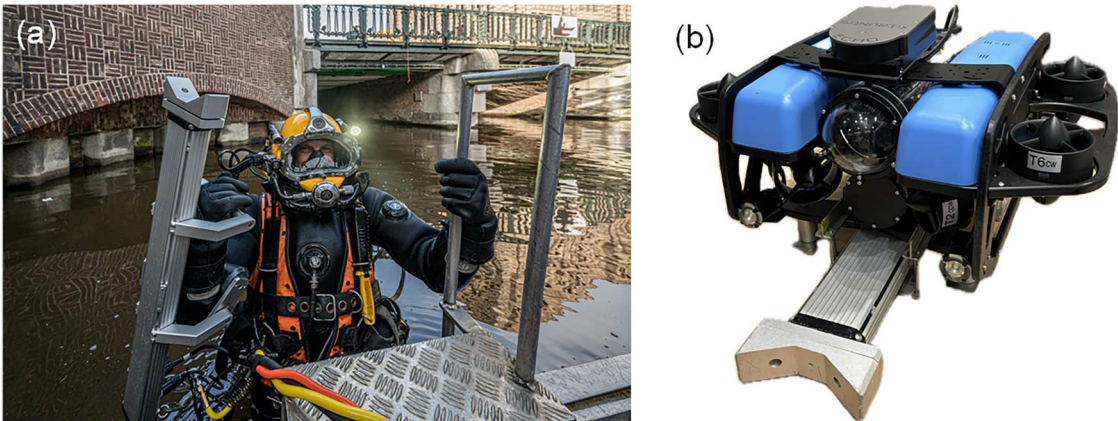
Figure 12. Micro-drilling conducted underwater on wooden piles by: (a) diver, and (b) prototype of ROV incorporating a micro-drilling tool developed by Baars-CIPRO (Baars-CIPRO 2024).

the applicability of micro-drilling in Venice may be limited due to the fact that the piles are concealed beneath the soil layer of the foundations of houses and bridges, as noted by Cavaggioni and Lionello (2009). Typically, the water in the canal is drained during periodic canal cleaning, using provisional dams installed between two consecutive points of the canal (Pizzo *et al.* 2016). This allows access to the foundations by carefully removing part of the soil covering the canal's side, enabling workers to examine the piles, extract wooden cores, and potentially perform micro-drilling measurements. An even more difficult challenge exists with houses in Amsterdam, where access to the foundation often necessitates removing the flooring of the house, facing the issues related with historical heritage of monumental buildings and troubles caused to residents. The scenario differs in Amsterdam for bridges and quay walls. In these cases, the upper part of the foundation (the heads of the piles) is accessible to divers underwater, since it is situated between the horizontal foundation and the canal's soil layer. It is important to note that micro-drilling may not be suitable for all Venetian or Dutch foundation piles due to the inaccessibility of piles that are either not visible or hard to reach, as well as the dense embedding of the piles in the ground.
