## Overflow Tests on Grass-Covered Embankments at the Living Lab Hedwige-Prosperpolder

### An Overview

Koelewijn, André R.; Rikkert, Stephan J.H.; Peeters, Patrik; Depreiter, Davy; van Damme, Myron; Zomer, Wouter

Water (Switzerland)

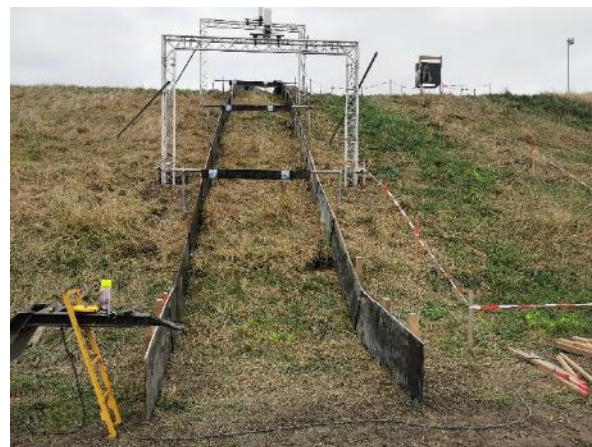
**Figure 2.** Standard setup of an overflow experiment, view from the landside dike toe. Camera and sensor frames are placed across the 2 m wide test section, prior to execution.

During an overflow test, the overflow generator is positioned on the dike slope near the crest; in the case of the Polder2C's experiments, this was the riverside slope. Using a frequency modulated pump setup (driving a dual Hidrostral I16K-SS in 2020 and spring 2021) or a combination of BBA pumps BA300 and BA500, a predefined discharge was pumped into the overflow simulator. During the Polder2C's experiments, discharges as low as 50 l/s/m and as high as 550 l/s/m have been applied.

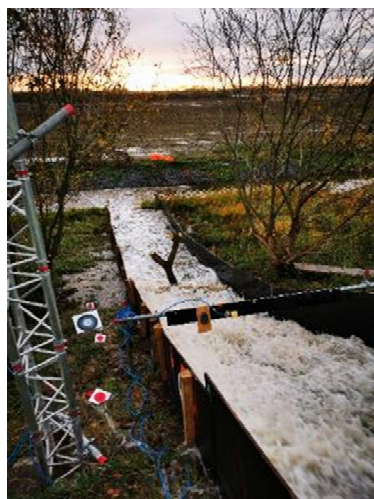
**Figure 4.** Anomaly test section with a tree trunk at the toe of the dike.

1. the presence of a tree at the toe of a dike in the test section (Figure 4);
2. a damaged dike profile at the toe, mimicking damage by animals like grazing sheep;
3. hard structures and transitions on the dike (e.g., concrete staircase).

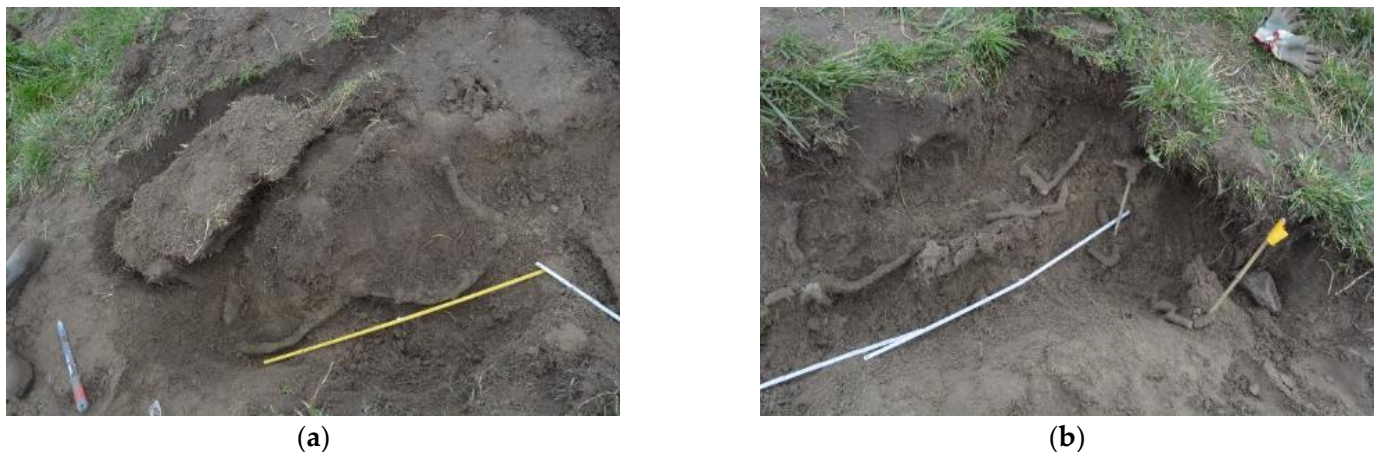
**Figure 10.** (a,b) Examples of excavated grouted animal burrows.

To learn more about the structure, dimensions and depth of animal burrows, some burrow systems were filled with grout and exposed (Figure 10). These activities led to an increased understanding of the processes at hand [16,18]. The critical factor in the damage to develop appears to be whether the burrows are in contact with the sand core and whether sand can be mobilized from within the core and exported to the outside of the dike. The requirements for this seems to be (1) a burrow system that is connected over meters to decameters distances; (2) a burrow system that reaches deep enough so that the dike clay cover is pierced and contact with the sand is made; (3) a flow of water through the burrow system is generated by the overflow process so that core sands are mobilized. Surprisingly, the artificially made holes, supposed to resemble animal burrows, were generally better resistant to flow, even if they were clearly connected to the sand core, with both an entry pipe and an exit pipe. In test B-11 for instance, the artificial hole was the very last part to collapse.
