Overflow Tests on Grass-Covered Embankments at the Living Lab Hedwige-Prosperpolder

An Overview

Overflow Tests on Grass-Covered Embankments at the Living Lab Hedwige-Prosperpolder: An Overview

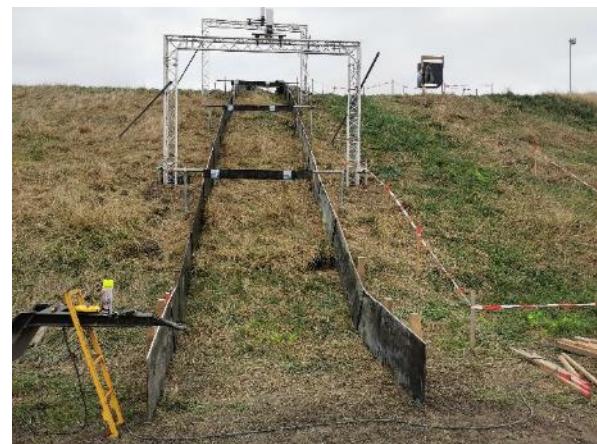
Figure 2. Standard setup of an overflow experiment, view from the landside dike toe. Camera and sensor frames are placed across the 2 m wide test section, prior to execution.

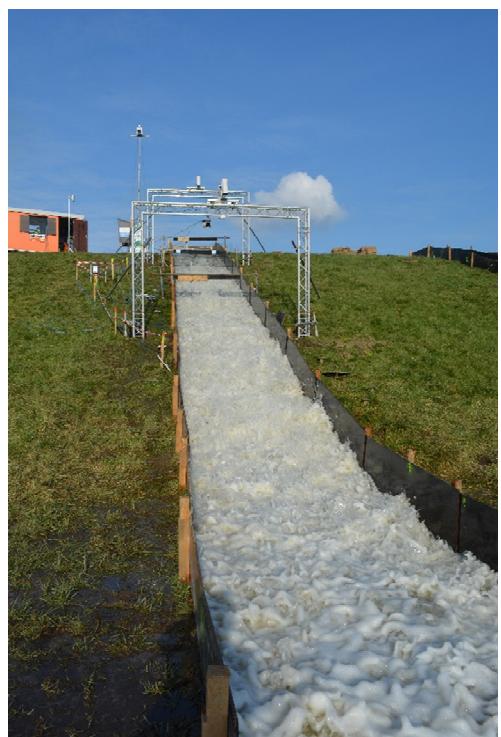
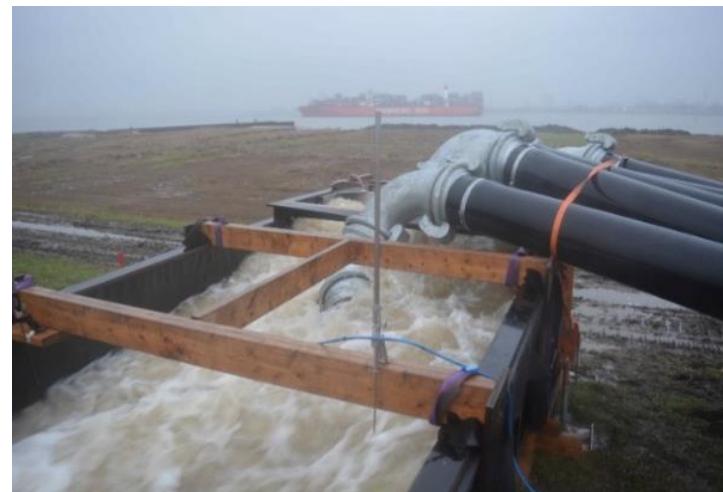
Figure 3. (a) Overflow in progress; (b) Overflow generator at maximum discharge of 1100 L/s.

The flow canal used for directing the water flow over the grass cover of the dike was 2 m wide. At the crest of the dike it was connected to the overflow generator. Both sides of the flow canal were made of coated hardboard plates of $2 \times 0.7 \times 0.01$ m. The plates were hammered and sliced into the ground to a depth varying between 7 and 15 cm deep. The plates were screwed to wooden poles of a size of approximately 0.1–0.1–1.0 m with one pointed end. The poles were hammered into the ground to a depth of approximately 0.2–0.3 m. Figure 3a shows a typical flow canal that was realized on virtually every test section during the overflow experiment. Figure 3b shows the uppermost part at the maximum discharge.

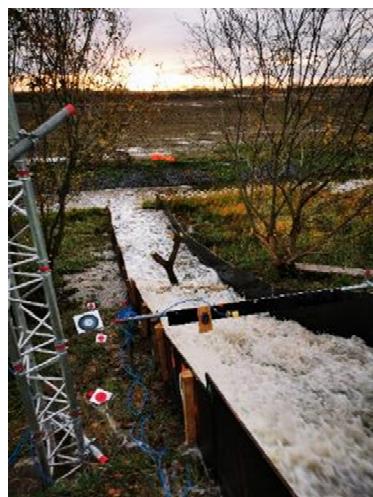
Figure 4. Anomaly test section with a tree trunk at the toe of the dike.

1. the presence of a tree at the toe of a dike in the test section (Figure 4);
2. a damaged dike profile at the toe, mimicking damage by animals like grazing sheep;
3. hard structures and transitions on the dike (e.g., concrete staircase).

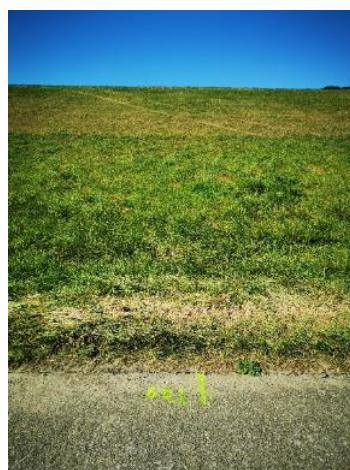
Figure 6. Dutch reference test section (September 2020).

The reference tests carried out on an undamaged Dutch dike (see for an impression Figure 6) all had more or less the same proceeding: the test duration could be held for tens of hours (up to 30 h) without any critical damage occurring, despite measured flow velocities ranging from 2 to 4.5 m/s. This result is significantly better than the results collected in [4]. During the proceeding of such tests, it was observed that the density of the grass layer decreased while the grass roots were becoming slightly exhumed (centimetre scale). Due to the ‘jumping’ effect of the water over grass sods, decimetric step structures in the soil profile were observed, but this did not lead to any significant downward or headcut erosion. With increasing discharge, this effect appeared to develop faster and become more prominent.

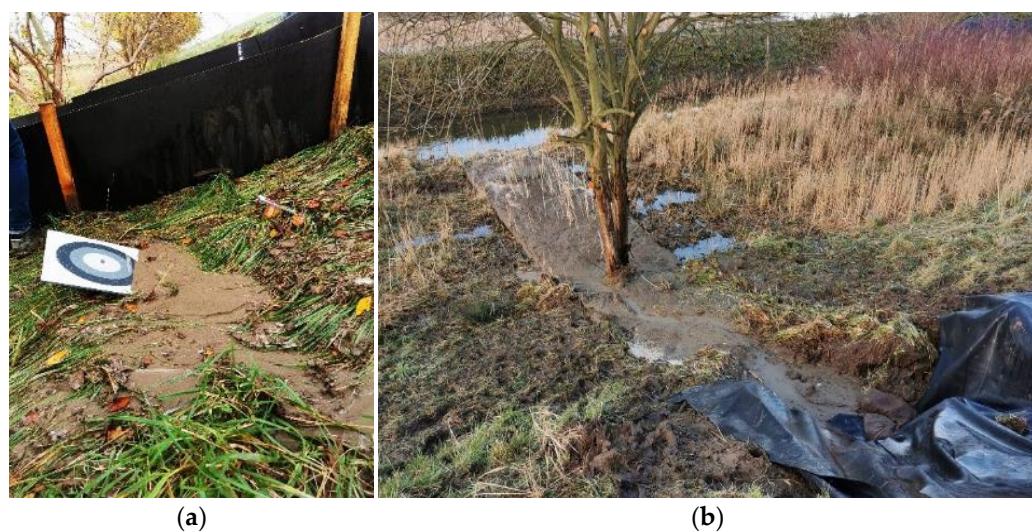
Figure 9. The role of burrows and the outcome of dike cover collapse at the second test with a tree: (a) puddle of sand flowing out at burrows near the dike toe; (b) the aftermath of a collapsed dike slope after sand outflow at the toe. Note that the tree itself is in place and did not appear to influence the process.

It was observed in several cases that burrows at or near the dike toe expelled sediment coming from the dike core. This transport of sand undermined the dike clay cover up to the point that it caused the cover layer to collapse. From that point onwards, the outflow of water saturated sands from the dike core, and the overflowing water would quickly transport the exposed sands and further support fast backward headcut erosion, in the order of several meters within minutes. Figure 9a shows outflow of sand next to the test section and the failure induced by animal burrow in a test section that was initially focusing on the effect of the presence of vegetation during overflow (Figure 9b). These observations instigated additional research [16,17].

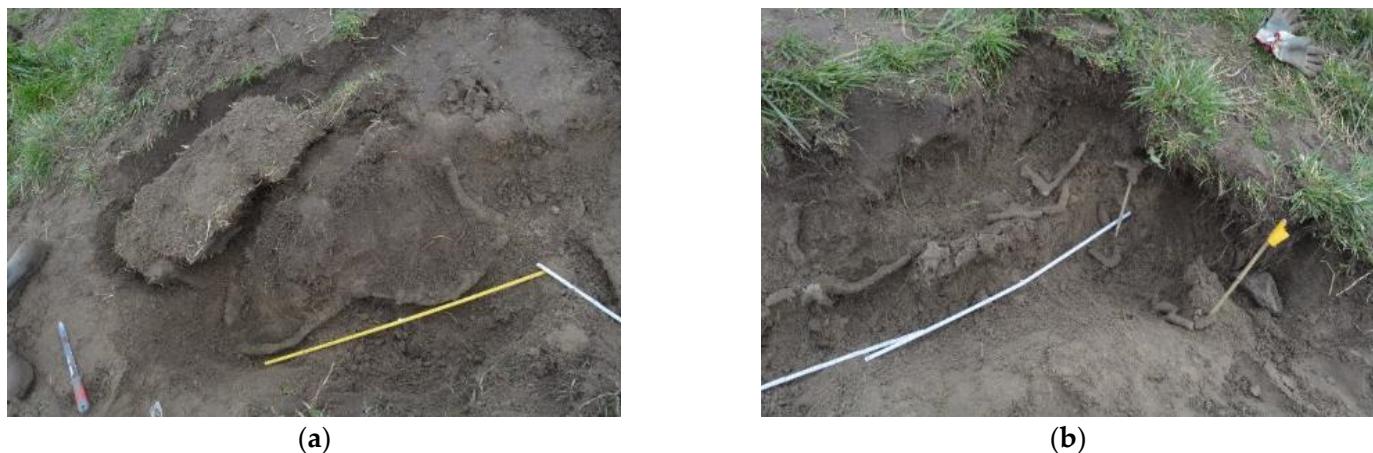
Figure 10. (a,b) Examples of excavated grouted animal burrows.

To learn more about the structure, dimensions and depth of animal burrows, some burrow systems were filled with grout and exposed (Figure 10). These activities led to an increased understanding of the processes at hand [16,18]. The critical factor in the damage to develop appears to be whether the burrows are in contact with the sand core and whether sand can be mobilized from within the core and exported to the outside of the dike. The requirements for this seems to be (1) a burrow system that is connected over meters to decameters distances; (2) a burrow system that reaches deep enough so that the dike clay cover is pierced and contact with the sand is made; (3) a flow of water through the burrow system is generated by the overflow process so that core sands are mobilized. Surprisingly, the artificially made holes, supposed to resemble animal burrows, were generally better resistant to flow, even if they were clearly connected to the sand core, with both an entry pipe and an exit pipe. In test B-11 for instance, the artificial hole was the very last part to collapse.
