Repairing impacted thermoplastic composites using ultrasonic welding to restore the compressive strength

MASTER OF SCIENCE THESIS

For obtaining the degree of Master of Science in Aerospace Engineering
at Delft University of Technology

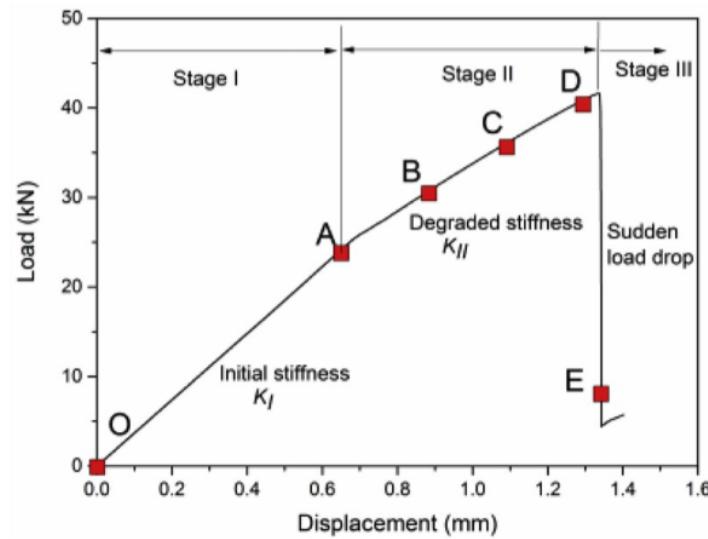
Figure 2.5: Stiffness degradation during the three stages of CAI [6]

than the section with fiber damage. The area of delamination damage was the largest and exhibited an irregular shape [6]. The different stages of CAI are shown in figure 2.6 using strain and displacement data which were obtained by digital image correlation (DIC).

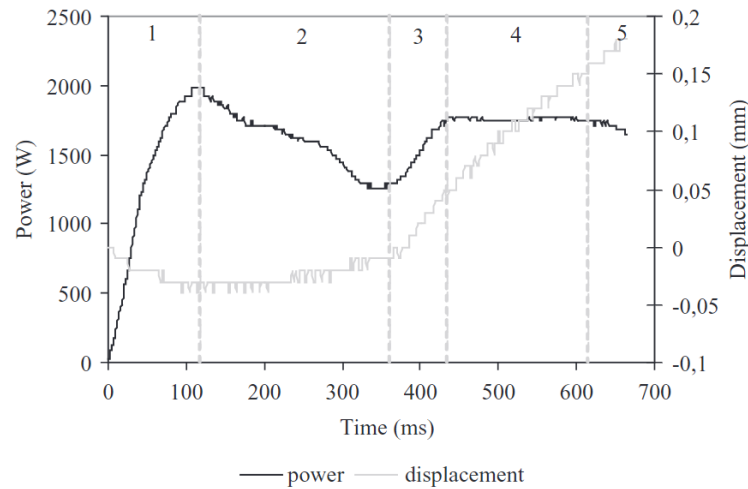
Figure 2.10: The 5 different stages during the welding process indicated on the power and displacement curves of a welded lap joint with flat ED. Positive values indicate a downward displacement of the sonotrode. [8]

The parameters that lead the welding process are welding force, vibration amplitude and vibration time [48]. The heating rate is determined by both the welding force and the vibration amplitude. An increase in the value of either one of the two parameters will result in an increase of the heating rate [52]. This means that, for high welding forces and vibration amplitudes, shorter welding times can be achieved, hence less heat dissipation to the surrounding material and, therefore, a smaller heat affected zone in thickness direction. Important to note is that the welding force should not be too low as this will promote the loss of contact between the sonotrode and the adherend. This loss of contact is also known as hammering and, as the vibrations from the sonotrode are not properly introduced into the adherend, makes the welding process less efficient and less predictable.

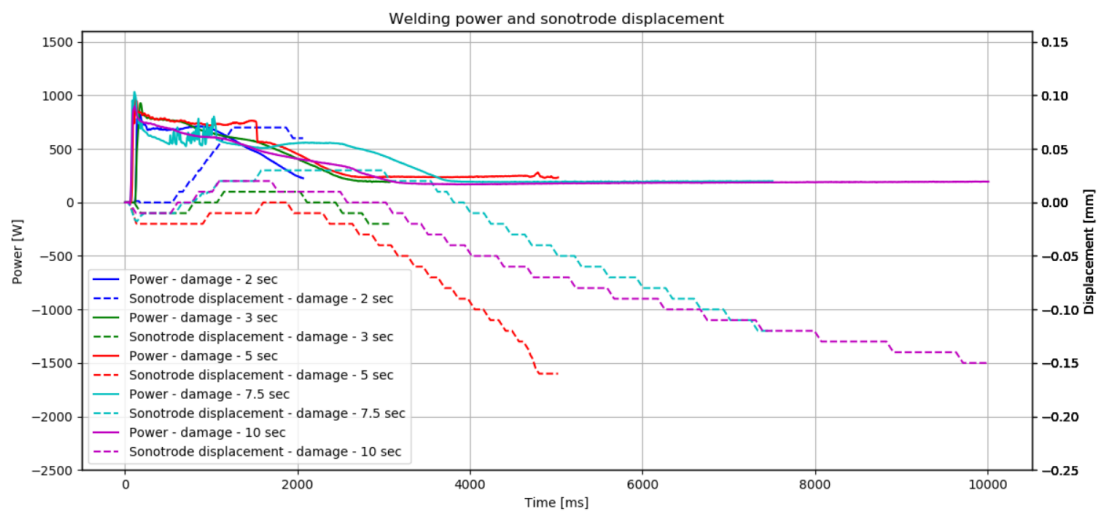
Figure 5.2: Power and displacement curves for welds performed on damaged specimens

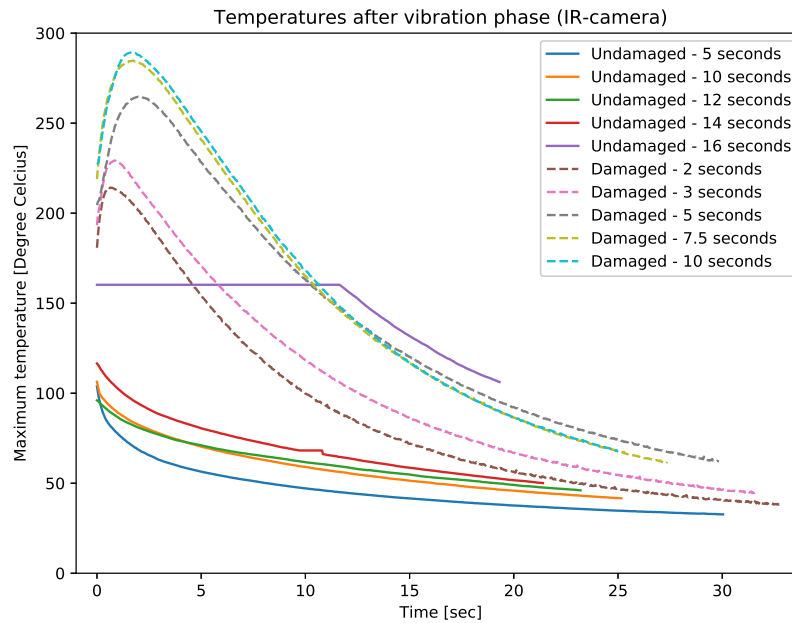
Figure 5.3: Maximum temperature curves of the top surfaces of the welded specimens. Measurements start directly after the vibration phase.

weld. The maximum temperature is chosen over a fixed location because the temperature is not homogeneously distributed. Therefore, the curve represents the highest temperature reached independent of its location. Unfortunately, for the trial with undamaged specimens, the IR-camera used a calibration up to 160°C. This resulted in the fact that all readings above 160°C are shown as 160°C. Therefore, the 16 second weld on the undamaged specimen shows a constant 160°C for the first 12 seconds.

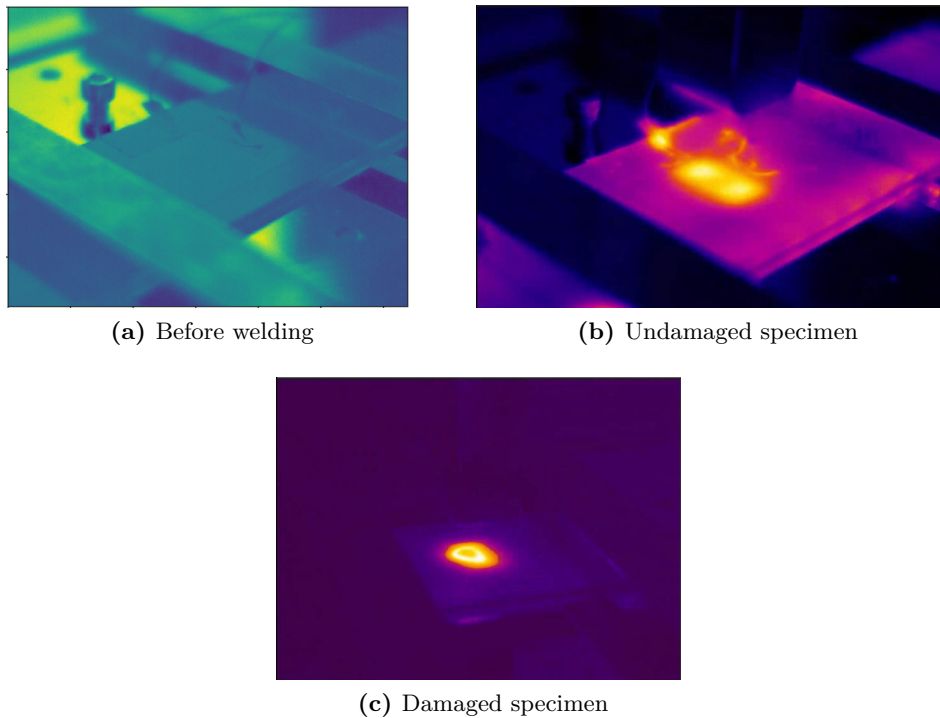
Figure 5.4: Temperature distribution on the top surfaces of welded specimens directly after the vibration phase and lifting of the sonotrode. (a) Picture before welding to provide more clarity to what can be observed in (b) and (c). (b) Undamaged specimen welded for 14 seconds. (c) Damaged specimen welded for 7.5 seconds.

Comparing the temperature curves of the undamaged and damaged specimens, there are a few differences. The initial temperatures of all undamaged specimens are lower (although this cannot be determined for the 16 seconds weld) compared to the damaged specimens. This holds not only for welds with similar durations but even the 2 second weld on a damaged specimen shows higher temperatures than the 14 second weld on an undamaged specimen. Also, the temperature of the undamaged specimens immediately decreases when the vibration phase ends. However, for damaged specimens, the temperature increases first and, after the peak is reached, starts to decrease. Finally, after the same amount of time the remaining temperatures are higher on the damaged specimens, indicating more bulk heat energy is present.

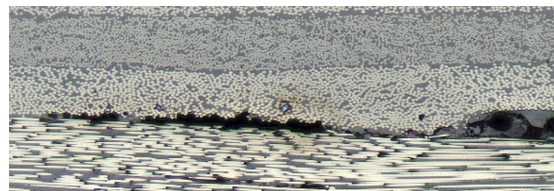
(b) Heat induced delamination

Figure 5.7: Figures show two types of delaminations. The difference can be seen by looking at the roughness of the edge of the ply and if there are thickness variations within the ply.

two is variation in ply thickness around the delaminated area. If a delamination is induced by an impact event, the plies detach from one other but do not deform as the ply itself remains intact. However, when a delamination occurs due to melting of the material, the plies surrounding the delamination are also affected as they melt too. This often causes the plies to deform and vary in thickness, see figure 5.7. Additional to the previously mentioned signs, damaged specimens can also indicate melted areas when there are no delaminations present at locations where delaminations are expected as, after melting, the delaminations re-consolidate. However, after an impact event, the presence of delaminations at certain locations is never guaranteed and, therefore, the absence of delaminations cannot guarantee melting. Also, even when T_m is not reached, when above T_g , the material softens and the delamination can close without bonding together. Although the delamination is still present, it becomes increasingly difficult to detect. Finally, some plies have a smooth delamination that has the appearance of a thin crack in between the plies. However, there are also delaminations that are filled with debris from the impact event [14]. These delaminations can easily be mistaken for voids in the interface or delamination induced by the welding process, see figure 5.8.

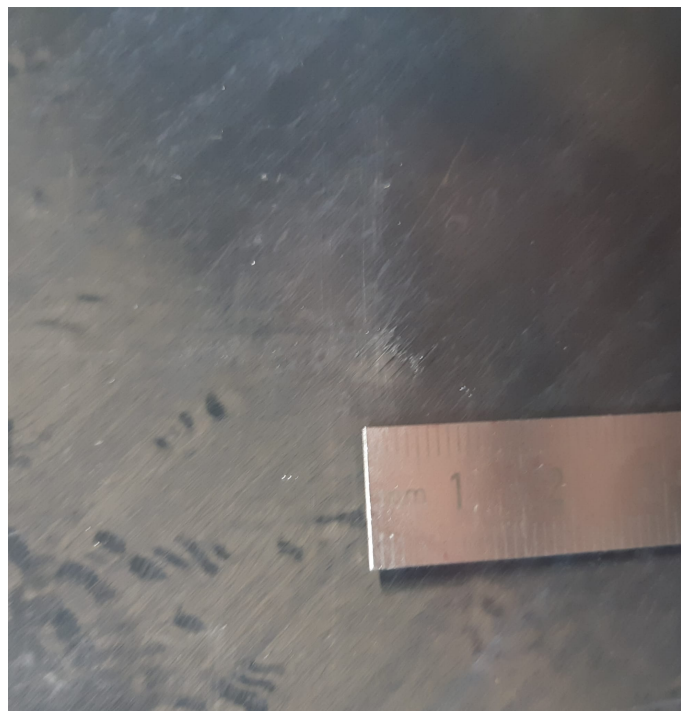
Figure C1: Fiber damage on the non-impacted side of specimen 1.2

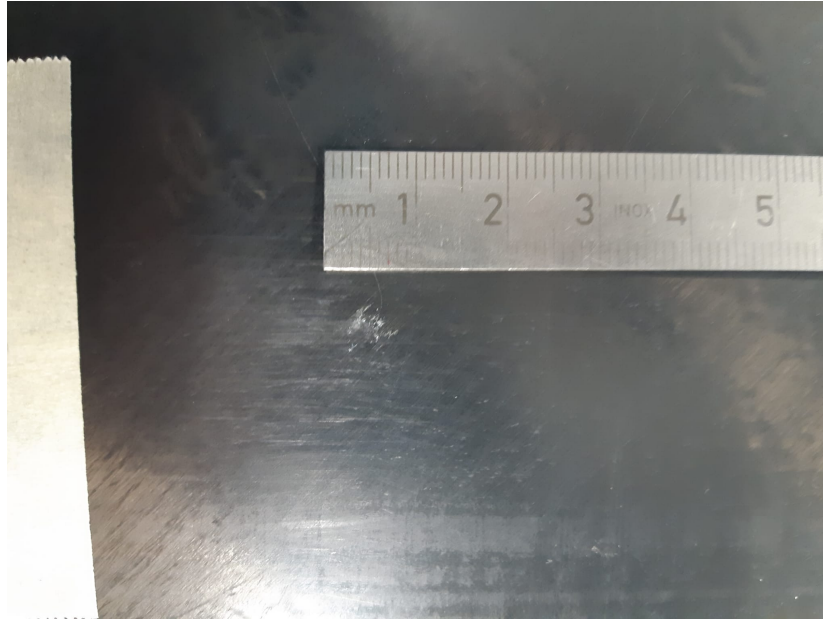
Figure C2: Fiber damage on the non-impacted side of specimen 1.9
