Damage assessment of highly-loaded low-speed roller bearings with acoustic emission monitoring

A full-scale laboratory evaluation

To obtain the degree of Master of Science in
Offshore and Dredging Engineering

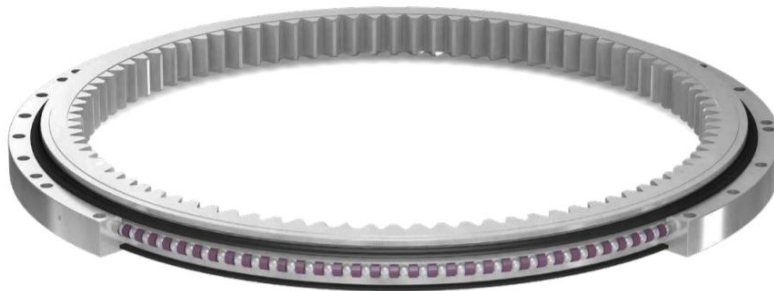
Figure 2.2: Example of a slew bearing [13]

Notable offshore application for slew bearings are, wind turbine pitch blades [14], heavy lift cranes, turntables for FPSO turrets and their main bearings. Other applications are in hoisting and conveying machines e.g. mobile cranes [15][16], material processing machines, harbor machines [17], metallurgic machines e.g. electric arc furnace and caster turrets [18], medical facilities e.g. electron accelerator gantry [19], radar and missile launchers [17][1].

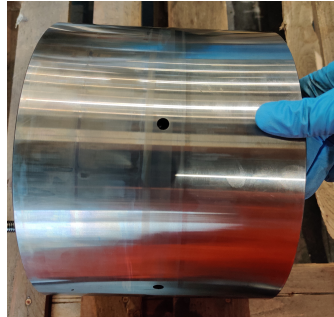
Figure 4.6: 180 degrees rotated inner ring, no wear visible

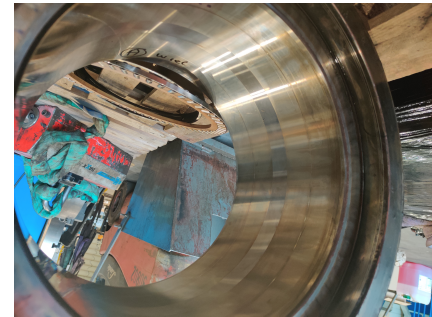
Figure 4.7: Raceway of outer ring, 1st inspection. Wear visible on raceway

To visually inspect the damage, the available bearings were opened up. From the outer ring, it can be observed that traces of wear are visible over the entire raceway. Grooves at the raceway are visible at the locations of the sides of the rollers. The raceway of the outer ring is shown in figure 4.7. The pictures of the inner ring are shown in figure 4.5 and 4.6. Only on a specific side of the inner ring, traces of wear were observed, see figure 4.5. The reason for wear only on this specific side is that the inner ring was stationary and most often loaded in one direction. The outer ring was continuously rotating. The inner ring rotated 180 degrees with respect to figure 4.5, no clear indication of wear was visible, see figure 4.6. During opening up of the bearing, sufficient lubrication of all components was observed.

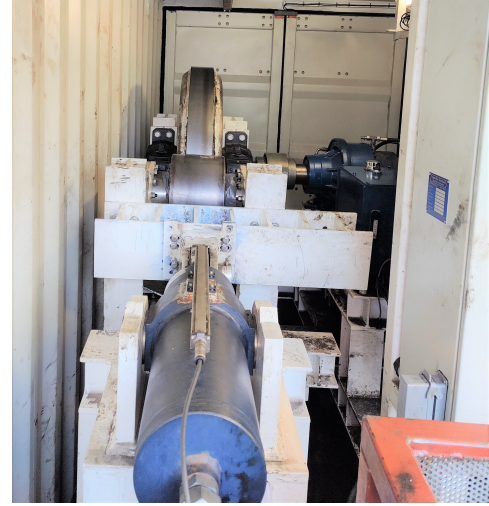
Figure 4.13: Front view test set up

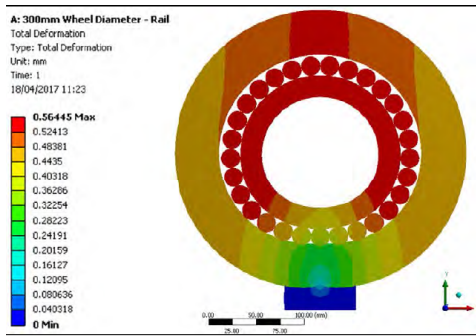
Figure 4.15: FEM analysis of a 300 mm bearing supported on a rail

From an earlier finite element analysis by Allseas [131], it has been concluded that supporting the wheel on a rail results in an increased load on the bearing in comparison with a radial support. If the wheel is supported on the rail, the rollers are subjected to a load which is 1.7 times higher than a wheel which is supported radially. This factor is only valid for the 400 mm TLS wheel. For other wheel sizes, different factorial increases were concluded. This means that the dynamic equivalent radial load P_r should be multiplied by this factor to compensate for the rail support.

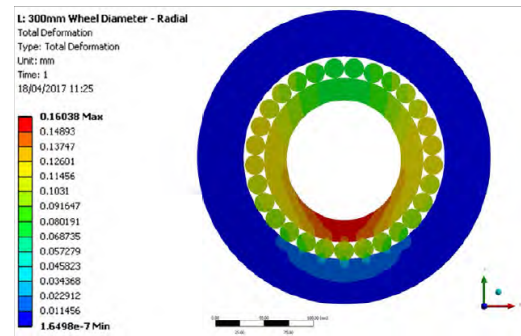
Figure 4.16: FEM analysis of a 300 mm bearing radially supported

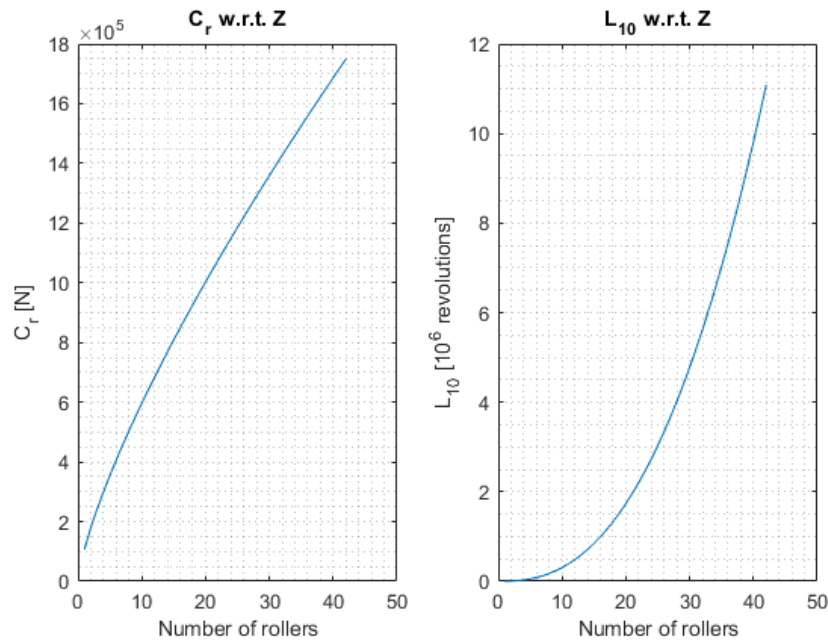
Figure 4.19: Relation between number of steel rollers, basic dynamic load rating C_r and basic rating lifetime L_{10}

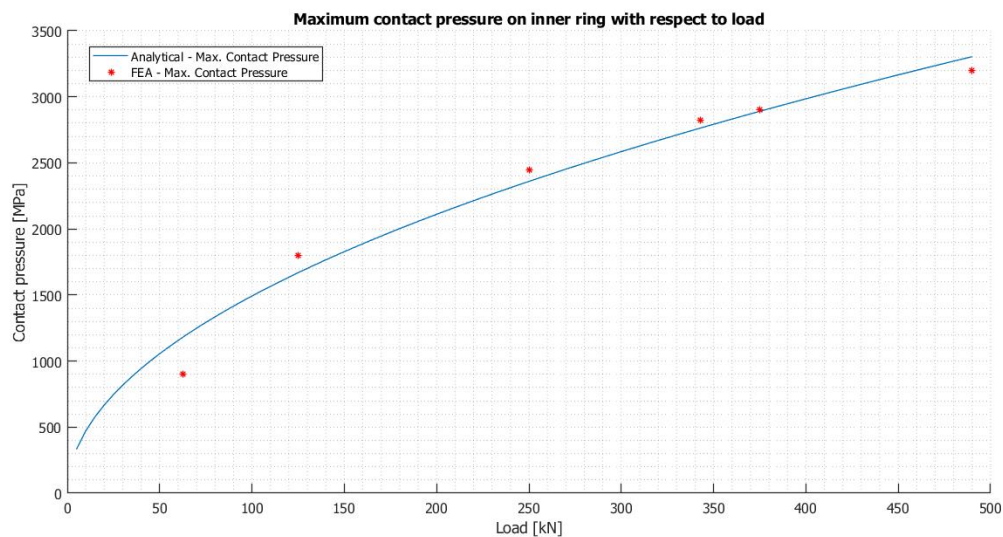
Figure 4.23: Results for the maximum contact pressure with respect to applied load for FEM and analytical solution

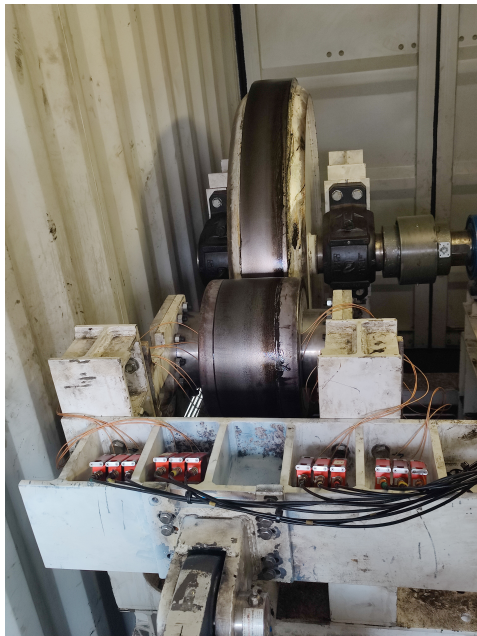
Figure 4.25: AE measurement system installed in test set up

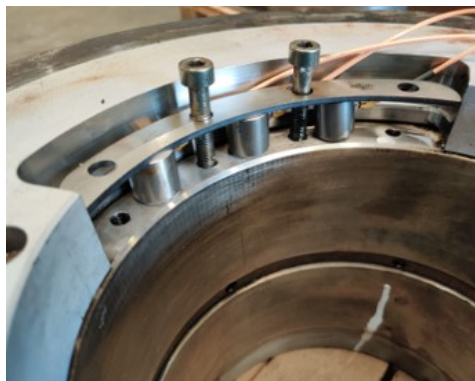
Figure 4.29: A set of sensors mounted on the inner ring

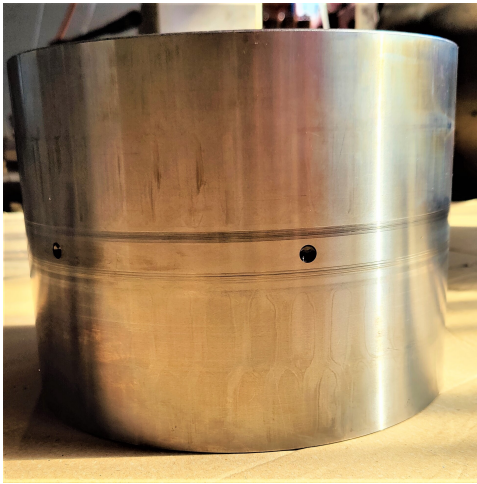
Figure 5.10: Picture of unworn side of inner ring before duration test.

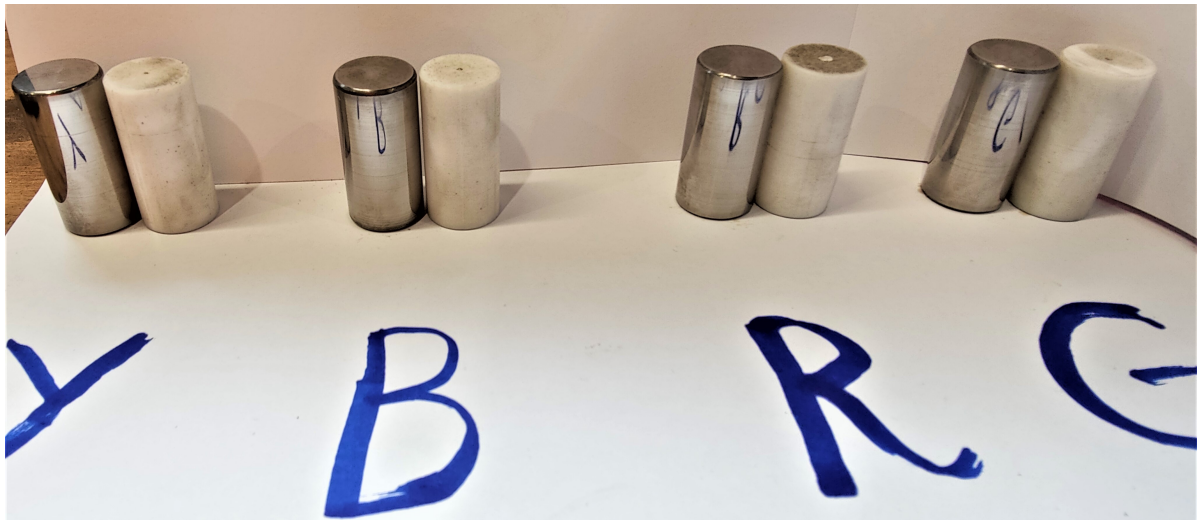
Figure A.18: Rollers after duration test shown per raceway. Sorted positioning from most left raceway to most right raceway. Directions left and right are taken as reference from figure 4.25.

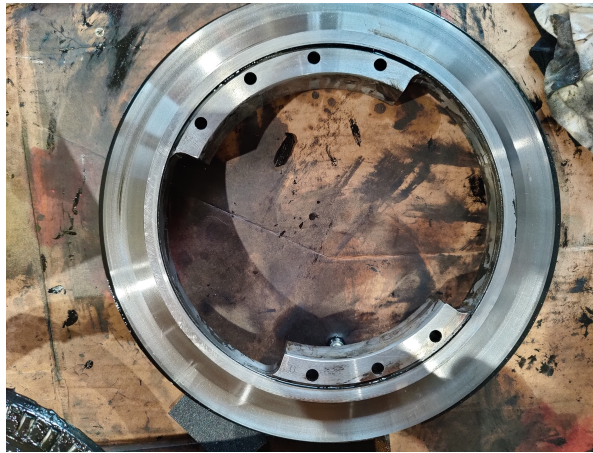
Figure A.29: One of the flanges after duration test

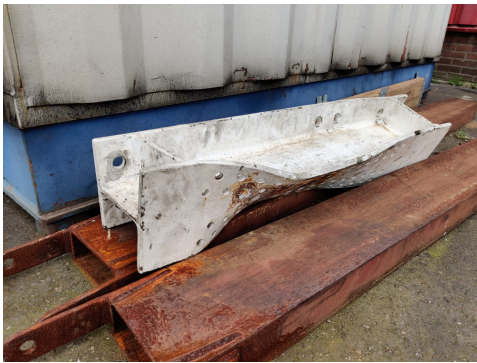
Figure A.47: Warped cylinder hinge connection beam

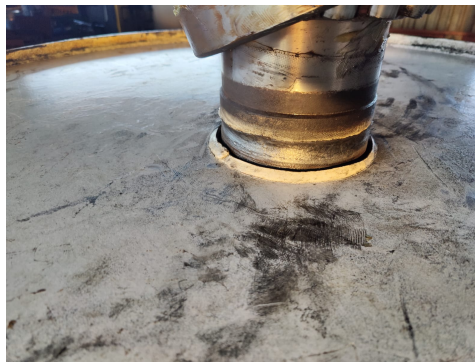
Figure A.49: Failure of test wheel: welded connection between wheel structure and shaft broken

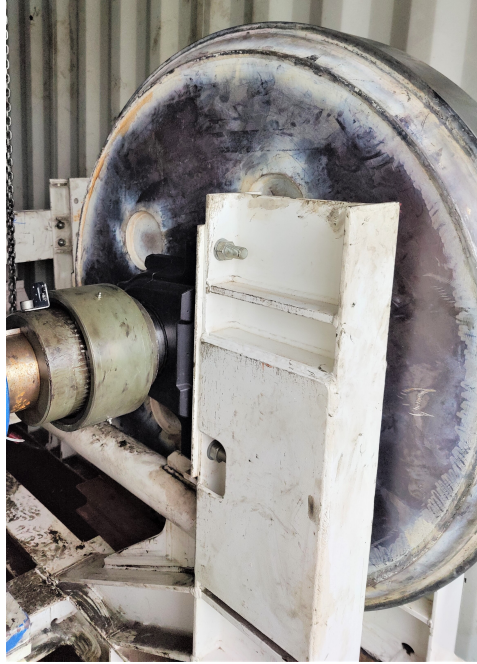
Figure A.50: New designed test wheel
