## Effect of moisture on tuffstone weathering

Lubelli, Barbara; Nijland, T.G.; Tolboom, H.J.

Use and conservation of Rhenish tuff in the Netherlands, Germany, Flanders and Denmark

### Effect of moisture on tuffstone weathering

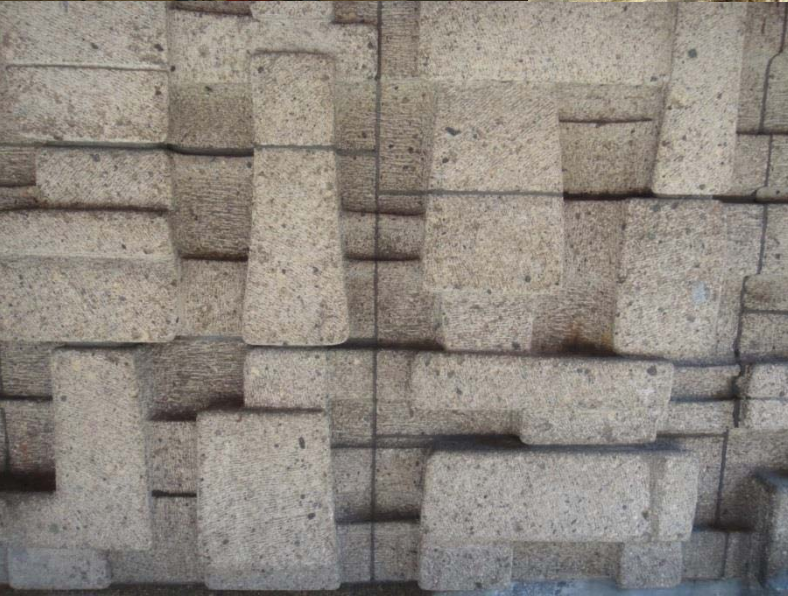
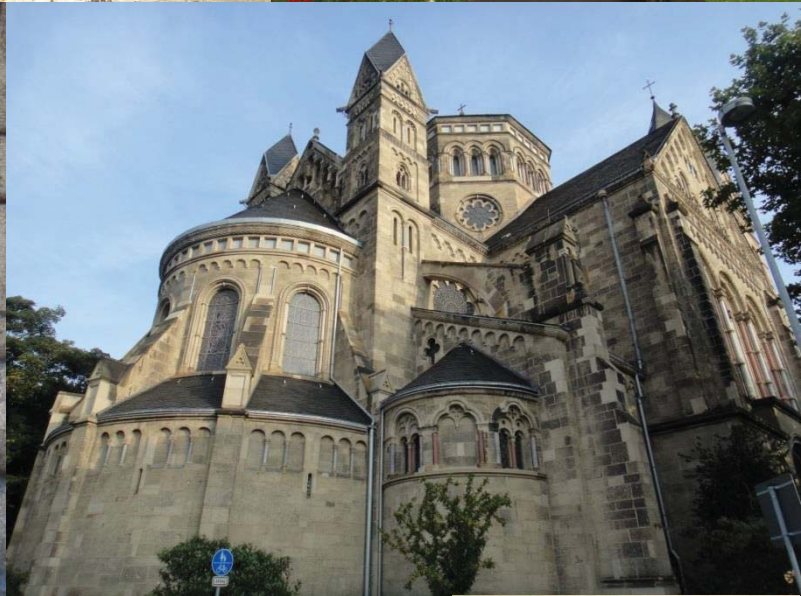
*Fig. 1. Typical longitudinal cracking (left) and final damage in mullions of Ettringen tuff at the tower of Eusebius' church in Arnhem, The Netherlands (pictures T.G. Nijland, 2009).*

on Ettringen tuff elements (Fig. 1). It is unclear whether this is due to the nature of the stone itself, or, at least in part, an artefact of the architectural use (Römer tuff is, for example, never used a larger elements in mullions or sills, but nearly always in block) This type of damage also (but much more rarely) occurs on Weibern tuff (Fig. 2), that has been used for similar building elements as Ettringen tuff.

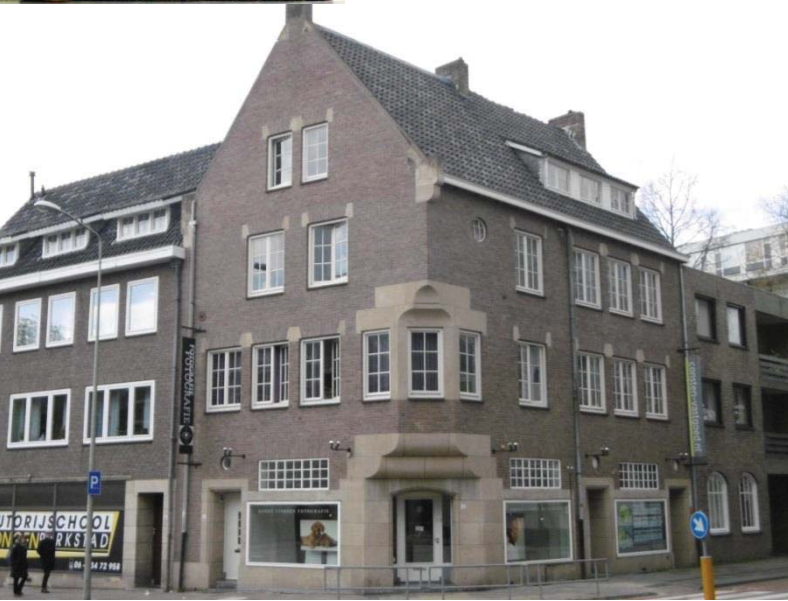
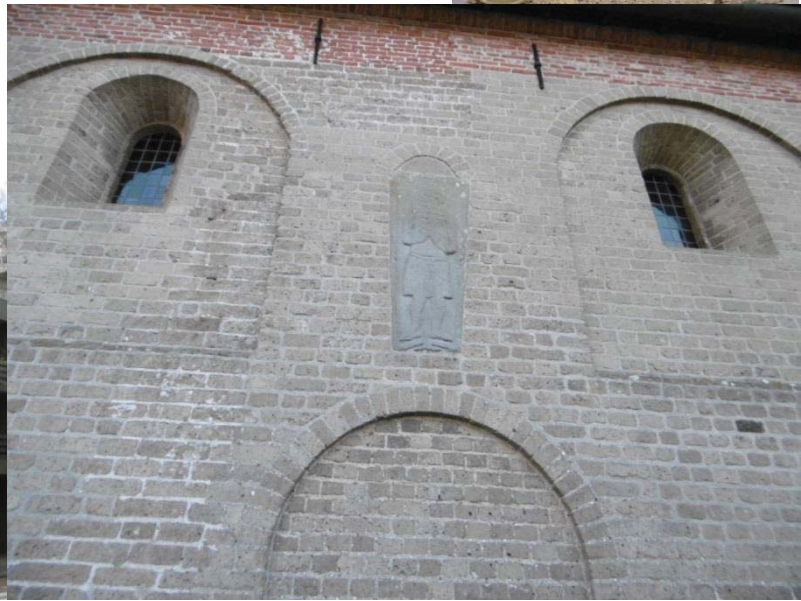
*Fig. 2. Typical longitudinal cracking (left) and final damage in mullions of Weibern tuff at the nave of St. Peter's church in Leiden, The Netherlands (pictures T.G. Nijland, 2005).*

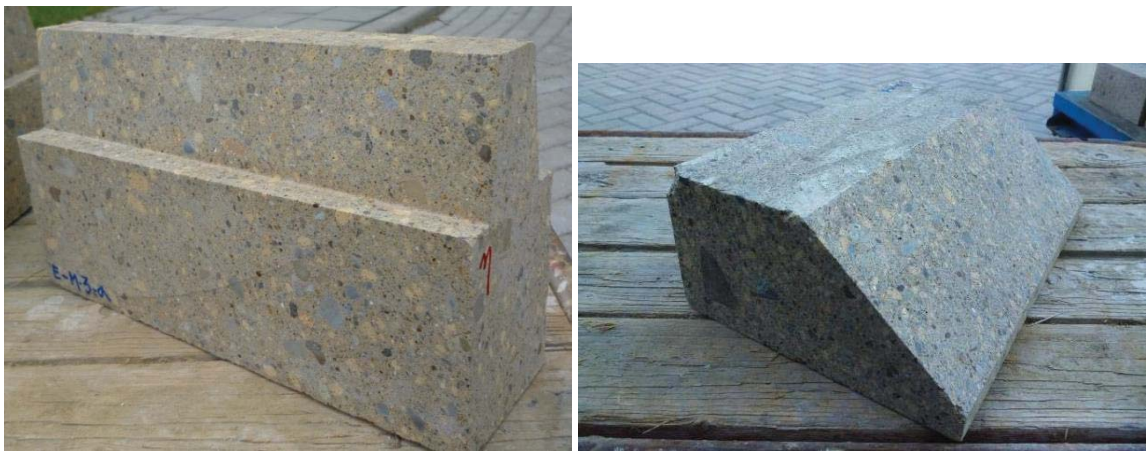
*Fig. 3. Examples of cut mullion and window sill.*

The test plan consisted of a weathering test, aiming at simulating in laboratory the wet-dry cycles occurring in the field, and a series of characterization tests, some of them carried out before and after the weathering test. Specimens of different sizes were used for the tests: cubes, prisms, and small scale mullions and window sills. Part of these were simply cut by a saw, and untooled (Fig. 3). Part of the samples have been made in a traditional way by hand a stone mason (Fig. 4), and tooled by a chisel (Fig. 5) for reasons given above.

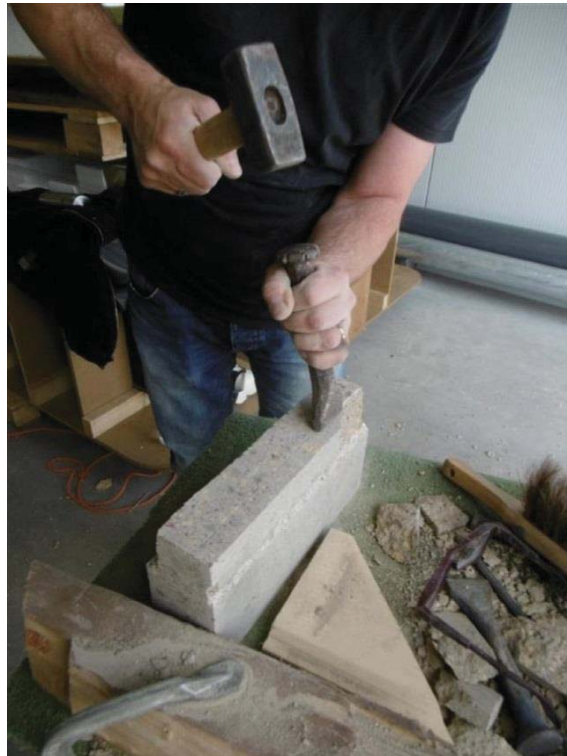
*Fig. 4. Making of a mullion by hand.*

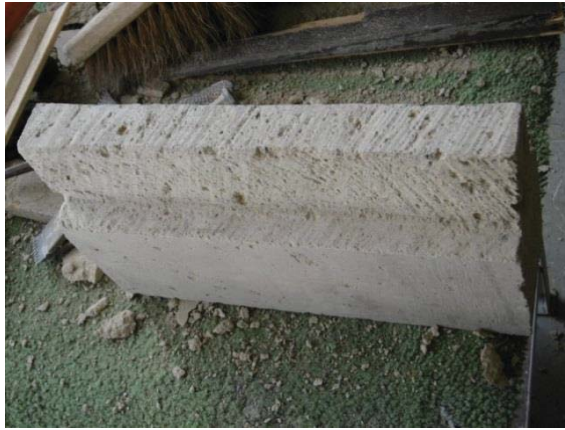
*Fig. 5. Example of a tooled mullion.*

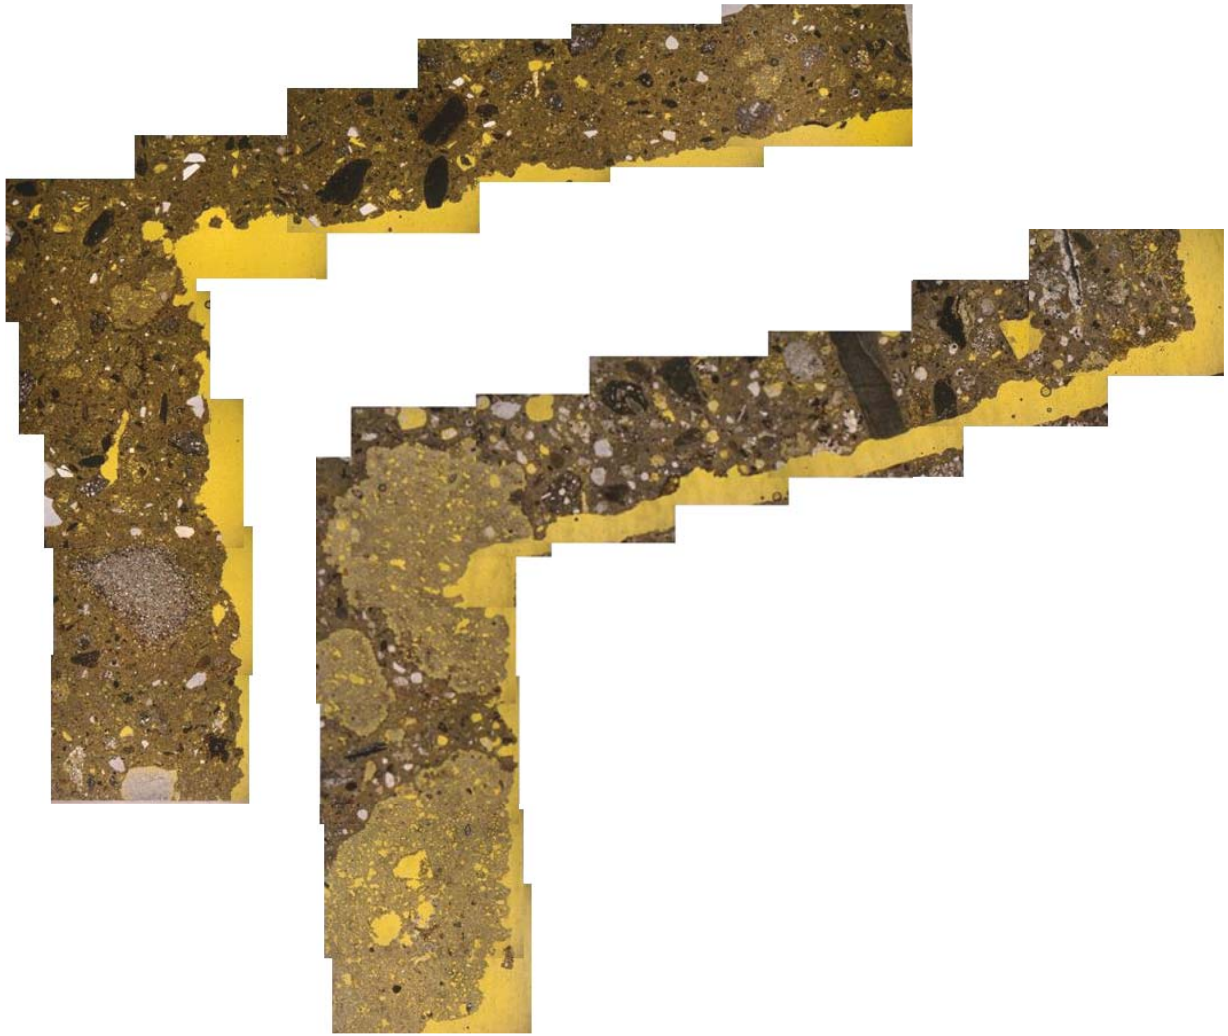
*Fig. 19. Microphotographs over the bend in a tooled Ettringen (above) and Weibern (below) tuff mullions. Note the absence of any microcracks.*

In order to evaluate the effect of tooling, i.e. the possibility of crack initiation by a stone mason prior to weathering, samples have been investigated means of thin sections. Neither in the case of Ettringen tuff, nor in the case of Weibern tuff, any cracks have been initiated, confirming previous results on Weibern tuff and Portland stone (Fig. 19; Nijland 2005).
