Wave overtopping simulator on a 1/15 slope protected by two local grass species

Yen Binh, Thach That, Ha Noi - June, 2012

Report of measurements and observations

Communications on Hydraulic and Geotechnical Engineering 2012-02

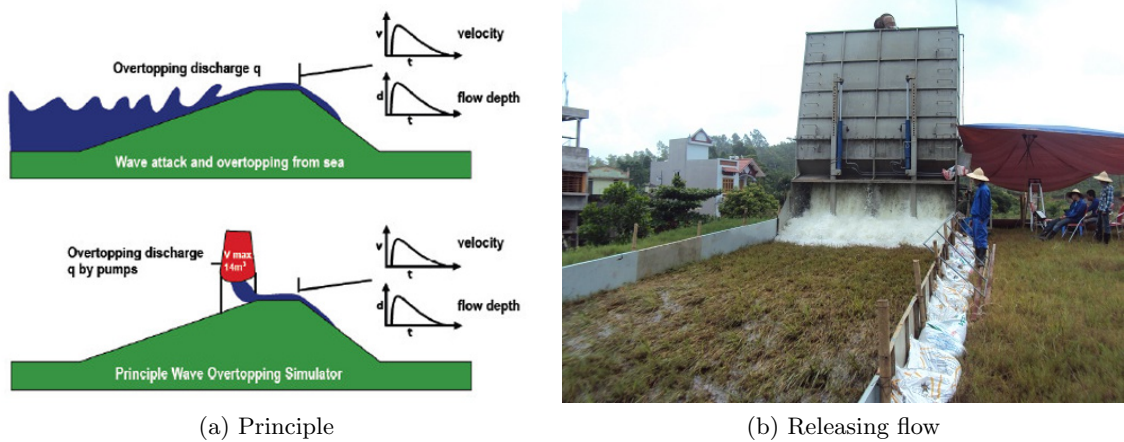
Figure 1.3: Principle of the Wave Overtopping Simulator and an overtopping flow is being generated.

Basically, the Simulator is a water tank which can be easily moved from place to place. The maximum volume is 5.5 m³ per 1 m of width (22 m³ for the Simulator of 4 m in width). The Simulator is continuously filled by one or more pumps with a certain discharge and is emptied at desired moments through two butterfly valves at the bottom in a way that simulate the overtopping tongues on the dike crest and then on the landward slope. Figure 1.3 illustrates the principle of the Simulator and its operation on site. As can be seen from the figure, as long as the flow velocity and the flow depth released from the Simulator are similar to those in reality on the dike crest, the flow characteristics on the landward slope will then automatically follow.

On a dike slope with a inclination of 1/3, flow velocity can reach 6 to 7 m/s [Le, 2011] and the flow is highly turbulent with a lot of white bubble, as depicted in Figure 1.3 (right panel). Most of the laboratory devices are not designed for this kind of condition. In 2009, measurement devices and measurement methods were developed further in order to obtain reliable data. Then, flow depth was measured with a floating device which was a wooden board connected to a rotary encoder. The board can rotate around an axis when the flow runs over and pushed it up, the angle at the axis is recorded by the rotary encoder and then converted into the flow depth. The front velocity was estimated by using a digital camcorder capturing the flow from above or aside.

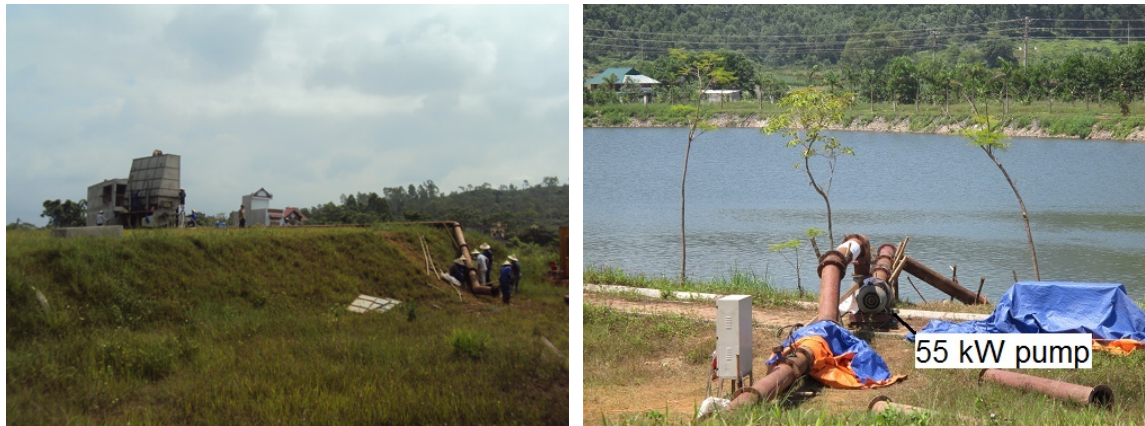
Figure 2.2: The super dike model with the simulator, pump and pipes.

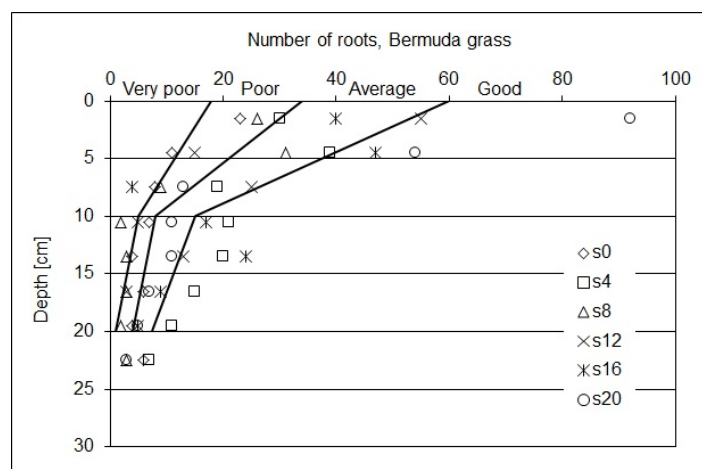
Figure 2.4: Root distribution in depth of Bermuda grass compared to Min [2006].

part). About 12 samples of Bermuda grass and Carpet grass were taken giving distributions of roots in depth as shown in Figure 2.4 and 2.5. The grass cover condition was poor to average for Bermuda grass and average to good for Carpet grass according to Min [2006],

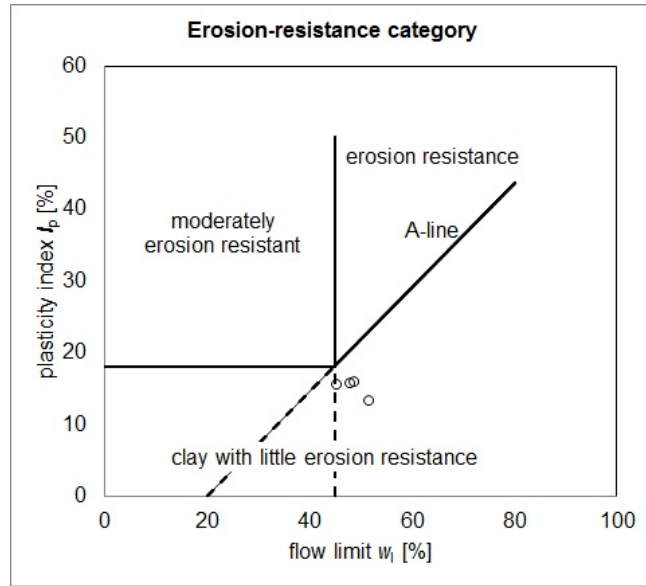
Figure 2.6: Erosion resistance category based on flow limit and plasticity [TAW, 1996], round dots are soil samples taken from the super dike body.

Analysis results indicated that the super dike body is constructed of clay with sand content of less than 40 %. According to the guidelines currently applied in Viet Nam [Vie], sand contents of grains with size smaller than 2 mm and larger than 0.005 mm. While sand grain sizes vary between 0.063 and 2 mm in TAW [1996]. Obtained values of w_l and I_p are plotted in the erosion-resistance category diagram given in TAW [1996]. Similar category remains an issue that needs to be established in Vietnamese condition. As can be seen in Figure C.5, the super dike soil is classified into clay with little erosion resistance. The analysed value points are close to the A-line, the limit between erosion resistance and little erosion resistance. However [TAW, 1996] does not describe clearly characteristics associated with these categories, for example, maximum flow velocity and corresponding applied duration.

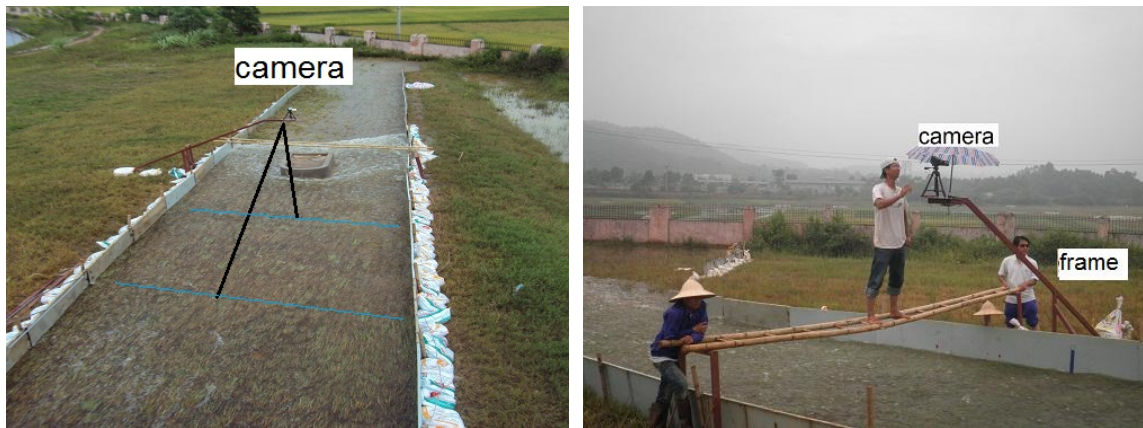
Figure 3.1: Set-up of the camcorder to capture overtopping flow on the dike slope

Flow released from the Simulator are very turbulent with high density of air bubbles which normally makes flow very white. Presently, there is no reliable device for this kind of flow. In previous simulator tests in Hai Phong, Nam Dinh and Thai Binh, digital camcorders were applied in determining front velocities on the dike slope. Based on the differences in positions of the front part of the overtopping flow between successive images, with a given distance and given time step, front velocity can be derived. Set-up of the first camcorder is shown in Figure 3.1. The camcorder was mounted on a steel frame to capture the flow over a distance of 10 m. The second camcorder was positioned aside to capture the flow as shown in Figure 3.2.

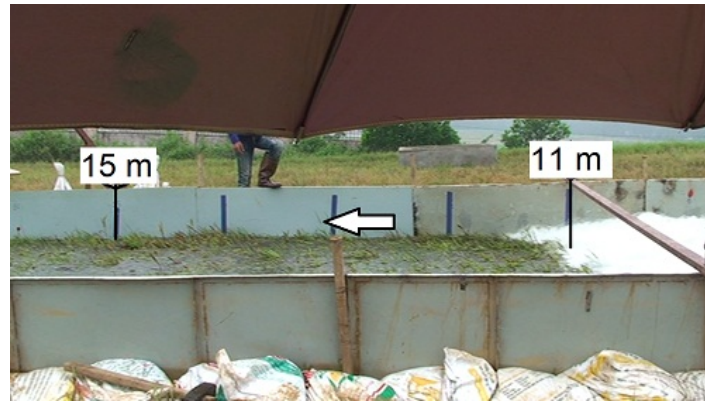
Figure 3.2: The flow captured by a camcorder positioned aside.

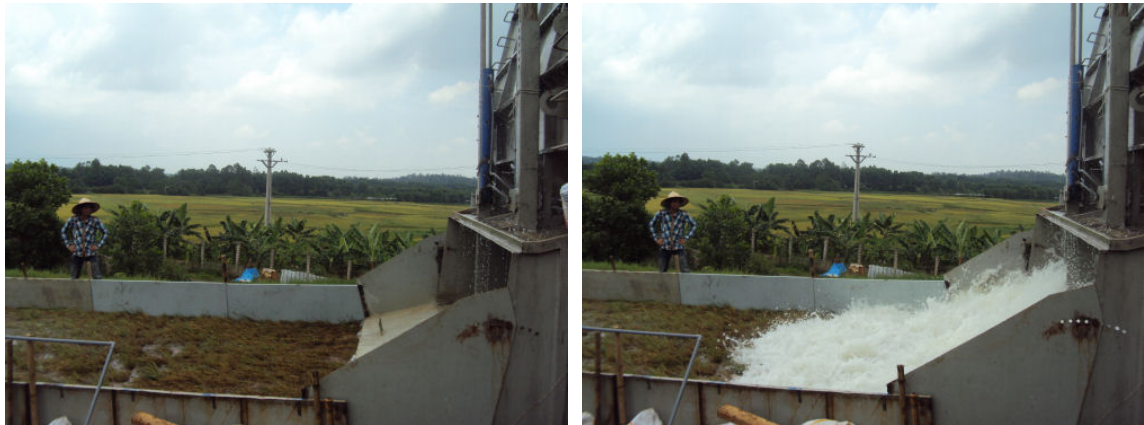
Figure 6.3: Energetic flow at the simulator gate.

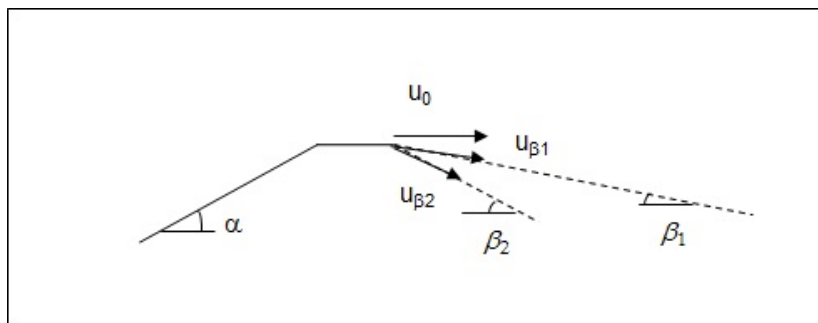
Figure 6.4: Flow velocity at the crest edge.

Also another part of the energy discrepancy between the two regimes causes damage of the dike toe which is actually the bed of flow.

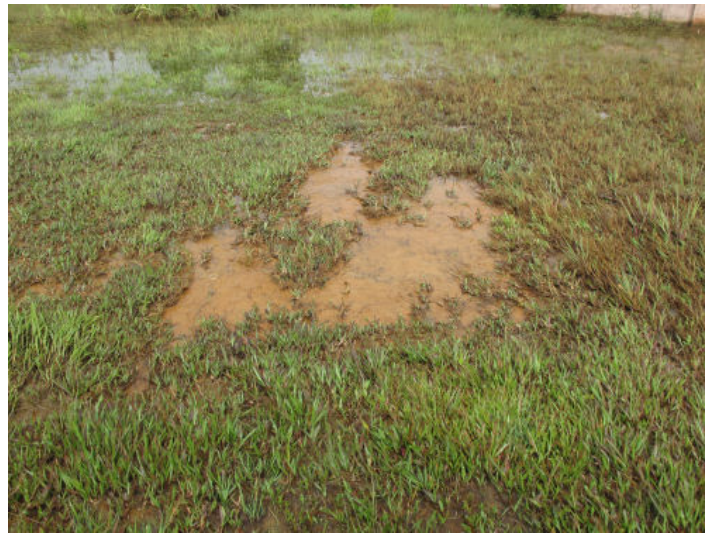
Figure 6.5: Damage at the YB3 dike toe after 60x4 + 80x6 + 100x4.

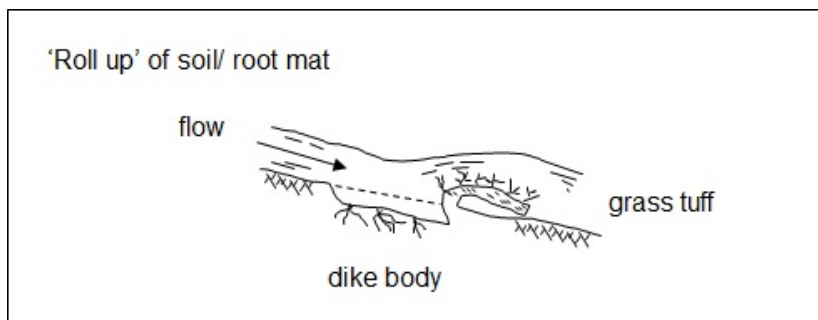
Figure 6.7: Mechanism 'roll up', grass mat is cut underneath and pushed up gradually.

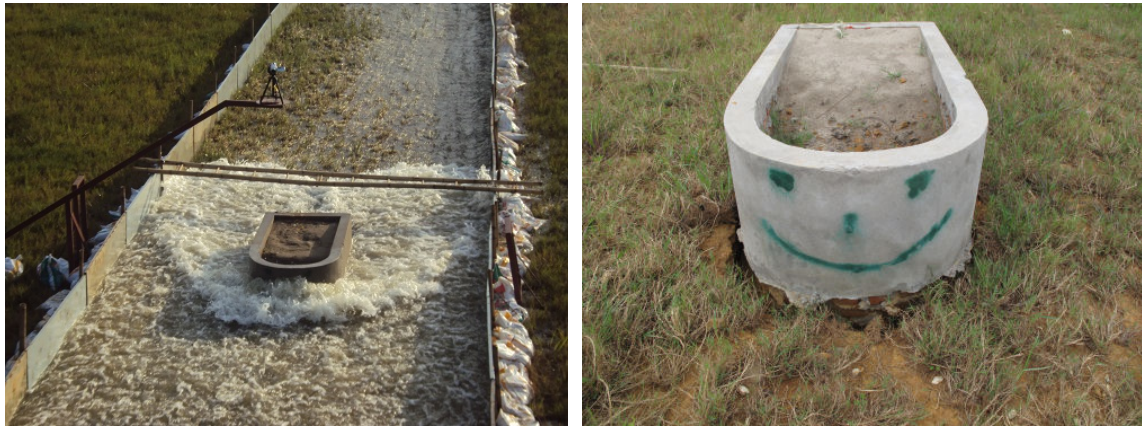
Figure 6.8: Left: flow around the round obstacle at YB1. Right: damage in front of the round obstacle.

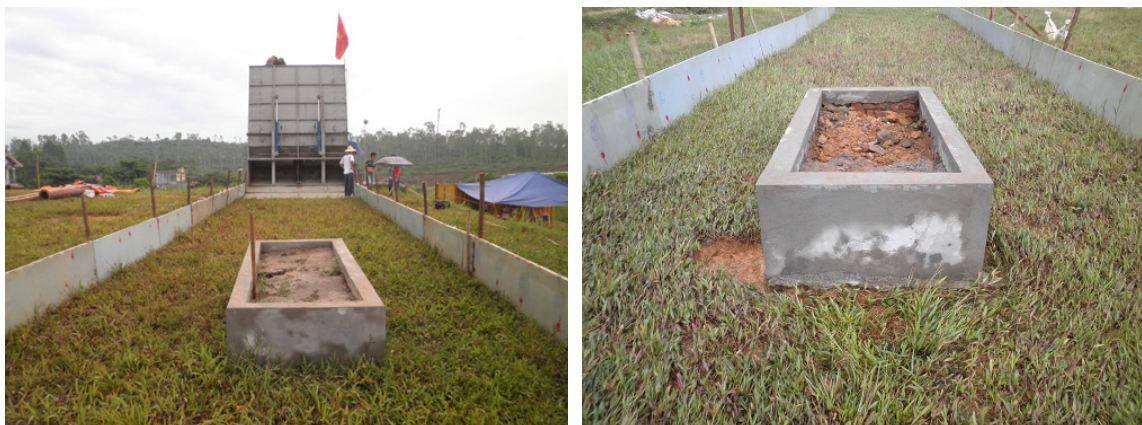
Figure 6.9: Grass mat around the square obstacle at YB4. Left: initial condition. Right: after 40x2 + 60x6.

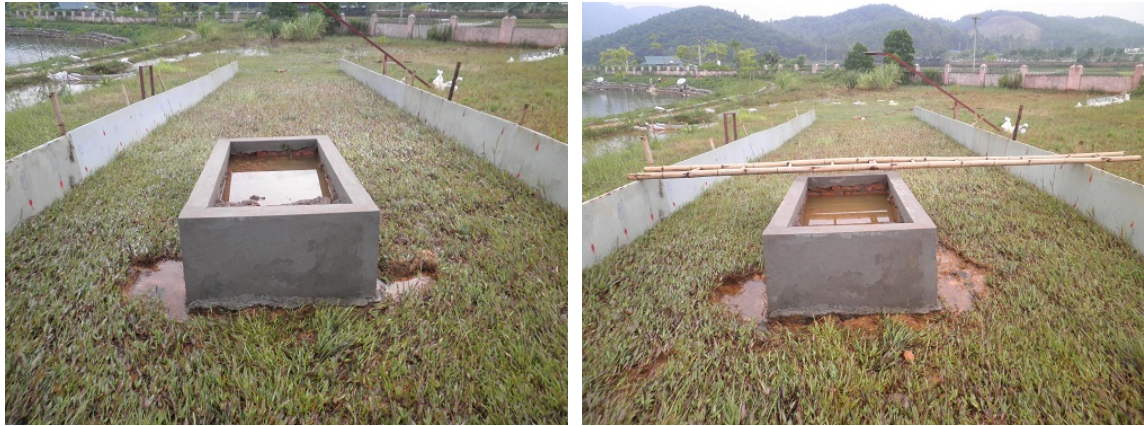
Figure 6.10: Damage around the square obstacle at YB4. Left: after $0 \times 2 + 60 \times 6 + 80 \times 4$. Right: after that $80 \times 2 + 100 \times 4$.

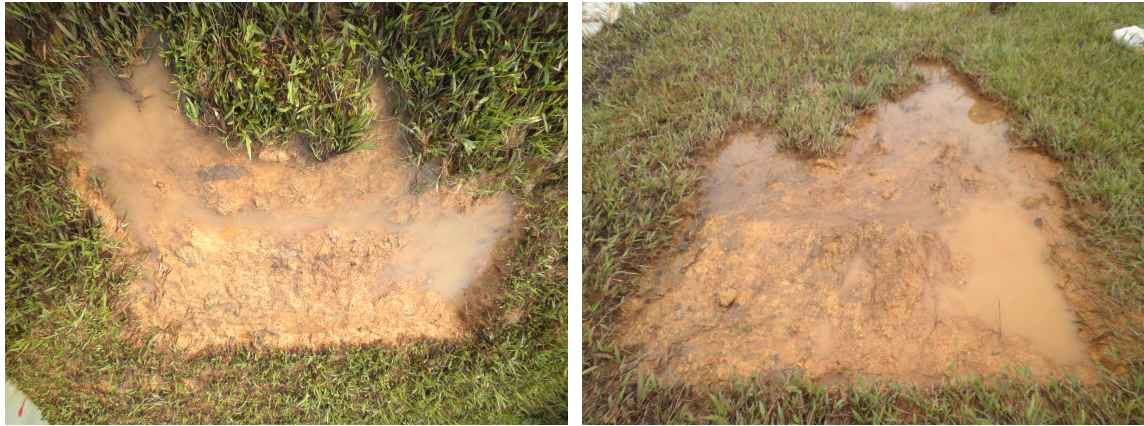
Figure 6.12: The 5bc damage after 40x1 + 60x2 (left) and after that 60x4 + 80x6 + 100x6 (right), wave height of 2.0 m.
