PROPOSAL AND VERIFICATION OF RIP CURRENT DETECTION USING AI

T. Ishikawa¹, R. Shimada², R. Sawagashira² and T. Komine²

¹Research and Development Initiative, Chuo University, 1-13-27, Kasuga Bunkyo-ku, Tokyo 112-8551, Japan. ishikawa.195@g.chuo-u.ac.jp.

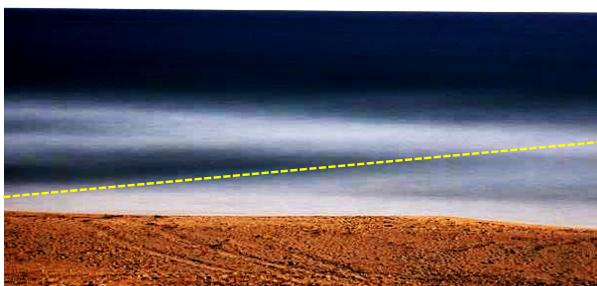
(a) 15:10-15:15, 19 December 2018 (case 32) (b) 15:40-15:45, 21 December 2018 (case 36)
 Figure 14. Example of the result of Image analysis in case 32 and 36

the surf zone, and the formation of a bar and trough by Lippmann and Holman (1989). Figure 14 shows an example of the result which was made at an averaged image of approximately 550 images every 5 minutes using image data of Cam 01. The rip current can be confirmed in the dark colored area with an oblique angle (a yellow dotted line of Fig. 14(a)), because the waves are hard to break in the rip current area. However, the dark colored area cannot be confirmed in the no rip current situation (Fig. 14(b)). Therefore, if the averaged image has the dark colored area that crosses the surf zone, we evaluated it as "rip current occurred". On the other hand, when there was not any dark colored area and the color was uniform, we evaluated it as "no rip current occurred".

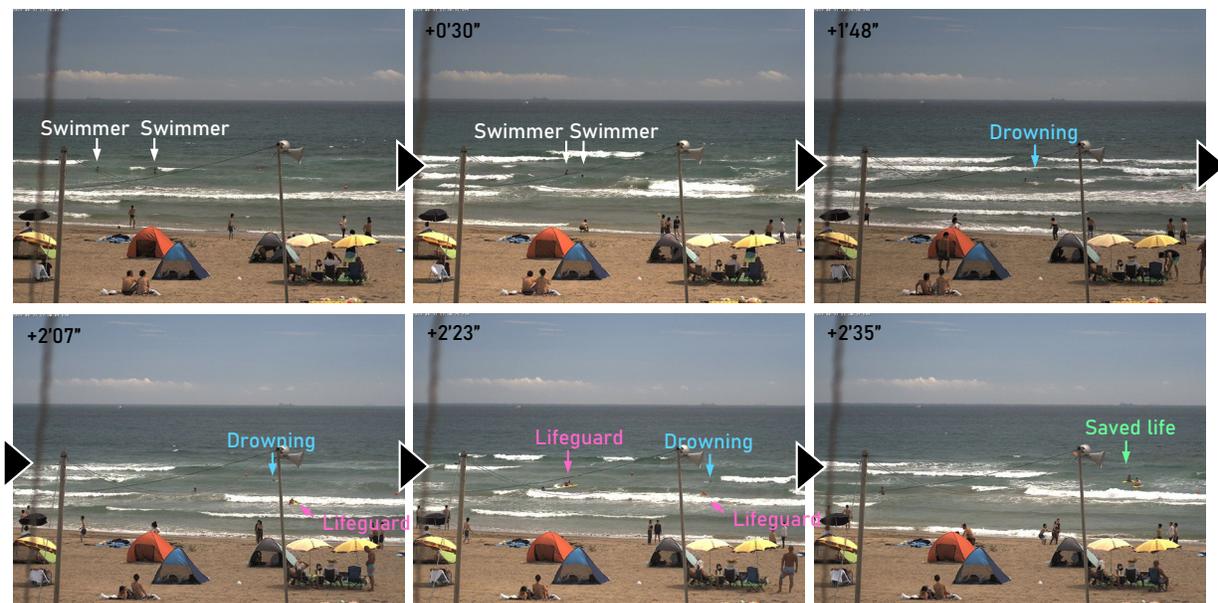
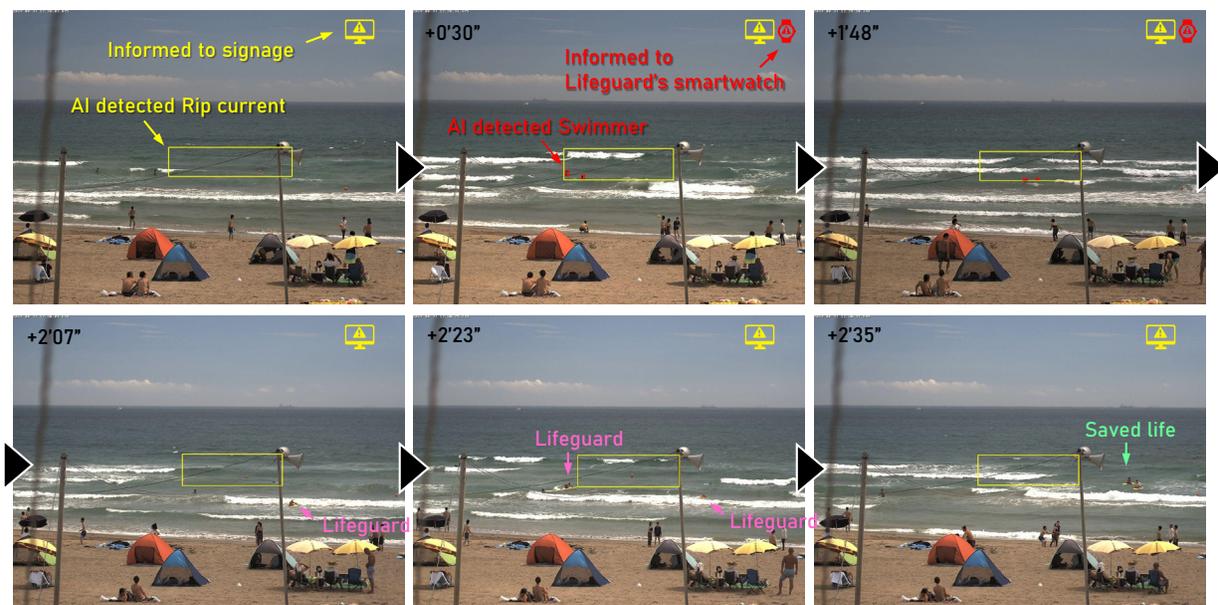
of rip current alerts by the system were 2,425 for a total of 51 days from July to August 2019. In fact, some swimmers were rescued by lifeguards under the system. Figure 20 shows an example of a rip current accident. It can be confirmed that one swimmer was drowning in the rip current area. Figure 21 shows the detection areas by the analysis of the system log data on the images at same time as Fig. 20. It was confirmed AI could detect rip currents and human entrance into rip current areas. Also, the detected rip current areas mostly accorded with actual rip current areas which shift due to wave conditions. In this rip current accident, although the swimmer was near drowning, lifeguards could take early action by receiving the information quickly from the system to their smartwatches. The life of the swimmer was saved by approximately 50 seconds. As in this example, some swimmers were rescued by lifeguards under the system in 2019.
