## Experimental research on salt contamination procedures and methods for assessment of the salt distribution

Construction and Building Materials

The RILEM TC ASC-271 is developing a new laboratory test to assess the durability of porous building materials to salt crystallisation. The test encompasses two phases: salt accumulation and damage propagation. This paper focuses on designing a procedure for the accumulation phase; this is considered successful when salts crystallise at the material's evaporative surface (common situation observed on site) without the occurrence of damage. Two procedures were developed and tested on two limestones with different porosity: (1) capillary absorption of a salt solution followed by drying, and (2) continuous capillary absorption. Sodium chloride or sodium sulphate solutions were used. Several methods for assessing the salt distribution were employed: ultrasonic pulse velocity, drilling/scratching resistance, hygroscopic moisture content, ion chromatography, scanning electron microscopy, and micro X-ray fluorescence. The results enabled the selection of the most effective protocol for the salt accumulation phase.

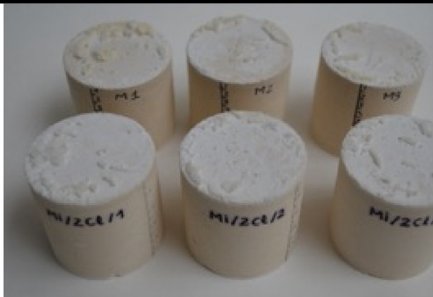
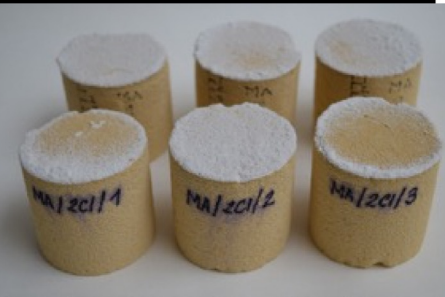
**Fig. 4.** Summary of the macroscopic visual observations on the specimens contaminated with NaCl. Scores of severity of damage: low (+) to high (++++). Scores of extension of damage: small (+) to large (++++ surface area).

Samples contaminated with NaCl with both procedures developed only salt efflorescence, and no visible damage was detected (Fig. 4). The type and amount of salt efflorescence (Fig. 6a) varied according to the procedure followed and type of stone used: a lower amount of NaCl efflorescence developed in the less porous stone (Migné) with procedures P1-1S and P2, but the amount was still slightly higher than for the more porous stone (Maastricht) with procedures P1-1 W and P1-2 W. The results of mass loss (Fig. 7a) can be considered negligible (lower than 0.05 wt%) and confirm the visual observations.

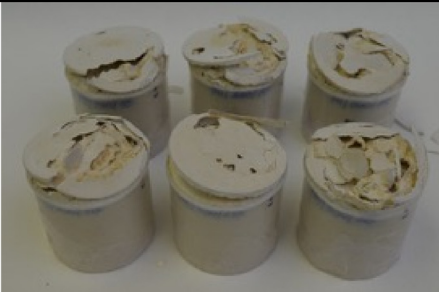
**Fig. 5.** Summary of the macroscopic visual observations on the specimens contaminated with Na<sub>2</sub>SO<sub>4</sub>. Scores of severity of damage: low (+) to high (++++). Scores of extension of damage: small (+) to large (++++). surface area.

Both types of stones contaminated with  $\text{Na}_2\text{SO}_4$  showed damage with all procedures (Fig. 5). Minor damage was observed in Migné after  $\text{Na}_2\text{SO}_4$  contamination with procedure P1-1S, leading to ca. 1 wt% of mass loss (Fig. 7b); the amount of salt efflorescence observed was very low and concentrated close to the evaporative surface. After one rewetting,  $\text{Na}_2\text{SO}_4$  contaminated Migné specimens (P1-1 W) suffered rapid and severe damage (within 24 h of drying). For this reason, the planned second rewetting was not performed, and these specimens were not subjected to the analysis of salt distribution.

In the case of the more porous stone (Maastricht), samples contaminated with  $\text{Na}_2\text{SO}_4$  with procedure **P1-1S** developed slight granular disintegration and scaling, leading to  $0.7 \pm 0.4$  wt% mass loss (Fig. 7b). After one rewetting (**P1-1 W**), the amount of salt efflorescence increased significantly; the amount of efflorescence reached almost 90 wt% of the salt introduced, whereas mass loss was ca. 1.1 wt%. The 2nd rewetting step (**P1-2 W**) induced more damage (ca. 2 wt% of mass loss) and slightly more salt efflorescence. In contrast with Migné, damage occurred in Maastricht samples contaminated with  $\text{Na}_2\text{SO}_4$  with procedure **P2**.
