Assessing the Error Budget for Permanent Laser Scanning in Coastal Areas

Proceedings FIG Working Week

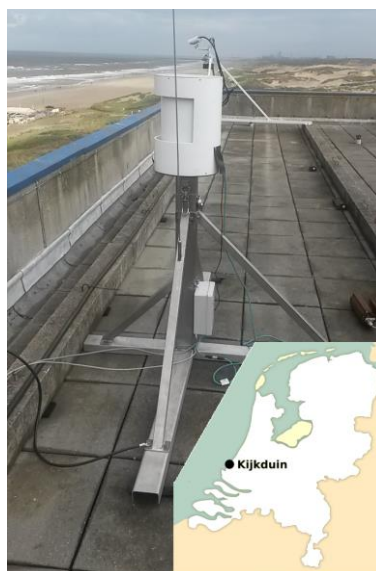
Figure 1: Experimental set up: A Riegl VZ2000 laser scanner is mounted on a steel frame on the roof of a hotel near the beach in Kijkduin, NL. The scanner is covered with a protective casing to shield it from wind and rain while not operating.

Our permanent laser scan system consists of a Riegl VZ 2000 laser scanner, mounted on a specially designed frame (see **Fejl! Henvisningskilde ikke fundet.**). It consists of a stainless-steel main column on four legs supported by cross-legs. The frame is buffered on rubber and weighted down with floor tiles. The system is protected by a double protection case equipped with special borafloat glass with a 1% reflection factor for the 1550 nm wavelength of the scanner.

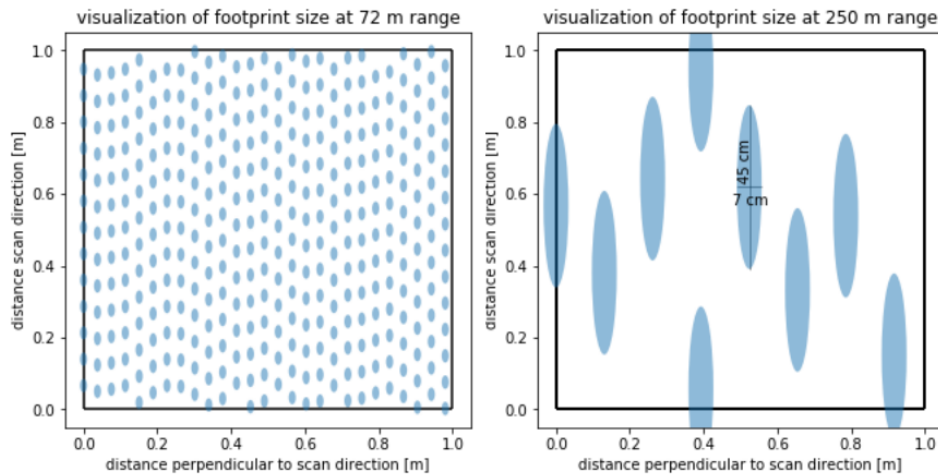
Figure 3: Laser footprint size and shape and point density per square meter at a short range (72 m) on the top of the dunes and at a long range (250 m) close to the water line.

The scans are acquired with a vertical and horizontal angular spacing of 0.03° . The beam divergence is 0.27 mrad, (Riegl, 2019). This leads to a footprint size of about 2 cm on top of the dunes and a point spacing of ~ 5 cm. However, close to the water line on the beach, the footprint resembles an ellipse with diameters of about 7 cm across and up to 45 cm along (see **Figure**). This is mostly due to the small grazing angle (and therefore large incidence angle). As illustrated in **Figure** also the point density varies a lot depending on the distance to the laser scanner. At a shorter range of around 72 m the point density is ~ 350 points per square meter and close to the water line (~ 250 m range) around 10 points per square meter.

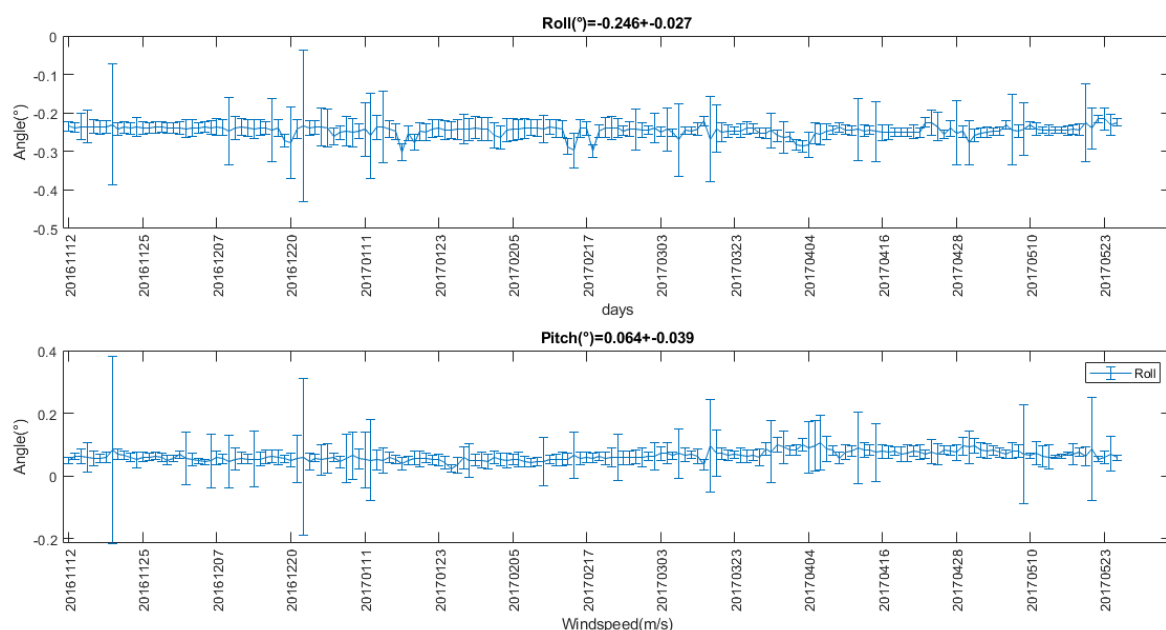
Figure 6: Calculated mean roll and pitch values per scan over time. The calculated standard deviations are based on about 250 individual pitch and roll measurements during a scan. Larger standard deviations indicate larger movements of the laserscanner during a scan.

The laser scanner contains two inclination sensors with an accuracy of ± 0.008 degrees (Riegl, 2019), which we use to assess the rotational stability of the laser scanner position over time. The inertial compass was unfortunately not available for data analysis. The data from the internal inclination sensors provide mean pitch and roll as well as standard deviation in pitch and roll for every scan (based on about 250 pitch and roll measurement per scan). **Fejl! Henvisningskilde ikke fundet.**6 shows the roll and pitch variation over the six months period. These values are compared to the PLS range data to stable reference planes on the roof of the building. In general the roll values show a larger variation than the pitch values, which matches our findings from the analysis of the range on reference planes. There is more movement in the W-E-direction than in the N-S-direction. We still need to establish if the observed magnitude and timing of

the movement matches between the two methods. Larger inclination values could indicate movement of the entire building on which the scanner is mounted.

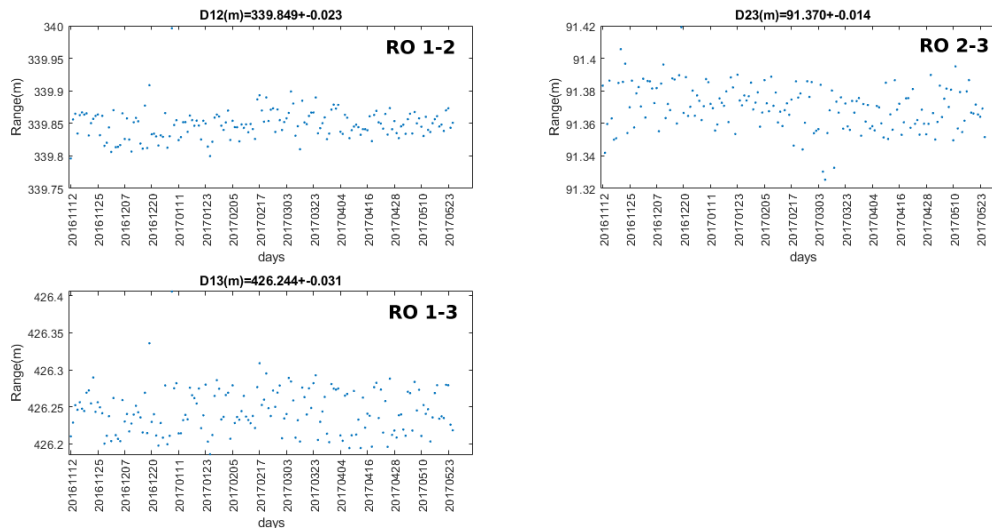
Figure 8: Distances between reference objects over time.

Deformations within each point cloud are analysed by measuring the distances between the three reference objects. The results are shown in Figure 8. Distances vary in the order of centimetres or up to 0.01% of the distance between the reference points and don't show any obvious trend. The observed variations could be the result of small movements of the reference objects themselves, for example the information signs do not necessarily have to be stable during strong winds. Other reasons could be issues in the object detection method, movement of the scanner during a scan or refraction effects due to varying atmospheric conditions.
