## Iterative Prototyping of Aircraft Tire Wear Measurement using Laser Profilometer

Schuurman, Michiel; Groves, Roger

AIAA Aviation 2019 Forum

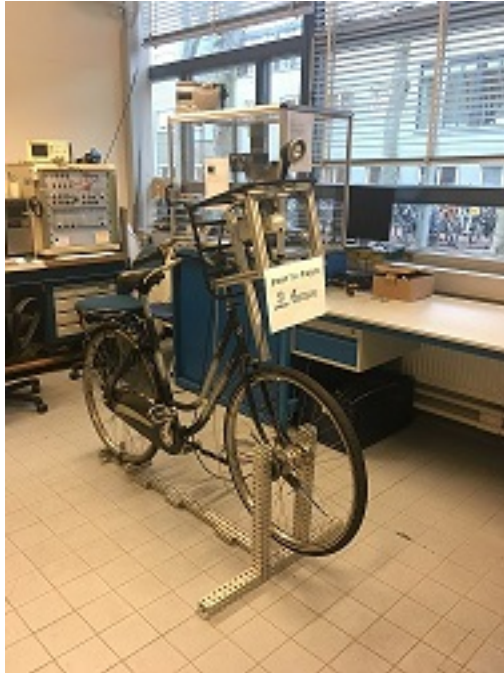
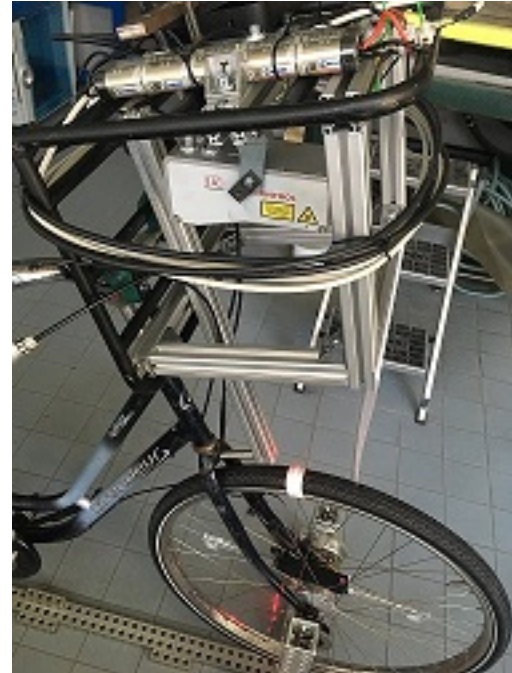
(a) Test setup bicycle.

(b) Close up laser setup on bicycle.

**Fig. 1 Bicycle test stand.**

The first step in the profilometer system development was to source and connected components together for prototyping. The objective in this first phase was to integrate the system and allow data to be recorded for later analyses. For this phase, an off-the-shelf Dutch city bicycle was procured. The bicycle was equipped with a five speed internally geared rear hub with 28 inch front and rear wheels with used tires. The front bicycle wheel tire tread would be measured. By attaching a purpose-built aluminum rack to the steering column the laser could attached and pointed downwards at the tire treads for measurement. For static testing a stand was built which would elevate the front wheel axle and allow the front wheel to rotate freely. The bicycle test setup used for static testing is shown in Fig. 1a.

This static test stand enabled data collection of the front bicycle wheel treads using the profilometer system connected to a computer and normal main power supply. Using a cordless drill the front wheel was rotated at a constant speed, and data could be collected and recorded for later analyses. The static unit data was subsequently analyzed and assessed. During these stationary tests, the power requirement of the system was measured in order to size the battery pack for the next iteration.

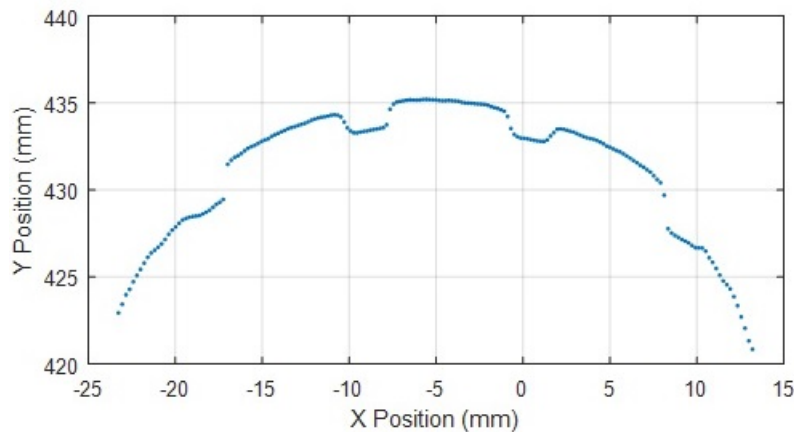
**Fig. 2 Profilometer output bicycle front wheel cross section (one data sample).**

One data sample (cross section) from the profilometer unit is shown in Fig. 2. By stitching together multiple data samples (cross sections) as the bicycle tire rotated a three-dimensional model was created, which could be used for anomaly detection (flat spot or foreign object damage). Analyses of the static test revealed that a tire wobble was detected through data analyses. Furthermore, small stones and debris embedded into the tread area was detected during data analyses. Data visualization and deviation detection algorithm forms the basis for identifying anomalies. The dynamic

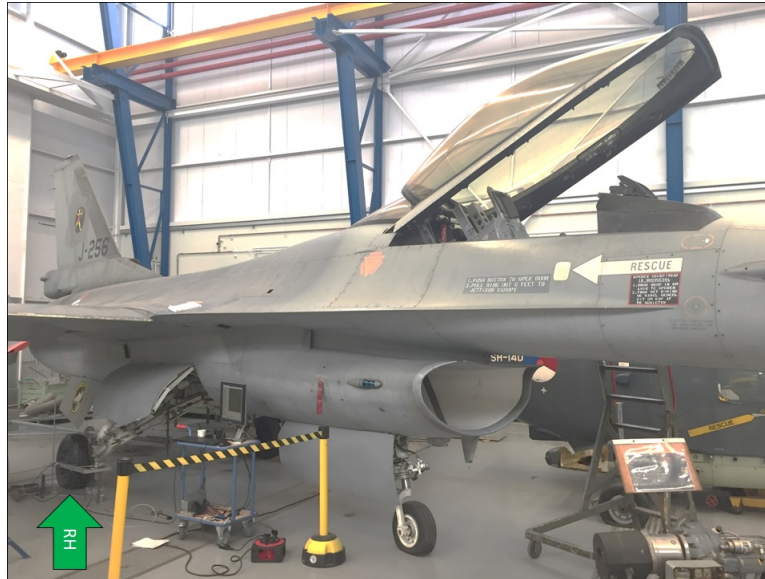
**Fig. 3 F-16 profilometer Ground Test, main landing gear tires (right hand main wheel shown with green arrow).**

In order to get a more representative tire measurement it was decided to make use of the available aircraft on static display at the Faculty of Aerospace Engineering. In the faculty hanger, a F-16 (Fig. 3) was available which is fitted with Goodyear 25.5x8.0-14, 20-ply aircraft tires (NSN 2620011426461) having a width of 200 mm. The main left and right hand tire were chosen as they were at both ends of their service life.

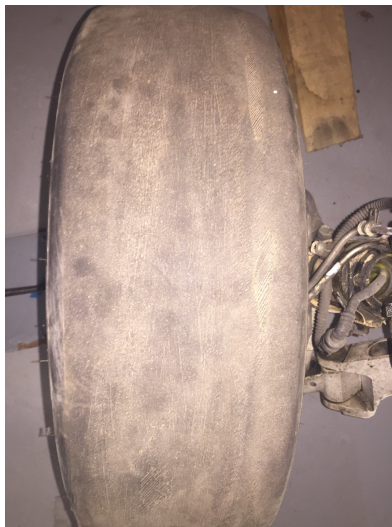
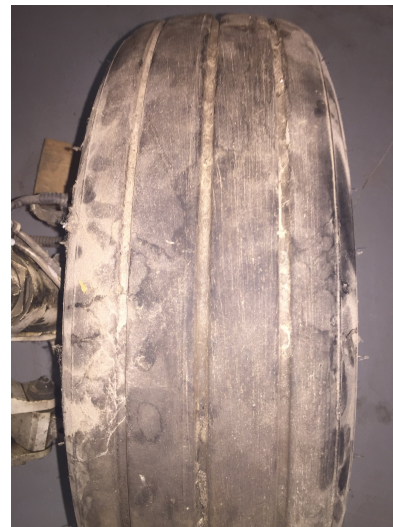
(a) Left hand tire - bald tread.

(b) Right hand tire - new tread.

**Fig. 4 F-16 main landing gear tires.**

The left hand tire (Fig. 4a) was bald and in one area the ply was visible, which meant this tire was well beyond its operational service life. The right hand tire (Fig. 4b) on the other hand, was new and showed no signs of wear, which meant it was at the beginning of its operational service life. Despite efforts, equipment was not available which would allow the F-16 up to be hoisted in the air or jacked-up to allow for free rotation of the tires. Therefore a purpose-built armature attached to the wheel axis was built that could be rotated around the tire circumference for an almost full tire tread sweep (290° angle). Because the armature with the laser unit was rotated around the tire axis, a comparison could be made between the two tire tread measurements.

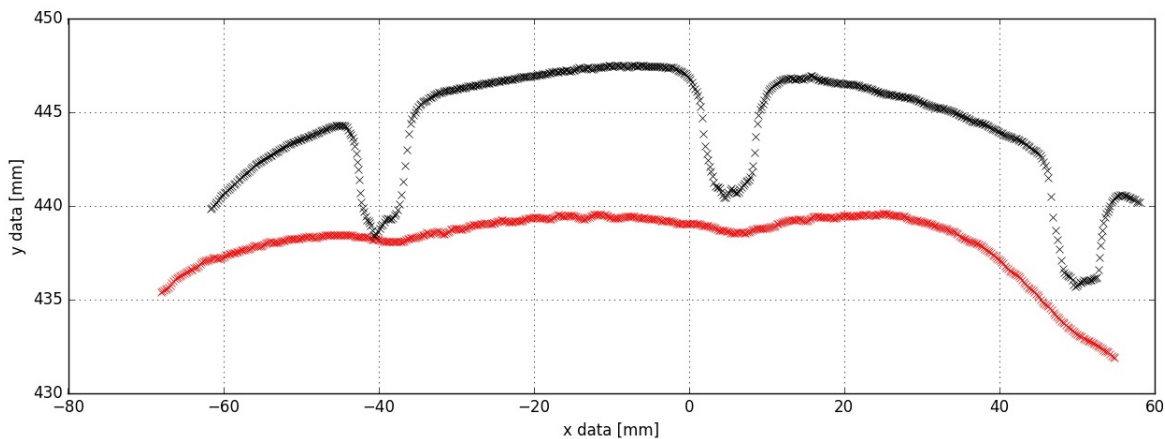
**Fig. 5 F-16 Tire cross section comparisons between a new right hand (black) and left hand bald (red).**

Analysis between the left and right hand F-16 tire data shows a distinct difference. Fig. 5 depicts the right main landing gear tire (top trace) and the left main landing gear tire (bottom trace) cross-section. Clearly, the three treads are detected in the right hand tire, but are not present for the left hand tire. The delta between the two traces shows the tire wear. Further analysis also shows that in one area (right side) the left hand tire wear is past the two bottom grooves of the right hand tire. This suggests the tire ply should be visible at that location, which was already noted before. The 110 mm scan width of the measurement system was not sufficient to detect the full 200 mm width of the tire, as no information is captured on the state of the tire shoulders.

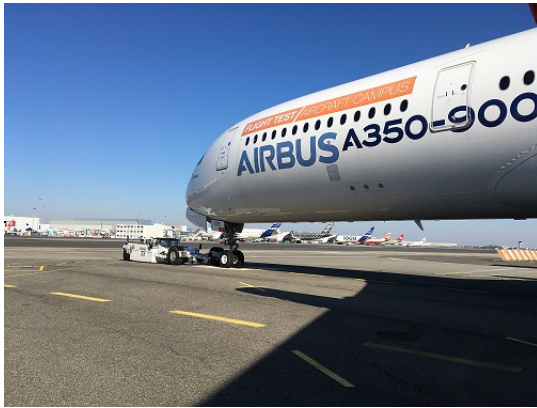
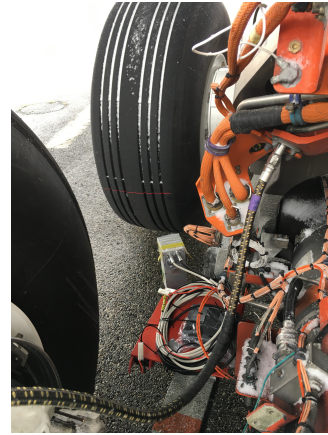
(a) Airbus A350-900 Flight Test / Aircraft Campus.

(b) Profilometer system cradle on left main landing gear outboard brake strut.

**Fig. 6 A350 ground test.**

As part of the AGUPP project arrangement, access was granted to the Airbus A350-900 Flight Test/Campus Aircraft see Fig. 6a. This former A350 Flight Test aircraft was deployed in the A350 XWB test program which included performance testing at high and medium altitudes, cold weather and hot temperatures and long-range flights. Currently, the aircraft is preserved without engines at Toulouse-Blagnac Airport where it is designated as Flight Test/Campus Aircraft. The aircraft is still being used for a variety of tests and serves as an easy accessible A350 exemplar. The A350-900 has two main landing gear bogies with a 4-wheel configuration. For this test iteration, it was decided to test the system on the A350 Flight Test/Campus Aircraft while towing it around Toulouse-Blagnac Airport. The main goal of the towing test was to evaluate the profilometer proof of concept on an actual aircraft and to assess system maturity.

option was to fix the unit onto the main gear leg fairing door which in turn is attached to the main gear strut. In this proposed setup, the laser would be aimed at the aft wheel. The second option was to attach the profilometer unit to the landing gear bogie brake strut assembly. This would allow the profilometer to measure the forward wheel of the bogie. The main technical constraint set by Airbus at the start of the project was that the profilometer system would not interfere with or damage facilities and equipment. As the connection to the leg fairing door was technically hard and did not fall within the certified force requirements, this option was rejected. Therefore the second mounting option was chosen, which resulted in fabricating a purpose-built cradle see Fig. 6b which could be mounted on the outboard brake strut. The cradle unit was padded with foam material as not to damage the brake strut assembly. For securing the cradle onto the brake strut assembly, metal toggle clamps with rubber ends were selected. The removable clamped cradle created an excellent base plate where the required profilometer system components could be housed.

On February 28th 2018 a towing test was performed on Toulouse-Blagnac Airport with the profilometer unit attached to the A350 Flight Test Aircraft brake strut. Due to the weather conditions, the scheduled route and test were shorted due to airport snow operations. An example tire cross-section recorded is provided in Fig. 7. The data recorded during this towing test showed that no wear (delta), this was also expected due to the limited recording time and towing operation.

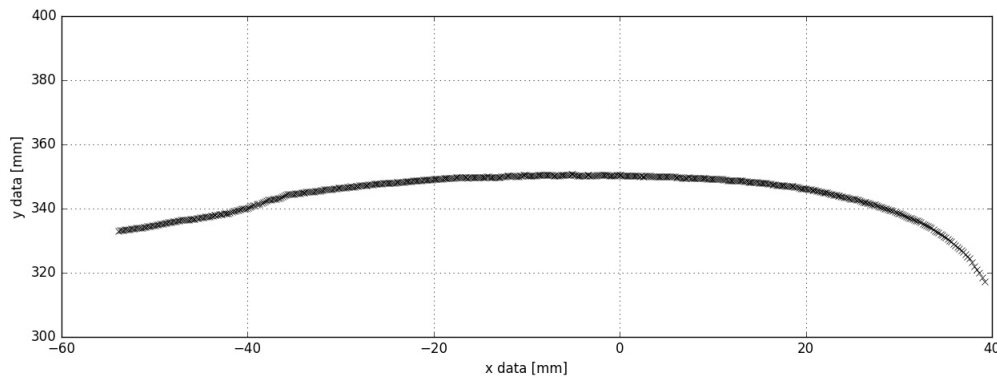
**Fig. 7 Profilometer plot showing cross section A350 Main Landing gear tire.**

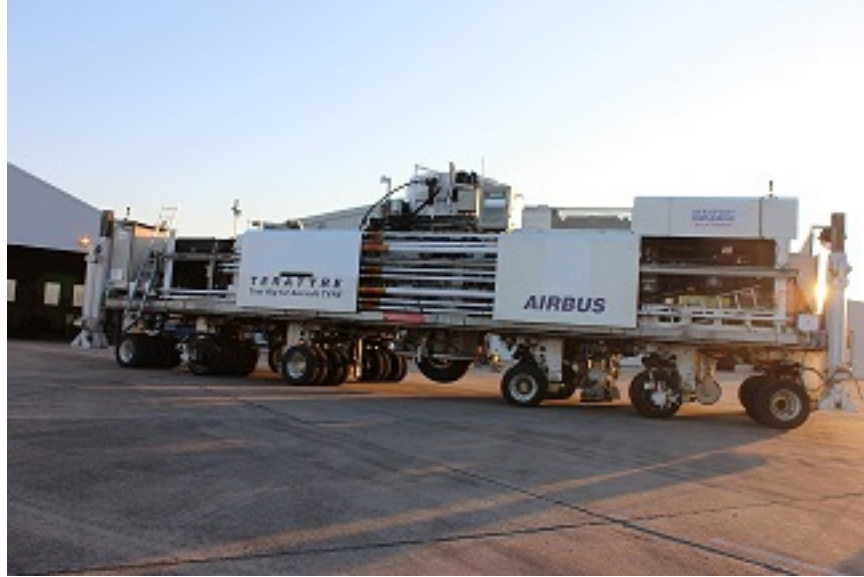
**Fig. 8 Test Rig for Aircraft Tires (TeraTyre) at Châteauroux Airport with in the centre the aircraft tire being tested.**

The developed tire test rig can rotate the tire at a high slip angles which normal dynamo-meters cannot do. The TeraTyre test rig has overall dimensions of 14.5 x 4.5 meters and is 5 meters tall. The rig weighs 115 metric tons and is powered by a 1500 horsepower engine which allows the rig to reach a maximum speed of 90 km/h. The TeraTyre test rig can move and test one aircraft tire at a time along a linear or curved trajectory. With its pneumatic turret system the tire can be loaded to different weights. Due to the high slip angle capabilities, the aircraft tire is tested to its limits and well beyond ordinary wear seen in normal service life operation. With the extreme conditions to which TeraTyre is testing tires, the profilometer capability can be investigated and aircraft tire wear can be evaluated.

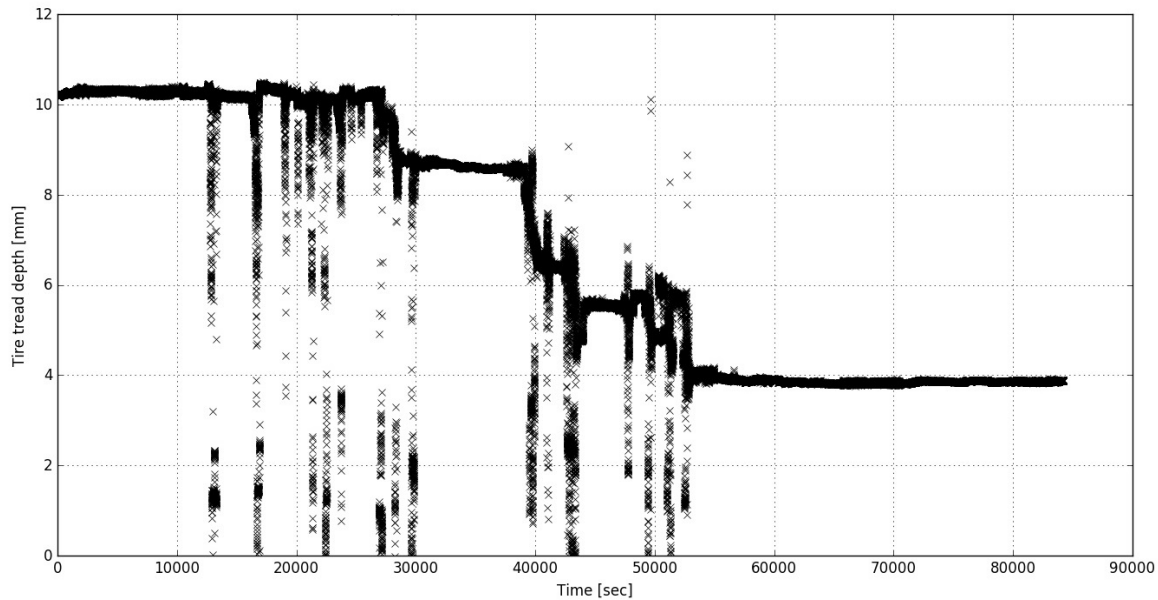
**Fig. 9 TeraTyre Profilometer tire wear plot result Test wheel 9.**

Fig. 9 shows an unfiltered data set for Test wheel 9. The data is for a single measurement point which was in the field of view, the tread depth is calculated by subtracting the profile measurement of the valley and the groove. At the start of the test, the detected tread depth was ten mm, which is reduced by the end of testing to four mm. Depending on the test profile speed, slip angle and weight differences a distinct difference in the data traces and amount of wear. The preliminary data analyses showed a decrease in tire tread depth, which demonstrates wear was detected by the profilometer system. In a follow-up paper, the test results will be discussed in more detail.
