Thermal comfort for multi-functional use in monumental churches

Case study Stevenskerk in Nijmegen

P5 report

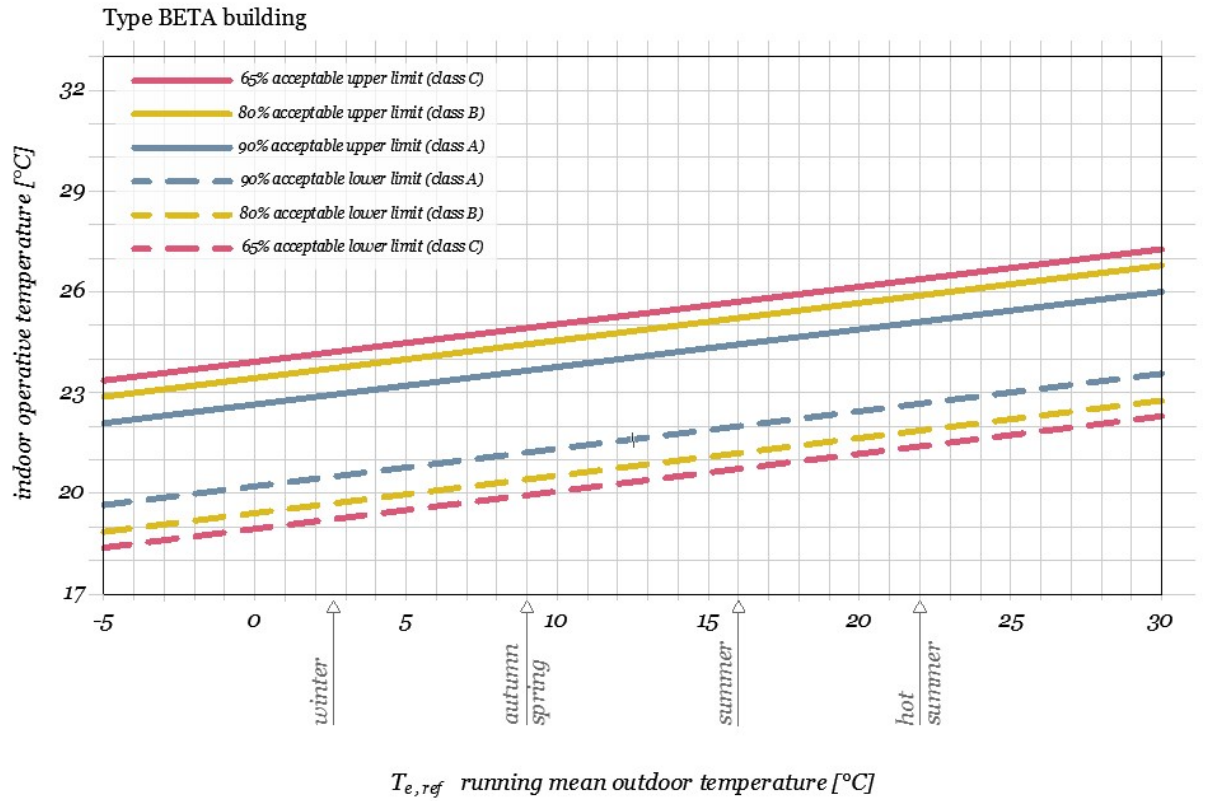
The *adaptive comfort standard* combines both theories. It recommends comfort ranges for the indoor operative temperature in relation to the ATG (*Adaptieve Temperatuur Grenswaarden*) neutral temperature which is calculated from the daily maximum and minimum outside temperatures over four days (Raue et al., 2006). The ATG guideline is applicable for naturally ventilated buildings (Bluyssen et al., 2009). Overall, the adaptive comfort standard allows for a wider range of acceptable temperatures. Figure 4.1 illustrates the comfort limits according to the ATG guideline for type Beta spaces depending on the running mean outdoor temperature (Raue et al., 2006). The Stevenskerk can be classified as a Beta building with a limited degree of occupant control with regards to thermal comfort for example due to non-operable windows.

Figure 4.1: ATG comfort limits for Beta buildings in relation to $T_{e,ref}$ from (Raue et al., 2006)

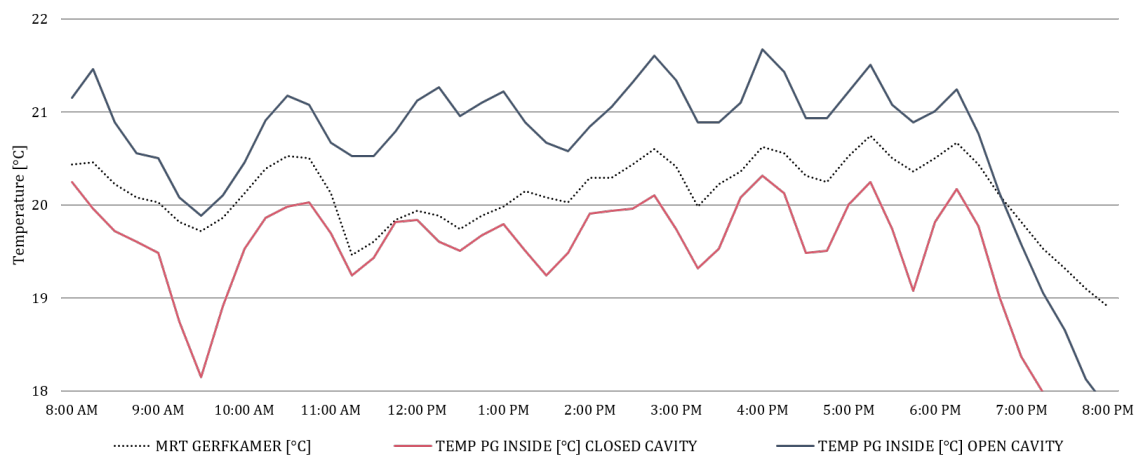
Figure 5.8: Graph Gerfkamer 24/01/2022 with heating:
Surface temperatures protective glazing inside for open and closed cavity and MRT

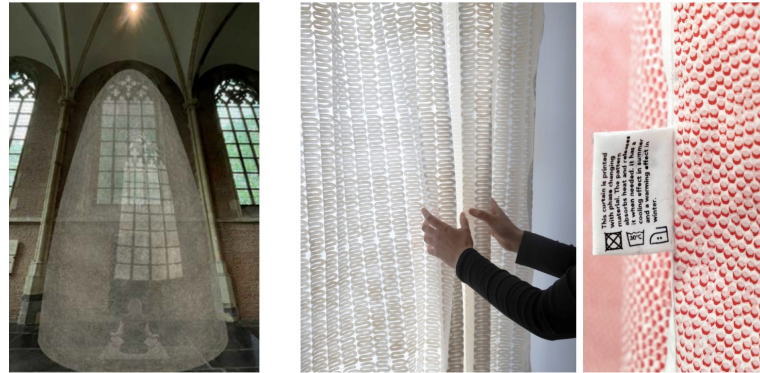
Figure 5.15 left shows the chapel curtain which was suggested as a concept for compartmentalization of the indoor space in the Stevenskerk enabling separate climate conditions. (Rijksdienst voor het Cultureel Erfgoed, 2021). The curtain on the right (figure 5.15 - r) is made of fabric on which a phase change material (PCM) was printed. Therefore, it stores or releases heat depending on the external temperature conditions and thereby supports the regulation of the indoor temperature (Haan, 2020).

Figure 5.15: Chapel curtain Stevenskerk (l) (Rijksdienst voor het Cultureel Erfgoed, 2021) and curtain containing PCM (r) (Haan, 2020)

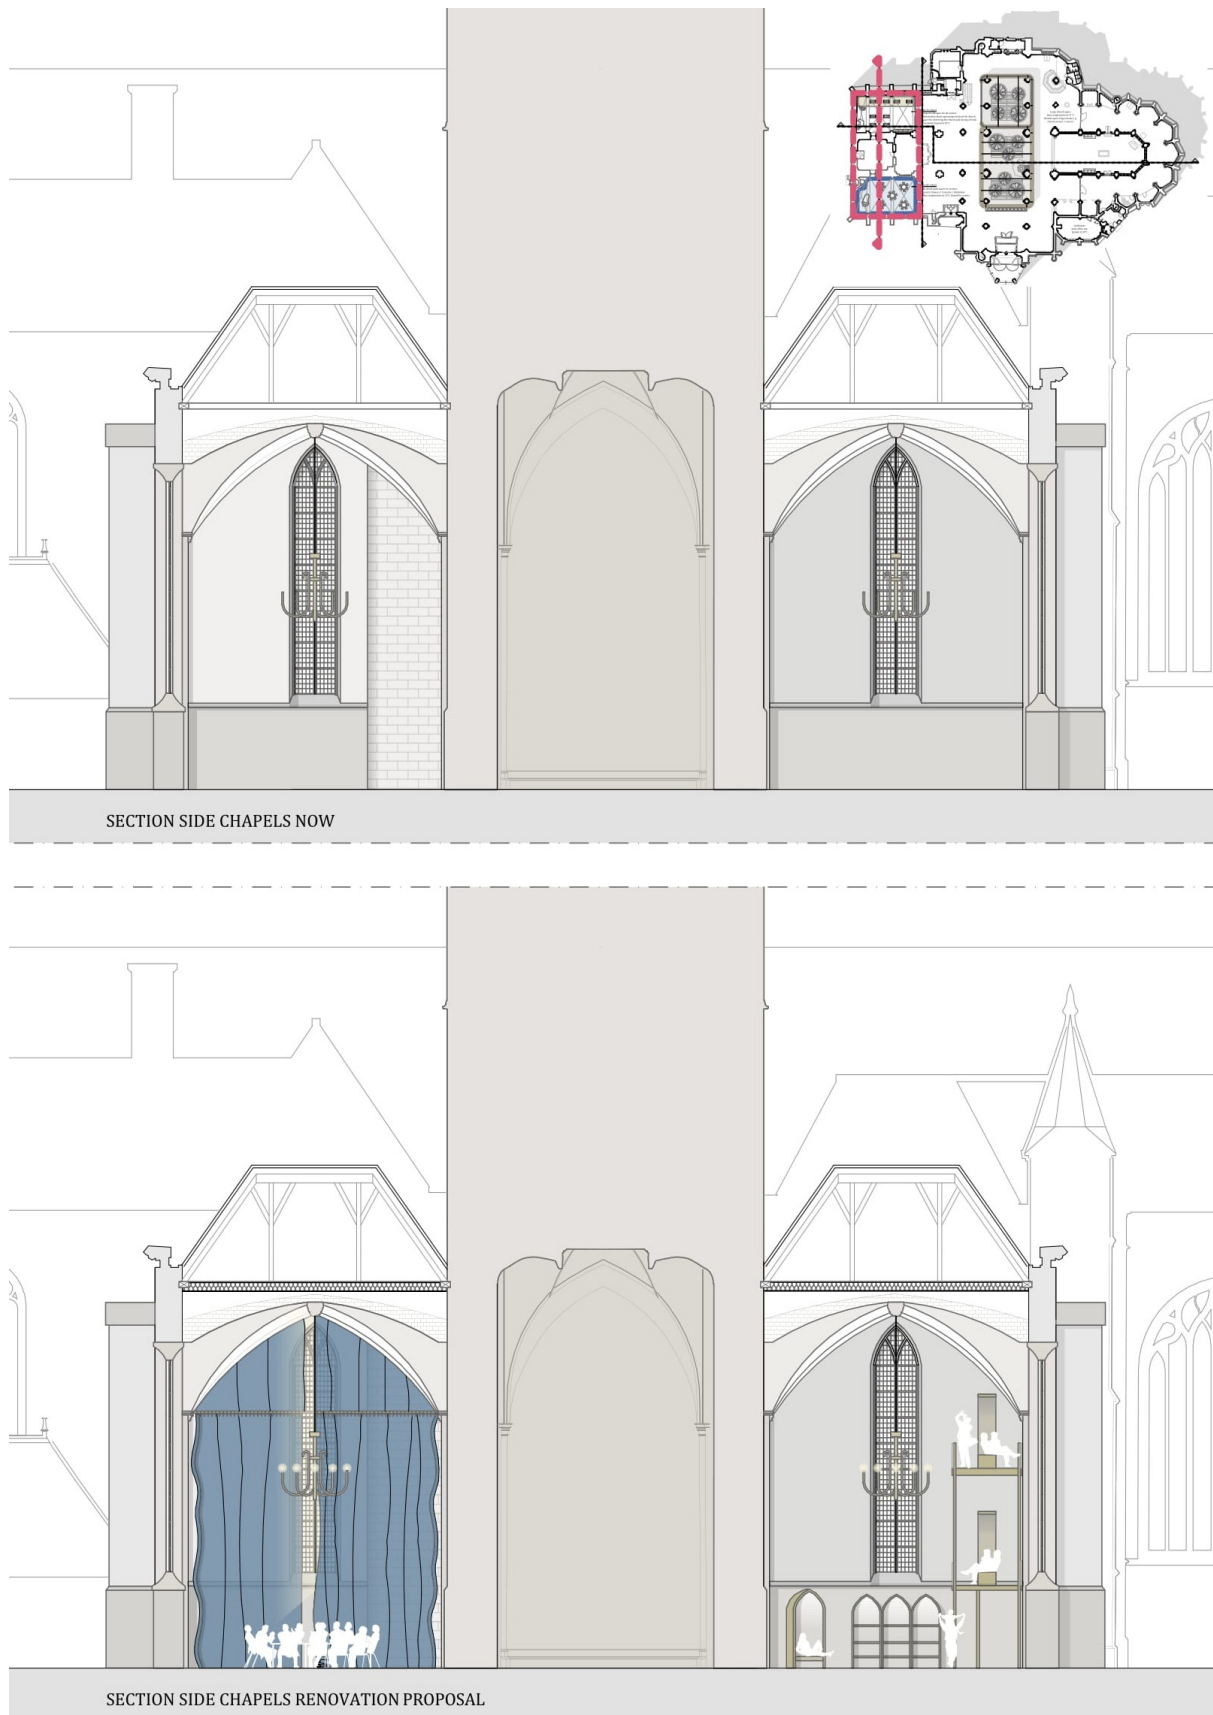
Figure B.8: Section Stevenskerk - South chapel with textile radiation screen, North chapel with walkways
