**SITE MEASUREMENTS
SCHARSTERRIJN BRIDGE 2009**

Short-term Monitoring

Stevin: 6.09.02

May 2009

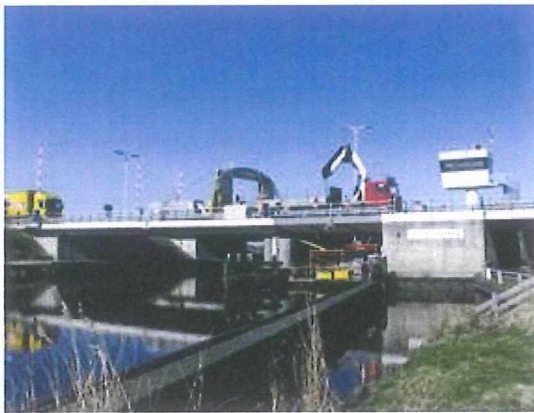
Figure 1 – Scharsterrijn Bridge (fixed part on the left side and movable part on the right side).

Scharsterrijn Bridge is located in Friesland, a northern province of the Netherlands, in the highway A6. The bridge is composed of two independent bridges, one for each traffic direction, both with a fixed and a movable part (Figure 1 and Figure 2). The main girders of the movable bridge have a total span of 8300 mm. The bridge deck consists of an orthotropic steel plate of 12 mm thickness, stiffened by “U-shape” longitudinal stiffeners and divided by 4 crossbeams of 2530 mm span (Figure 3). The nominal thickness of the epoxy surfacing system is 7 mm. The second steel plate of 6 mm thickness, 4200 mm width and 8200 mm length was bonded to the existing deck plate in the right lane of the movable bridge.

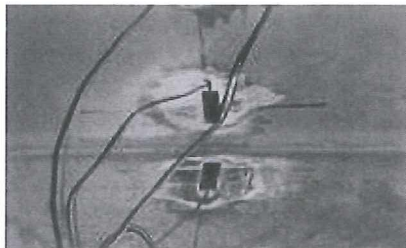
Figure 6 – Strain gauge 2 and 3.

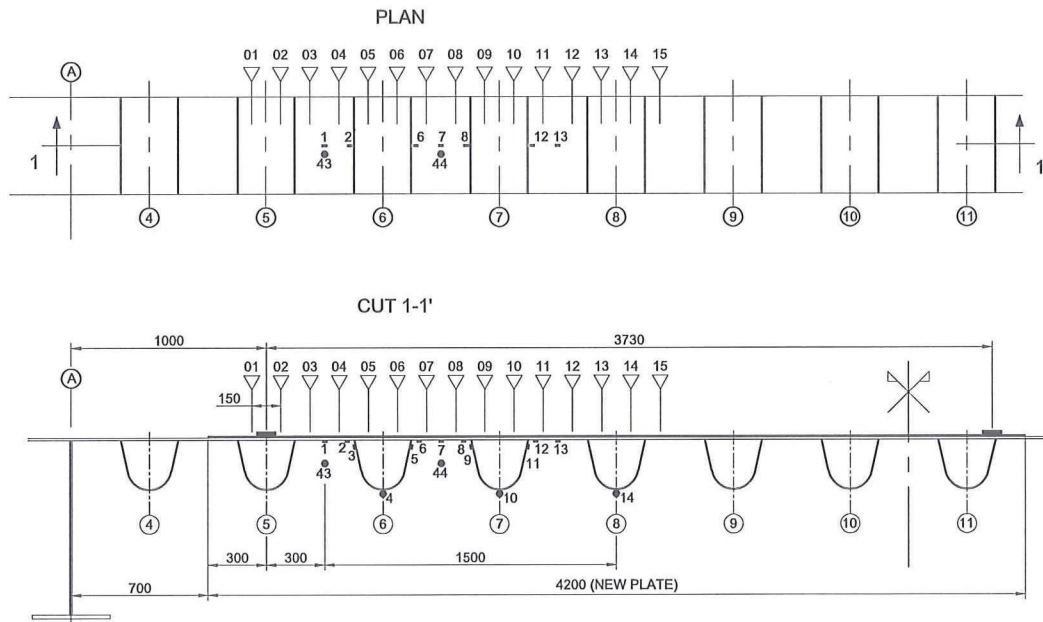
Figure 10 – Middle span cross section: 15 wheel load positions and strain gauge positions.

The strains on the deck plate were recorded using a calibrated truck when no traffic was running on the bridge. The lorry was placed at 15 transverse positions on the deck. These positions were located in the right lane where the rehabilitation took place (Figure 10). The transverse position of the calibrated truck was fixed by visual observation (Figure 11) and using laser equipment. From the measurements, influence lines of the strains along the deck plate can be drawn due to the axle load. The reference point for the wheel position is the middle of the tyre for the front wheel and the middle of the outside tyre for the rear wheel.

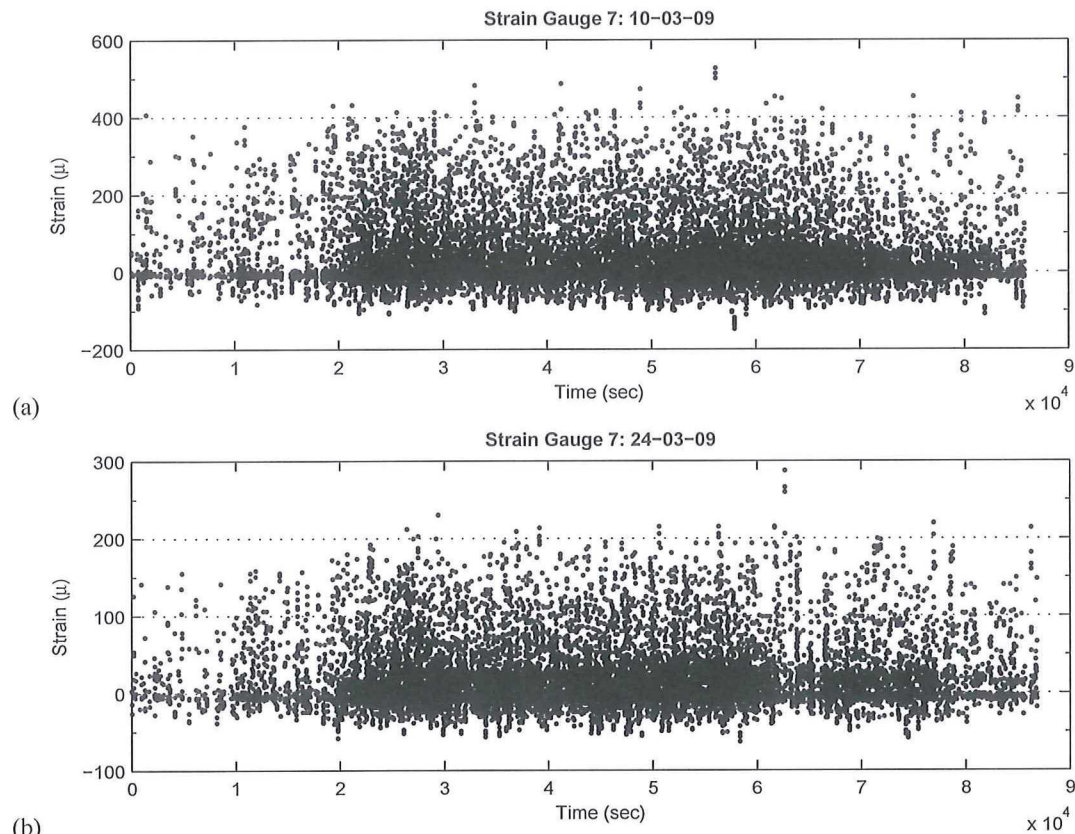
Figure 14 – Strain history measurements of strain gauge 7 before renovation at 10-03-09 and after renovation at 24-03-09

The x-axle corresponds to 24 hours plotted in seconds. The origin of the x-axle is 00.00 of each day. The data is successive maximum and minimum values caused by each axle load running on the bridge. The data was previously corrected to take into account the temperature that affects the measurements of the strain gauges.

Looking at the difference between the maximum strain values before and after the renovation, it can be observed that the strains after the renovation are lower than before the renovation.

As an example, the strain history recorded on strain gauge number 7 (deck plate between stiffener’s webs) is presented in this chapter during one day before and after the renovation (Figure 14 (a) and (b)). In order to compare the results before and after the renovation, the same week day is presented. The days plotted are Tuesday 10th of March (Figure 14 (a)) and Tuesday 24th of March (Figure 14 (a)), before and after the renovation respectively. The same graphs are presented in Annex B for the other 15 strain gauges.

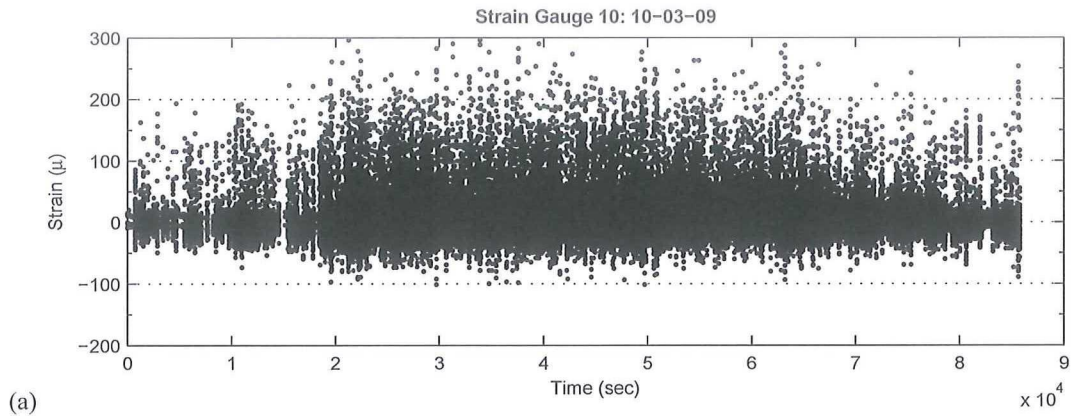
Figure B-9 – Strain history measurements of strain gauge 10 at (a) 10-03-2009 and (b) 24-03-2009.

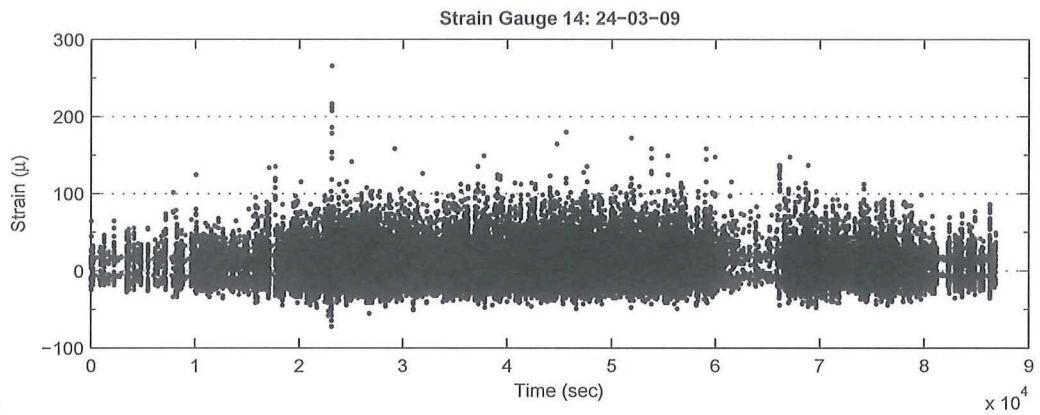
Figure B-13 – Strain history measurements of strain gauge 14 at (a) 10-03-2009 and (b) 24-03-2009.

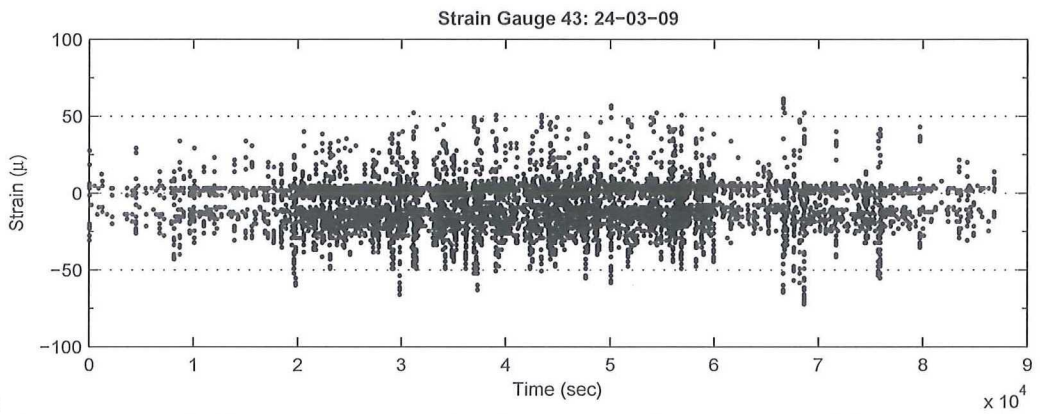
Figure B-14 – Strain history measurements of strain gauge 43 at (a) 10-03-2009 and (b) 24-03-2009.

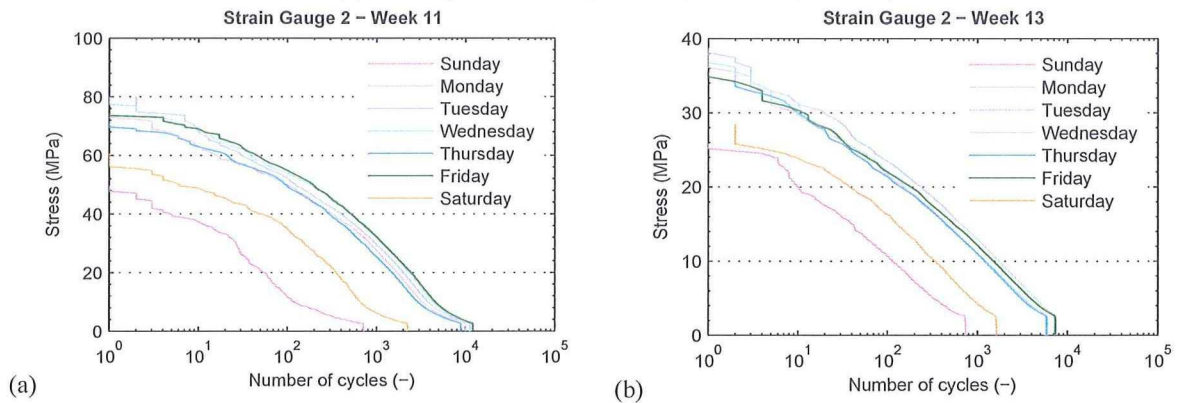
Figure D-2 – Stress Spectra for Strain Gauge 2: (a) Day Spectra for Week 11 (b) Day Spectra for Week 13 and (c) Week Spectra before (Week 11) and after (Week 13).

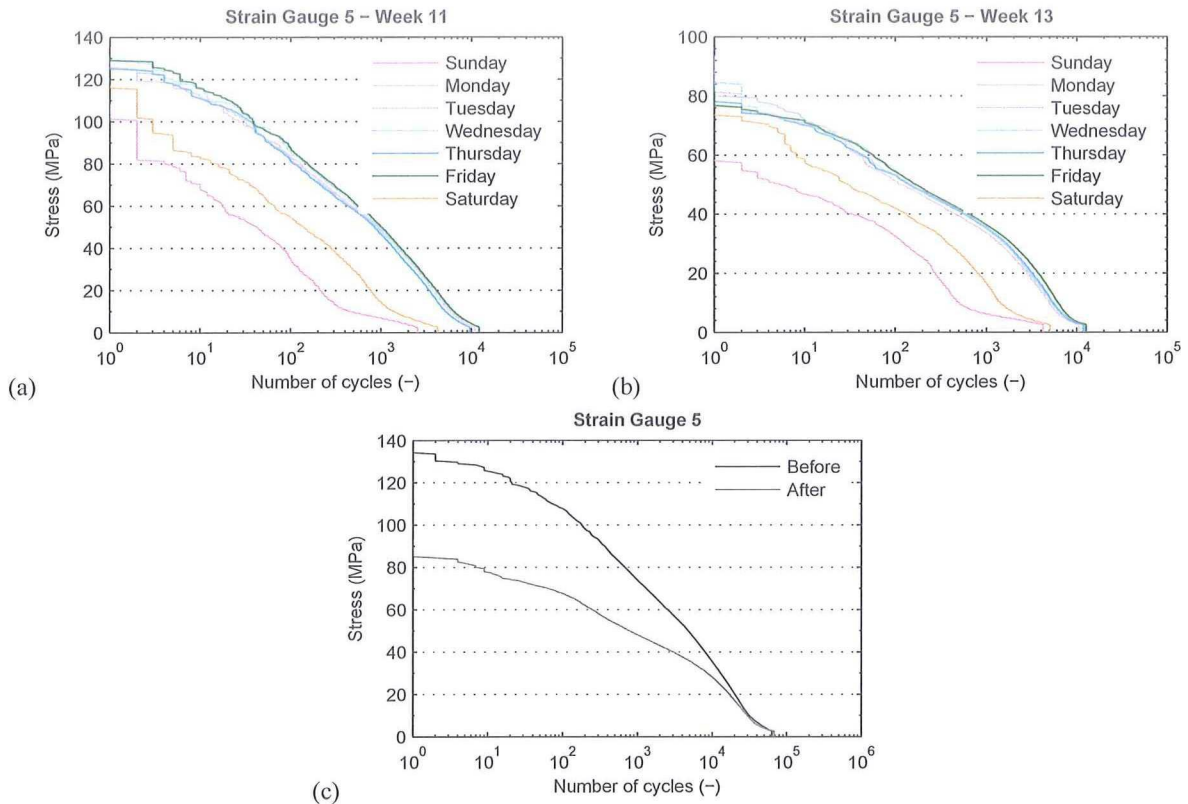
Figure D-5 – Stress Spectra for Strain Gauge 5: (a) Day Spectra for Week 11 (b) Day Spectra for Week 13 and (c) Week Spectra before (Week 11) and after (Week 13).

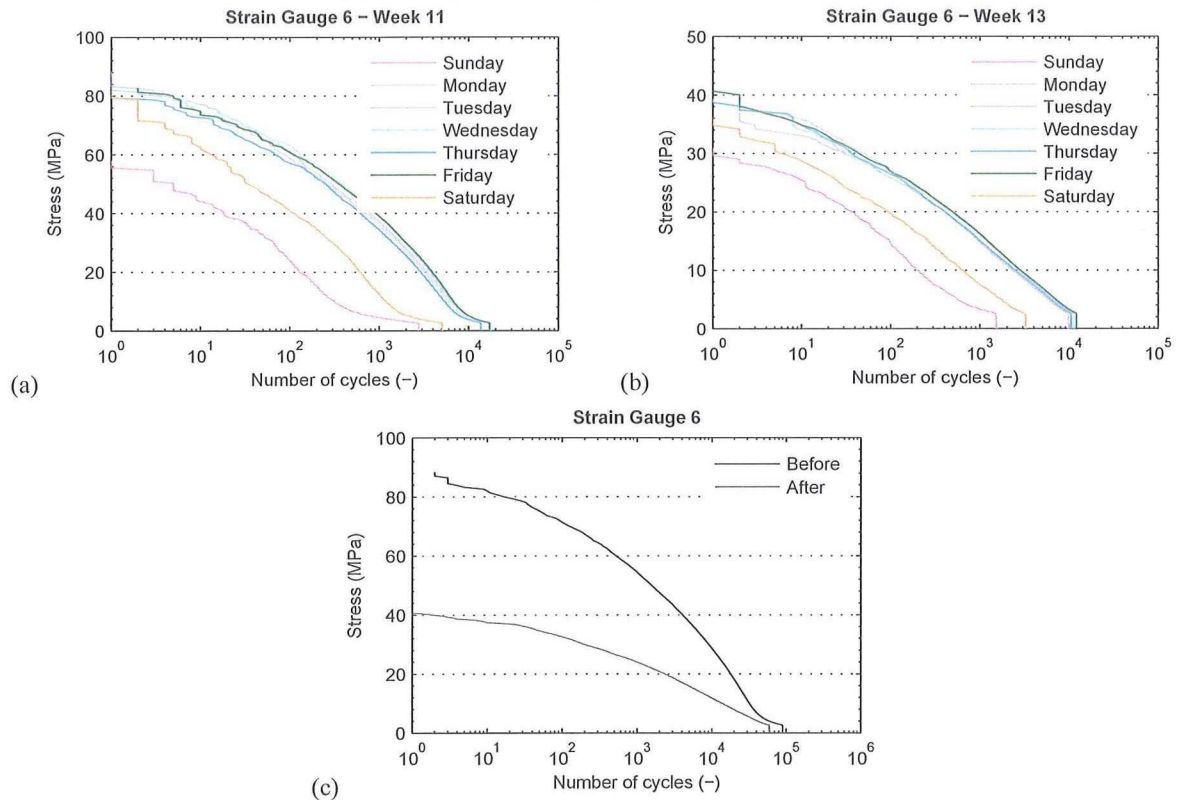
Figure D-6 – Stress Spectra for Strain Gauge 6: (a) Day Spectra for Week 11 (b) Day Spectra for Week 13 and (c) Week Spectra before (Week 11) and after (Week 13).
