Conservation of natural stone

Quist, W. J. (2025). Conservation of natural stone. In B. Lubelli, U. Pottgiesser, W. Quist, & S. Rexroth (Eds.), *Dealing with Heritage: Assessment and Conservation* (pp. 17-36). TU Delft OPEN Publishing.

2 – Conservation of natural stone

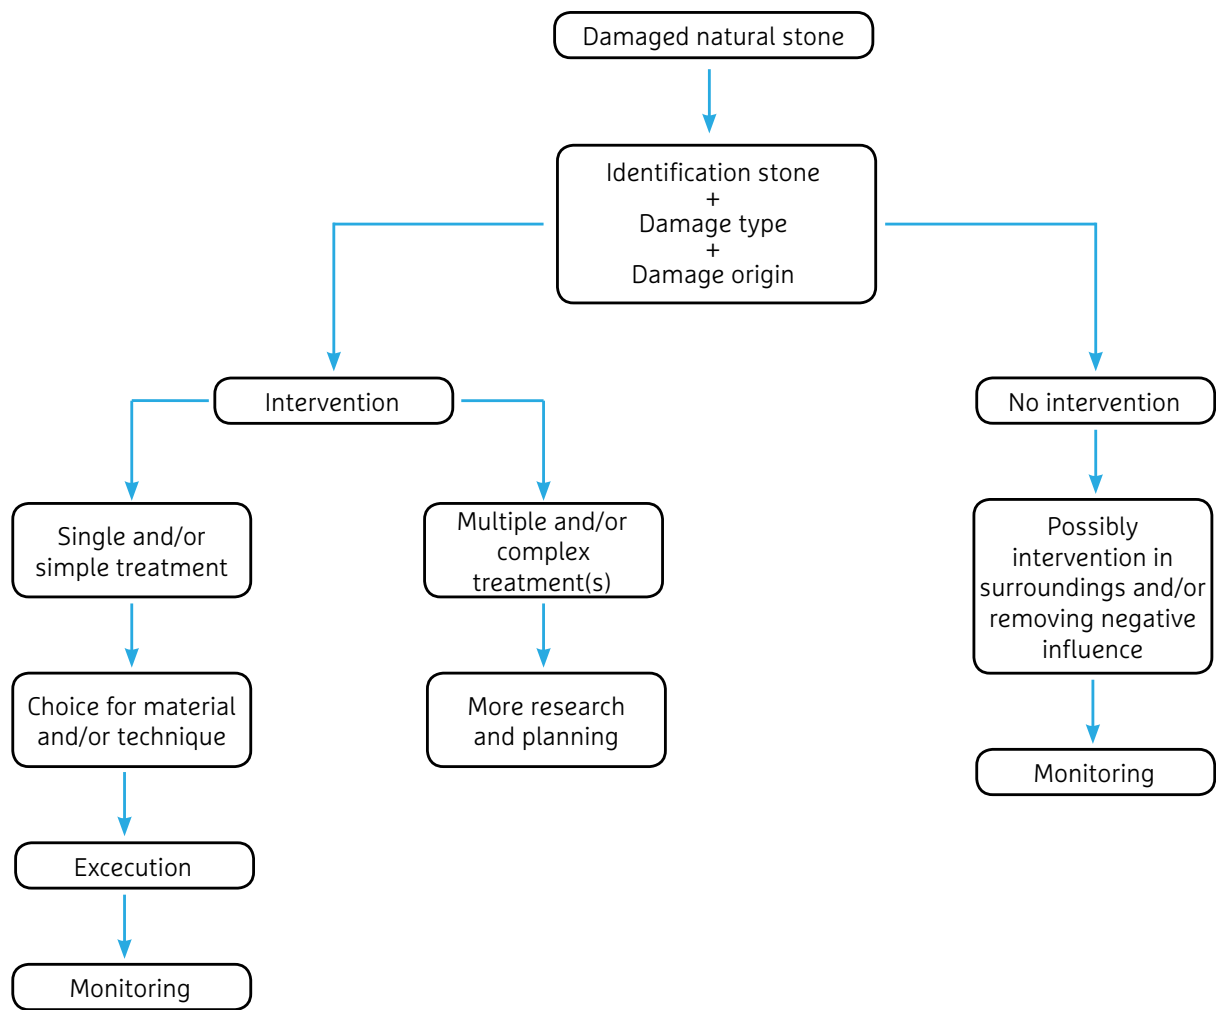
FIG. 2.1 Schematic representation of the maintenance of natural stone

to intervene, possibly followed by the choice of a particular conservation technique. In this chapter these aspects will be dealt with successively using the diagram in [FIG. 2.1].

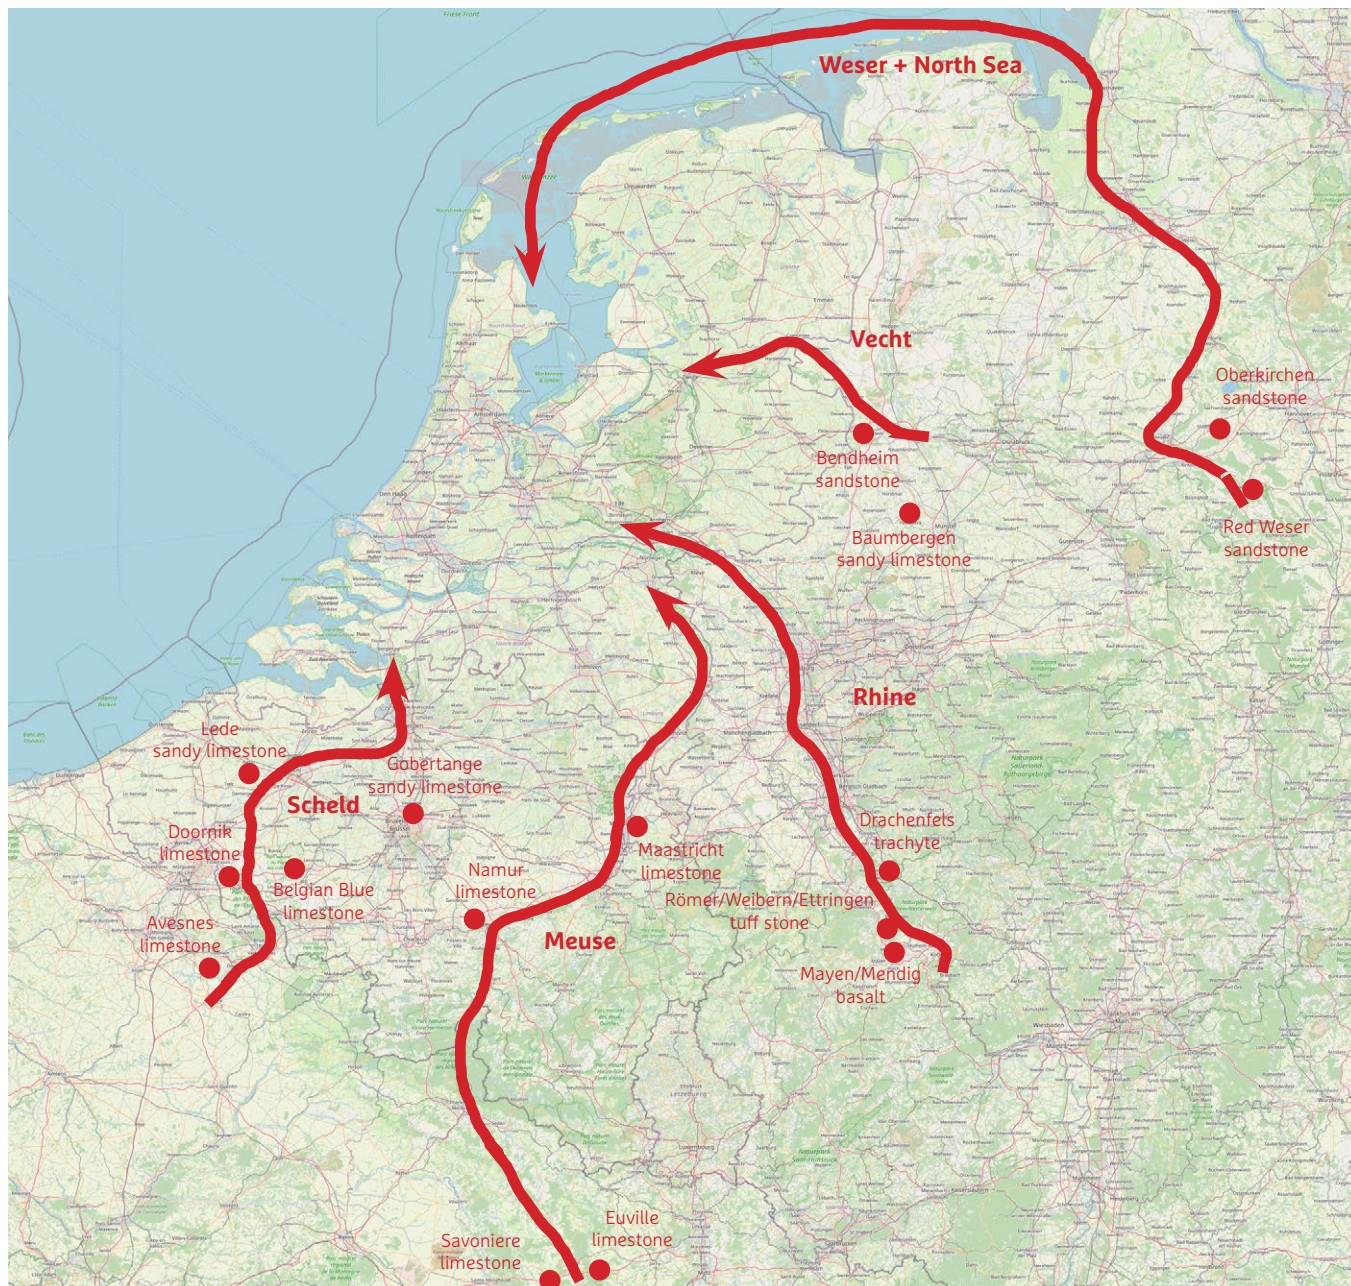
FIG. 2.2 Areas of origin of natural stone types used in historic buildings in the Netherlands with their direction of distribution (base map: openstreetmap)

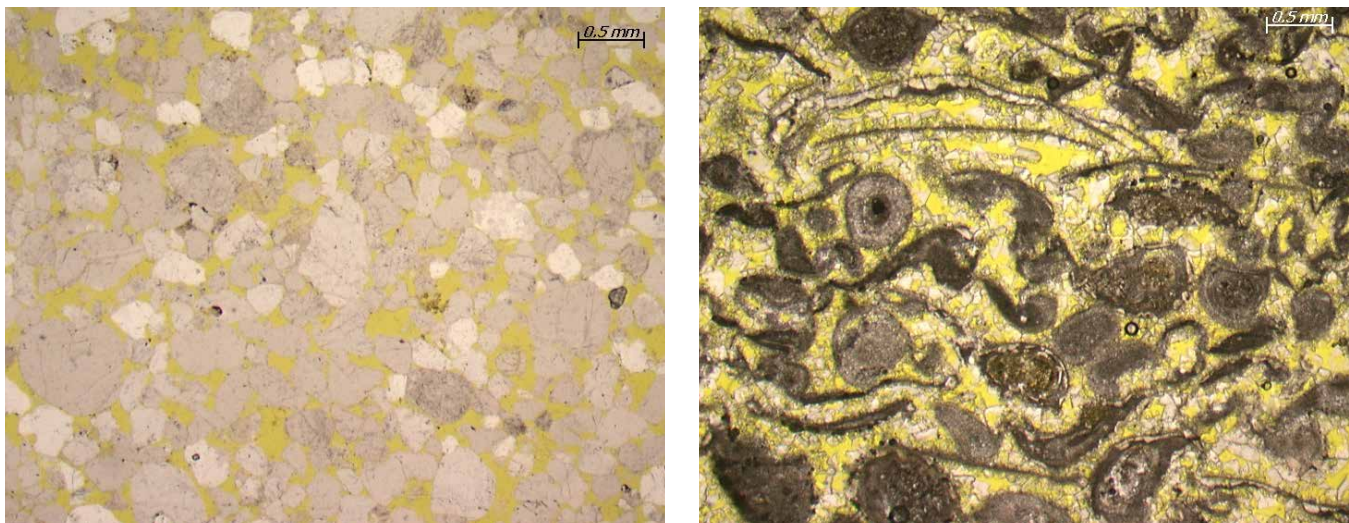
FIG. 2.3 Thin-section of Bentheim sandstone (left, TNO-00445) and Morley limestone (right, TNO-0364). The yellow in both grinding plates is the synthetic resin that has run into the (open) pores during impregnation. In the image of Bentheimer sandstone, the grey/white quartz grains are clearly visible, whereas in the image of Morley limestone various fossil and oolites remains are visible / Photos: T. G. Nijland, TNO

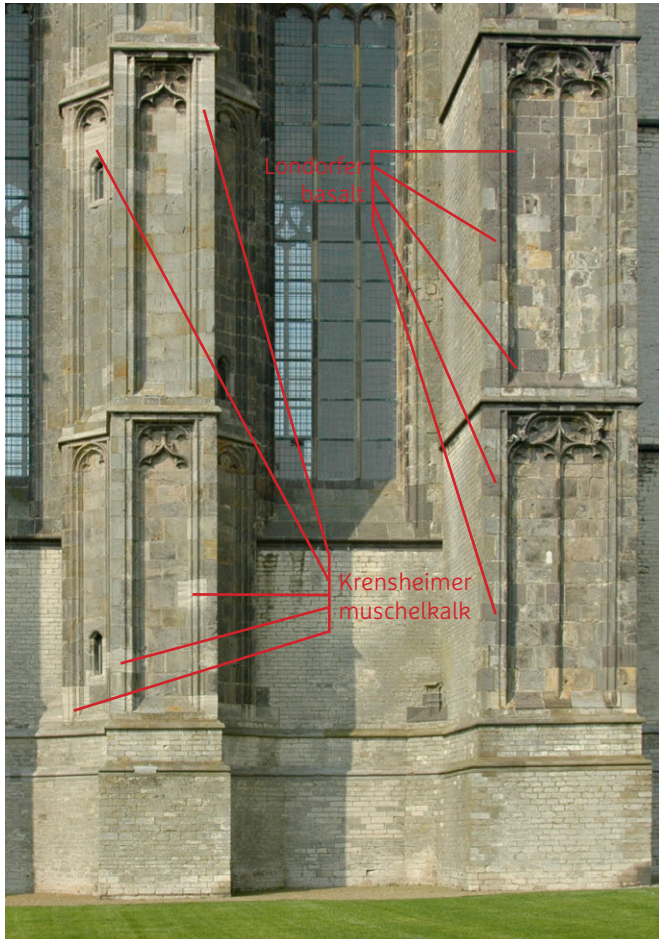
FIG. 2.4 Two adjoining buttresses on the Lievensmonster Tower in Zierikzee, with Krensheimer muschelkalk (left) and Londorfer basalt (right) as replacement stones for Bentheimer sandstone / Photo: W.J. Quist

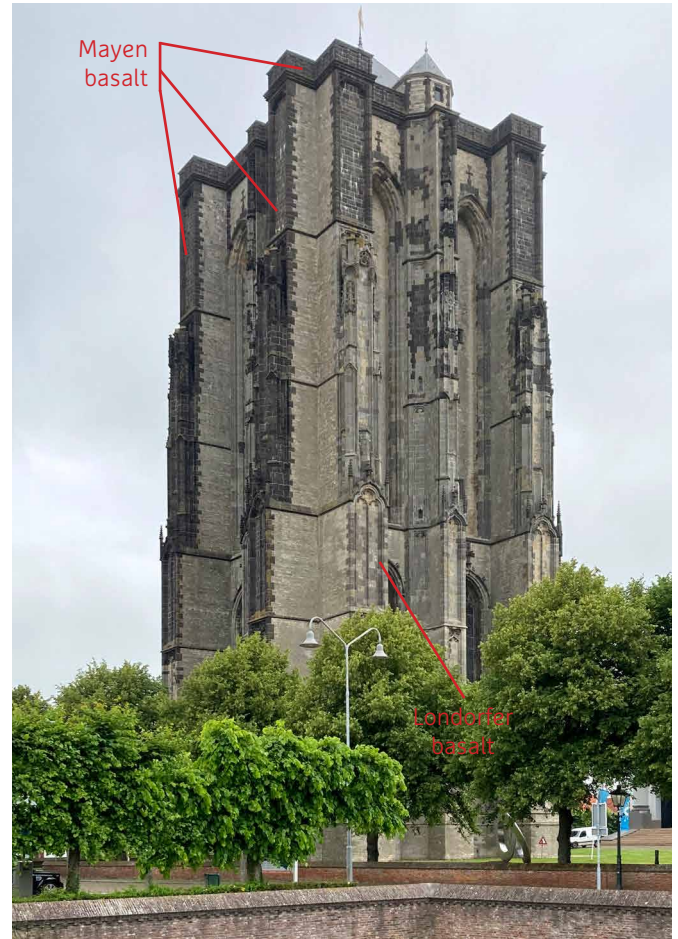
FIG. 2.5 Londorfer basalt was used as a replacement stone in the lower section of the south side of the Lievensmonster Tower in Zierikzee. At the top and on the west side, mainly Mayen basalt can be seen / Photo: W.J. Quist

The use of Bentheim stone was first restricted in the Steenhouderswet (Stonemasons Act) and its decrees (1911/1921) and later in the Zandsteenbesluit (Sandstone Decree, 1951) (Quist 2011a, p.75-8). When the stone types used to replace Bentheimer sandstone are analysed, it appears that they were often chosen because of a colour corresponding with the grey-patinated Bentheim stone. The National Sculptor Slinger initially selected two types of stone for the restoration of the Lievensmonster Tower in Zierikzee because of the similarity in (weathering) colour and their high durability: Londerfer basalt and Krensheimer Muschelkalk. Trial applications are still a reminder of this decision making moment [FIG. 2.4]. Londerfer basalt was selected as the best choice for this restoration, but halfway through the restoration another replacement stone, Mayen basalt, was chosen because of the high cost associated with the former. Mayen basalt is a very dark basalt type and it unfortunately has little in common with the (weathered) sandstone for which it serves as a replacement [FIG. 2.5] (Quist 2012a; Quist 2012b).

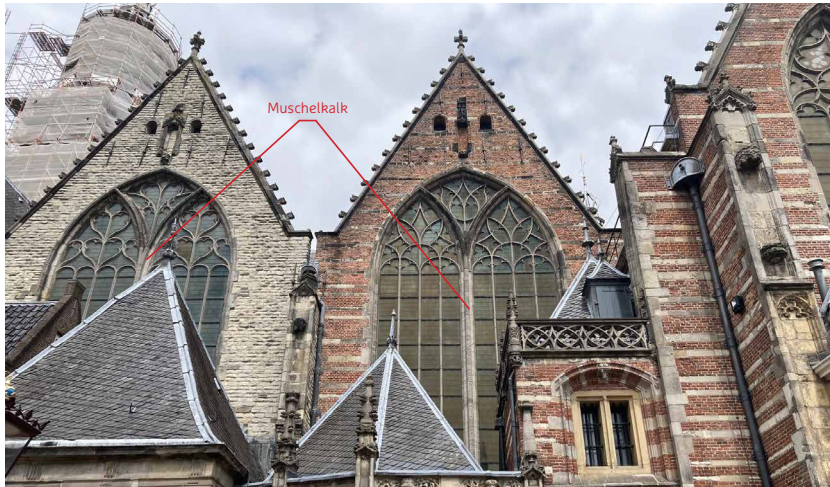
FIG. 2.6 Muschelkalk limestone as a replacement for Bentheim sandstone in the middle posts of the windows of the southern side aisle of the Oude Kerk in Amsterdam / Photo: W.J. Quist

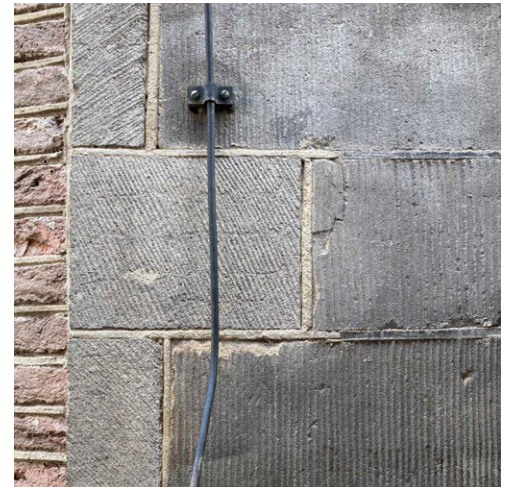
FIG. 2.7 Peperino Duro (left) used to replace Bentheim sandstone (right) in the Nieuwe Kerk in Amsterdam / Photo: W.J. Quist

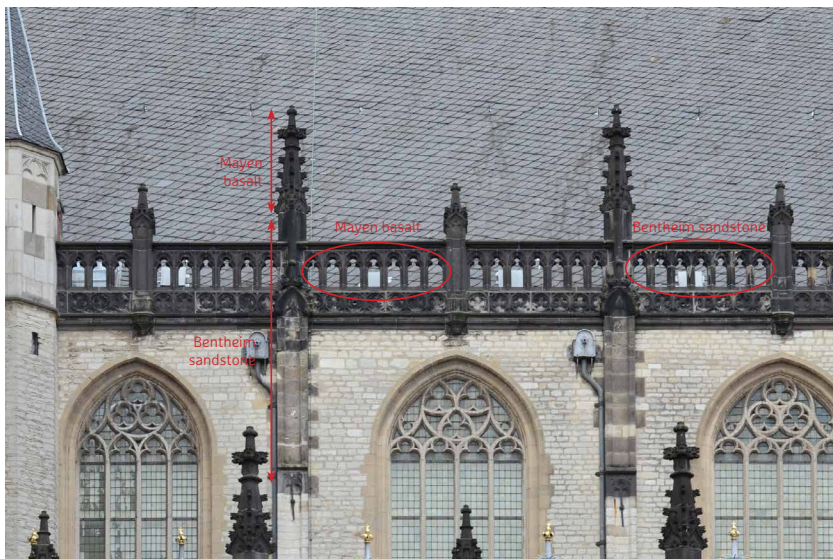
FIG. 2.8 Mayen basalt used to replace Bentheim sandstone in the Nieuwe Kerk in Amsterdam / Photo: W.J. Quist

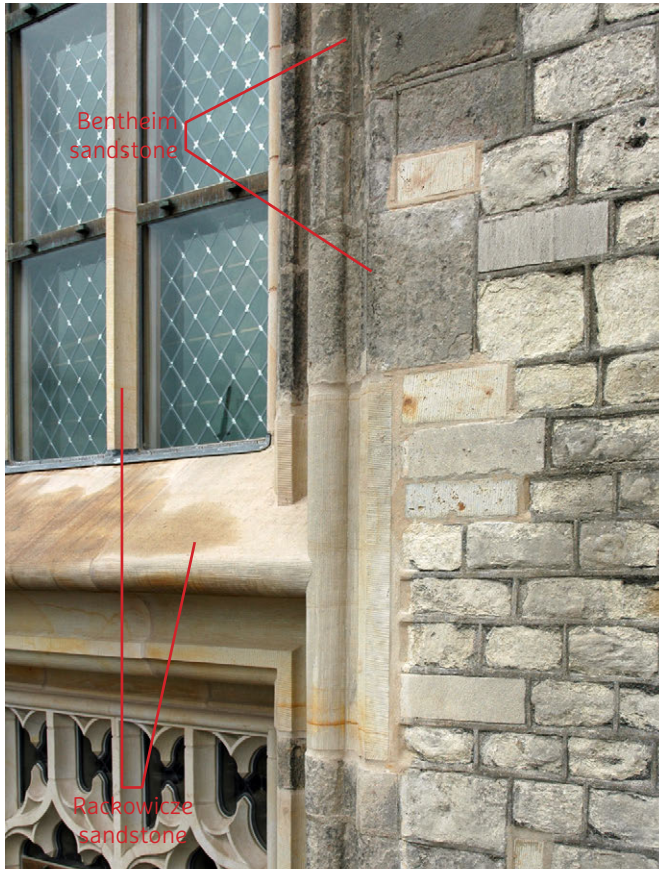
FIG. 2.10 Rackowicze sandstone at the large window in the north transept of the Pieterskerk Leiden / Photo: W.J. Quist

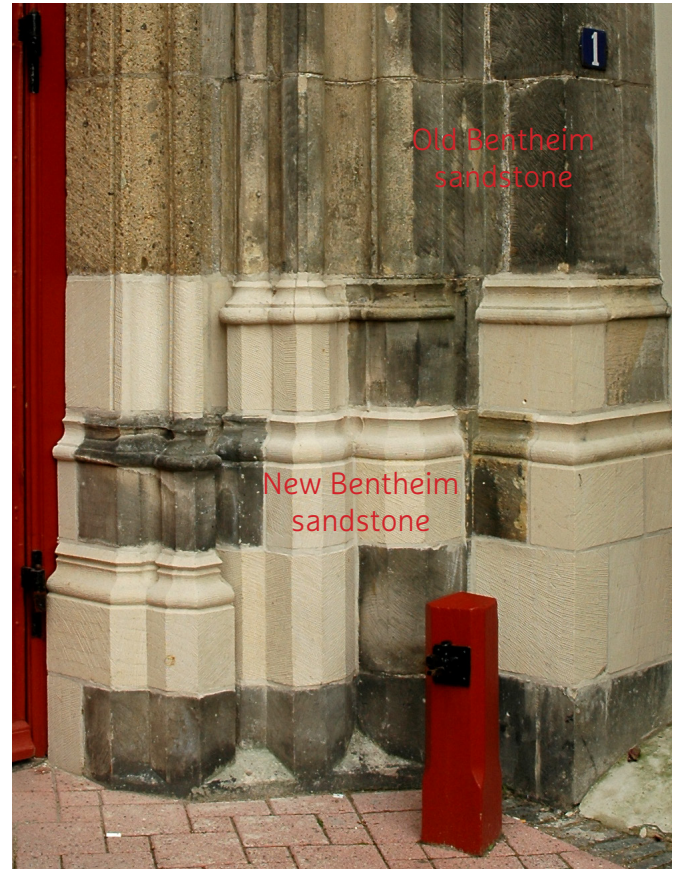
FIG. 2.11 Bentheim sandstone at the south portal of the Sint-Joriskerk Amersfoort / Photo: W.J. Quist

of Bentheim sandstone also returned to such a degree in this period that currently almost no other replacement stone is used [FIG. 2.11]. The (large) colour difference between the dark weathered old sandstone and the light, cream-coloured fresh stone is a factor to consider. Sometimes the choice is made to show this difference, including also the difference in surface finishing, but more often the choice is now made to 'artificially patinate' or 'undisturb' (as opposed to restore) the new stone. This involves either applying colour to the stone surface using chalk in various shades, which is then fixed with a binding agent, or by spraying several colours of silicate paint (Brans 2012; Nijland 2012).

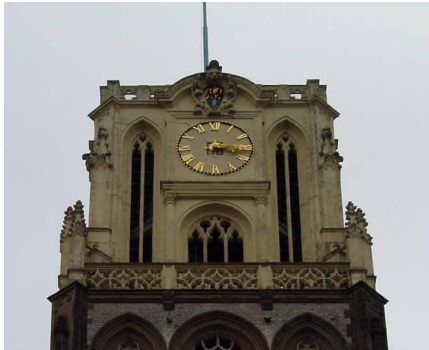
FIG. 2.12 The painted lantern of the Laurens Church tower in Rotterdam before conservation / Photo: W. Quist

During the conservation of the lantern of the tower of the Laurens Church in Rotterdam, all layers of paint were removed and the tuff stone – from an earlier restoration – was largely replaced by Bentheim sandstone, of which the lantern had once consisted entirely. In order not to let the fresh new stone stand out from the weathered old stone, an artificial patina was applied to the sandstone in the lantern. It was, however, decided not to patinate the – completely replaced – cornice pinnacles, as they together form an architectural unity [FIGS. 2.12/2.13/2.14]. Over time, the balustrade with corner pinnacles will develop a patina, depending on their orientation. The argument for architectural legibility was also used in the restoration of the facades of the Royal Palace in Amsterdam. For these façades, which consist of Bentheim sandstone and Obernkirchen sandstone, a detailed vision on the conservation was formulated at block level: it was decided to use a mix of cleaning, patch repair, replacing and artificially ageing, with the aim of bringing the façades into technical order and creating architectural unity (Bommel, 2012; Nijland 2012).

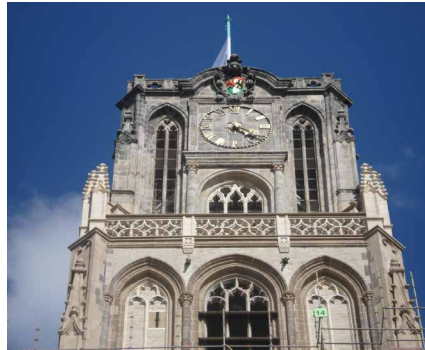
FIG. 2.13 The lantern of the Laurens Church tower in Rotterdam after conservation / Photo: W. Quist

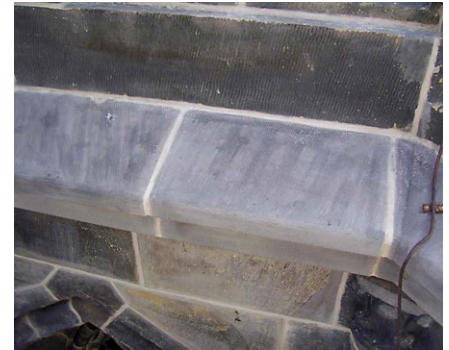
FIG. 2.14 Artificially patinated Bentheim sandstone on the lantern of the Laurens Church tower in Rotterdam / Photo: T.G. Nijland

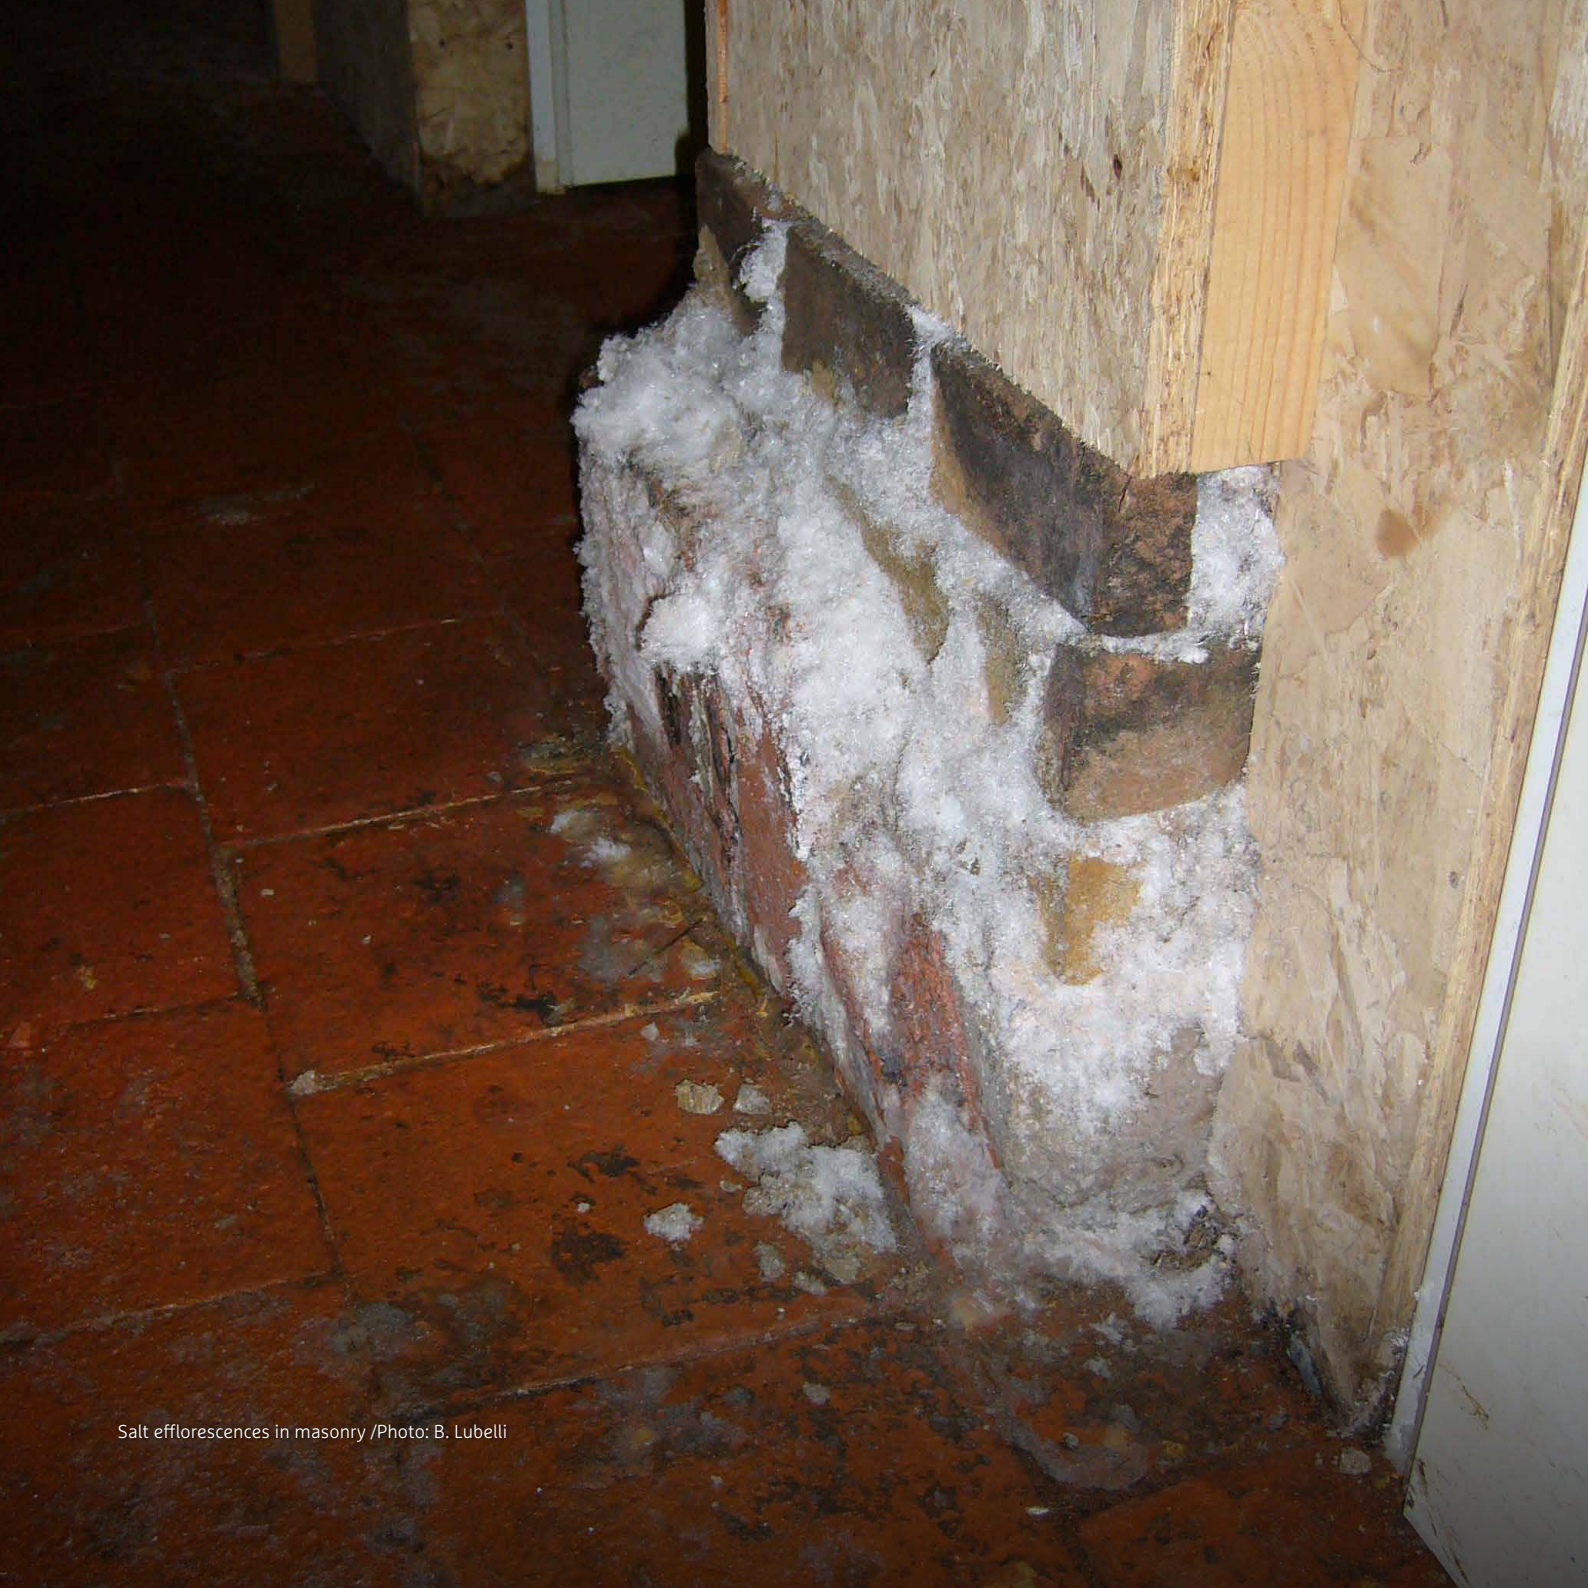
Salt efflorescences in masonry /Photo: B. Lubelli
