Detecting anomalies in diaphragm walls with electrical resistance measurements

Rodriaan Spruit*, Frits van Tol, Wout Broere and Evert Slob

Department of Civil Engineering, Delft University of Technology, the Netherlands

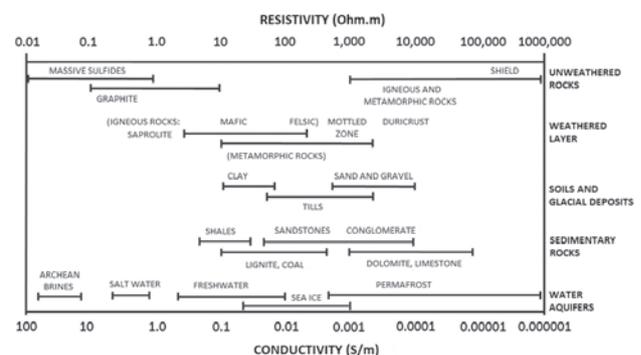
Figure 1 Indication of resistivity properties (Gunn *et al.* 2014).

- filling the three flat joints without defects with PUR foam;
- filling the basin with water from the nearby canal (conductivity = 134 mS/m, which is in the conductivity range of clays (Figure 1)).

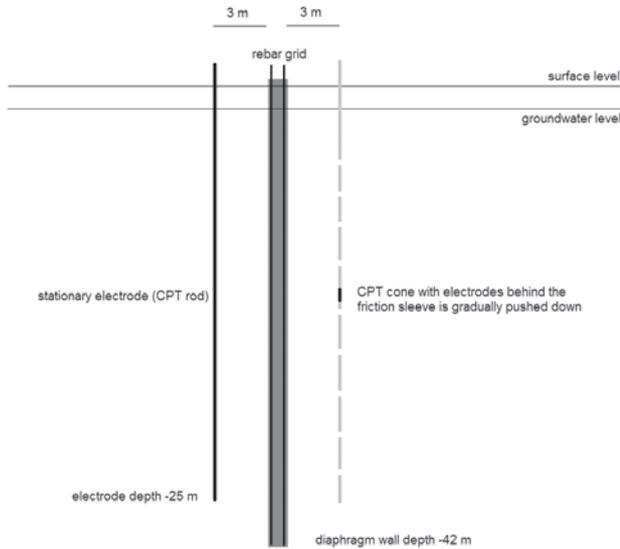
Figure 2 Schematic cross section of the field test (not to scale).

A day prior to the actual measurement, a stationary electrode was pushed in the soil on the outside of the building pit to a depth of 35 m below surface level, directly in front of the joint and 3 m away from the wall (electrode on the left in Figure 2).

On the test day, the cone penetration test (CPT) truck (Figure 3) was placed in front of joint 48-49 on the other side of the building pit (right side, Figure 2), 3 m away from the wall. The rebar cages on both sides of the joint and the previously placed stationary electrode were electrically connected to a switch box. This allowed the two electrode resistance measurement to be taken from the CPT cone to the electrode on the other side of the wall or from the CPT cone to the reinforcement cage north of the joint or from the CPT cone to the reinforcement cage south of the joint. Moreover, the local electrical ground resistance was measured in between two electrodes in the CPT cone. Each of these measurements was taken at 0.5-m interval. The cone, of which only one electrode was used for measuring the resistance to the stationary electrode and to the rebar cages, was a four-electrode GeoPoint earth resistivity cone.

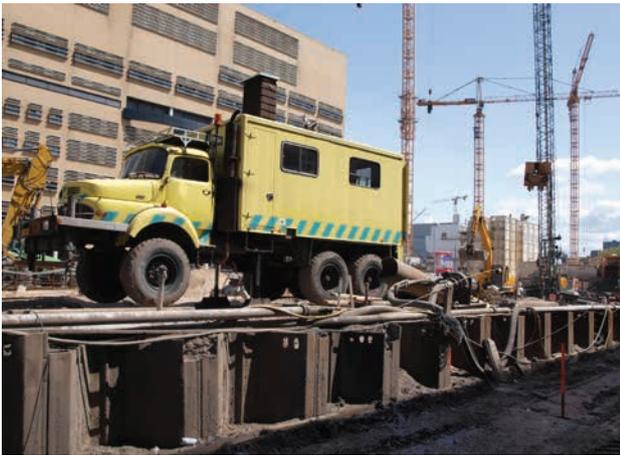
Figure 3 CPT truck during resistance measurements.

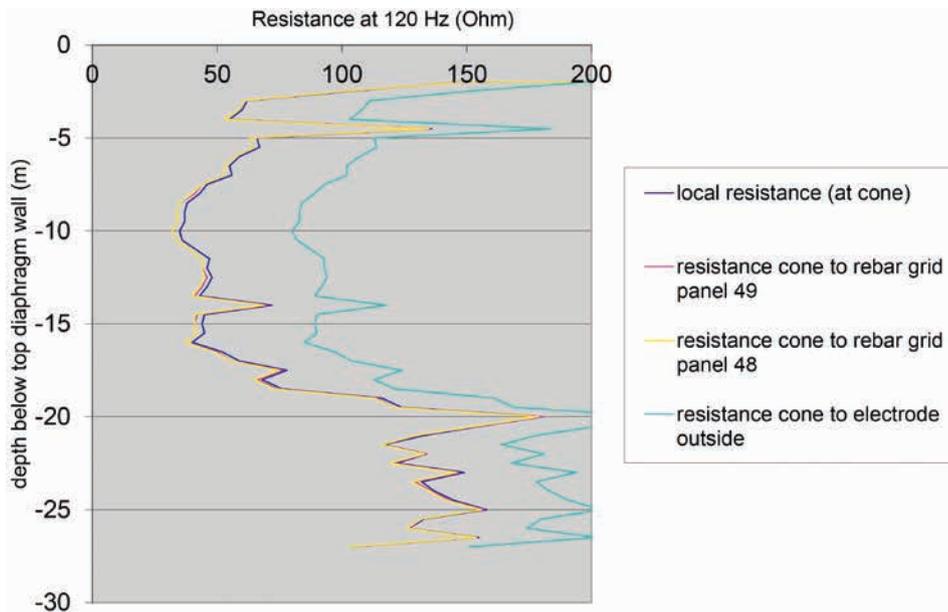
Figure 4 Resistance at 120 Hz.

Figure 4 shows the graphs of the local soil resistance (measured between two rings in the CPT cone), the resistance between the cone, and the rebar cages of both panels, and the resistance to the electrode on the opposite side of the diaphragm wall. All graphs run parallel to each other. In the upper five metres, high resistance has been recorded due to the partially saturated sandy top layer. Below -5 m, a sequence of clay and peat layers coincides with relatively low recorded resistance, with the peat layer between -8 and -10.5 m, showing the lowest resistance values. The very local higher resistance at -14 m corresponds with a 0.3-m-thick sand layer. This indicates that the contact resistance between the ring in the cone and the soil and/or the soil resistance may govern the measurements or that the defect in this specific joint does not extend to the full width of the diaphragm wall. Because of the strong effect of the thin sand layer, it appears that the measured resistance is primarily determined by the contact resistance of the electrodes in the CPT cone.

As a result, with a two-electrode setup, it will be hard to discriminate between defects in a diaphragm wall and soil resistivity variation or electrode contact resistance. For better results, a different electrode setup must be considered. It also seems worthwhile to use a reference measurement on an adjacent joint with no defects. The reference profile subtracted from the profile of the suspect joint might reveal the defects more clearly, assuming that the soil profile with its resistivity parameters is the same for both measurements.

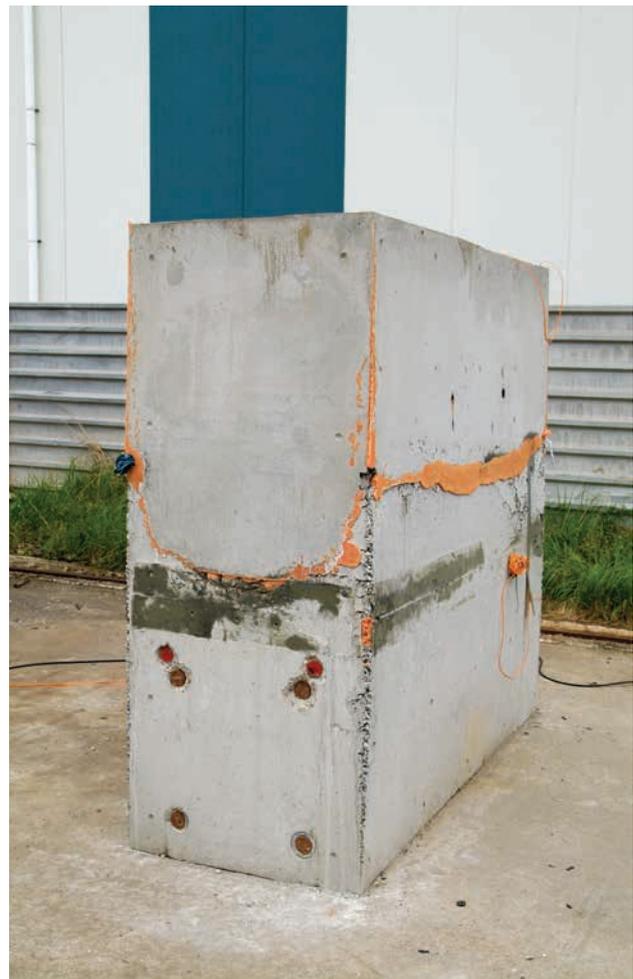
Figure 5 Test block subjected to ER measurement (dimensions: 1*2*2 m³)

In 2011, a preliminary effort was conducted by a commercial company specialising in resistance measurements, using their detection method (Vanni and Geutebrück 2011) on one of the test blocks (Figure 5) that were produced for the CSL measurements (Spruit *et al.* 2014). This test block was submerged for two weeks in a large container filled with water, and on the day the tests took place, the block was removed from the container. During the test, 208 sensors were connected to the outer surface of the test block in a 0.25-m grid (Figure 6). Such a test setup cannot normally be realised with *in situ* D-walls.

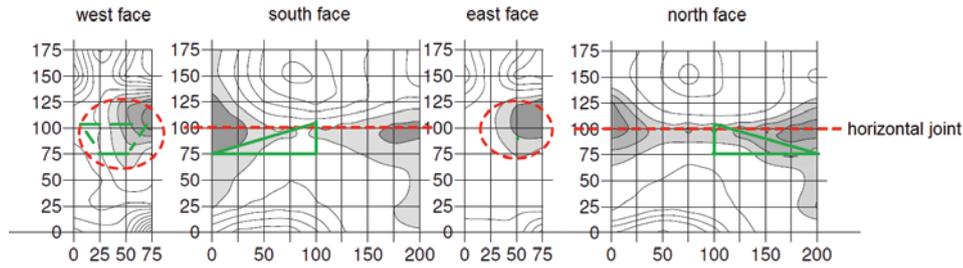
Figure 6 Measurement results (dimensionless); dimensions in centimetres.

The graphs provided by the company present a dimensionless parameter. Although the measurements theoretically contain resistance information, they are always reported as relative resistance. During the interpretation phase, the measurement results are scaled to such a degree that contrasts become visible in the graphs. The way this was done is not documented and depends on the engineer processing the data. Assuming that the dark areas indicate lower resistance (Figure 6), the joint between the two blocks could be located, but the included bentonite volume (indicated with green in Figure 6) could not.

The test does suggest that defects that continue throughout the total cross section of the concrete (in this case the joint between the two concrete blocks) might be located. However, the test block was saturated for two weeks and placed outside the water basin on the day of the tests. The concrete above and below the joint could have dried quicker than the concrete around the joint as the joint is partially filled with bentonite and will probably retain a higher moisture content because of this and the capillary effect of the joint.

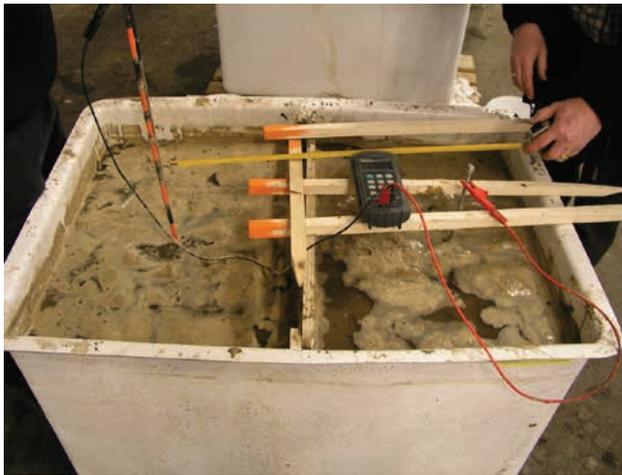
Figure 7 Test container (dimensions: 0.9*0.5*0.5 m³) with wooden barrier, water, and sand.

A perforated wooden barrier was placed in the centre of a plastic container of $0.9 \times 0.5 \times 0.5 \text{ m}^3$ (Figure 7). The barrier was connected to the inside of the container using silicone. The perforations were detectable with a two-electrode AC impedance tester (Voltcraft LCR 4080) when the electrodes were close to the barrier. This indicated that a two-electrode setup could be feasible. However, the measurements showed a strong influence of the contact resistance between the electrode and the soil, possibly limiting the resolution of a two-electrode setup.

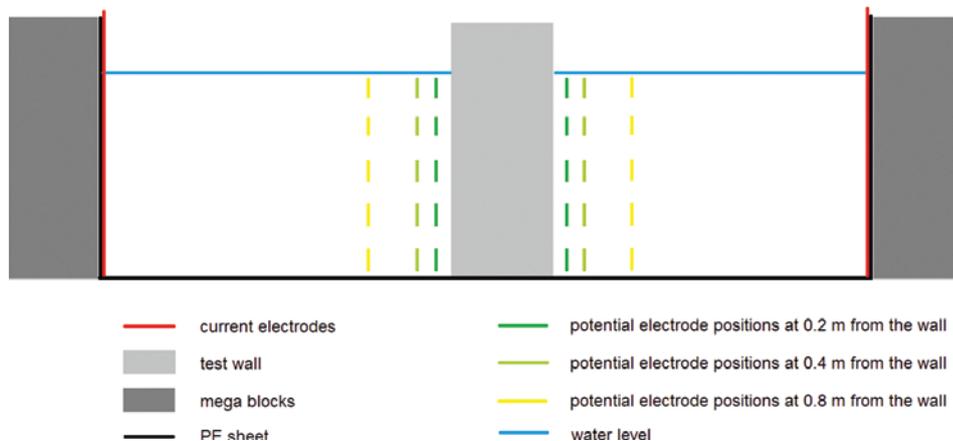
Figure 9 Cross section of the test setup.

The installation of the experiment (Figure 9) consisted of the following steps:

It was therefore decided to test several distances between the wall and the potential electrodes, ranging from 0.2 m from the wall up to 0.8 m from the wall (see Figure 9). The current electrodes remained stationary during the tests.

The current electrodes were galvanised iron grids (Figure 12) fully covering the outer walls parallel to the test wall (Figure 9). This ensured current lines perpendicular to the test wall in case of a homogeneous resistivity of the test object.

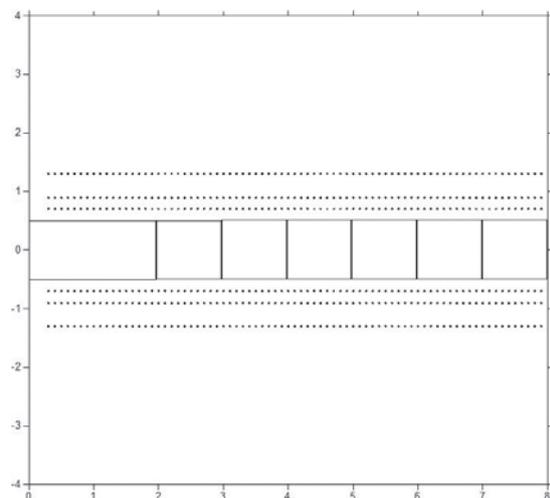
Figure 11 Top view of test wall with electrode positions (dots) for measuring the potential at 0.2, 0.4, and 0.8 m distances to the test wall; horizontal dimensions (in metres).

ment position to the next (see Figure 11). The horizontal spacing of the potential electrode positions along the test wall was 0.1 m, resulting in 80 electrode positions along the wall at five different depths below the water table and at three potential electrode distances to the test wall (see Figures 9 and 11).

The dots presented in Figure 11 only show the horizontal distribution of the measurement locations. During the tests, five depths were measured, i.e., at 0.2, 0.4, 0.6, 0.8, and 1 m below the water table.

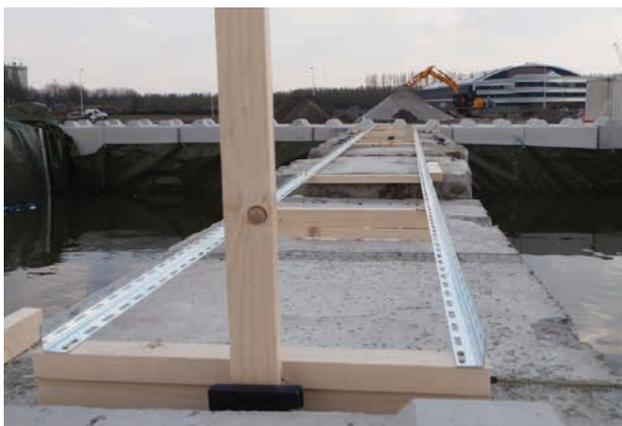
Figure 10 Top of test wall with track for positioning the potential electrodes.

The potential electrodes were installed onto a wooden frame bolted on a trolley. Both the horizontal distance of the potential electrodes to the wall and the vertical position of the potential electrodes (below the water level) could be adjusted. The trolley was able to run over a track that was installed on top of the test wall (Figure 10), providing the positioning of the electrodes parallel to the wall.

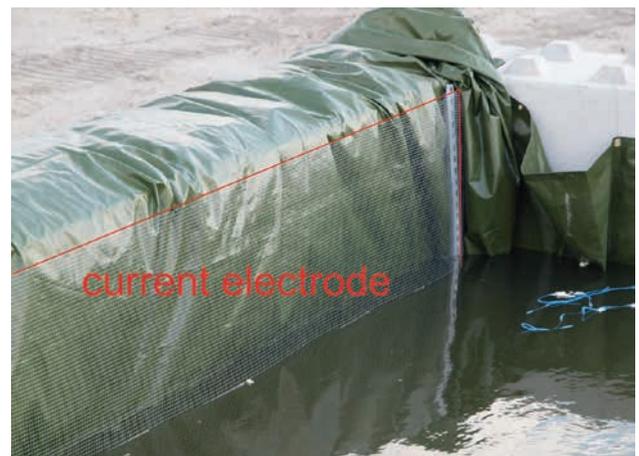
Figure 12 Current electrode grid.

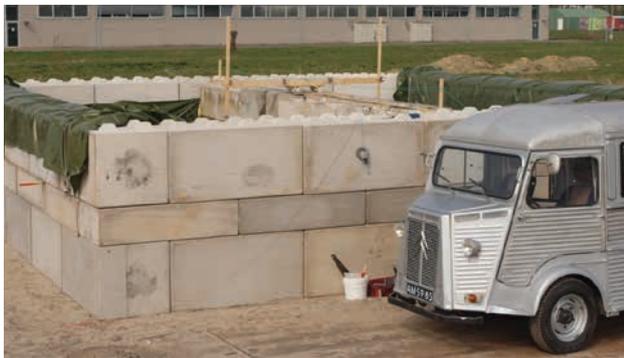
Figure 13 Test setup overview (looking northeast).

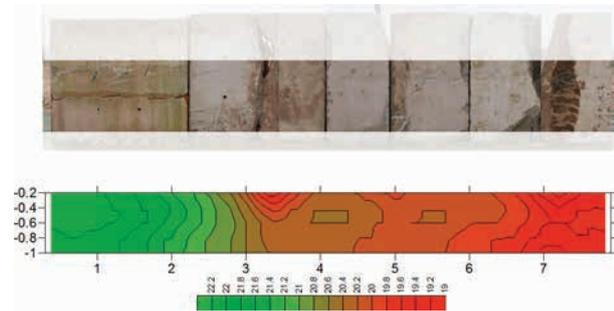
Figure 14 Resistance (in ohms) results for potential electrodes, 0.2-m distance to the test wall (x-axis and y-axis in metres).

When the electrodes are located at 0.2 m to the test wall (Figure 14), the defects at 3.2, 5, and 7 m are recognisable by the relatively low resistance.

Figures 14, 15, and 16 show the resistance results for the electrode distance to the test wall of 0.2, 0.4, and 0.8 m, respectively.

Block 1 does not show a defect, although a known bentonite inclusion is inside. Moreover, the horizontal joint at half height does not show up in the measured resistance. The joints that were injected with PUR foam (at 0, 2, 4, 6, and 8 m) are invisible in the resistance measurements. This indicates that it is likely that only defects extending the full width of the wall can be detected with these ER measurements. This seems to be coherent with the measurements described in Section 2.

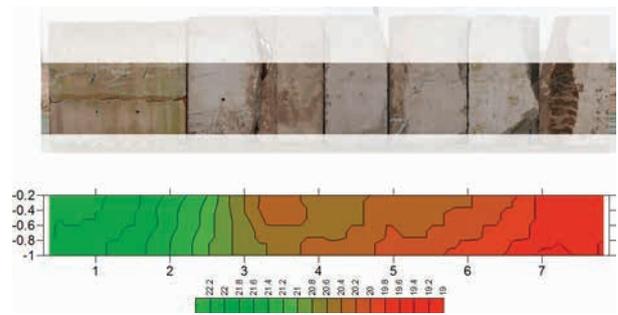
Figure 15 Resistance (in ohms) results for potential electrodes, 0.4-m distance to the test wall (x-axis and y-axis in metres).

After increasing the distance of the electrodes to the test wall from 0.2 to 0.4 m (Figure 15), most details are already lost. The only defect that is still recognisable is at 3.2 m. The average resistance has not changed much, suggesting that the resistance is mainly governed by the properties of the wall and that the additional water between the electrodes has a negligible effect on the absolute value of the measurements.

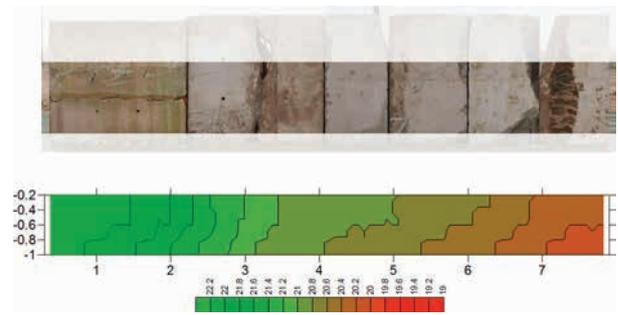
Figure 16 Resistance (in ohms) results for potential electrodes, 0.8 m distance to the test wall (x-axis and y-axis in metres).

After increasing the distance between the electrodes and the wall from 0.4 to 0.8 m (Figure 16), there are no longer any recognisable defects. The average resistance along the wall is still in the same league as during the tests with the electrodes closer to the test wall, confirming that the resistivity of the test wall is the predominant factor in this test.

A trend with high resistance on the left and low resistance on the right can be recognised in Figures 14–16. By subtracting

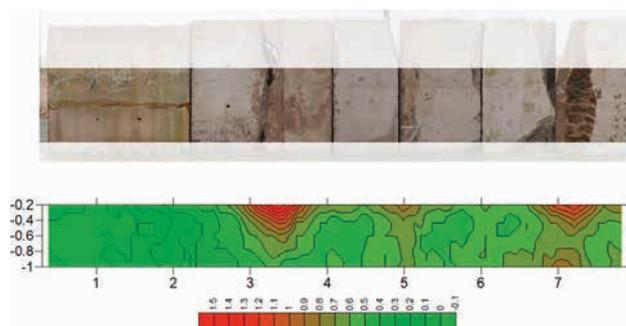
Figure 17 Resistance (in ohms) results for potential electrodes, 0.2-m distance to the test wall, corrected with the results at 0.8-m distance (x-axis and y-axis in metres).

the resistance results at 0.8 m between the test wall and potential electrodes from the results at 0.2 m, this trend is effectively filtered out, as shown in Figure 17. Even the joints at 5 and 6 m, which were not distinguishable before, show up.

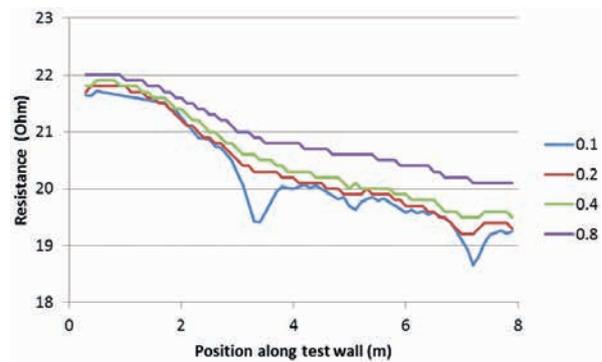
Figure 18 Resistance at 1 m below water table for 0.1, 0.2, 0.4, and 0.8-m electrode distance to the test wall.

An extra run at one depth with 0.1-m separation from the wall was made (see Figure 18), although such a small distance increases the practical problems with irregularities on the outside of the D-wall. Moreover, push-in electrodes tend to deviate towards areas with lower horizontal stresses (due to the excavation of the D-wall trench), probably resulting in push-in electrodes hitting the concrete of the D-wall more often if introduced this close to the wall.

If the scan line at 1-m water depth is plotted for all electrode distances to the test wall (including the extra scan line at 0.1-m distance between the potential electrodes and the test wall) (see Figure 18), it becomes clear that the resolution for local anomalies

lies dramatically decreases with increasing distance of the electrodes to the test object.

Electrode distance to object (m)	Detection limit illustrated	Description of known anomaly	Anomaly size (m ²)
0.1	Figure 18 at 5.0 m	Cast concrete joint of 1 mm wide and 0,1 m high	0.0001 (0.1 m * 0.001 m)
0.2	Figure 14 At x=5.0 m Y=-0.2 m	Opening of 2 cm by 5 cm	0.001 (0.02 m * 0.05 m)
0.4	Figure 15 At x=3.5 m Y=-0.4 m	Opening of 10 cm by 20 cm	0.02 (0.1 m * 0.2 m)
0.8	No anomalies detected	N/A	N/A

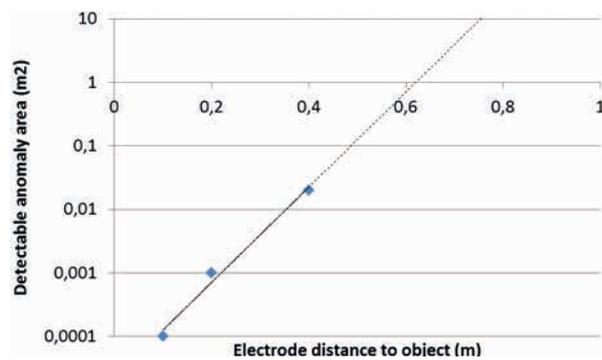
Figure 19 Detectable anomaly size and electrode distance to the test object.

When the above results are plotted on a logarithmic scale for the anomaly area (Figure 19), it becomes clear that, at 0.8-m electrode distance to the object, no anomalies were found because all anomalies in the test wall were smaller than 10 m².

Based on the average size of the anomalies and the limits of detection, an estimated detectable anomaly as a function of electrode distance to the object has been constructed. Table 1 shows an overview of the typical anomalies that were detectable at the different electrode distances to the test wall.

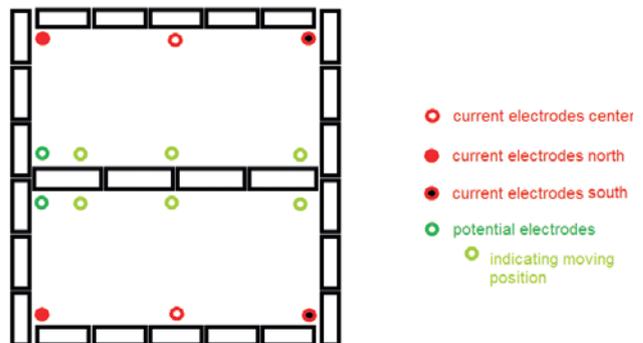
Figure 20 Current electrode positions for single rod electrodes.

the basin were used as current injection electrodes (Figure 20). Figure 21 shows the difference in measured resistance between the grid-shaped current electrodes and the single vertical steel rods in the outer corners of the test basin (north and south) or in the centre of the outer walls (see Figure 20 for electrode positions). The resistance is influenced by the position and the shape of the current electrodes. The electrodes in the outer corners of the basin show a large deviation from the measurements with the electrode grids. This is probably caused by the asymmetric distribution of the current and potential lines due to the isolated walls of the basin. The image obtained with the electrodes in the centre of the outer walls is rather useable. The difference between the grid electrodes and the single rods in the centre of the outer walls of the test setup is almost negligible. In a field setup, single electrodes may therefore be used as long as the target area is more or less in the middle of the shortest line between the current electrodes.

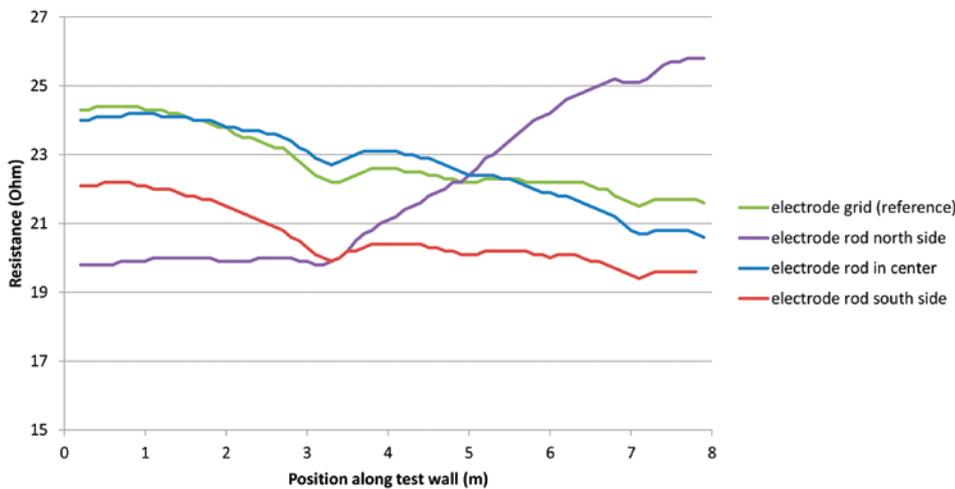
Figure 21 Current electrode shape and position influence (position 0 is north side of test wall).

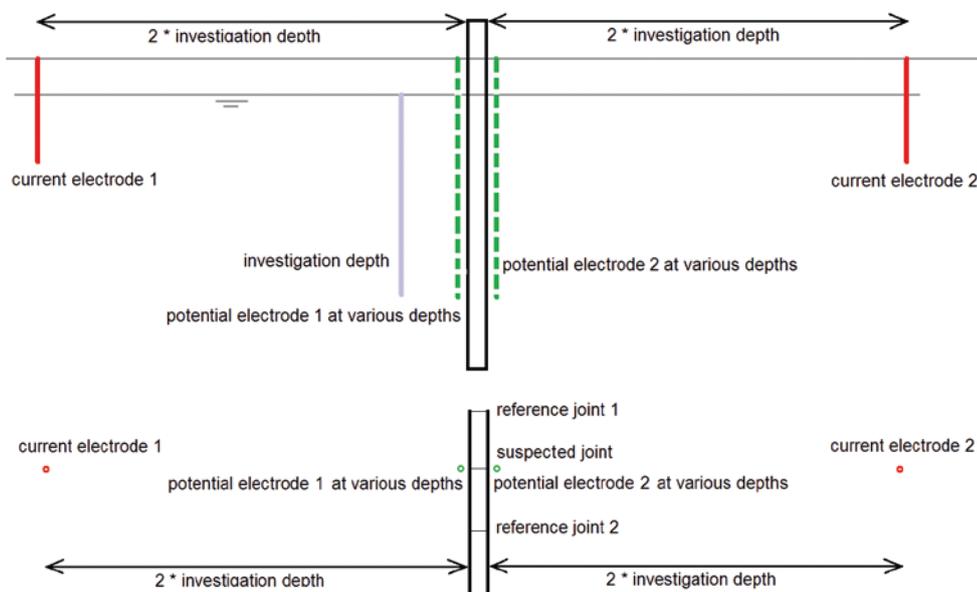
Figure 22 Suggested measurement setup for testing a diaphragm wall before excavation of a building pit (side view).

Figure 23 Suggested measurement setup for testing a diaphragm wall before excavation of a building pit (top view).

- A four-electrode setup in which a current is fed from current electrode 1 to current electrode 2, across the wall. The local potential at close distance to the wall is measured with potential electrodes 1 and 2, running simultaneously vertically along the joint(s) (Figures 22 and 23). It will already be hard enough to detect anomalies; contamination from electrode–soil contact resistance is unavoidable with a two-electrode setup. The contact resistance will probably obscure the small effect of an anomaly. With a four-electrode setup, the influence of contact resistance is negligible.

- Perform a relative measurement using known good joints as references (from CSL measurements).
- Current electrodes should be placed at least 3 m into the groundwater to guarantee good contact.

- Current electrodes should preferably be placed more than two times the investigation depth away from the wall that is being tested.
- Potential electrodes should be located less than 0.2 m from the wall.

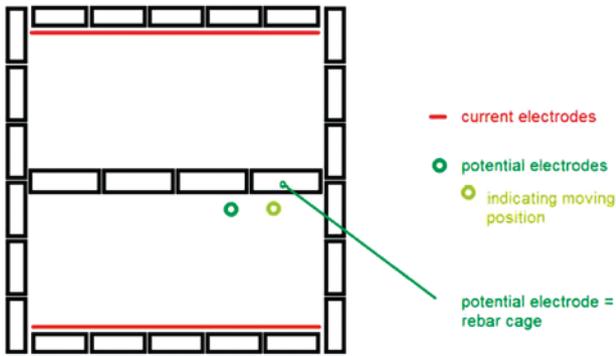
Figure 24 Test setup with two current electrodes, one mobile potential electrode, and the rebar cage acting as the second potential electrode (four-electrode setup).

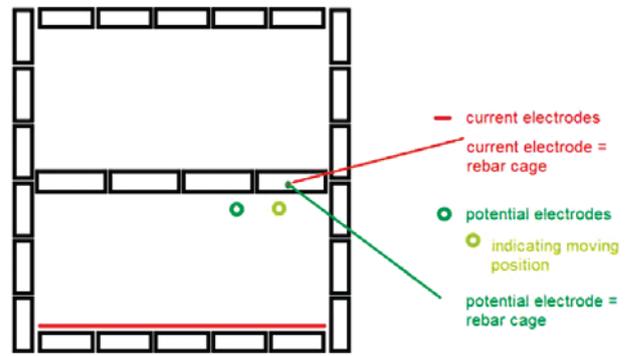
Figure 26 Test setup with one distant current electrode, one mobile potential electrode, and the rebar cage acting as both the second potential and the second current electrode (three-electrode setup).

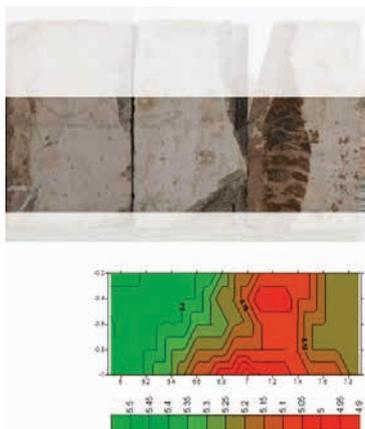
Figure 25 Resistance (in ohms) results for the four-electrode test setup as indicated in Figure 24 (x and y axes in metres).

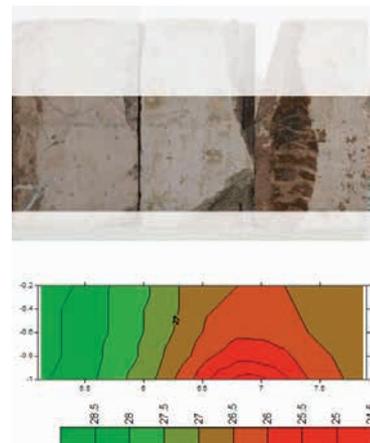
Figure 27 Resistance (in ohms) results for the three-electrode test setup as indicated in Figure 26 (x-axis and y-axis in metres).

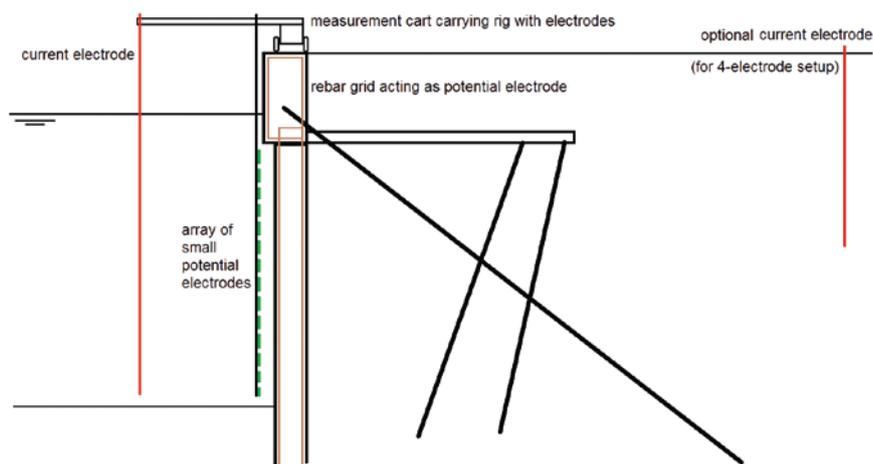
Figure 28 Suggested three-electrode measurement setup (with an optional fourth electrode) for concrete quality check on quay walls.

side) is suggested for large-scale testing of the quality of diaphragm wall concrete. If anomalies are detected, a local four-electrode measurement setup, illustrated in Figure 28 with the optional current electrode, can be used to better determine the size and shape of the anomaly. Note that such a measurement setup has not been tested within the scope of this research. Based upon the results of the test, it is expected that damaged or low-grade concrete covering the rebar cages can be detected using the above-described procedure.
