Additional thesis (CIE5050-09)

Master track: Water Management  
Specialisation: Hydrology

# An analysis of hydrological and geotechnical parameters of rotational landslides in pegmatite lithology in North Western Rwanda

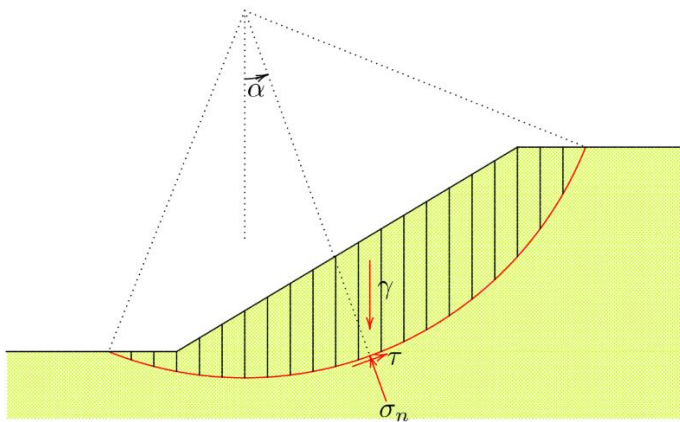
Figure 2.1: Circular slip surface. Basic assumption of most slope stability models (Verruijt, 2007)

The stability of a slope is determined by the ratio between the strength (shear strength) and the load (shear force) along a surface of failure, the slip surface. This ratio is called the safety factor,  $F$ . For a basic circular slip surface this can be written as:

There are many different alterations proposed to formula (2.3). Fellenius assumed no forces between the adjacent slices, whereas Bishop did, but assumed the resultant force to be horizontal (Verruijt,

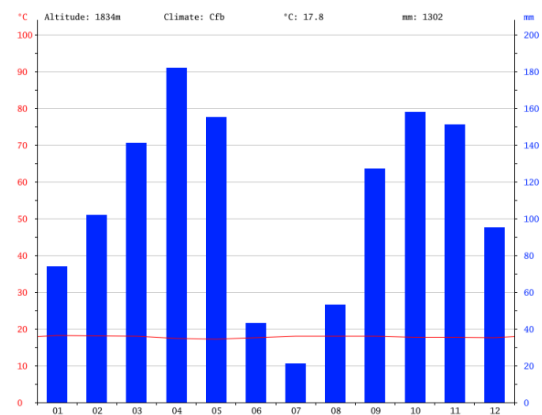
Figure 3.1: Yearly climate data chart of the Musanze district (N.W. Rwanda) ("Climate Musanze", 2018)

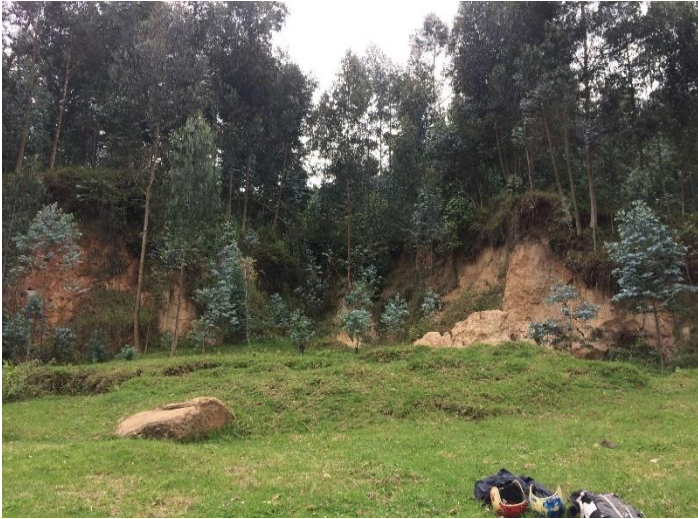
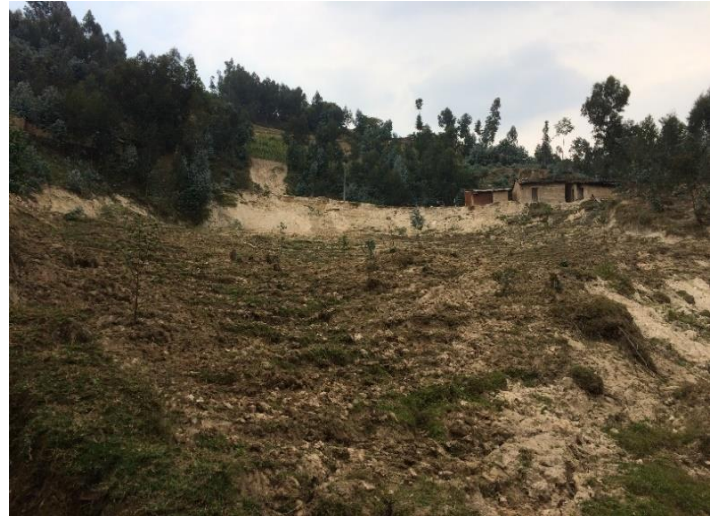
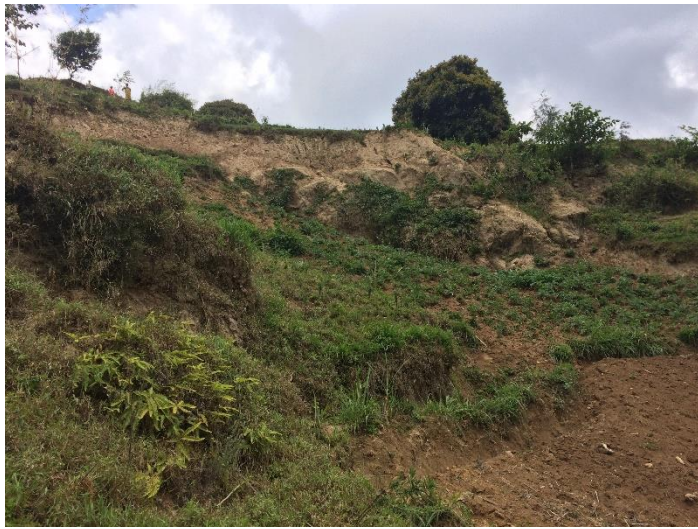
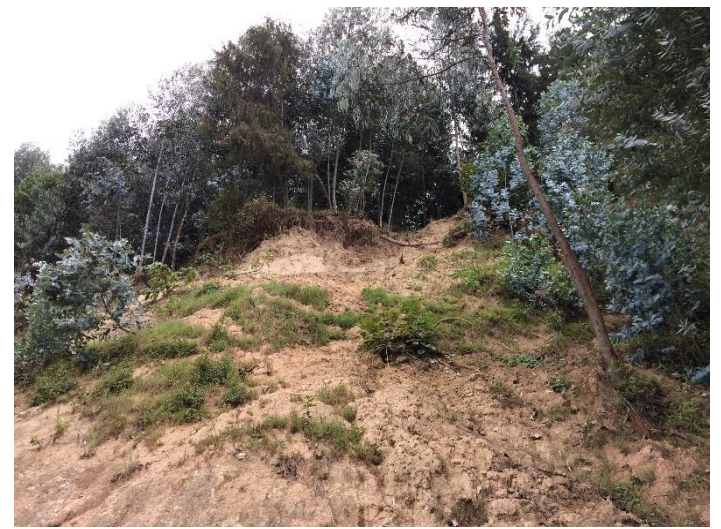
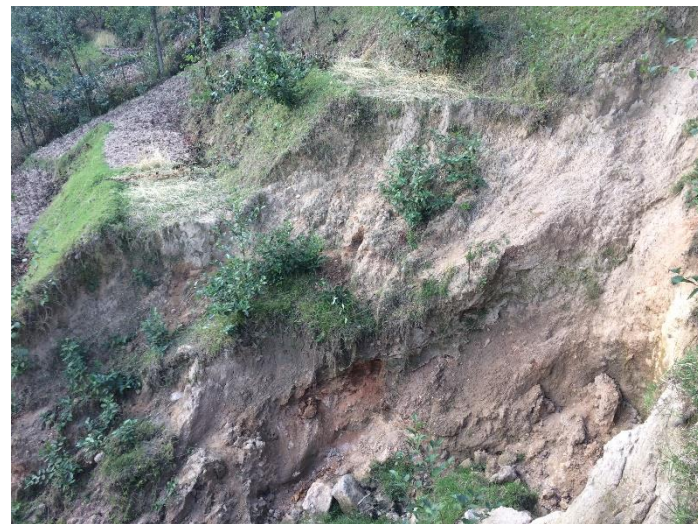
Figure 3.2: From top left to bottom right: 1) Landslide 50, 2) Main study site Karago landslide nr. 63, 3) Landslide 128, 4) Landslide 187, 5) Landslide 219, 6) Map of the area with all landslides, including land use, marked.

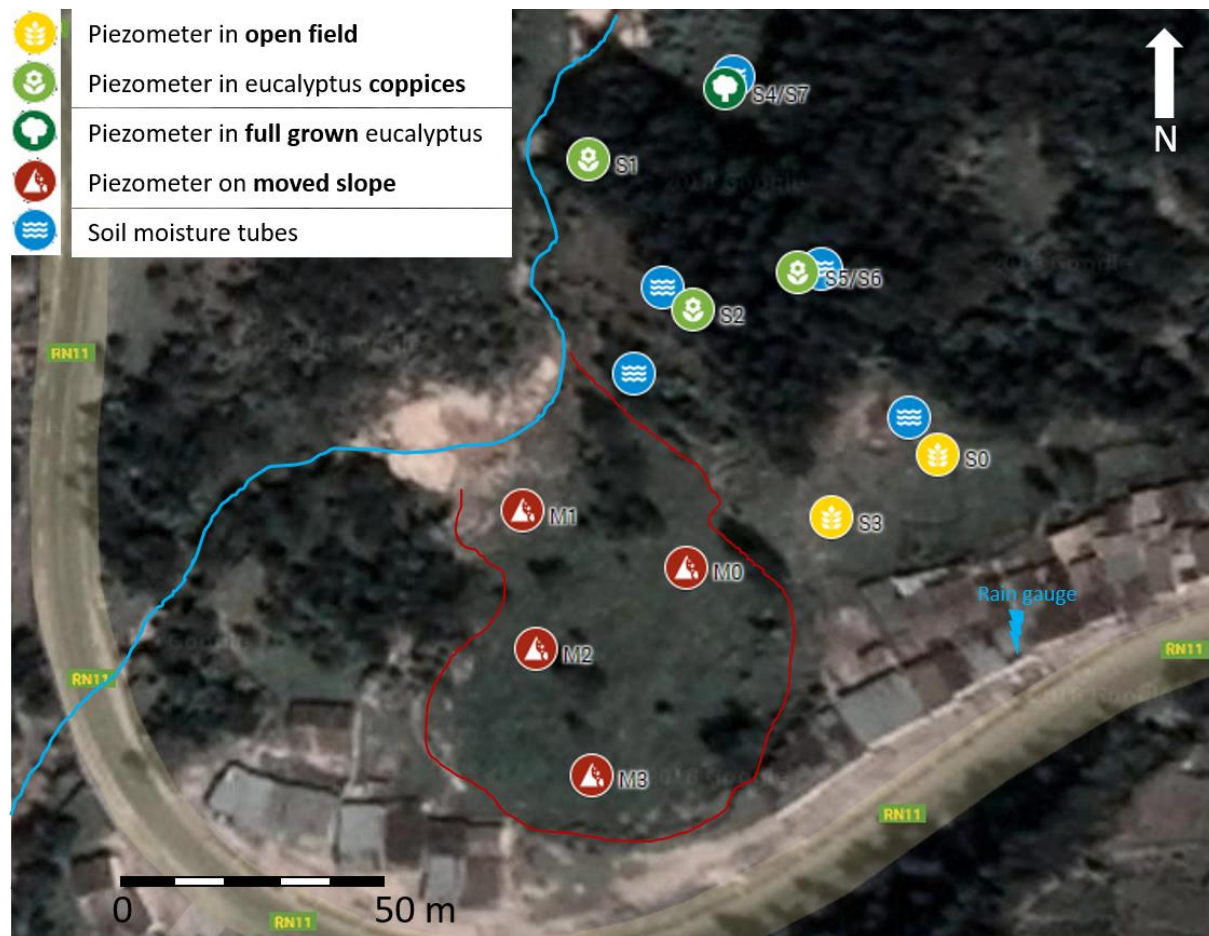
Figure 4.1: Location of piezometers installed at Karago landslide

At the Karago landslide piezometers were placed on both the moved and stable slope to measure the groundwater level. Four piezometers (M0, M1, M2, M3) were installed on the moved slope. Six piezometers were installed on stable slopes. Piezometers S1 and S2 were installed on a stable ridge with Eucalyptus coppices (0-9 months). Piezometers S5 and S6 were also installed in Eucalyptus coppices (<2 years). Piezometers S4 and S7 were installed in full grown Eucalyptus (>2 years). Piezometers S3 and S0 were installed upslope of the stable slope on small agricultural plots.

All the piezometers were self-made. PVC pipes ( $\varnothing$  5.5 cm) were placed in auger holes of diameter 7 or 10cm. The bottom  $\pm 40$ cm of the pipes were perforated and then covered with stockings to prevent soil from entering the pipe. After placement in the auger hole the remaining space was filled with sand to ensure free groundwater flow into the standpipes and prevent clogging. Additional piezometer data can be found in Appendix A.

Near a number of piezometers on the stable slopes, soil moisture access tubes for the Delta-T PR2 ("PR2 Profile Probe – analogue version", 2018) probe were installed (fig. 4.1). The maximum depth of these access tubes was 0.9 m.

In addition, an automatic logging rain gauge with a tipping bucket was installed on the rooftop of a house near the road (fig. 4.1).

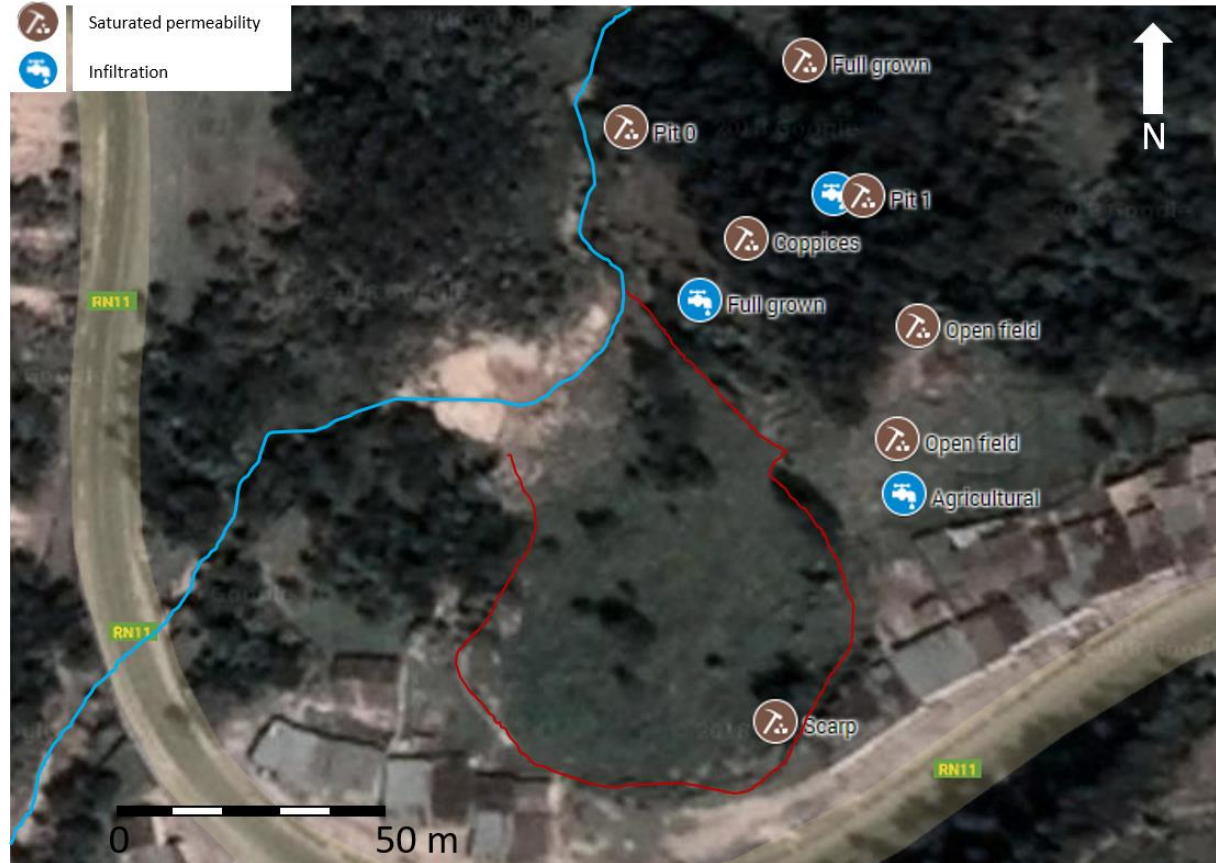
Figure 4.2: Location of double ring infiltrometer tests, and inverse auger hole tests and/or sampling location for constant head test

The saturated permeability was determined in-situ using the inverse auger hole method, because the soil layers considered were in the unsaturated zone. Inverse auger hole tests were carried out for as many soil layers as possible in the two pits dug on the stable slopes (fig. 4.2). In addition, several extra inverse auger hole tests were done in full grown Eucalyptus, Eucalyptus coppices, and in open field. The maximum depth of these tests was limited at 1.1m by the depth of the auger.

For the infiltration tests a double ring infiltrometer with outer diameter 49.2cm and inner diameter 30cm, and ring heights of 84.2cm was used. The infiltration of the top soil layer near piezometers S2 (full grown Eucalyptus), S3 (agricultural plot) and near S5/S6 (Eucalyptus coppices) was measured in this way.

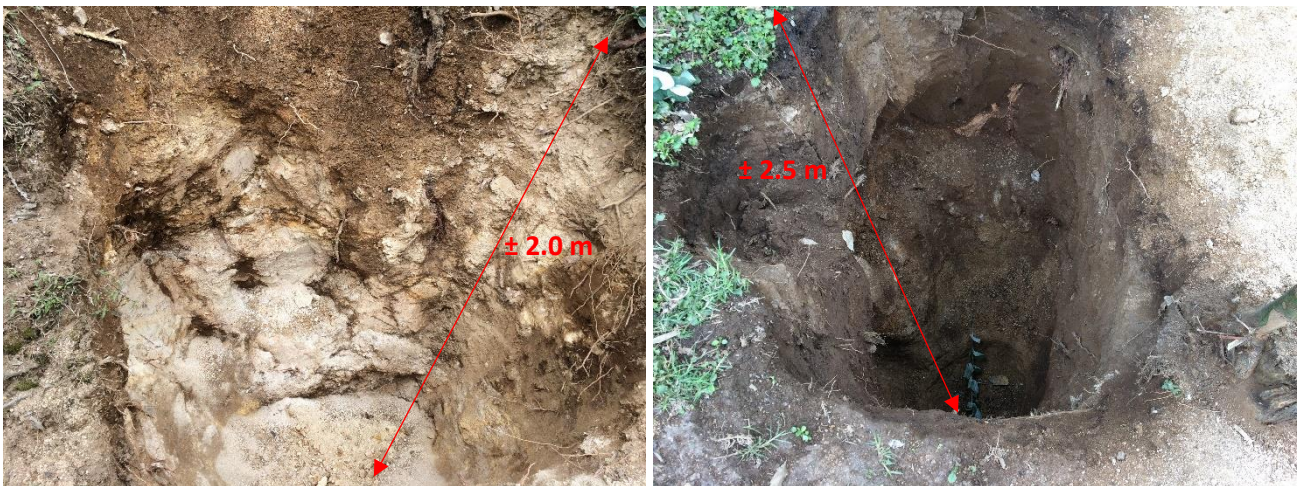
Figure 4.3: Sampling pit 0 (on stable slope S0) left and sampling pit 1 (on stable slope S1) right

Soil sampling was done for particle size analysis, bulk density analysis, constant head testing, and direct shear testing. For particle size analysis a disturbed sample suffices. For bulk density, constant head, and direct shear testing and undisturbed sample is required. Undisturbed samples of the landslides 50, 128, 187, 219, and of the moved slope of the Karago landslide were taken from their scarps. To retrieve undisturbed samples from all layers from the stable slopes S0 and S1 at Karago two pits were dug (fig. 4.3). At each location the in-situ moisture content was also measured using the Delta-T ML3 soil moisture sensor ("ML3 ThetaProbe Soil Moisture Sensor", 2018).

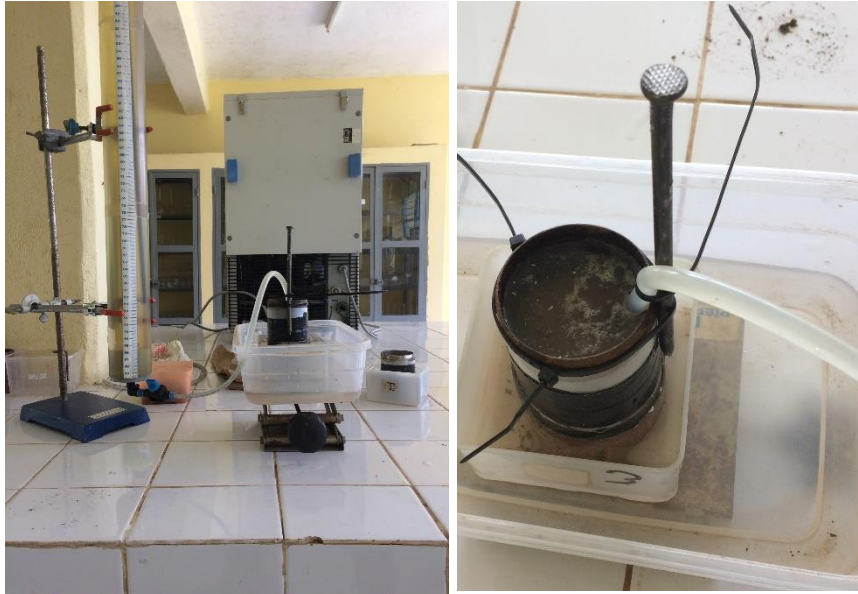
*Figure 4.4: Saturated permeability set-up in laboratory (left) and close-up of sample being tested (right)*

The saturated permeability was also tested in the laboratory using a self-made constant head test whereby a constant head is maintained across the soil sample to create a steady discharge through the sample. By attaching a core cylinder watertight on top of a sample container, and connecting that core cylinder watertight to a Mariotte bottle using a flexible tube, a constant head is maintained above the sample (fig. 4.4). The sample is covered at the bottom with gauze to prevent soil from flushing out, and raised slightly from the bottom to ensure free outflow of water.

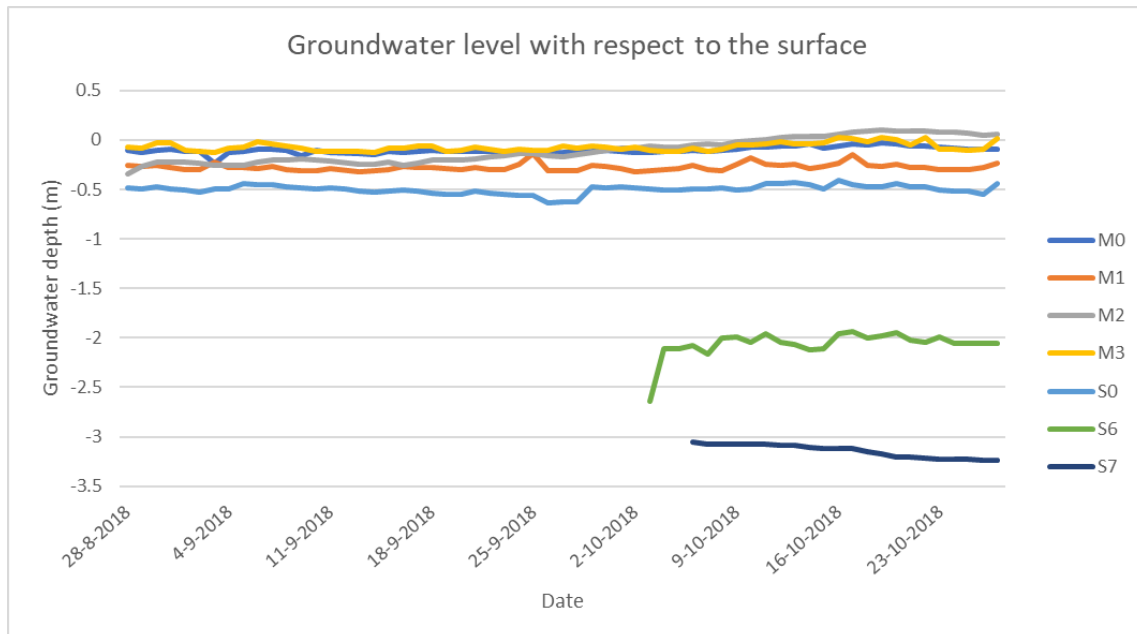
Figure 5.1: Groundwater levels in piezometers with respect to the ground surface (=0)

Almost all piezometers installed on the stable slopes were dry because they were not deep enough. S6 and S7 were installed on stable slope S1 at a later date and were deeper than S5 and S4 nearby. Figure 5.1 shows the groundwater table of the stable slope is fairly deep, and the depth increases from S0 upslope, to S7 near the river. S0, which was installed just upslope of the well, was the only piezometer on the stable slopes with a fairly high groundwater table. The groundwater table on the moved slope is just beneath the surface, and towards the end of the time series the water level in piezometer M2 is even slightly higher than the ground surface, indicating ponding. This is reasonable since the surface of the moved slope is much closer to the groundwater table and infiltration is high as well because of the disturbed soil. A schematic of the groundwater level in piezometers on the moved slope and stable slope S1 can be found in Appendix B.

When comparing figure 5.1 to the rainfall data (fig. 5.2) no direct correlation is visible. Due to some initial errors in the rain gauge set up, the data from figure 5.2 comes from a rain gauge already set up at the nearby Nyabihu tea factory, less than 1km away. Though the groundwater table in the piezometers fluctuates from day to day there seems to be no evident relation to the fluctuations in rainfall. The relation between precipitation and groundwater recharge, however, is rarely straightforward since there are many more processes involved. To be able to correlate the rainfall data to the groundwater table more insight is needed in the specific processes taken place on these slopes, and probably a more extensive measuring period is required including at least one complete rainy season.

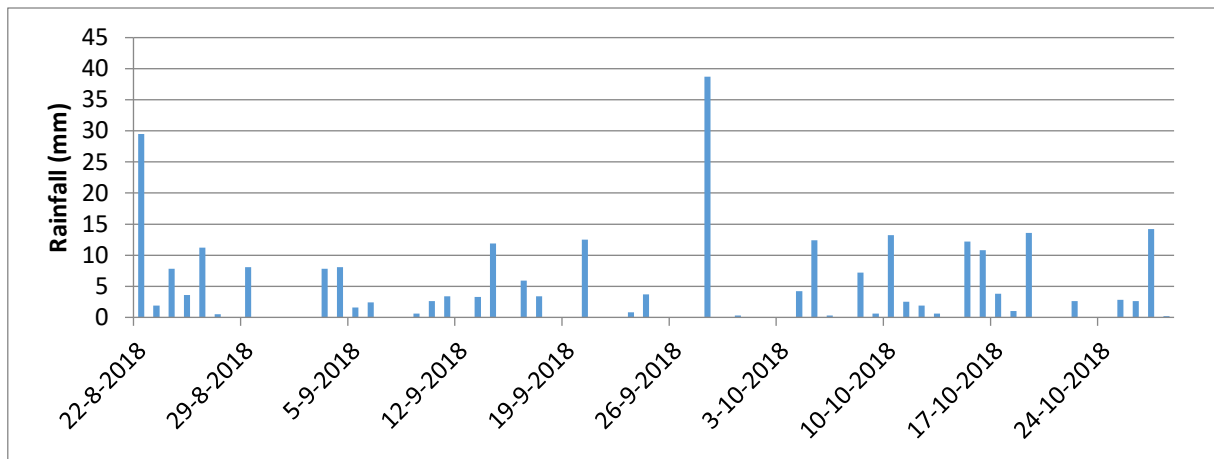
Figure 5.2: Precipitation data from August 22<sup>nd</sup> 2018 to October 29<sup>th</sup> 2018

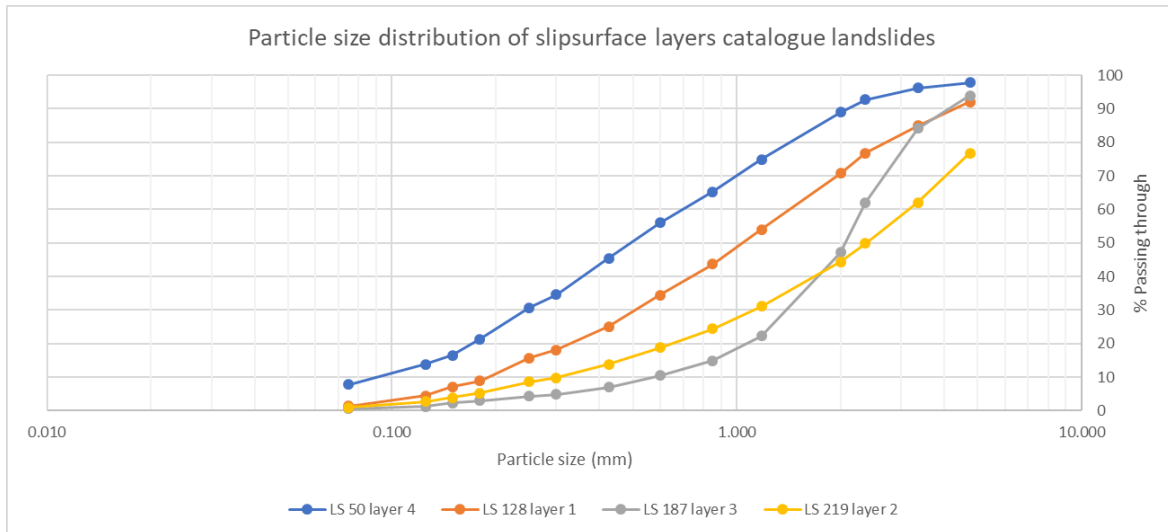
Figure 5.6: Particle size distribution of slip surface layers of regional landslides

Figure 5.6 shows the grainsize distributions of the slip surface soil layer of landslides nr. 50, 128, 187, and 219. Figures 5.7-5.9 show the grainsize distribution for all the layers of the moved slope and the two stable slopes of the Karago landslide, nr. 63.

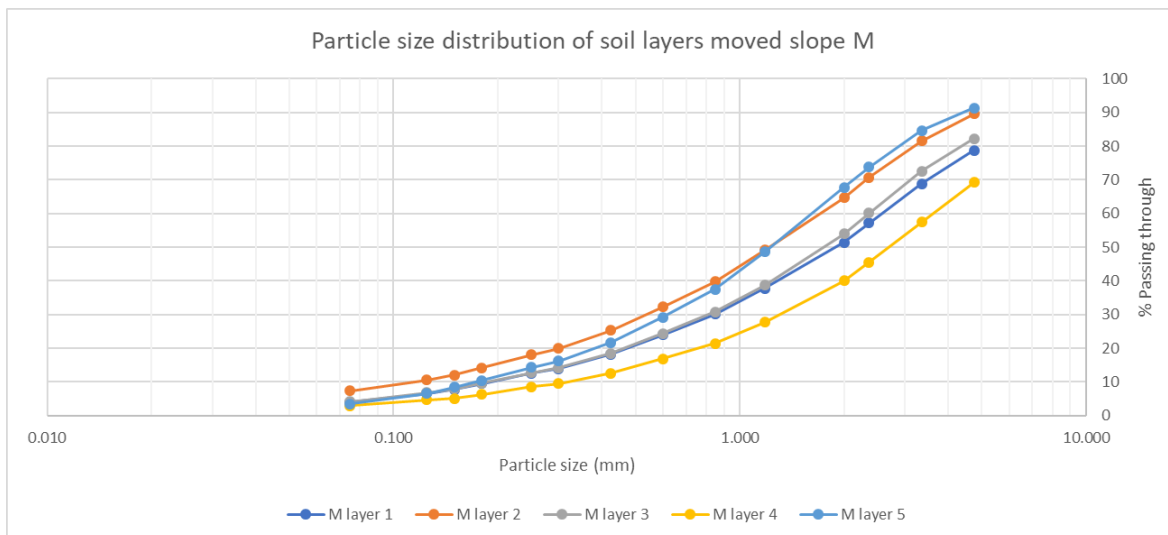
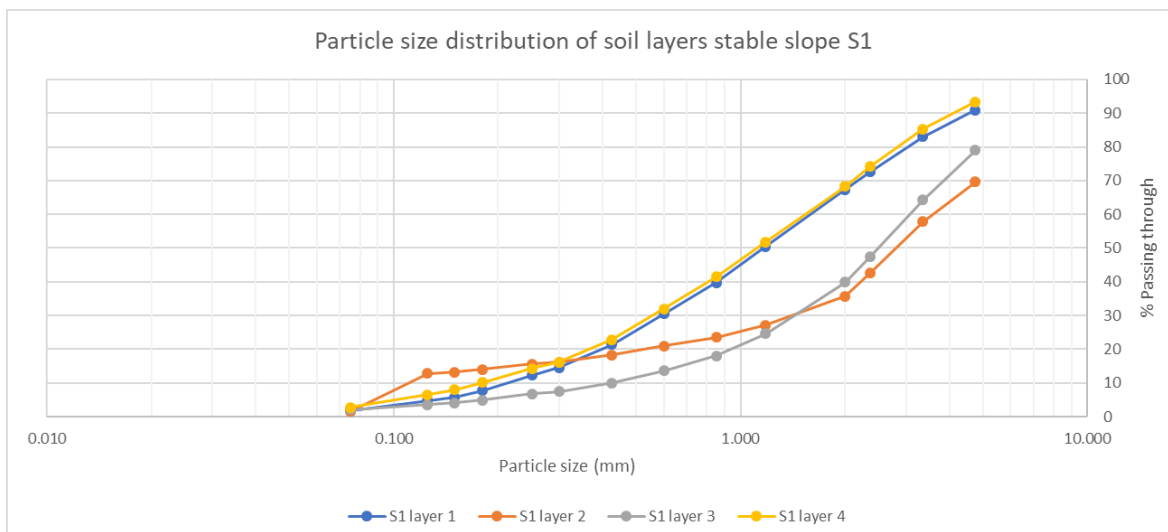
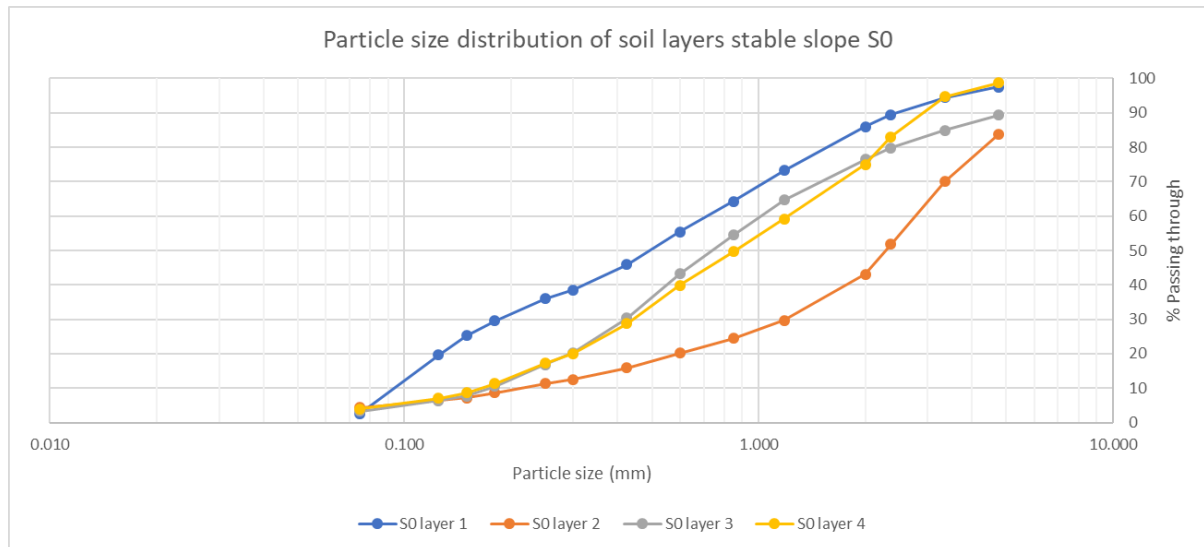
Figure 5.7-5.9: Particle size distribution of soil layers of moved slope M, stable slope S0 and stable slope S1

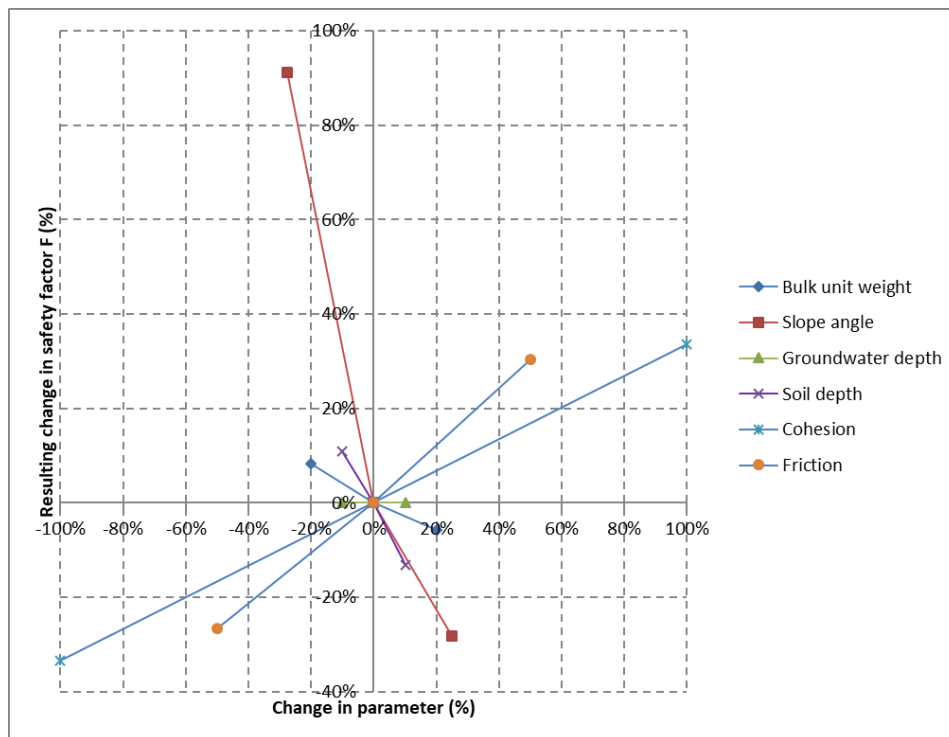
Figure 7.1: Sensitivity analysis of the SLIP5EX input parameters for landslide nr. 50

For the particular case of LS50 (fig. 7.1) it can be seen that a small change in the slope angle (x-axis) already brings about a large change in the safety factor (y-axis). The exact value by which the factor of safety changes also depends on the value of the input parameter, and may thus be slightly different for other landslides. However, the slope of the lines in figure 7.1 remain roughly the same, and say the most about the influence of each parameter. Hence, by changing other parameters than C and  $\phi$  a significant change in safety factor can be achieved, allowing C and  $\phi$  to be set to more realistic values in some cases, to achieve a safety factor of 1.

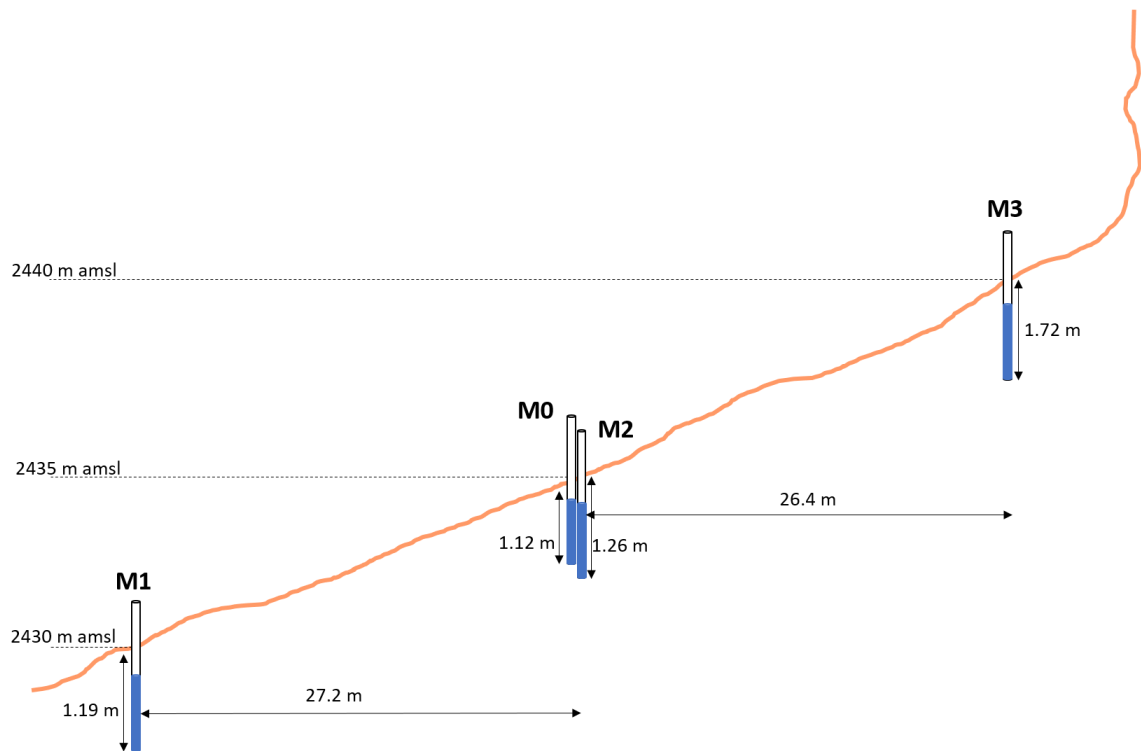
Figure B.1: Schematic of groundwater level in piezometers on moved slope. M0 and M2 are actually located behind each other, perpendicular to M1-M3

From this schematic it becomes clear that the depth of the groundwater table increases from the well (stable slope) or the scarp (moved slope) to the river. The river has excavated its way through the landscape which makes that there is a significant (3-5m) drop from the toe of the slopes to the riverbed. This low-lying river could have a significant influence on the groundwater level of the surrounding slopes.

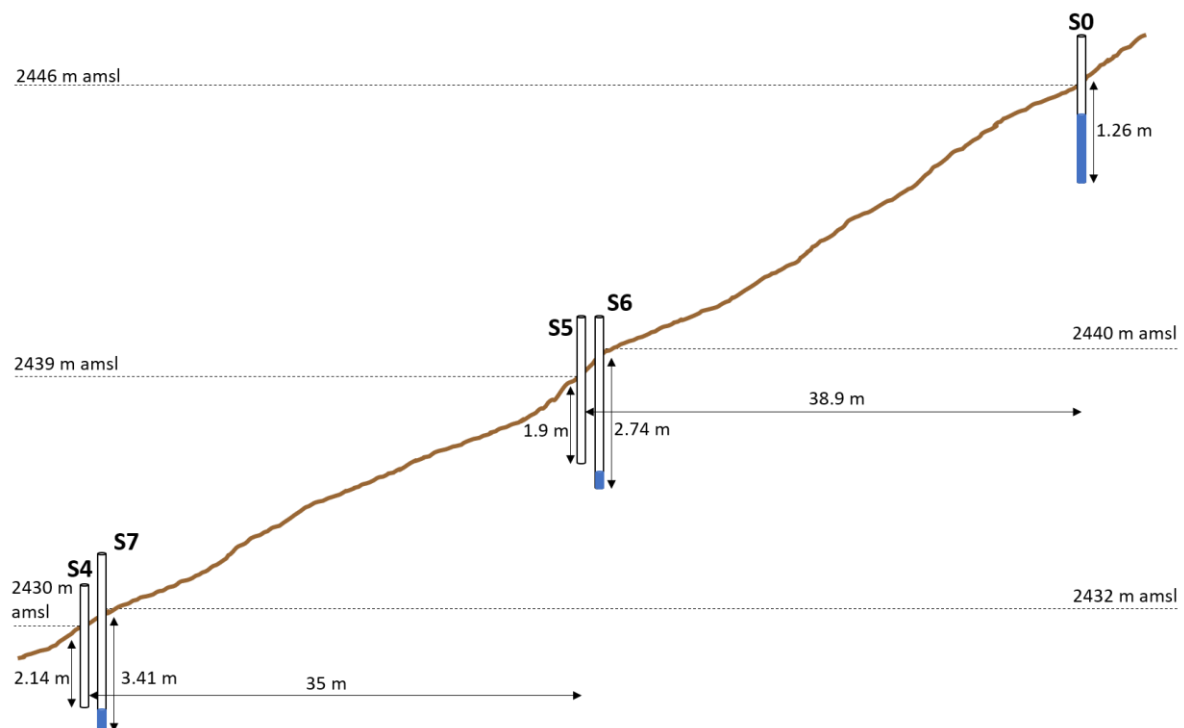
Figure B.2: Schematic of groundwater level in piezometers on stable slope S1. S6 and S7 are installed next to S5 and S4 resp. at a later date (and greater depth).

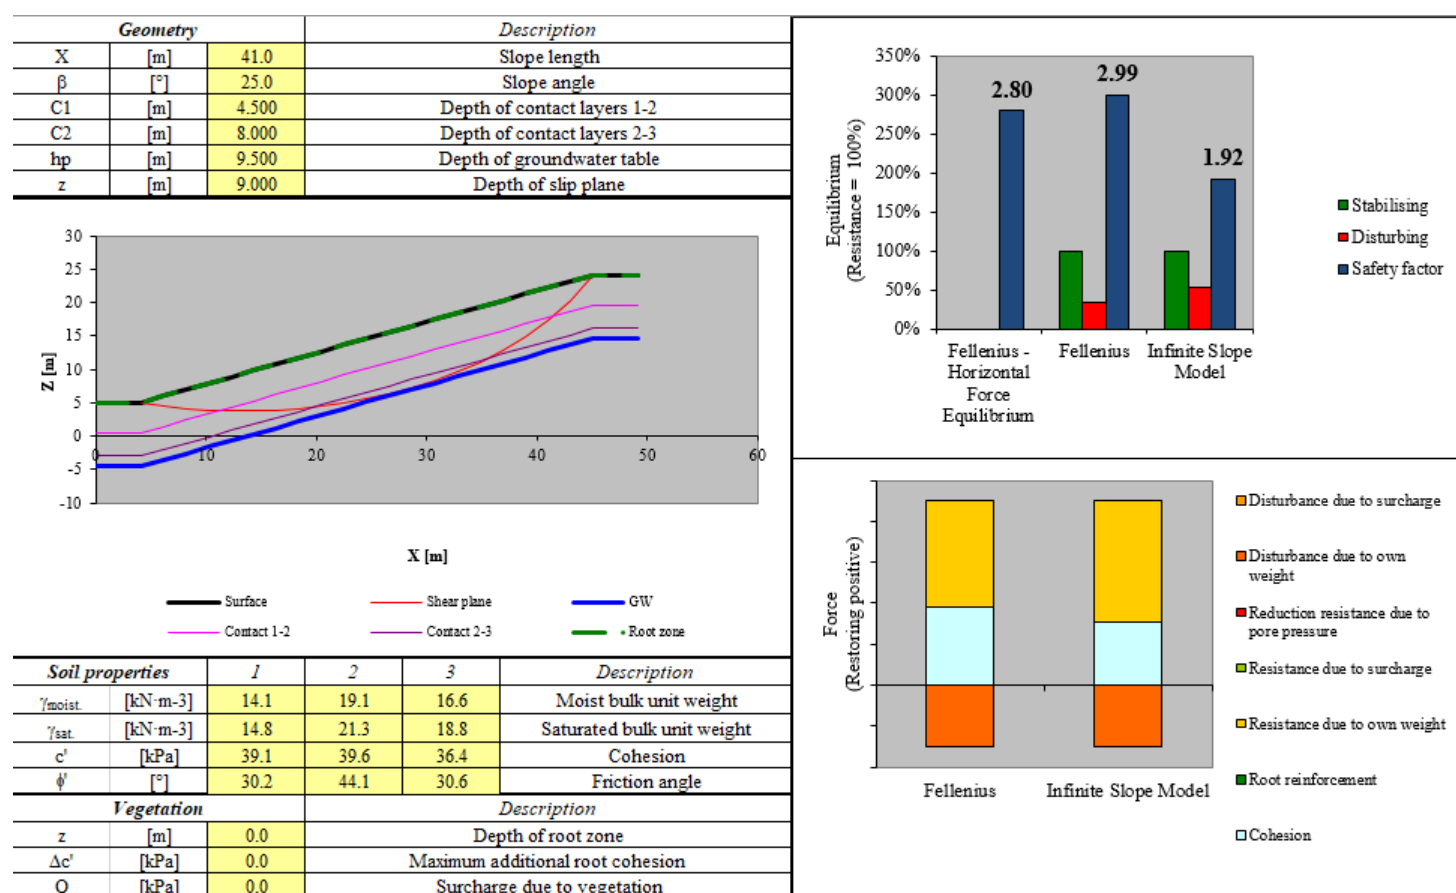
Figure C.1: Screenshot of a SLIP5EX run of landslide nr. 50, with C and  $\phi$  values from the direct shear results.

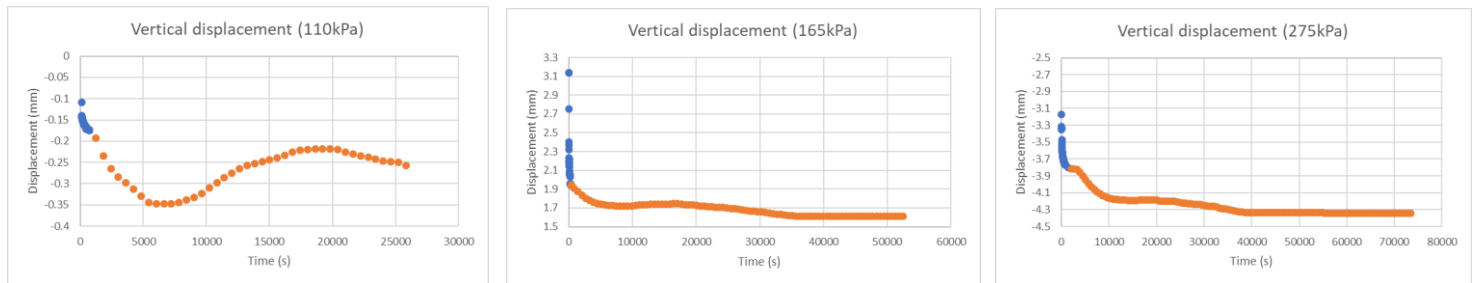
Figure I.1: Vertical displacements for the 3 tests of ML5. Blue is consolidation prior to shearing. Orange is vertical displacement during shearing.

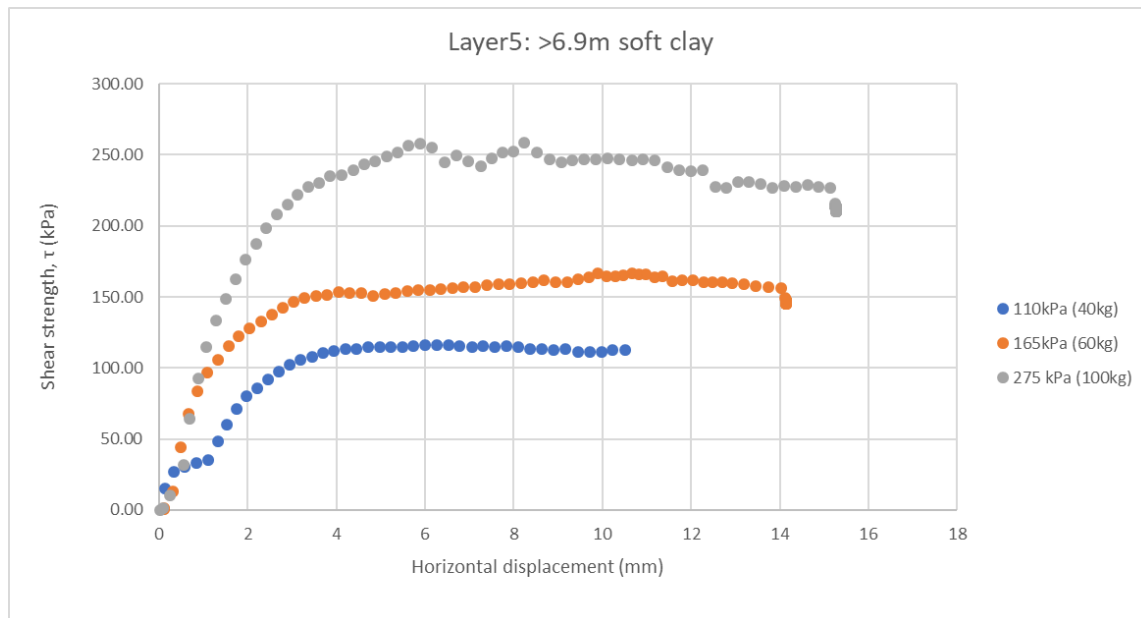
Figure I.2: Raw results of the 3 direct shear tests for different normal loads.

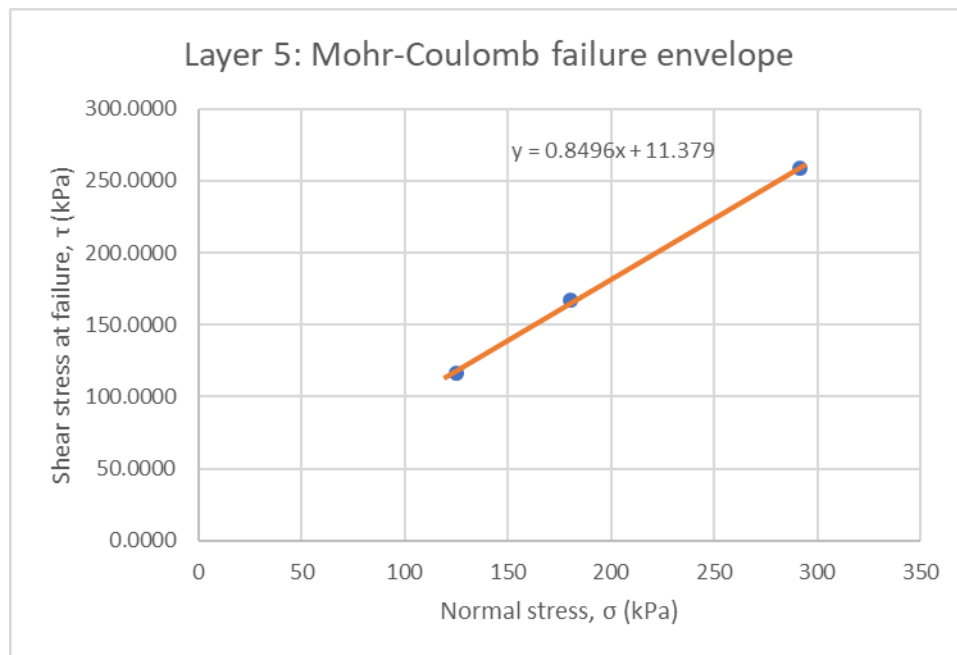
Figure I.3: Mohr-Coulomb failure envelope of the 5<sup>th</sup> layer of the moved slope. Y-intercept of best fit line is the cohesion. The slope of the best fit line is the angle of internal friction.

Finally, the results of the direct shear test can also be found in figures 5.3-5.5. A discussion of these results can be found in the next chapter, Back analysis of slope stability. An example of the direct shear results for the moved slope M can be found in Appendix I.
