# Optimization of Design and Monitoring of Immersed Tunnels

MASTER OF SCIENCE THESIS

For the degree of Master of Science in Geo-Engineering at Delft  
University of Technology

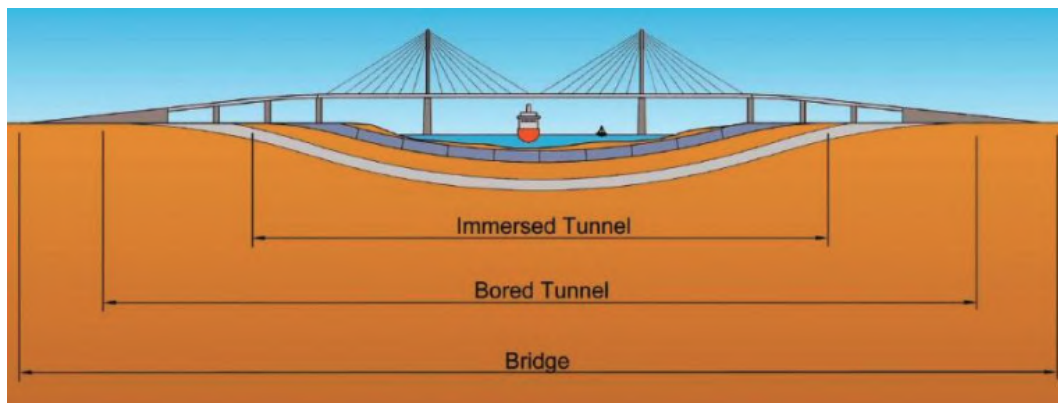
**Figure 1-1:** Layout of immersed tunnels (Van Montfort, 2018)

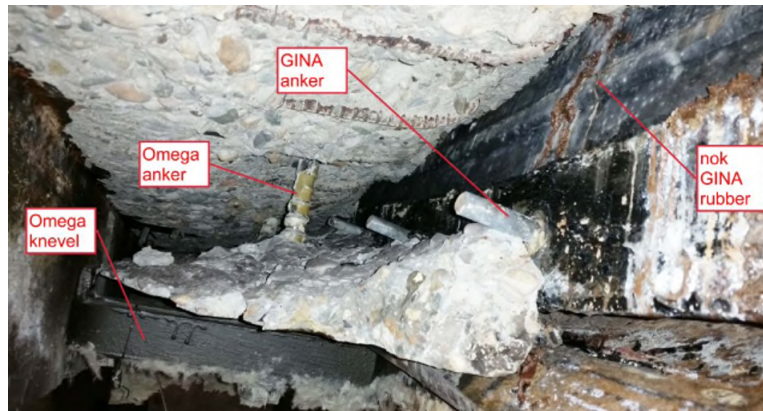
**Figure 2-2:** Damage picture in early 2015 showing damaged Gina gasket and Omega seal of Rotterdam Metro Tunnel (Molendijk et.al, 2019)

From various inspections it was noticed that the Gina gasket was damaged and locally shifted as the bolts of the Gina gasket had failed as shown in Figure 2-2. Molendijk et al. (2019) claimed that neither differential settlements nor hydrostatic pressure were high enough to cause the failure. Since the cofferdams were filled with sand after the tunnel elements were immersed the joints were filled with sand. Furthermore, the joint widths were found to vary between 90 -130 mm based on water depth and the hardness of the rubber. This was combined with a temperature-induced semi-annual joint movement of 5 -10 mm. Rahadian (2017) assumed that the failure had occurred due to a large surcharge load from the overlying sand in the immersion joints. Due to the joint gap's exposure to over 50 years of loading and unloading cycles arising from seasonal thermal expansion and contraction of tunnel elements, there was an increase in load stress. This, in turn, was hypothesised to further densify soil and increase soil stress. This reduced the mobility of the Gina gasket and forced it to shift inwards. Based on experimental and Plaxis FEM investigations conducted by Rahadian (2017) it was found that the gasket moved continually inwards as the soil density and stresses increased with time. The mechanism behind the inward movement is illustrated in Figure 2-3.

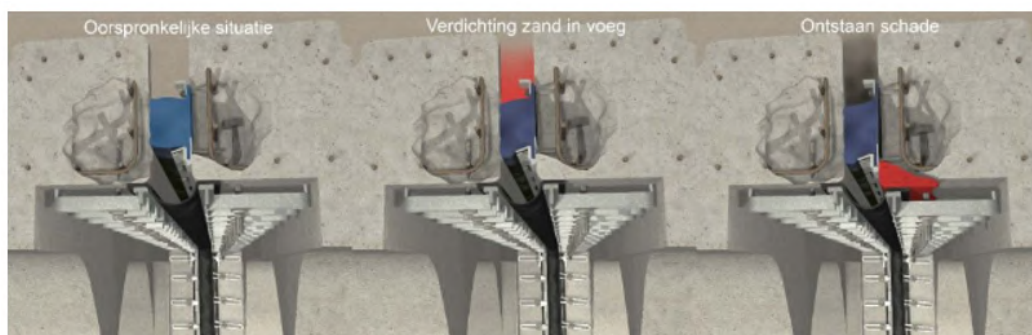
**Figure 2-3:** Joint movement (left), compaction of sand in joint (middle) and damage occurs (right) in Rotterdam Metro Tunnel (Molendijk et.al, 2019)

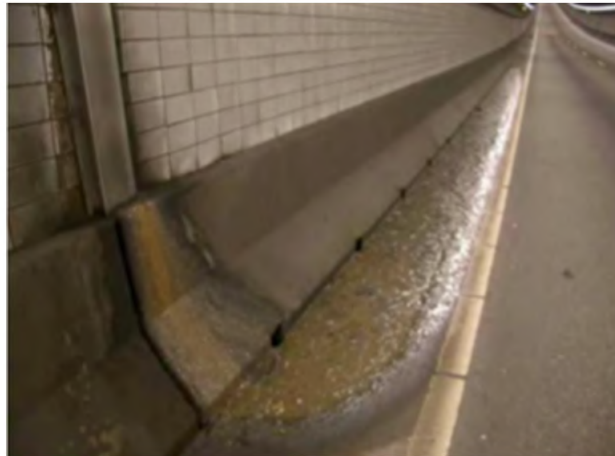
**Figure 2-5:** Sand and water leak in east tube of First Coen Tunnel (Leeuw, 2008)

- Joint gap opening/ closure:  
Based on the report 'Lekkage in Tunnels' by Leeuw (2008) joint gaps greater than 10 mm at certain points were noticed. This led to the tearing of the Omega seal. Cracks of 2 -3 mm were also formed on the Omega seal.
- Leakage at immersion joint:  
Two leakages of rates  $9 \text{ m}^3/\text{day}$  were observed at the immersion joints in 2010. This resulted in sand and water leak in the east tube as depicted in Figure 2-5. It was found to occur due to the presence of cracks in the concrete collar. A rectangular concrete

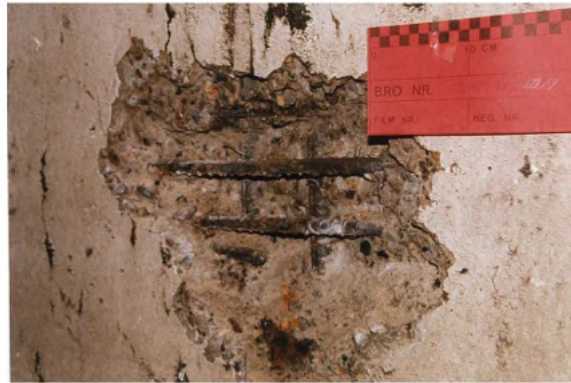
**Figure 2-10:** Reinforcement corrosion from inspection in 1988 (SEG, 2019)

The reinforcement was corroded due to prolonged exposure of the tunnel interior to salt water sprays from de-icing salts on the roads and leakage of water through the outer walls and top slab of the tunnel, see Figure 2-10. As a result, the expensive concrete repair was done after a period of 25-30 years. No significant corrosion of reinforcement had been observed in later inspections (SEG, 2019).

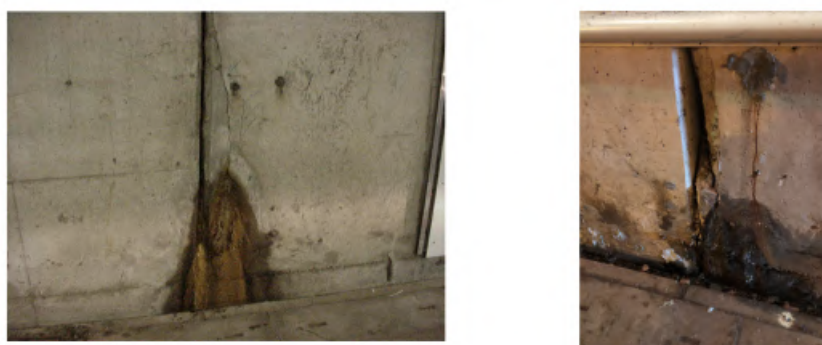
**Figure 2-15:** Leaky expansion joint with crack in concrete cover of Kil Tunnel identified in 2001 (left) and in December 2019 (right) (Yang, 2020)

expansion joints, a water inflow of 1.5 l/s and a sand quantity of approximately 10 l per week was observed. The presence of leakage at the expansion joints is illustrated in Figure 2-15. Yang (2020) demonstrated through FEM simulations that the leaks do not impact the settlement. However, the leaks changed the composition of the base layer which may affect settlements. Due to leakage inflow, there was greater water pressure at the periphery of the pancake which meant that more sand was washed away and a nearby clay layer might have flowed in. This foundation layer change was found to be a minor factor in settlement.

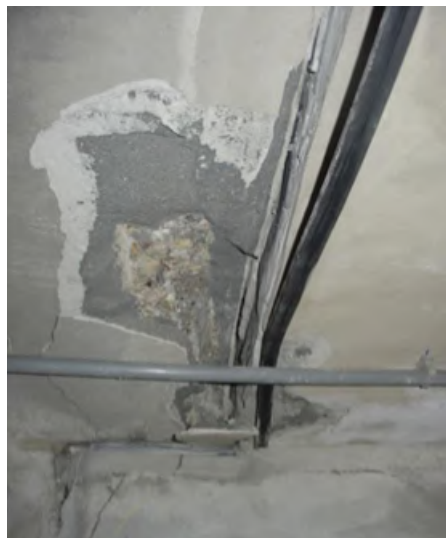
**Figure 2-29:** Delaminated concrete (Schols, 2012)

Furthermore, variation in joint widths across the joints can result in joint rotations. These rotations put added pressure on the joints as shown previously in Figure 2-26. Depending on the type of joint rotations, the edges of joints come under pressure as the floor or roof elongates. For small joint rotations, no problem arises. However, there is a high-stress concentration on the bearing surface of the joint surface which becomes bigger when it is combined with differential settlements. According to Sinha (2017), when the horizontal displacements are greater than 10 mm the joint gap undergoes significant opening. As a result, a high line load develops on the concrete collar and cracking takes place. Moreover, the concrete might peel off, see Figure 2-29 (Schols, 2012).

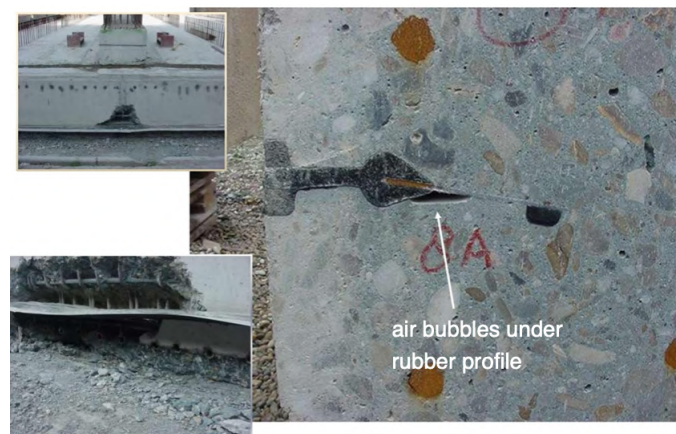
**Figure 2-35:** Lack of workmanship during concreting (Leeuw, 2013)

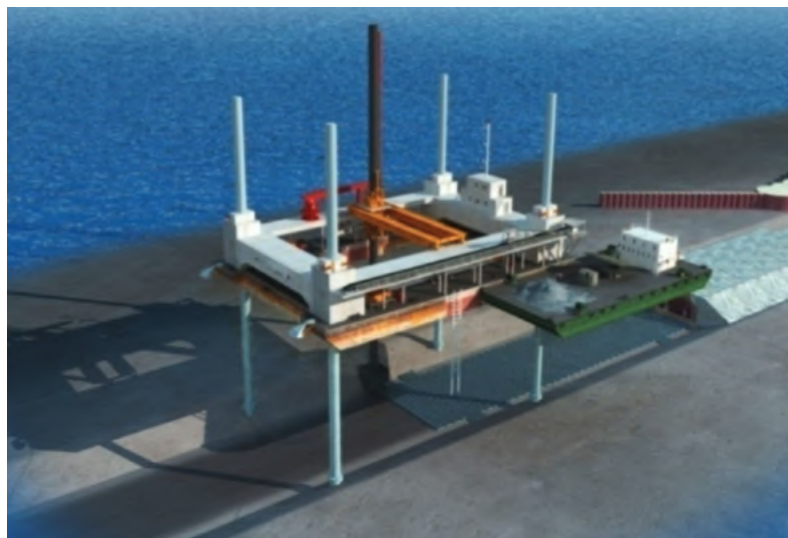
**Figure 3-11:** Construction of gravel bed (Wang et al, 2020)

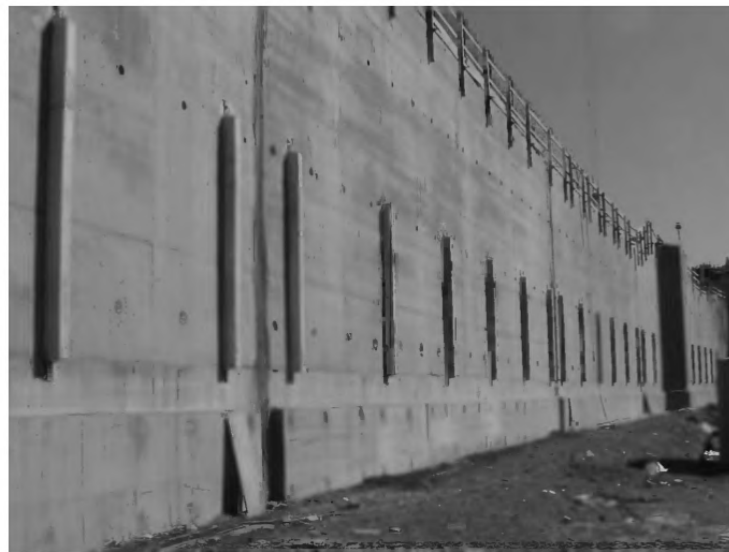
**Figure 3-16:** Arrangement of anodes on the exterior of Bjørvika Tunnel (Lunniss and Baber, 2013)

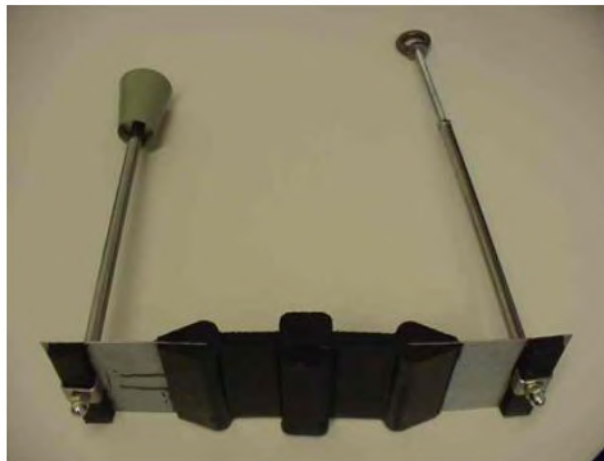
**Figure 3-23:** W9U-i profile (Leeuw, 2008)

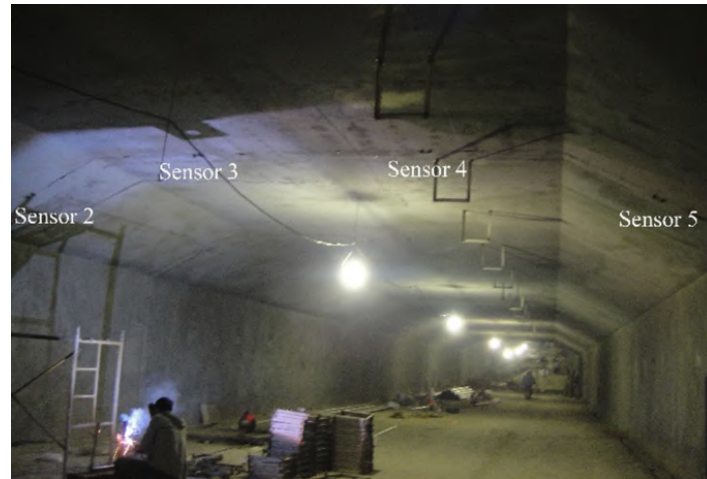
**Figure 4-5:** Field installation of FBG sensors (Wei et al., 2018)

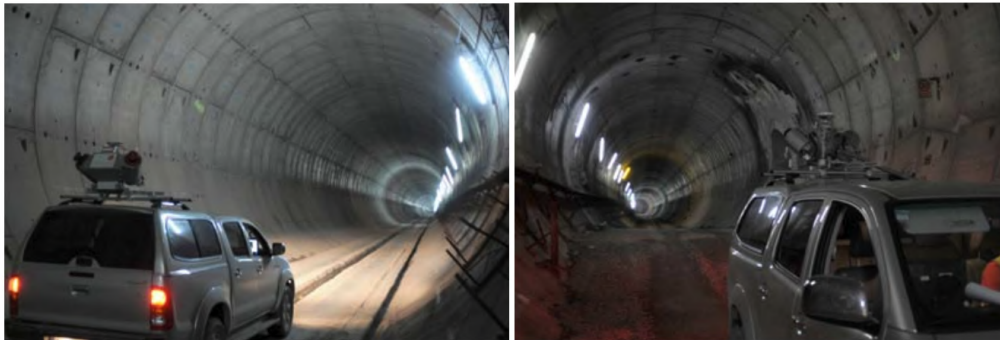
**Figure 4-16:** Laser scanner mounted on a van (Bovaida et al, 2012)

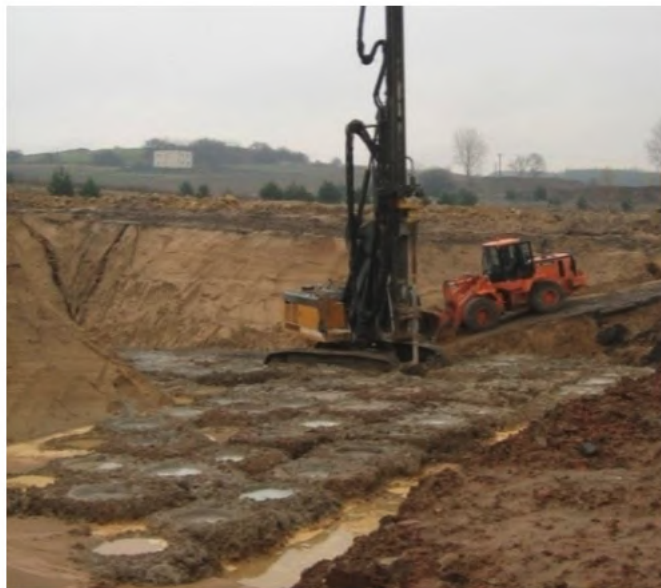
**Figure 5-2:** Methodology of soil mixing (Topolnicki, 2016)
