## Condition assessment of reinforced and prestressed concrete bridges using visual inspection and 3D modeling

This study explores UAV-based 3D modeling for bridge damage assessment. UAVs with high-resolution cameras captured images of two bridges at different life cycle stages and locations. These images were processed into detailed 3D models, offering more accurate evaluations than traditional visual inspections (VI). The models provided precise damage localization, geometric data information, and identified areas requiring urgent maintenance, reducing repair costs and time. Despite the advantages, challenges such as model accuracy and flight planning precision were noted. The results showed that larger and more complex bridges require significantly greater resources for 3D modeling, including longer flight and processing times, higher data volumes, and increased detail in the models, as reflected in the differences between the two case studies. Future research should focus on optimizing data acquisition, enhancing algorithms, and integrating augmented reality (AR) to improve collaboration and decision-making in bridge inspections.

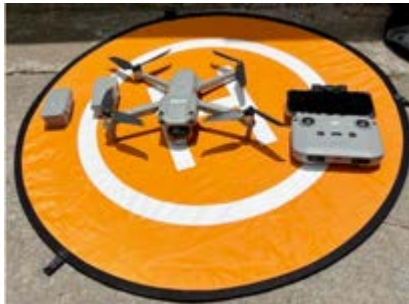
Figure 1. Example of a UAV used for VIs [17]

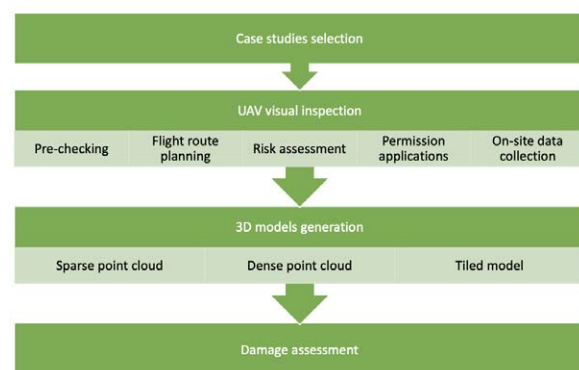
Figure 2. Methodology

The methodology used in this research is illustrated in Figure 2. First, two bridges were selected for this study. They represent different stages of their life cycle, are located in distinct geographical areas, and vary in their geometric characteristics. The first bridge, a reinforced concrete girder bridge, built in 1980, is located over the Tambura ravine on the old Ilumán-San Antonio highway in the Imbabura Province, Ecuador, with a length of 34.3 meters in three spans (Figure 3).

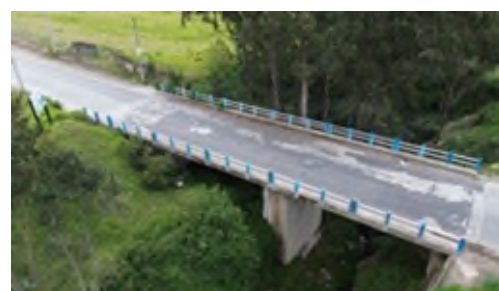
Figure 3. Bridge from Case Study 1

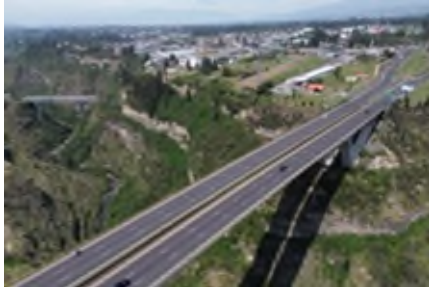
Figure 4. Bridge from Case Study 2

The second bridge, a post-tensioned box girder bridge built in 2014 using the balanced cantilever method, is located in the Ruta Viva highway, which provides access to Mariscal Sucre Airport in the capital city of Quito, Ecuador, and has a length of 315 meters (Figure 4).

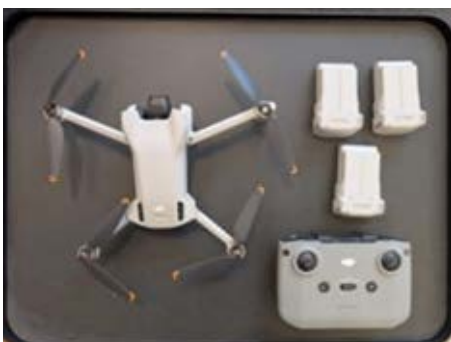
Figure 5. UAV used for the inspection

To conduct an effective and thorough bridge inspection, several key aspects were considered. The DJI Mini 3 [21] was selected as the drone to be

used in the inspection (see Figure 5). A flight time of a minimum 25 minutes was essential to ensure uninterrupted inspection sessions, and two additional batteries were required. The drone's high-resolution camera allowed for the capture of detailed images in low-light conditions, which are commonly found under bridge decks [22]. Moreover, the drone was capable of recording high-quality video for video-based inspections when needed. The locations of the bridges required the use of a drone equipped with a long-range remote-control system to access areas that were otherwise inaccessible.

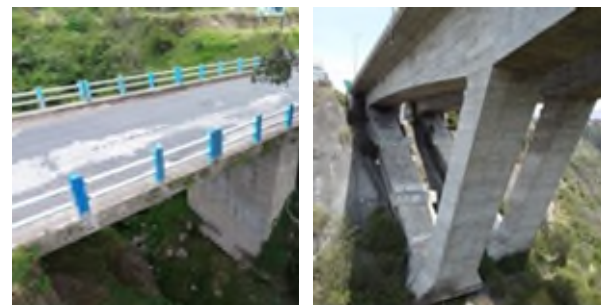
Figure 6. Sample images captured using the UAV on case study bridge 1 (left) and 2 (right)

rely on empirical observations. However, some studies recommend an endlap of  $60\% \pm 5\%$  and a sidelap of  $30\% \pm 15\%$ , or a minimum of 50% overlap [23]. In the UAV inspections conducted, a 70% overlap was used in all directions. Finally, the distance between the UAV and the bridges was influenced by factors including the camera field of view, sensor resolution, and the safety of the equipment [13]. Figure 6 shows a sample of the images obtained from the inspection.

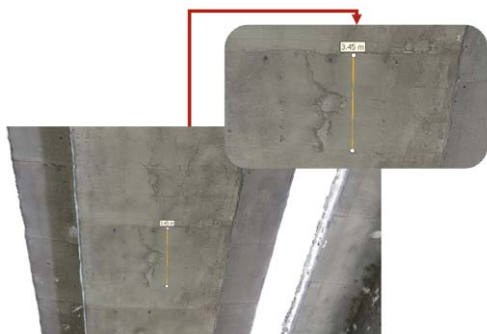
Figure 9. Damage measurements of Case Study 2

Through these models, several structural defects were identified and measured, including concrete spalling (see Figure 8), as well as the size of holes and exposed reinforcement on the piers of Case Study 1 (see Figure 9). This approach enabled precise measurements, allowing for a more detailed evaluation compared to traditional visual inspections (VI). However, while the lengths of cracks could be measured and crack maps could potentially be developed, crack widths could not be determined, representing a limitation. It is recommended to use complementary non-destructive testing (NDT) methods to address this issue or incorporate modern segmentation models for crack image analysis [24].
