### An Integrated Approach for the Estimation of Structural Performance and Residual Service Life

Gard, Wolfgang; Ravenshorst, Geert; van de Kuilen, Jan Willem

# Historical Wooden Pile Foundations in Amsterdam: An Integrated Approach for the Estimation of Structural Performance and Residual Service Life

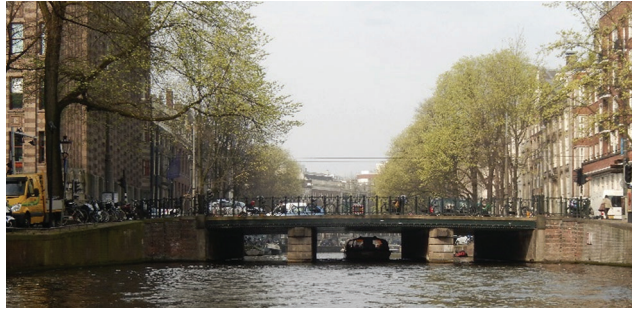
**Fig. 1.** Bridge on wooden pile foundation in Amsterdam/Netherlands

Timber as a structural material may be found in many buildings and structures around Europe, with a current age of sometimes more than 500 years. Already in the Roman era the foundations were made with timber, both in form of horizontal beams under brick walls and as vertical piles for deeper foundations. Timber can be found in foundations of famous heritage buildings such as the Royal Palace in Amsterdam, the Netherlands and bridges (Fig. 1). Timber foundations are in these cases true foundations of cultural

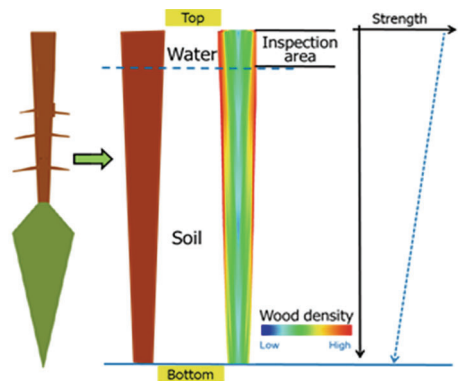
**Fig. 2.** Sketch of a sound tree stem as foundation pile upside down; possible density development along the length of the pile (colored picture); possible strength development along the length; accessible inspection zone at the top of the piles.

14 m in length. The piles are normally tapered. The wood species is mainly spruce (*Picea abies* (L.) H. Karst). In total, 60 complete piles were retrieved from different locations. The piles under the bridges are below the water table, surrounded approximately by 1.5 m of free water before entering the saturated soil (more than 85% of the pile) where the pile is not accessible for inspection. The physical and mechanical properties of the pile such as density and compression strength vary along the height and the cross-section, because of the natural variability of the stem of the tree (Fig. 2). In a sound foundation pile, higher mechanical/physical properties can be expected at the top (bottom of the tree) and lower properties at the bottom of the pile [1]. This is because of the natural growth of a tree. The foundation piles are placed in the soil by turning the tree stem upside down (Fig. 2).

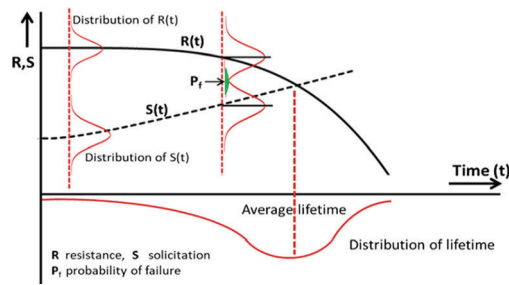
**Fig. 4.** Lifetime distribution of structures

Basically, strength and loads have to be far enough away from each other in order to avoid structural failures during the lifetime of the structure (Fig. 4). If the strength and loads are modelled as standard normal distributions, then Fig. 5 gives insight in the probability of failure. The greater the overlap between the two curves, the higher the probability of failure.

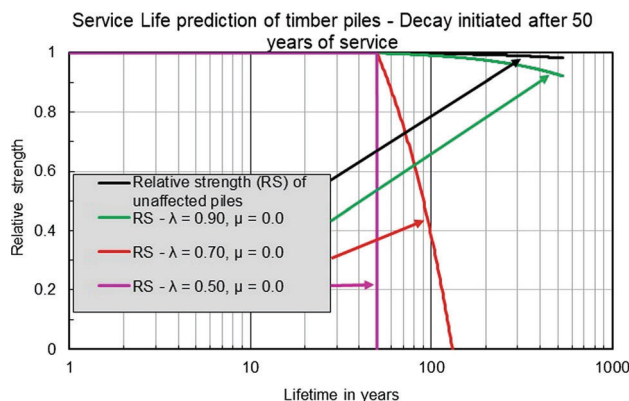
**Fig. 5.** Lifetime prediction of timber piles. Scenario: Biological decay initiated after 50 years, decayed wood has 0% strength of non-decayed wood, Cross section reduced by 10% (green line), 30% (red line) and 50% (pink line) [8]

In Fig. 5 an example is given for Service life calculation taking in consideration dead load, assumed live loads and biological decay with associated decay rates [8]. It can be clearly observed that the residual carrying capacity decreases over time while the accumulated damage increases (relative strength reduces).

In this example, it is assumed that the remaining strength of decayed wood is zero, which is a safe approximation, so  $\mu = 0$ . However, if that would not be the case, then the value of  $\mu$  can be easily adapted in the model, and the remaining service life will automatically increase. By the way the model is formulated (Eq. 2), the stress on the remaining sound cross section will automatically increase when the decay progresses, so for each period  $\Delta t$ , the damage increase  $\Delta\alpha$  will increase a bit more as the stress ratio  $\sigma(t)/f(t)$  increases with the ageing process, see Fig. 6. From the analysis it follows that if half of the original cross section is degraded at  $t = 50$  years, the residual lifetime drops to 0 almost instantly, but if it is reduced by 30% (so 70% remaining), the residual lifetime is still considerable with almost 100 years before structural failure. This shows that time to failure processes are really sensible for the load level on the one hand, directly influencing the remaining service life. These processes are logarithmic on the time-scale. For foundations the main load component is dead load. Variable loads from traffic are also present, but over the history of 100–300 years are less relevant. More important is to get an accurate estimate of the constant dead load over the pile's history. In that case the damage Eq. (2) is more straightforward to solve regarding the applied load. The failure process is then governed for long term static loading, without having the complexities of random variable loading. The assessment of parameters affecting the load bearing capacity is however, complex. Measurable assessment parameters are very limited, since only a very small 'window', approx. 10% of the whole pile at the top, is available for the assessment, and from this assessment, an estimate for the entire pile must be made.

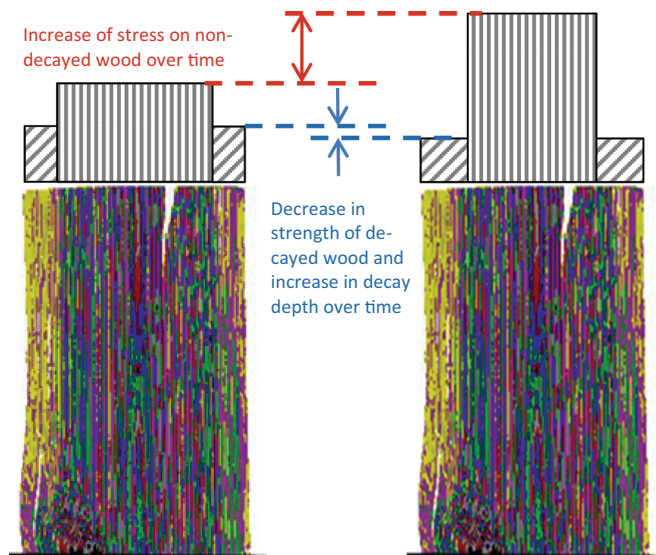
**Fig. 6.** Effect of stress redistribution over the pile cross section as a result of increasing decay, CT scan of a decayed pile section in longitudinal direction, low density: yellow, high density: blue)

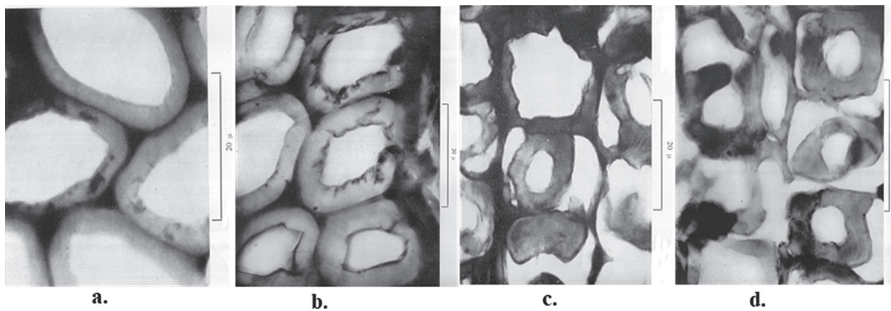
**Fig. 7.** a. Onset of bacterial decay in the cell wall, b. S3 layer decayed and S2 layer affected, c. Cell wall collapse visible, d. Cells completely decayed and collapsed [11].

The investigated foundation piles were 100 to 300 years in service under the bridges. The piles are subject to an aging process over time, which has both biological and mechanical causes. From our research, it appears that biological deterioration is mainly caused by bacteria and barely by soft rot fungi. As far is known to the authors, deterioration of wooden foundation piles under water by bacteria was indicated for the first time about 90 years ago by Varossieau in old foundations in Rotterdam, the Netherlands [11]. The severity and the development stages of the decay are shown in Fig. 7.

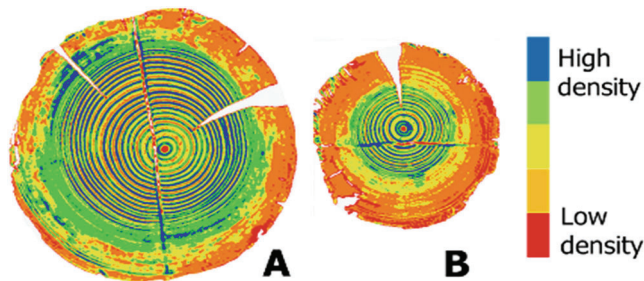
**Fig. 8.** CT scan of a pile cross-section at the top (A) and bottom (B) of the pile. Low density (orange) at the outer circumference indicates decay, green color at the inside means high density.

The decay by bacteria propagates over time from the outside (high concentration of bacteria) to the inside of the pile (Fig. 8). In general, sapwood is the part of the stem cross-section with the least resistance to microorganisms [12]. Highly decayed parts have a low density and less decayed vice versa (Fig. 4). From the CT (computer tomography) scans in Fig. 4 it can be observed that the decay is not equally distributed along the height of the pile. In the cross-section at the top of the pile (large diameter) the width of the decayed ring is smaller than at the bottom (small diameter). It can be assumed that the decayed area over the cross-section is mostly sapwood. The decay rate is often expressed in term of loss of mass per time. However, loss of mass is different from loss of strength.

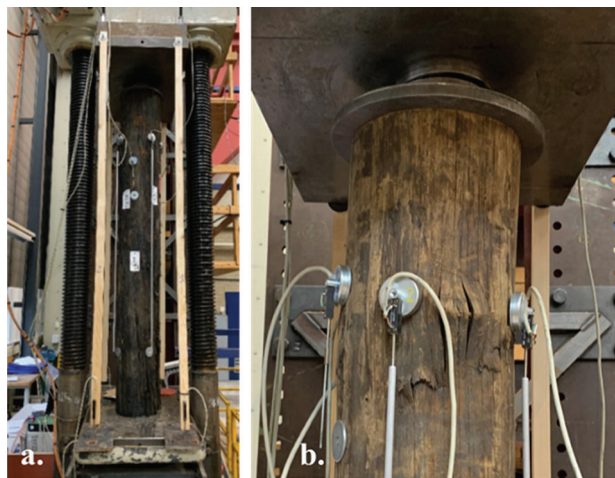
**Fig. 9.** a. Set-up for compression tests, b. LVDTs are mounted around knots.

Before testing, the piles are submerged to reach the wet condition for the compression test, which means a moisture content higher than 70%. Figure 9 shows the compression test set-up with pile sections up to 1800 mm length. LVDT sensors are placed between the plate heads and on the piles themselves to determine the static modulus of elasticity. In order to obtain both global and local strength and stiffness information, LVDT measurement devices are placed over the length of the section, over the section with the largest knots (location of whorls) or the section that is expected to fail in compression first. Because of eccentricities of knots in the cross section, failure may concentrate on one side of the pile only. Apart from compression wrinkles, longitudinal cracks also develop at later stages.

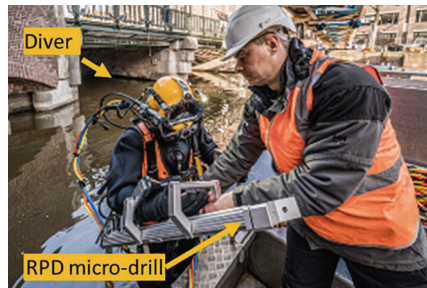
**Fig. 10.** RPD deployment underwater by a diver.

One of a few semi-non-destructive and in-situ methods that is available for wood inspection is micro-drilling, such as IML-RESI PD. An IML-Resi for underwater use (hereinafter RPD), is currently developed and in a trial stage on timber foundation piles under bridges and quay walls in Amsterdam/Netherlands (Fig. 10.). In [14] an extensive analysis of microdrilling resistance and some of the pros and cons of the technology

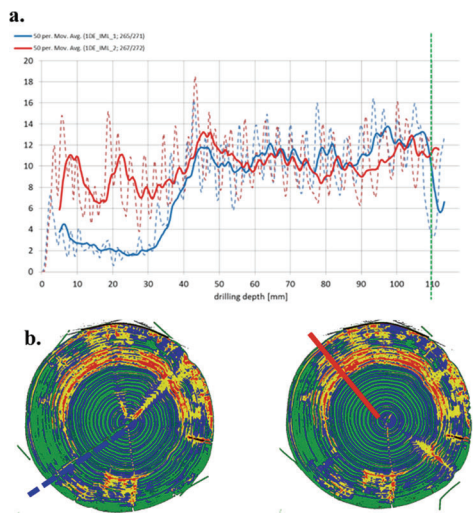
**Fig. 12.** a. microdrill measurements over half of the cross-section of the pile at 2 different spots of the circumference, b. CT scans of the cross-section confirming the density map (high density: red, low density: green).

The spectrum of the microdrilling measurements along half of the cross-section of the piles show annual ring profiles, with maximum amplitudes marking latewood and minimum amplitudes pointing towards earlywood (Fig. 12). There are also extreme maximums and minimums. Those with higher values can be associated with the knots and other high-density anatomical variations, and lower value extremes pointing towards piths and cracks. Figure 12 shows a not evenly decayed cross-section of a pile where 2 microdrillings were applied at different locations. The blue line (drilling amplitude) in Fig. 12. a. shows a considerable low density area at the outer layer of pile which is recognised as decay, in comparison to the red line shows a higher density which is recognised as less decayed. Both lines are confirmed by CT scans of the cross-section where high and low density areas can be identified. The blue and green colour indicates lower densities. Lower density areas towards to the pith of the pile indicates the juvenile wood and not decayed by bacteria.

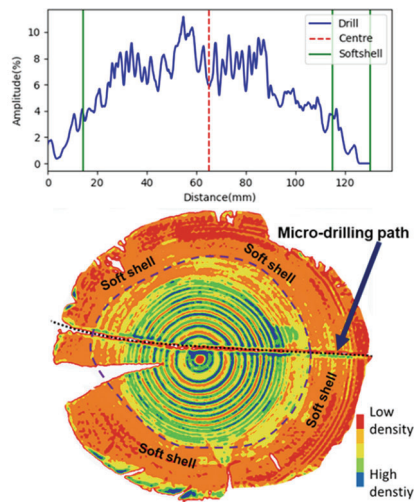
**Fig. 13.** Microdrill measurement along the whole diameter of the pile with a severe decay (soft shell) at both sides: left and right, blue line in the graph is the drilling amplitude.

The degree of decay is defined by the relative density differences compared to sound wood, which can be assumed in the centre part of the pile cross-section. For very severe decay areas the term ‘soft shell’ has been introduced. In Fig. 13. a microdrilling is carried out along the whole diameter of the pile. A ‘soft shell’ of around 18 mm is indicated from the outside towards the centre of the pile. Also here, the area of the juvenile wood can be identified.

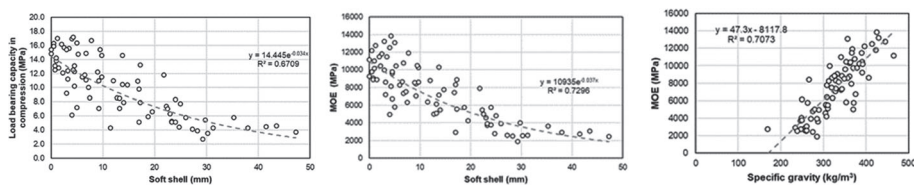
**Fig. 14.** Correlation between soft shell width and load carrying capacity in compression (left graphic) and the MOE (middle graphic) and the correlation between specific gravity and MOE (right graphic).

Even if the inspection area at the pile top in-situ is very restricted, with the ‘new’ development of the RPD for under water use, relevant information about the state of the piles can be obtained. With these data a ‘pile model’ has been developed to determine the state of the wood along the whole pile length with regard to the decay, sapwood, juvenile wood, density and pile shape (taper). The ‘soft shell’, identified through micro-drilling at the top of the piles, can have a considerable influence on the remaining load carrying capacity and the average modulus of elasticity (MOE) of the pile cross section as shown Fig. 13. Also, the overall specific gravity shows a high correlation with the MOE ( $R^2 = 0.70$ ) (Fig. 14).
