## Full-size field test of prestressed concrete T-beam bridge

Structural Faults & Repair 2018 and European Bridge Conference 2018

# FULL-SIZE FIELD TEST OF PRESTRESSED CONCRETE T-BEAM BRIDGE

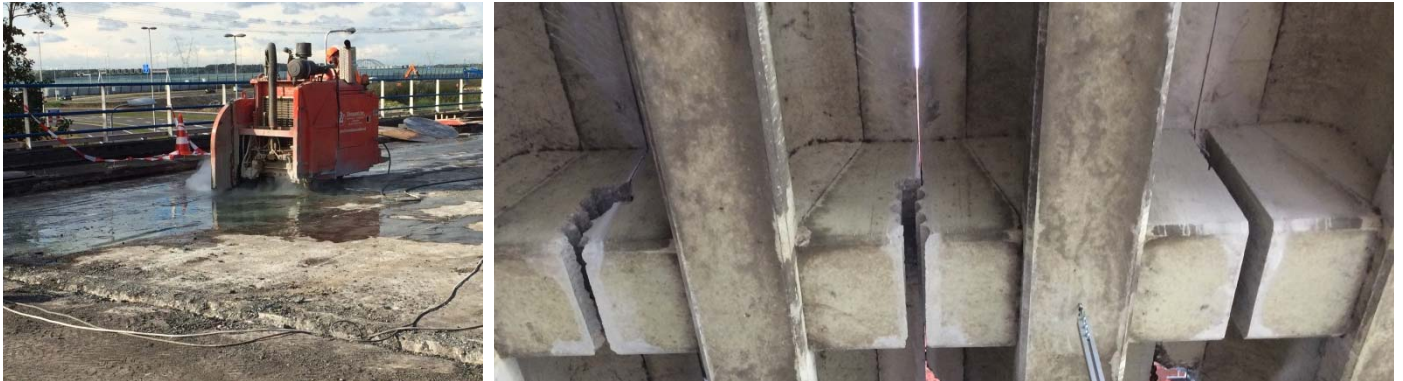
Figure 4 Sawing through the cast-in-between slab (left), sawing and drilling through the cross-beams (right).

In total seven experiments were carried out. The numbering of the experiments can be found in Figure 1 and Table 1. The numbering of the beams is shown in Figure 2. Prior to the experiments, the asphalt was first removed by an asphalt ripper in such a way as to minimize damage to the concrete deck. In span 2, the cast-in-between deck was sawn in longitudinal direction, so that the individual behaviour of the beams could be tested. Additionally, three of the four cross-beams, with the exception of the end cross-beam opposite to the load location, are sawn, see Figure 4. This was done as to prevent uncontrolled rotation during the single beams tests.

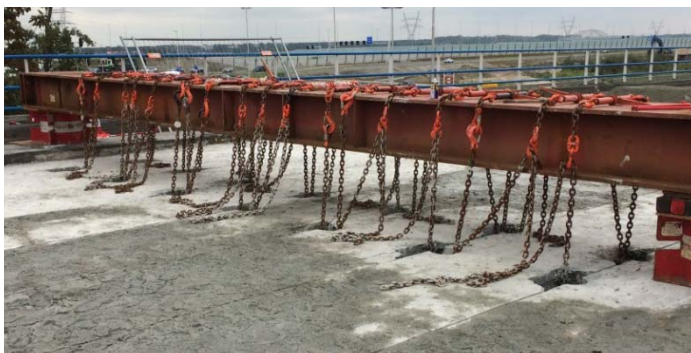
Figure 6 Safety system for single beam tests (steel chains), top side (left), bottom side (right).

For the individual beams in span 2 a safety system was put in place to prevent a complete collapse of a beam. This was achieved by steel chains around the beams for which holes were drilled through the deck. The chains are anchored in place by a steel beam placed in transverse direction, so that the tested beam would be caught by the chains in the event of a complete collapse of the beam, see Figure 6.

Halfway during test 4 and 5 as well as during test 7, unloading was necessary to be able to adjust the safety chains as shown in Figure 6, in order to accommodate the observed deformations of the beam. The shear failure itself can be seen in Figures 17 and 18. In test 7 the beam almost completely separated into two parts being kept together only by the prestressing tendons.

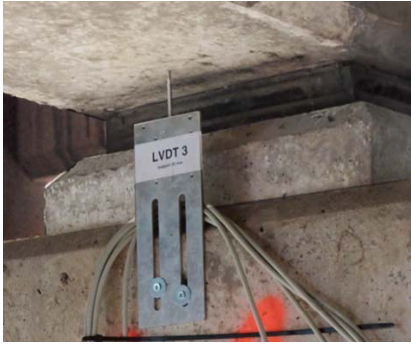
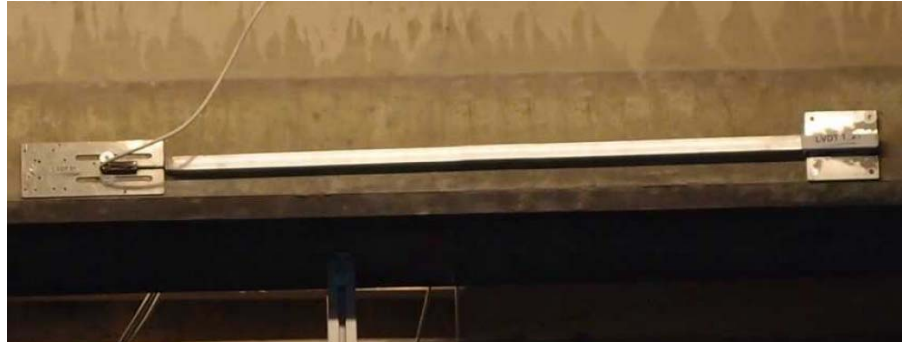
Figure 7 Vertical LVDT at support (left), horizontal LVDT at bottom flange beam (right)

The measurements that were applied during the experiments determined the applied force at the jack, the vertical deformations of the loaded beam, the adjacent beams as well as the elastomeric bearings at the supports, and the longitudinal strain at the bottom flange of the beam, see also Figure 7. The force was measured with a load cell, and all displacements were measured with LVDTs. The longitudinal strain under the point load was measured by applying an LVDT horizontally over 1 m. Therefore, it could be observed during the experiment when the cracking moment of the tested beam was reached, see Figure 7 (right). Additionally, on both sides of the tested beam camera's were placed to continuously take photos and record video. Finally, a radar interferometry system was used during the first two experiments, to evaluate if in future field tests, the contact measurements can be replaced by non-contact measurements. For more details about the measurement the reader is referred to (Koekkoek 2017).

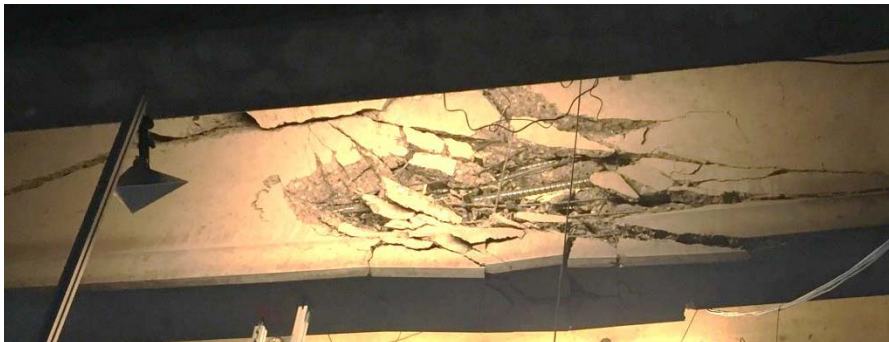
Figure 8 Shear failure beam test 1

In span 4, three experiments were carried out in order to investigate the behaviour of the beams within the structural system. Therefore, a single point load of 400 x 400 mm was placed directly on the T-beam. The test setup for test 1 is also shown in Figure 5. Both test 1 and 2 resulted in a shear failure of the loaded beam, see Figures 8 and 10. However, in both cases the shear failure of the beam is preceded by a punching failure of the loading plate through the top flange of the beam and the slab, see Figure 9. Of course, at the instant the punching failure occurs the load distribution to the adjacent beams is largely lost and the loaded beam suddenly receives the full loading resulting in an immediate shear failure. The punching failure was somewhat unexpected and could have been prevented by using a larger loading plate or multiple point loads.

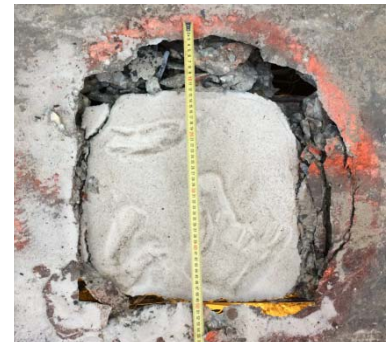
Figure 9 Punching failure deck test 1

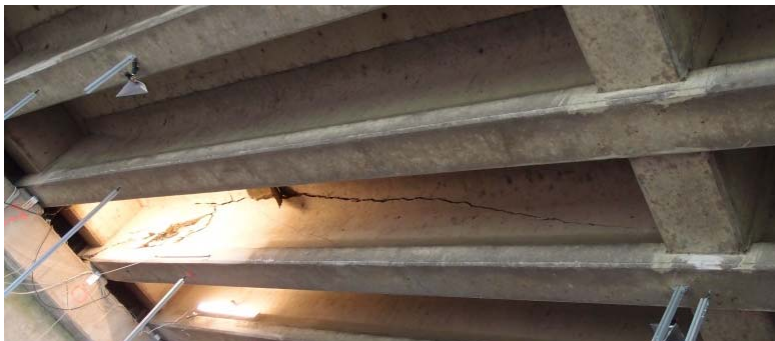
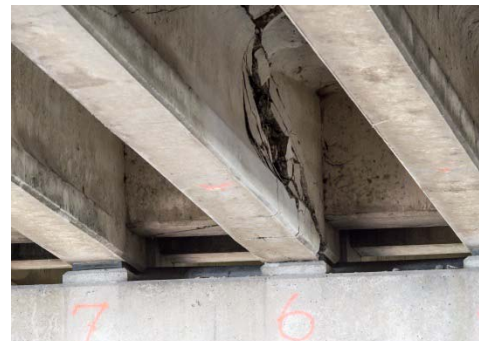
Figure 10 Shear failure beam test 2

The load-displacement graphs for tests 1 and 2 are shown in Figures 11 and 12. In these tests the displacement of the adjacent beams, at the same distance from the support, was also measured. It was observed that, in both tests 1 and 2 a large shear crack occurred from the loading position in the opposite

direction towards the first intermediate cross-beam, see Figure 10 (left). Especially for test 2 this was somewhat unexpected since the distance from the load to the support was 2250 mm, whereas the distance from the load to the intermediate cross beam was 5750 mm. As shown in Figure 11 and 12, for test 1 and 2 the failure loads are 3004 kN and 3444 kN respectively. However, it can be argued that the ultimate failure load in both tests would have been higher if the punching failure could have been prevented. Also the load was applied as a single point load whereas normally the live load would consist of a number of axel loads as well as distributed loads.

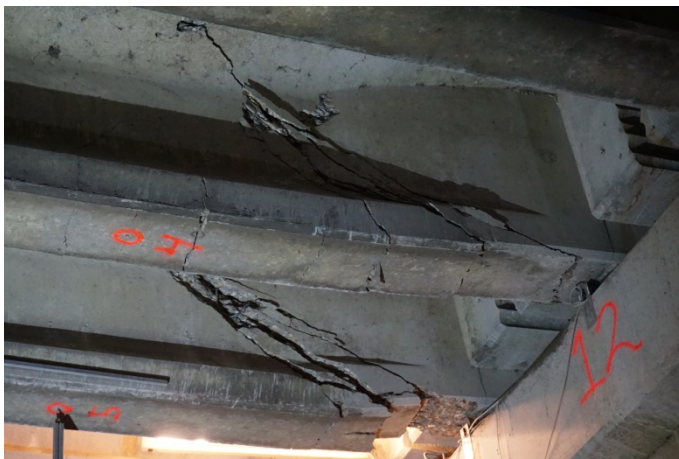
Figure 17 Shear failure beam test 4 and 5

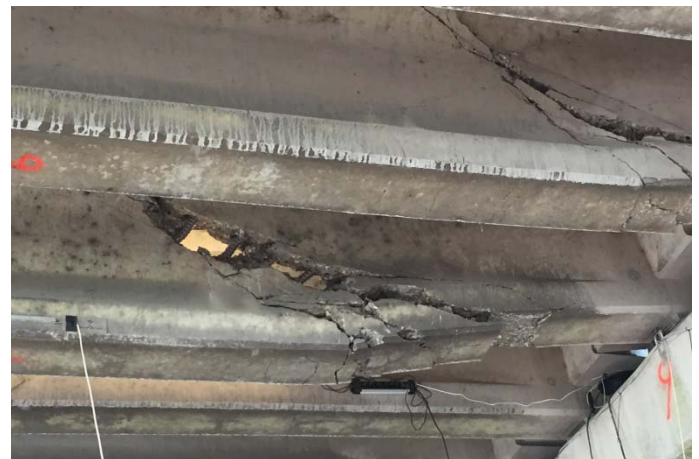
Figure 18 Shear failure beam test 6 and 7
