**Debris-flow hazard assessment at the archaeological UNESCO world heritage site of villa romana del casale (sicily, Italy)**

International Journal of Disaster Risk Reduction

# Debris-flow hazard assessment at the archaeological UNESCO world heritage site of Villa Romana del Casale (Sicily, Italy)

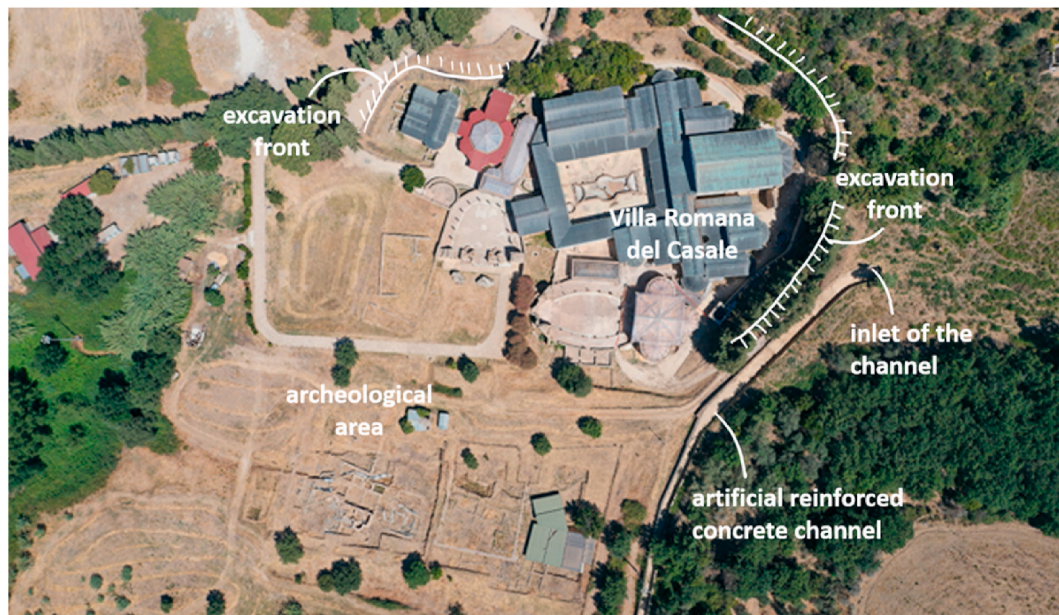
Fig. 2. Aerial image of the archaeological site of the Villa Romana del Casale taken during one UAV survey.

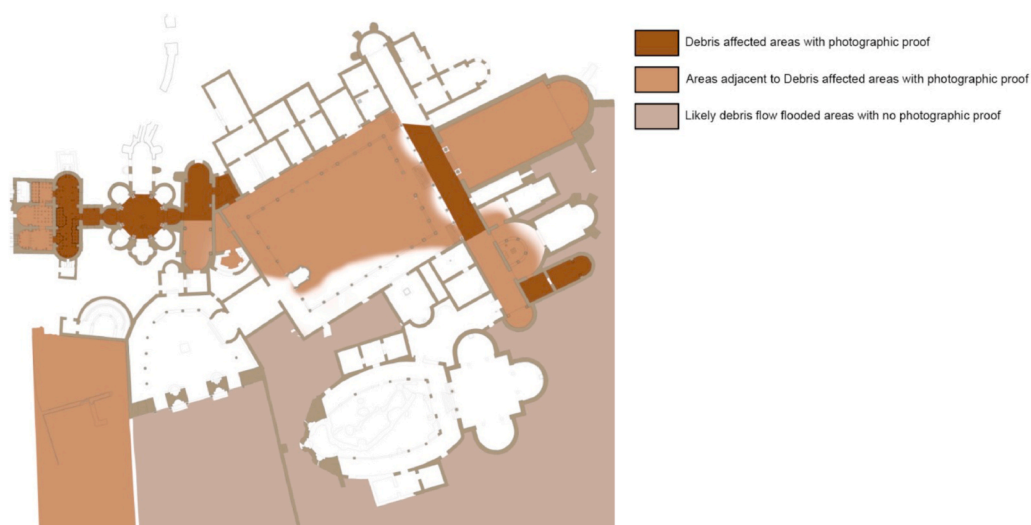
**Fig. 7.** Map of areas flooded in 1991. In dark brown areas with debris on the mosaics recorded through photos; in mid brown adjacent areas, which very likely have been invaded by debris, even if there are no photographs; in light brown areas likely invaded by debris, because of their geomorphological features.

affected for half of its extension, mosaics covered by debris. Major damages were: the detachment of mosaic tiles and fracture of decorations. Pictures in Fig. 6 show how areas at lower levels are easily flooded and are affected by high residence time, which increases damages to fragile decorative features, like mosaics and frescos, due to the prolonged exposure period to water or wet materials contact. Examining the photographs taken in 1991 after the debris flow event, it has been possible to deduce the areas that were hit and flooded by the flow, as shown in Fig. 7.

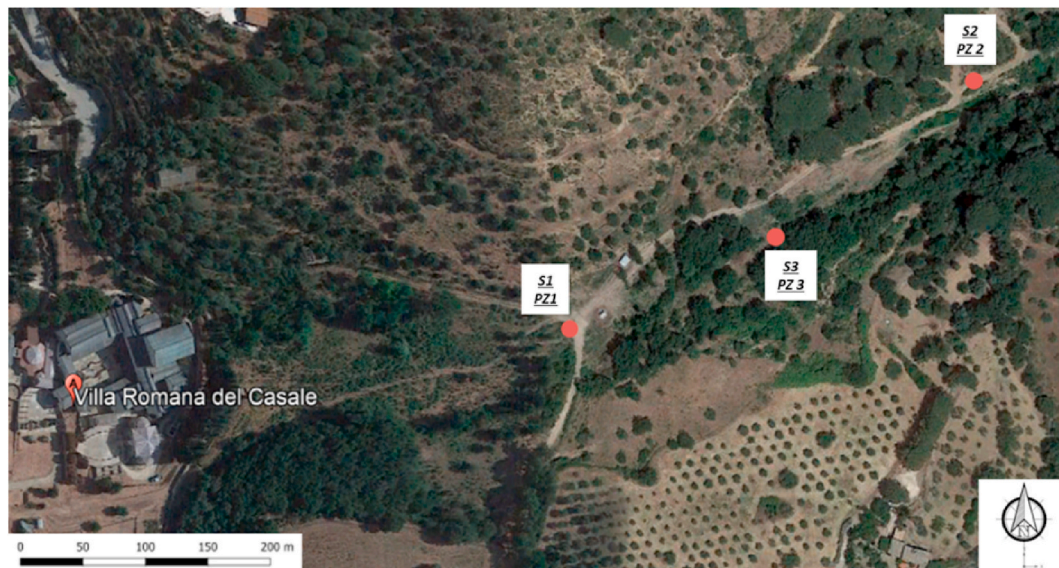
Fig. 19. Location of the three boreholes realized within the basin of the Villa Romana del Casale.
