Colour alterations of historic concrete surfaces during the Dutch Interwar Period

Case Studies in Construction Materials

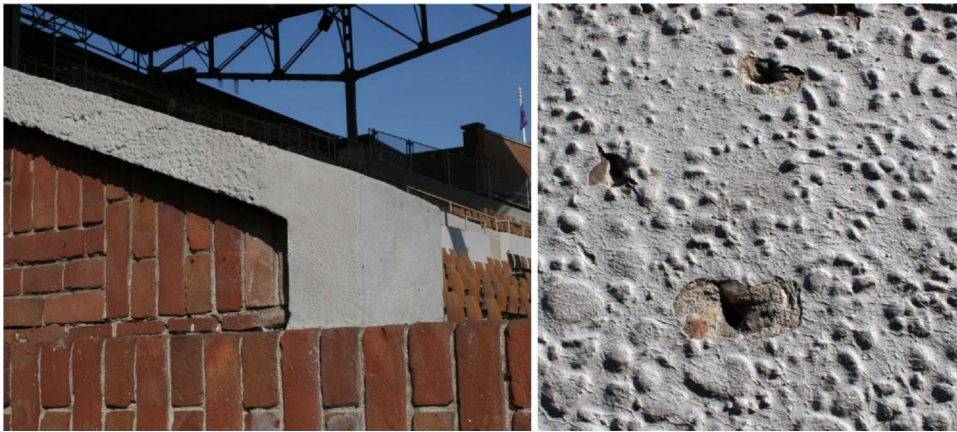
Fig. 1. Example of an aesthetically incompatible repair of historic concrete. Left: Due to a monochrome, grey layer of paint and local smooth repair, the original colour and textural scheme of brickwork and concrete is impeded. Right: Close up of the surface; where the paint has detached, the original polychrome surface influenced by the gravel and cement is visible (Olympic stadium Amsterdam, architect J. Wils, 1928).

The appearance of monuments, including their surface, influences strongly their heritage values and social acceptance. Concrete heritage still faces prejudices on whether it is entitled to be preserved [2]. Recognition of the spectrum of historic concrete surfaces would positively influence the appreciation of historic concrete buildings. In addition, a correct characterisation of the historic surface is relevant to evaluate the concrete durability. In practice, this would require a sound investigation of how the original surface was achieved, the influence of time on the surface (e.g., erosion, discolouration) and the impact of both damage and repair on the surface (Fig. 1).

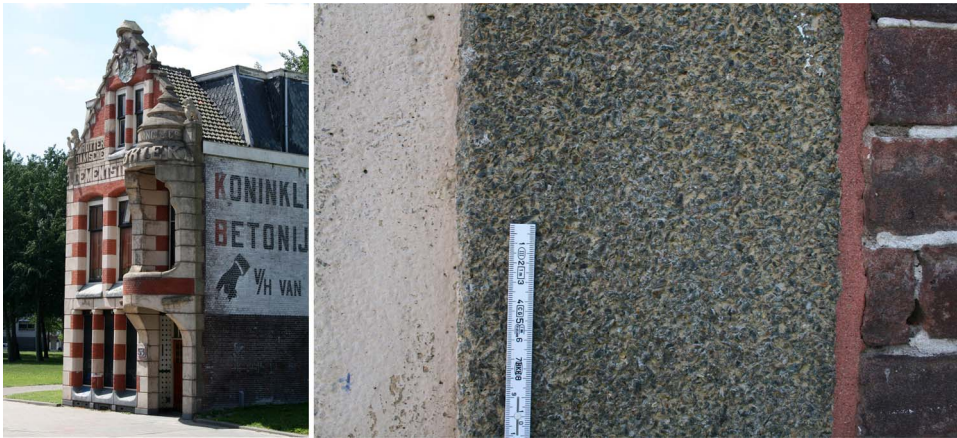
Fig. 2. Former head office of the artificial stone company Rotterdamsche Cementsteenfabriek Van Waning & Co (1898). Left: Overview of the main façade with artificial stone elements painted white. Right: Detail of the corner showing the original, tooled concrete surface made with greenish aggregate.

Experience with precast coloured concrete had been previously gained with natural stone imitations, a variation of precast concrete. By using a variety of coloured constituents and by tooling the surface, the concrete could resemble a variety of natural stone. In Germany, for example, an entire artificial stone industry existed, with several recipes for imitating different natural stones like sandstone, grey wacke, porphyry, tuff, limestone and granite [14]. Dutch examples are the products of the company *Rotterdamsche Cementsteenfabriek Van Waning & Co* (Fig. 2) [15].

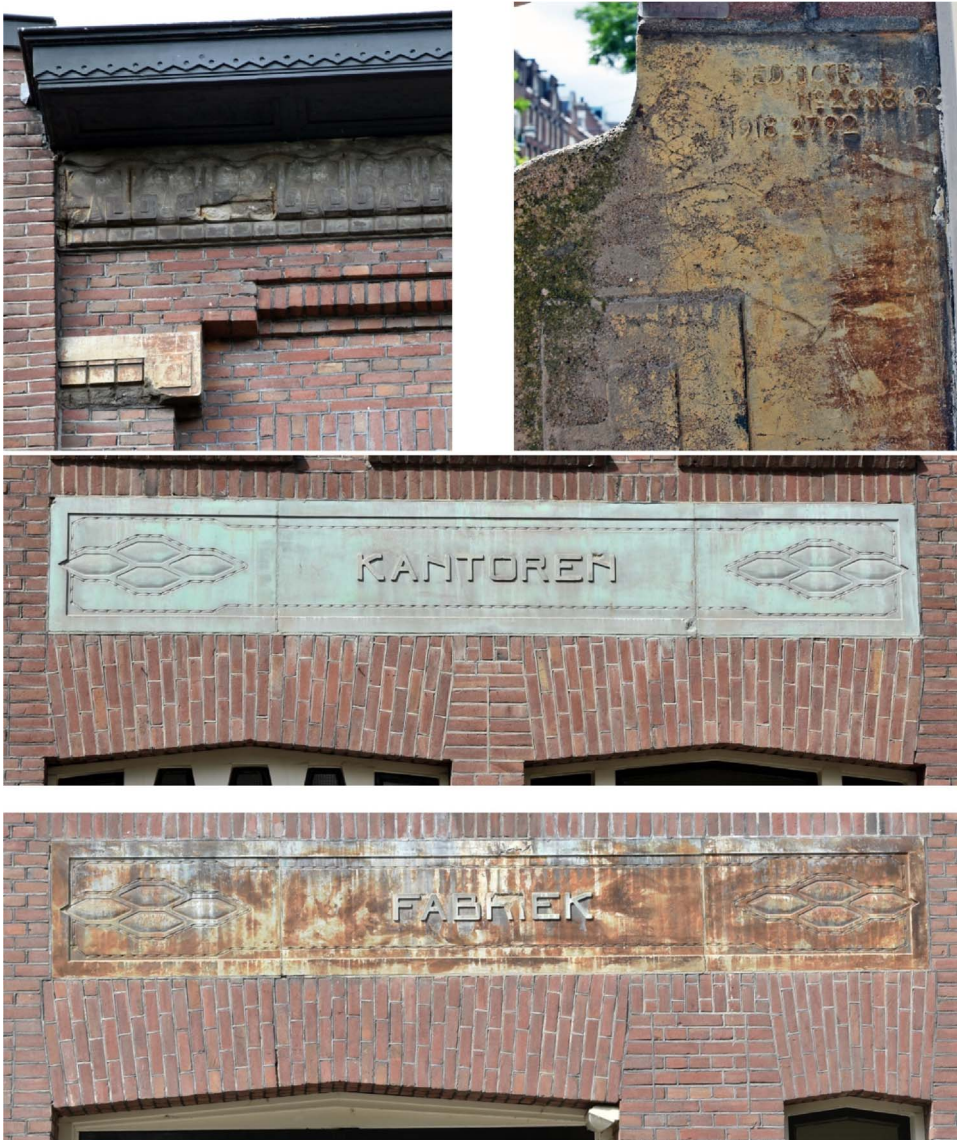
Fig. 3. Overview of precast metallised concrete elements in a former factory (architect C. Tenenti, Amsterdam, 1921). Top left: Cornice made with dark coloured concrete and capital with a sand stone coloured metallised concrete with local darker patches. Top right: detail of a yellow-brown coloured base, with visible inscription of the year and patent number. Middle: Green copper coloured precast metallised concrete sign above entrance for offices. Bottom: Multicolour (green, rust coloured) sign above the entrance to the factory.

A rare collection of metallised concrete can be found in Amsterdam; the decorative façade elements of a former factory building dating from 1921 are made of precast metallised concrete (Fig. 3). On the bases, the number and year of the patent for metallisation is still visible. It cannot be stated whether the present colours are similar to the original, as the effects of ageing on metallised concrete are not known. Local colour variations influenced by the geometry of the elements indicate that the colour changed during time. For example, the yellow-brown bases and capitals are darker in more protected zones. The green copper colour of the signboard for the entrance to the offices however is still rather homogenous. The green might have been made with a copper salt and the brown colours with an iron salt. This indicates that not all shades of metallised concrete possess the same durability. The concrete itself, however, shows damage which affects the surface. Besides spalling and visible corroded reinforcement, the surface is locally eroded. In these areas, no traces of metallisation can be seen.

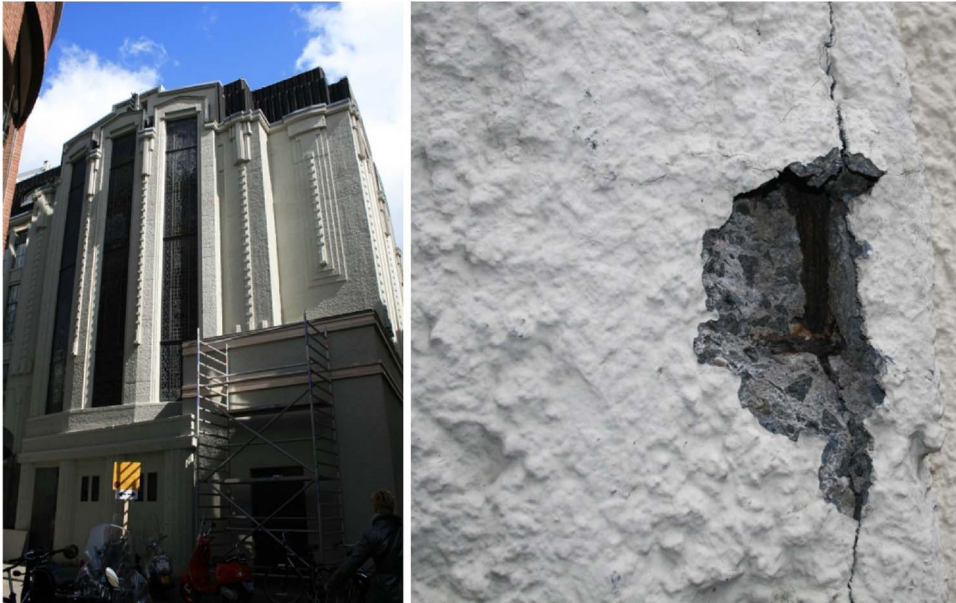
Fig. 4. One of the first Dutch buildings with exposed concrete, yet currently painted (architect A. Moen, 1915). Left: Overview of the rear façade. Right: Detail of a pilaster with spalling, cracking and corrosion, showing the original concrete made with crushed porphyry and with a tooled surface under a layer of paint.

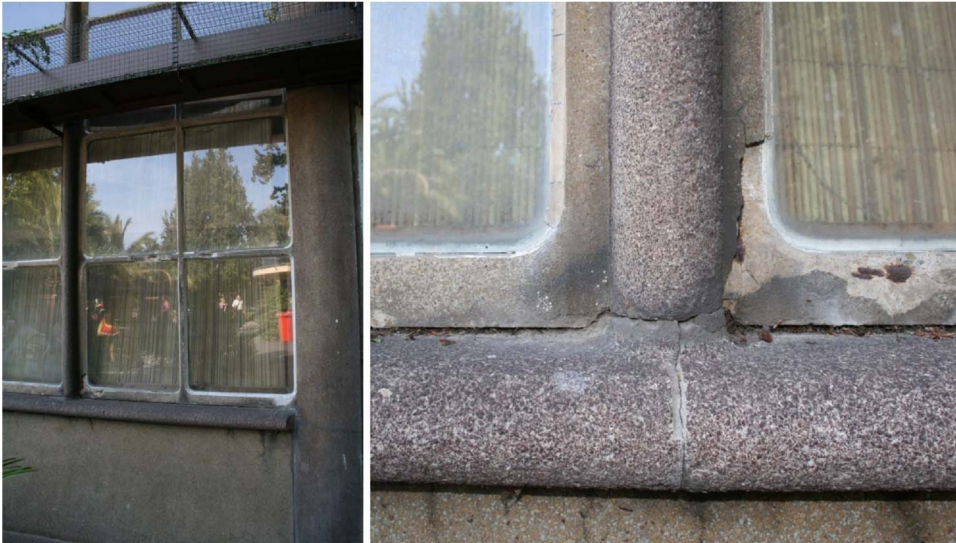
Fig. 5. Precast concrete elements (window frame and sill, plinth, columns etc.) made by Schokbeton N.V., using different ground aggregates to alter the colour of the concrete (Zoo Blijdorp, architect S. van Ravesteyn, 1939). Left: overview façade. Right: beige-sandstone coloured window frame and a more pink-purple coloured windowsill and column. Partially spalling and cracking has occurred, exposing the reinforcement, and discolouration due to soiling.

In the 1930s, an increase use of coloured, precast concrete made with crushed natural stone can be observed. An architectural ensemble – ranging from window frames, sculptures and entire façades – of such precast coloured concrete can be found the Rotterdam Zoo Blijdorp designed by S. van Ravesteyn between 1938 and 1940 (Fig. 5). The elements were produced by the then recently founded Dutch company Schokbeton N.V., which used a patented compaction method.

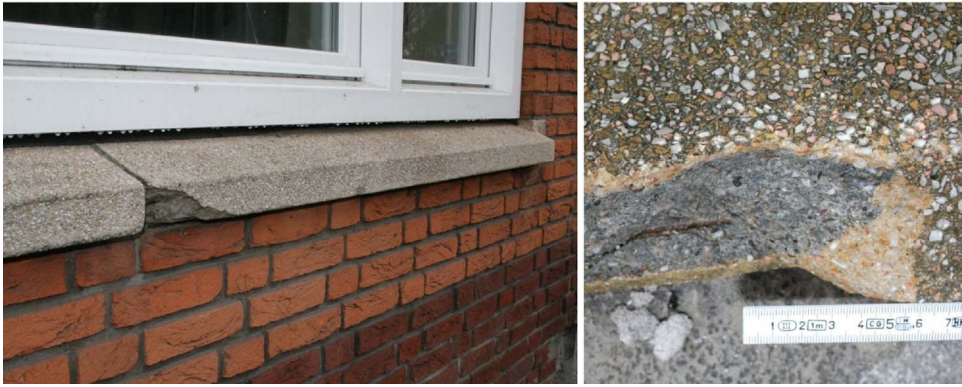
Fig. 6. Typical mass-produced precast concrete windowsill dating from the 1930s. Left: Overview of a windowsill with a broken off corner. Right: Close-up of a damaged windowsill showing a coloured facing layer and a grey backing concrete. Due to soiling, the original colour changed from a beige-orange colour to a more dirty shade of green.
