Dowel type connections in laminated bamboo with multiple slotted-in steel plates

Annex H – Test results

Auteur, studentnr: JJB Debije, 4309995
Datum: 06-02-2017

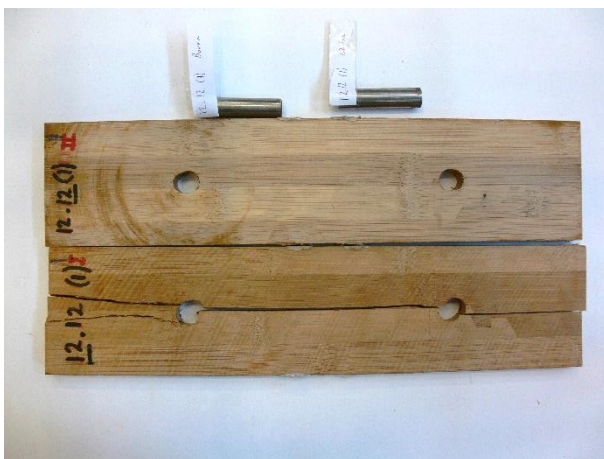
Failure: Mode 1
Plug Shear + splitting
Brittle

- Plug shear occurs with little embedment deformation of the bolthole. The connection strength may benefit from a larger end distance.

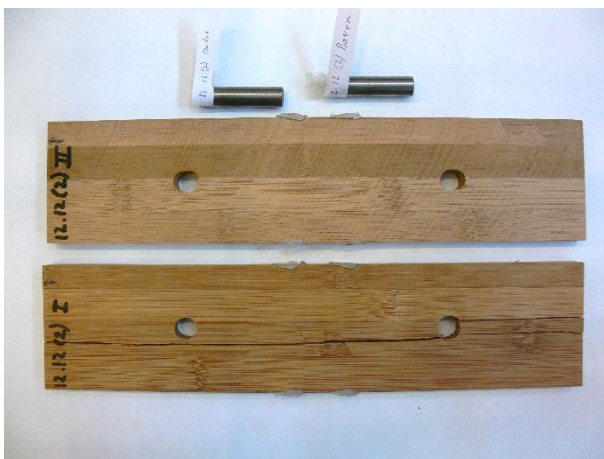
Failure: Mode 1
 Plug Shear + splitting
 Brittle

- Plug shear occurs with little embedment deformation of the bolthole. The connection strength may benefit from a larger end distance.

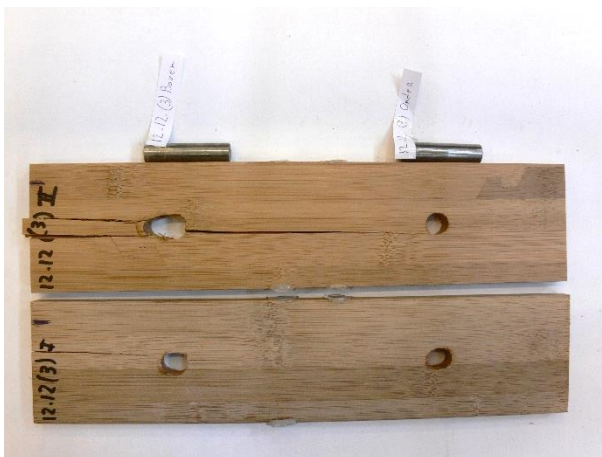
Failure: Mode 1
Plug Shear + splitting
Brittle

- Plug shear occurs with little embedment deformation of the bolthole. The connection strength may benefit from a larger end distance.

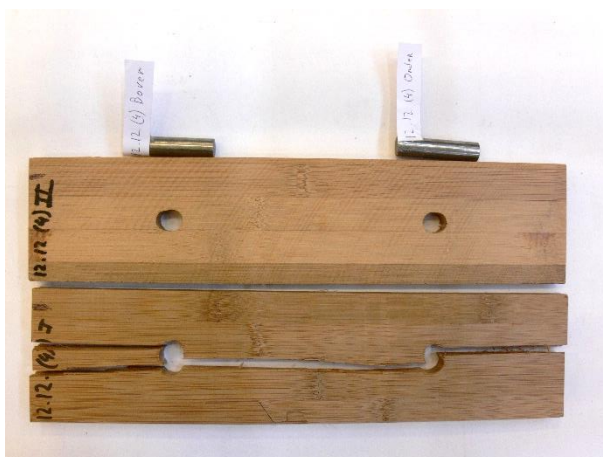
Failure: Mode 1
Plug Shear + splitting
Brittle

- Plug shear occurs with little embedment deformation of the bolthole. The connection strength may benefit from a larger end distance.

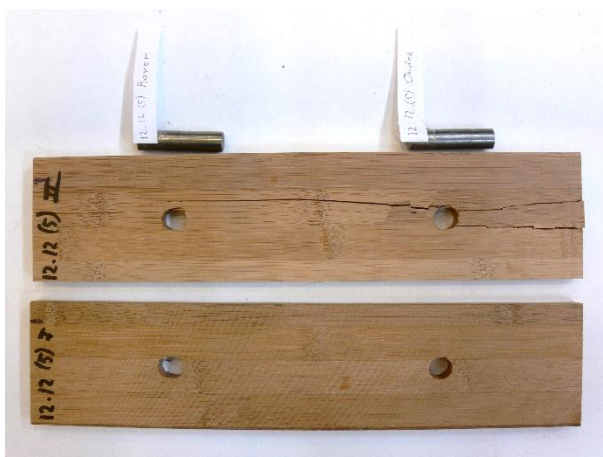
Failure: Mode 1
 Plug Shear + splitting
 Brittle

- Plug shear occurs with little embedment deformation of the bolthole. The connection strength may benefit from a larger end distance.

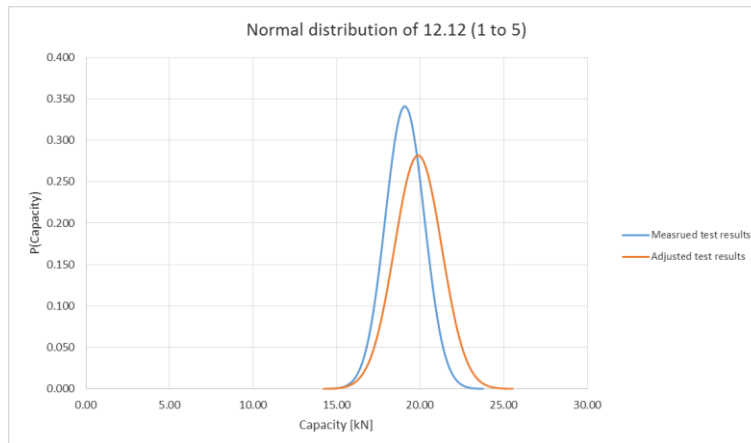
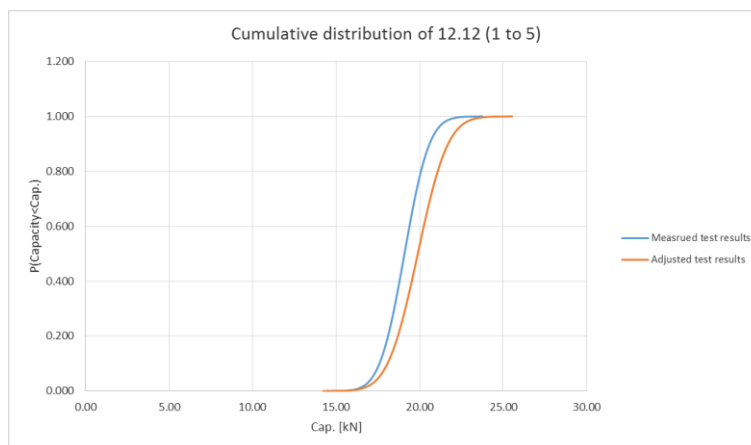
Tests	12.12 (1 to 5)
Material thickness left:	12mm
Material thickness right:	12mm
F_{est}	18.3kN
$F_{adjusted}/F_{est}$	1.0863

- The resistance $F_{adjusted}$ given here is the average of the measured capacities that has been adjusted by use of the findings in 'Annex F – Probabilistic analysis of test data'. The formula found in this annex makes it possible to approximate the actual average capacity and standard deviation.
- The 5-percentile value is calculated by $x_k = \bar{x} \pm k_s * \sigma$ with $k_s = 2.46$

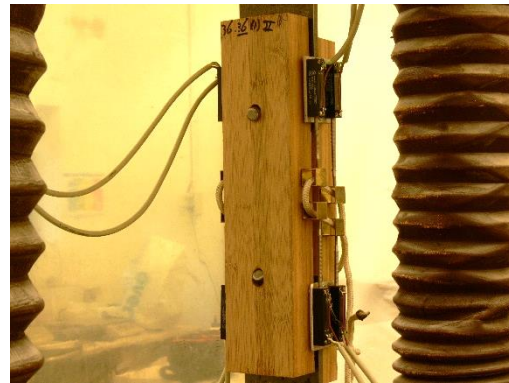
Failure: Mode 2
 Unexpected deformation
 Test stopped

- Due to a lack of connection between the two individual pieces, a deformation occurred that was not anticipated (one piece moving up and the other one down). This resulted in just an increase in deformation without a significant increase in measured force. Since this is no behaviour of an actual connection and for the protection of the displacement meters the test was stopped

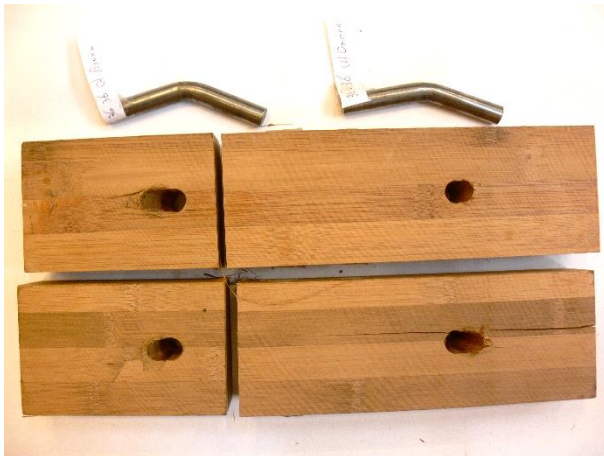
Failure: Mode 2
 Unexpected deformation
 Test stopped

- This test piece shows the same deformation behaviour as 36.36 (1).
- From this point on, pieces of laminated bamboo (9mm thickness) will be glued between the individual members to ensure that these deformations cannot occur. For this, a PVAc glue was used.

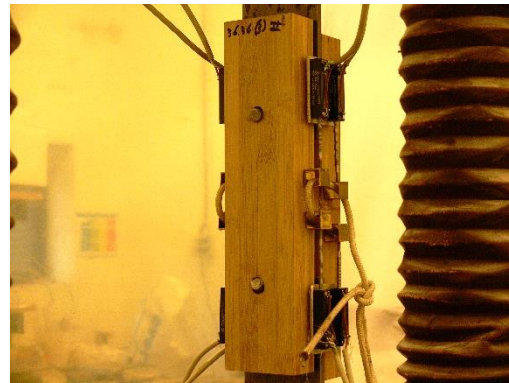
Failure:	Mode 2 Glue line broke Test stopped
----------	---

- To prevent the deformation behaviour from tests (1) and (2), a piece of laminated bamboo was glued in between the two individual members. For this a PVAc glue was used..
- At about 32kN of loading the glue line broke. This can be seen as a drop in the graph. After that the same failure behaviour as in tests (1) and (2) occurred.
- For the following tests, the length of the glued-in piece is increased so that the glue line is larger and the resistance of the glue line increases.

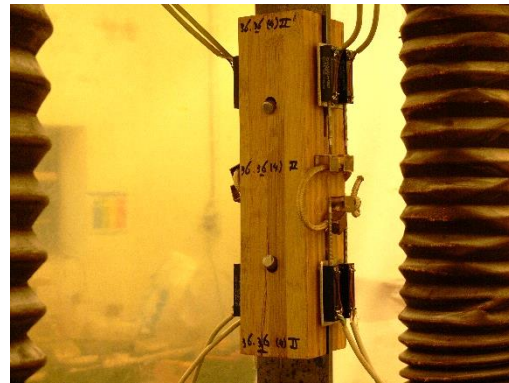
Failure:	Mode 2 Splitting + embedment Ductile
----------	--

- The measured force deviates by more than 20 percent of the estimate. For the next test the estimate needs to be updated and the test protocol needs to be adapted.
- The glue line holds and a large deformation (about 11mm) can be obtained before failure occurs.

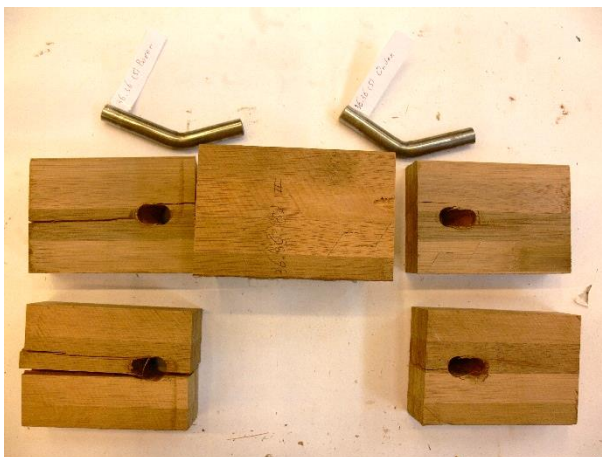
Failure: Mode 2
 Plug shear + embedment
 Ductile

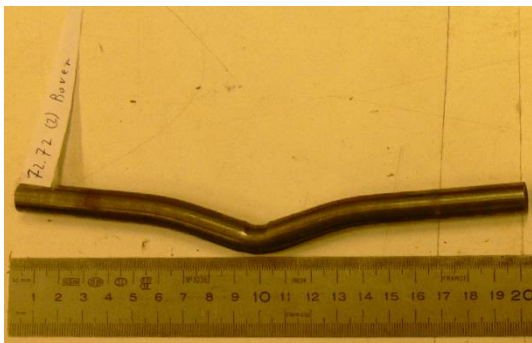
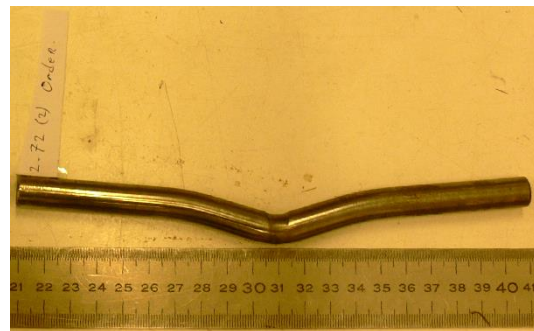
Failure: Mode 3
 Ductile

- In test (1) a large embedment deformation was seen in the slotted-in plates. After this testing variant all test pieces have to be equipped with two sets of slotted-in plates. So to make sure that the upcoming testing variants do not warp due to a difference in deformation between the sets of slotted-in plates for this test, the other pair of plates is used. By doing this, the other pair of plates will have the same embedment deformation as the pair used for test 72.72 (1).
- At a displacement of 6,5mm a slight change of inclination can be seen in the displacement graph. It is at this point that the embedding of the steel plate has stopped.

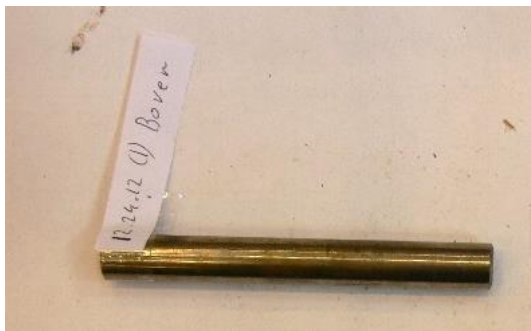
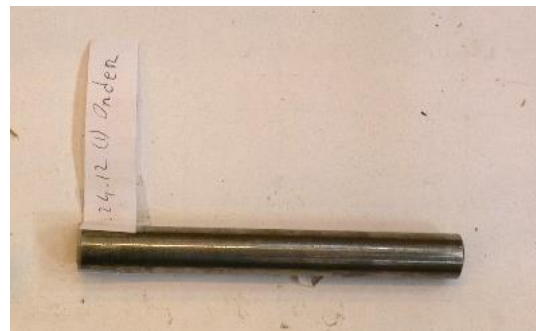
Failure:	Mode 1 Splitting Brittle
----------	--------------------------------

- As this test variant was tested before testing of the variants 36.36 took place, the glued-in piece of laminated bamboo is not present. During testing of this variant the unexpected failure behaviour (warping of the test piece) did not take place.

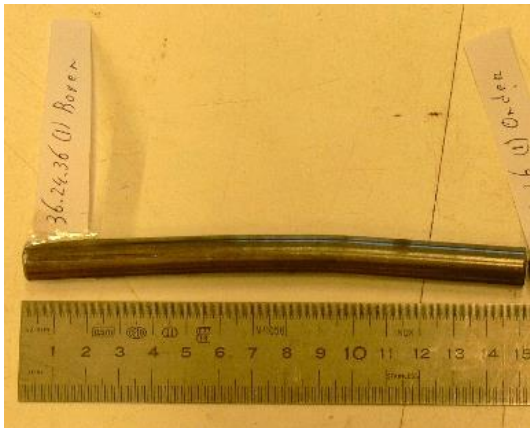
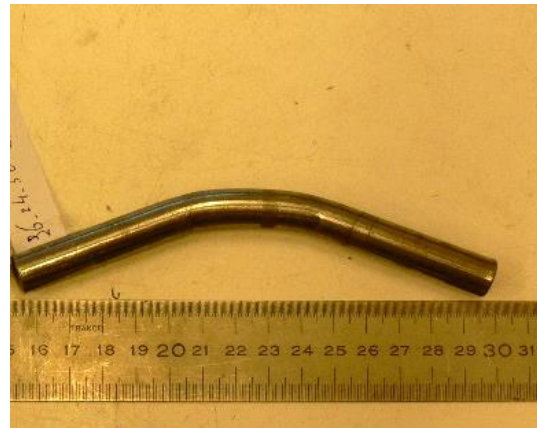
Failure:	Mode 1 at 2mm
	Mode 2 at 14mm

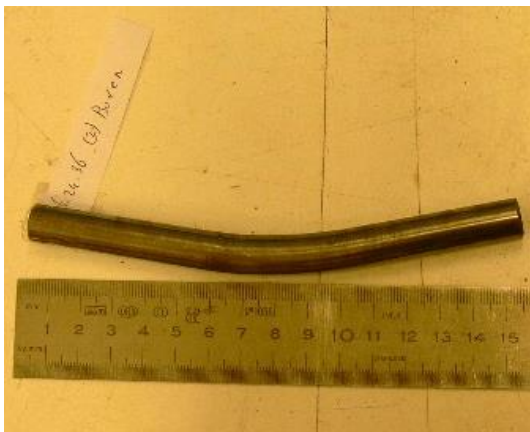
Failure:	Mode 1 at 3mm
	Mode 2 at 6mm

- Mode 2 had a relatively low deformation capacity.

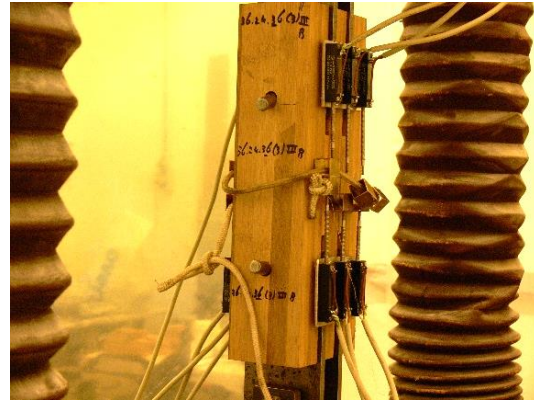
Specimen	36.24.36 (2)
Material thickness left:	36mm
Material thickness middle:	24mm
Material thickness right:	36mm
F_{est}	52.4kN
$F_{measured}$	59.92kN
Max dowel angle	20°
Final testing speed	0.04mm/s
Test duration	780 seconds
Failure:	Mode 1 at 7mm Mode 2 at 9.5mm

- Mode 1 had a relatively high deformation capacity.
- Mode 2 had a relatively low deformation capacity.

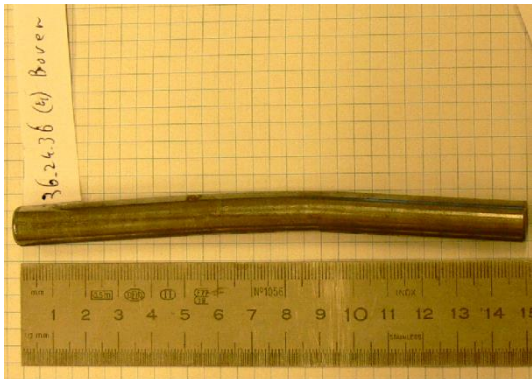
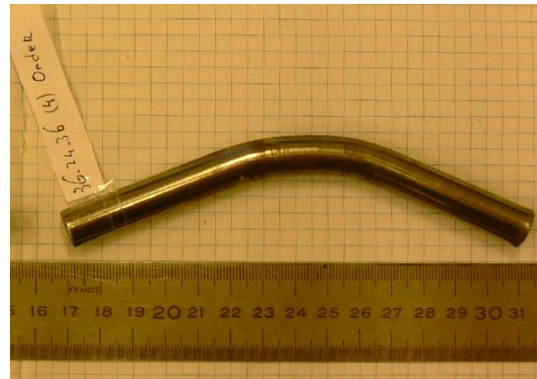
Specimen	36.24.36 (2)
Material thickness left:	36mm
Material thickness middle:	24mm
Material thickness right:	36mm
F_{est}	52.4kN
$F_{measured}$	52.63kN
Max dowel angle	20°
Final testing speed	0.04mm/s
Test duration	870 seconds
Failure:	Mode 1 at 4mm Mode 2 at 14mm

- Due to the glued-in pieces between the individual members, the displacement between the various meters does not differ anymore. Therefore, a choice was made to now only install 4 meters (one at the top and one at the bottom of the specimen at both sides). The pictures show 8 meters, four of these are activated.

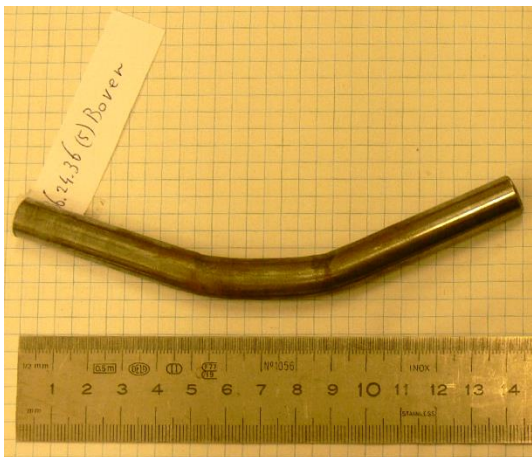
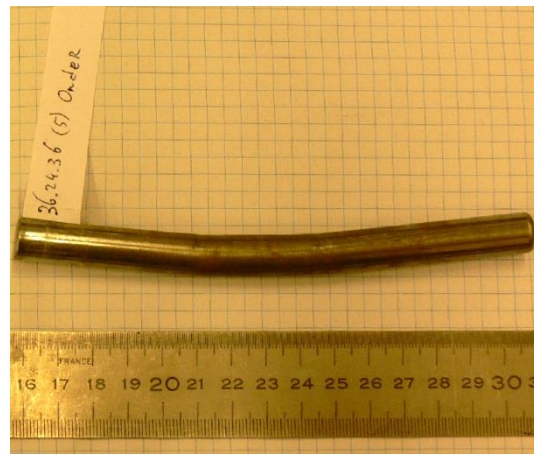
Specimen	36.24.36 (2)
Material thickness left:	36mm
Material thickness middle:	24mm
Material thickness right:	36mm
F_{est}	52.4kN
$F_{measured}$	57.50kN
Max dowel angle	25°
Final testing speed	0.04mm/s
Test duration	830 seconds
Failure:	Mode 1 at 5.5mm Mode 2 at 11.5mm

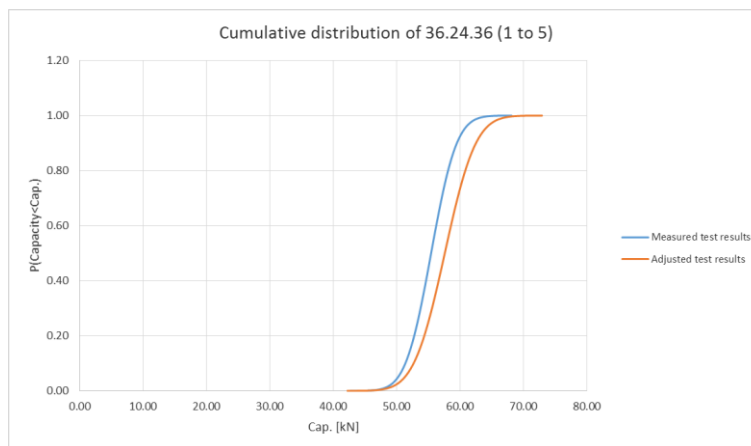
Tests	36.24.36 (1 to 5)
Material thickness left:	36mm
Material thickness middle:	24mm
Material thickness right:	36mm
F_{est}	52.4kN
$F_{average}/F_{est}$	1.0990

- The resistance $F_{adjusted}$ given here is the average of the measured capacities that has been adjusted by use of the findings in 'Annex F – Probabilistic analysis of test data'. The formula found in this annex makes it possible to approximate the actual average capacity and standard deviation.
- The 5-percentile value is calculated by $x_k = \bar{x} \pm k_s * \sigma$ with $k_s = 2.46$.

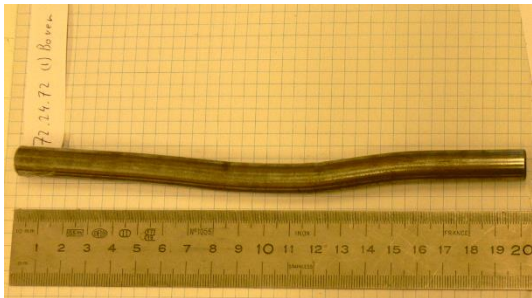
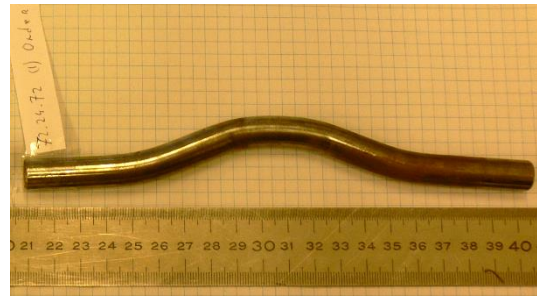
Specimen	72.24.72 (1)
Material thickness left:	72mm
Material thickness middle:	24mm
Material thickness right:	72mm
F_{est}	61.8kN
$F_{measured}$	60.59kN
Max dowel angle	35°
Final testing speed	0.06mm/s
Test duration	810 seconds
Failure:	Mode 1 at 2mm Mode 3 at 11mm

- Due to a large shock as a consequence of the first failure, a lot of blocks from the displacement meters fell off during testing. For the upcoming tests all 8 displacement meters will be installed to prevent loss of data.
- The embedment deformation of the slotted-in plates has increased slightly. Due to this increased deformation, the thickness of the slotted-in plates (around the dowel hole) has also increased. To account for this increase in thickness also the glued in pieces of bamboo have to be made thicker (from 9 to 12mm). This increase ensures that the slotted-in plates can still be inserted in between the individual members of the test pieces.

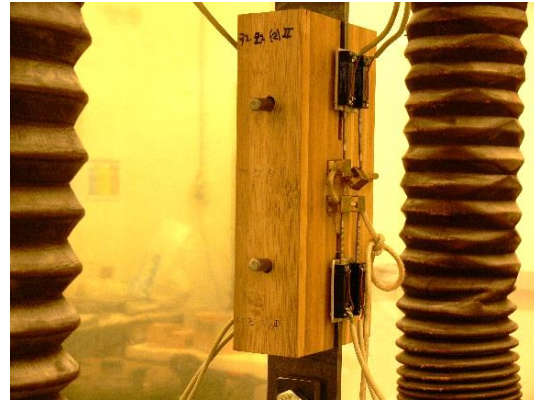
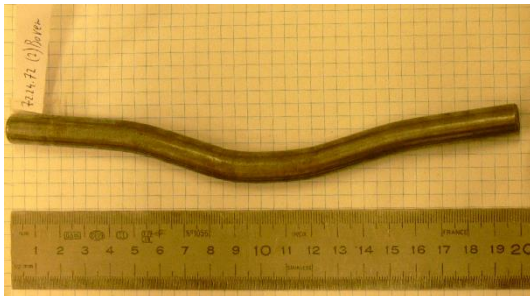
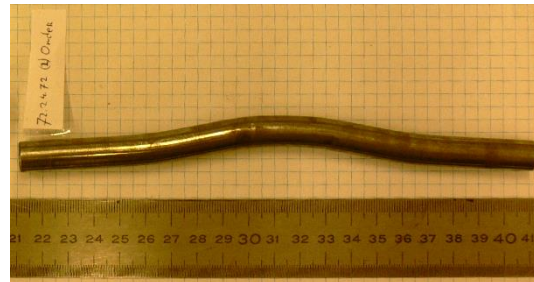
6.2 Test 72.24.72 (2)

Specimen	72.24.72 (2)
Material thickness left:	72mm
Material thickness middle	24mm
Material thickness right:	72mm
F_{est}	61.8kN
$F_{measured}$	62.61kN
Max dowel angle	36°
Final testing speed	0.06mm/s
Test duration	820 seconds
Failure:	Mode 1 at 2mm Mode 3 at 10mm

- After the first peak (failure) the test specimen shows a lot of residual strength. The maximum measured force is reached long after the initial moment of failure at a displacement more than two times as high.
- An initial increase in deformation shows that the test specimen had some backlash at the start of the test.
- This specimen is still made using thin glued-in pieces.

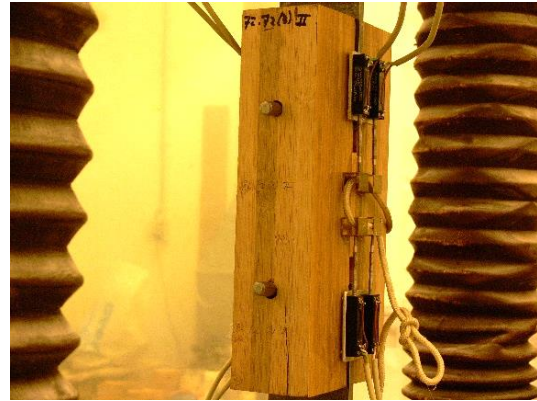
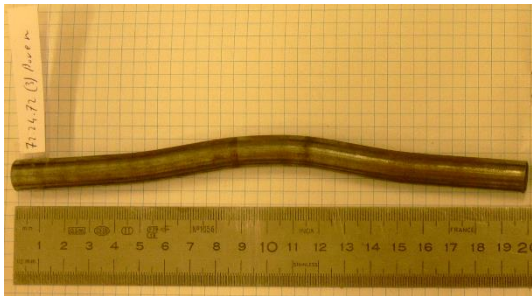
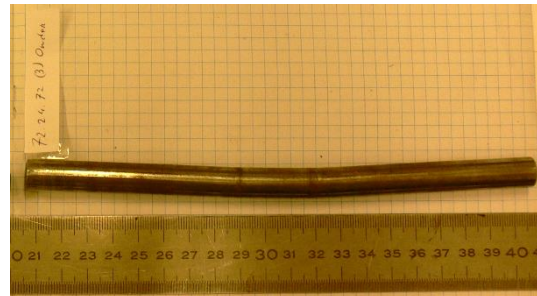
Specimen	72.24.72 (3)
Material thickness left:	72mm
Material thickness middle	24mm
Material thickness right:	72mm
F_{est}	61.8kN
$F_{measured}$	61.60kN
Max dowel angle	44°
Final testing speed	0.06mm/s
Test duration	780 seconds
Failure:	Mode 1 at 3mm Mode 3 at 9.5mm

- As with the previous specimens, there is a lot of residual strength left after the first moment of failure.
- This specimen is still made using thin glued-in pieces.

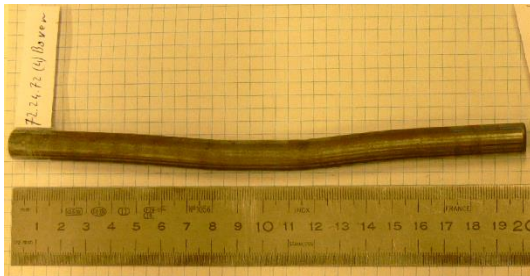
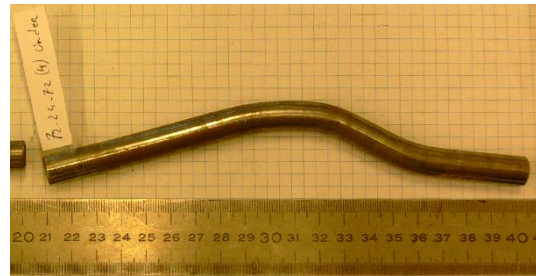
Failure: Mode 1 at 4mm
Mode 3 at 11mm

- As with the previous specimens, there is a lot of residual strength left after the first moment of failure.
- This specimen is the first to be made with thick glued-in pieces ($t = 12 \text{ mm}$).

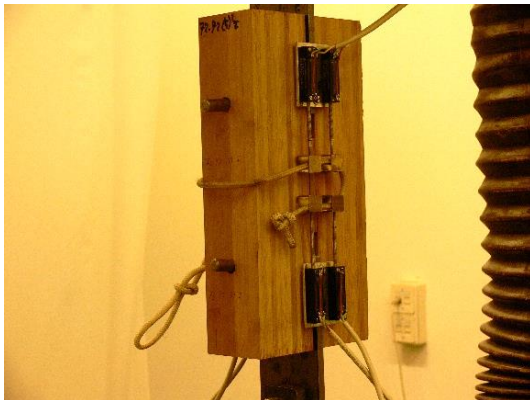
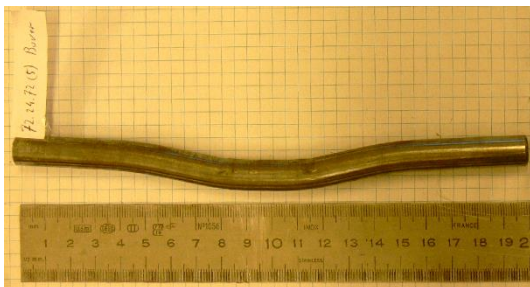
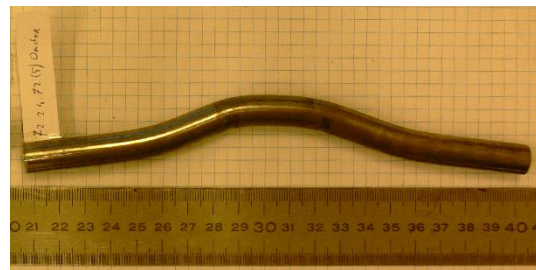
Failure:	Mode 1 at 8mm
	Mode 3 at 12mm

- As with the previous specimens, there is a lot of residual strength left after the first moment of failure.
- Failure mode 1 shows a lot of deformation capacity.
- Thick glued in pieces ($t = 12 \text{ mm}$).

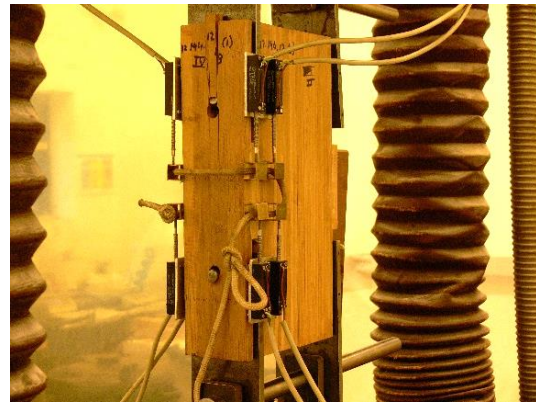
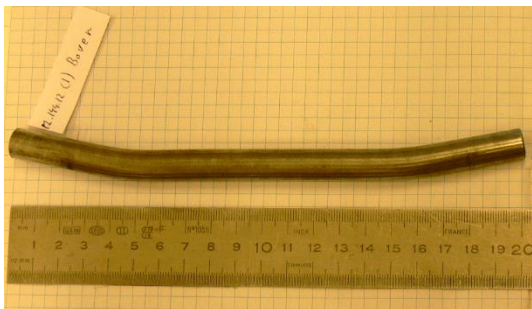
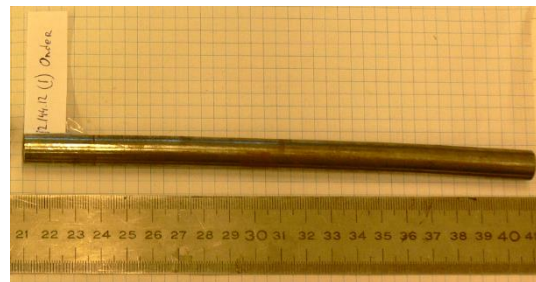
Specimen	12.144.12 (1)
Material thickness left:	12mm
Material thickness middle	144mm
Material thickness right:	12mm
F_{est}	61.8kN
$F_{measured}$	57.85kN
Max dowel angle	13°
Final testing speed	0.06mm/s
Test duration	610 seconds
Failure:	Mode 1 at 2mm Test stopped

- The first peak of the force displacement diagram is at 57.85kN. This is in line with the expectation of the failure load being slightly lower than 61.8kN.
- After the first peak a few smaller drops in the resistance can be seen. This is caused by the cracking of the outer plates. Finally at 36kN a sharp drop is seen. This is caused by the splitting of plate 1 after which the plate darted away. Now the dowel has no resistance anymore from the outer plate and is free to start bending. The bending of the dowel and the lack of the outer plate allowed the slotted-in plate to rotate. As the slotted-in plate was not designed to resist this kind of loading and the plates were needed to conduct the remainder of the tests, this test had to be stopped to prevent failure of the slotted-in plates.

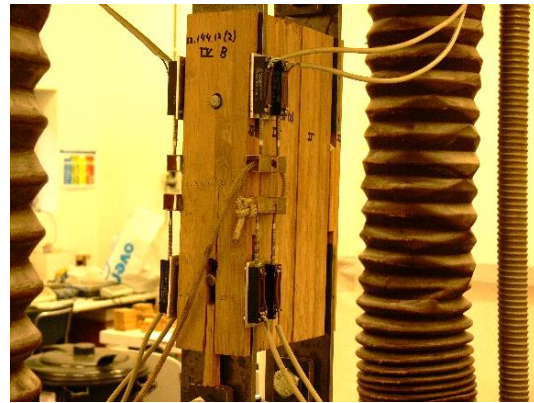
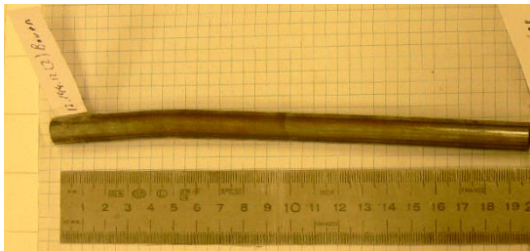
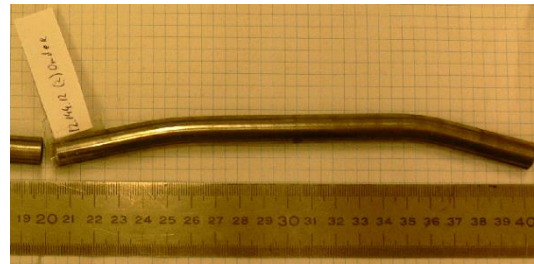
Final testing speed	0.06mm/s
Test duration	620 seconds

Failure:	Mode 1 at 2mm Test stopped
----------	-------------------------------

- As with test (1) of this series, the test had to be stopped to protect the slotted-in plates from failure.
- Due to the deformation of the dowel within the thick middle member, a large amount of force was necessary to remove the dowel from the test piece. This caused the middle members to crack and split (the same phenomenon can be seen in all further tests).

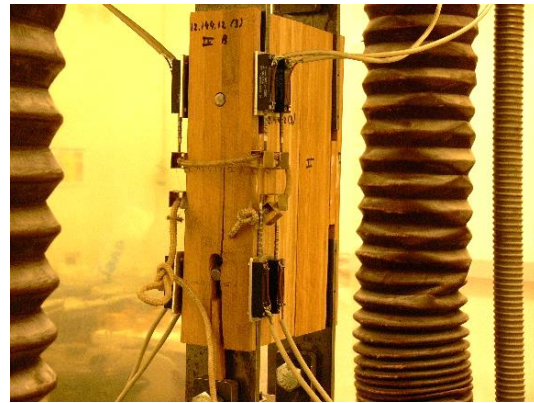
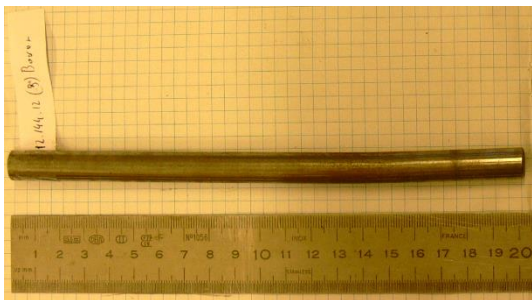
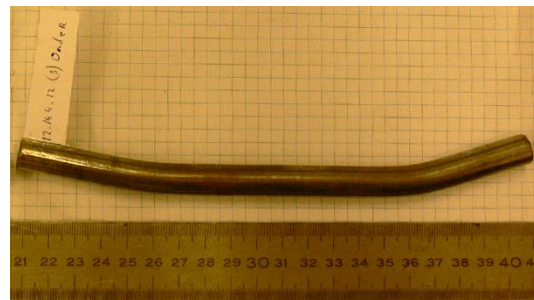
Specimen	12.144.12 (3)
Material thickness left:	12mm
Material thickness middle	144mm
Material thickness right:	12mm
F_{est}	61.8kN
$F_{measured}$	53.38kN
Max dowel angle	16°
Final testing speed	0.06mm/s
Test duration	620 seconds
Failure:	Mode 1 at 1.5mm Test stopped

- As with test (1) of this series, the test had to be stopped to protect the slotted-in plates from failure.

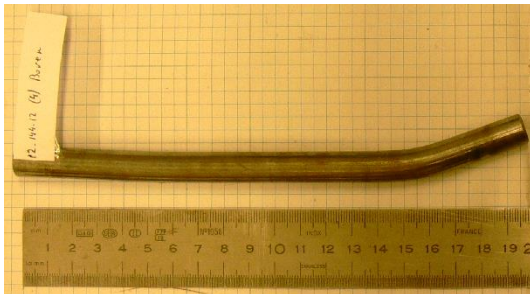
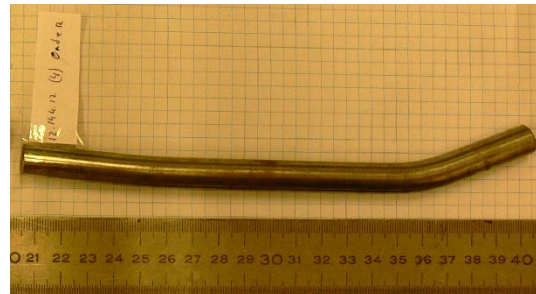
Final testing speed	0.06mm/s
Test duration	660 seconds

Failure:	Mode 1 at 3mm
	Test stopped

- As with test (1) of this series, the test had to be stopped to protect the slotted-in plates from failure.

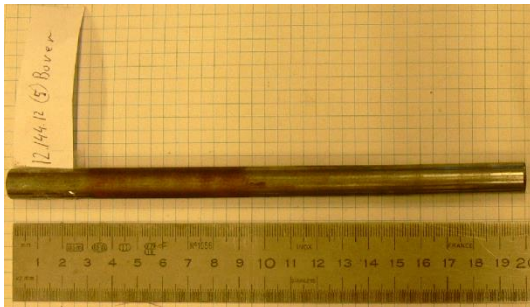
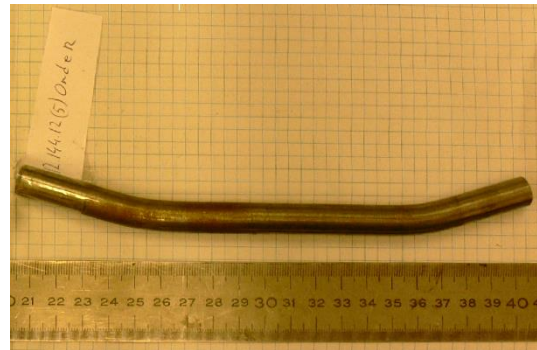
Specimen	12.144.12 (5)
Material thickness left:	12mm
Material thickness middle:	144mm
Material thickness right:	12mm
F_{est}	61.8kN
$F_{measured}$	50.80kN
Max dowel angle	18°
Final testing speed	0.06mm/s
Test duration	620 seconds
Failure:	Mode 1 at 1.5mm Test stopped

- As with test (1) of this series, the test had to be stopped to protect the slotted-in plates from failure.

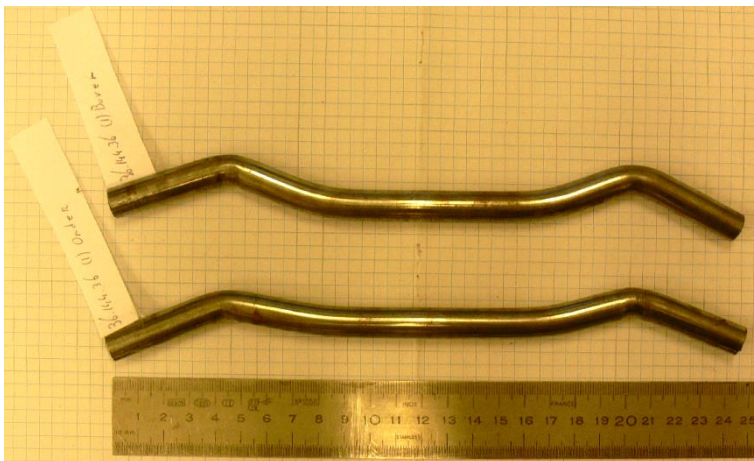
Specimen	36.144.36 (1)
Material thickness left:	36 mm
Material thickness middle	144mm
Material thickness right:	36mm
F_{est}	77.5kN
$F_{measured}$	99.34kN
Max dowel angle	45°
Final testing speed	0.06mm/s
Test duration	850 seconds
Failure:	Mode 2 at 11mm

- In the picture above can be seen that the dowels showed a large bending angle. Due to this large deformation, a considerable amount of force was necessary to extract the dowels from the failed test piece. In the process the middle members had to be split in half.
- The measured resistance of the test piece is more than 20% higher than expected. For the next tests, the expected capacity thus needs to be adapted. The expected capacity of the following test pieces is taken as 99.34kN.

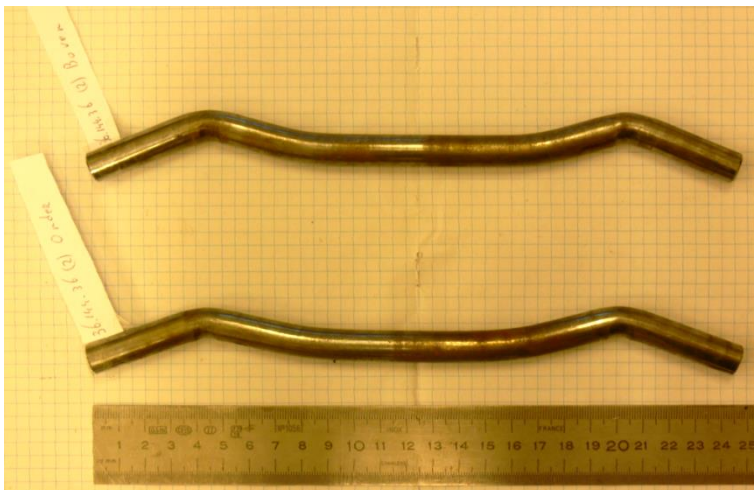
Failure: Mode 2 at 10mm

- The adapted expected capacity of 99.34kN suffices.

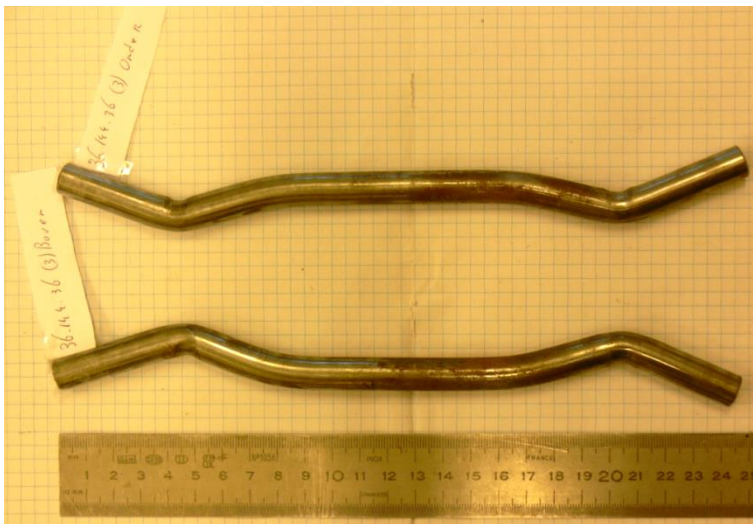
Specimen	36.144.36 (3)
Material thickness left:	36mm
Material thickness middle	144mm
Material thickness right:	36mm
F_{est}	99.34kN
$F_{measured}$	102.48kN
Max dowel angle	36°
Final testing speed	0.06mm/s
Test duration	800 seconds
Failure:	Mode 2 at 10.5mm

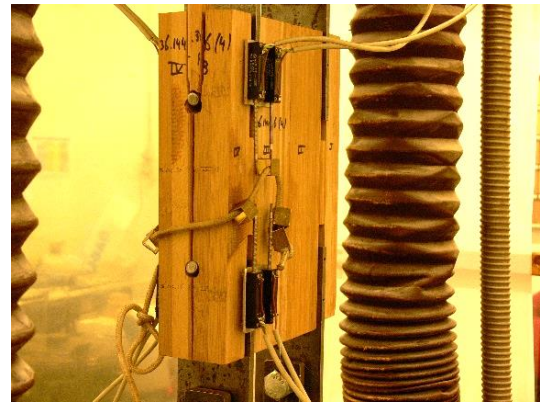
Specimen	36.144.36 (4)
Material thickness left:	36mm
Material thickness middle	144mm
Material thickness right:	36mm
F_{est}	99.34kN
$F_{measured}$	104.29kN
Max dowel angle	36°
Final testing speed	0.06mm/s
Test duration	820 seconds
Failure:	Mode 2 at 11.5mm

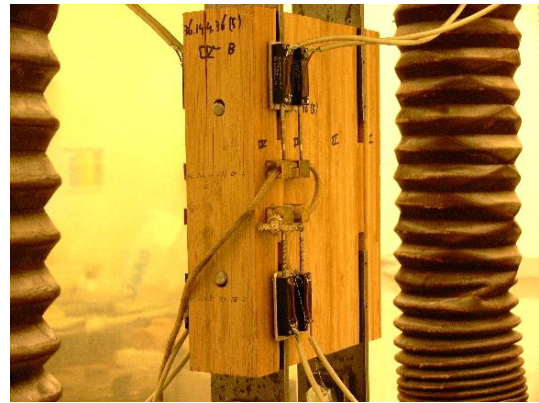
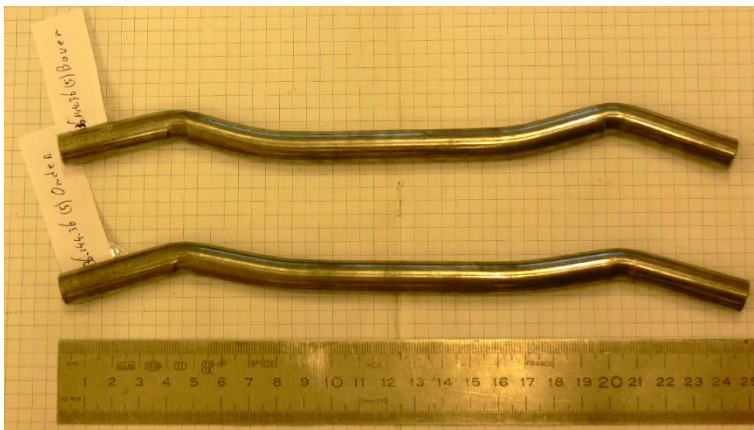
Specimen	36.144.36 (5)
Material thickness left:	36mm
Material thickness middle	144mm
Material thickness right:	36mm
F_{est}	99.34kN
$F_{measured}$	99.09kN
Max dowel angle	32°
Final testing speed	0.06mm/s
Test duration	720 seconds
Failure:	Mode 2 at 8.5mm

- This specimen had a relatively low deformation capacity.

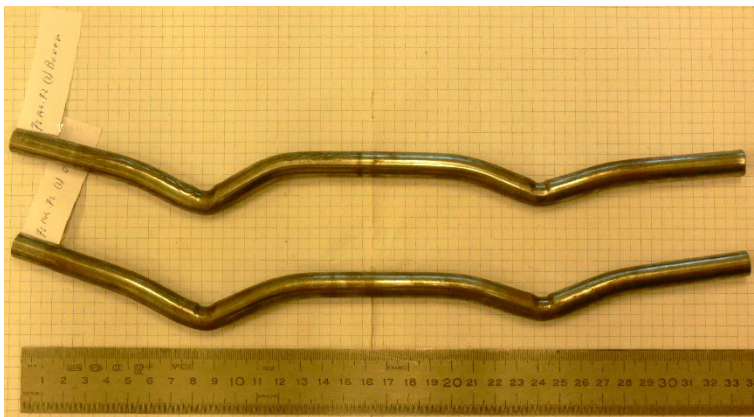
Failure: Mode 3 at 13mm

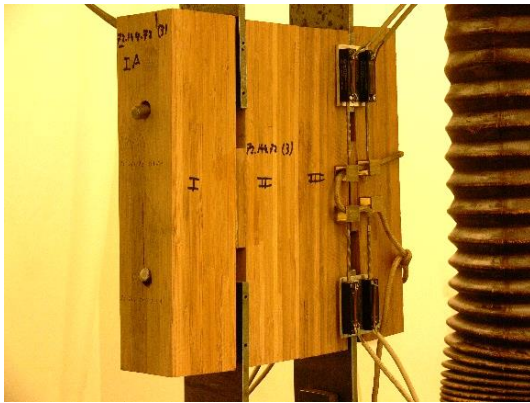
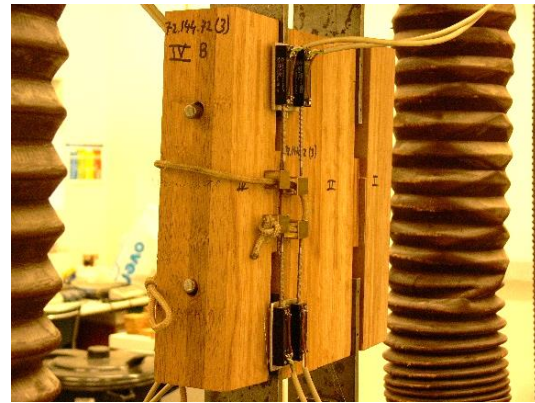
Specimen	72.144.72 (3)
Material thickness left:	72mm
Material thickness middle:	144mm
Material thickness right:	72mm
F_{est}	112.20kN
$F_{measured}$	111.05kN
Max dowel angle	60°
Final testing speed	0.06mm/s
Test duration	1170 seconds
Failure:	Mode 3 at 10.5mm

- Although the first crack appeared at a relatively low displacement of 10.5mm, this specimen showed a very large deformation capacity in comparison to the other specimens of this series.
- A large dowel bending angle was reached during this test.

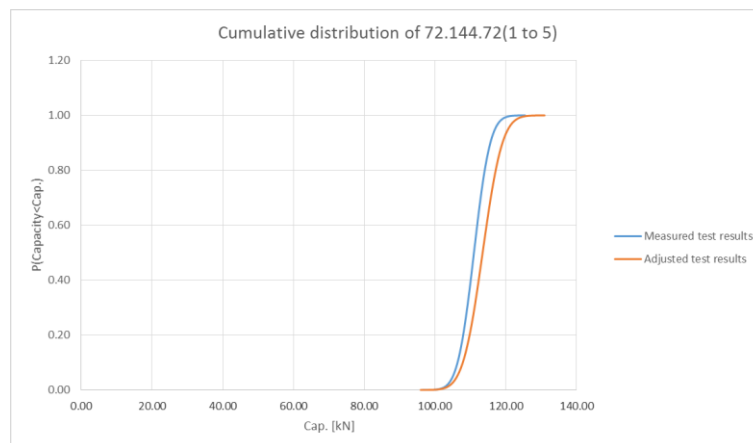
Tests	72.144.72 (1 to 5)
Material thickness left:	72mm
Material thickness middle:	144mm
Material thickness right:	72mm
F_{est}	86.9kN
$F_{average}/F_{est}$	1.3056
