### **Transformation of vacant office buildings into housing**

Remøy, HT; van der Voordt, DJM

# **A NEW LIFE: TRANSFORMATION OF VACANT OFFICE BUILDINGS INTO HOUSING**

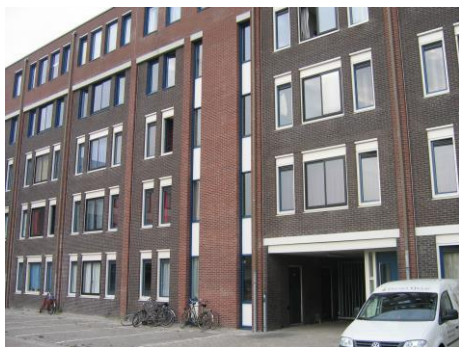
The façade of the building has not been altered

of the building there's an elevator, the staircases are situated on each end of the building. This granted that nothing had to be done to the building as to make sure it would apply to the prescriptions for fire-escapes. Another important factor was the state of the façade. The restrictions on noise on the façade are harder for housing than for offices (max 50dB for housing compared to max 60dB for offices). The façade did not meet standards for housing, but the municipality was willing to make an exception. Another common problem is that in many offices, windows can't be opened manually. In this building though, most windows could be opened, or at least one window per structural bay. This was an important factor in keeping down cost for reconstruction. A third factor that can add up on the costs of restructuring is the internal installation. Heating, air and electric installations could be re-used. Sub-meters were placed as to measure electricity used by each unit. Radiators were re-used and got added meters as well.

Little was done about the design of the building. The entrance was refurbished, as to allow for 83 students to use it on a daily basis. In the wall, 83 post-boxes were placed, together with 83 doorbells. A program was set up in agreement with the mayor student organisation in Groningen. This resulted in rooms of 20-25 square meters, with an own kitchen and bathroom and an own address, mailbox and doorbell. Dividing walls between the units were made sound- and fireproof by using layers of gypsum plates. In this way, as little as possible weight was added to the construction. The transformed building is an anonymous one, little was changed physically, but the use of the building is radically transformed.

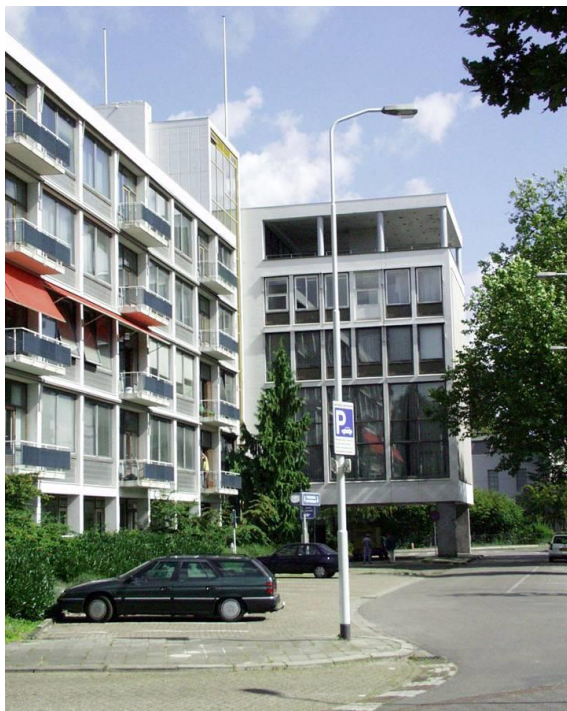
Office building in use as office

The existing building had various technical disadvantages, for instance the façade was outdated and not energy efficient. The floors were too thin to function well as the division between two apartments. There were several possibilities to solve these problems. Finally one concept was chosen that would solve all the technical problems; each apartment was designed as a box that was placed in the existing structure like a drawer in a chest of drawers. This solved as well the isolation of the interior walls and floors as the façade. During construction though, it became clear that the building also wasn't built to modern standards. The measurements of the columns and the distances between varied from floor to floor. The 'drawers' had to be manufactured specially for each unit. This was causing high extra costs. Another factor adding up to the construction costs was the state of the existing construction. Although the façade was radically altered, the characteristic structure of the building and its identity were kept. (Photo's 1 and 2) The large scale left over spaces that this building comprises, are kept public and open. This is one of the obvious qualities that are provided by the existing structure and which could not be provided for through a new building built specific for its use.

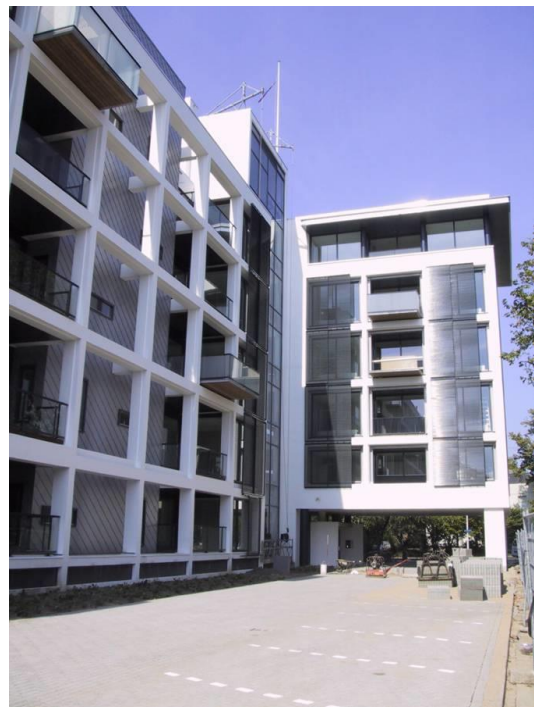
Office building transformed into housing
