Induction healing of concrete reinforced by bitumen-coated steel fibres

9th International Conference on Fracture Mechanics of Concrete and Concrete Structures

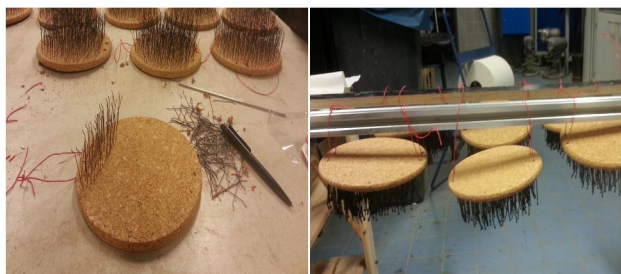
The steel fibres were embedded within one hooked extremity (10mm) in cork slabs. Kuwait 40/60 penetration class bitumen was heated in the oven at 160°C for 2 hours and poured into a basin inside which the slabs were sank and then hanged till bitumen got cold. The process can be seen in Figure 1.

Figure 1: Bitumen coating of steel fibres.

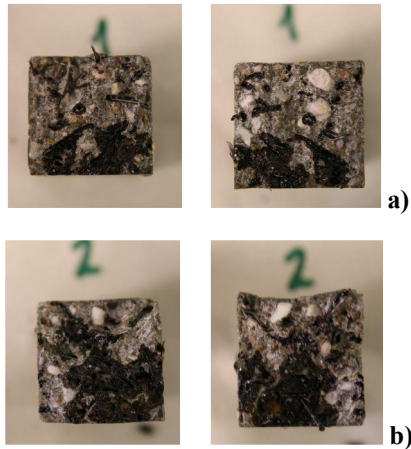
The presence of an initial elastic branch was observed in the case of healed beams. This characteristic behaviour can be attributed to the elastic deformation of the layer of bitumen within the crack surfaces. The failure of the bitumen layer occurs for the chosen rate of displacement and afterwards the load is taken by the ligament and the slip of the fibres bridging the crack. Figure 11 shows the symmetry of the

bitumen footprints on two pairs of crack surfaces; hence the failure is likely to occur within the bitumen layer instead of at the concrete-bitumen interface.

Figure 11: Symmetry of the bitumen layer fracture.
