Delft University of Technology

**Hydrogen absorption and conservation of operational
capabilities in remanufactured bearing steel exposed to
corrosion**

*A thesis submitted in partial fulfilment of the requirements
for the degree of Master of Science in*

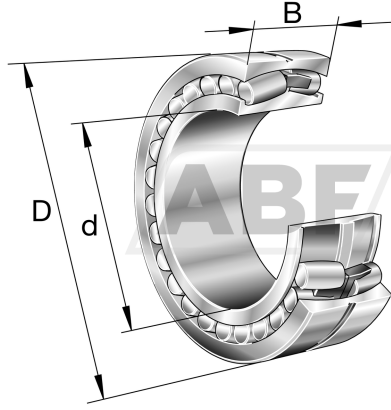
Figure 1: *FAG 239/560-B-K-MB-C3 ring [17].*

All the bearings used throughout the present work are bearings provided by SKF, obtained from their industrial bearing remanufacturing centre in Steyr, Austria. The material used is from two primary bearings, namely bearing A and bearing B, which exhibit distinct levels of corrosion. Both are spherical roller bearings (SRB) with two rows of symmetrical rollers as the one shown in Figure 1.

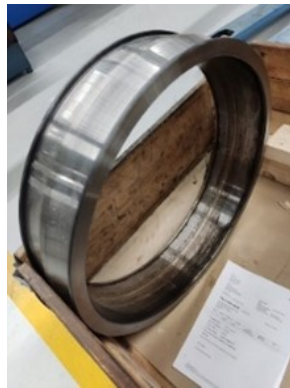
Figure 2: *Slightly corroded bearing from Steyr, bearing A.*

In both cases the investigation is focused on the inner ring of the bearings. Bearing A, Figure 2, displays minimal corrosion marks while bearing B, Figure 3a, is markedly affected by corrosion. Figure 3b show a closer look of the corrosion patterns observed on bearing B.

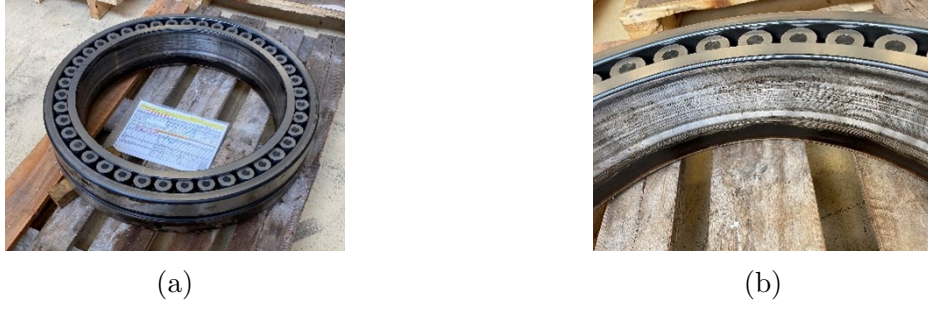
Figure 3: (a) *Corroded bearing from Steyr, bearing B.* (b) *Closer look of Corroded bearing from Steyr.*

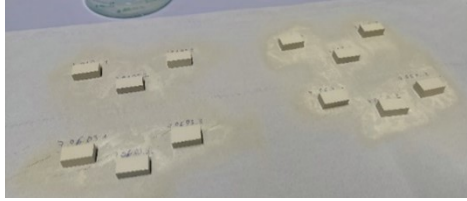
Figure 5: Samples sprayed with CROP 1K Anti Corrosion Primer.

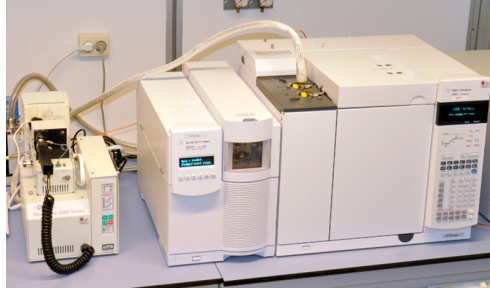
Figure 6: *CDS Analytical Pyroprobe 5000 system. Equipment used for the Thermal Desorption Analysis (TDA).*

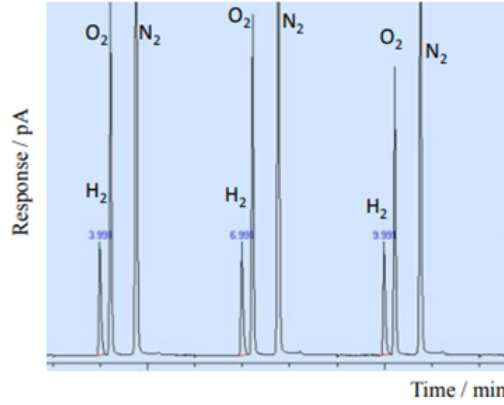
Figure 7: *Peaks obtained from calibration of the equipment. A measurement is performed within 3 minute intervals, where three peaks are detected corresponding to hydrogen, oxygen and nitrogen gases [20].*

minute intervals. In each interval three peaks are detected corresponding to hydrogen, oxygen, and nitrogen gases, illustrated in Figure 7. The measurement is performed 3 times in 3 different samples in order to study the replicability.

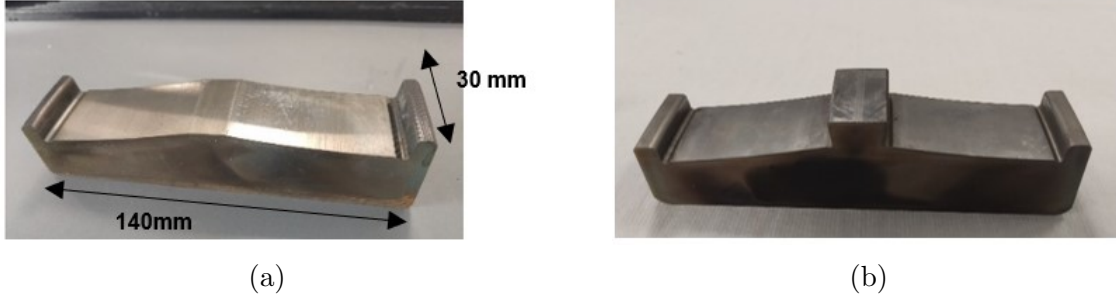
Figure 8: (a) *Segment from Bearing A, non-corroded* (b) *Segment from Bearing B, corroded in P&P industry*

Both inner rings from bearings A and B are cut into 30 mm thick segments. Figure 8a shows a segment obtained from Bearing A, and Figure 8b a segment from Bearing B, severely corroded.

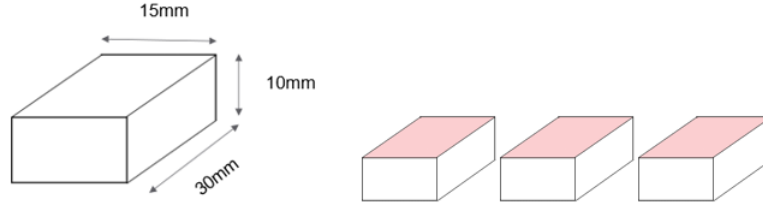
Figure 10: *Measurements of the samples to be exposed in the climate chamber. These are placed in sets of 3. The top red surface represents the exposed surface.*

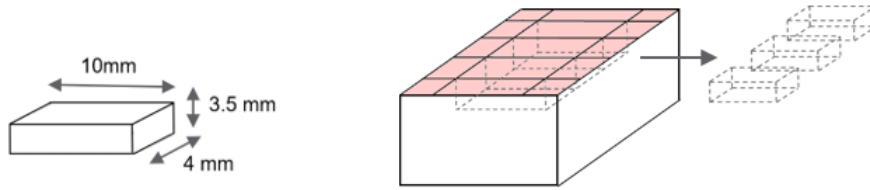
Figure 11: *Subsamples for the MET and TDS, obtained from samples previously cut. The top red surface represents the exposed surface.*

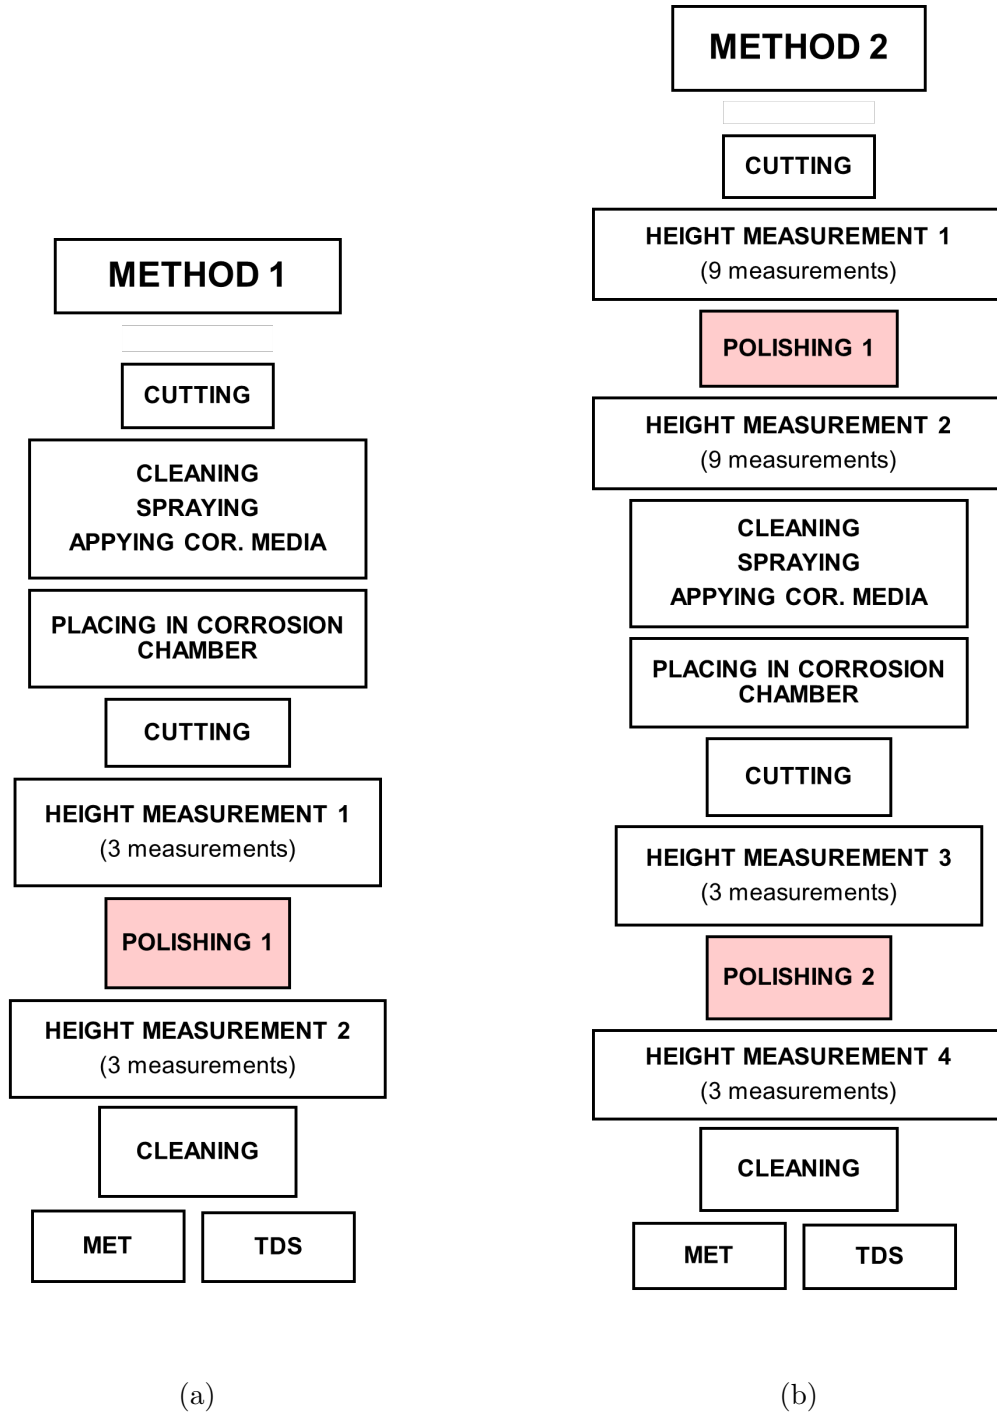
Figure 13: (a) Step by step illustration of METHDD 1, polished after corrosion exposure. (b) Step by step illustration of METHDD 1, polished before and after corrosion exposure.

1, Figure 13a, and METHOD 2, Figure 13b, is used to understand if the exposure of the newly generated surface surface has an effect in the hydrogen absorption.

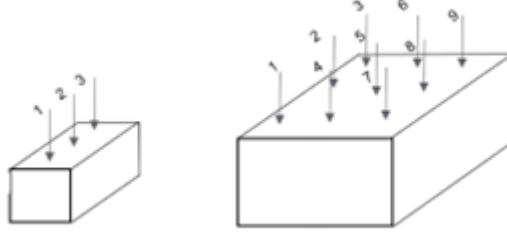
Figure 14: *Illustration of locations for height measurements in METHOD 1 (left) and METHOD 2 (right).*

polishing in 3 different locations. The effect of roughness (METHOD 2) is studied in samples polished before being placed in the chamber. 9 points of the surface are measured in order to cover the whole surface. Both polishing methods are illustrated in Figure 14. Before every height measurement the samples were cleaned ultrasonically for 2 minutes in a bath of PE.

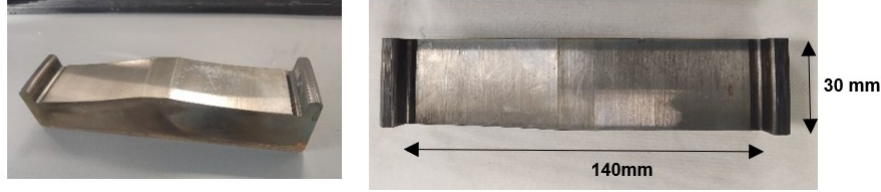
Figure 15: *Lateral and top view of segments obtained from the non-corroded/reference bearing, Bearing A.*

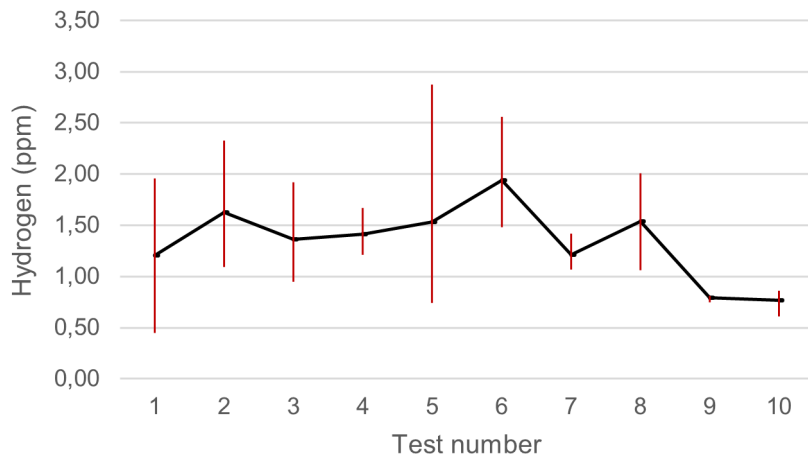
Figure 18: *Hydrogen (ppm) and SD in non-polished reference Bearing A for each test number (1 to 10).*

Test	Reference	
	Hydrogen (ppm)	Oxygen (ppm)
1	1.2 ± 0.8	6.5 ± 2.6
2	1.6 ± 0.6	11.2 ± 7.5
3	1.4 ± 0.5	10.7 ± 1.7
4	1.4 ± 0.2	20.6 ± 8.2
5	1.5 ± 1.2	11.3 ± 0.4
6	2.0 ± 0.6	12.5 ± 3.8
7	1.2 ± 0.2	13.3 ± 1.2
8	1.5 ± 0.5	8.4 ± 0.2
9	0.8 ± 0.0	6.0 ± 1.9
10	0.8 ± 0.1	6.8 ± 4.4

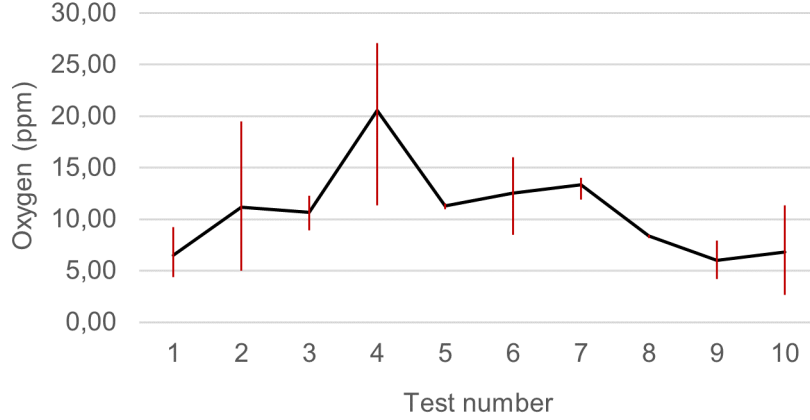
Figure 19: *Oxygen (ppm) vs. test number and deviation in non-polished reference Bearing A for each test number (1 to 10).*

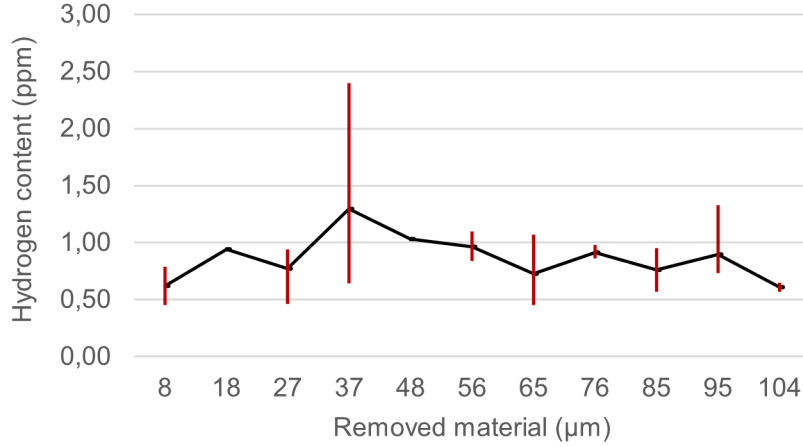
Figure 20: *Hydrogen (ppm) vs. polished material (μm) and corresponding deviation in polished reference Bearing A.*

not completely removed and there is some still left on the surface. After the removal of some more material (40 μm on), a linear trend was visible. Hydrogen content decreases as the removed material increases. Nonetheless, the considered contents are too small and the scatter too notable to make any solid statement. No significant conclusions can be drawn and more tests need to be performed.

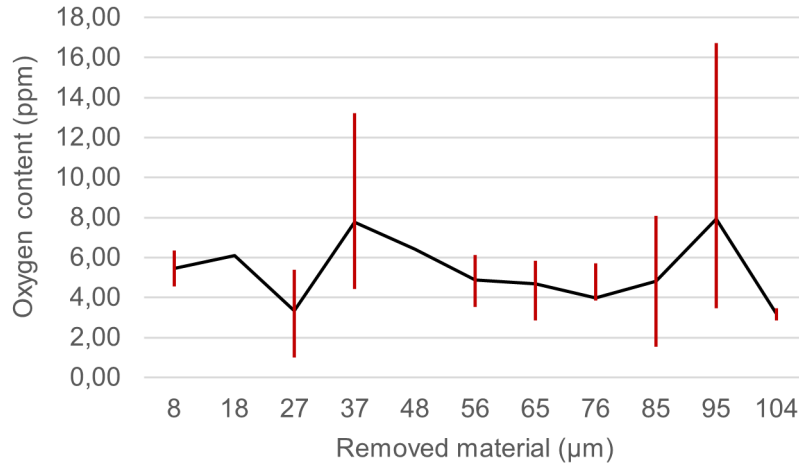
Figure 21: *Oxygen (ppm) vs. polished material (μm) and corresponding deviation in polished reference Bearing A.*

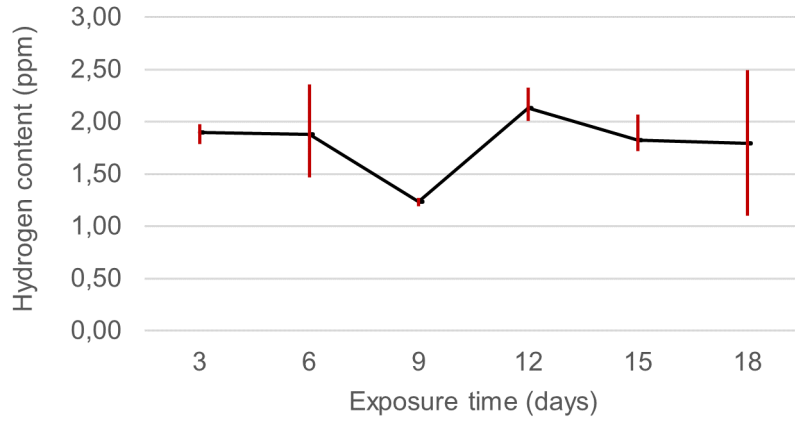
Figure 22: *Hydrogen (ppm) vs. exposure time (days) and corresponding deviation in polished samples exposed to pH 1.5 H_2SO_4 .*

D	3	6	9	12	15	18
H	1.9 ± 0.1	1.9 ± 0.4	1.2 ± 0.0	2.1 ± 0.2	1.8 ± 0.2	1.8 ± 1.0
O	20.8 ± 5.3	19.5 ± 6.6	28.3 ± 7.3	36.5 ± 5.4	34.9 ± 11.1	23.4 ± 13.1
P	38 ± 3.5	48 ± 20.9	81 ± 17.9	49 ± 10.1	134 ± 89.4	63 ± 19.2

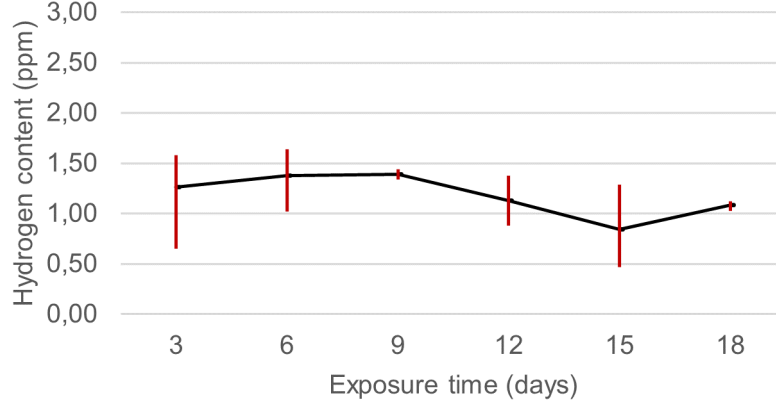
Figure 23: *Hydrogen (ppm) vs. exposure time (days) and corresponding deviation in polished samples exposed to pH 3.5 H_2SO_4 .*

D	3	6	9	12	15	18
H	1.3 ± 0.5	1.4 ± 0.3	1.4 ± 0.0	1.1 ± 0.2	0.8 ± 0.4	1.0 ± 0.0
O	12.8 ± 3.1	10.9 ± 5.2	11.3 ± 1.8	11.7 ± 0.4	6.7 ± 1.0	27.4 ± 12.5
P	35 ± 13.4	14 ± 7.3	17 ± 8.0	34 ± 9.4	27 ± 12.5	61 ± 28.1

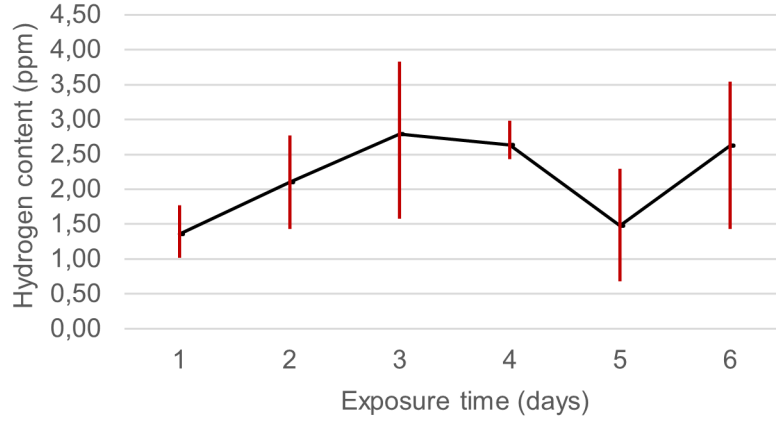
Figure 24: *Hydrogen (ppm) vs. exposure time (days) and corresponding deviation in polished samples exposed to pH 7 0.1 M NaCl.*

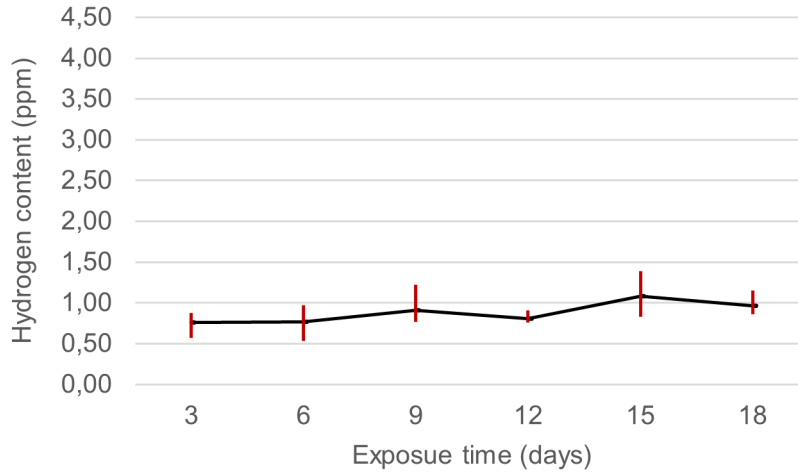
Figure 25: *Hydrogen (ppm) vs. exposure time (days) and corresponding deviation in polished samples exposed to pH 7 0.6 M NaCl.*

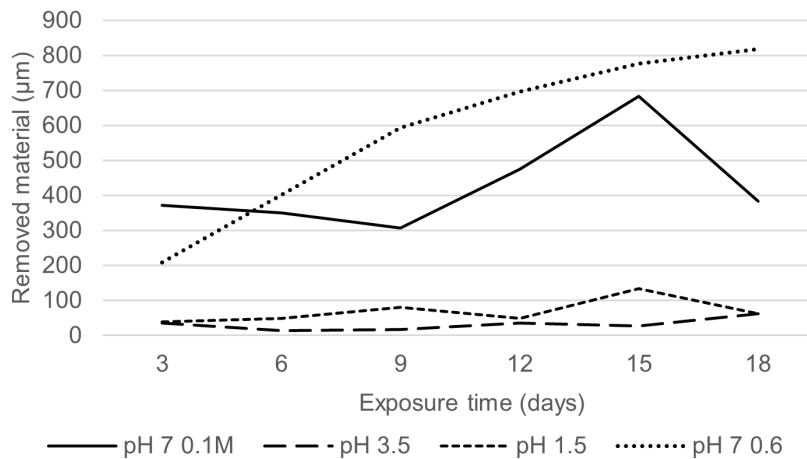
Figure 26: *Polished material (μm) vs. exposure time (and) and corresponding deviation in polished samples exposed to pH 1.5 H_2SO_4 , pH 3.5 H_2SO_4 , pH 7 0.1 M NaCl and pH 7 0.6 M NaCl.*

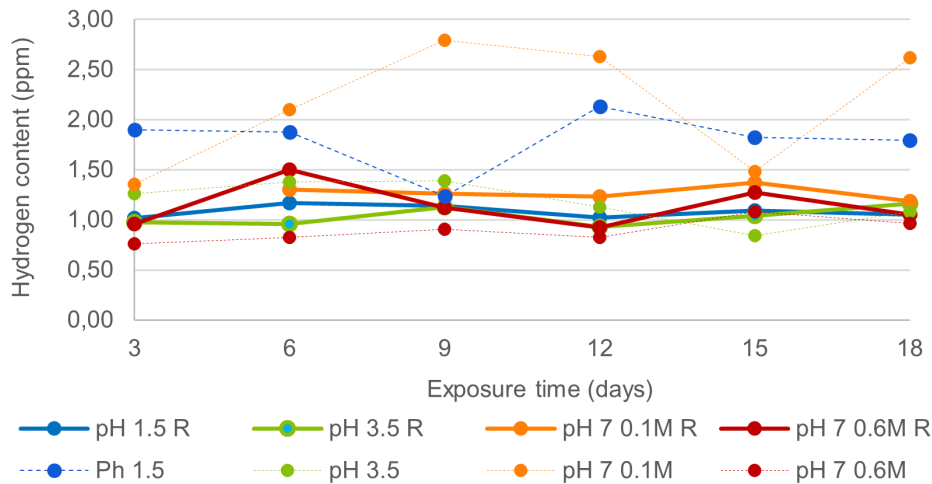
Figure 27: *Hydrogen (ppm) vs. exposure time under pH 1.5 H_2SO_4 , pH 3.5 H_2SO_4 , pH 7 0.1 M NaCl and pH 7 0.6 M NaCl in samples polished before exposure corrosion (R), and non-polished before exposure.*

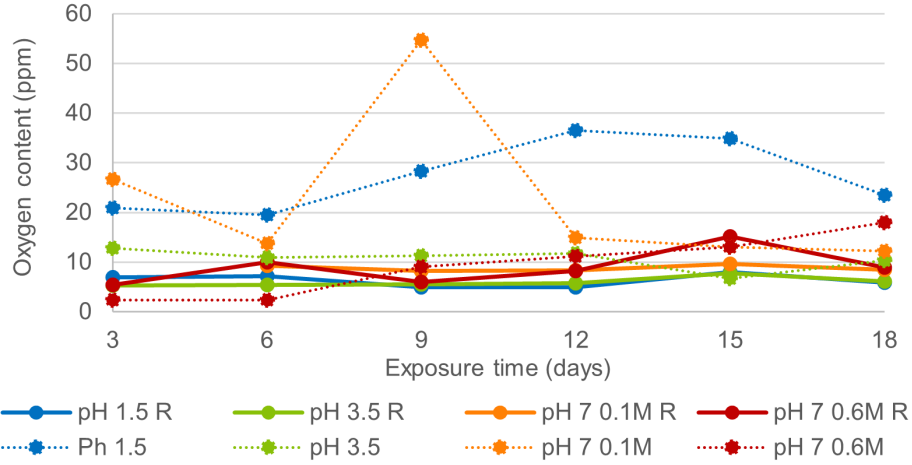
Figure 28: *Oxygen (ppm) vs. exposure time under pH 1.5 H_2SO_4 , pH 3.5 H_2SO_4 , pH 7 0.1 M NaCl and pH 7 0.6 M NaCl in samples polished before exposure corrosion (R), and non-polished before exposure.*

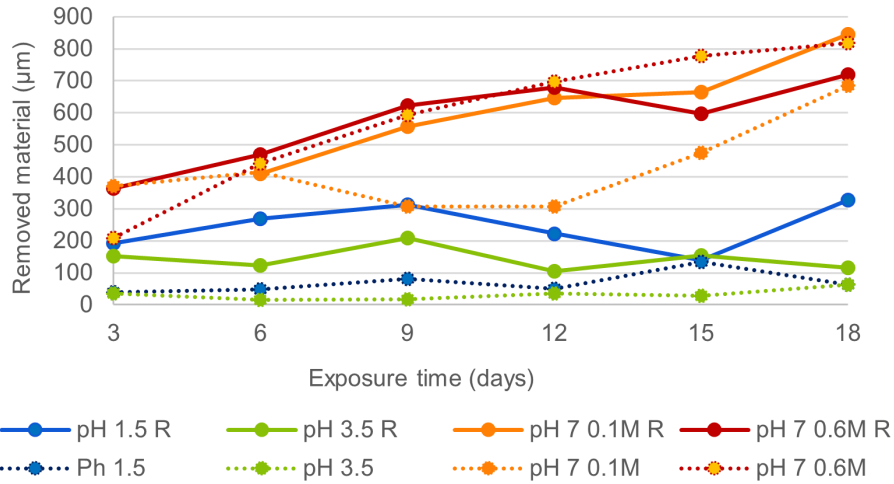
Figure 29: *Removed material (μm) vs. exposure time under pH 1.5 H_2SO_4 , pH 3.5 H_2SO_4 , pH 7 0.1 M NaCl and pH 7 0.6 M NaCl in samples polished before exposure corrosion (R), and non-polished before exposure.*

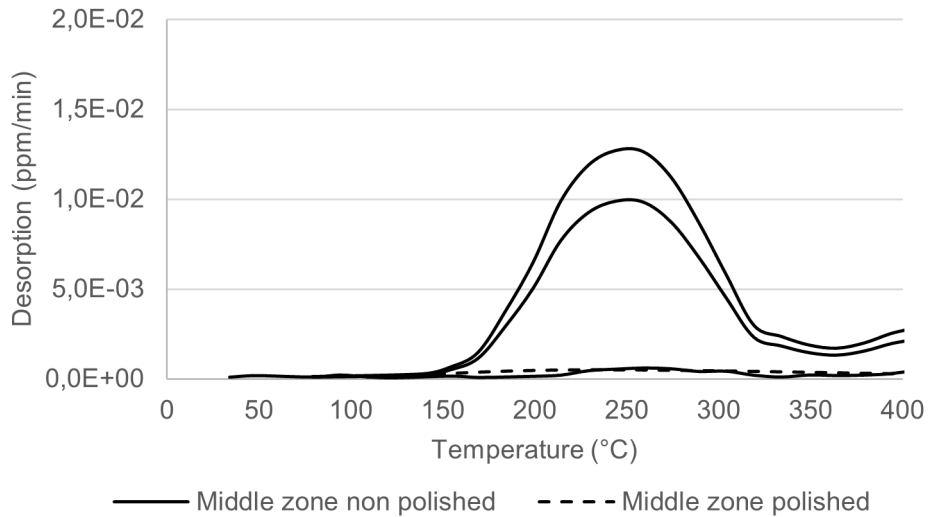
Figure 30: *Hydrogen desorption rate (ppm/min) vs temperature (°C) in corroded front middle zone (CM).*

Sample / zone	Hydrogen (ppm)	Removed material (μm)
Corroded middle non-polished (CM)	0.2 ± 0.2	0
Corroded middle polished (CM)	-	40.7 ± 28.4

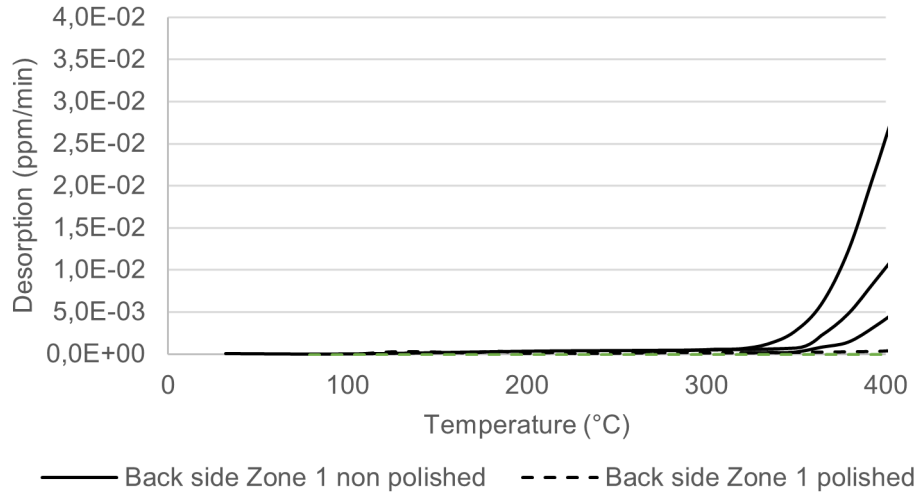
Figure 31: *Hydrogen desorption rate (ppm/min) vs temperature (°C) in corroded Back Zone 1 (CBK1).*

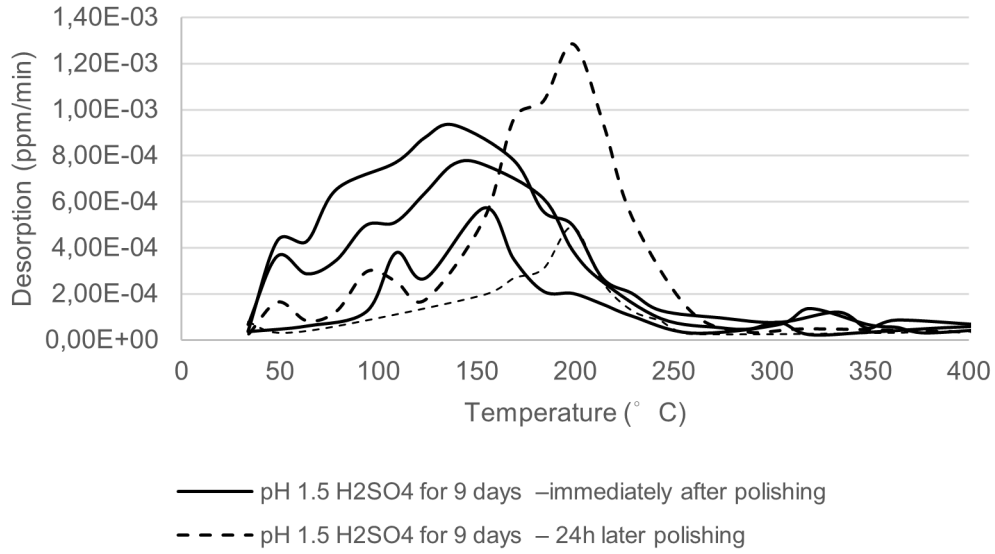
Figure 32: *Hydrogen desorption rate (ppm/min) vs temperature (°C) in polished samples exposed to pH 1.5 H₂SO₄ for 9 days; taken out from the chamber, polished and measured immediately (polished), and measured 24h after (prepolished).*

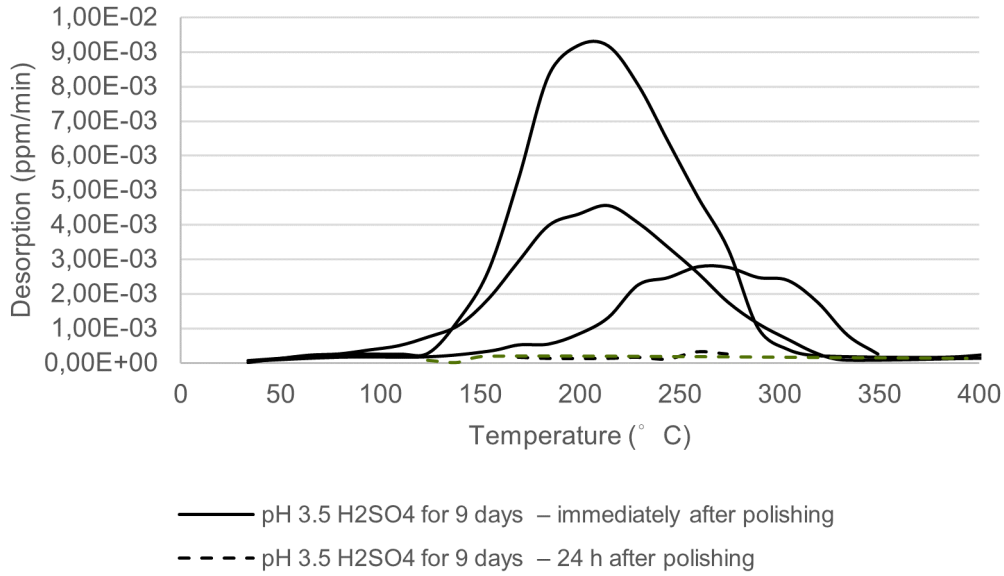
Figure 33: *Hydrogen desorption rate (ppm/min) vs temperature ($^{\circ}\text{C}$) in polished samples exposed to pH 3.5 H_2SO_4 for 9 days; taken out from the chamber, polished and measured immediately (polished), and measured 24h after (prepolished).*

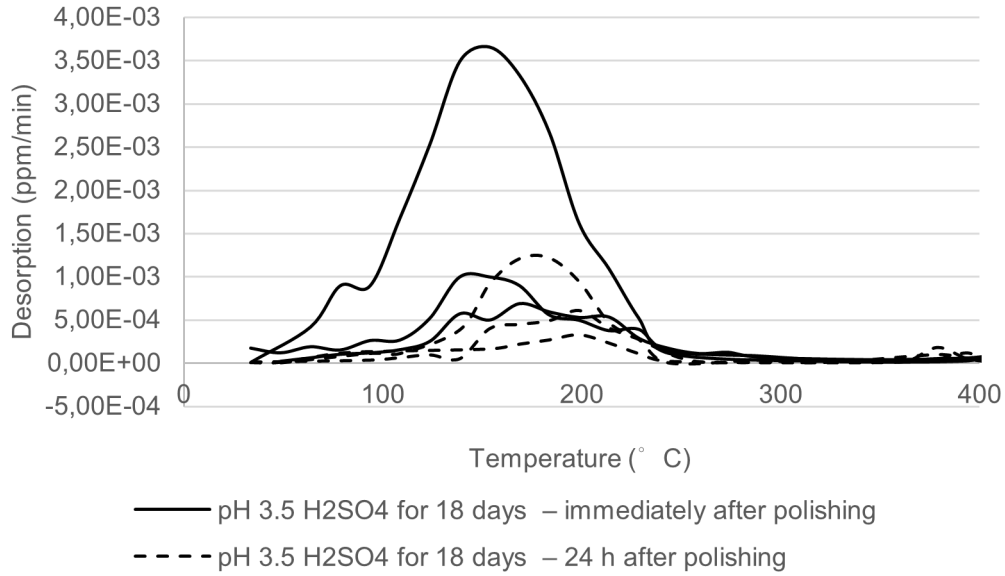
Figure 34: *Hydrogen desorption rate (ppm/min) vs temperature (°C) in polished samples exposed to pH 3.5 H₂SO₄ for 18 days; taken out from the chamber, polished and measured immediately (polished), and measured 24h after (prepolished).*

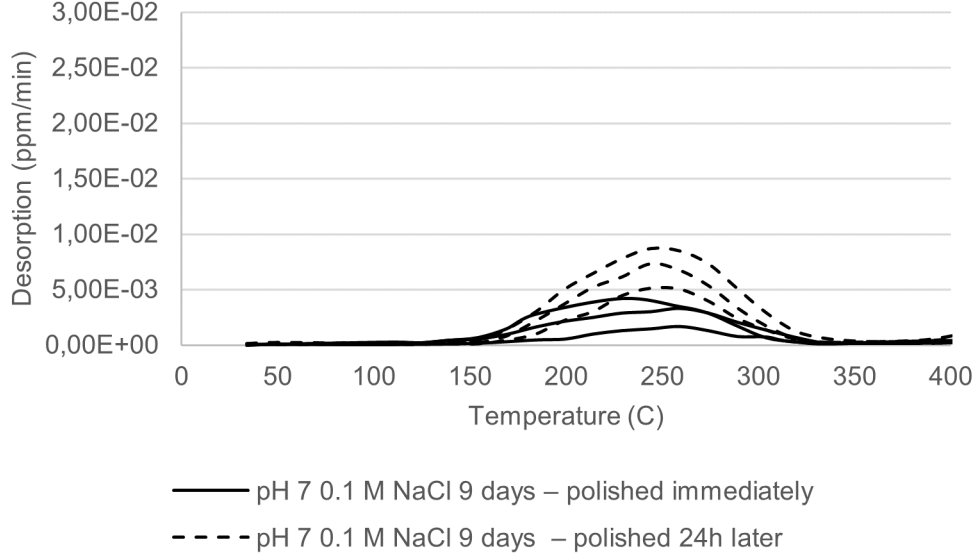
Figure 35: *Hydrogen desorption rate (ppm/min) vs temperature (°C) in polished samples exposed to pH 7 0.1 M NaCl for 9 days; taken out from the chamber, polished and measured immediately (polished), and measured 24h after (prepolished).*

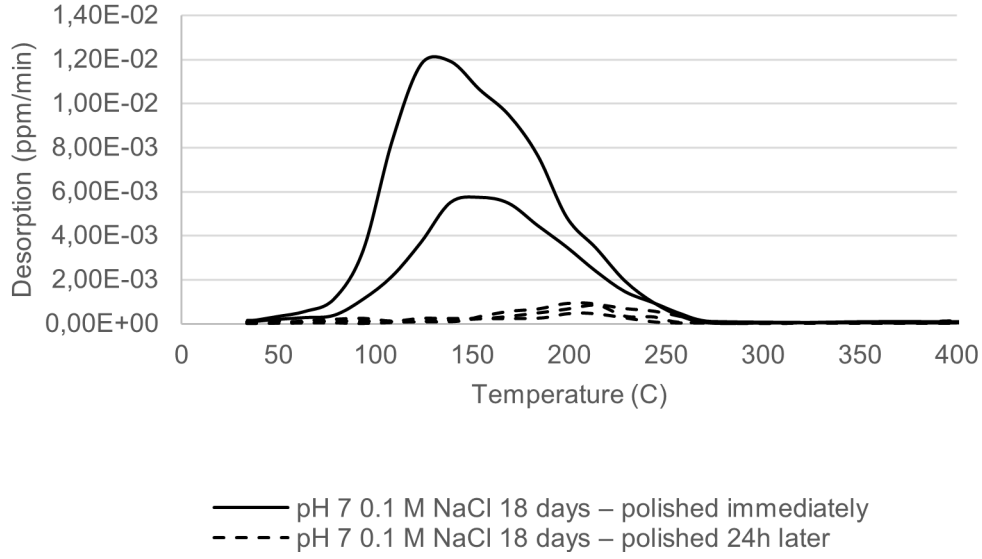
Figure 36: *Hydrogen desorption rate (ppm/min) vs temperature ($^{\circ}\text{C}$) in polished samples exposed to pH 7 0.1 M NaCl for 18 days; taken out from the chamber, polished and measured immediately (polished), and measured 24h after (prepolished).*

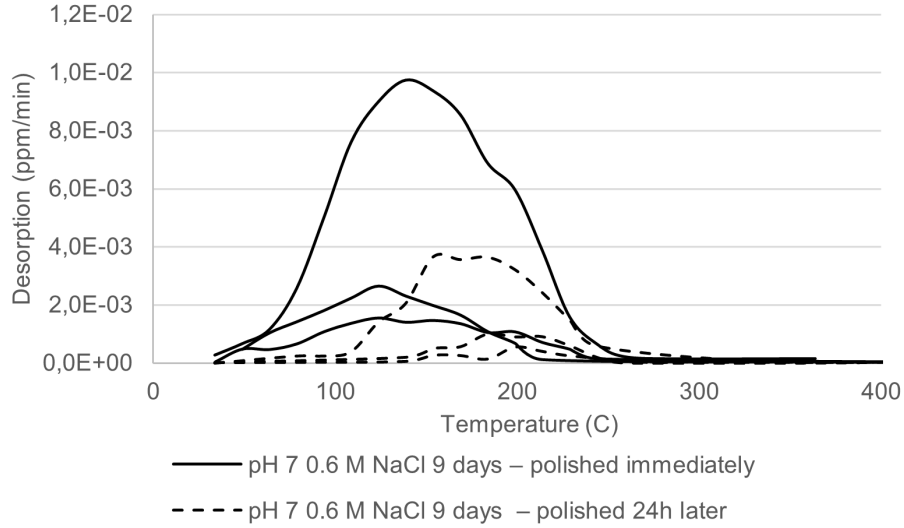
Figure 37: *Hydrogen desorption rate (ppm/min) vs temperature ($^{\circ}\text{C}$) in polished samples exposed to pH 7 0.6 M NaCl for 9 days; taken out from the chamber, polished and measured immediately (polished), and measured 24h after (prepolished).*

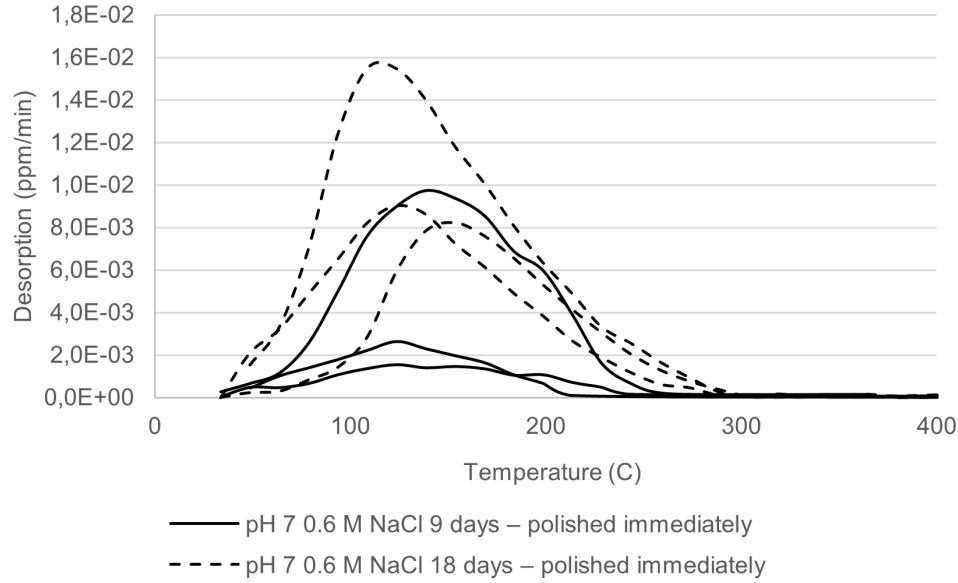
Figure 38: *Hydrogen desorption rate (ppm/min) vs temperature (°C) in polished samples exposed to pH 7 0.6 M NaCl for 9 and 18 days; taken out from the chamber, polished and measured immediately (polished), and measured 24h after (prepolished).*

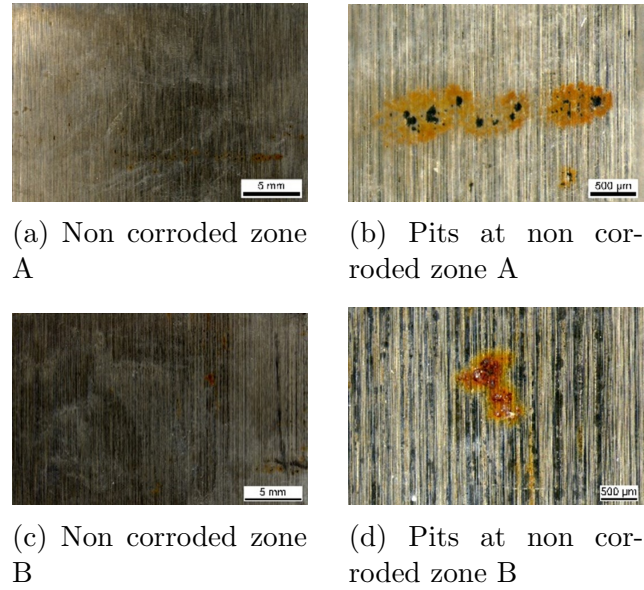
Figure 39: OM images of pits found in the raceway of the non-corroded/reference segment. Two different locations (top and bottom) where corrosion pits are found. On the right a closer look of these pits is shown.

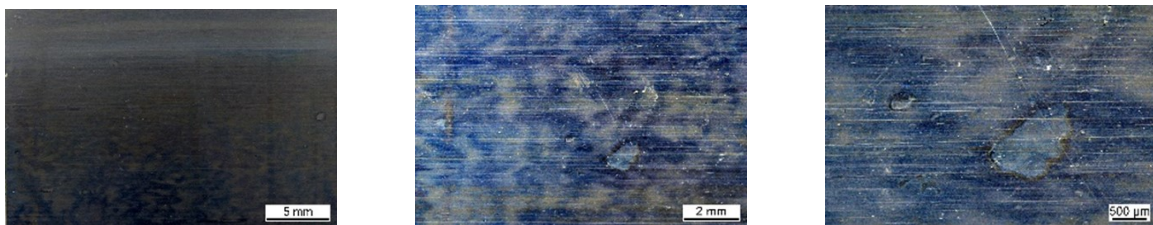
Figure 40: Left side of the raceway from the corroded bearing. The figures correspond to the same area (CL) but at different locations and focus. Small pits are visible at the surface.

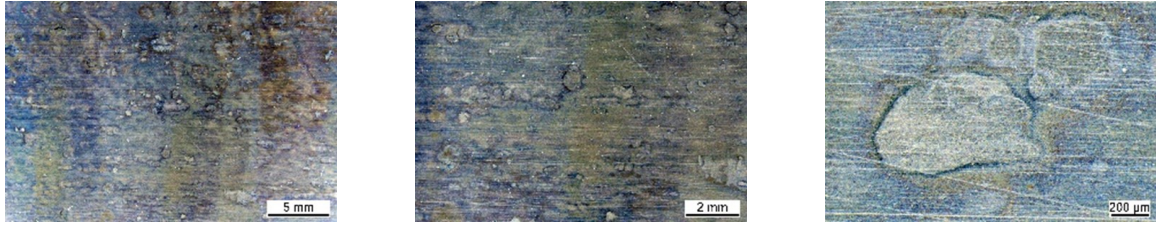
Figure 41: Right side of the raceway from the corroded bearing. The figures correspond to the same area (CR) but at different locations and focus. Small pits are visible at the surface.

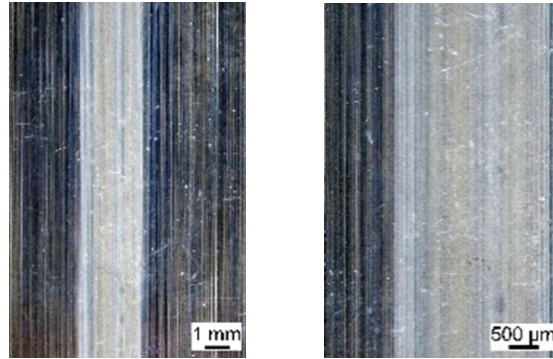
Figure 42: Middle zone of the raceway from the corroded bearing. The figures correspond to the same area (CM) but at different locations/focus. A wear mark is visible.

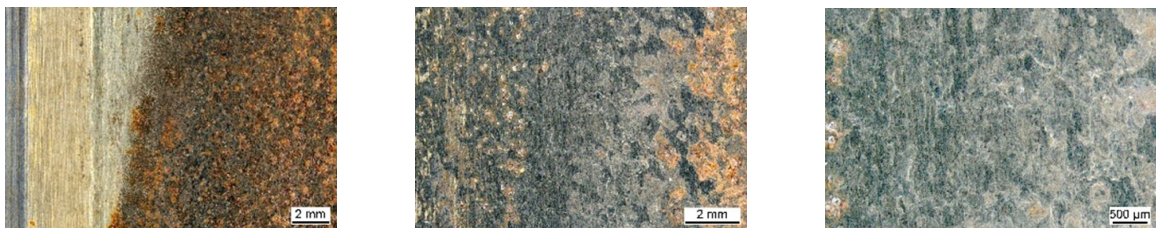
Figure 43: Corroded zone 1, CBK1 zone, in the back side of the corroded bearing.

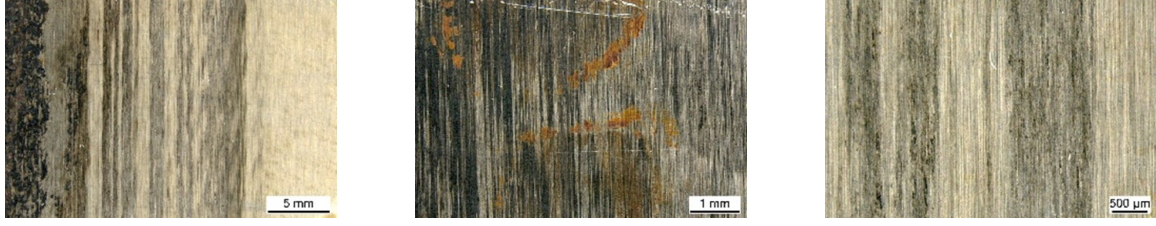
Figure 44: Corroded zone 2, CBK2 zone, in the back side of the corroded bearing.

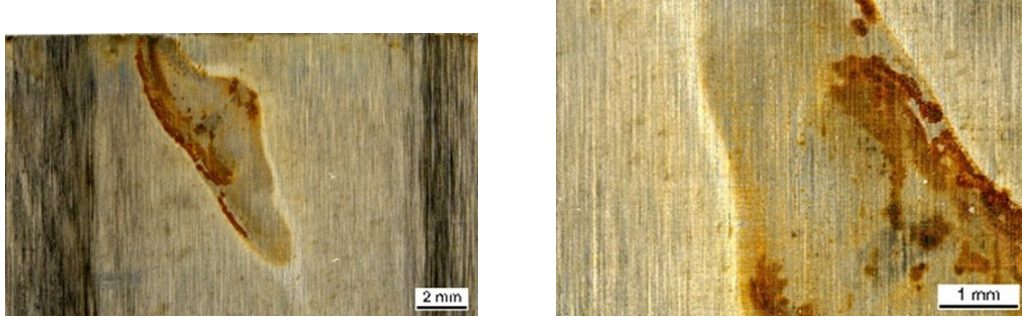
Figure 45: Corroded zone 3, CBK3 zone, in the back side of the corroded bearing.

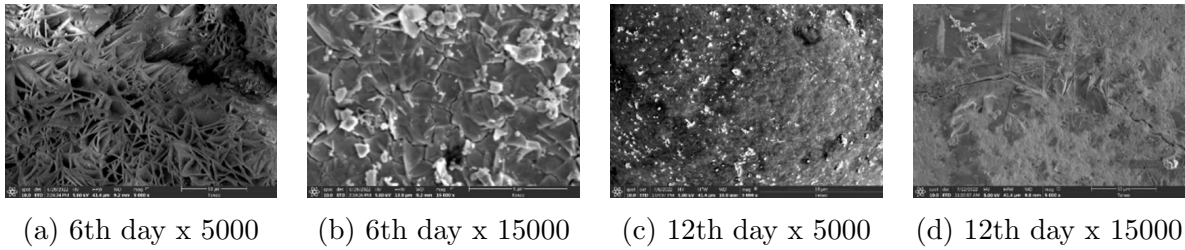
Figure 48: Corrosion product morphology of samples exposed to pH 7 NaCl 0.1 M (Exposure time and magnification).

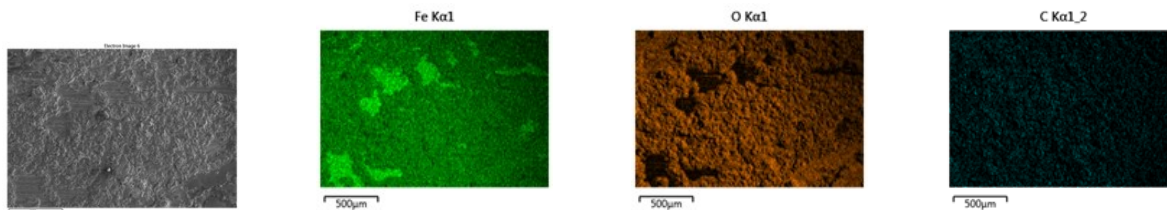
Figure 49: EDS mapping of the product, 9th day exposed to pH 7 NaCl 0.1 M.

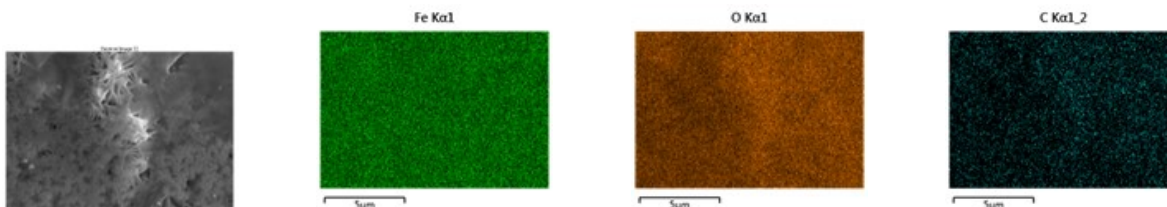
Figure 50: EDS mapping of the product, 15th day exposed to pH 7 NaCl 0.1 M.

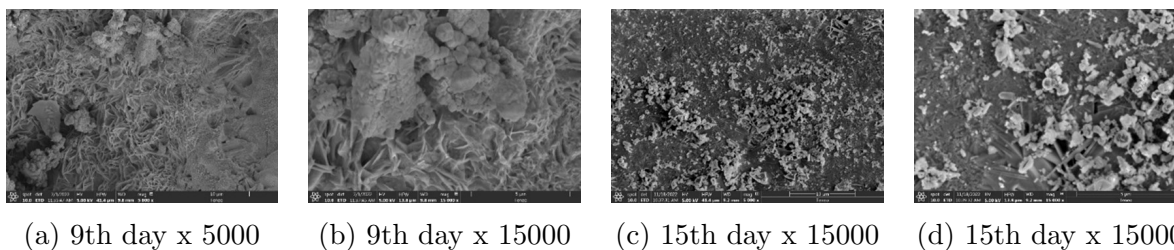
Figure 51: Corrosion product morphology of samples exposed to pH 7 NaCl 0.6 M (Exposure time and magnification).

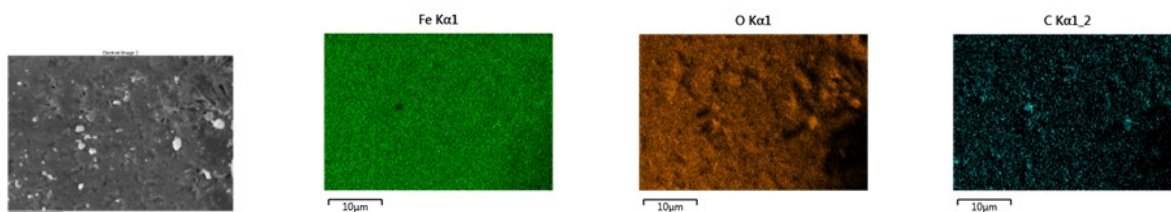
Figure 52: EDS mapping of the product, 9th day exposed to pH 7 NaCl 0.6 M.

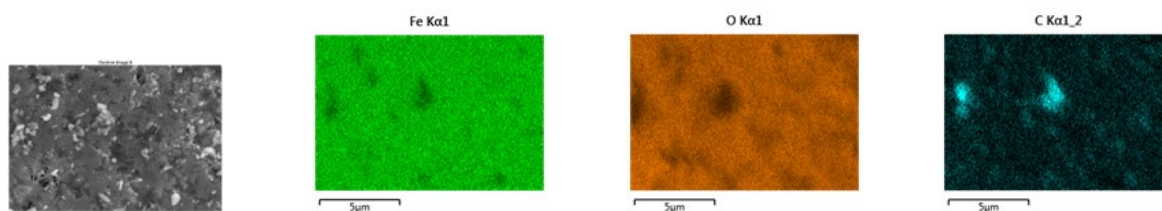
Figure 53: EDS mapping of the product, 15th day exposed to pH 7 NaCl 0.6 M.

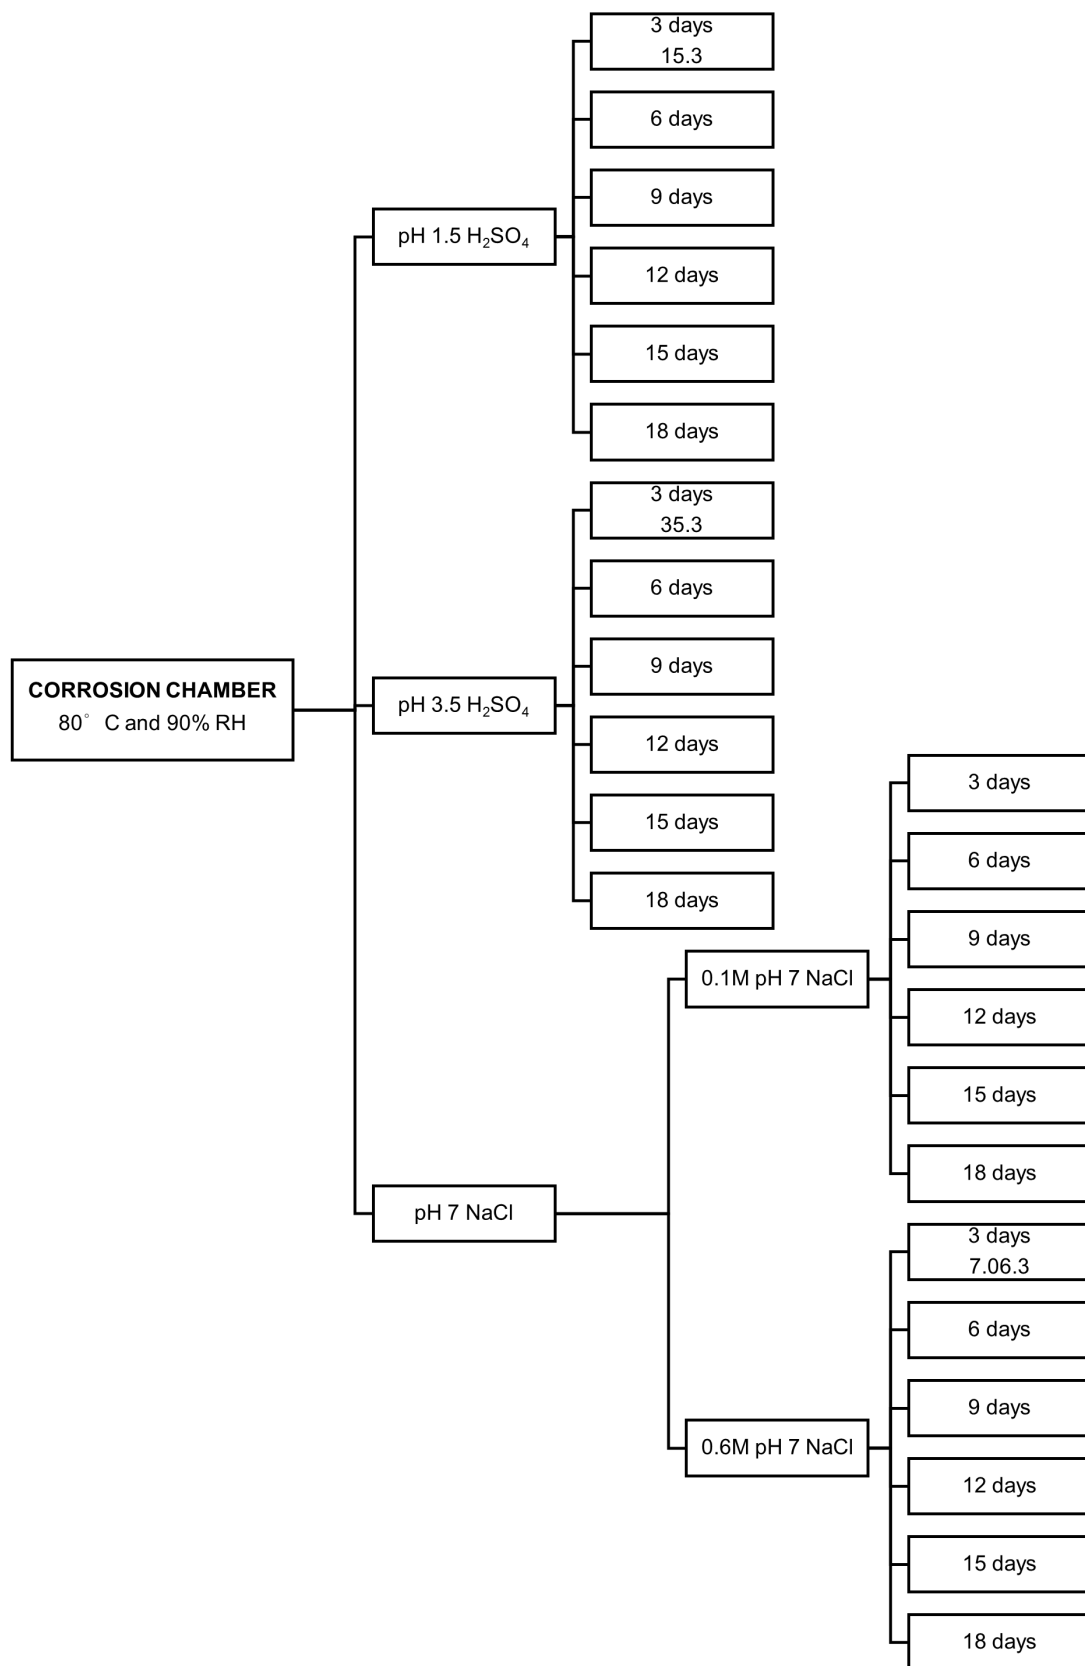
Figure 54: Overview of samples placed in the corrosion chamber. These are organized based on the applied corrosive media and the exposure time.

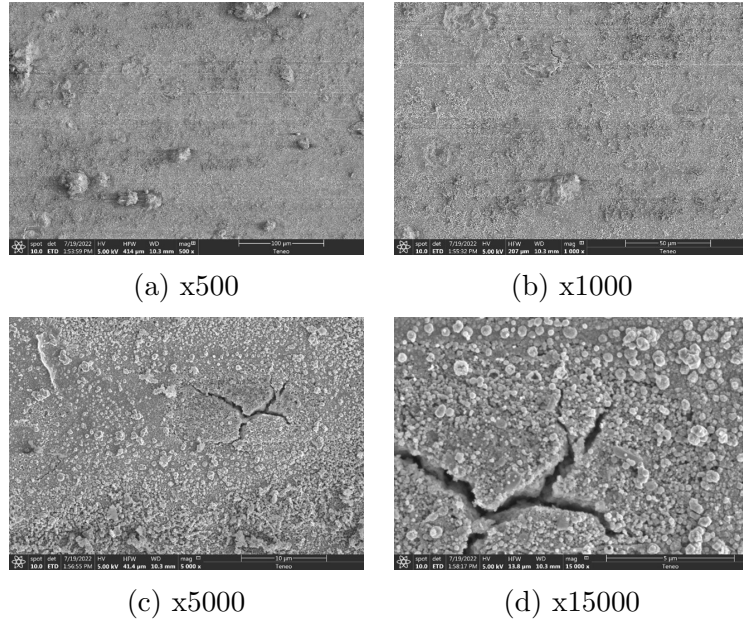
Figure 57: Corrosion product on samples exposed to pH 1.5 H_2SO_4 15 days

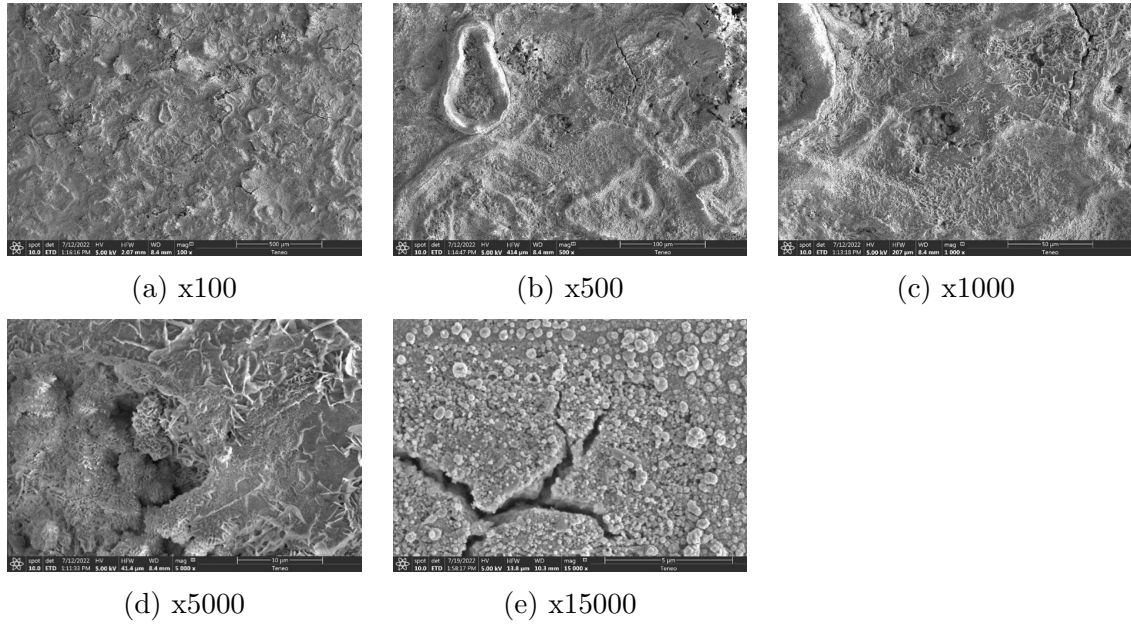
Figure 58: Corrosion product on samples exposed to pH 1.5 H_2SO_4 18 days

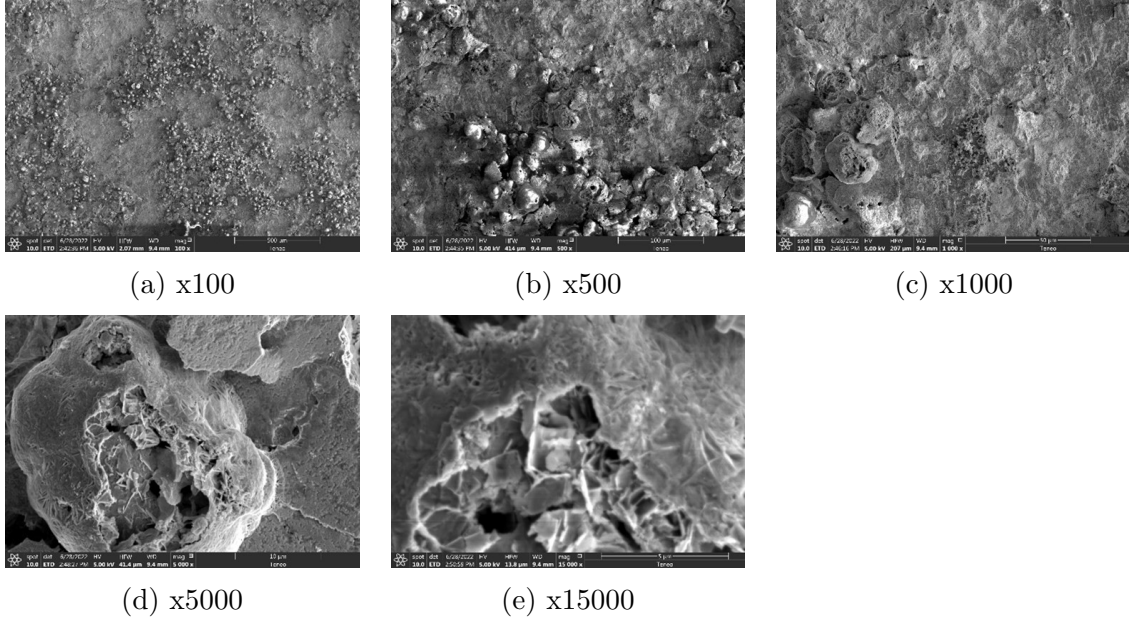
Figure 59: Corrosion product on samples exposed to pH 3.5 H_2SO_4 9 days
