Delft University of Technology

**Hydrogen absorption and conservation of operational
capabilities in remanufactured bearing steel exposed to
corrosion**

*A thesis submitted in partial fulfilment of the requirements
for the degree of Master of Science in*

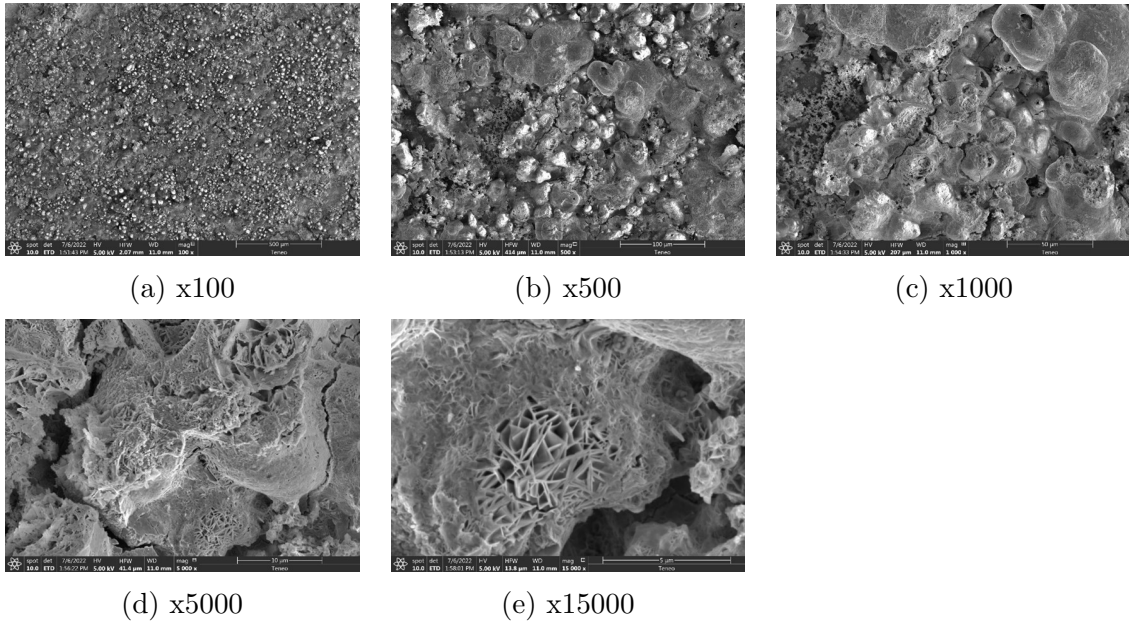
Figure 60: Corrosion product on samples exposed to pH 3.5 H_2SO_4 12 days

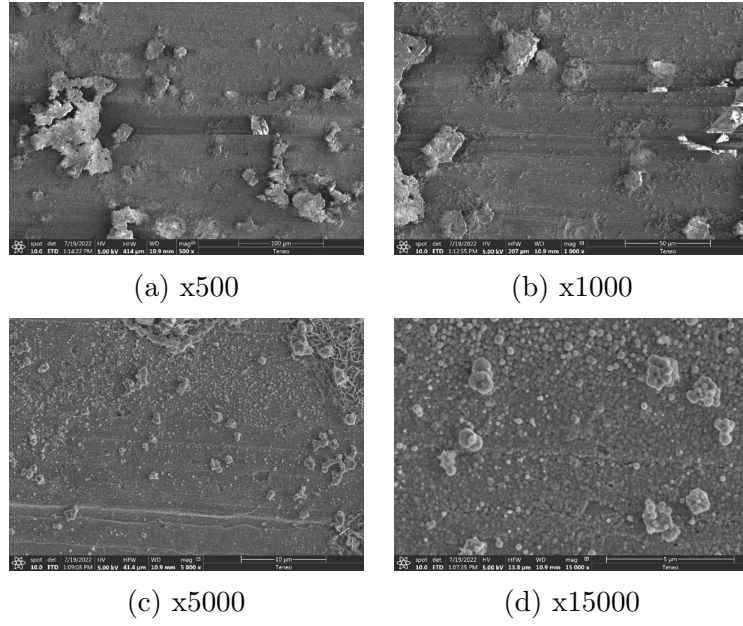
Figure 61: Corrosion product on samples exposed to pH 3.5 H_2SO_4 15 days

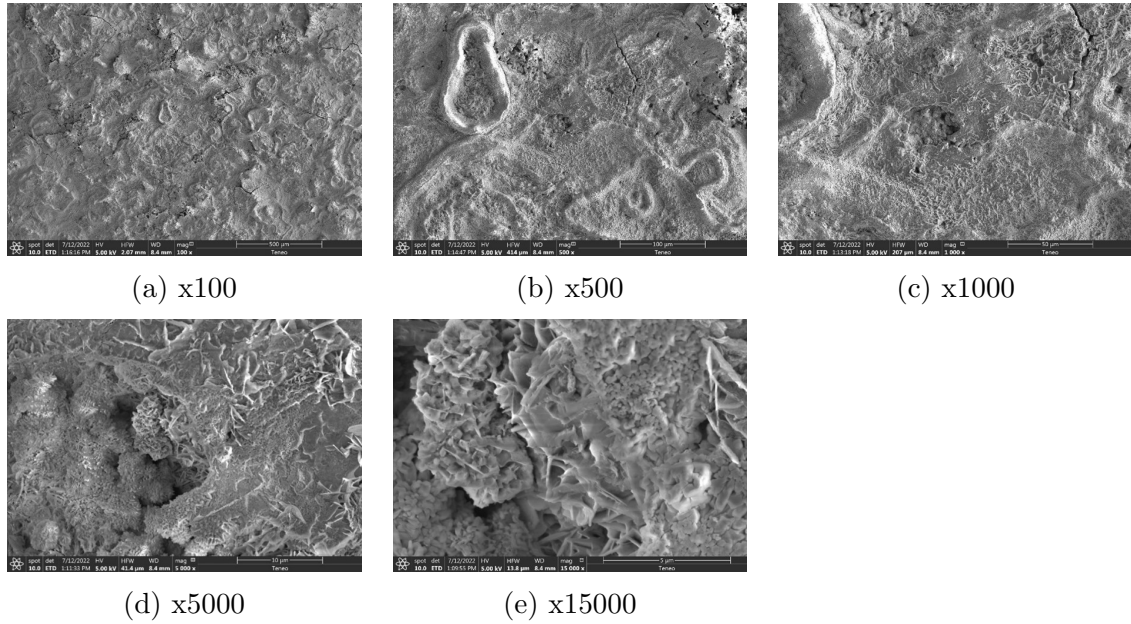
Figure 62: Corrosion product on samples exposed to pH 3.5 H_2SO_4 18 days

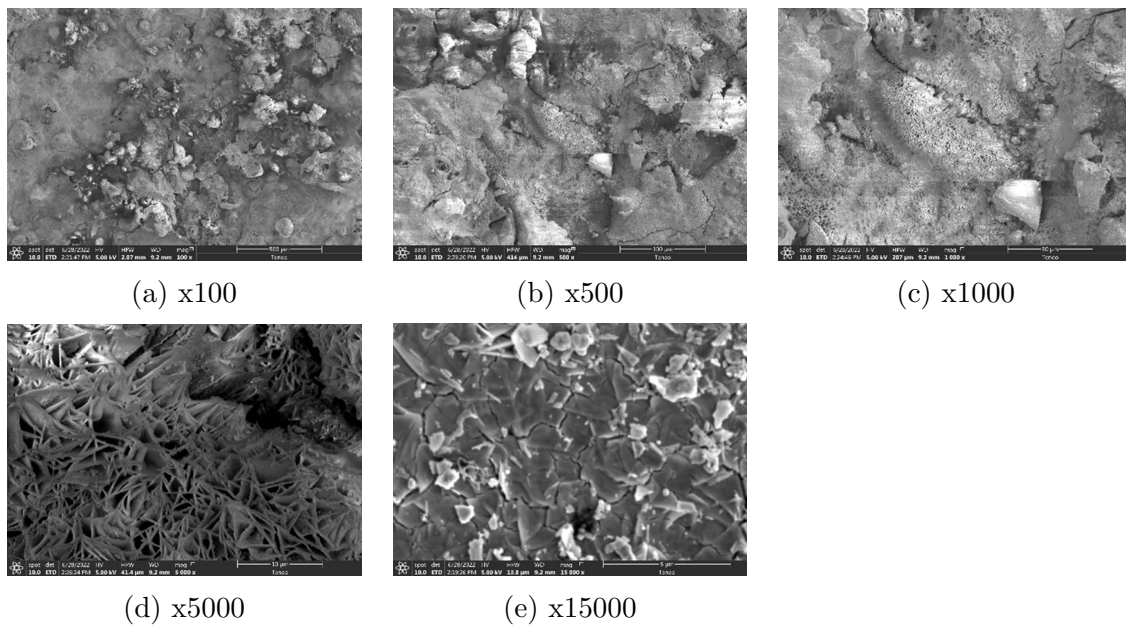
Figure 63: Corrosion product on samples exposed to pH 7 0.1 M NaCl 6 days

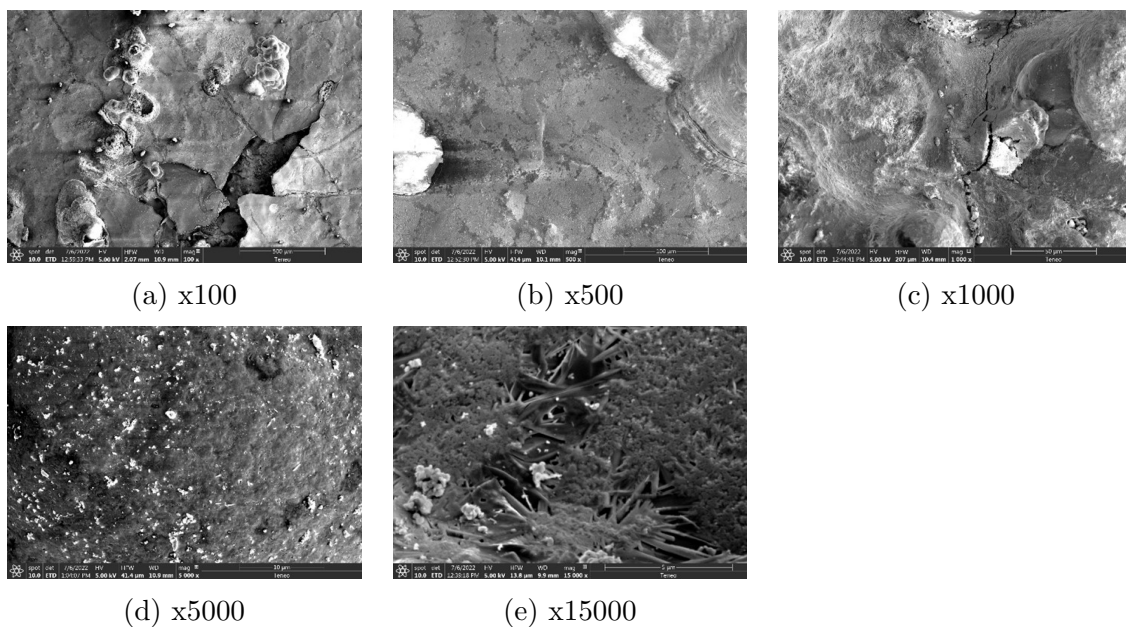
Figure 64: Corrosion product on samples exposed to pH 7 0.1 M NaCl 12 days

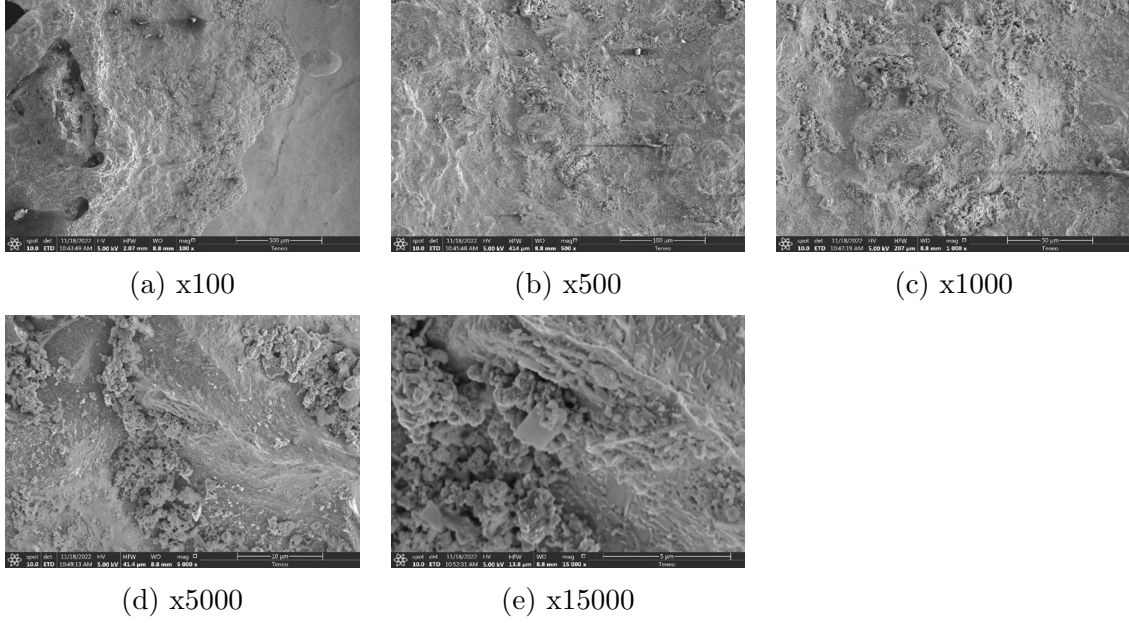
Figure 65: Corrosion product on samples exposed to pH 7 0.6 M NaCl 9 days

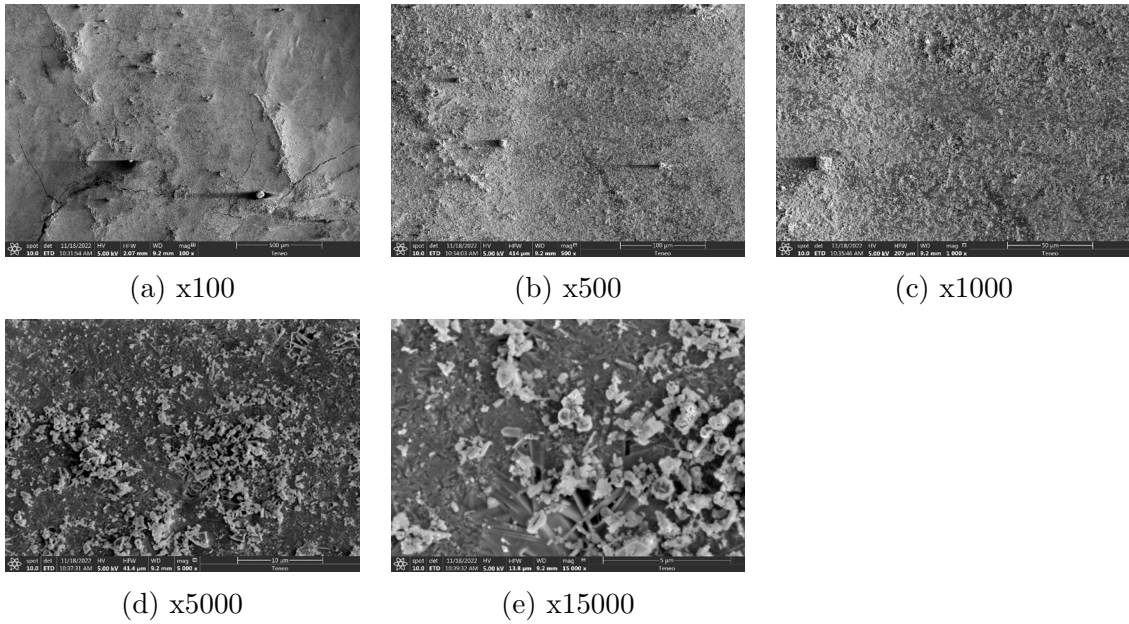
Figure 66: Corrosion product on samples exposed to pH 7 0.6 M NaCl 15 days
