3 Continue with Cuypers Renovation of the Rijksmuseum

Paul Meurs

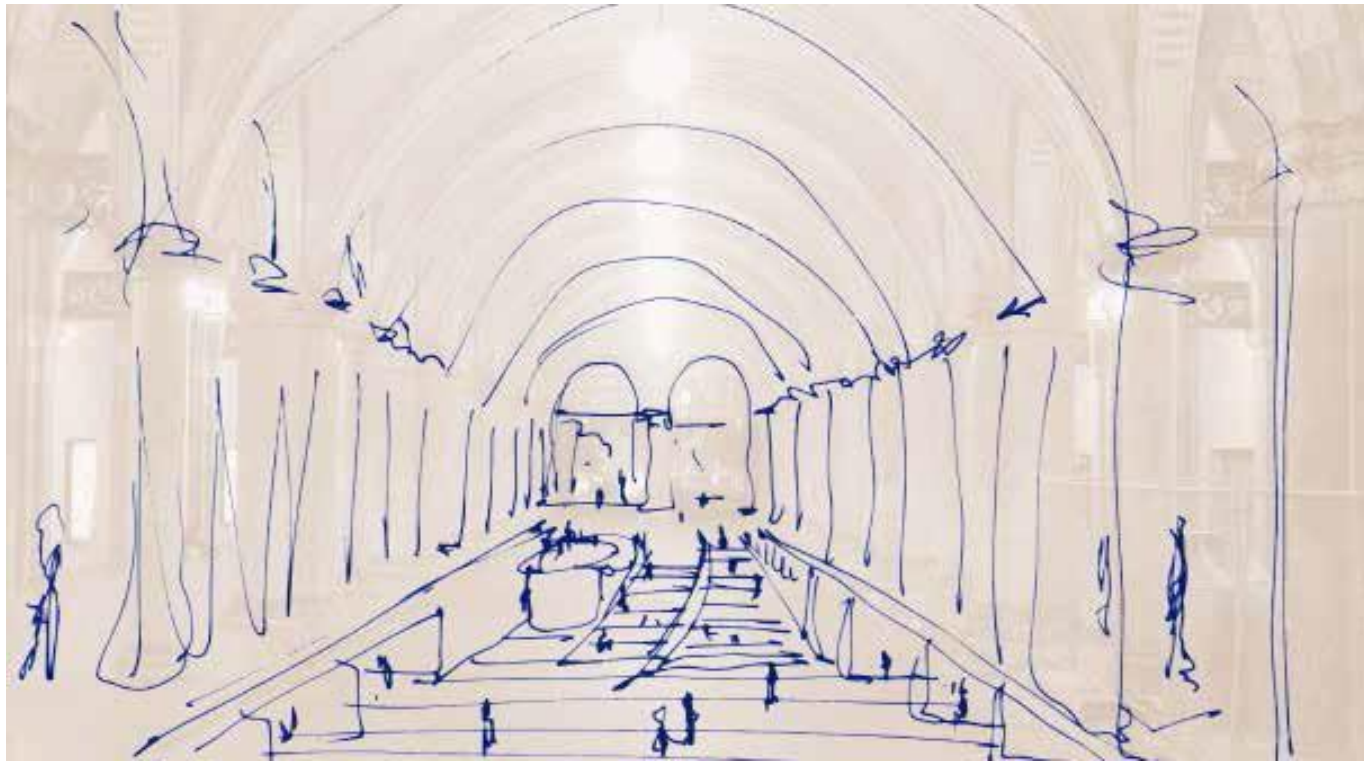
3.01

3.1 Sketch of the lowered entrance area in the central passageway, Cruzy Ortiz 2001.

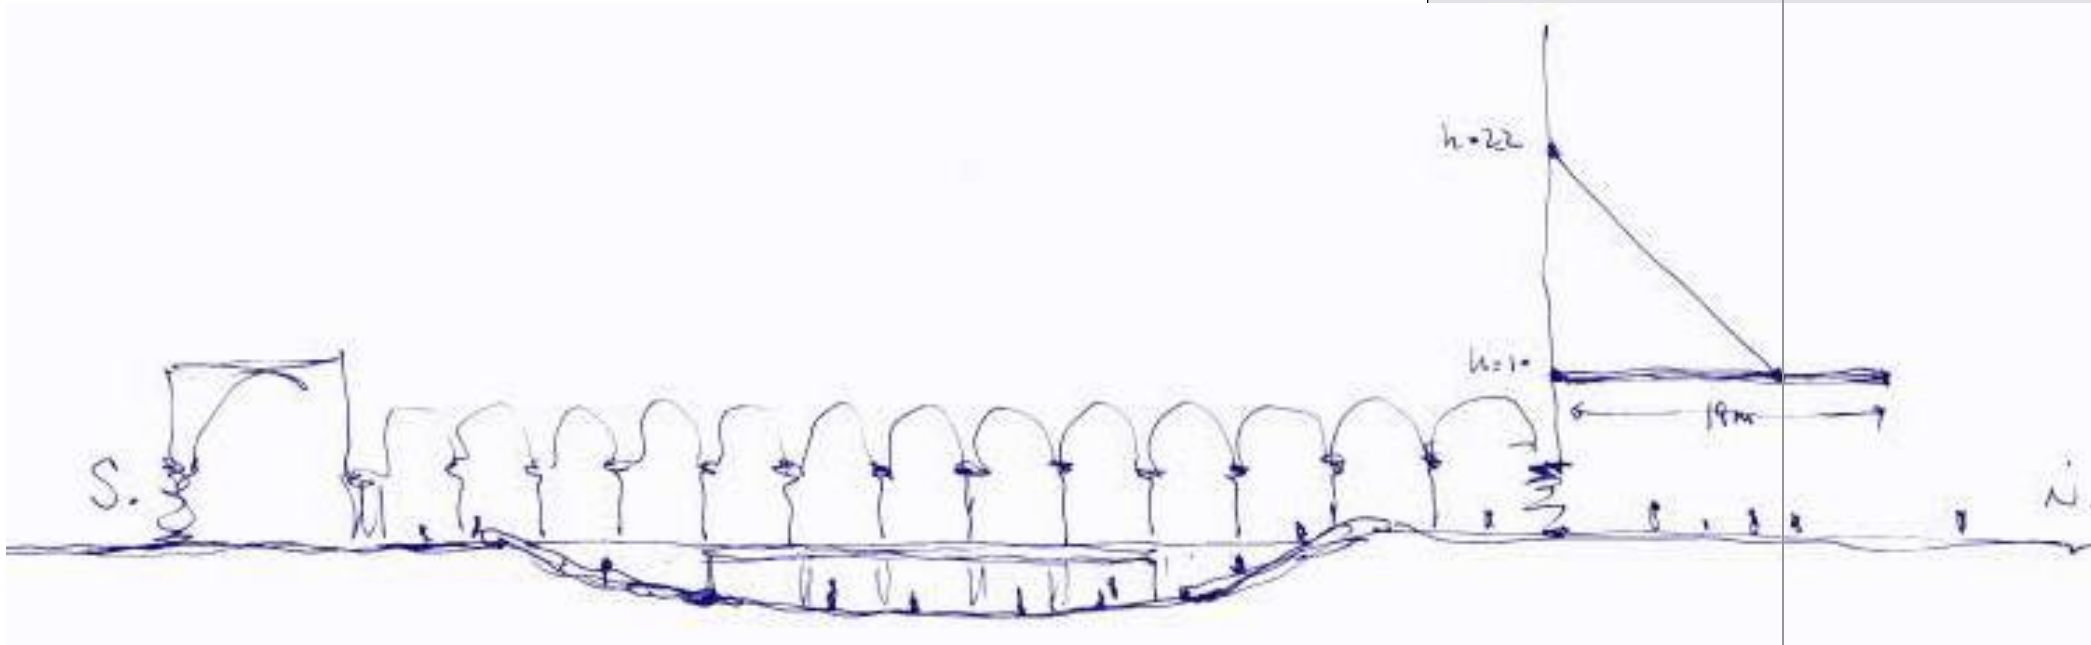
3.02

3.2 Longitudinal sketch of the central passageway with the connection between the lowered courtyards beneath it. A glass awning has been added on the city side.

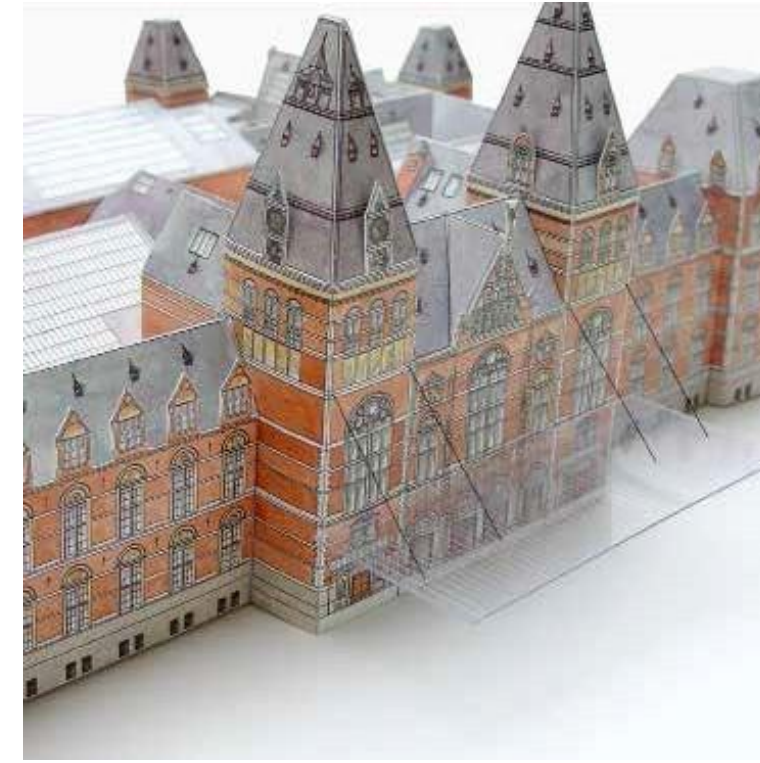
3.03

3.3 Impression of the glass awning attached to the front façade.

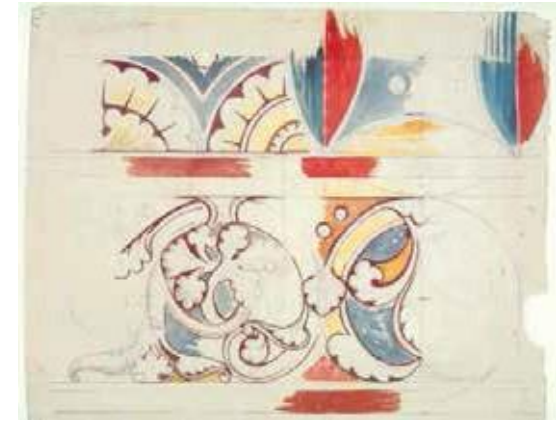
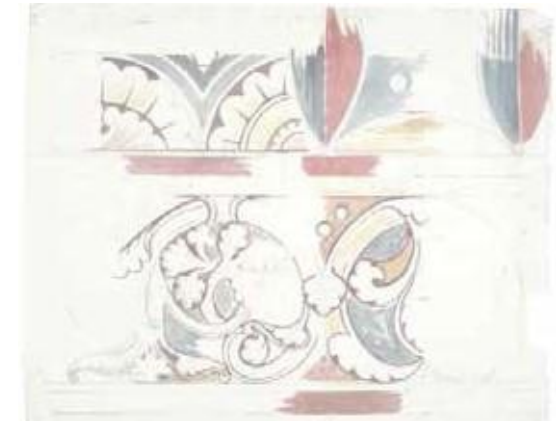
3.04

3.4 Proposal for toning down the bright colours in the interior.

Night Watch Gallery. The decision to use the main building almost entirely as exhibition space meant that the offices, storerooms and supporting functions would have to move to neighbouring buildings or disappear from Amsterdam altogether. Three additions completed the ensemble: an awning on Stadhouderskade, the Asian Pavilion between the main building and the South Wing, and a basement below the courtyards containing an auditorium, educational spaces and service areas (3.03, 3.07, 3.17-3.21). There was no plan for the garden. The architects wanted to restore Cuypers' decorations in some places, but in muted colours so that they would not compete with the collection. For the sake of the acoustics they suggested carpet woven with the pattern of Cuypers' mosaic floors. For the courtyards they designed huge crystal chandeliers to filter the daylight and to give the entrance hall a ceiling and a sense of coherence (3.29-3.32). The assessment committee spoke (unanimously) of a lucid concept that resolved the logistical problems of the Rijksmuseum and delivered a fine entrance. The Asian Pavilion was regarded as a stroke of genius. The only ideas rejected by the committee were those for carpet in the galleries and an awning on Stadhouderskade.¹⁵ Since the committee did not consider these elements essential to the design, it assumed that good alternatives could be found at a later date. It is unclear why the idea of hanging a huge awning on the main facade did not attract the same judgement as many other interventions, namely that 'inside and outside the contours of the building . . . [they] were perceived to be too drastic and/or inappropriate'. Of the plans regarding Cuypers' interior, all that remained was the suggestion to tone down the bright colours and for the rest to make the galleries as light as possible (3.04).

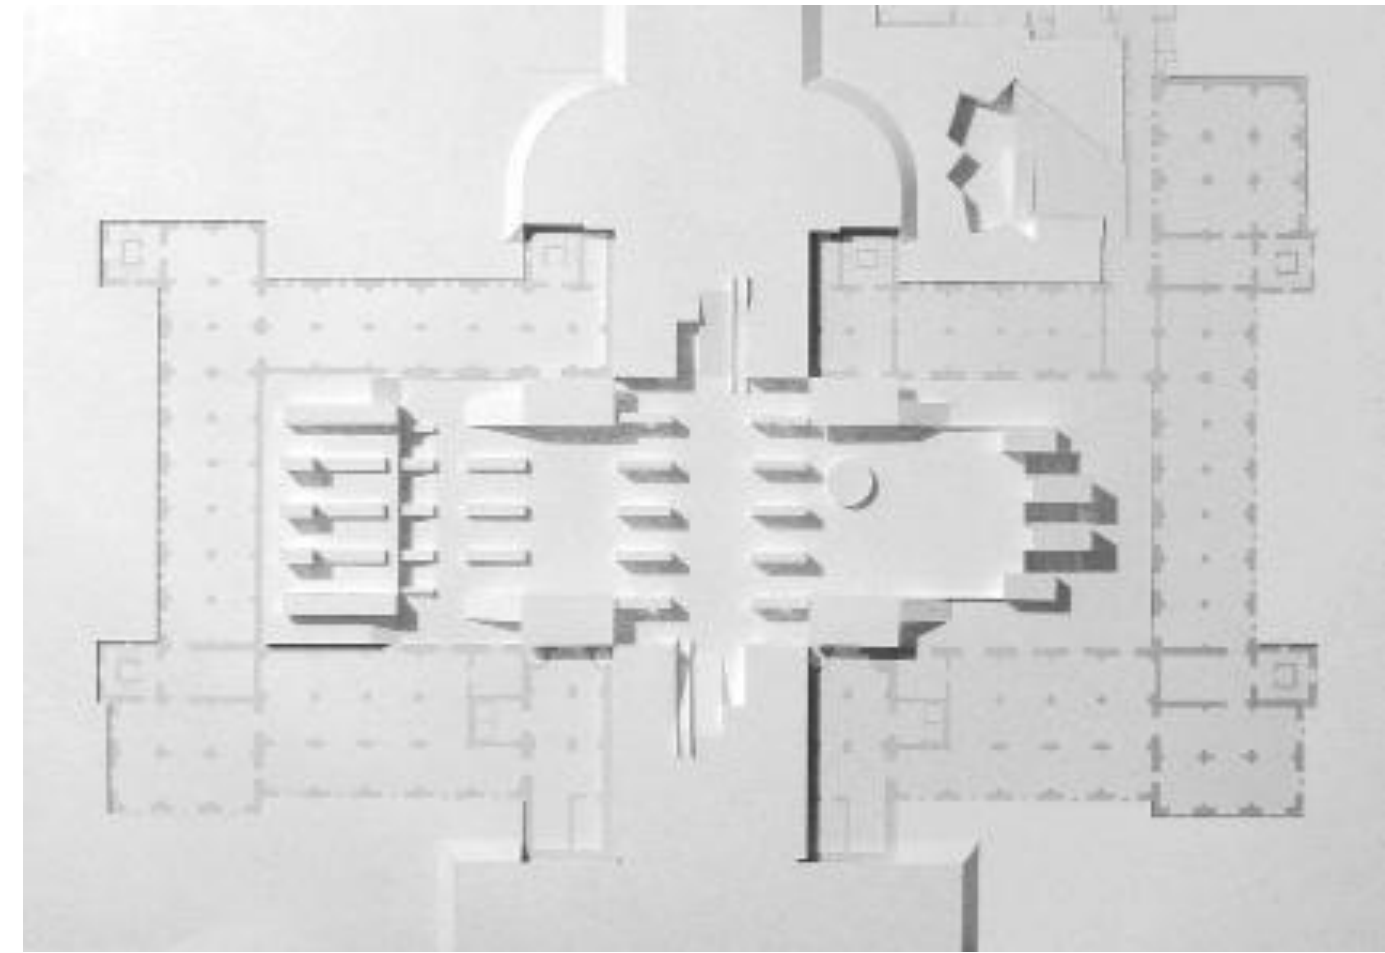
3.05

3.5 Model of the lowered courtyards and the entrance in the central passageway.

the Rijksmuseum was spelled out, for example with respect to layout and square metres, building services, constructional approach, heritage restoration and architecture.¹⁹ The original concept remained essentially intact: a central entrance in the passageway with stairs to the sunken entrance hall (3.05). There was a new solution involving cables and ducting in an underground services tunnel around the main building, from where the entire building could be serviced via vertical shafts. One striking addition was the Study Centre, a tower over 30 m high next to the main building, between the director's villa and the Teekenschool (Drawing School, now National Print Room) (3.23-3.28). This tower was intended to become an important node, with access to the engine rooms and the energy centre in the basement, the staff entrance on the ground floor and on the floors above reading rooms and a library tower. The building was conceived in concrete, with large windows and a cladding of Swiss limestone. This was later changed to a Portuguese limestone whose bluish cast complements the Belgian Blue limestone of the historic building.

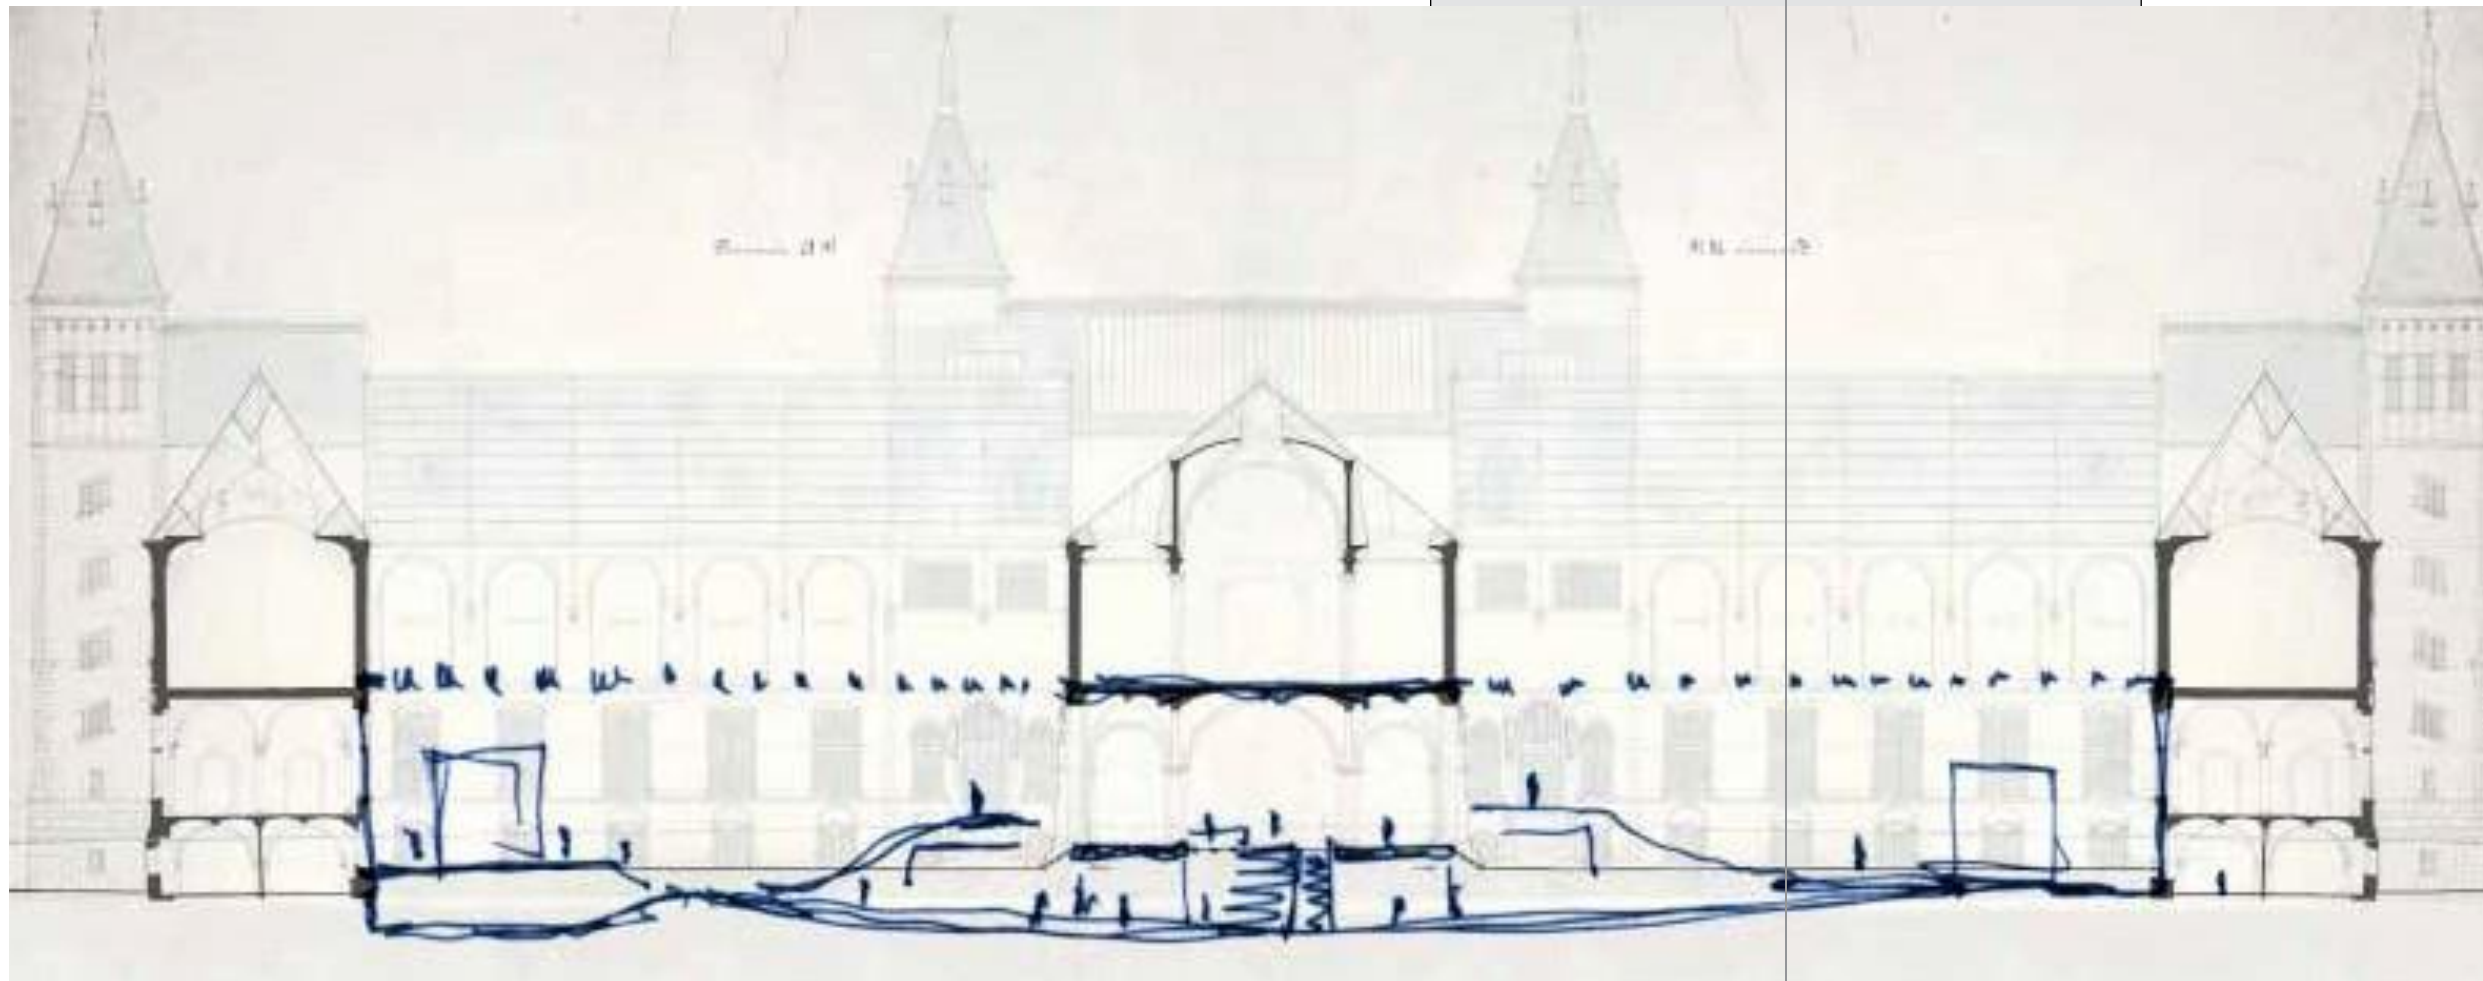
3.06

3.6 Sketch of the walking routes between the entrance, the courtyards and the museum galleries.

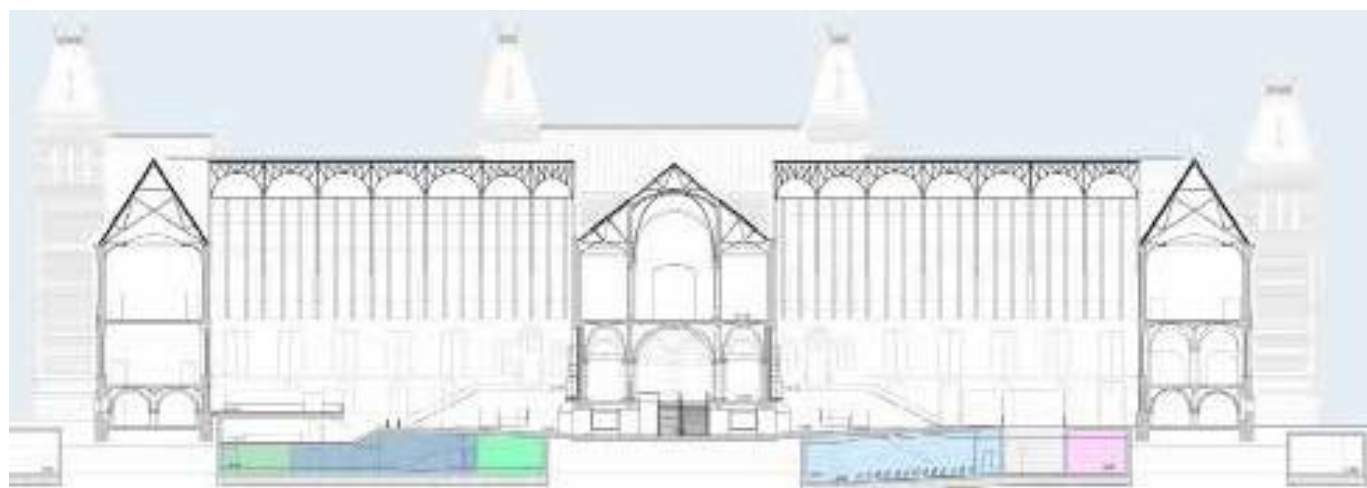
3.07

3.7 Auditorium and service areas beneath the lowered courtyards.

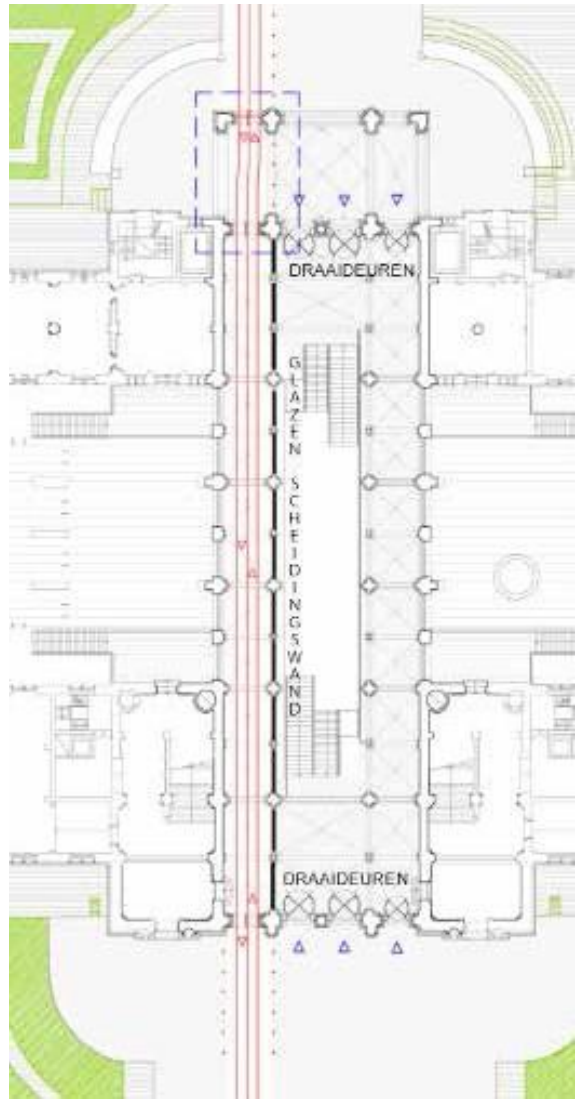
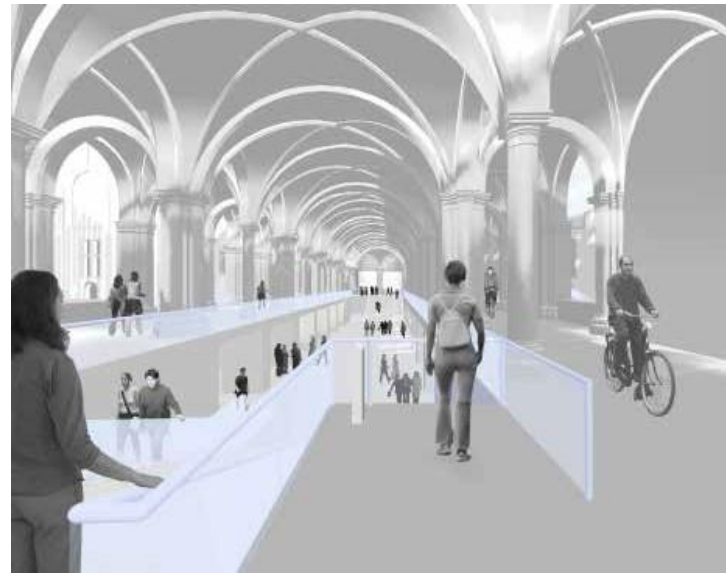
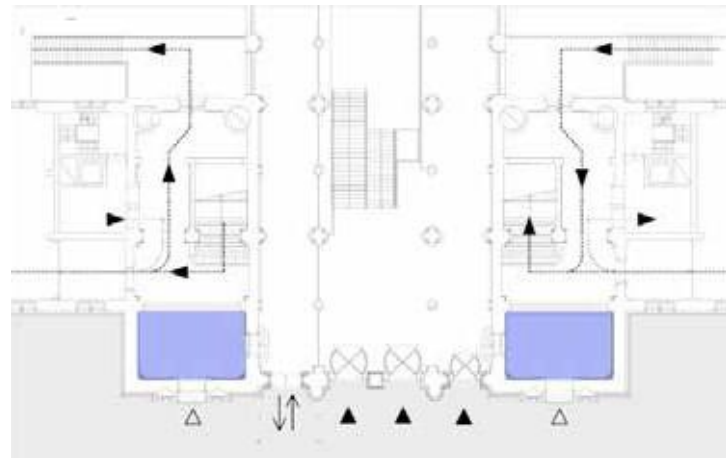
3.08-10 Entrance area designs by Cruz y Ortiz from the PD, 2002.

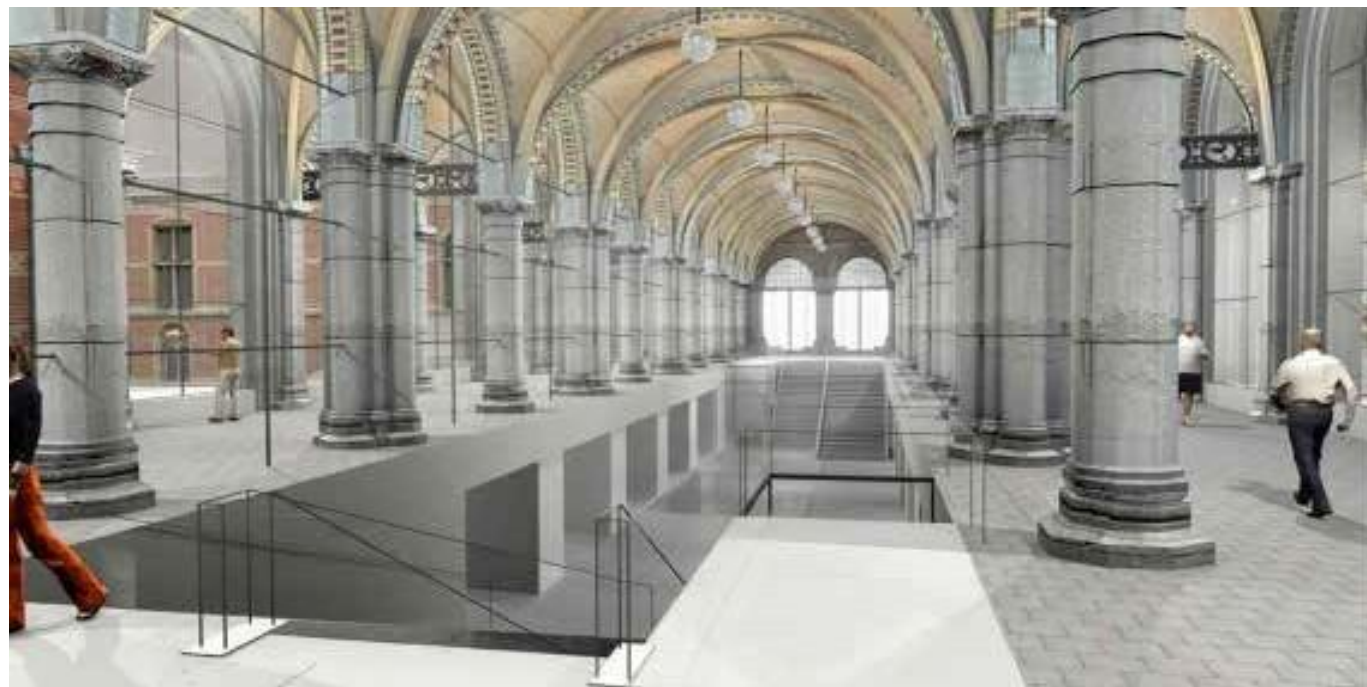
3.11 The PD features a continuous glass wall separating the bicycle path and entrance area.

In the elaboration of the passageway, the cycle path remained in the open air, but the entrance zone and the footpath were incorporated into the building. The result was that behind both façades a revolving door was placed in three of the four archways and, along the entire length of the passageway, the cycle path was screened by a glass wall (3.08-3.11). To make it possible to access the various routes from the entrance hall through the museum galleries, and to solve the problem of emergency exits, lifts and stairs were added. This resulted in two galleries on the main floor being reduced by one bay.²⁰ The chronological arrangement, which pursued a serpentine course through the building, would present an interrelated display of art, applied art and history. The two attic spaces on the north side were reserved for study collections, with thematic displays of ceramics, textiles, ship models and arms. Autonomous sections of the collection were housed in separate buildings, such as the so-called Asian Pavilion and the former Teekenschool. The South Wing was designated for temporary exhibitions, printing and photography. The former library became a reading room and café and was incorporated into the museum route.

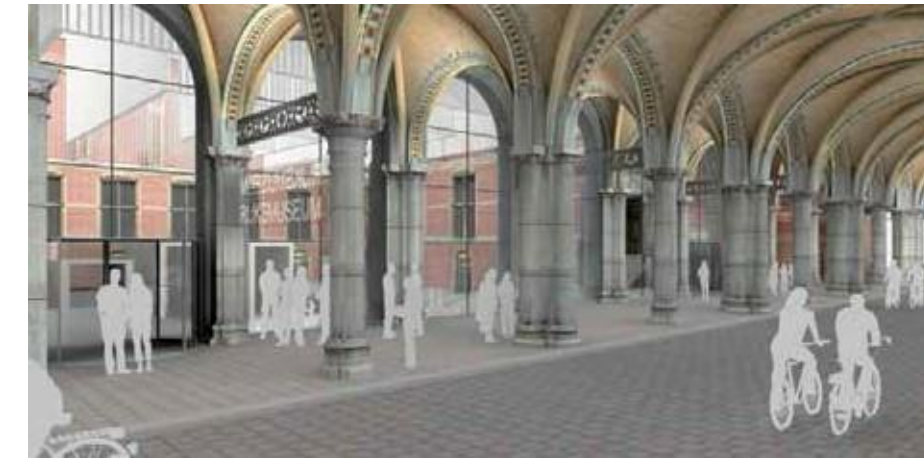
3.12 Modified version of the entrance design, 2005. Here there is no longer a sunken entrance in the central passageway; instead, revolving doors provide entrance to the museum. This is the version that was ultimately used.

At around the same time that the first phase of the FD appeared in October 2004, Mels Crouwel was installed as the new Chief Government Architect. His reaction to the FD was positive and included the recommendation to stick with the architectural concept for the passageway.⁴³ Crouwel only wanted to be involved in a few implementation aspects, such as the climate separation in the passageway, the insulation of the external façades and the design of new windows. The intervention design was as good as complete, with the exception of the passageway. When the Oud-Zuid district council passed the Ruimtelijk Afwegingskader Rijksmuseum (Rijksmuseum Spatial Evaluation Framework) in 2005, the city's wishes with regard to the passageway were established: retention of the cycle route and permanent public accessibility.⁴⁴ The design had already been modified accordingly.⁴⁵ The passageway remained intact and accessible across its entire width. The climate separation shifted to the wall between the passageway and the courtyards, where the museum entrances with revolving doors, stairs and lifts would be located to either side of the passageway. Instead of entering via the passageway, visitors would descend to the entrance area in the courtyards (3.12).

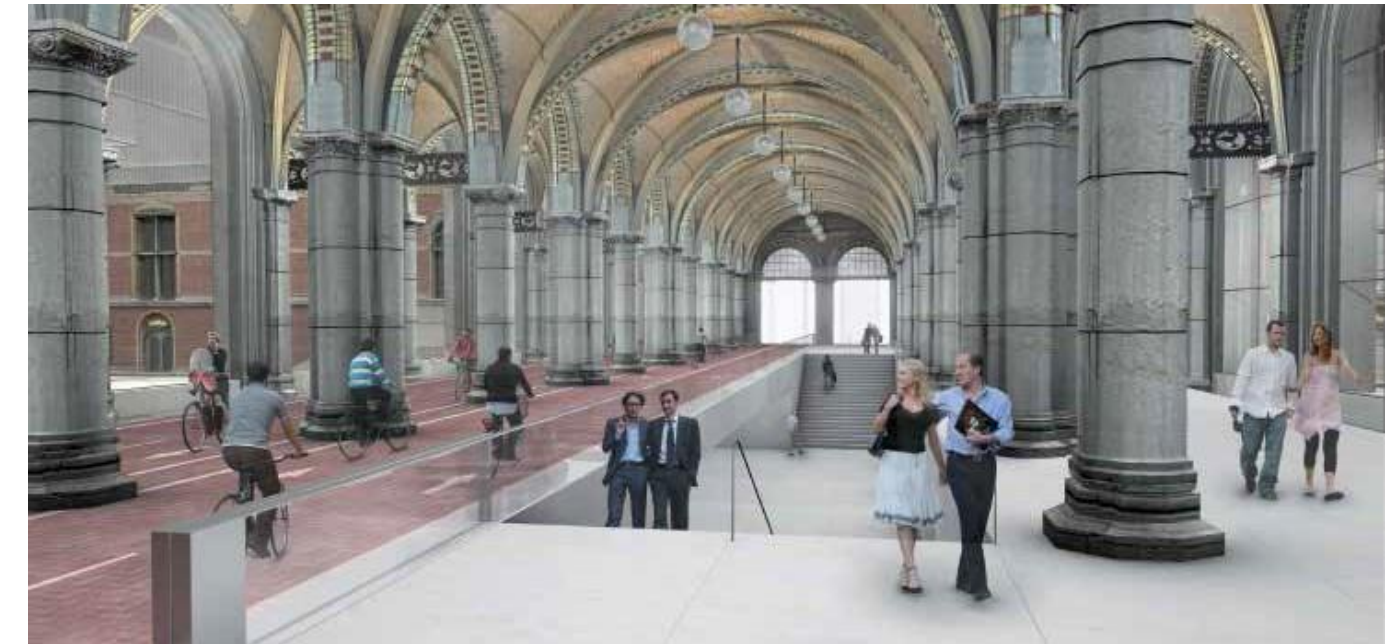
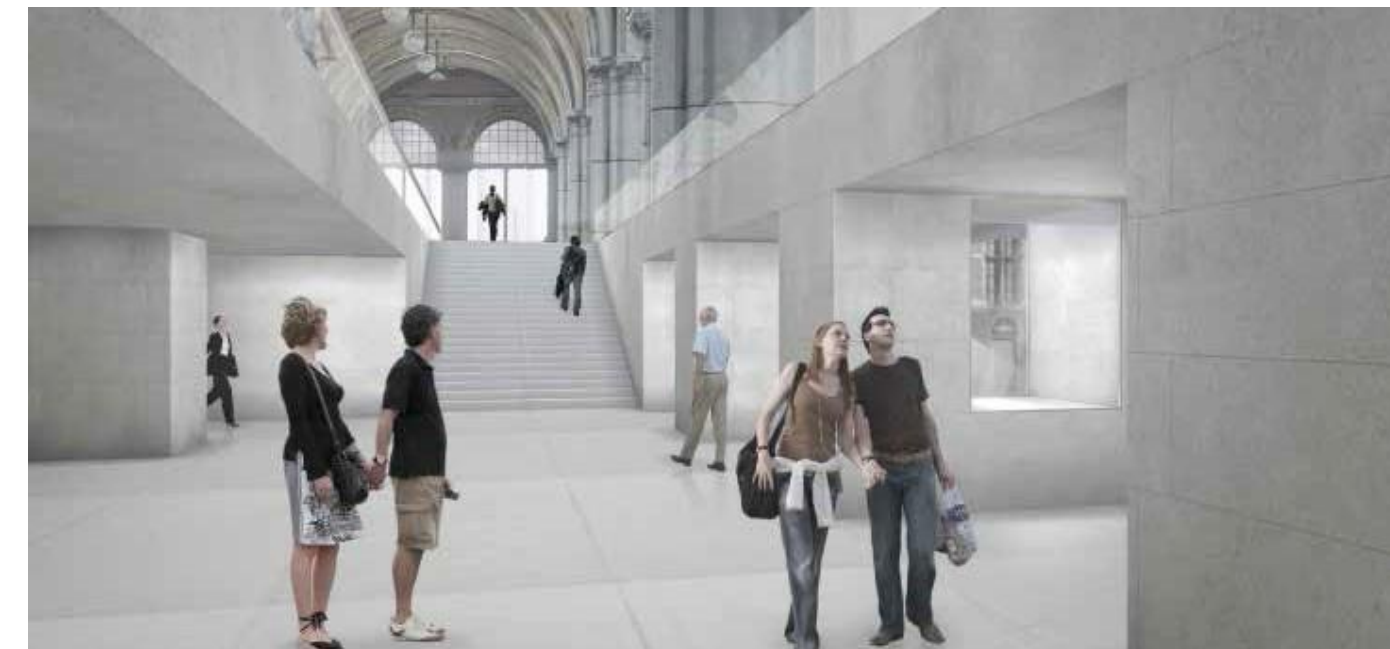
3.13-14 Visualization by Cruz y Ortiz, used by Wim Pijbes and Liesbeth van der Pol from 2008 onwards in an attempt to win sufficient support for the original entrance area concept.

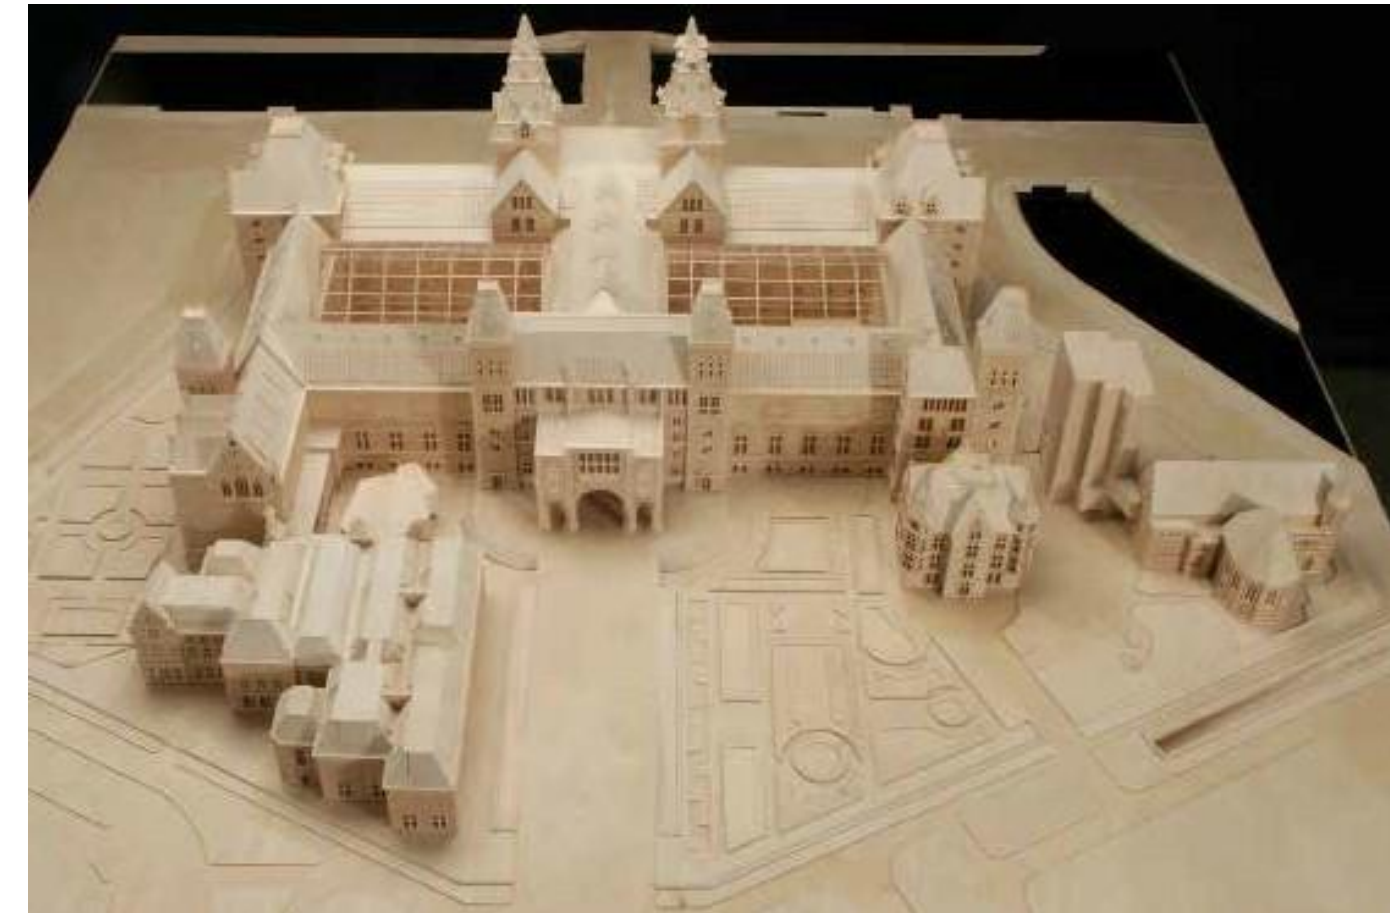
3.15 Model of the Cruz y Ortiz competition design (2004), with the Asian Pavilion and the Study Centre added to the ensemble.

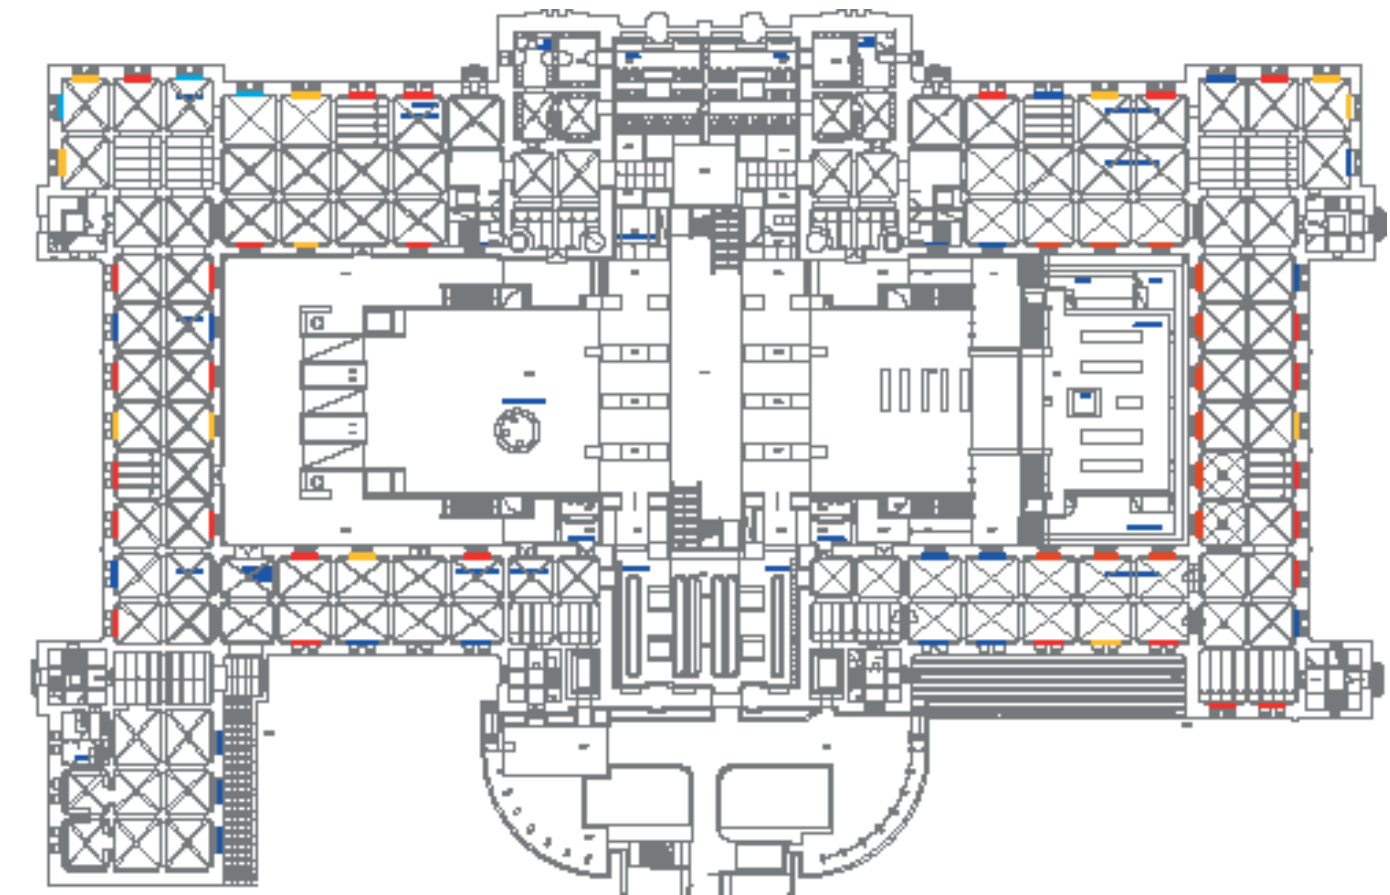
3.16 Plan for window openings, Cruz y Ortiz 2004.

- closed window — always
- closed window — not reversible
- closed window — not easily reversible
- closed window — easily reversible
- open window
- translucent window level

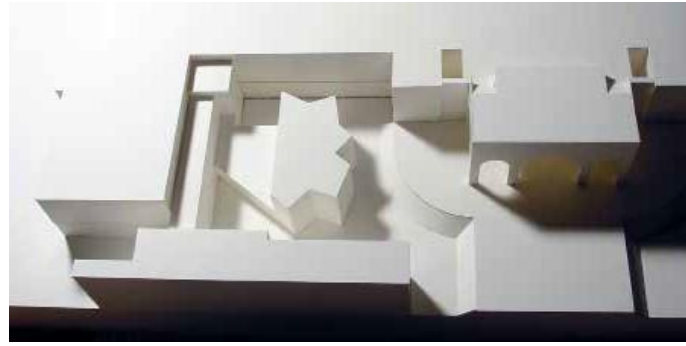
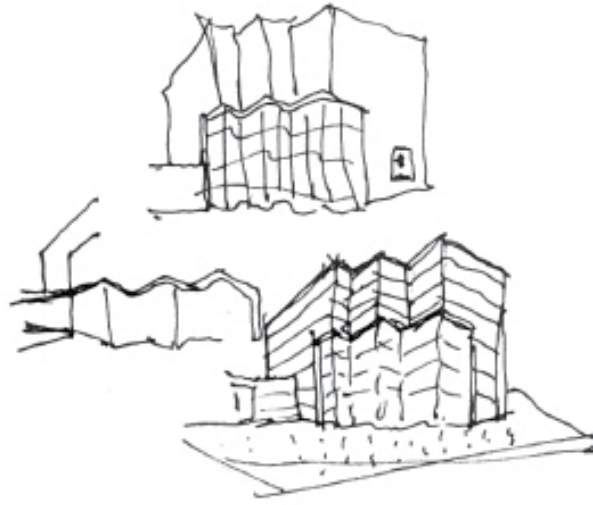
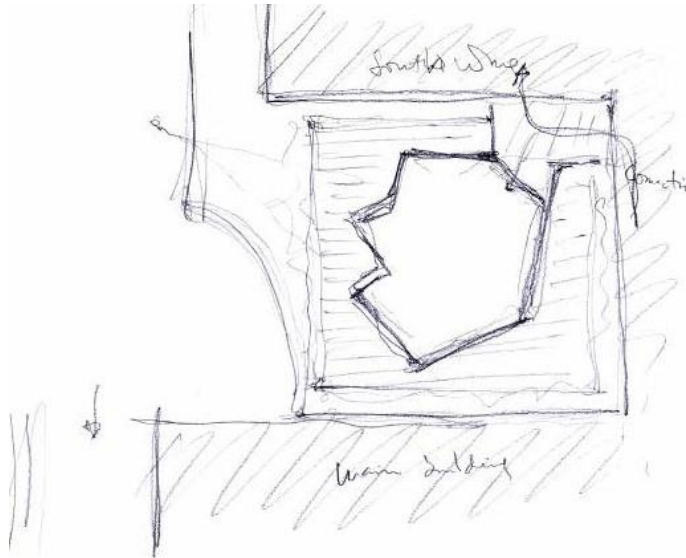
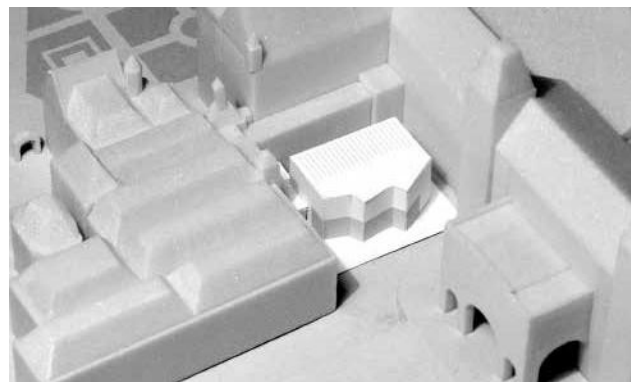
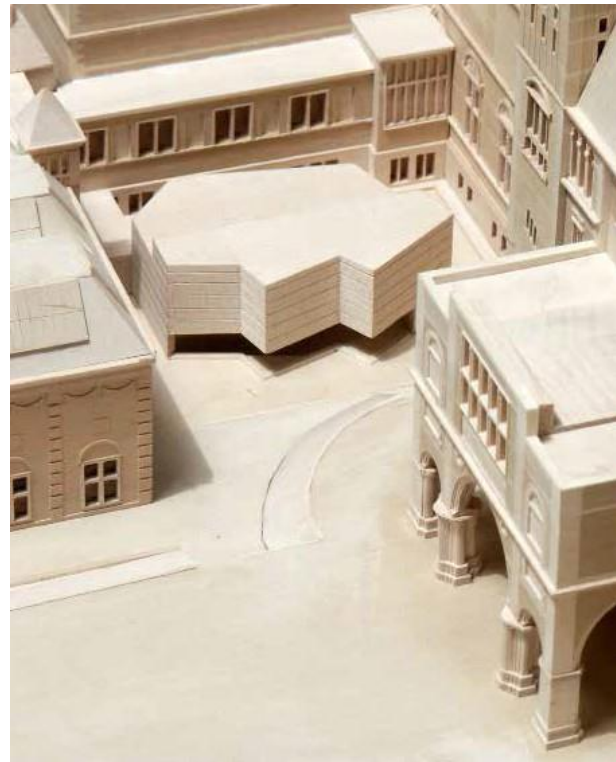
3.17-21 Stages in the design of the Asian Pavilion, 2001-2004.

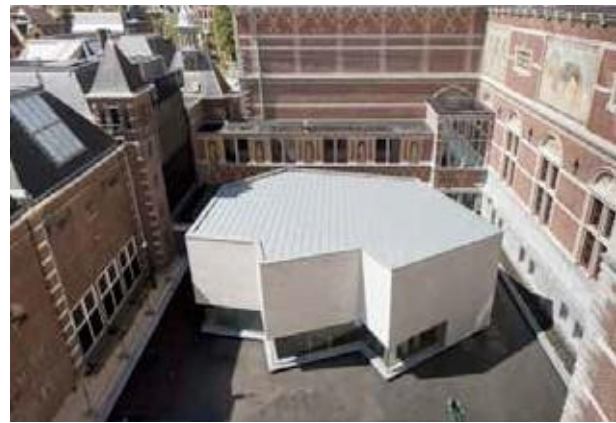
3.22 The completed Asian Pavilion.

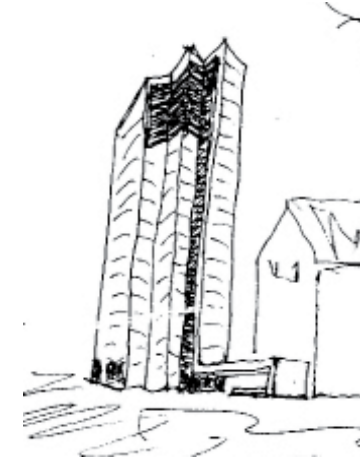
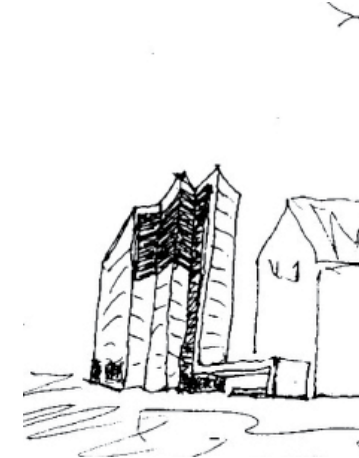
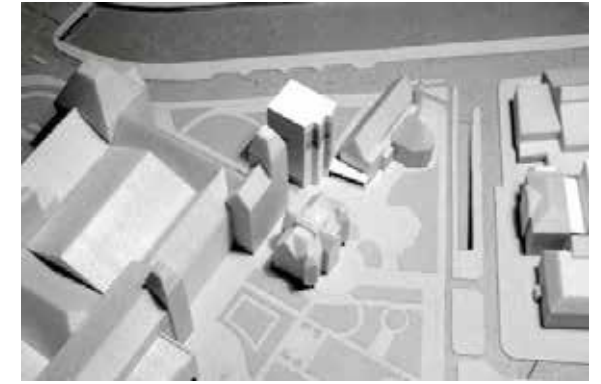
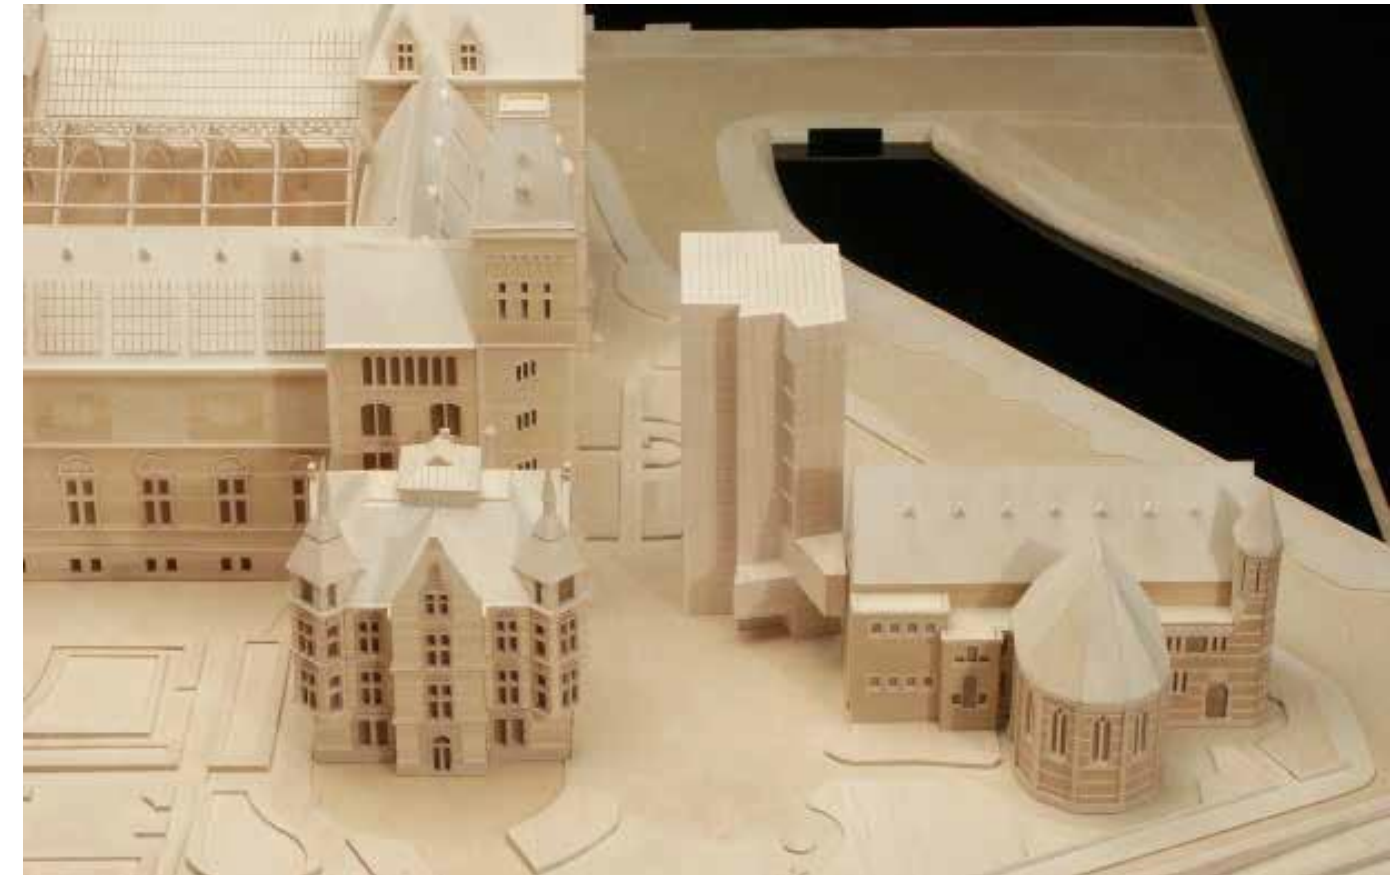
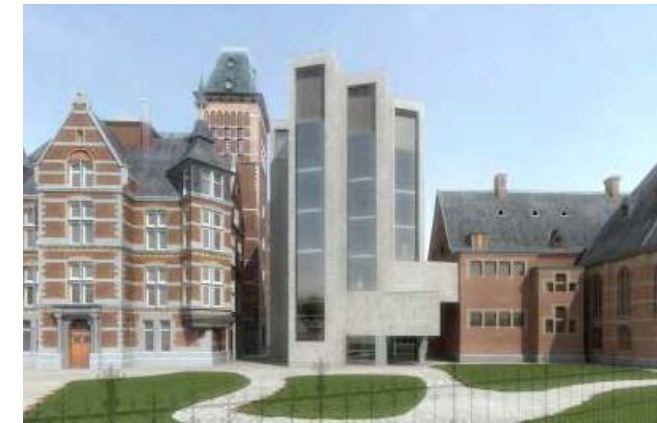
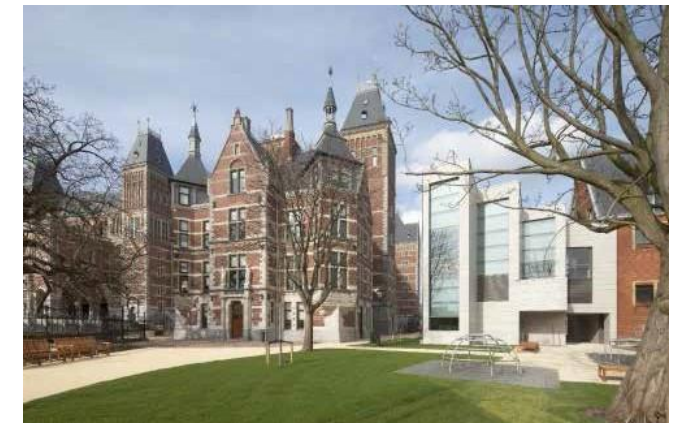
3.23-28 Design and integration studies for the Entrance Building, previously called the Study Centre, with successively smaller building volumes, 2002-2013.

The elaboration of the entrance zone cleared the way for the finalizing of the building application, which was duly completed in March 2006.⁴⁶ The most important modification from this final design phase was the reduction of the towering Study Centre to a subordinate volume next to the Teekenschool (3.28).⁴⁷ After earlier critical remarks about the tower's impact on the ensemble and under pressure from The Hague, the project office was evidently not willing to take the risk that this new building might further delay the construction work. The reading rooms, the offices and the flue gas exhaust moved to another part of the museum complex.⁴⁸ The new section henceforth designated the Entrance Building, contained only entrances for the staff, deliveries, the energy centre, the multidisciplinary educational centre, (underground) storerooms, reading rooms and the National Print Room.

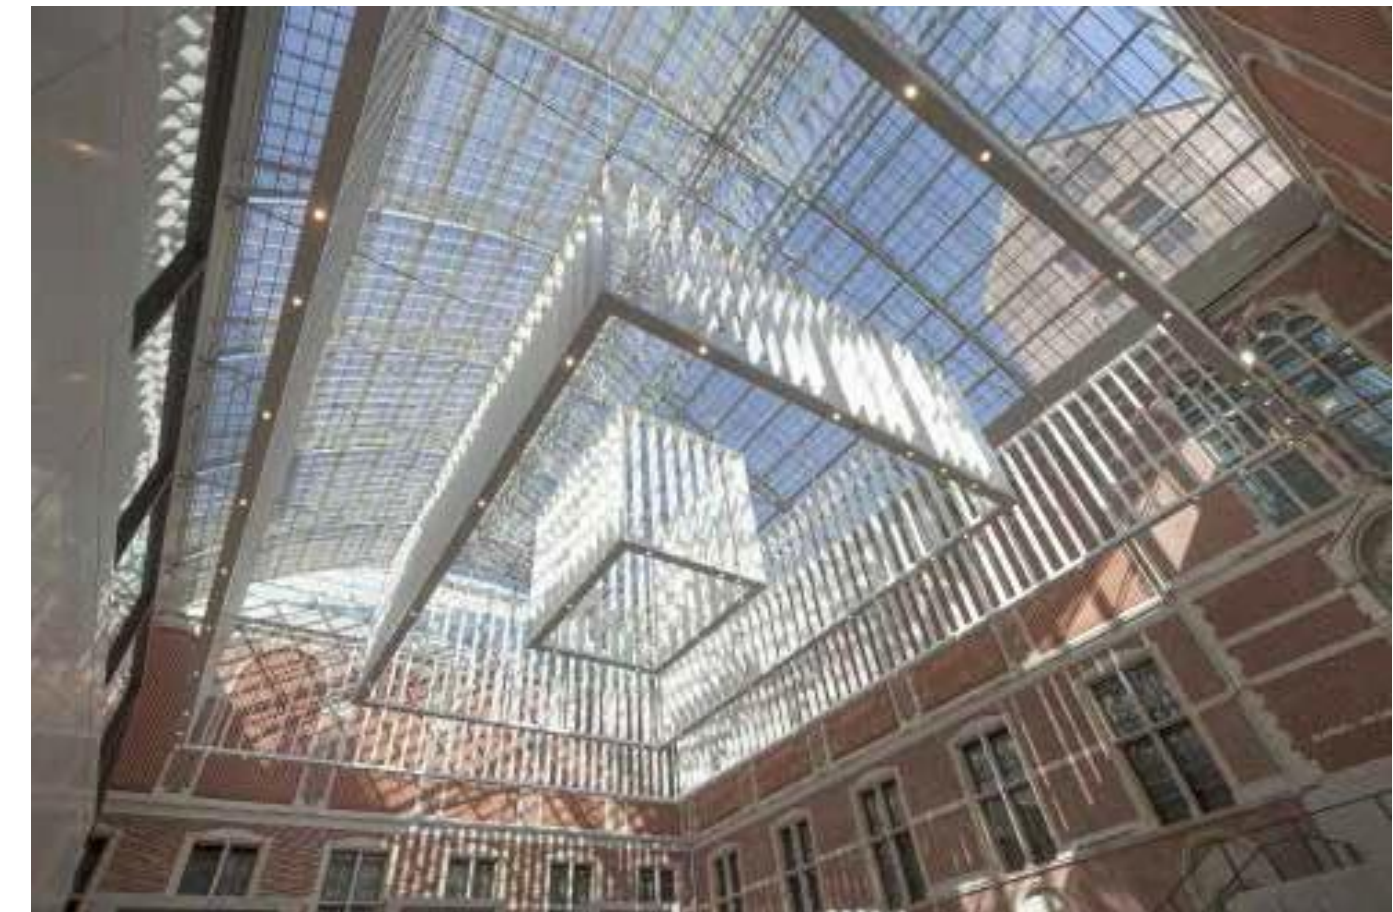
3.35 One of the two final identical chandeliers.

Compared with the PD, some minor changes had been introduced. The height of the Study Centre was slightly reduced for the sake of the silhouette of the ensemble. The chandeliers in the courtyards changed from crystal to aluminium with perforated MDF with sound absorbent material, 'a moderately spectacular touch' (3.29-3.35).³⁷ The café in the library disappeared. The architects proposed keeping more windows open than the museum had requested (3.16).³⁸ In the galleries they wanted to conjure a contemporary experience of the historical space through the use of light and colour. The most striking aspect of the FD was what
