3 Continue with Cuypers Renovation of the Rijksmuseum

Paul Meurs

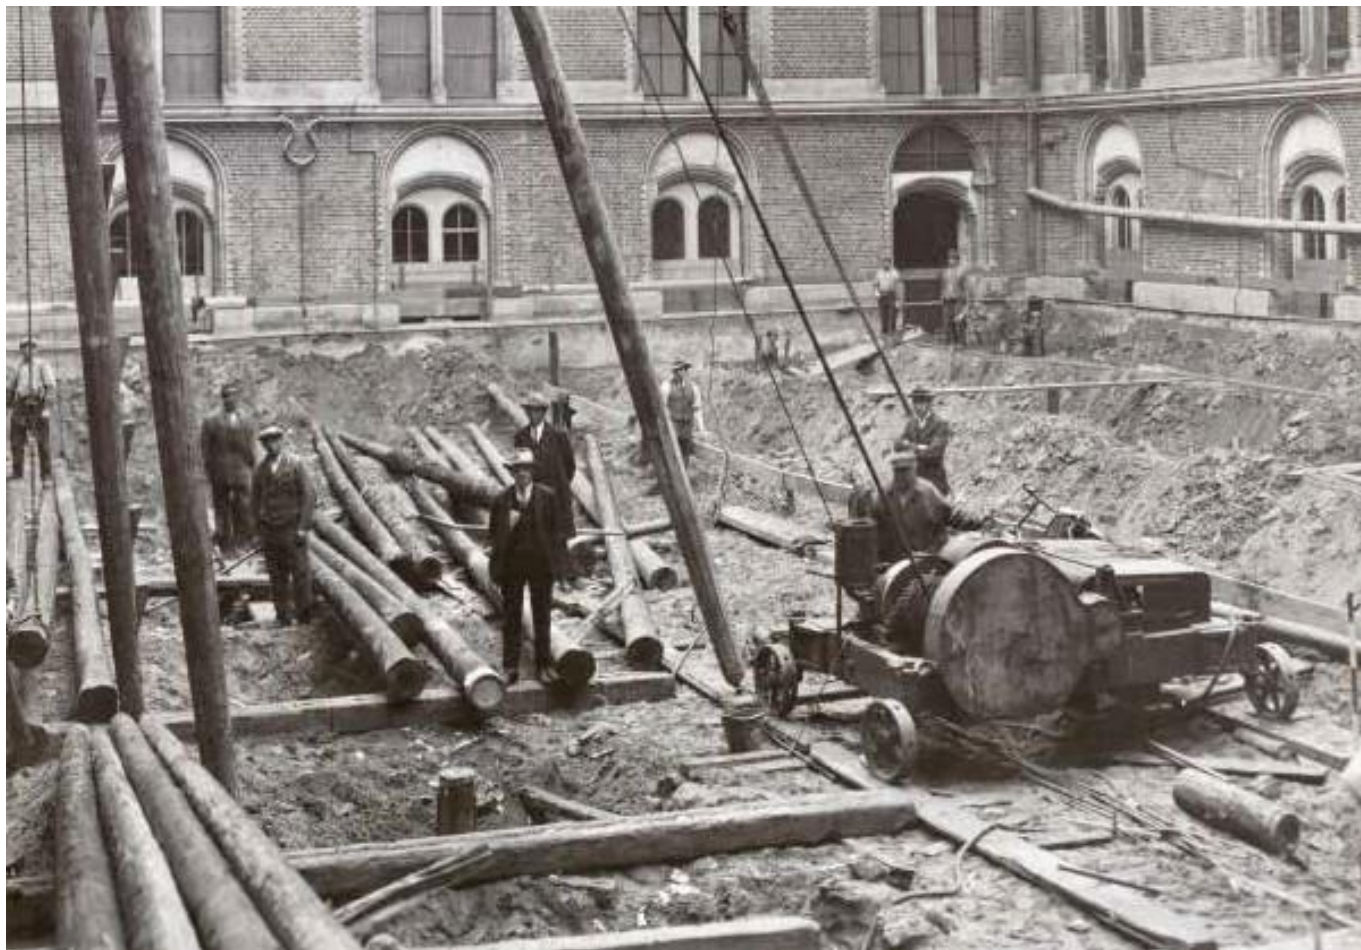
C.01

C.1 Driving piles in the courtyard, 1929.

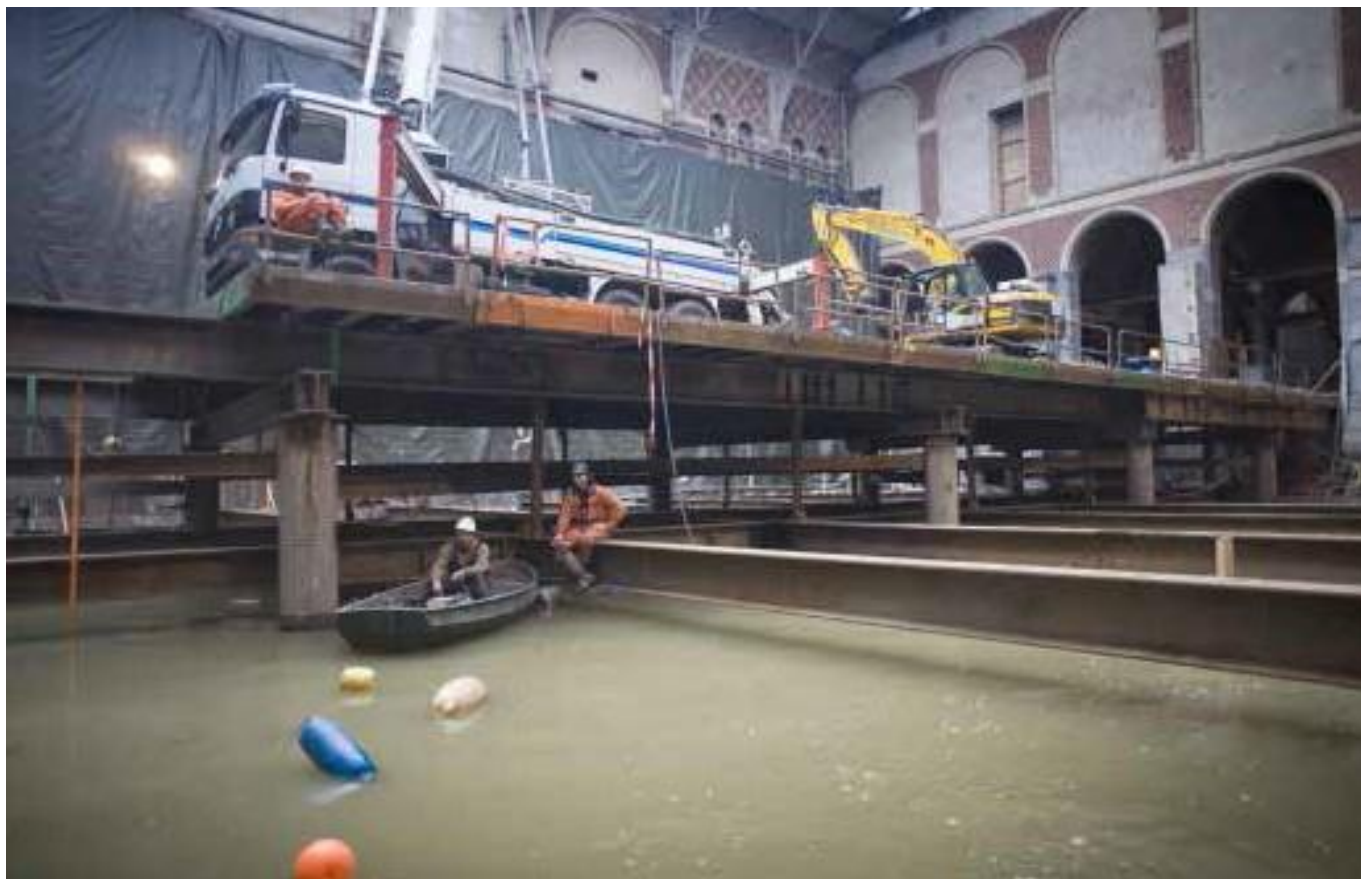
C.02

C.2 Pouring concrete underwater in the east courtyard with assistance from divers, November 2006.

To avoid major problems with the existing foundation, the construction of the new underground levels had to be approached carefully. If the excavation in the courtyards had begun without any special precautions, then drainage would have been necessary in the foundation pit. But this would have placed the wood foundation piles at risk of drying out, a situation that could lead to significant settlement. The alternative was wet excavation. First, sheetpile walls were driven deep into the ground next to the existing foundations and the wooden foundation piles. The method used did not cause vibrations. Then 468 new foundation piles were driven for the new floors and walls of the atrium. To avoid damage to the museum, concrete screw injection piles were used. This procedure involves drilling a hole in the ground, installing a steel pile, and encasing it in injected grout, a mixture of cement and water that blends with the soil. Only after the completion of the foundations were the underground areas excavated. During excavation, the pit was filled with water. This maintained a constant water table and prevented groundwater pressure from breaking open the bottom of the pit. A layer of underwater concrete was poured as a work floor at 7 m below NAP. When it hardened, it created a watertight basin consisting of the work floor and the steel sheetpile walls. Divers checked whether all the connections and joints really were watertight and removed deposits of sludge. The basin was then drained; the piles prevent it from floating upwards. The underground levels are attached to the main building by a flexible structure that allows the two to move independently without cracking or doing damage to the foundations. A layer of sand was poured into the dry foundation pit before the structural floors and walls were built.

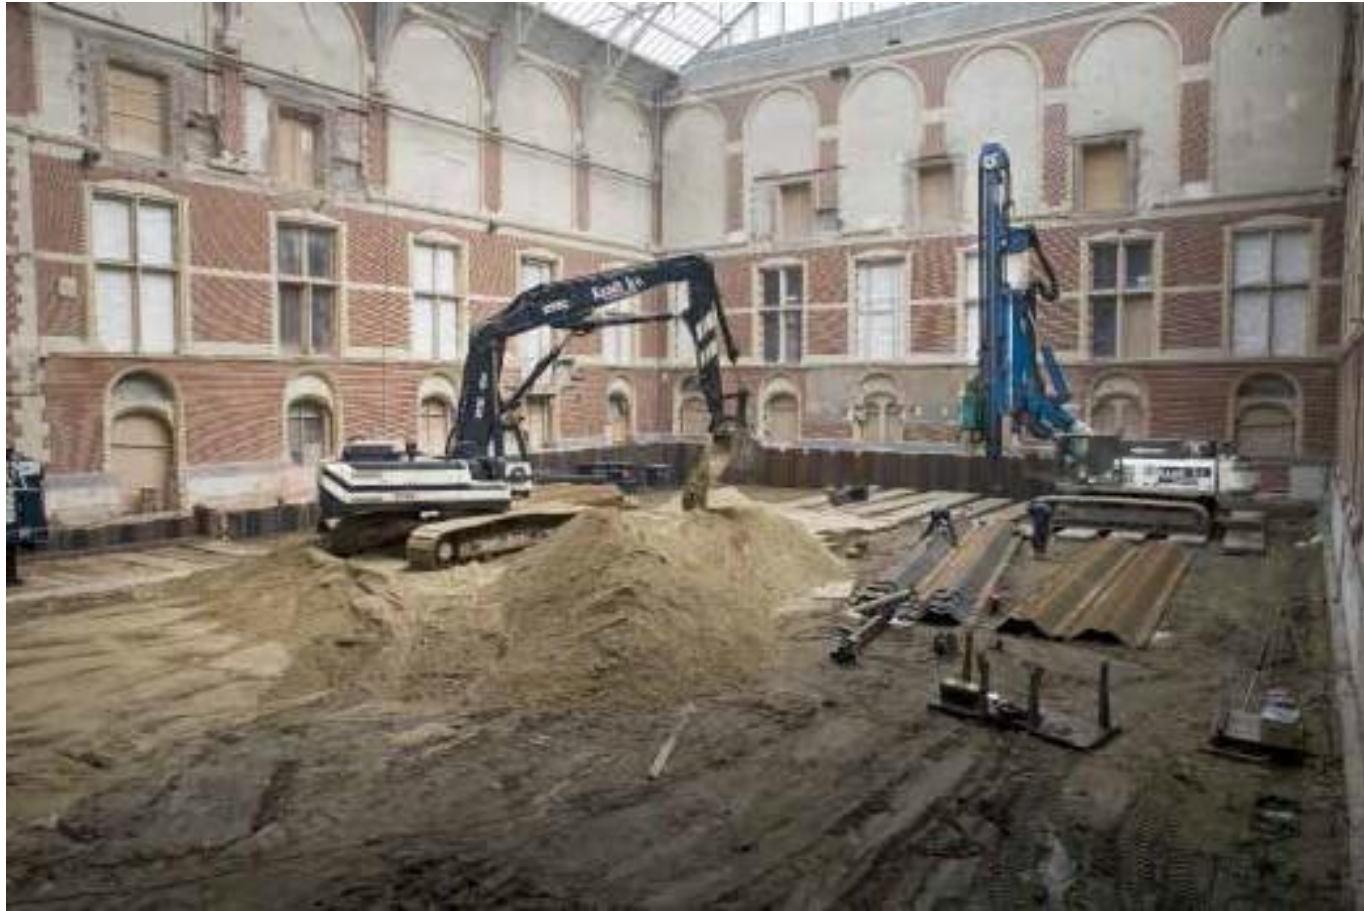
C.03 Pressing the sheet piling prior to excavation of the east courtyard, June 2006.

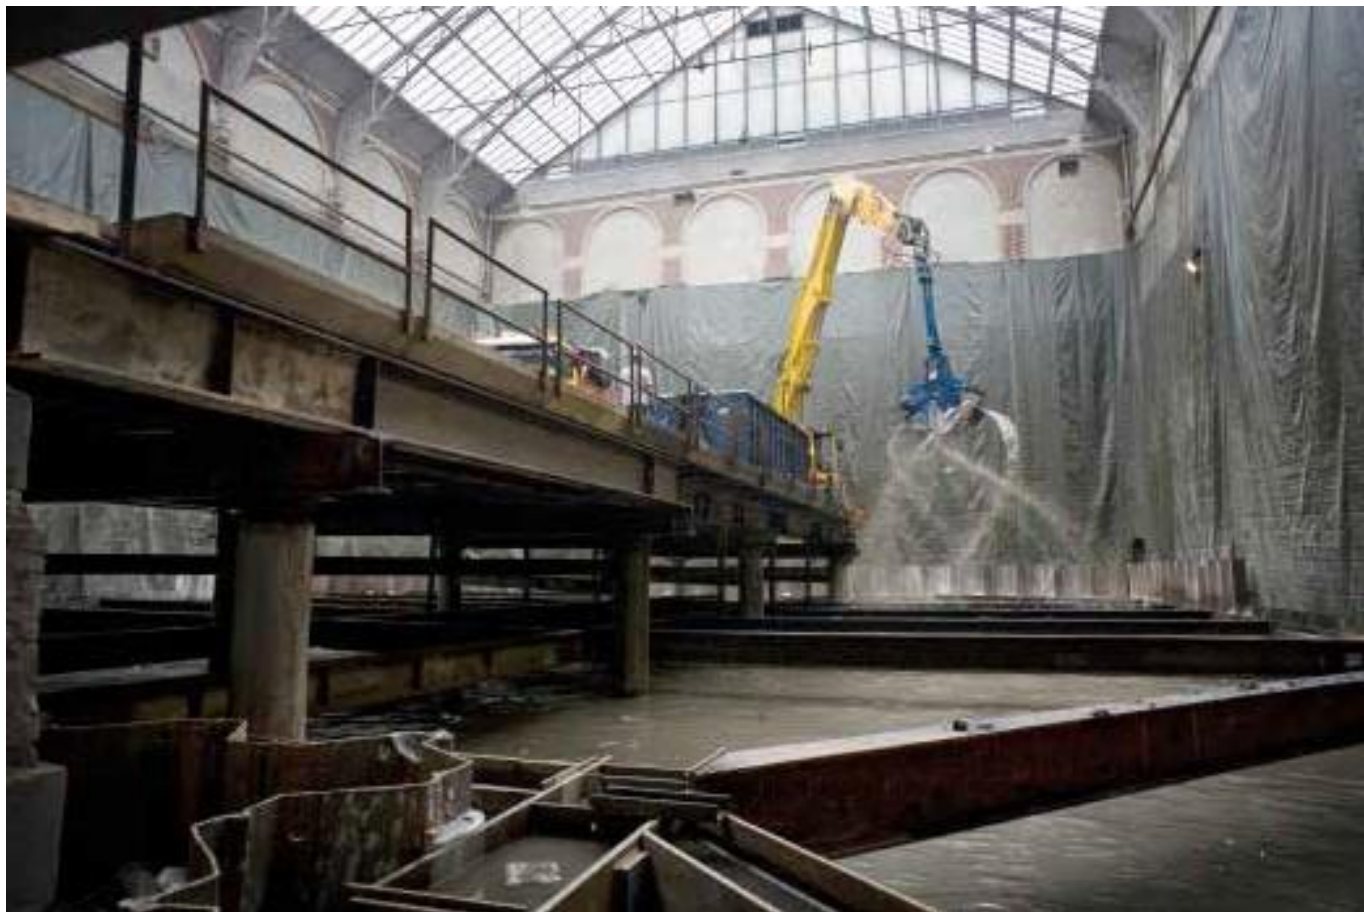
C.04 The underwater excavation of the east courtyard. A temporary work platform was constructed on a temporary foundation for this purpose, September 2006.

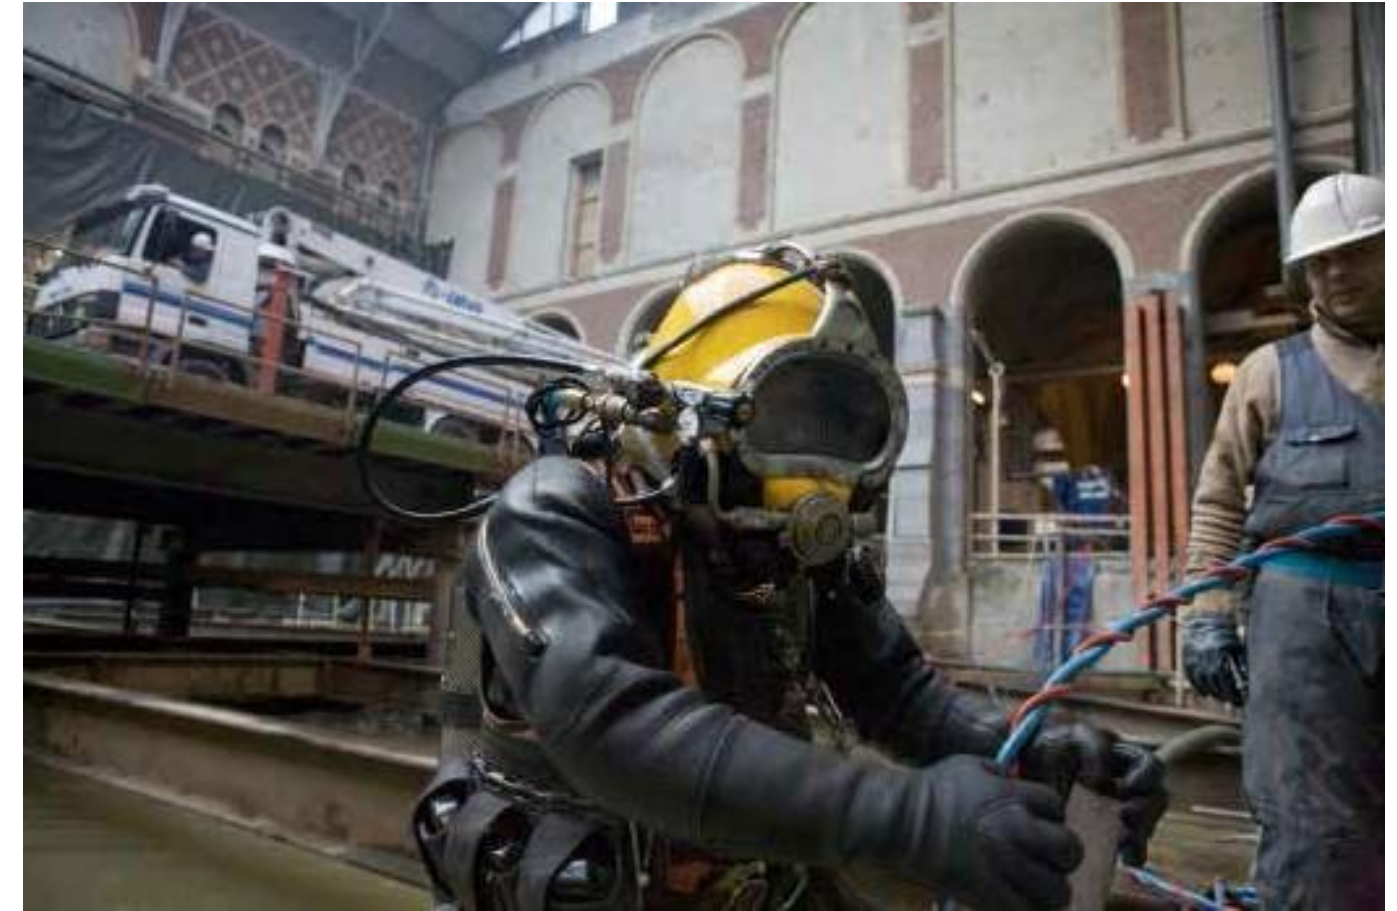
C.05 Pouring concrete underwater in the east courtyard; divers checking connections and joints, November 2006.

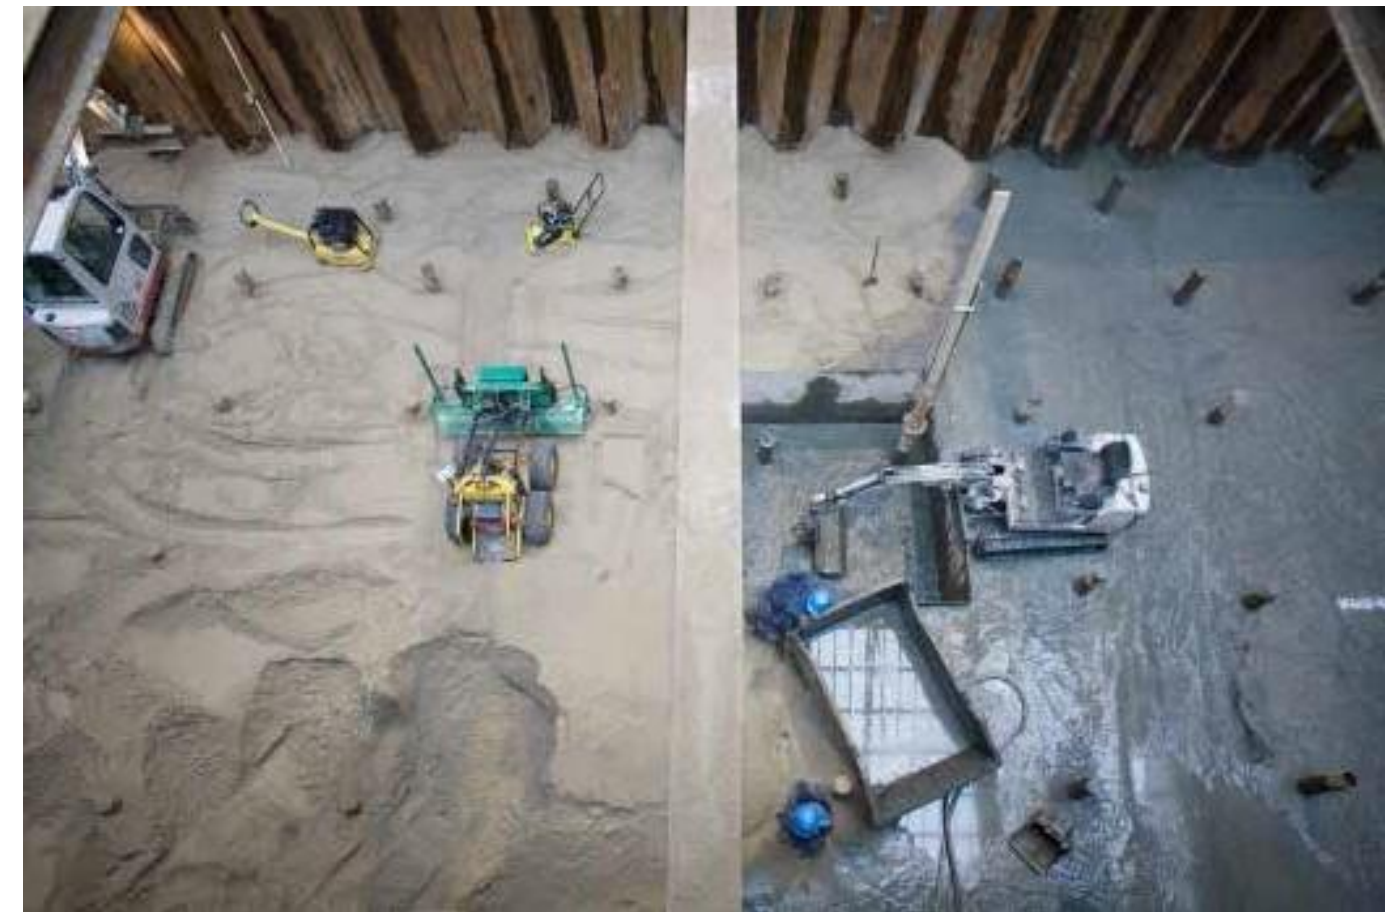
C.06 Pouring a layer of sand onto the hardened underwater concrete at the lowest point after draining the east courtyard, December 2006.

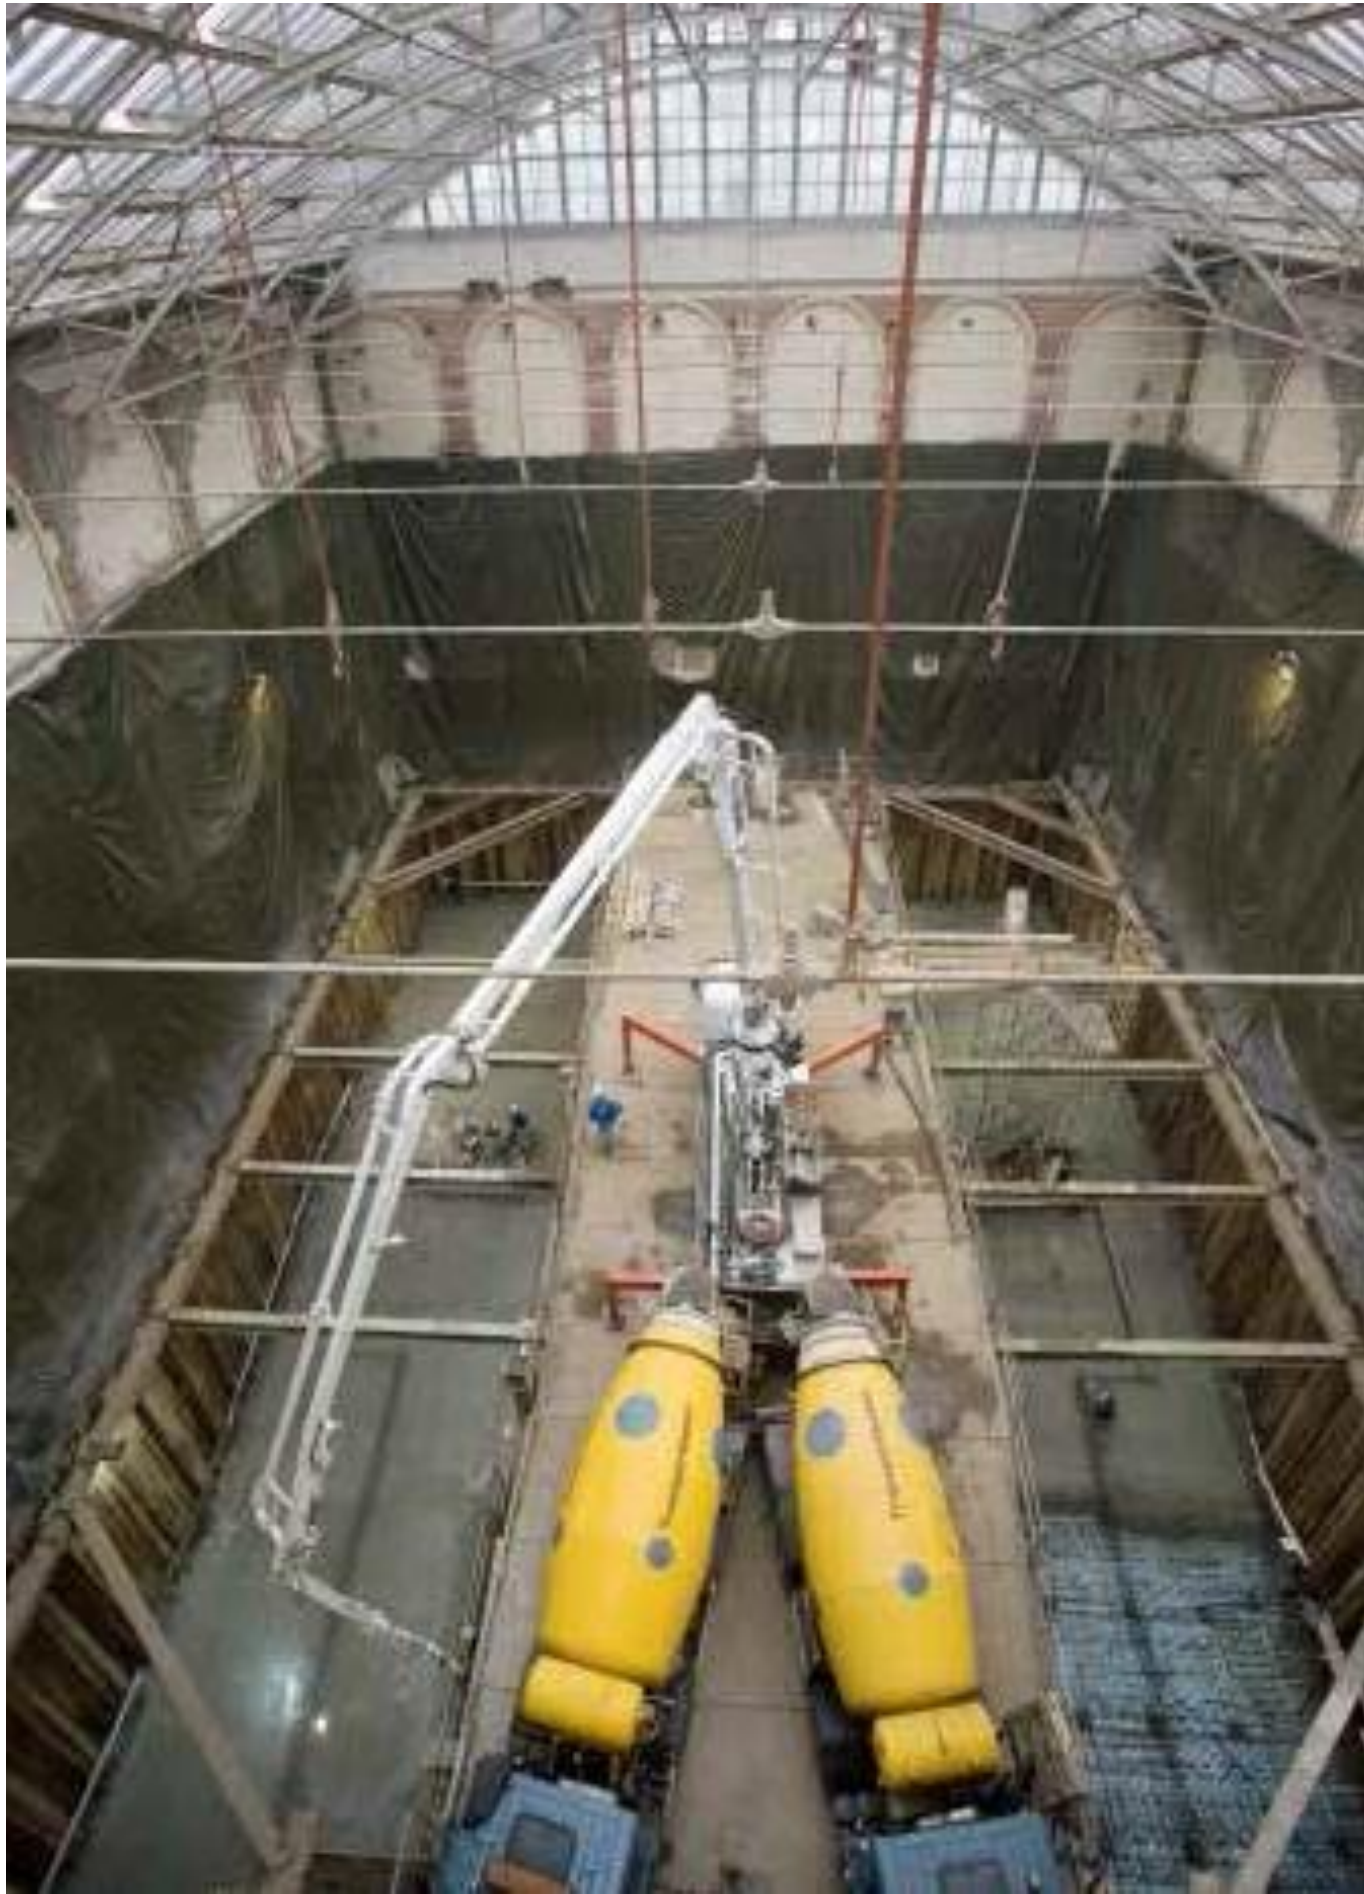
C.07

C.7 Pouring the new concrete sub-floor over the sand layer in the west courtyard, view from above, February 2007.

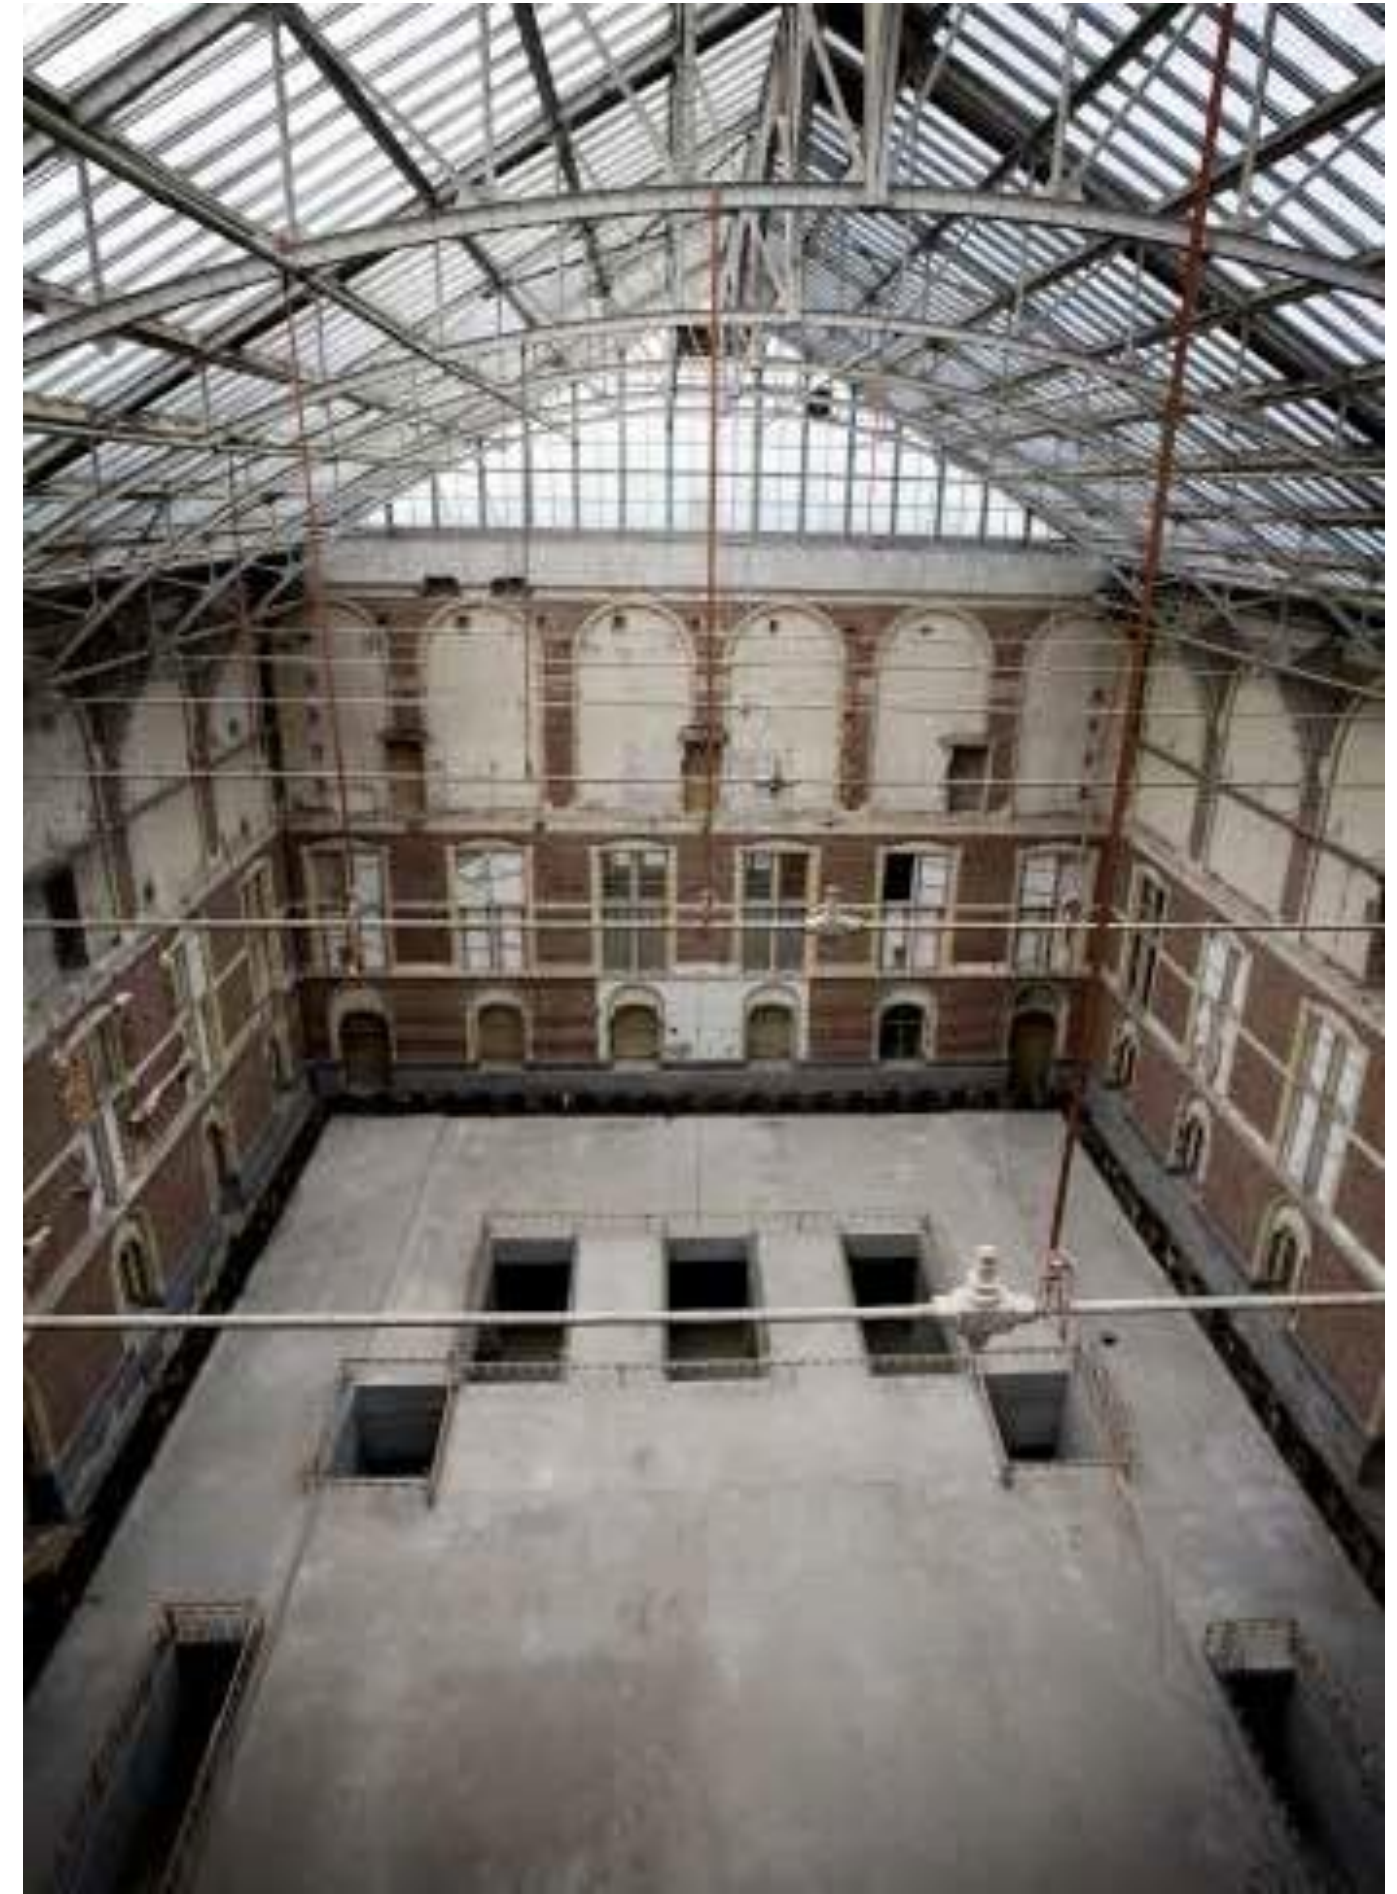
C.08

C.8 View of the west courtyard from above; the new cellar has been completed. The sheetpiling is still clearly visible, 2008.

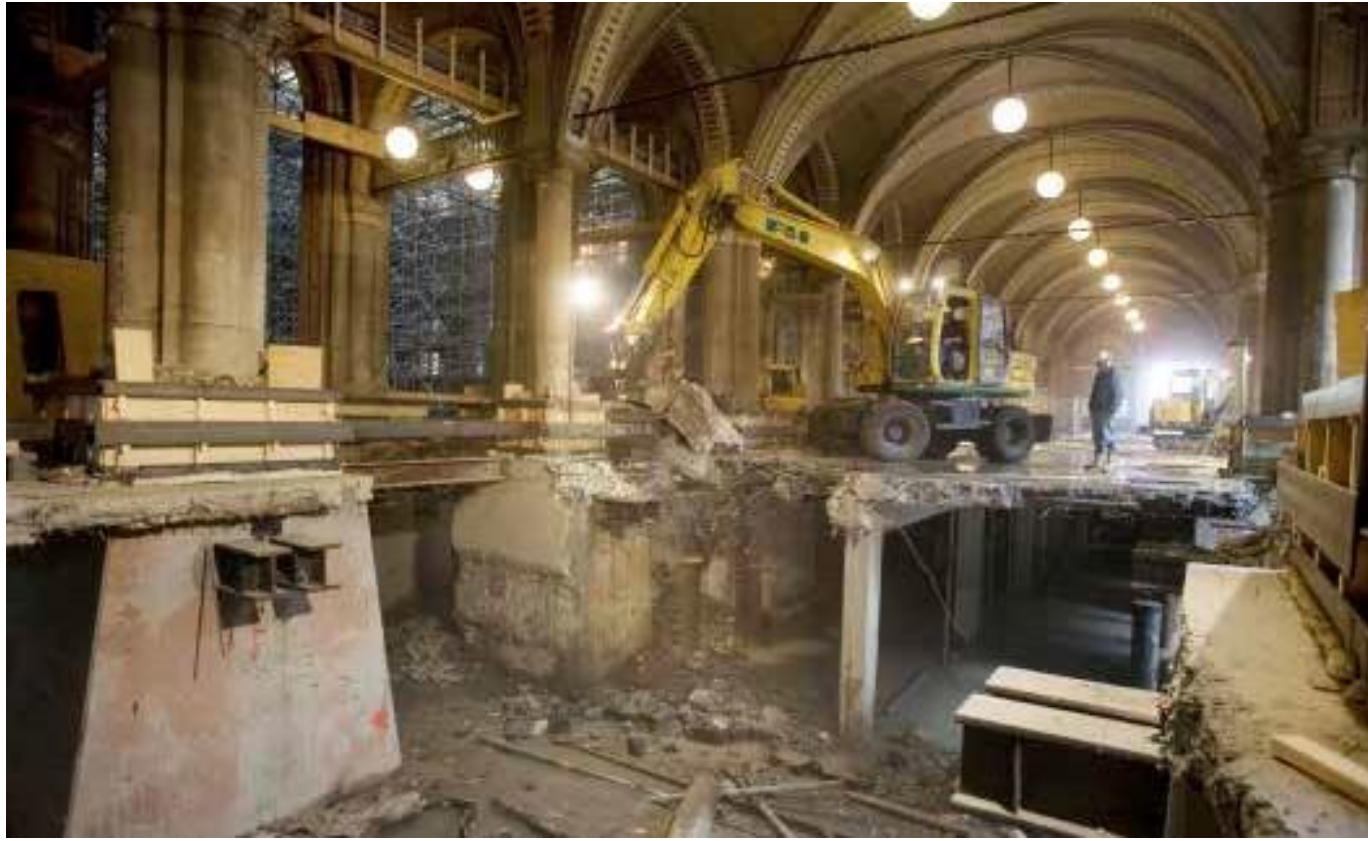
C.09

C.9 Demolishing the floor in the central passageway through the Rijksmuseum. The steel sections encased in concrete in the current foundation are clearly visible, held in place by jacks while the foundation is demolished, September 2009

One particularly impressive stage of the underground construction work was the construction of a passage between the excavated courtyards underneath the Rijksmuseum's central passageway. The old brick and concrete foundation had to be replaced by a much narrower one so that construction workers could pass directly from one underground courtyard to the other. The passageway remained in place during this stage, and all possible measures were taken to prevent damage such as cracking and settlement. First, foundation piles were driven around the existing foundations. These supported the passageway during construction. Then horizontal holes were drilled under the columns and walls of the passageway. These holes were filled with steel sections encased in a concrete mixture. Horizontal steel needle beams were inserted between the steel sections and the foundation piles. These beams were fitted with cross beams and jacks that could be adjusted with great precision. While the passageway was supported by this corset of steel sections, the old foundations were demolished and replaced by new ones.

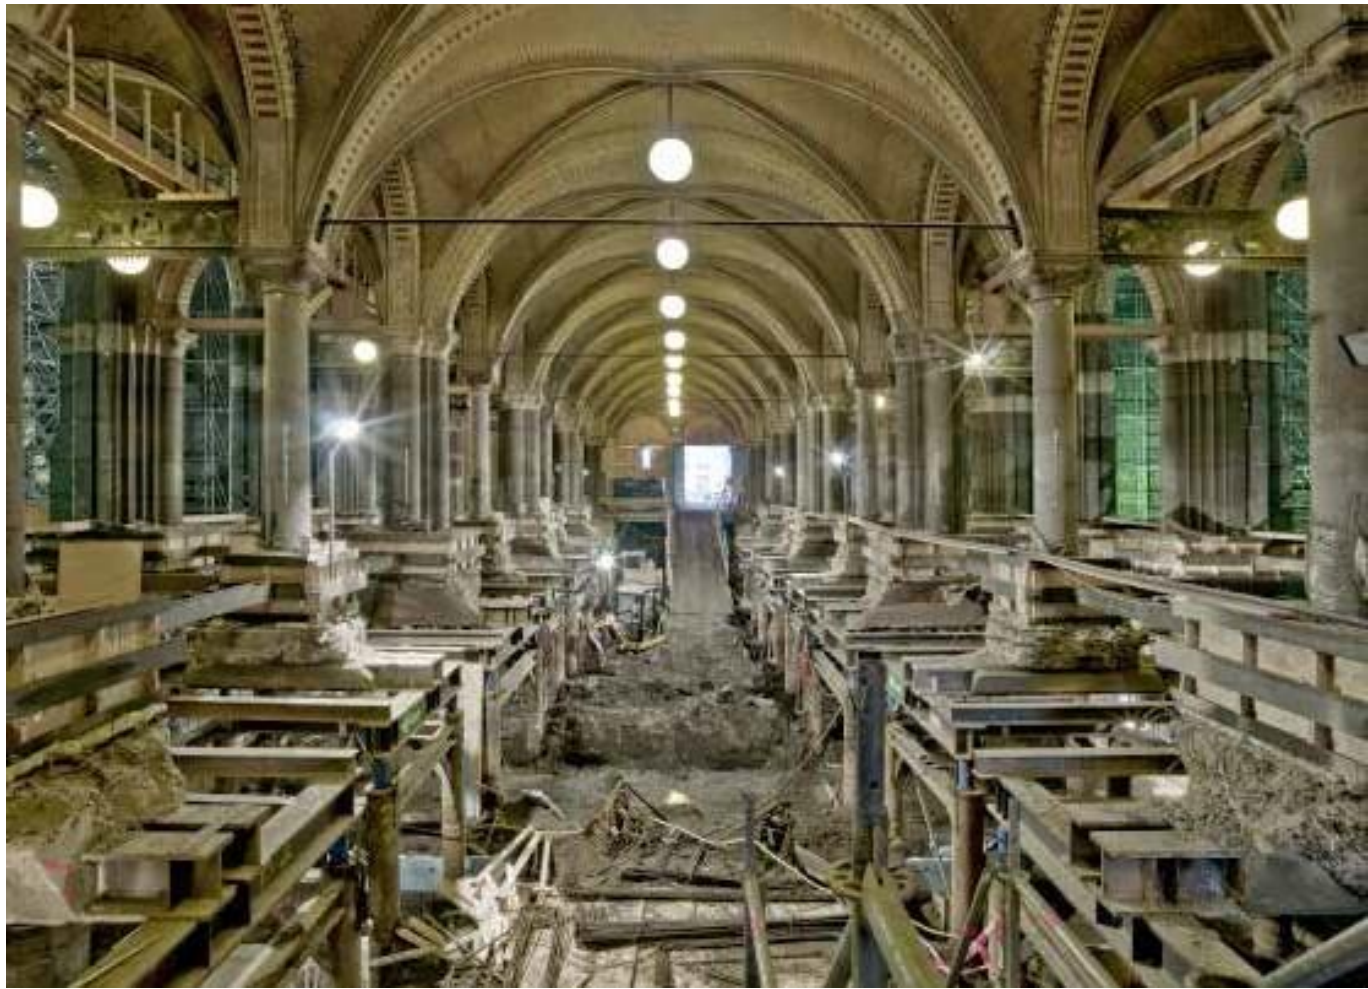
C.10 The foundation of the central passageway is demolished, leaving the Gallery of Honour 'suspended' on top of the temporary foundation and jacks, February 2010.

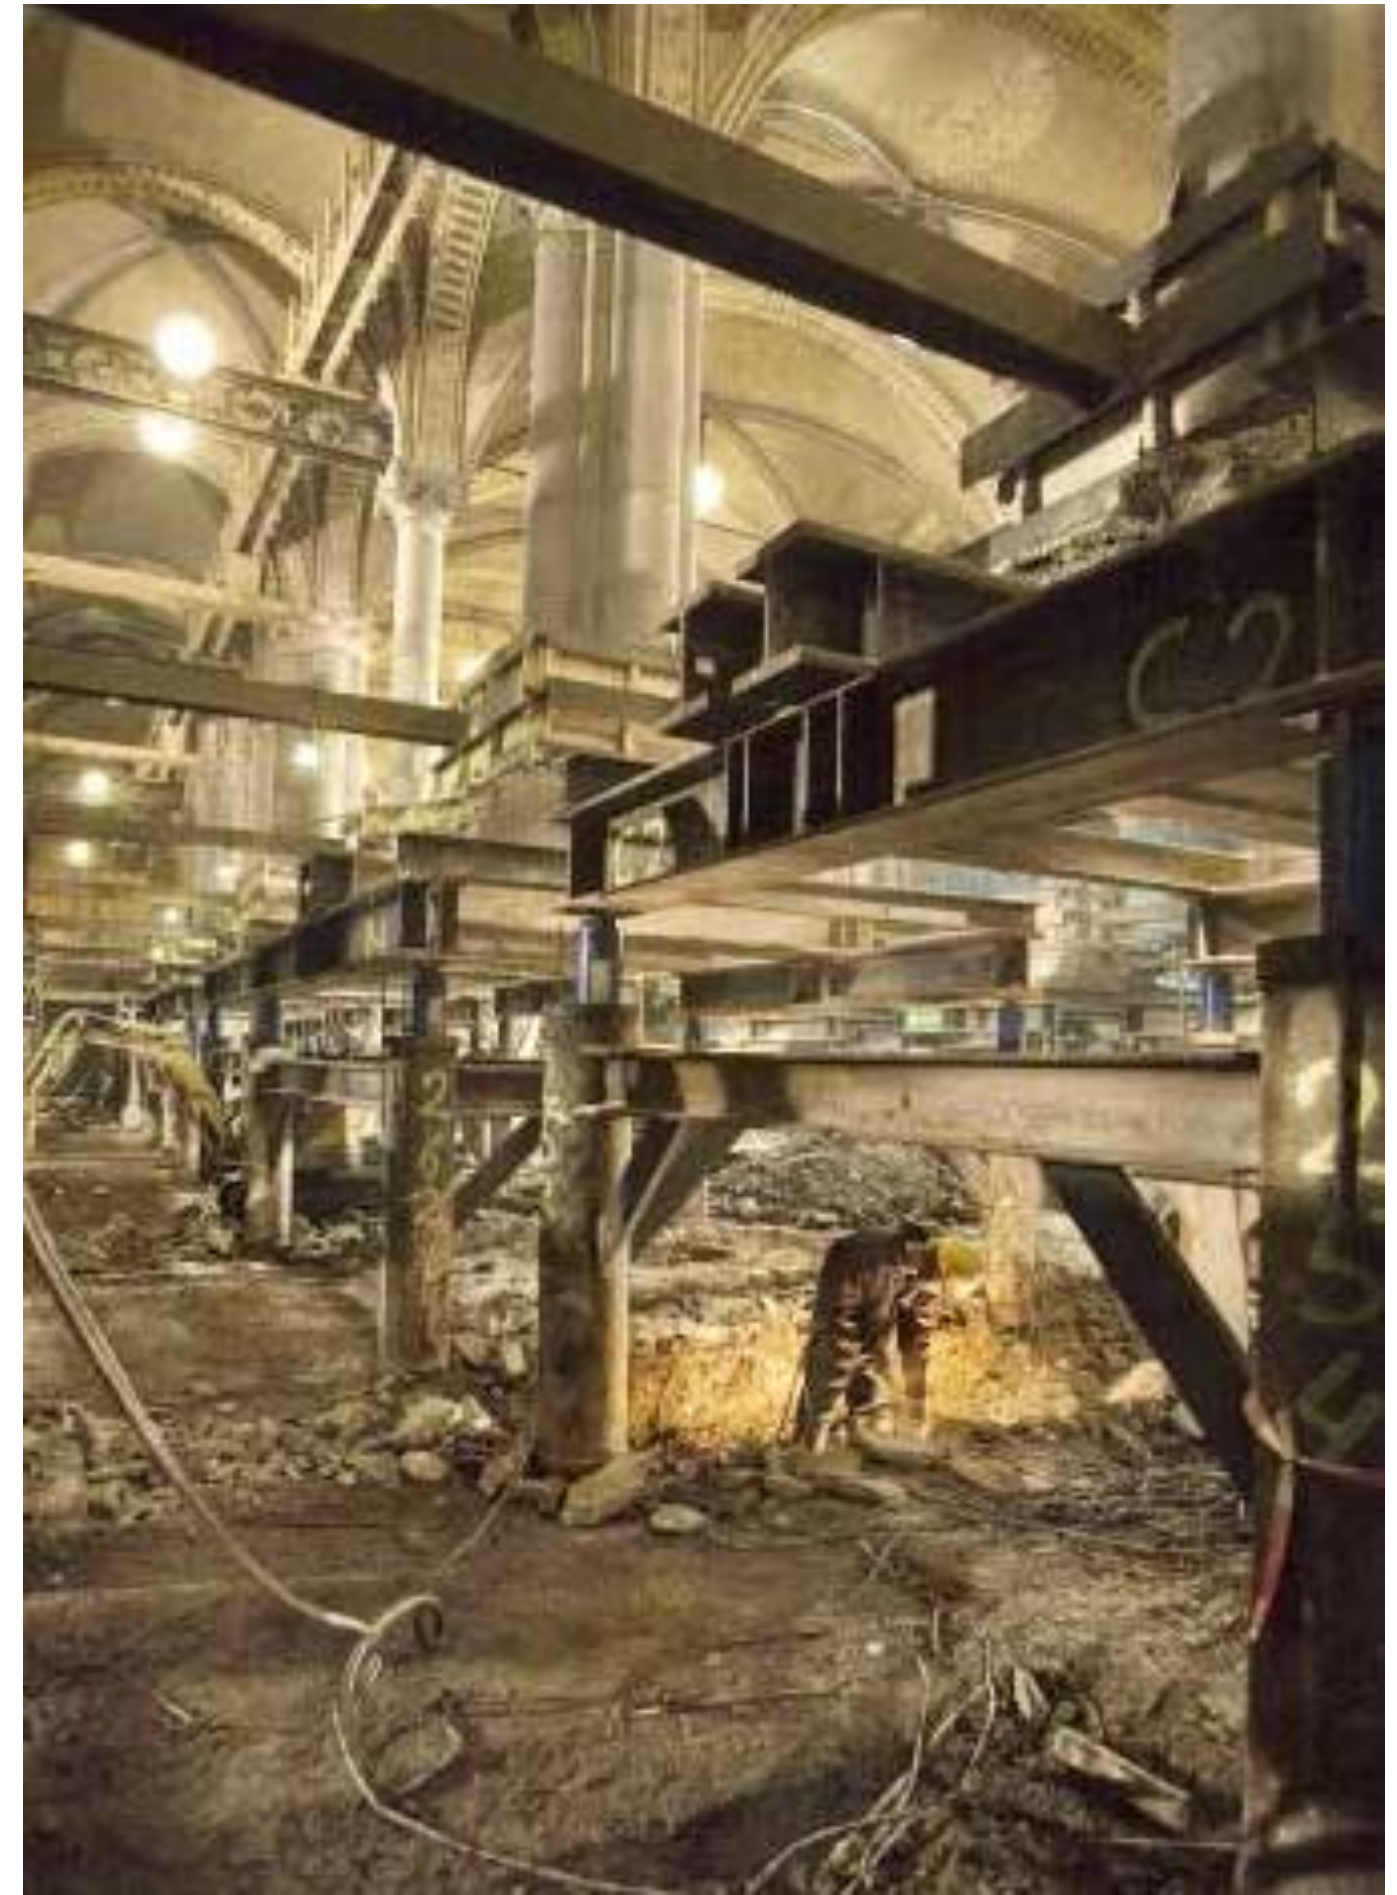
C.11 The foundation of the central passageway is demolished; the blue jacks are clearly visible, February 2010.

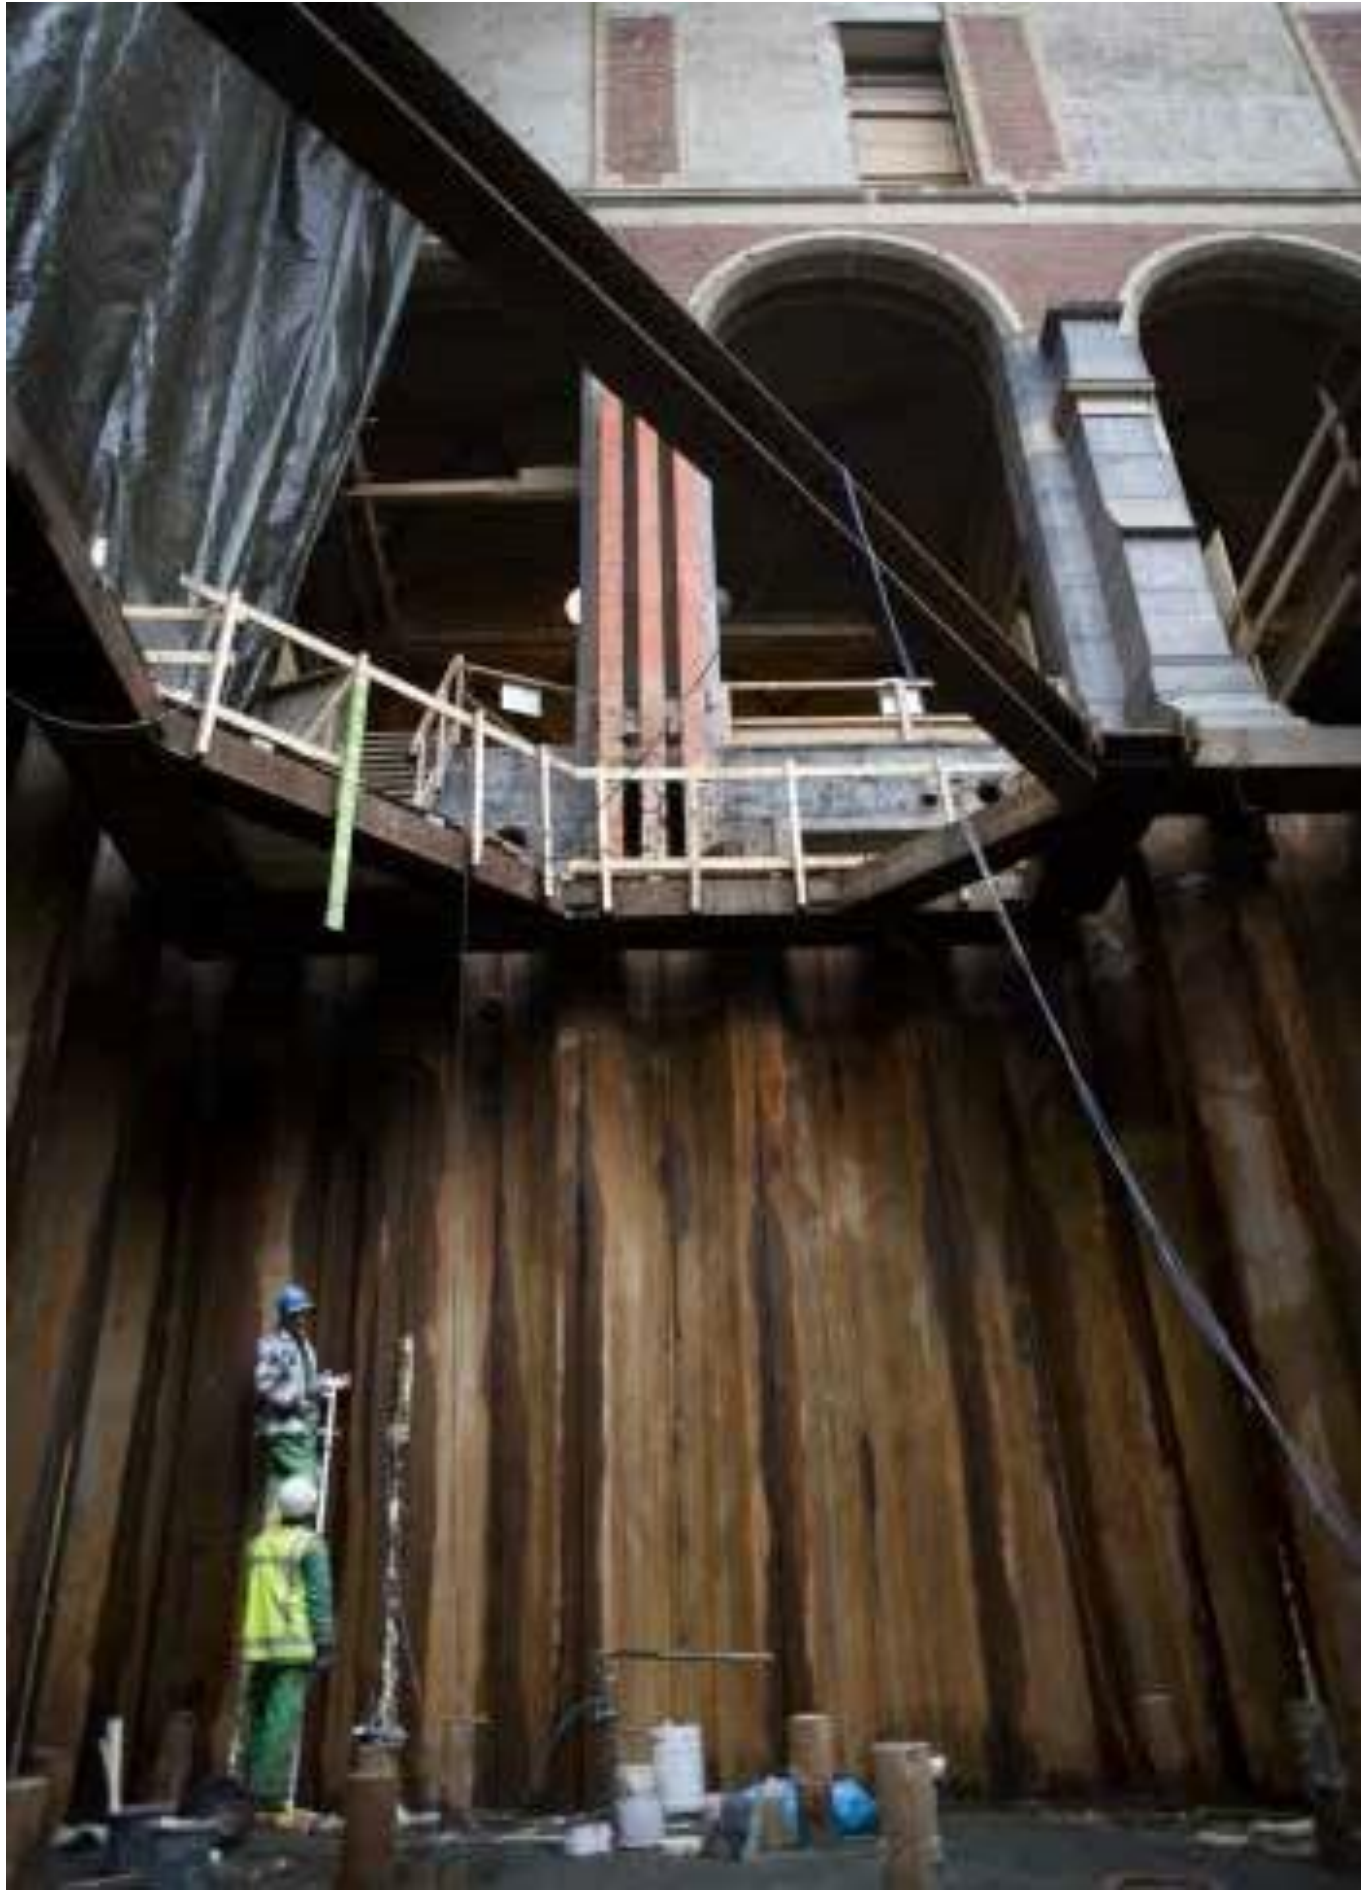
C.12 The deepest point under the courtyards is reached.

The courtyards were excavated to a depth of 7 m below Amsterdam Ordnance Datum (NAP) and more than 8 m below the street level of the central passageway. The building was found to have settled 10 to 15 cm since its opening in 1885. The historic structure is in almost constant motion, partly owing to differences between summer and winter temperatures. Because the subsurface is not uniform, there were and are different degrees of settlement. Nonetheless, the old foundations had held up very well through their many decades of use. The Norway spruce piles under the main buildings (approximately 8,000 in number) were almost completely intact, and hardly any significant cracking was found in the building's walls. The original load-bearing construction of the museum had been oversized, and this had had its benefits.
