3 Continue with Cuypers Renovation of the Rijksmuseum

Paul Meurs

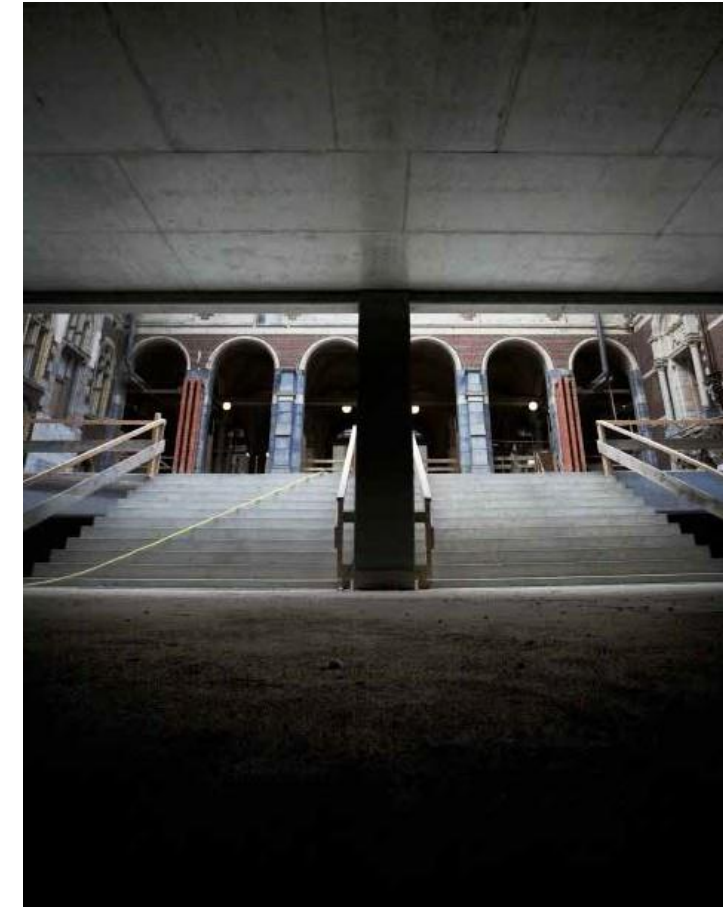
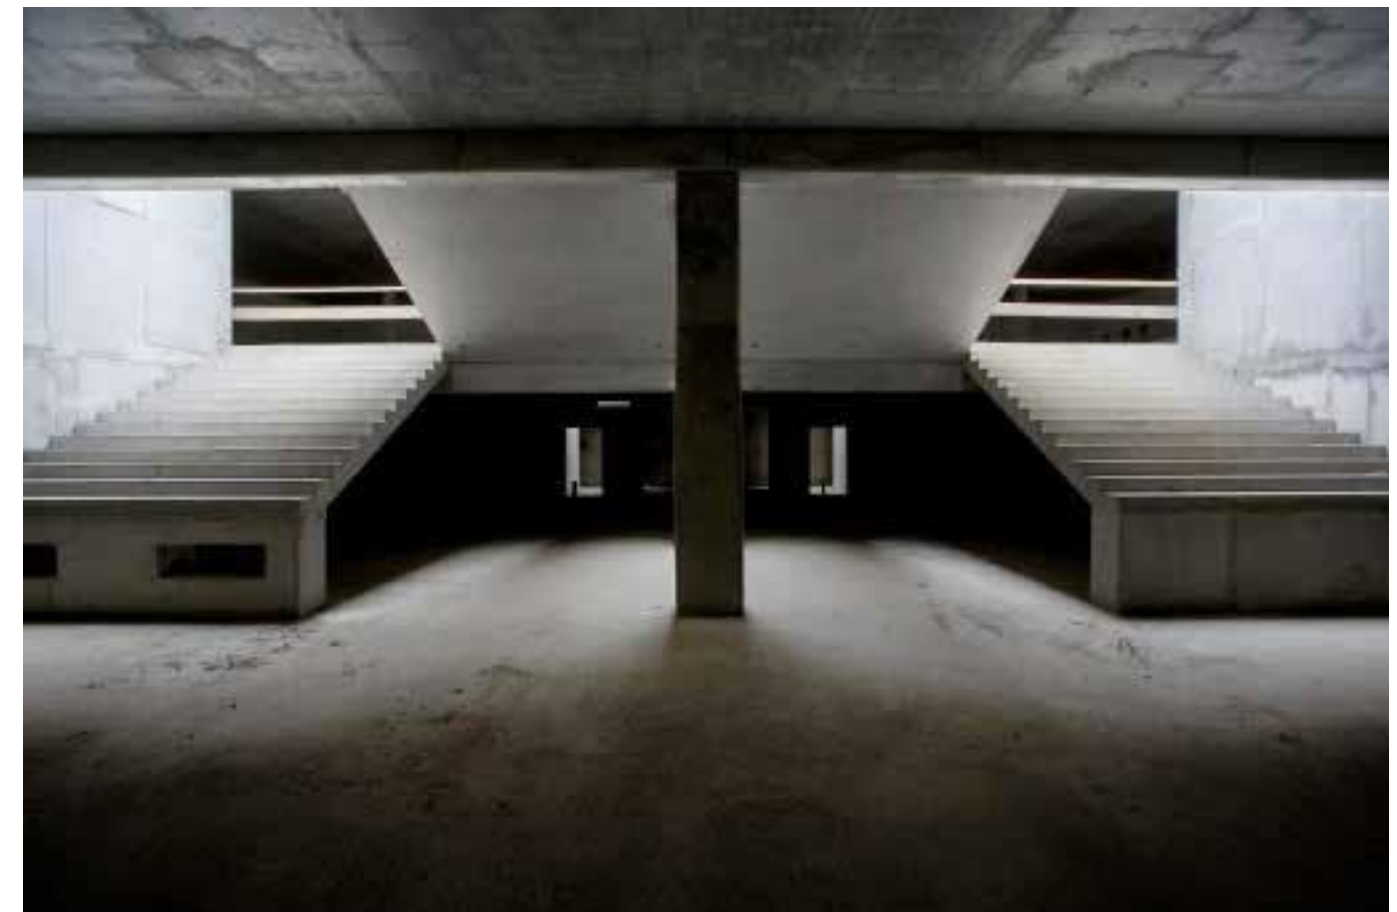
C.13-14 Concrete structure under the east courtyard.

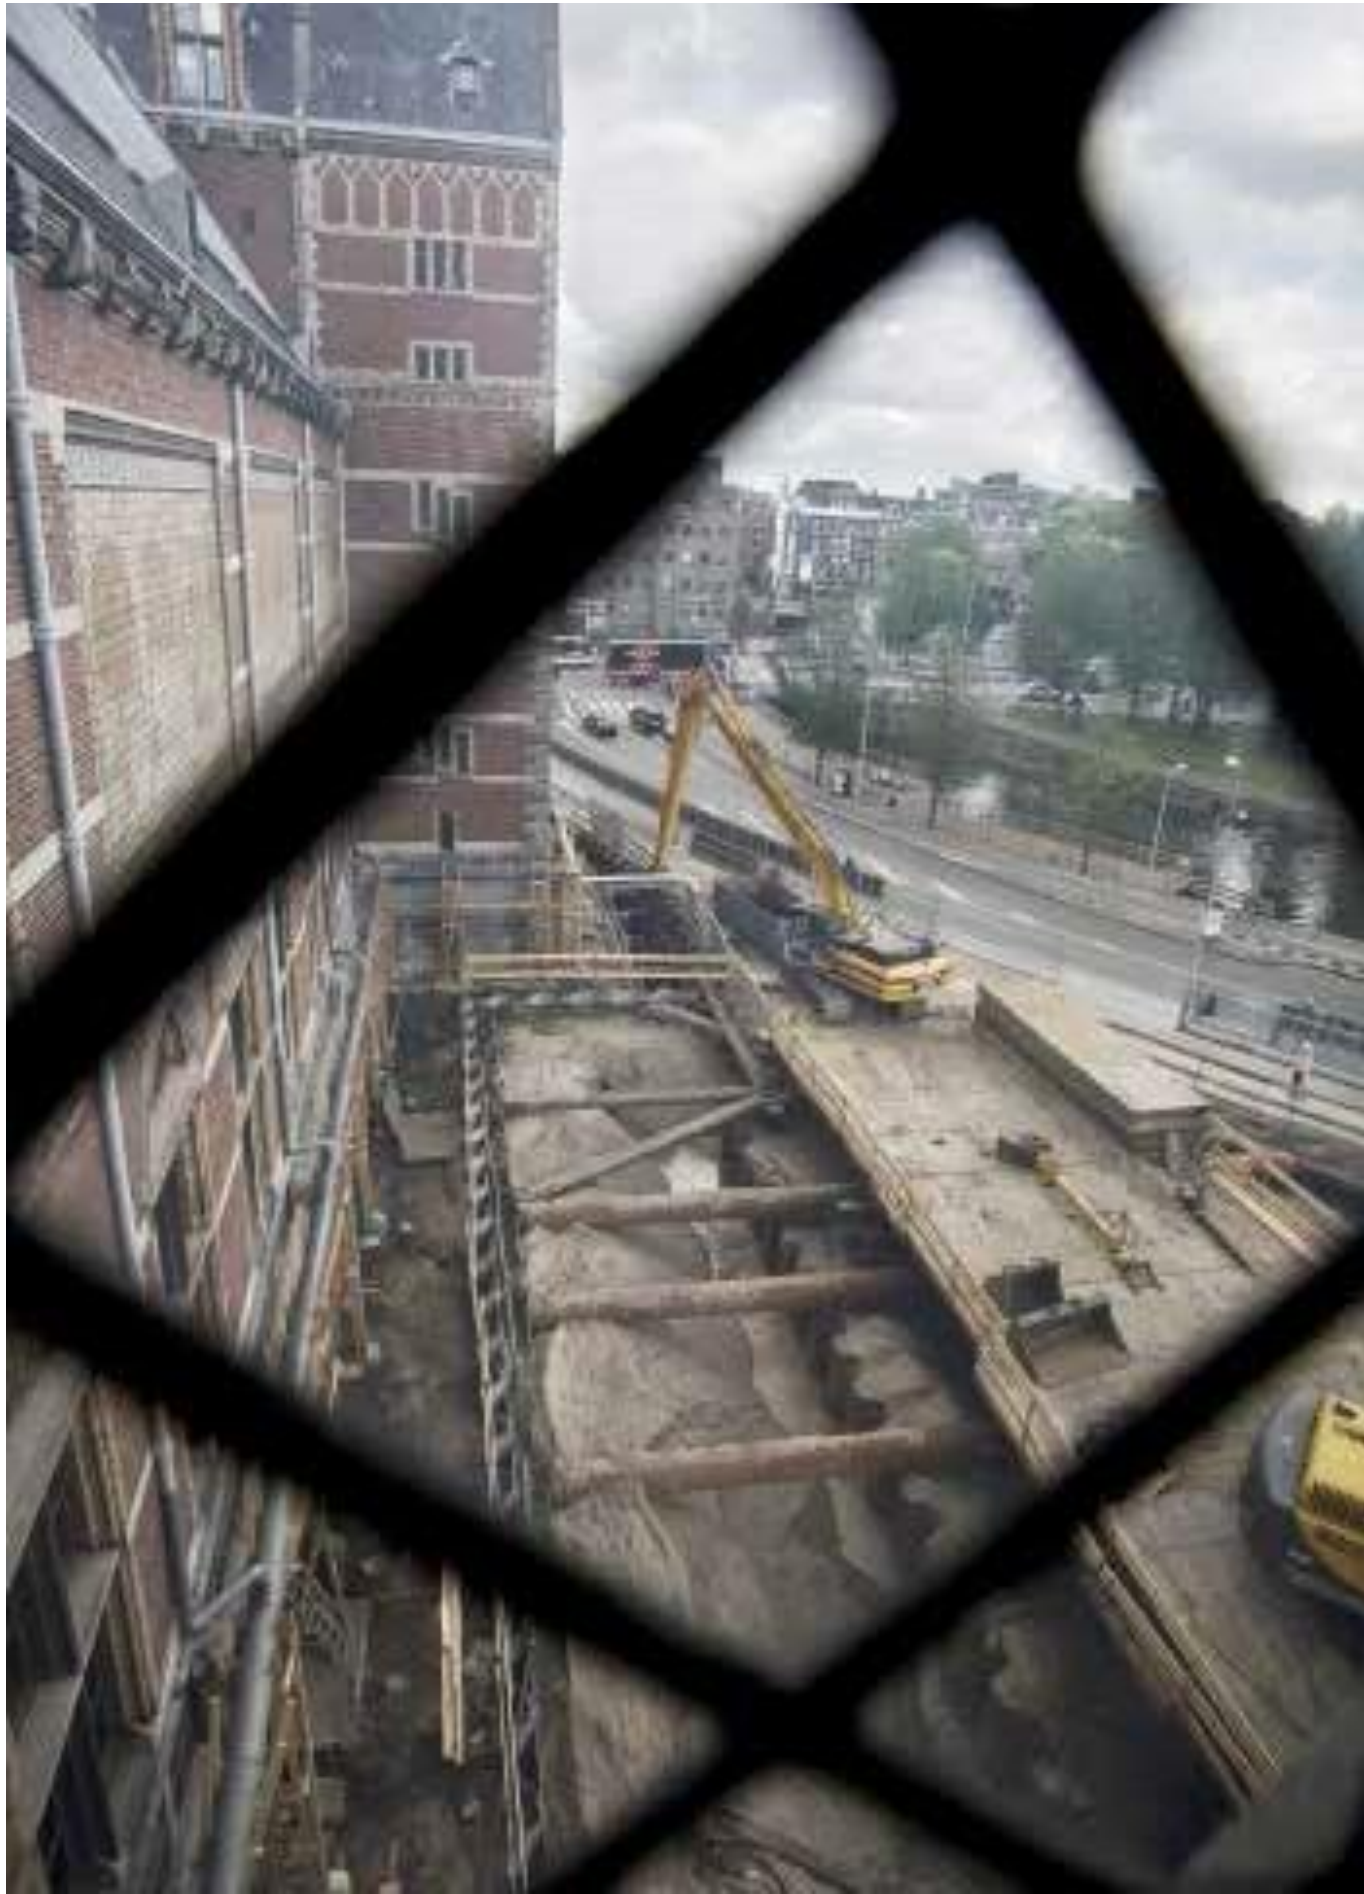
C.15 Excavation for the construction of the Energy Ring on the streetside (east) of the Rijksmuseum, June 2009.

The Energy Ring was constructed by the same method as the basements beneath the courtyards. This tunnel, 3.5 m high on the inside, encircles the building and passes under the courtyards between two sheetpile walls. The innermost ring of sheetpile walls turns the main building into a kind of polder, shielded from the high water table around it. This requires constant regulation by means of water pumps. A subsurface irrigation system in the museum garden allows water to be pumped in from the canal in times of drought. This prevents the wooden foundations from drying out. The reverse is also possible: the water table in the miniature polder can be lowered when surrounding water levels are high by pumping filtered water back into the canal.

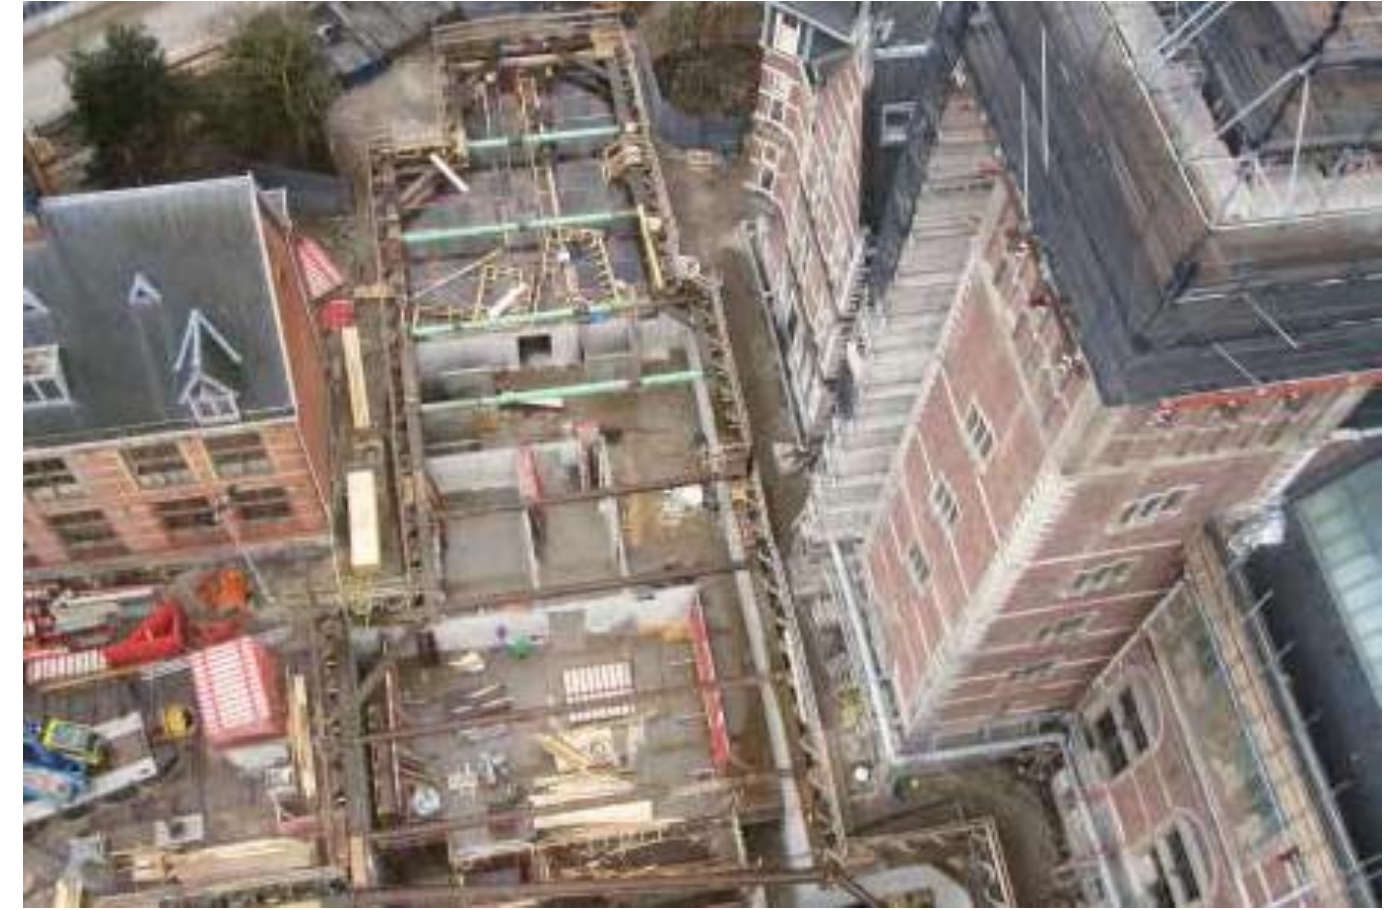
C.16 Work on the energy centre on the east side of the Rijksmuseum, under the future Entrance Building, March 2010.

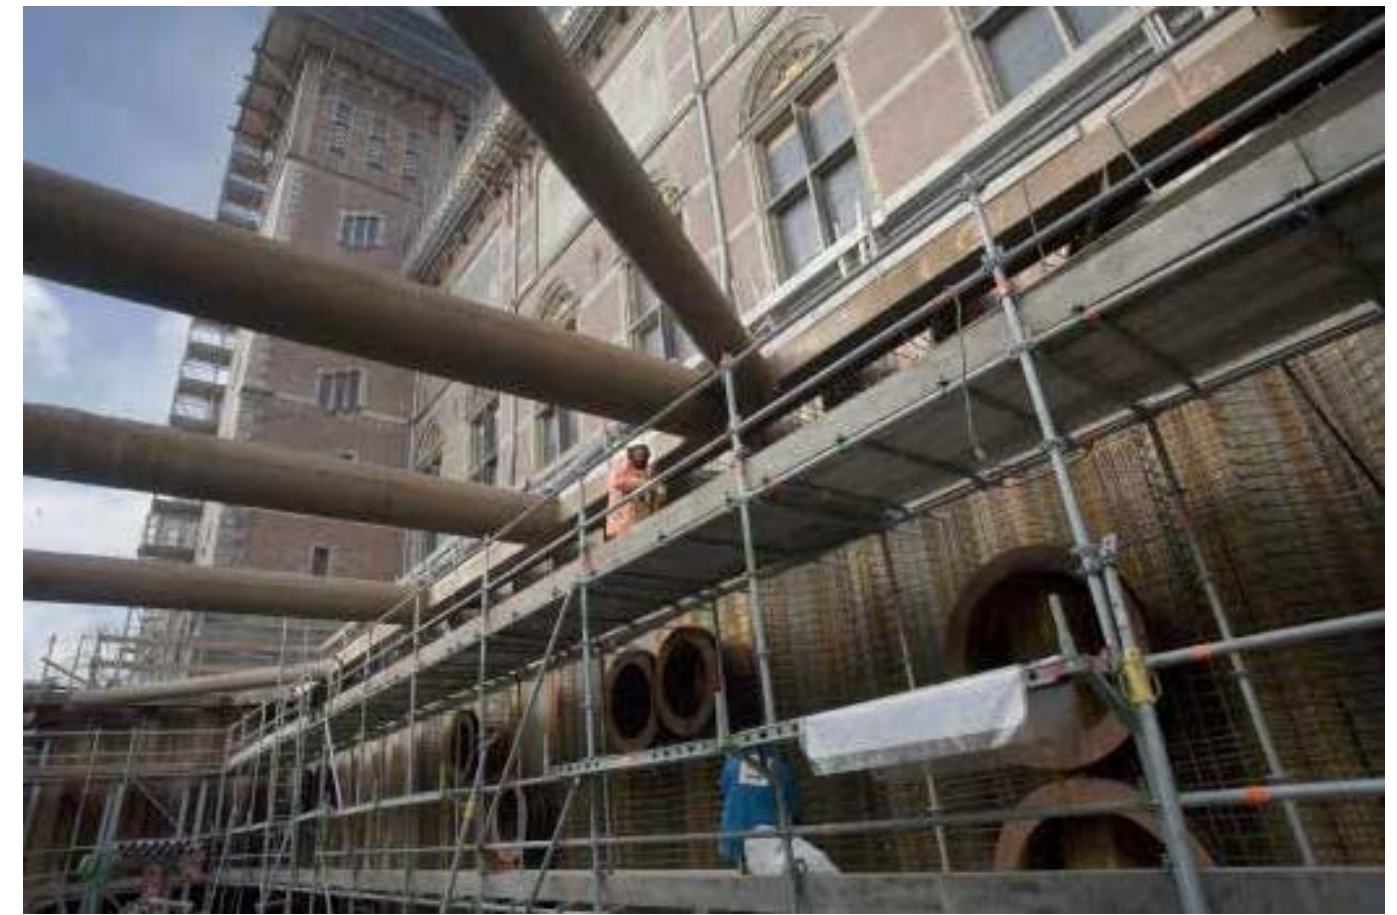
C.17 Work on the energy centre under the future Entrance Building; the ducts in the sheetpile wall are clearly visible, March 2010.
