Quantifying the probability of light damage to masonry structures

An exploration of crack initiation and progression due to seismic vibrations on masonry buildings with existing damage

Korswagen, Paul A.

Dissertation

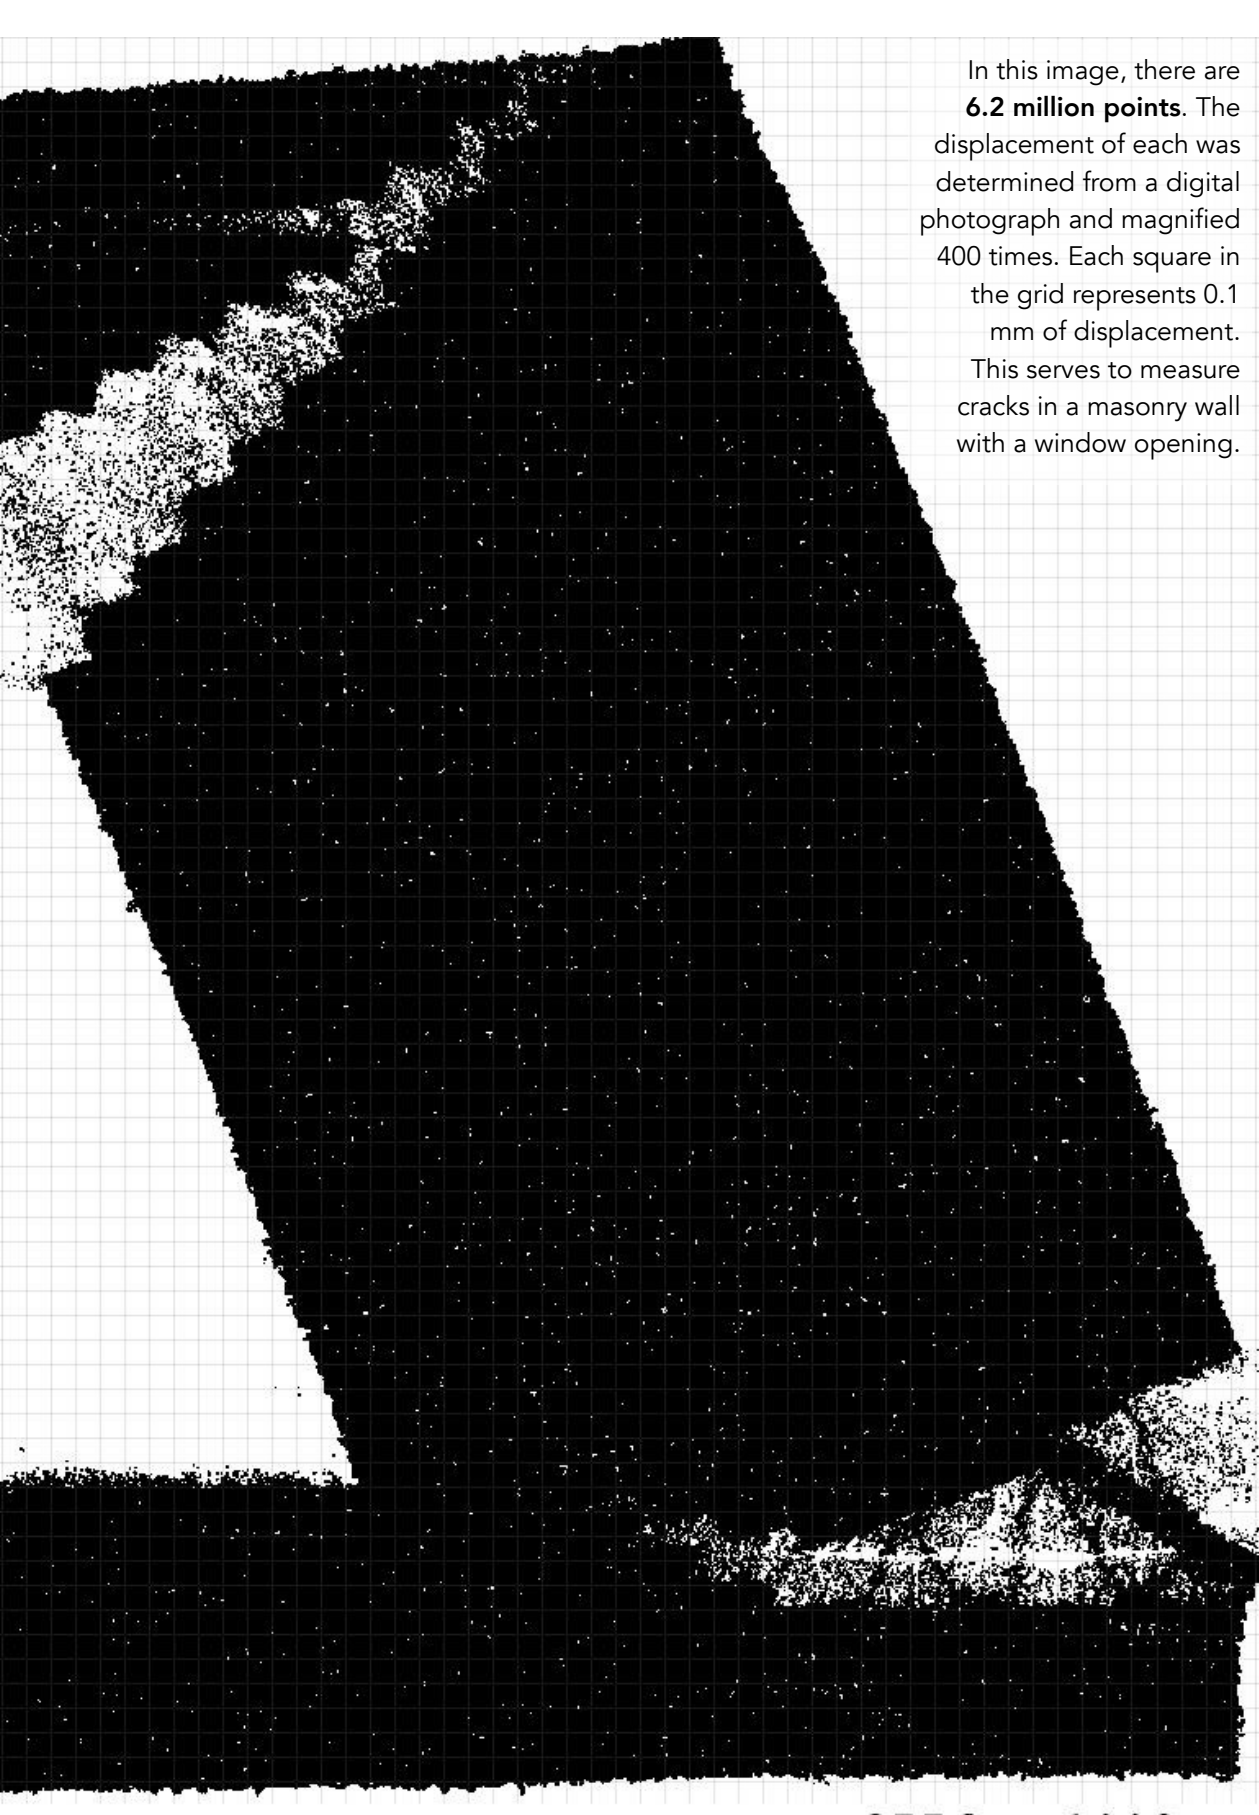
In this image, there are **6.2 million points**. The displacement of each was determined from a digital photograph and magnified 400 times. Each square in the grid represents 0.1 mm of displacement.

This serves to measure cracks in a masonry wall with a window opening.

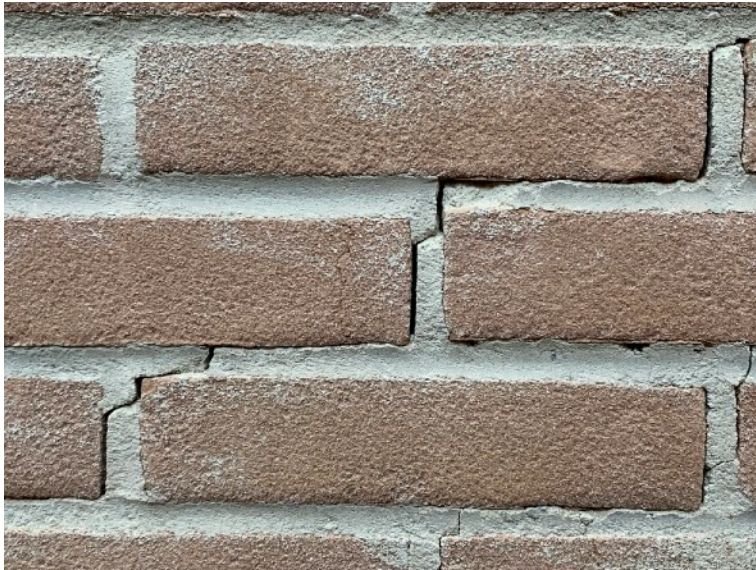
Figure 1.1.1. An example of a narrow crack in fired-clay brick masonry with a stretcher pattern and a cementitious general-purpose mortar in 10mm bed and head joints. This photograph was obtained from an experiment on a wall (see Chapter 3).

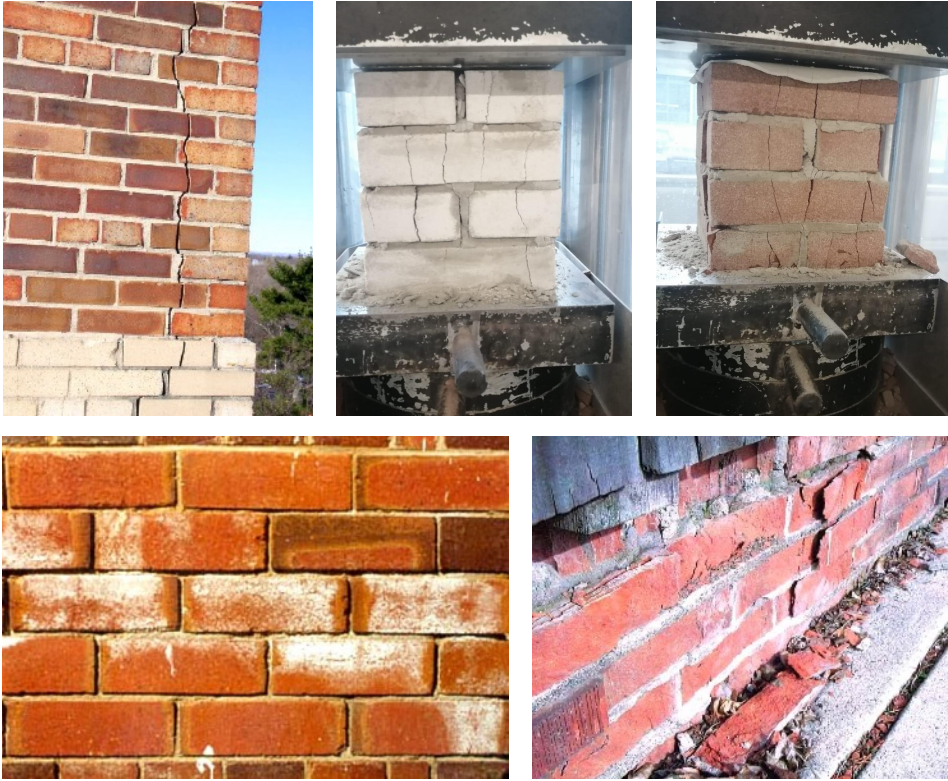
Figure 2.1.1. Examples of expressions of damage in masonry. a) A crack at the corner of a structure. b) Fine vertical cracks in the masonry due to excessive compression (crushing). c) Blistering on the bricks and the mortar due to efflorescence of salts. d) Serious scaling or delamination likely due to freeze-thaw cycles.

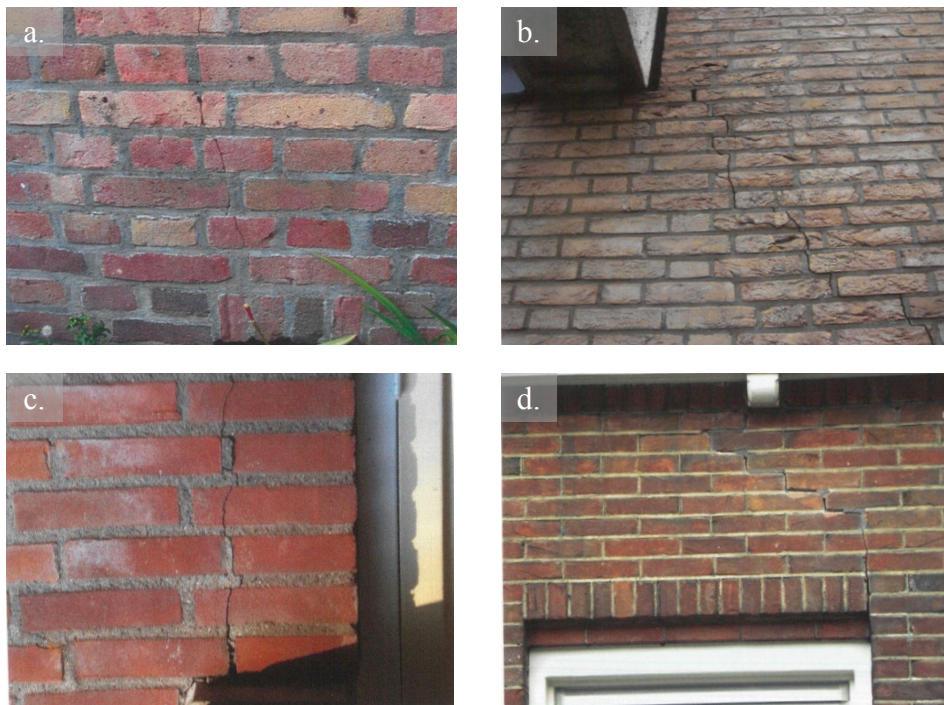
Figure 2.2.0. Photographs of cracks in bare masonry walls. (a) Small crack narrower than 0.5 mm; (b) crack approximately 2 mm wide; (c) crack narrower than 2 mm; and (d), wider than 5 mm. Adapted from [SBR].

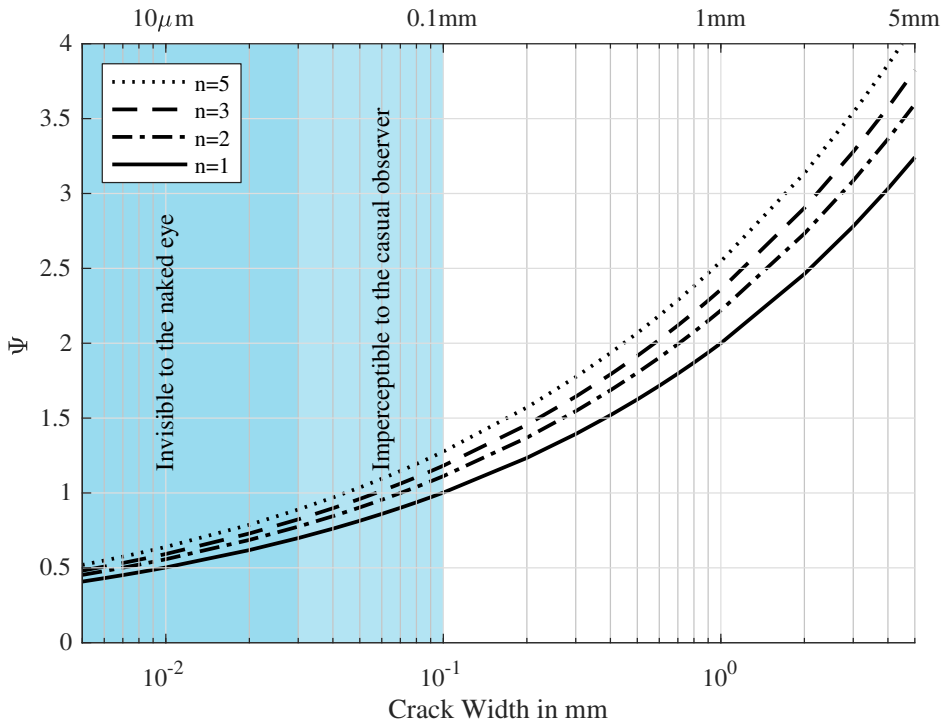
Figure 2.2.2. Relationship between the width of cracks (c), the number of cracks (n) and the damage parameter Ψ .

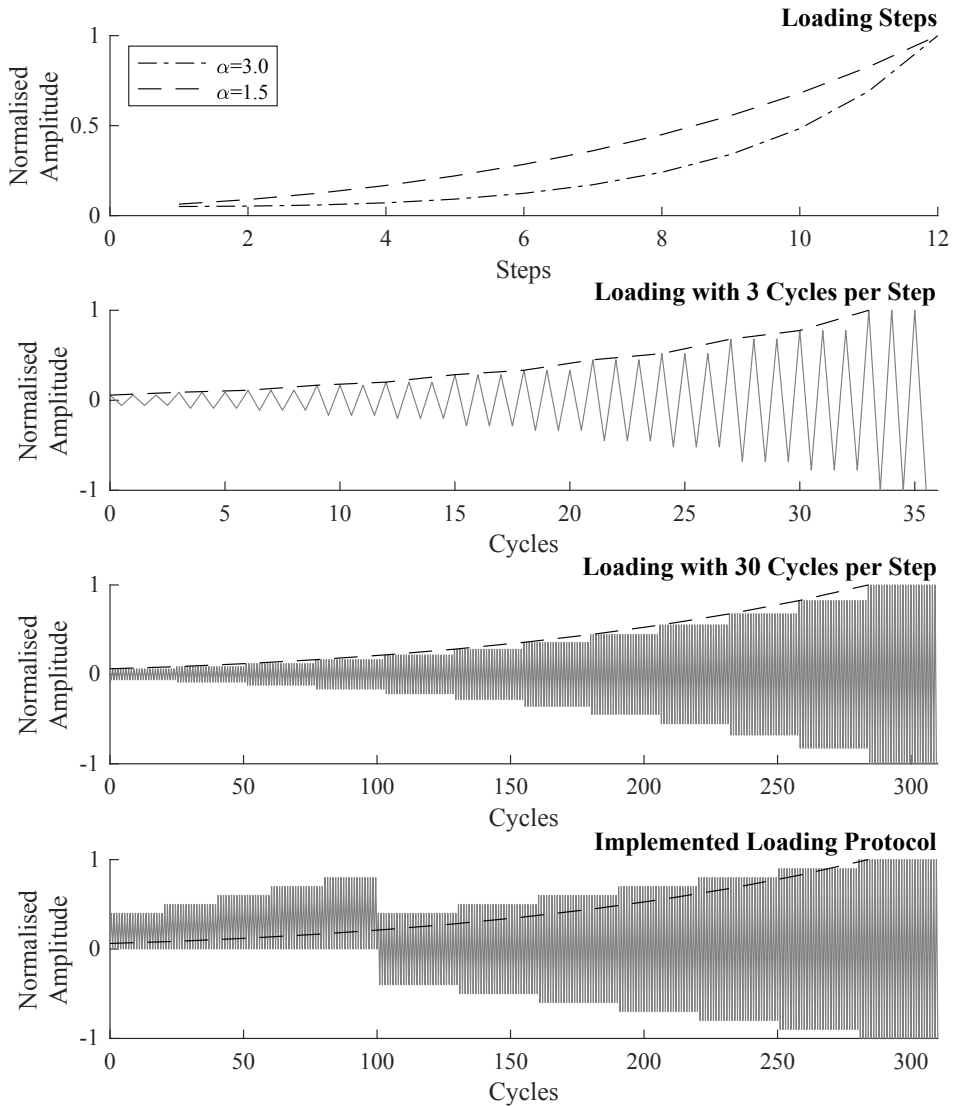
Figure 3.1.2: Comparison of loading protocols. Includes Beyer et al. (2015) methodology with 12 steps for two 'alpha' values, 12 steps with 3 cycles each at $\alpha=1.5$, adapted loading with 30 cycles per step, and this study's protocol for wall samples with a total of 310 cycles, combining repetitive (one-way cyclic) and bi-directional (two-way cyclic) parts.

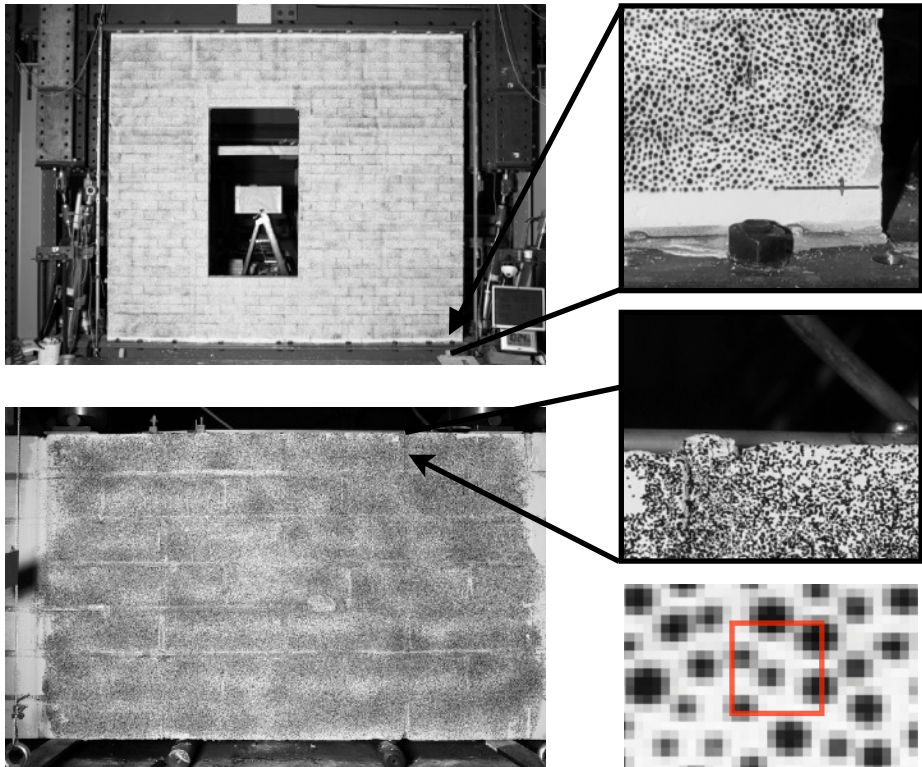
Figure 3.1.5. DIC pattern and subset. Top, wall and zoomed-in stencil speckle pattern. Bottom, spandrel and zoomed-in particle speckle pattern. And bottom right, subset of 10x10 pixels from the image.

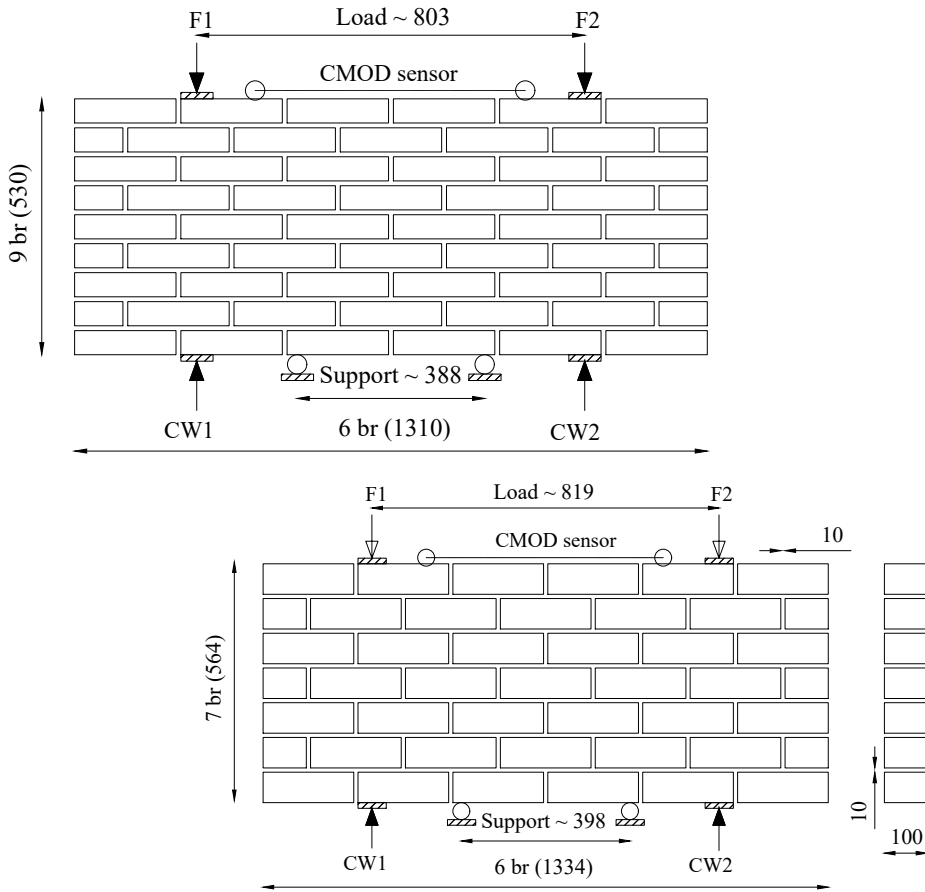
Figure 3.1.10. Geometry of fired-clay, top, and calcium-silicate, brick masonry spandrels. The exact dimension and positioning of the load actuators was measured for each specimen.

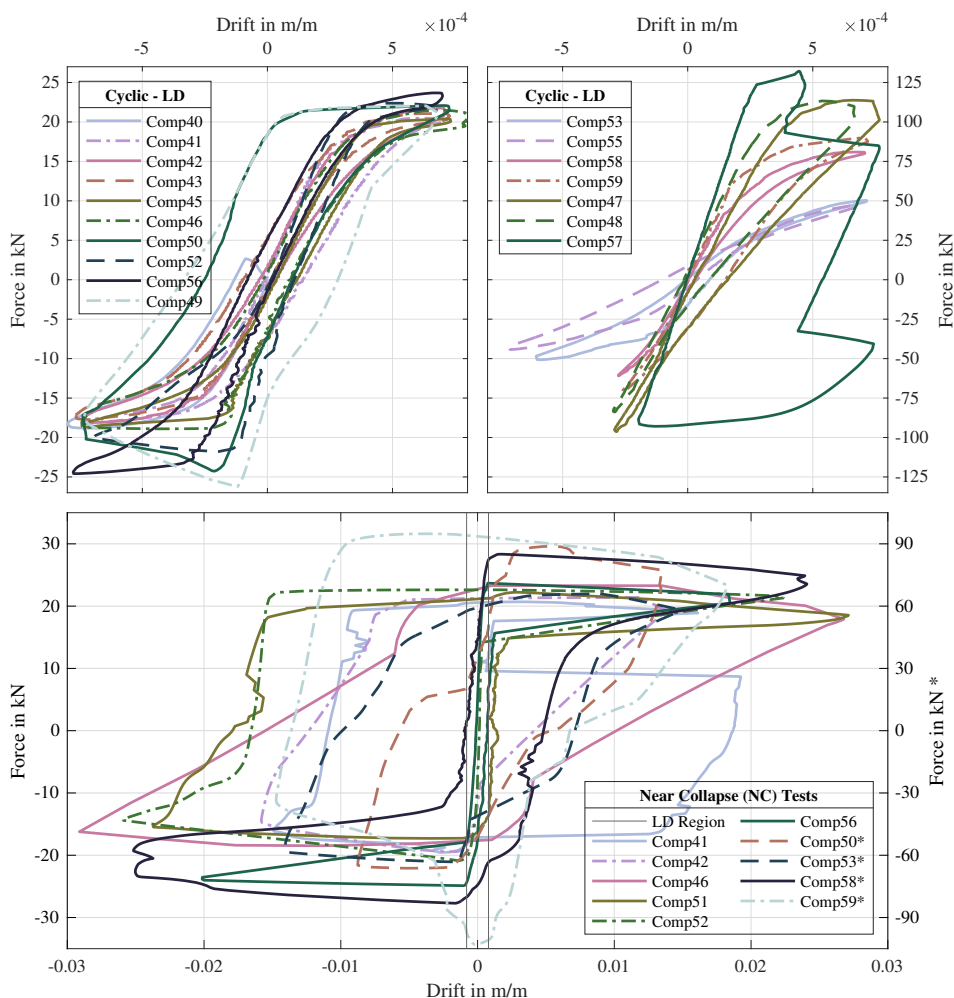
Figure 3.2.2. Envelope of the force-drift curves for the cyclic tests, top, and for the near-collapse tests, bottom. Walls with * are read on the right axis.

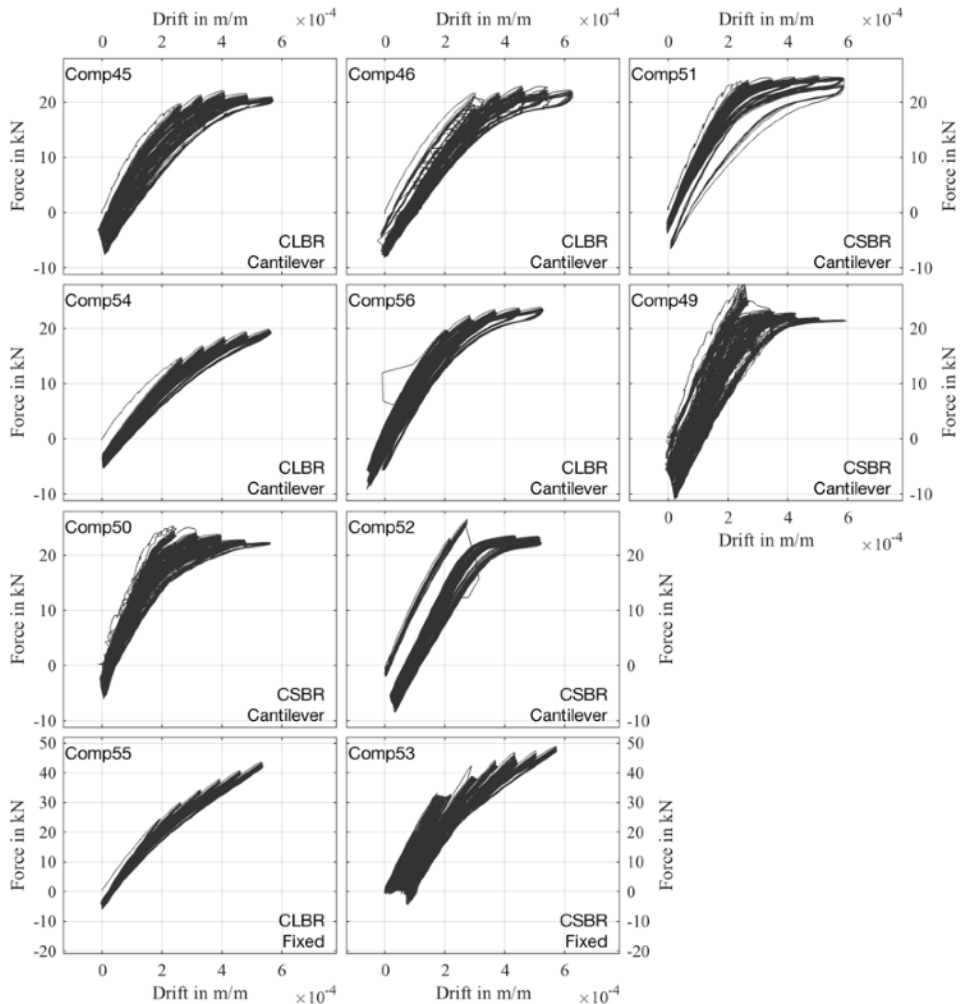
Figure 3.2.1a. Force-Drift curves for the repetitive parts of wall tests.

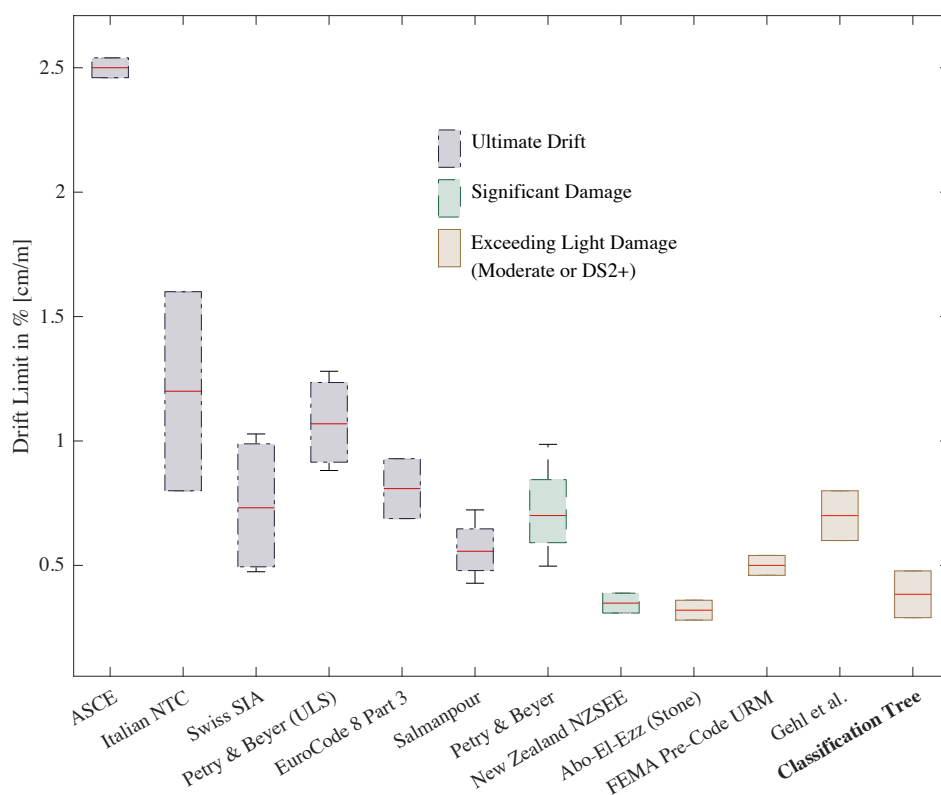
Figure 3.3.6. Comparison with other drift limits for various damage thresholds.

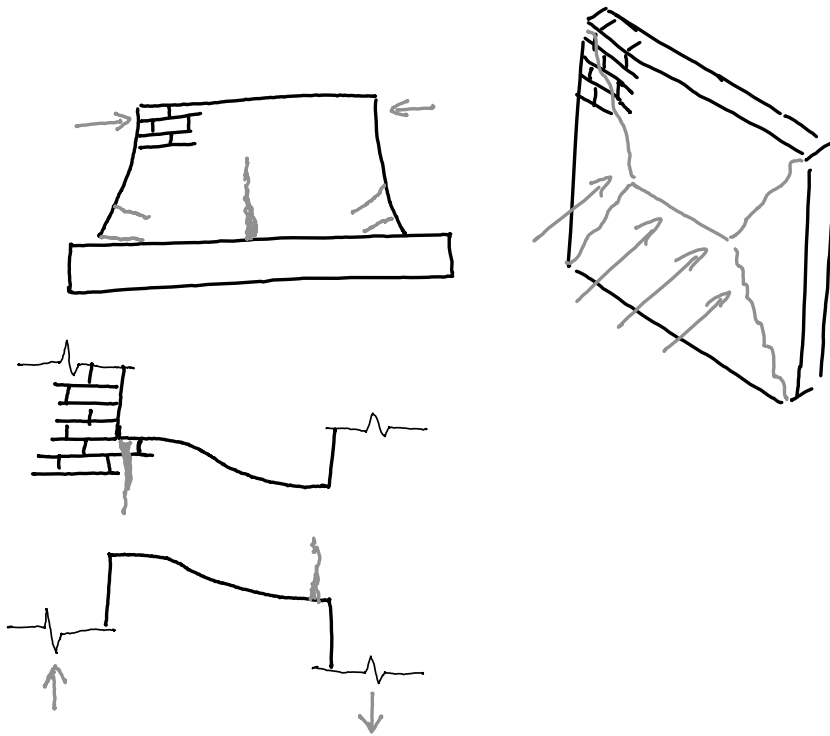
Figure 4.2.2. A scheme of masonry wall subjected to (top left) shrinkage, a deformation with is restrained by the stiff foundation, and (top right) out-of-plane loads resulting in two-way bending. Bottom, a spandrel, between two walls experiencing a relative displacement leading to bending in the spandrel. The schematic location of cracks is highlighted.

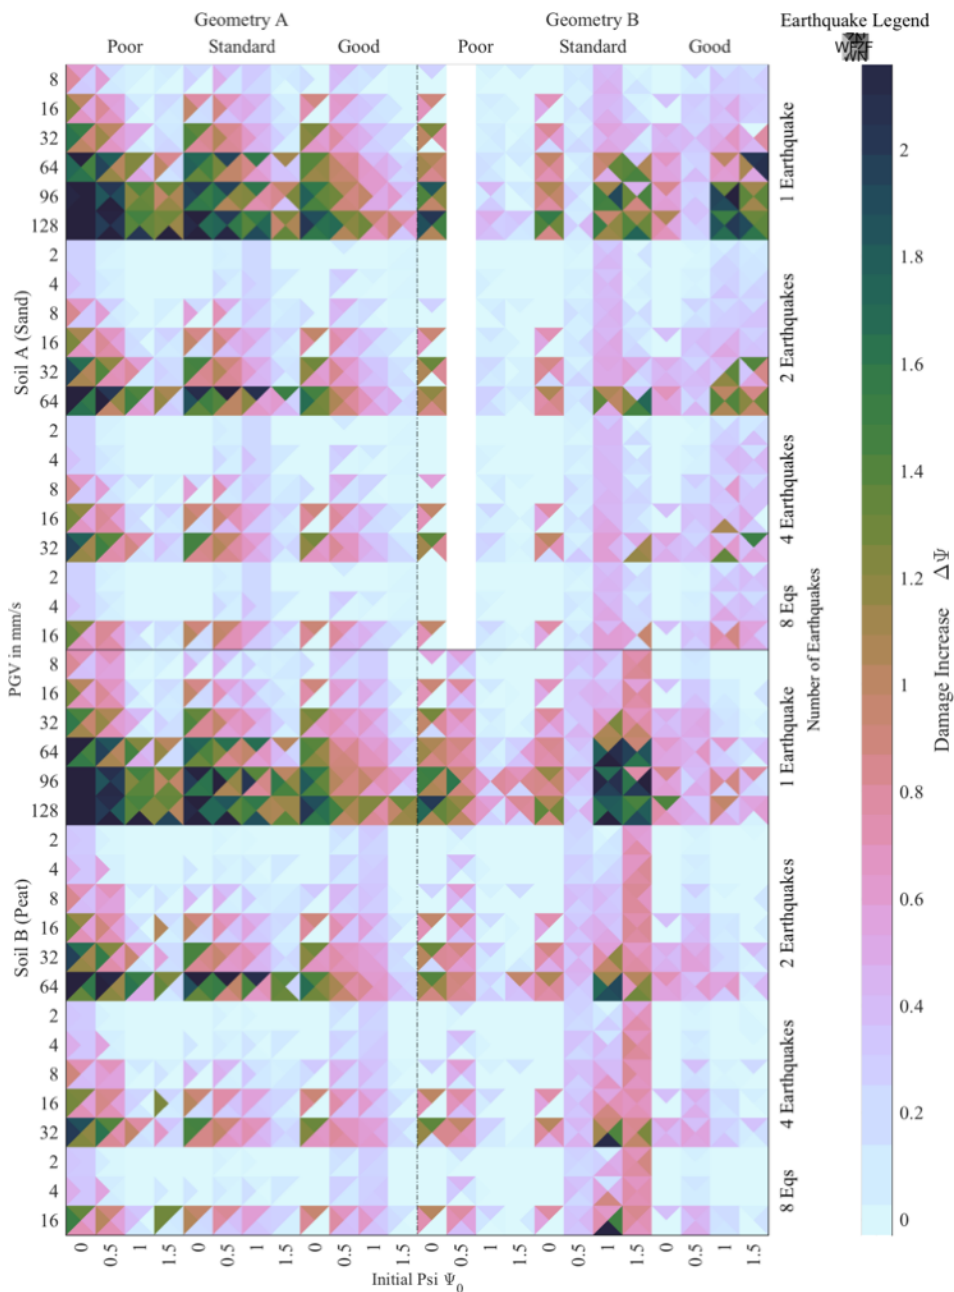
Figure 5.2.4. Results in terms of $\Delta\Psi$ from the permutations with the extrapolation models for fired-clay brick. There are 40x24 squares, each divided into 4 triangles. In total, 3840 results are displayed. This type of graph is referred to as the 'colour diamonds' table.

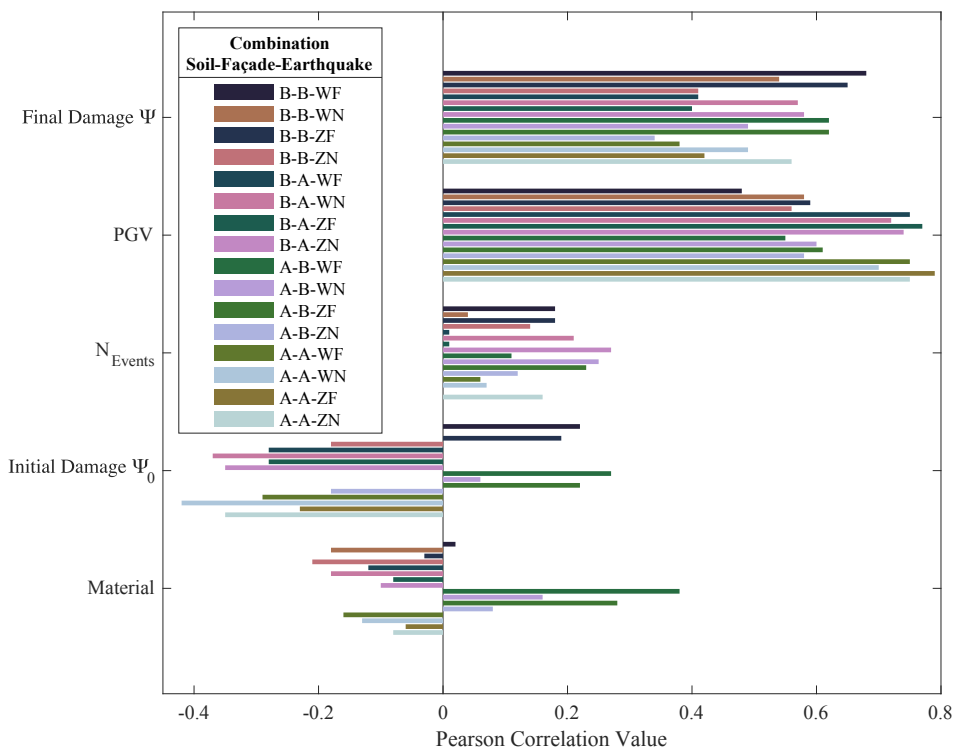
Figure 5.3.1. Pearson correlation values between $\Delta\Psi$ and the different variables in the regression model.

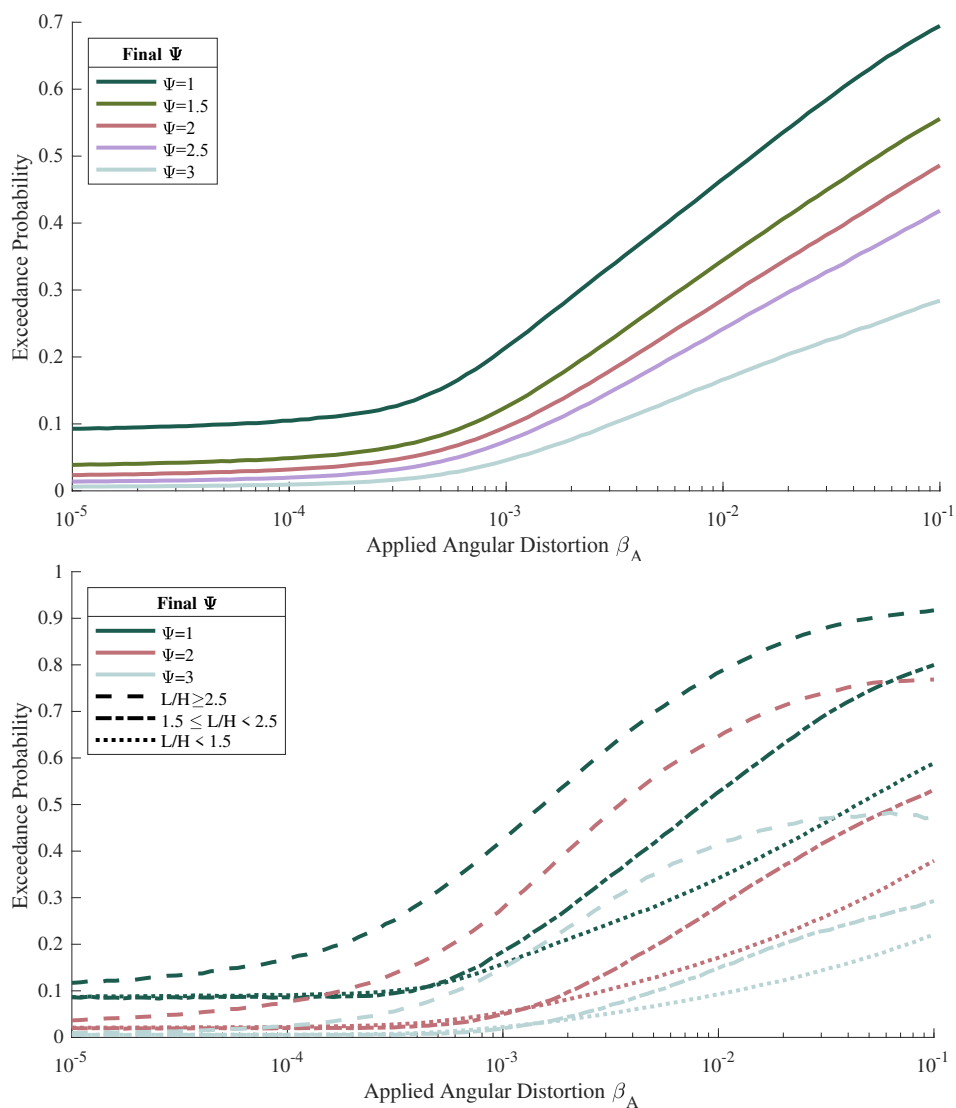
Figure 5.5.7. Fragility curves for soil angular distortion β . Bottom, segregated by L/H ratio.

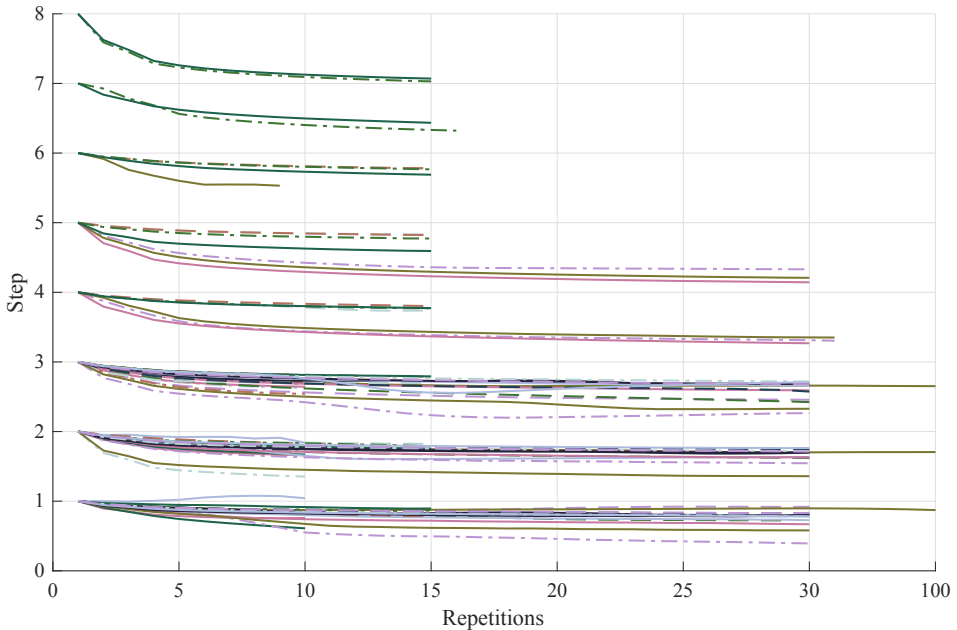
Figure 6.1.1. Force degradation for the spandrels segregated by step. Different lines are used only to distinguish overlapping instances; style and colour have no legend. Chapter 3.

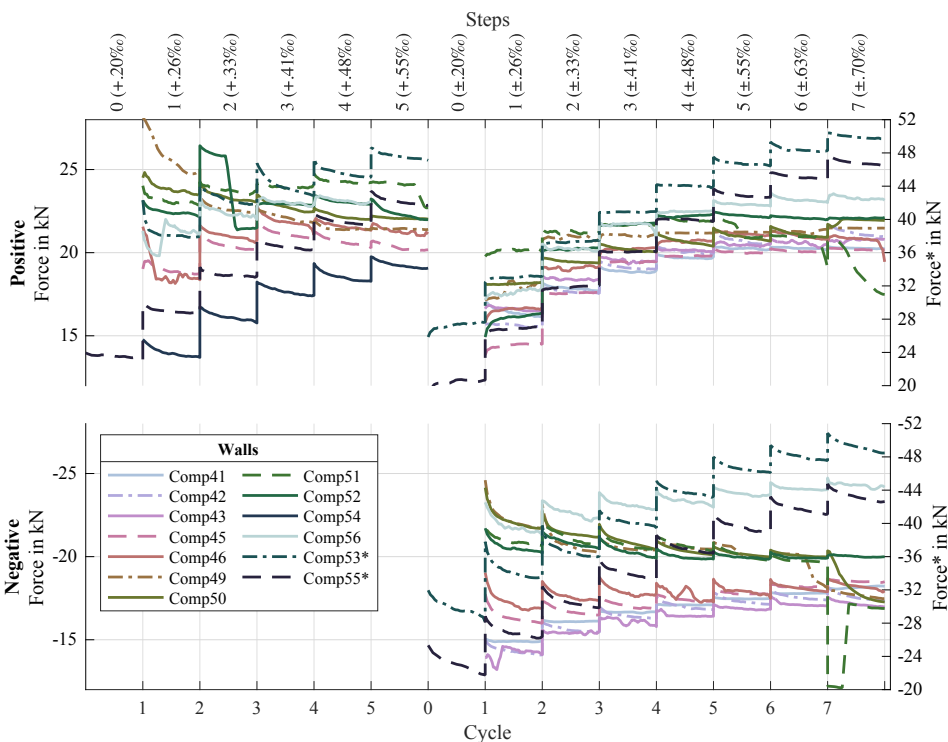
Figure 6.1.2. Force degradation for walls positive, cyclic.

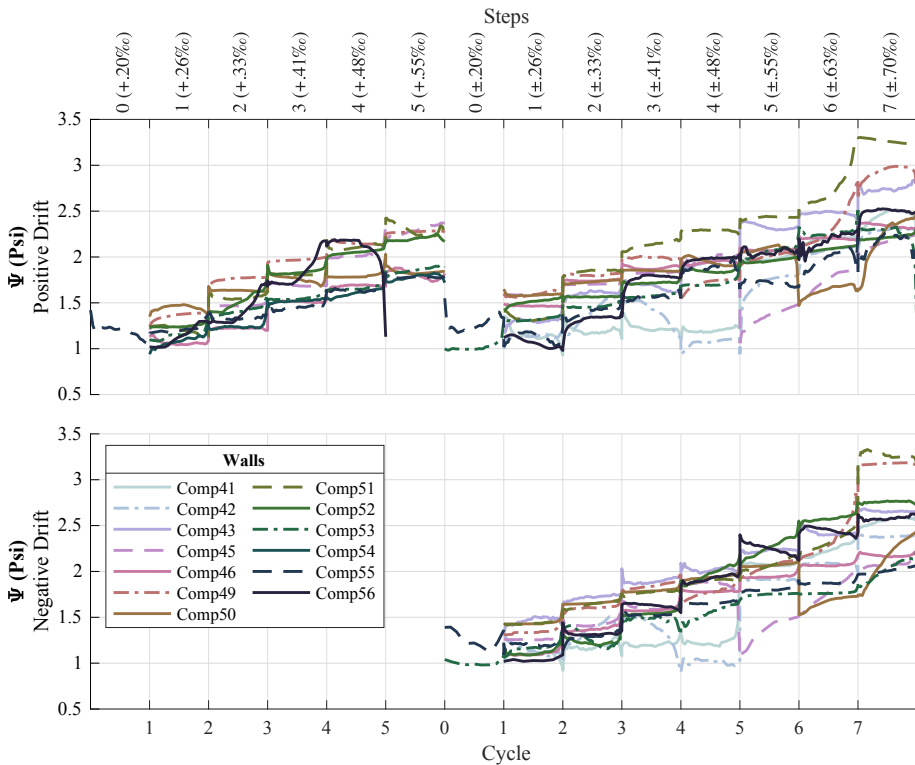
Figure 6.1.4. Evolution of Ψ over the repetitive and cyclic wall experiments.

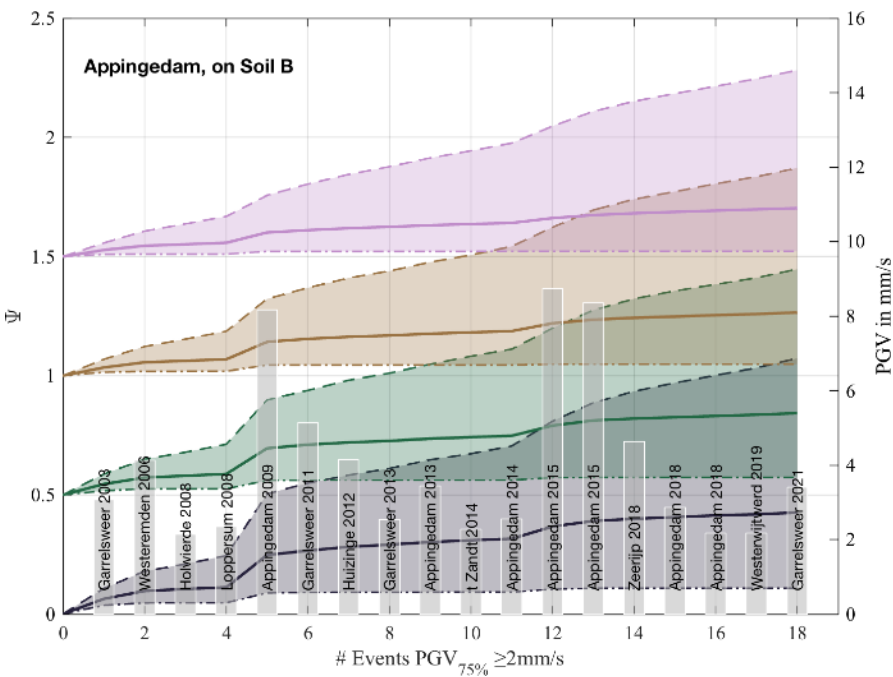
Figure 6.3.2. An example history for the sequences of PGV measured in Appingedam. Four initial values of Ψ are considered ranging from 0 to 1.5. The expected accumulated Ψ is marked with a solid line and the confidence interval 5-95% is highlighted for every case. Analysis based on wall of fired-clay brick masonry.

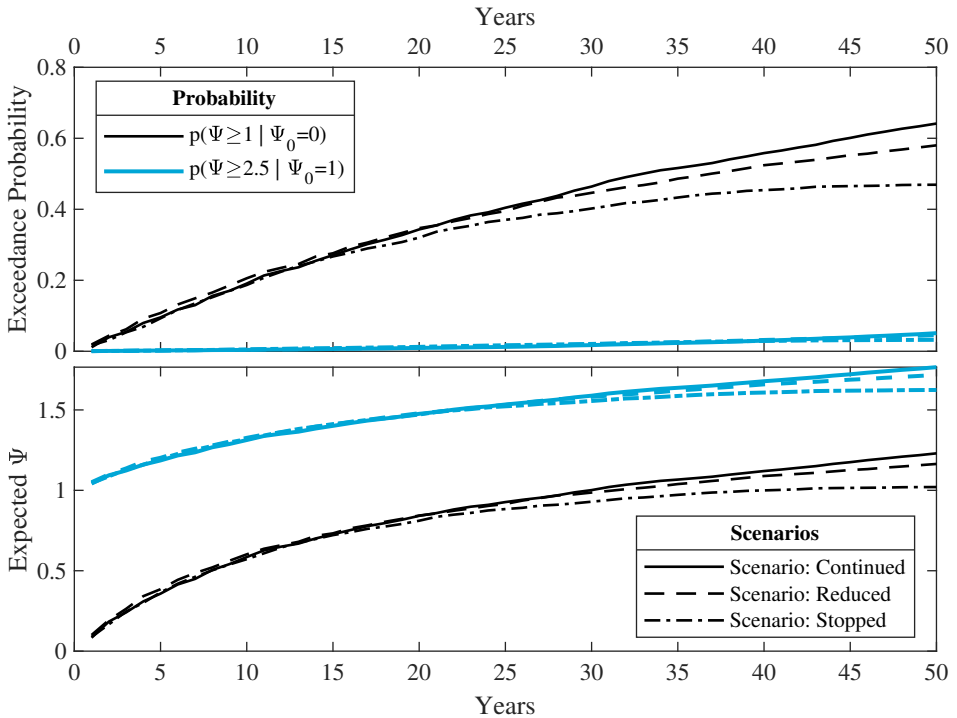
Figure 6.4.5. Fragility curves for the three scenarios as determined with the DAF analysis of multiple timelines per scenario. These are the fragility curves at the location of Loppersum based on idealised future scenarios with simplified assumptions. Year zero of the simulation corresponds to last year of the real history.

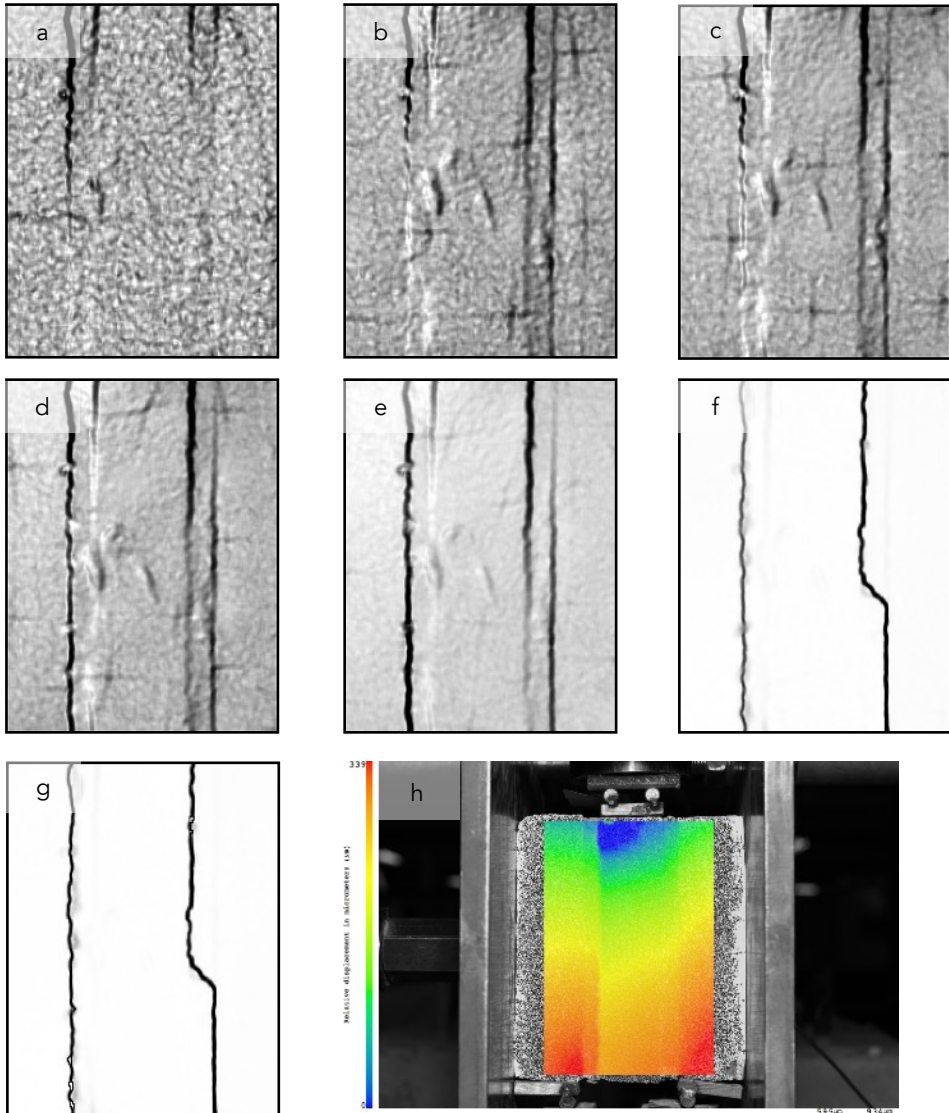
Figure A.1.2. Normalised principal strain plots of a section of a shear-triplet test sample (h) towards the end of the test starting at the last zero position (a), followed by the last peak displacement (b) and throughout the monotonic phase until total failure (g). Notice how initially incipient strains are localised at the top of the four potential failure planes. Then, the strains grow towards the bottom and also start to reach up from the bottom (c and d). In the case of the right mortar joint, the potential cracks grow from the top at the face of the middle brick and from the bottom at the face of the right brick (e). This results in the crack that crosses the mortar joint diagonally (f).

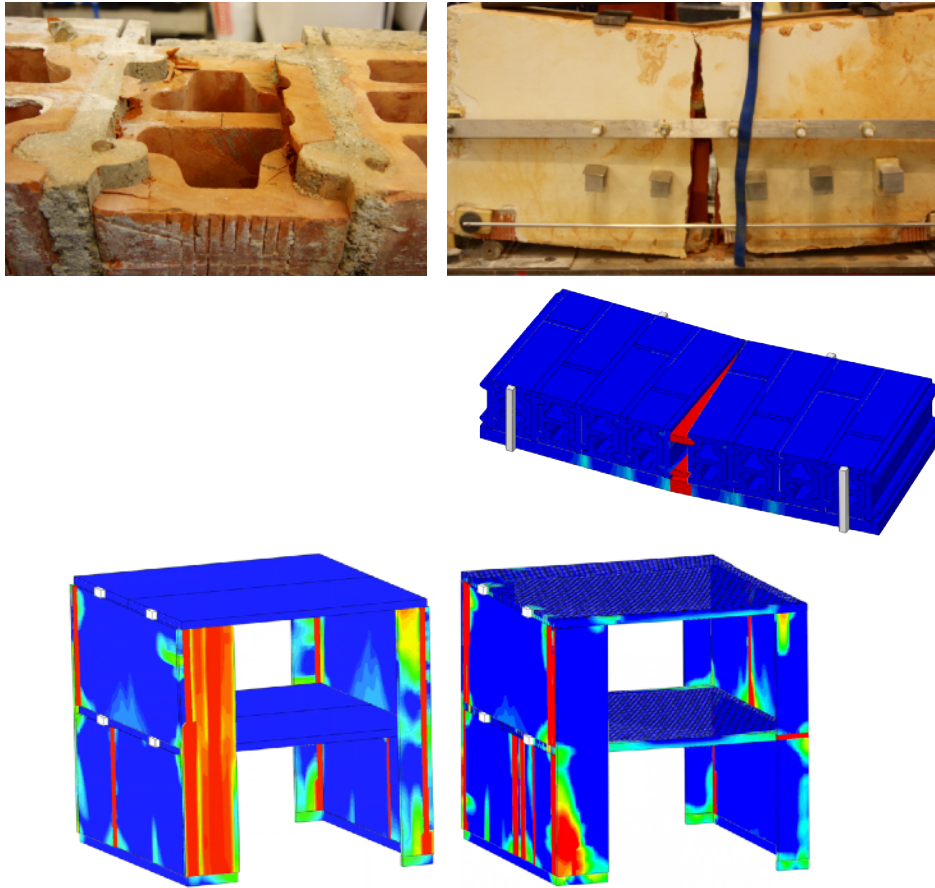
Figure A.3.b. Top left, shear triplet specimen after failure. Top right, 4-point bending test with flexural crack. Middle; reproduction with an Abaqus detailed model showing failure at the mortar and mortar-unit interface. Bottom, comparison of a masonry assemblage with concrete (left) or NeHoBo floors.

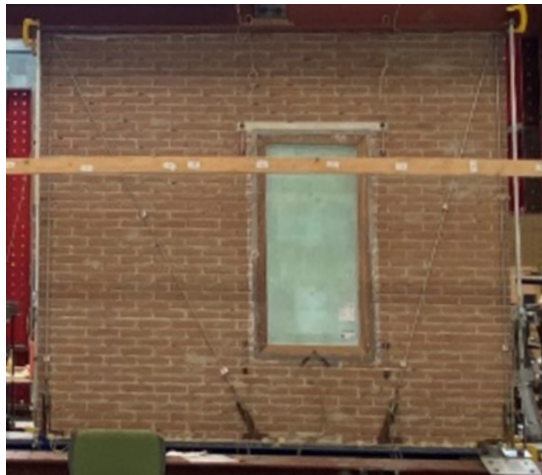
Figure A.5.1. Experimental masonry wall with window of timber-glass design. The glass is painted for DIC purposes.

The goal of the timber-glass design was to provide increased in-plane stiffness during small values of drift. This would reduce light damage during vibrations as the stiffer structure would develop smaller inter-storey drift. The glass was attached to the timber frame with a thin, semi-flexible adhesive. At larger values of drift, the adhesive would tear. The relative sliding between timber and glass, together with crushing of the timber, lead to an extremely high capacity for the release of hysteretic energy. Hence, for larger values of drift associated with the near-collapse stage, the masonry structure would acquire significant dampening capacity, which significantly decreases the spectral demand. In this manner, the strengthening solution does not lead to increased forces on the foundation or other structural elements, a typical ailing of many strengthening methods. Hence, both light damage and near-collapse states are addressed.

In subsequent iterations, improvements were made in the installation of the window by injecting with grout the tolerance between masonry and timber frame. Moreover, an anchoring system, that allowed pushing the frame from the front of the wall, guaranteed that failure would never occur at the masonry-

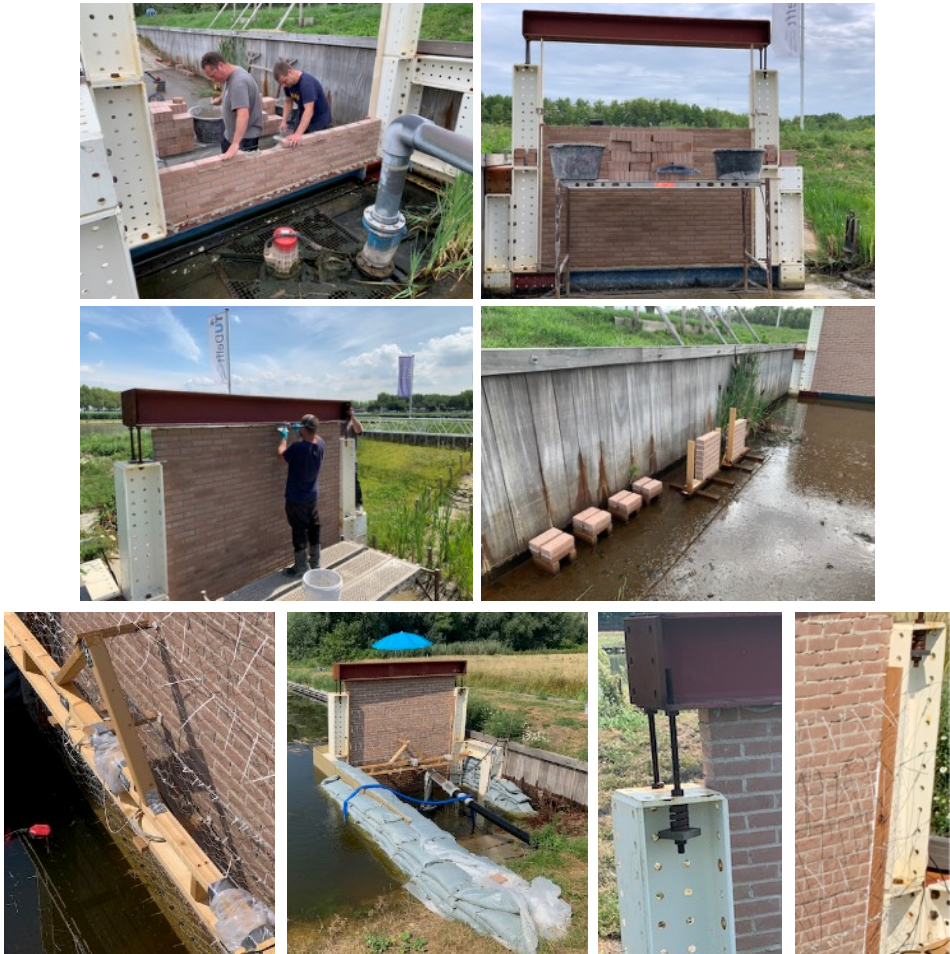
Figure A.7. Collage detailing the construction and context of the tested wall.

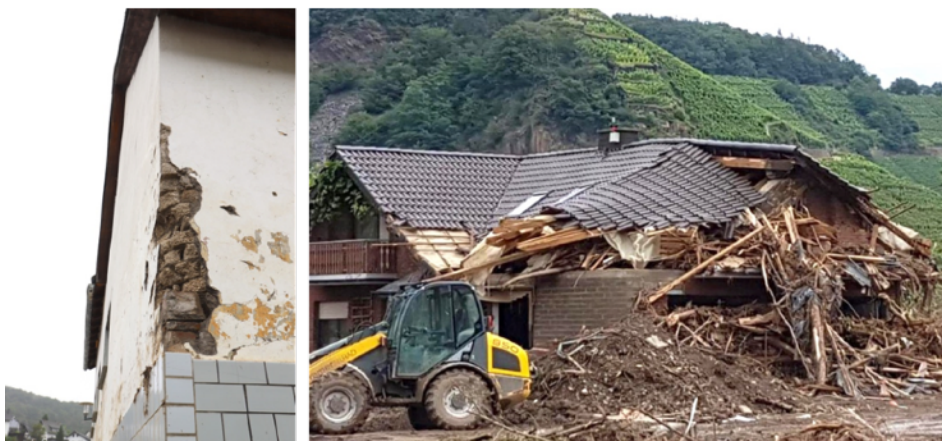
Figure A.8.1. Left, marks induced on buildings by debris impact, and right, debris damming around building openings.

Debris impacts were noted to occur mostly at the corners of buildings or around openings, suggesting that the collisions were partly responsible for structural failures. Debris dams formed upstream of buildings, blocking openings and contributing to backwater effects, which magnified the flood's impact by increasing the depth and extent of water around the buildings. The debris also posed a significant challenge by filling up space inside buildings, reducing the capacity for floodwaters to flow through, thereby increasing the pressure on the buildings' walls and foundations.

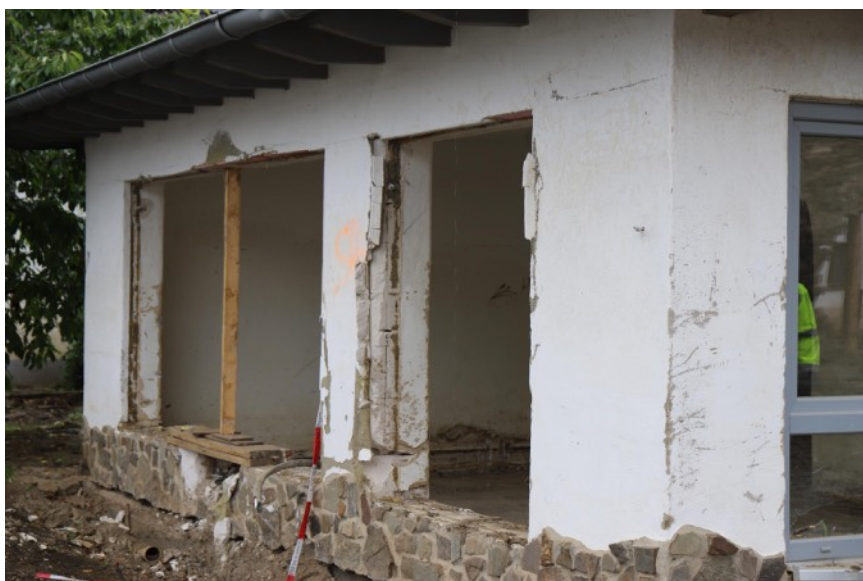
Figure A.8.2. Example of a façade where the flow of water and floating/trapped debris removed windows and knocked out a pier.
