Quantifying the probability of light damage to masonry structures

An exploration of crack initiation and progression due to seismic vibrations on masonry buildings with existing damage

Korswagen, Paul A.

Dissertation

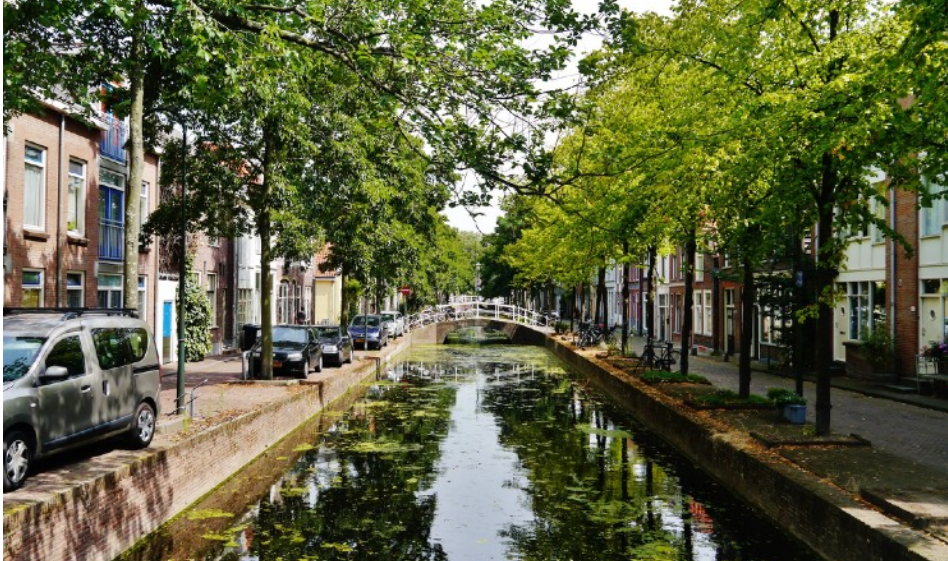
Figure 1. Old city-canal in Delft with masonry quay walls and a masonry overpassing with abutments.

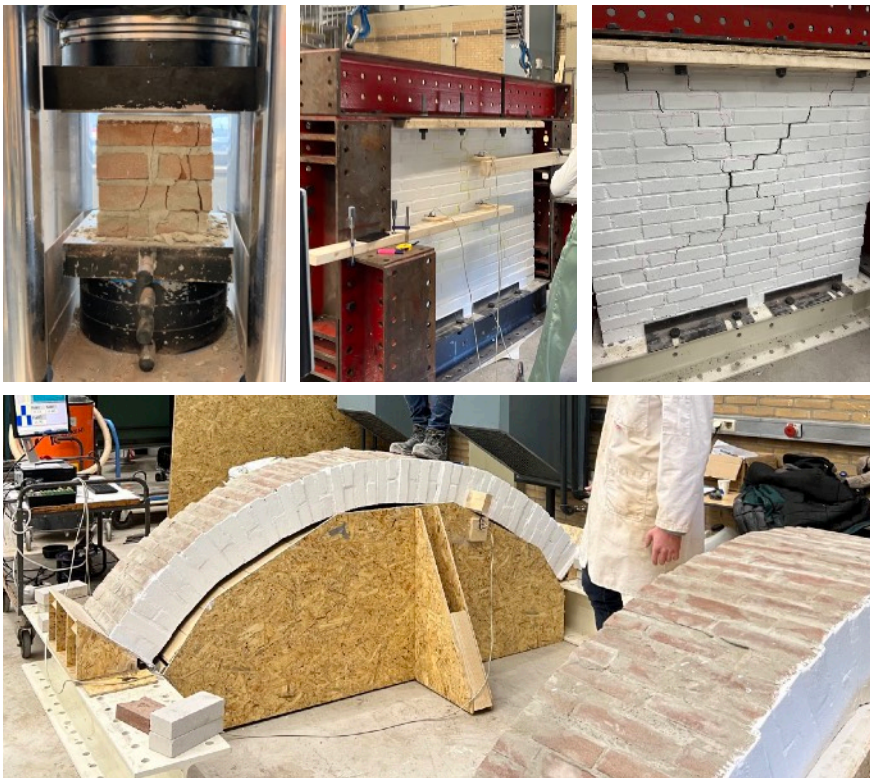
Figure A.10. Various experiments from the course, featuring a compressive test on masonry, a wall tested out-of-plane, with vertical and horizontal cracking, and an arch.

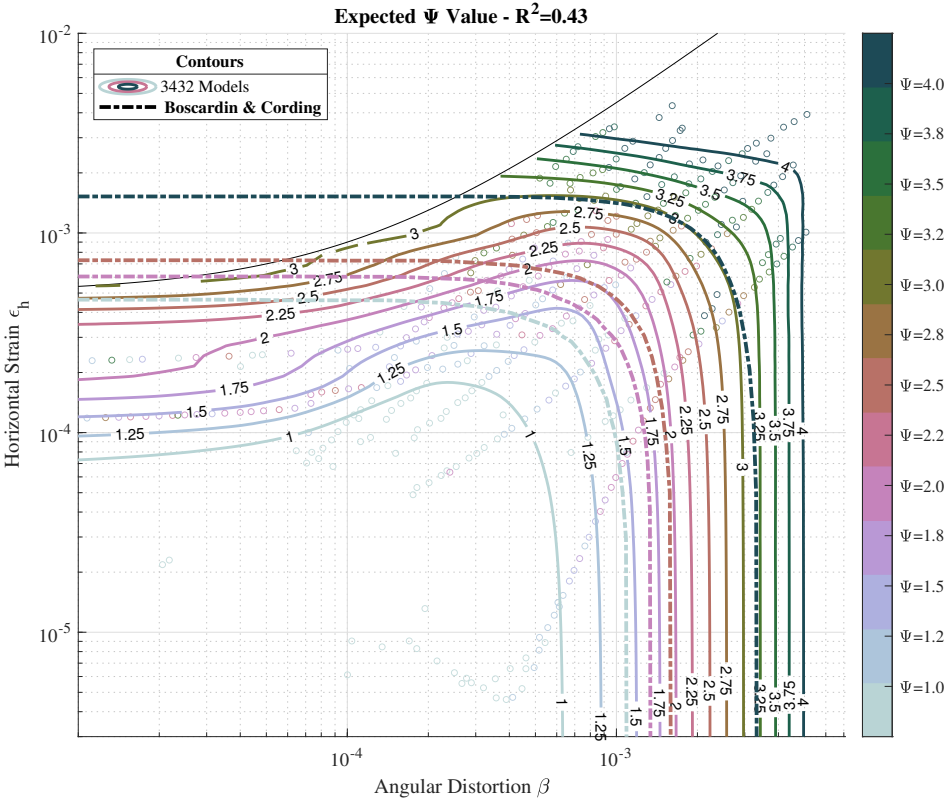
Figure A.14.1. Thresholds for Ψ given a combination of Greenfield tensile horizontal strain and soil curvature.

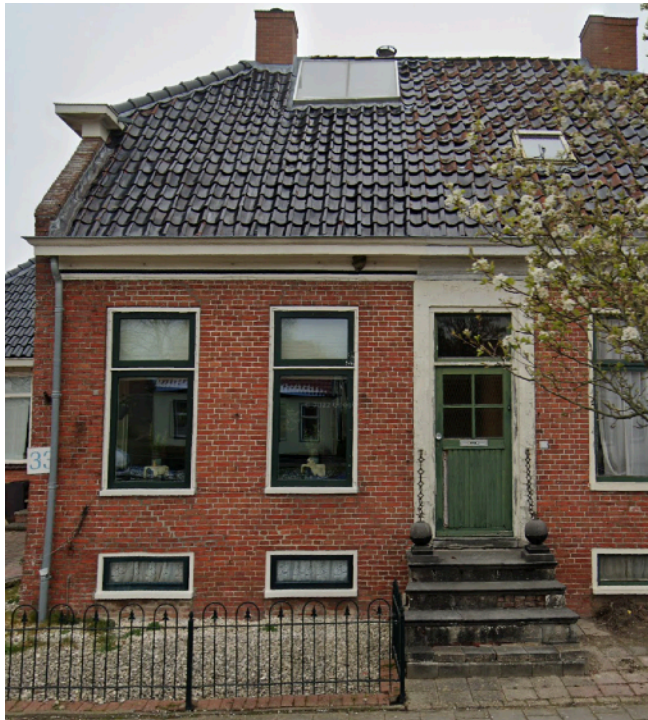
Figure E.3. At close inspection, the bed joints appear plastically deformed.

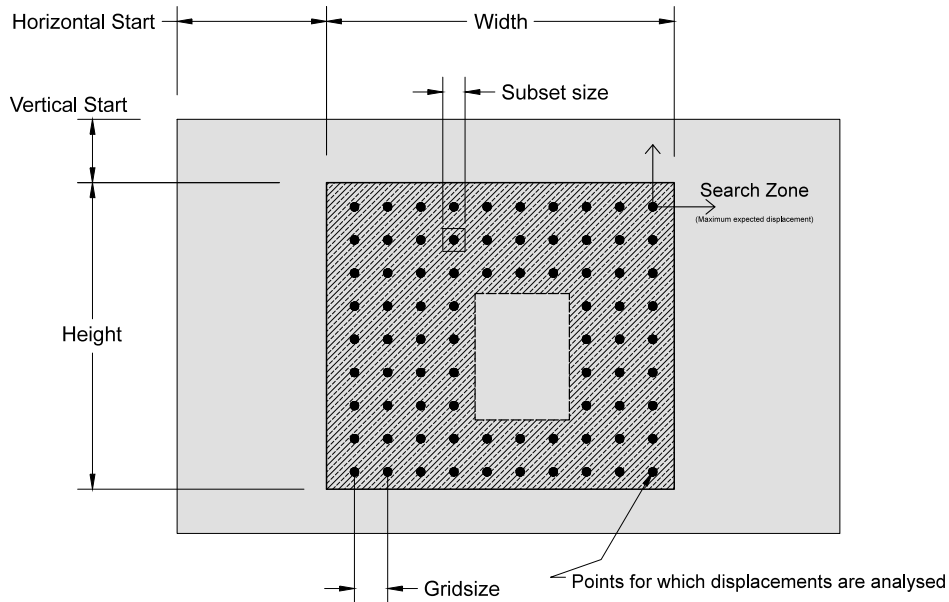
Figure G.2.1. Scheme of main parameters. Area of interest (with an opening) within the image.
