Additional Thesis

Markus Pleij

Delft University of Technology

Investigating flow problems in the supply pipeline of PDAM Tirtawening.

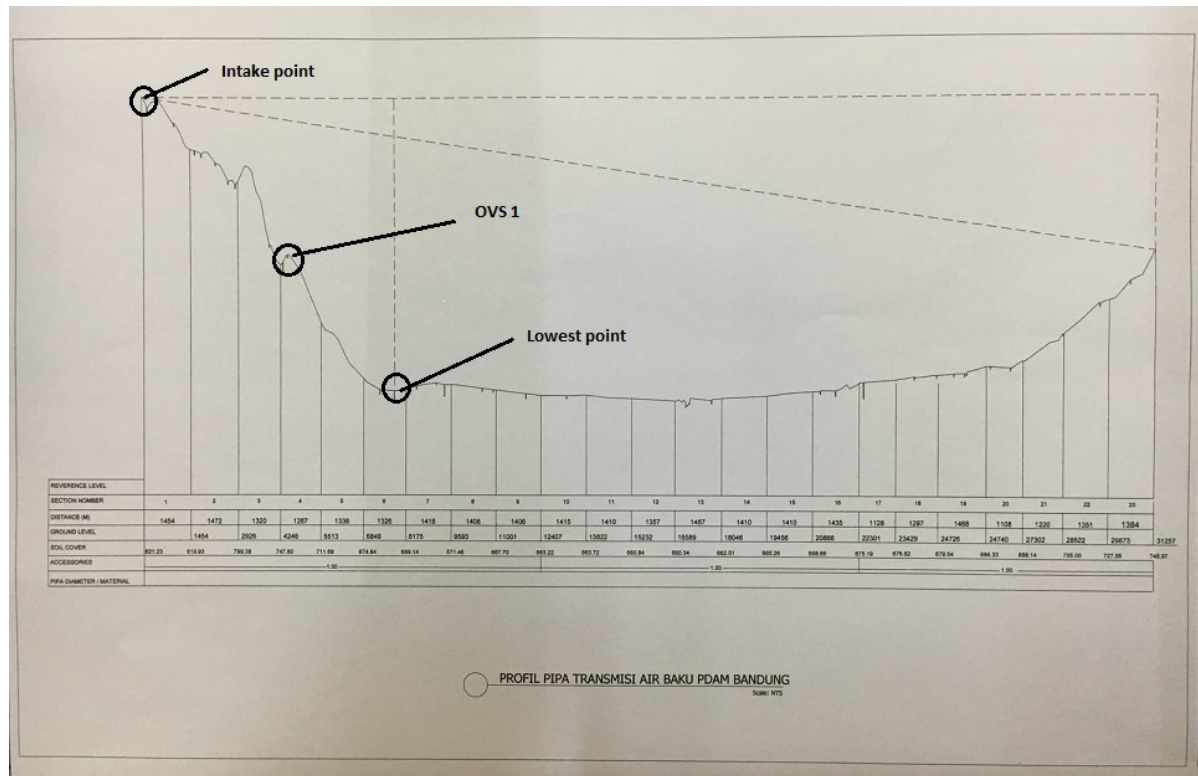
Figure 3.2: cut trough picture of pipeline

The pipeline ends at Badaksinga which is 752 meters above sea level. The water flows “freely” to the treatment plant. This means that the pressure drops to atmospheric level right after it leaves the pipeline. The pipeline has 35 air valves where the pressure in the pipeline can be measured. It also contains 30 washouts to clear the pipeline of debris. One of the problems PDAM is facing is that many of these air valves and washouts do not work properly or cannot be reached because of traffic.

The pipeline is simulated in EPANET with the help of figure 3.1 and figure 3.2. The coordinates of the pipeline in vertical and horizontal direction can be found in these figures. The diameter as already mentioned is 0.85 meter and the roughness coefficient will be slightly higher than average because of the old age. Along the length of the pipeline multiple disruptive elements can be found that influence the results of the simulation. These disruptive elements consist of sharp bends, concrete sections and sections used for maintenance. These elements have influence on the flow, energy level and other results. These elements have been simulated as much as possible, but an error margin caused by this has to be accepted. What also has to be kept into mind is the fact that Epanet can only be used to model pressurized systems. If a system has parts that are not pressurized, additional measures have to be taken in order to model these parts. The pressure dataset obtained from the field measurements will be compared with the data obtained from the Epanet model. This comparison will be used to determine possible flow interrupting obstacles. These obstacles include sediment build-up, air pockets and corrosion which were previously discussed in this chapter.

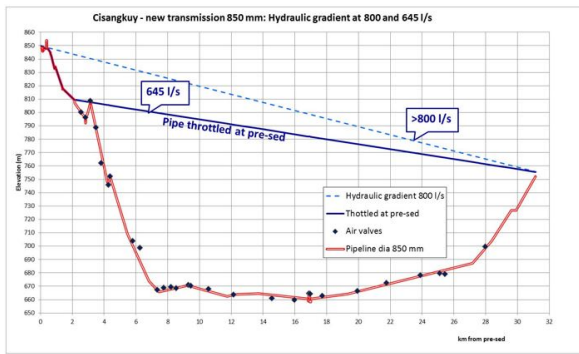
Figure 3.3: overview figures of gradient pipeline

Figure 3.3a shows the hydraulic gradient presented for the design flow and the current flow. In figure 3.3b the hydraulic gradient is presented when the pipeline is closed. The pipeline is closed several times a year for maintenance and inspection. Because the water intake is regulated at the top of the pipeline at Chikalong, stagnant water cannot be removed as shown in figure 3.3b.

(a) pipeline gradient for 800/s and 645 l/s

(b) Gradient when pipeline is closed

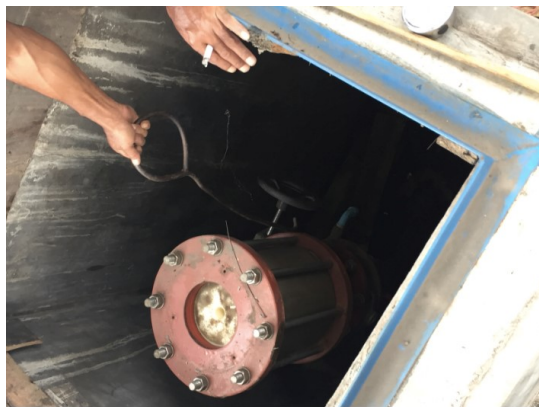
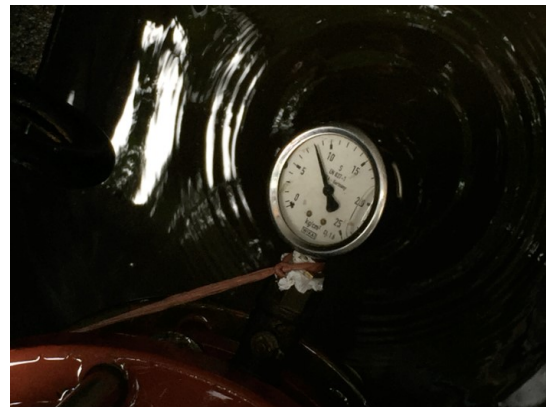
Figure 4.3: In field measured pressured over total length pipeline

The pipeline has 35 air valves along the entire length of the pipeline. On those air valves pressure meters were installed to obtain additional data which will be used to validate the modelling data. A device called mano-meter was installed on an air valve to measure the pressure on that exact location. The pressure was measured in kg/mc^2 . This way of measuring is relatively accurate but still some errors can occur because two reasons.

Figure 4.3 shows how the measurements in the field were performed. Every complete set of measurements consisted of 36 pressure checks performed at air valves that are located along the total length of the pipeline. These measurement sets have been performed four times to obtain data strings that give an accurate understanding of what the pressure is under varying conditions. Each set of measurements was performed under different flow levels. The data strings can be consulted in appendix B.

Sediment build-up is mitigated by flushing points shown in figure 4.3. These washout points are cleaned once a month and are located at the same locations as the air valves. However, many of these washouts are not reachable or do not perform up to standards, caused by lack of maintenance. In this particular situation sediment build up is a likely cause for the pipeline not meeting its design flow.

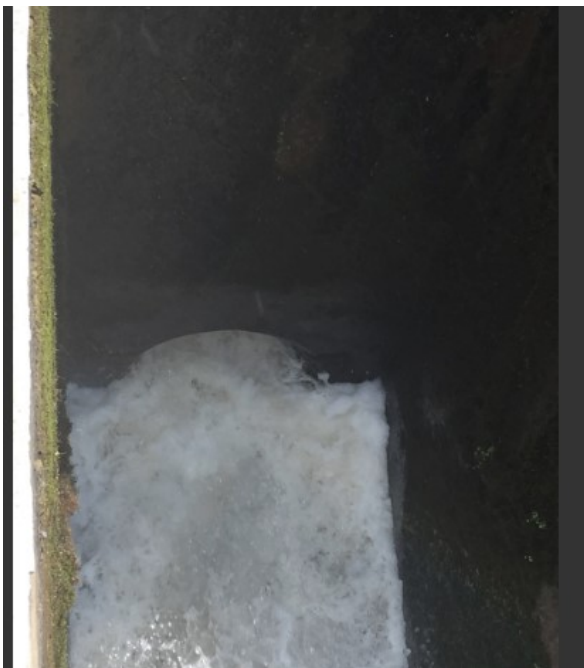
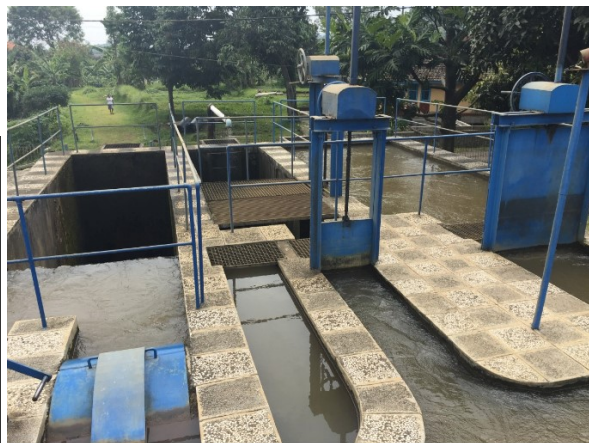
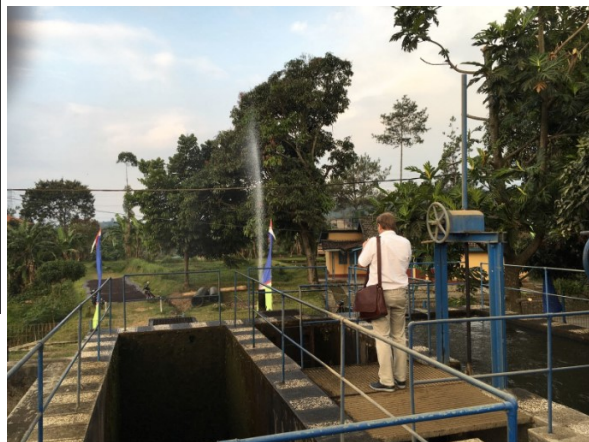
Figure 5.1: overview pictures of intake point

Figure 5.1a illustrates that the intake point of the pipeline is not completely submerged during the visual inspection, thereby letting in air into the pipeline. Figure 5.1b illustrates the total intake system which consist out of two open water basins both supplying the pipelines of raw water. These open water basins are fed with rain water from the catchment area upstream. Figure 5.1c illustrates a release valve located just a few meters below the intake point. This valve releases much air, which is a clear indication of air trapped inside the pipeline. Consequences of this trapped air are risk on cavitation, corrosion and air pockets.

(a) air intake pipeline

(b) open water basin intake point

(c) air release valve

Sediment build-up in a pipeline effects the flow in a negative way. Therefore it is important to mitigate sediment build-up and flush a supplying system when necessary. In this particular situation it is likely that there is sediment build-up within the pipeline. This is mainly because of the questionable quality of the pipeline because of its old age and absence of maintenance. This causes flow drops in the pipeline which causes sediment build-up. The raw water that is transported through the pipeline also contributes to the sediment build-up because it contains the sediment. The amount of sediment within the water is difficult to determine. However, it is clear that the raw water is not filtered before entering the pipeline and by visual inspection it is clear that there is a significant amount of sediment in the water. This can be seen in figure 5.1

- There is air intake at the intake point of the pipeline. This is also concluded with the help of the results obtained by visual inspection. The cause of this is the water intake throttling by PDAM at the intake point.

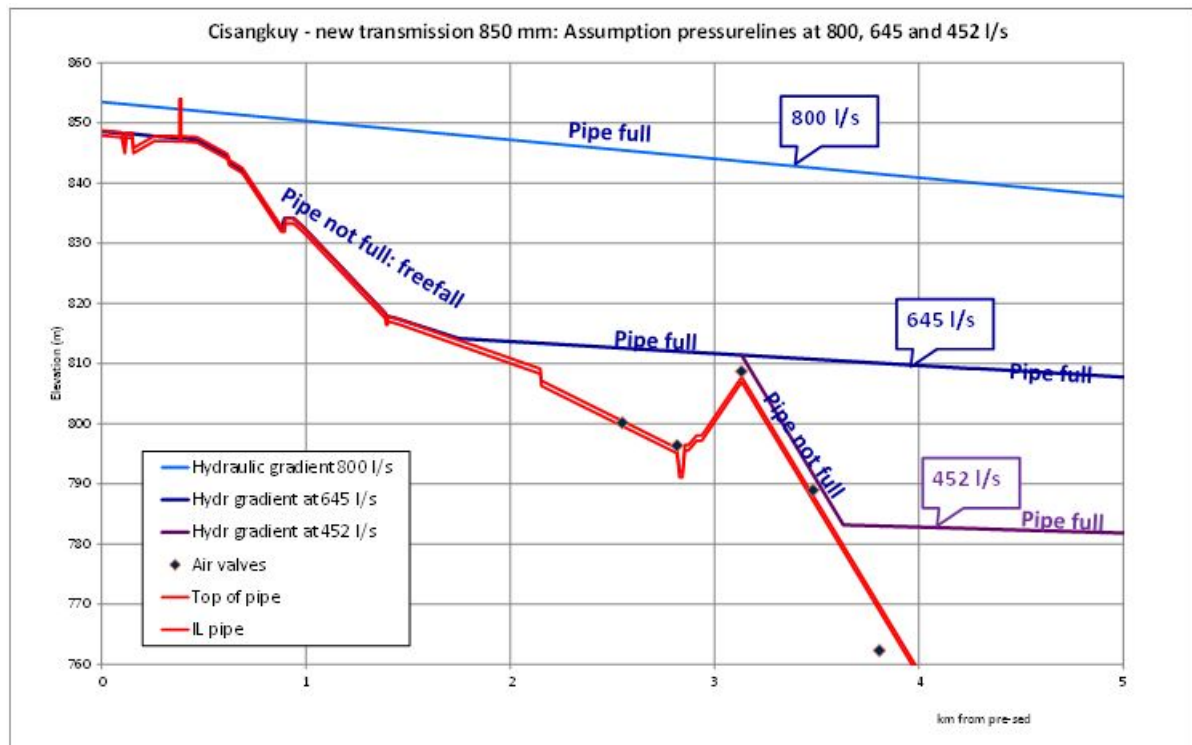
Figure 5.2: Assumptive pressure lines for the first section, 800 l/s - 645 l/s - 452 l/s

What becomes clear is that the first part of the pipeline acts like an open channel and the pressure is not high enough to completely fill the pipeline. When analyzing the first part of the pipeline figure 5.2 can be constructed with the resulting gradients for a debit of 452 l/s, 645 l/s and 800 l/s for the first part of the pipe line.

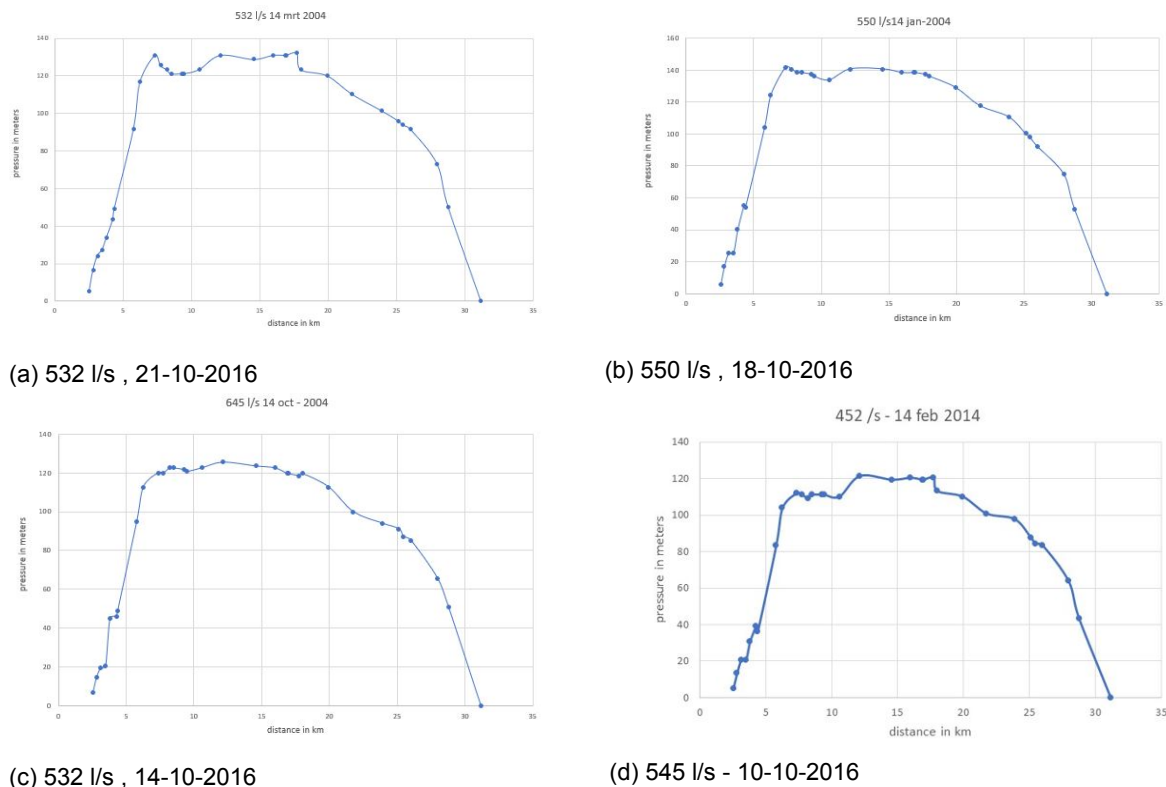
Figure 5.4: Modelled pressured over total length pipeline

The pipeline was divided into sections and from every section characteristic locations were selected and processed into Epanet. The roughness coefficient was set on 0.85 for regular parts of the pipeline. Subsections where irregularities occur, such as location OVS1, old or concrete sections, the roughness coefficient was set to a higher value. Because the pipeline runs through the city for 30 kilometers it is impossible to model all of these regularities, thereby accepting a margin of error.

In figure 5.4 a graphical overview of the four modelled pressure lines along the length of the pipeline are presented. The debit flow used in the model is equal to the debit flow measured in the field. These graphs will be compared with the pressure data obtained from field measurements.

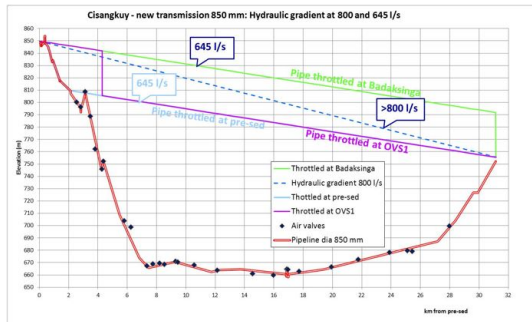
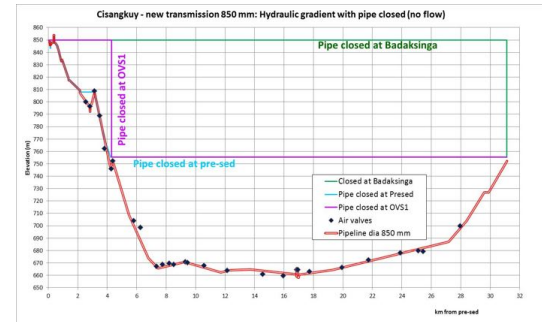
Figure 5.5: Hydraulic gradient and pressure levels

(a) pressures in pipeline during operation

(b) pressures in pipeline when closed

(c) hydraulic gradient in pipeline during operation

(d) hydraulic gradient in pipeline when closed

Regulate at:	While operating	While closed
1. At intake	13.2 bar at 8 km	9.2 bar at 8 km
2. Badaksinga	18 bar at 9 km	20 bar at 18 km
3. OVS1	13 bar at 8 km	11 bar at 5 km

Table 5.1 shows the maximum pressure (bar) for the three options. Appendix C contains calculations performed on collected data presented in appendix B. Also, the data in table 5.1 refers to the data in appendix C.
