# Rebuilding Zeeland with gifted houses

How the gifted houses impacted the reconstruction of  
Schouwen-Duiveland after the Watersnoodramp of 1953

AR2A011 Architectural History Thesis  
Faculty of Architecture and the Built Environment  
Delft University of Technology  
18 April 2024

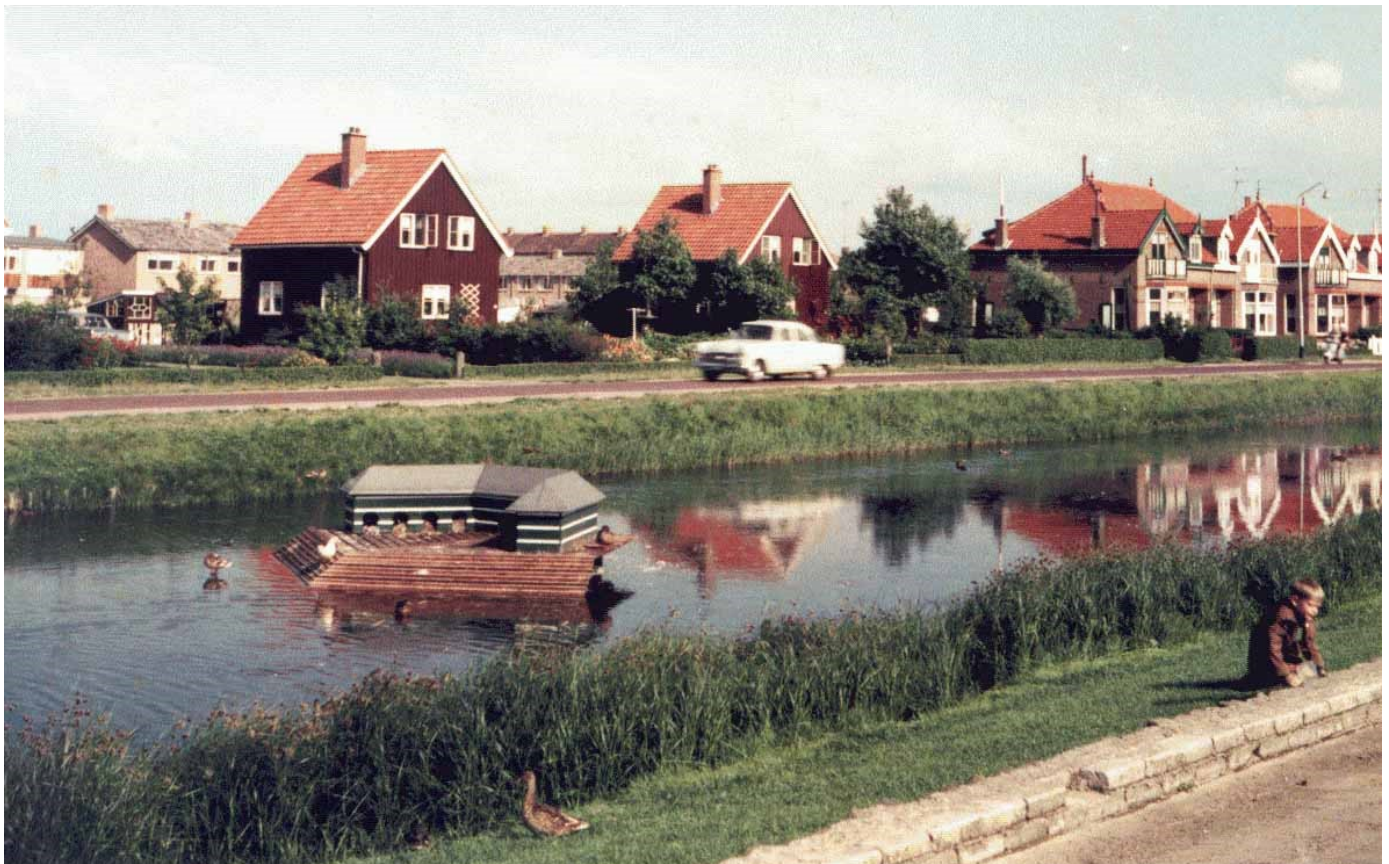
Fig. 1: Grachtweg in Zierikzee with gifted houses. (*Zierikzee, Grachtweg met geschenkwoningen*, 1955-1960, photograph, Zeeuws Archief, Fotoarchief familie Ochtman, nr O-2556)

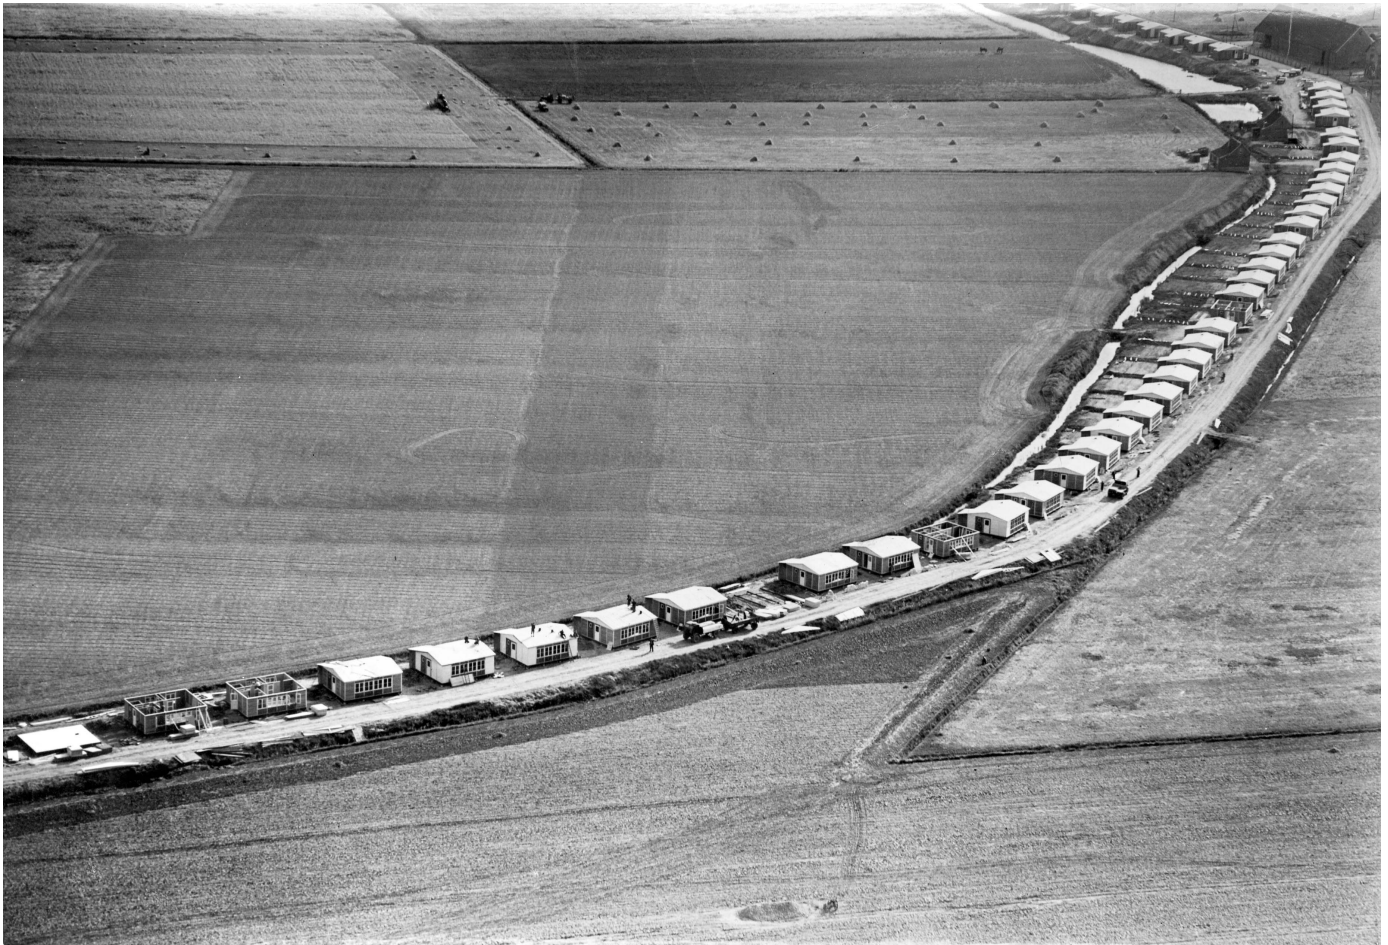
Fig. 10: Dutch emergency housing at Beijersdijkje. (KLM Aerocarto N.V., Zierikzee. *Beijersdijkje noodwoningen*, 1953, photograph, Zeeuws Archief, Beeldbank Schouwen-Duiveland, nr SW-1368)

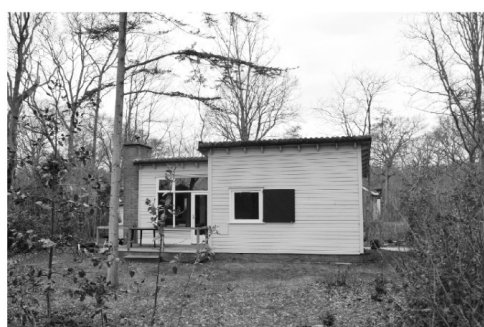
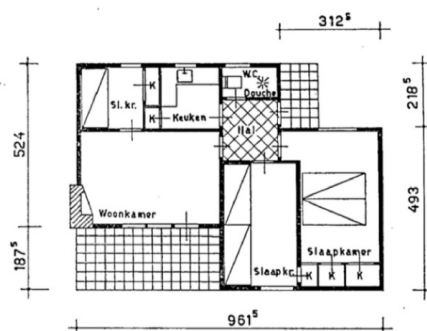
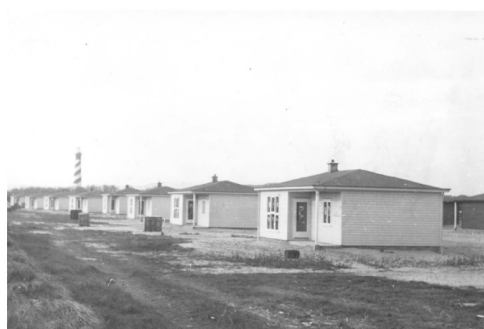
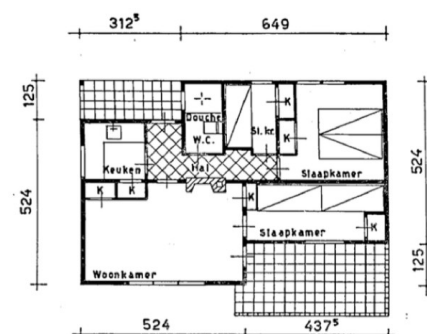
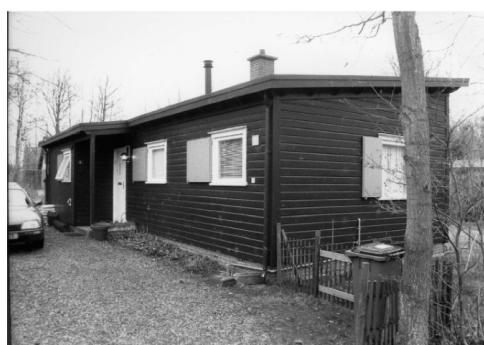
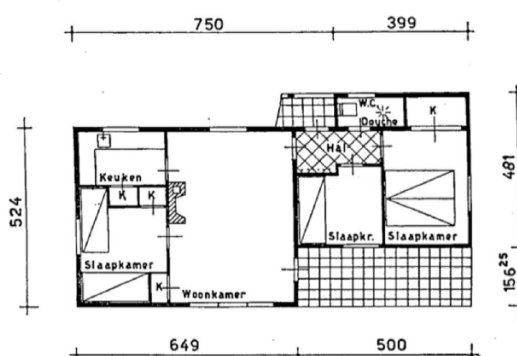
Fig. 11: Austrian summer houses (Types I, II, III in order) original appearances (Zeeuws Archief, Beeldbank Schouwen-Duiveland, nr X-5095, nr WA-0189, nr BUR-0033) and floorplans (G.W. Jansen, *Woningen voor de Watersnoodgebieden*, 1954, drawings, BOUW, nr.15, p.293).

Burgh-Haamstede. Colloquially, the neighbourhood with the hipped roof was often referred to as 'Korea'.<sup>94</sup>

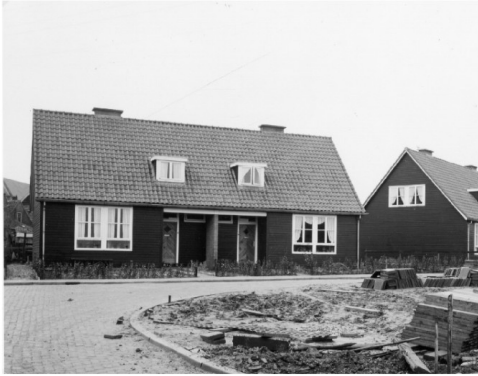
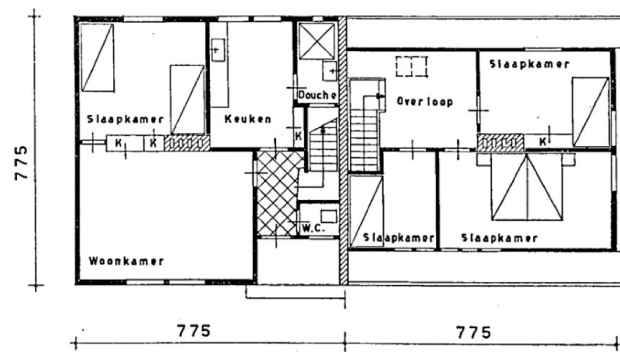
Fig. 12: Type Friesland original appearance (*Dreischor Mr. Pieter Moggestraat*, 1954-1955, photograph, Zeeuws Archief, Albums Schouwen-Duiveland, nr A-9311) and floorplans (G.W. Jansen, *Woningen voor de Watersnoodgebieden*, 1954, drawings, BOUW, nr.15, p.293).

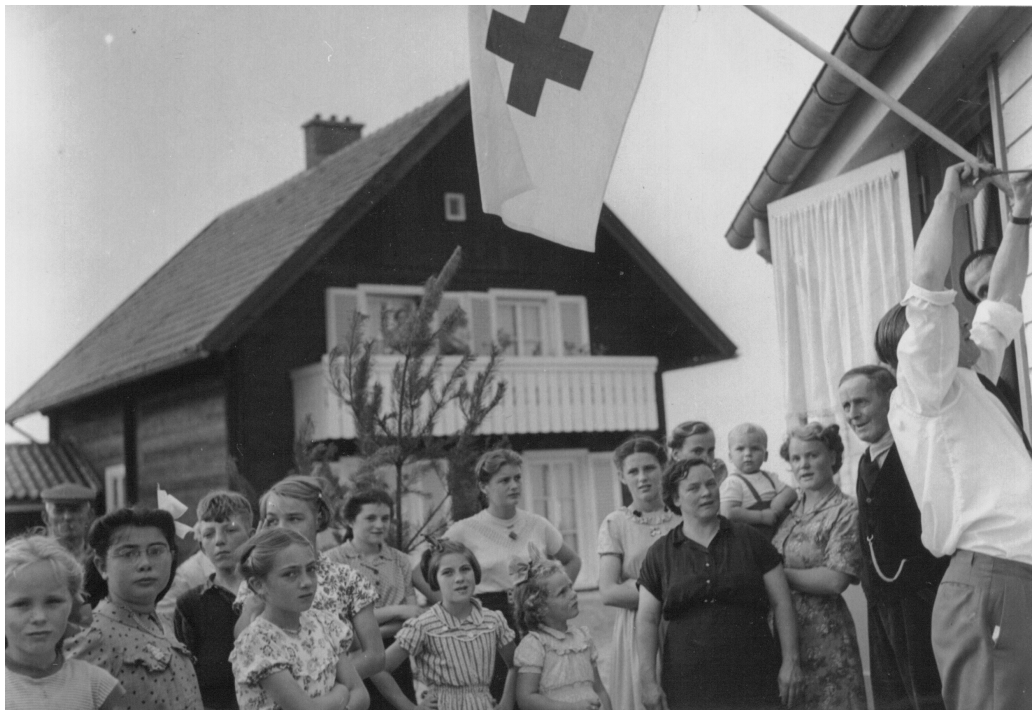
Fig. 13: Austrian Chalet (*Overdracht geschenkwoning*, 1953-1954, photograph, Zeeuwse Ankers, Beeldbank Watersnoodmuseum, WNM Sint Philipsland 422)

This type was donated to the Netherlands in World War II. Back then, these were exchanged for white cabbages, as there was food shortage in Austria and housing shortage in the Netherlands.<sup>96</sup> These houses were in possession of the Centraal Bureau Tuinbouwveilingen in the Netherlands and there are no floorplans found of this type. This type was known to be spacious and had a remarkable balcony. The wooden facade elements were dark brown and the window frames were white. Some municipalities considered these houses to be too luxurious and ended up giving them to municipal authorities.<sup>97</sup>

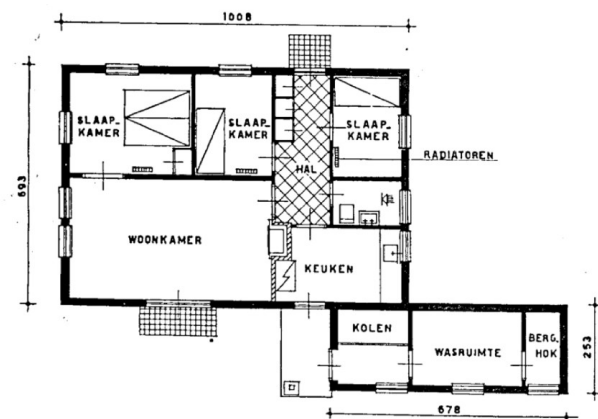
Fig. 15: De 5e bu original appearance (*Kerkwerf Beatrixstraat 7*, 1972, photograph, Zeeuws Archief, Beeldbank Schouwen-Duiveland, nr KWV-0121) and floorplan (G.W. Jansen, *Woningen voor de Watersnoodgebieden*, 1954, drawings, BOUW, nr.15, p.292).

The Danish home has 1 master bedroom and 2 smaller bedrooms. This house had a separate section for coals, laundry and storage accessible from outside.

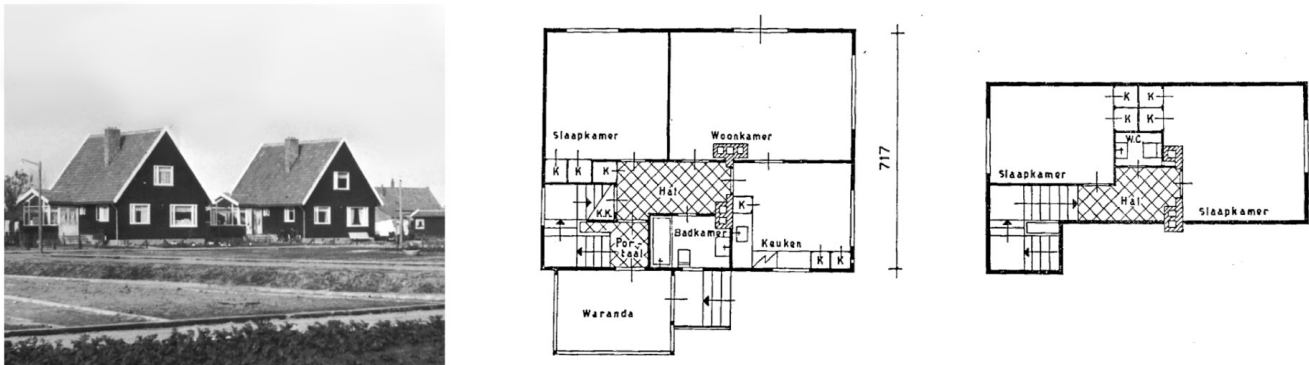
Fig. 16: Fi 7e original appearance (*Finse woningen*, n.d., photograph, J.L. Meyer boekhandel, Finlandplein in Nieuwe-Tonge) and floorplans (G.W. Jansen, *Woningen voor de Watersnoodgebieden*, 1954, drawings, BOUW, nr.15, p.288).

the basement, they did use high foundation walls to keep the original look, which is why the lower section of the house is covered in brick. The Finnish houses were delivered with an original watercolour of a Finnish artist.

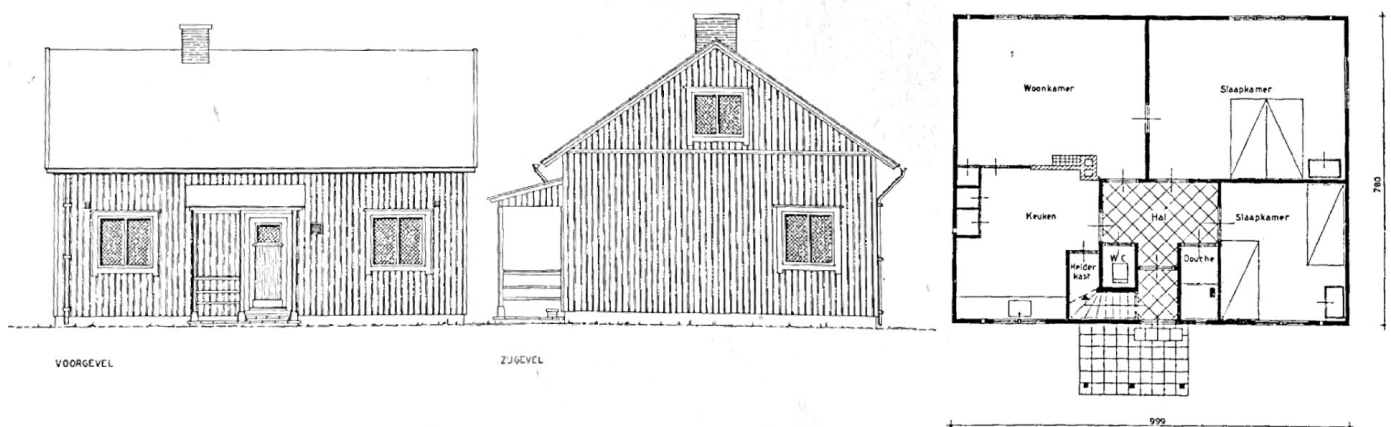
Fig. 17: Fi 5e original appearance and floorplan (G.W. Jansen, *Woningen voor de Watersnoodgebieden*, 1954, drawings, BOUW, nr.15, p.288).

The facade is characterised by small wooden elements, aligned vertically. The roof is less steep than type Fi 7e and the house is significantly smaller. The roof slopes extend over the main entrance to serve as shelter. This house also has a 'portal room' located before the main hall. The connection with the stairs was often not found in the main hall and was separate. This house doesn't include a standard bathroom: the toilet and shower are separate. No source can confirm how these houses were built exactly. What is noticeable is the stairs down, towards a basement. According to Dorp Stad & Land (2021), none of the houses were realised with a basement, making it very likely for this to be an outdated floorplan. According to G.W. Jansen (1954), one house of this type was donated to Herkingen in Zuid-Holland (see appendix, figure 34), but was not built yet when he wrote the article for the magazine BOUW in 1954. Organisation Dorp Stad & Land, have pinpointed that one of this type is located in Dreischor (Schouwen-Duiveland). However, this turns out to be false. Floorplans provided by real-estate listing website 'Funda', can prove this is an Austrian gifted house. This leaves to believe that Fi 5e might never have been built as there is no historical or contemporary proof.

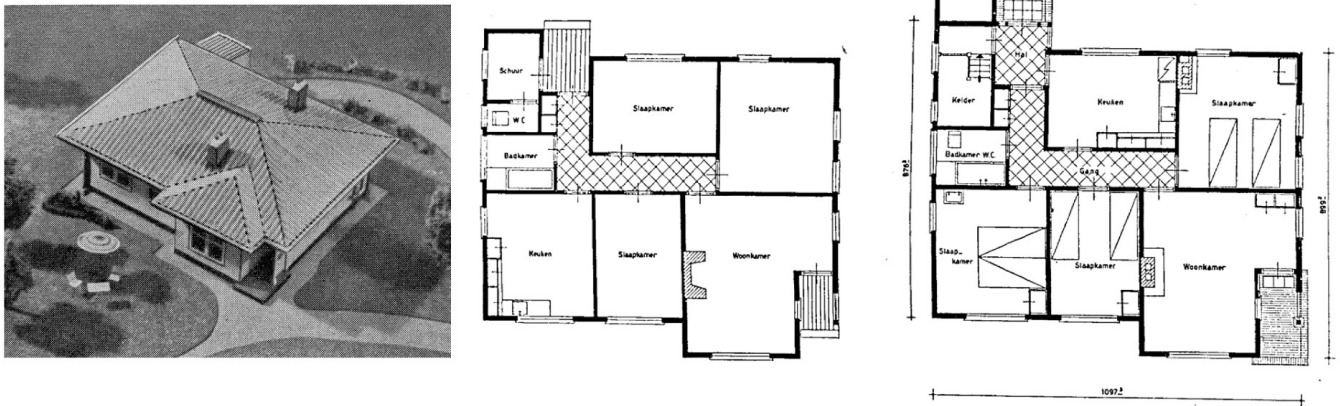
Fig. 18: French house original model (G.W. Jansen, *Woningen voor de Watersnoodgebieden*, 1954, photograph, BOUW, nr.15, p.294), original floorplan and altered floorplan (G.W. Jansen, *Woningen voor de Watersnoodgebieden*, 1954, drawings, BOUW, nr.15, p.294).

The prefabricated bungalow donated by the 'Société Industrielle de Construction des Maisons préfabriquées' was originally designed for export to Australia. It conforms to Australian building regulations, with the toilet located outside the dwelling. This was changed for Dutch living comfort. The living room's exterior door serves as the main entry point. There was only one house of this type donated. As of 2024 it still stands in Kerkwerve and carries the name it originally received: 'je me plais',<sup>99</sup> meaning 'I enjoy'.

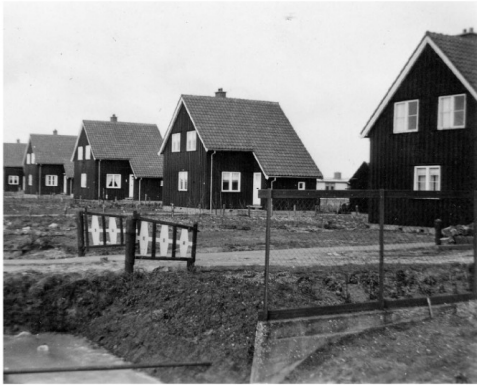
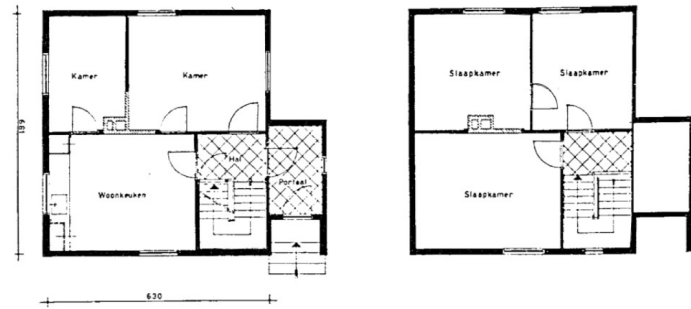
Fig. 19: No 7e original appearance (*Zierikzee Grachtweg*, 1954-1956, photograph, Zeeuws Archief, Beeldbank Schouwen-Duiveland, nr ZZE-1671) and floorplans (G.W. Jansen, *Woningen voor de Watersnoodgebieden*, 1954, floorplans, BOUW, nr.15, p.289).

houses (only in Lapland they had to be painted a corn-like yellow). In the Netherlands, people could not choose but a variety of colours were provided: brown, green, red, white, and yellow.<sup>103</sup> Forty houses in Burgh, Haamstede, and Renesse differ in construction, dimensions, and layout due to the involvement of 3 different factories. To simplify placement, half of the houses are mirror images of the other half. Complete sets of specifications and detailed drawings were prepared for both types to prevent implementation errors.

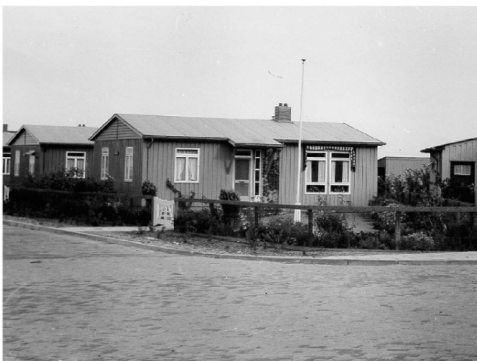
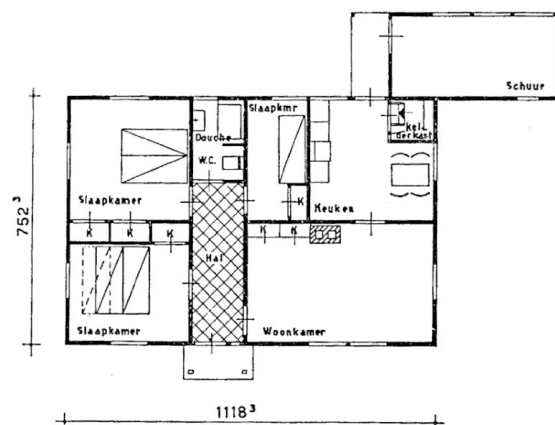
Fig. 20: No 5e bu original appearance (*Ouwerkerk Noorsestraat*, 1955-1960, photograph, Zeeuws Archief, Beeldbank Schouwen-Duiveland, nr D-0205) and floorplan (G.W. Jansen, *Woningen voor de Watersnoodgebieden*, 1954, floorplans, BOUW, nr.15, p.290).

The Norwegian Red Cross later donated another type of housing: the Norwegian bungalow, which is very similar to the Danish bungalow. The layout design for these bungalows was based on a standard type supplied by Norway for the American military in tropical and subtropical regions. The design followed a 1.22-meter modular system and utilized standard elements and manufacturing methods of the factory responsible for production. Additionally, the kitchen includes a dining area with a sunken pantry accessible from it. Because of aesthetic purposes, the storage space was integrated into the floorplan of the house.

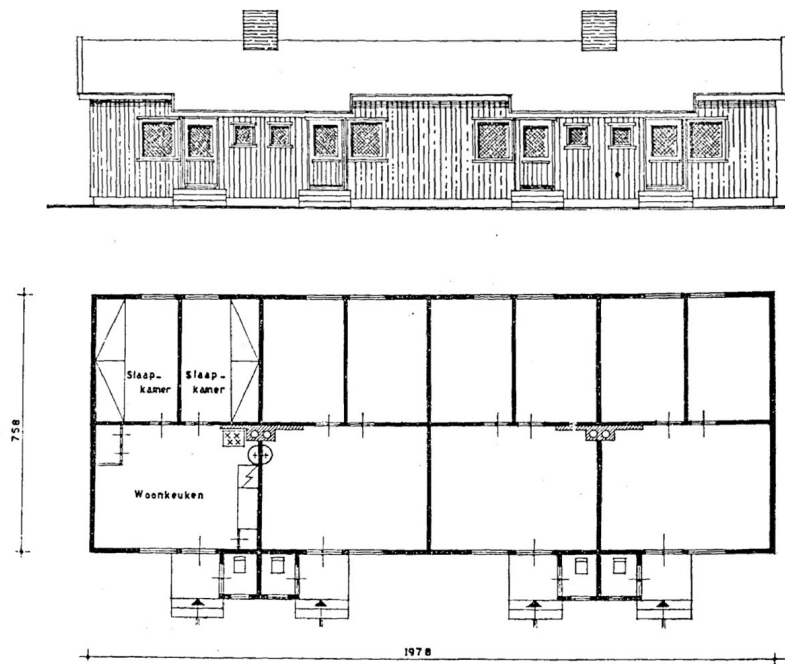
Fig. 21: Norwegian barracks original appearance and floorplan (G.W. Jansen, *Woningen voor de Watersnoodgebieden*, 1954, floorplans, BOUW, nr.15, p.290)

Norway's final donation was a residential barracks, consisting of four units with a living room, two bedrooms, a covered entrance, a bathroom, and a separate toilet. A Norwegian employers' association gifted it.<sup>104</sup> The barracks were added to the emergency housing complex in Zierikzee. Future plans included relocating and repurposing it as a community center or kindergarden. If this was ever done, is unknown. There are no historical pictures found of the Norwegian barrack. There are, however, images found of different gifted barracks in Oosterland. This particular barrack was not residential but intended as a kindergarden. It looks similar to the Norwegian barrack but was originally gifted by the Swedish 'Save the Children'.<sup>105</sup>

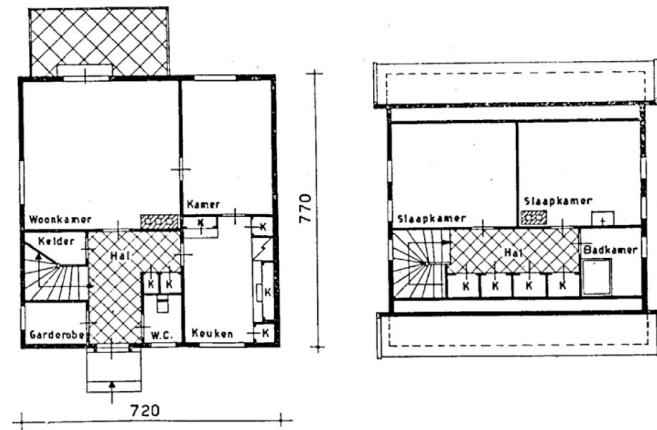
Fig. 22: Zw 5e original appearance (K. de Feijter, *Kerkwerpe Vloedstraat*, 1954, photograph, Zeeuws Archief, Fotoarchief familie Ochtman, nr O-2934) and floorplans (G.W. Jansen, *Woningen voor de Watersnoodgebieden*, 1954, floorplans, BOUW, nr.15, p.291).

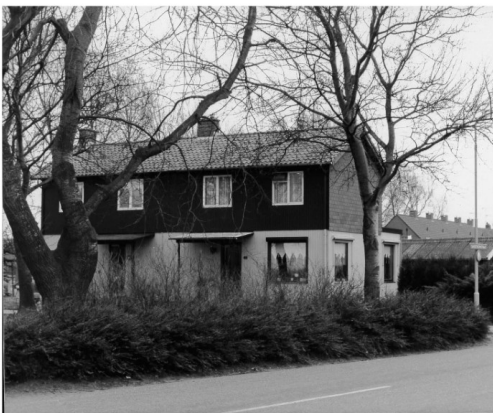
Fig. 23: Zw 5d original appearance (*Oosterland Sändstromstraat*, 1989, photograph, Zeeuws Archief, Beeldbank Schouwen-Duiveland, nr D-0745A) and floorplans (G.W. Jansen, *Woningen voor de Watersnoodgebieden*, 1954, floorplans, BOUW, nr.15, p.291).

In consultation with the technical and urban planning advisors of the Swedish Red Cross, the floor plan E 25 from the Efficient Housing Study Group was chosen for these homes.<sup>107</sup> This house's exterior is very similar to Zw 9d, but was designed for 5 people instead of 9. During World War II when Norway experienced housing shortage as well, Sweden donated these type of houses to Norway as well.<sup>108</sup>

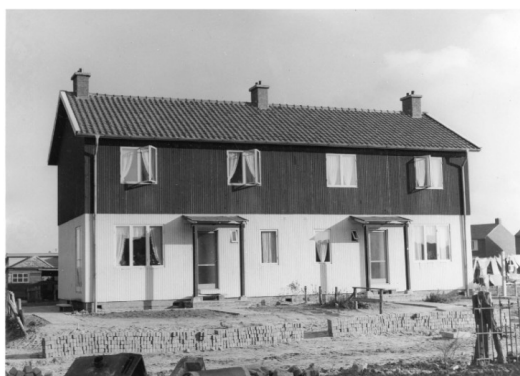
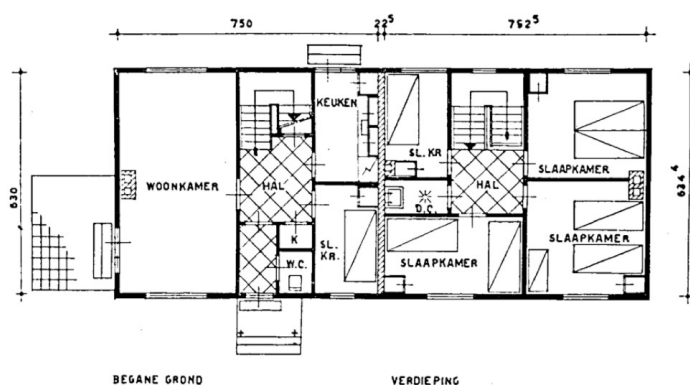
Fig. 24: Zw 9d original appearance (Zeeuws Archief, Beeldbank Schouwen-Duiveland, nr M-0300) and floor plan (G.W. Jansen, *Woningen voor de Watersnoodgebieden*, 1954, floorplans, BOUW, nr.15, p.292).

Asbestos-cement vents were installed for toilet and bathroom ventilation. Double storage spaces were added to these homes using funds donated from Austria. The continuous living room, extending from front to back with a double garden door frame, allows for optimal sunlight exposure. An awning above the front doors softens the architectural stiffness. The elevated basement and minimal roof overhang result in the houses appearing somewhat raised. Painting the upper floor in a dark color and the ground floor in a light color reduces the perceived height. Some municipal authorities did not pursue this suggestion, viewing it as too 'revolutional',<sup>109</sup> and applied the combination in reverse.

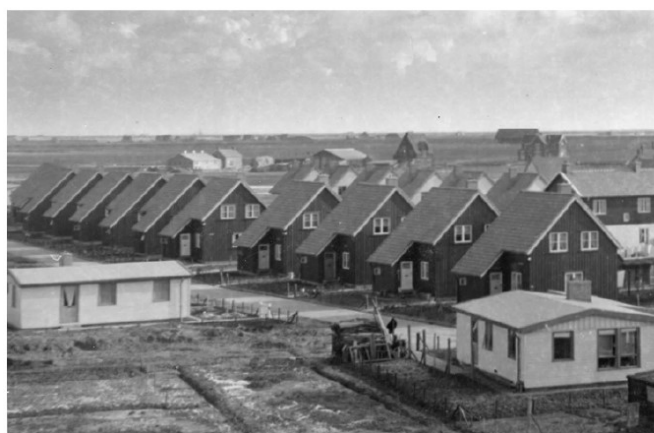
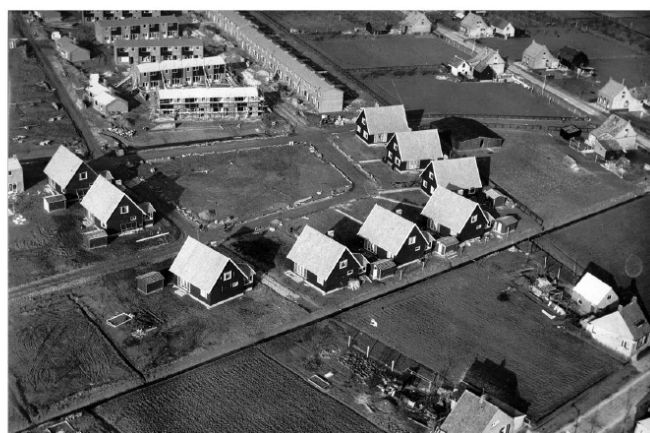
Fig. 25: Common forms of placement: Linear (K. de Feijter, Nieuwerkerk. Achterzijde Magnoliastraat; links de Erling Steenstraat, met de geschenkwoningen, 1954-1956, photograph, Zeeuws Archief, Beeldbank Schouwen-Duiveland, nr D-1317) and square (*Luchtfoto van geschenkwoningen op het Finlandplein*, 1953-1954, photograph, Zeeuwse Ankers, Beeldbank Watersnoodmuseum, WNM Nieuwe-Tonge 340)

Before the houses were placed, Sangster, Architectural advisor of the board of the Dutch Red Cross, wanted to locate the new houses as close to each other as possible.<sup>118</sup> Initially, the donated houses were mixed but a lot of commotion arose<sup>119</sup> which led to the final decision to place the houses together that were from the same donation country. They had to be placed in rows or around a square where there would be a playground or in some cases a memorial. Preserved drawings (see Appendix Figure 37 and Figure 38) of the placement mainly show the placement within cities outside of Schouwen-Duiveland, but the placement was not done much differently.

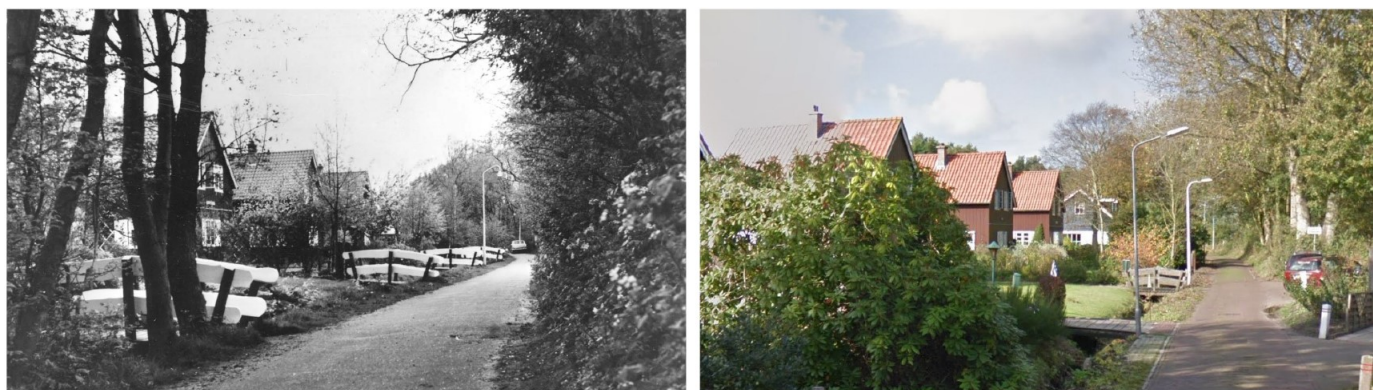
Fig. 26: Duinwegje (Burgh) in 1960 (Zeeuws Archief, Beeldbank Schouwen-Duiveland, nr WA-0017) and in 2023 (Google Street View, 2023)

Noticeably, most of the gifted houses have renewed facade material. Some of them are still wood, but most of them have exchanged the wood for plastic cladding which does stick close to the original look of the wood. The colours aren't original either. Restrictions to specific colours have been let go of and people are free to choose the colour for their facades. For a lot of streets, this means uniformity has been lost over the years, but there are still many streets in which they are coloured uniformly with their original colours.

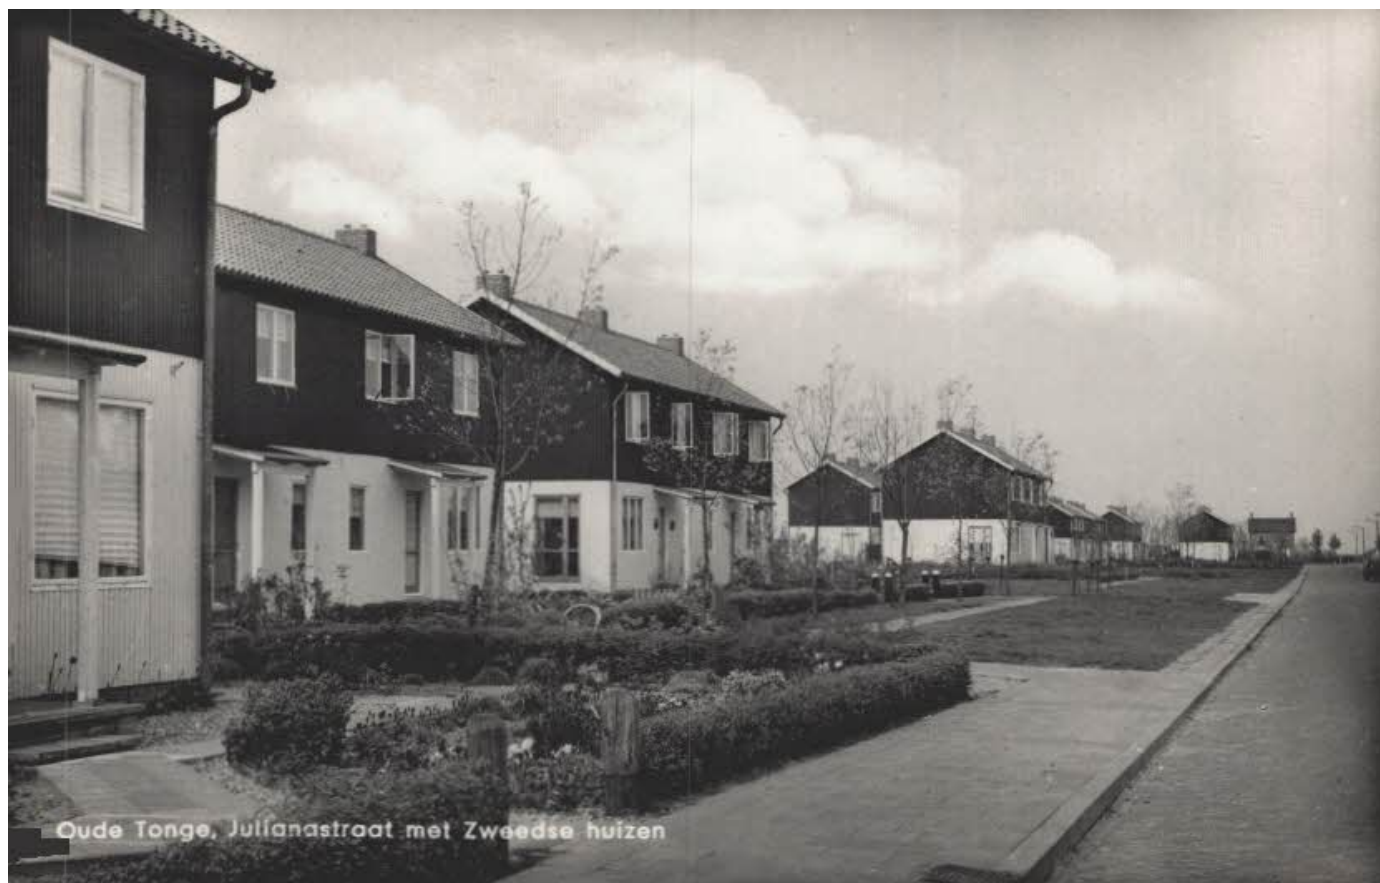
Fig. 27: Julianastraat (Oude-Tonge) with Swedish gifted houses (type Zw 9d). (Zeeuwse Ankers, Beeldbank Watersnoodmuseum, WNM Oude-Tonge 0442)

They were not only accepted into the cityscape, the style inspired the rest of the reconstruction as well. Within multiple streets, there are more buildings found that have typical Scandinavian features. An extreme case found is on the Julianastraat in Oude-Tonge (Goeree-Overflakkee), there are currently only 6 houses left from the original 24 (Swedish) houses. On the original plots of the gifted houses, they built new houses in Scandinavian styles and colours. This adoption of style is still present in Schouwen-Duiveland. In recent years the 'Scandinavian fields' were realised as a new neighbourhood in Zierikzee. As the name suggests, this neighbourhood is inspired by Scandinavian architecture but is more of a blend with Dutch housing architecture.

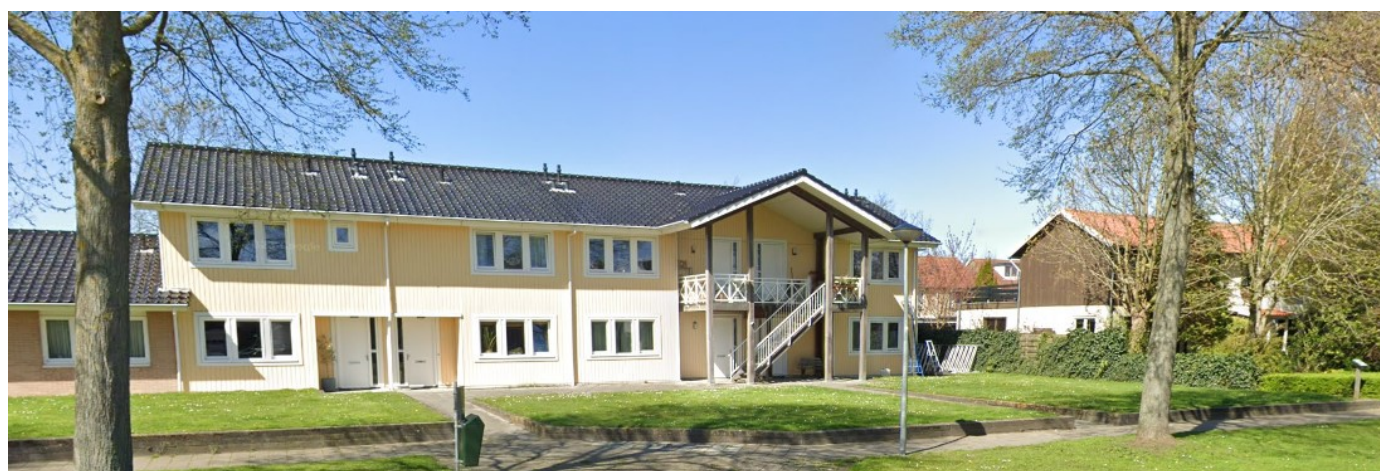
Fig. 28: Julianastraat in Oude-Tonge (2024), newly built Scandinavian-inspired housing next to original Swedish gifted houses.

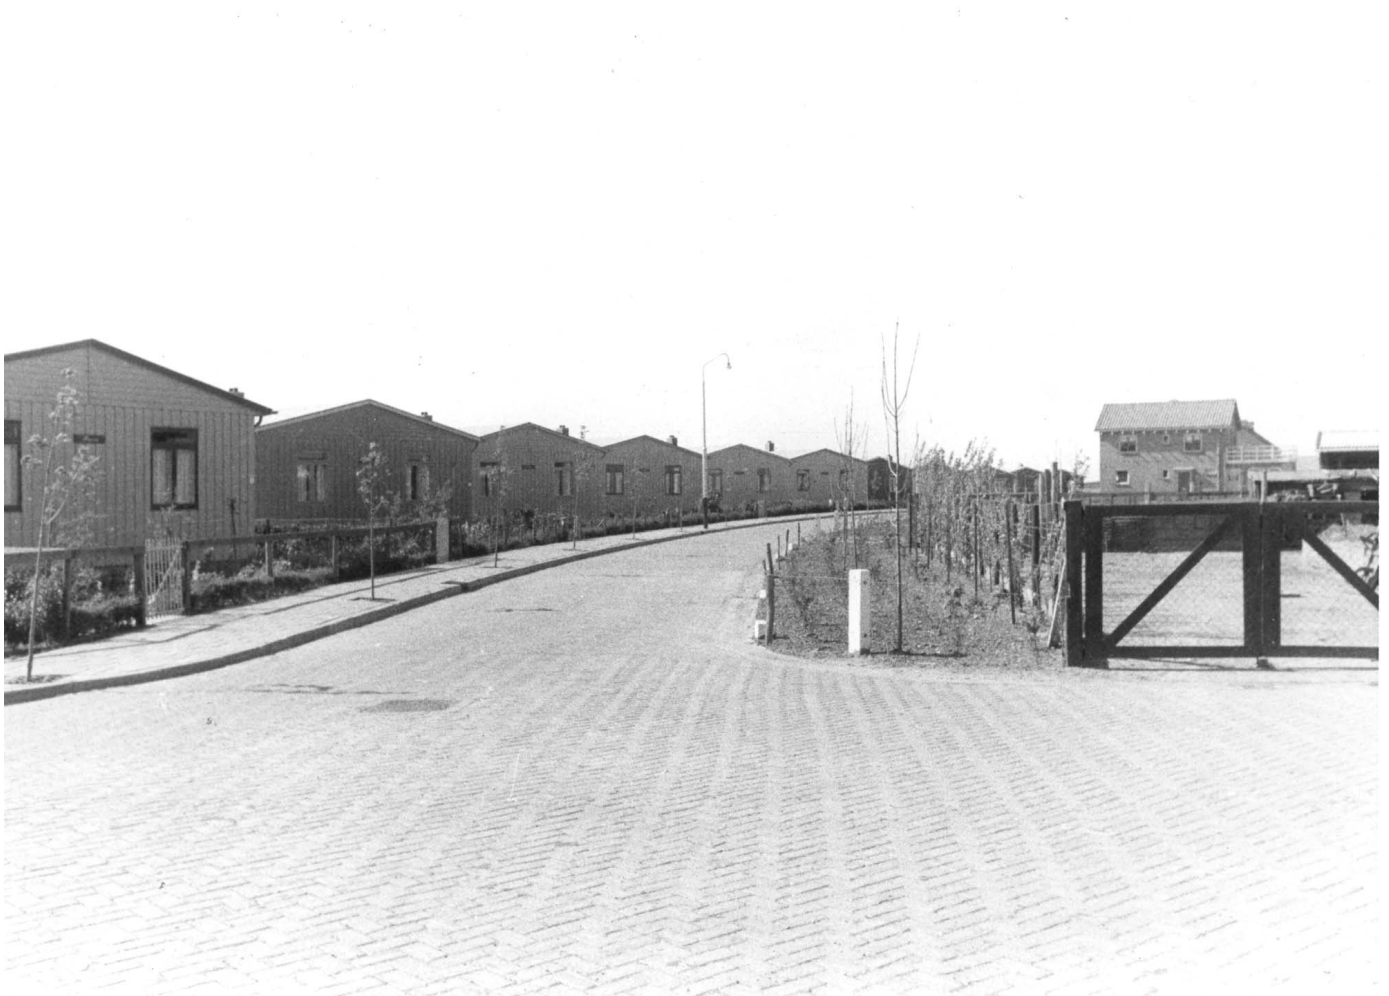
Fig. 31: Noorsestraat (left) with gifted houses from Norway and Zweedsestraat (right) without gifted houses. (*Ouwerkerk. De Noorsestraat, gezien vanaf het Oostslop*, 1954-1955, photograph, Zeeuws Archief, Beeldbank Schouwen-Duiveland, nr D-0047)

Several residences have undergone demolition, consequently resulting in the diminished presence of gifted houses on the particular streets designed for them. Notably, Deensestraat (Danish Street) in Ellemeet now boasts only a singular Danish gifted house, while Ouwerkerk features a Zweedsestraat (Swedish Street) devoid of any

gifted house. Historical photographic evidence can show the absence of the Swedish dwellings on this particular street<sup>124, 125</sup>. Because some streets are unrelated to the donor countries and some streets that are named after donor countries do not always exclusively hold gifted houses, it cannot always be recovered where the demolished gifted houses originally stood.

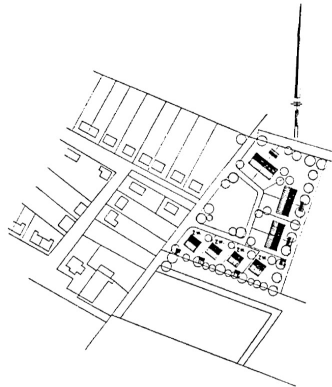
1. Four houses type Zw 5e and six houses type Friesland in Herkingen (Goeree-Overvlakkee, Zuid-Holland). Design by *Instituut Stad en Landschap*.

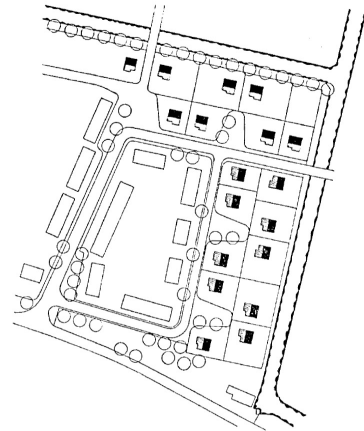
2. Eighteen gifted houses, type No 7e in Goudswaard (Zuid-Holland). Design by architectsbureau Kuiper, Gouwewet, De Ranitz and Bleeker.

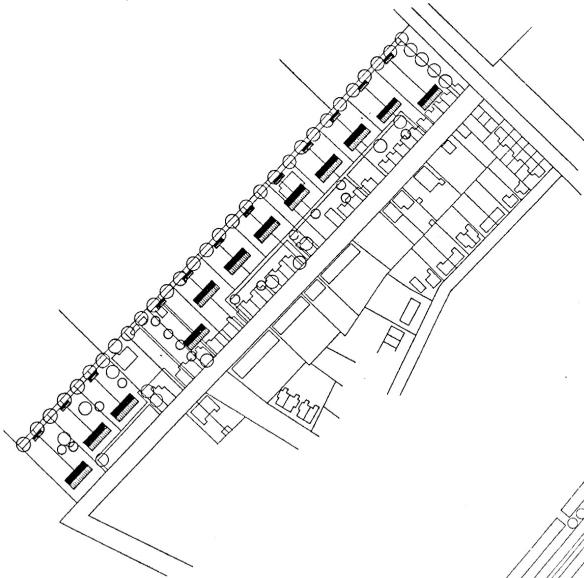
3. Sixteen gifted houses, type Zw 5d and 8 gifted houses, type Zw 9d in Oude Tonge (Goeree-Overvlakkee, Zuid-Holland). Design by *Instituut Stad en Landschap*.

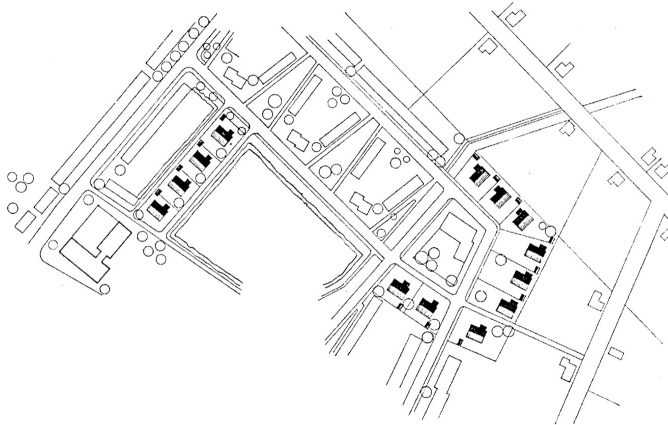
5. Thirteen gifted houses, type Fi 7e in Nieuwe Tonge (Goeree-Overvlakkee, Zuid-Holland). Design by *Instituut Stad en Landschap*.

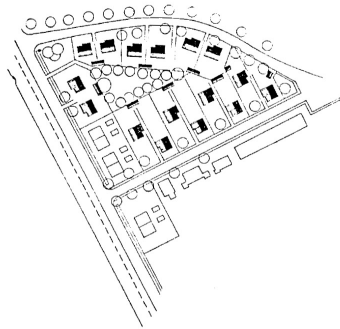
6. Sixteen gifted houses type No 7e in Stellendam (Goeree-Overvlakke, Zuid-Holland) Design by *Instituut Stad en Landschap*.

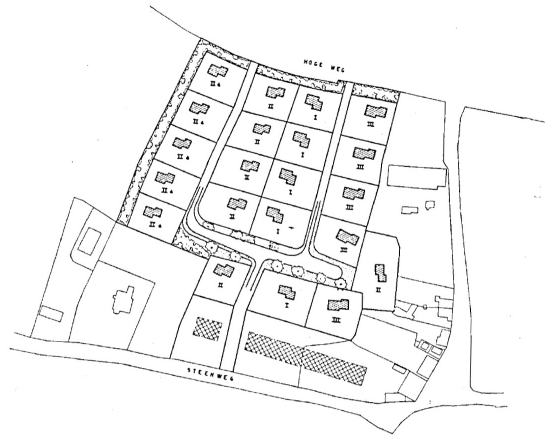
7. Twenty one gifted (summer) houses in Burgh (Schouwen-Duiveland, Zeeland) Design by *A. Komter*.

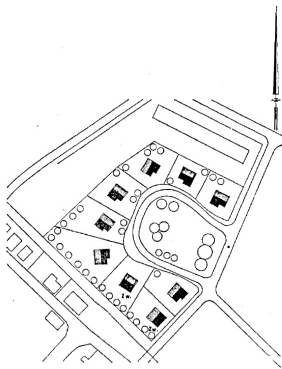
8. Seven gifted houses type No 7e and two gifted houses type Zw 5e te Almkerk (Noord-Brabant). Design by *Centrale Technische Dienst Land van Heusden en Altena*.
