## Fragility curves for light damage of clay masonry walls subjected to seismic vibrations

Korswagen, Paul A.; Longo, Michele; Rots, Jan G.

Bulletin of Earthquake Engineering

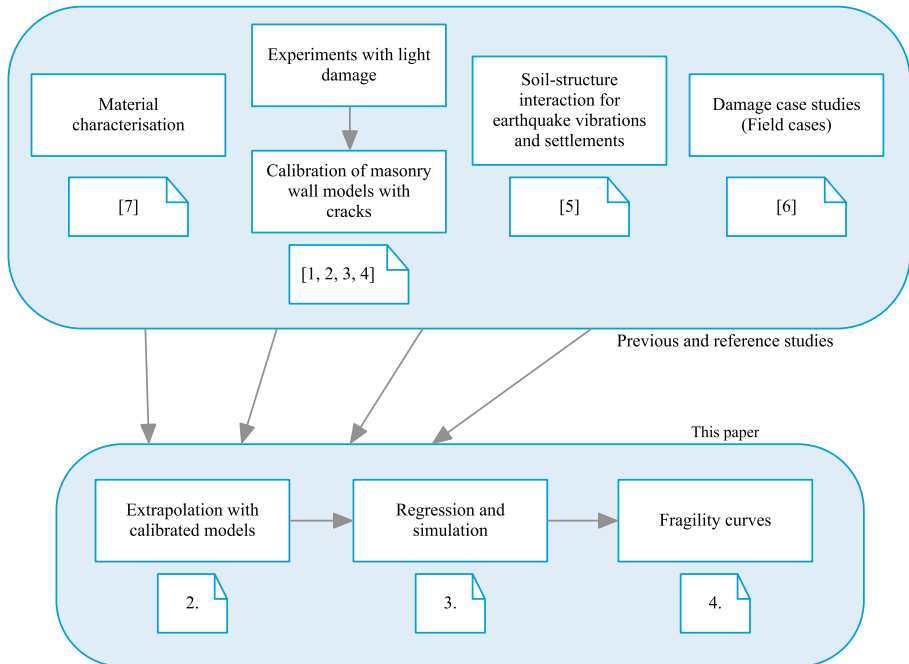
**Fig. 1** Earlier studies, with references ([1 to 4] Korswagen et al. 2019a, b, 2020a, b; [5] Longo et al. 2020; [6] Staalduinen et al. 2018; [7] Jafari et al. 2017), and the flow chart of this paper, indicating chapters (2. to 4.)

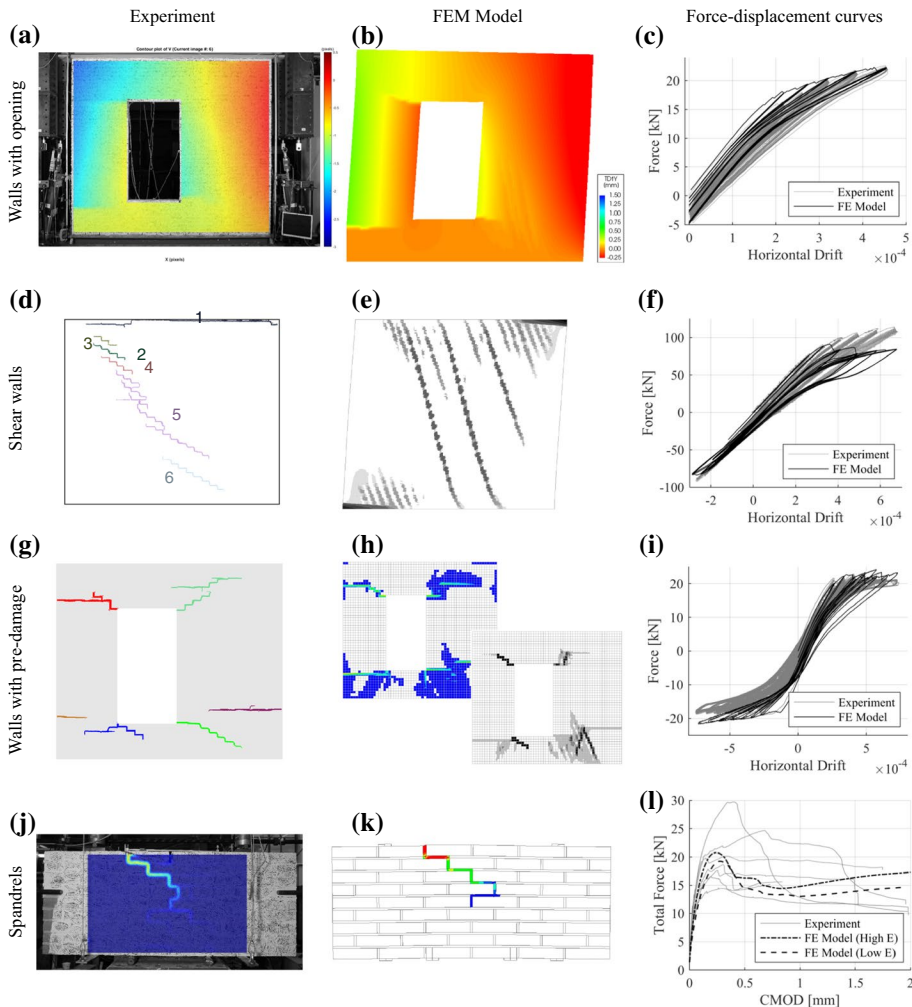
**Fig. 2** Graphic overview of experimental tests (left column), comparable crack patterns in finite element models (middle column) and comparison between experimental and computational force-displacement curves (right column). **a** Vertical displacement field captured with DIC from a laboratory wall with a window. **b** FEM model of the same wall. **c** Comparison of the force-displacement curve between the experimental (**a**) and the model wall (**b**). **d** Automatic crack identification from the DIC data for a laboratory wall without a window. **e** Crack strain plot of a FE model of the same windowless wall. **f** force-displacement curve of (**d**) and (**e**). **g** Crack locations for a wall with pre-damage. **h** FE model of such a wall, for tensile (left) and shear cracking (right). **i** Force-displacement graph for (**g**) and (**h**). **j** Spandrel-type wallet (window bank) surveyed with DIC displaying crack strains. **k** FEM micro-model of said wallet. **l** Force-displacement graph of the wallet for several experiments with monotonic loading (**j**) and two FEM models differing in the Young's modulus of the masonry material (**k**)

displacement fields and crack patterns and the middle column shows the equivalent view from a calibration FE model; the right column compares the force–displacement curve between experiment and model. Similarly, the first row depicts one of the tests on a virgin wall with an opening, while the second row outlines the case of a windowless wall. In both cases the loading protocol, inferred from the graphs, is asymmetric, consisting of a one-way cyclic displacement and a two-way cyclic portion with larger positive amplitude, respectively; and accordingly, the crack patterns displayed are not symmetric. The resolution of the imaging and processing systems for the laboratory cracks produced clear cracks, and the smeared models presented sufficient crack-localisation that the experimental patterns could be recognised; the crack locations, and their properties such as crack width, length and overall damage measured by  $\Psi$  (Korswagen et al. 2019a; Korswagen and Rots 2020b), contribute to the calibration process. The following two rows showcase the experiments with walls with two pre-cracked mortar joints and the wallets or spandrels; for the former, the full two-way cyclic loading protocol is presented, while for the latter, some of the monotonic tests are compared to two model possibilities. The figure presents, at a glance, the various calibration campaigns undergone.

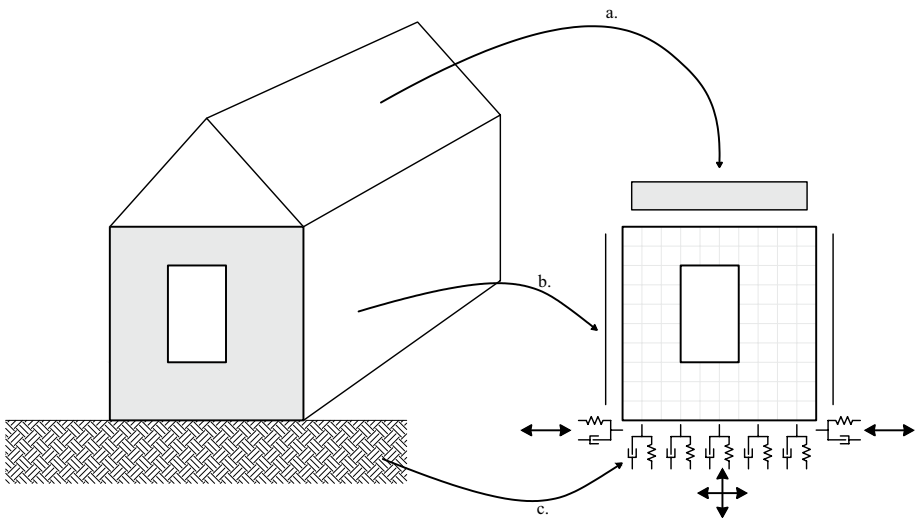
**Fig. 3** Schematisation of the model (right) with the representation of some of the model’s features: **a** top weight and dynamic mass, **b** lateral constraints, and **c** soil–structure interaction

- *Overburden* a vertical pre-compression of 0.12 MPa is applied at the top edge after the self-weight gravity load. This stress corresponds to the weight of one concrete floor or two timber storeys.

- *Top boundary* no steel beam is used at the top of the wall as in the laboratory; instead, a stiffness-free line mass element is incorporated to mimic the dynamic effect of a floor. The mass is set at 10 ton to simulate the presence of a fictitious rigid floor, an upper masonry wall, an upper floor and a roof. While the wall doesn't carry the vertical weight of these components, their mass does affect the horizontal in-plane behaviour of the wall; as such, the line mass does not influence the static condition. The mass is also used to calibrate the natural periods of the walls to match those of low-rise masonry buildings from which the walls are extracted. The flexible wall has a fundamental natural frequency of about 9 Hz and the stiff wall of about 13 Hz; depending on material, soil, and initial masonry condition, these periods can vary by up to  $\pm 2$  Hz.

- *Rayleigh damping* a 2% damping based on the first two modes, as judged by order of participating mass, is included in the model.
- *Soil-structure interaction* the bottom steel beam used during the calibration phase is replaced with a combination of springs and dashpots. These are placed underneath the wall in order to simulate the effect of the soil on the structure. Stiffness and damping are provided by two separate interface elements: (a) A non linear 2D line boundary interface (CL6TM-NL), which accounts for the stiffness and for the soil's behaviour, is characterised with a Coulomb friction law. The cohesion is set to 0.1 MPa while the friction and dilatancy angles to 0.61 rad. Additionally, a no-tension criterion is enforced for the springs representing the fact that no tension can develop between soil and foundation. (b) A similar, yet linear-elastic interface (CL6TM-LE), which includes the damping coefficients and offers no stiffness, is also included.

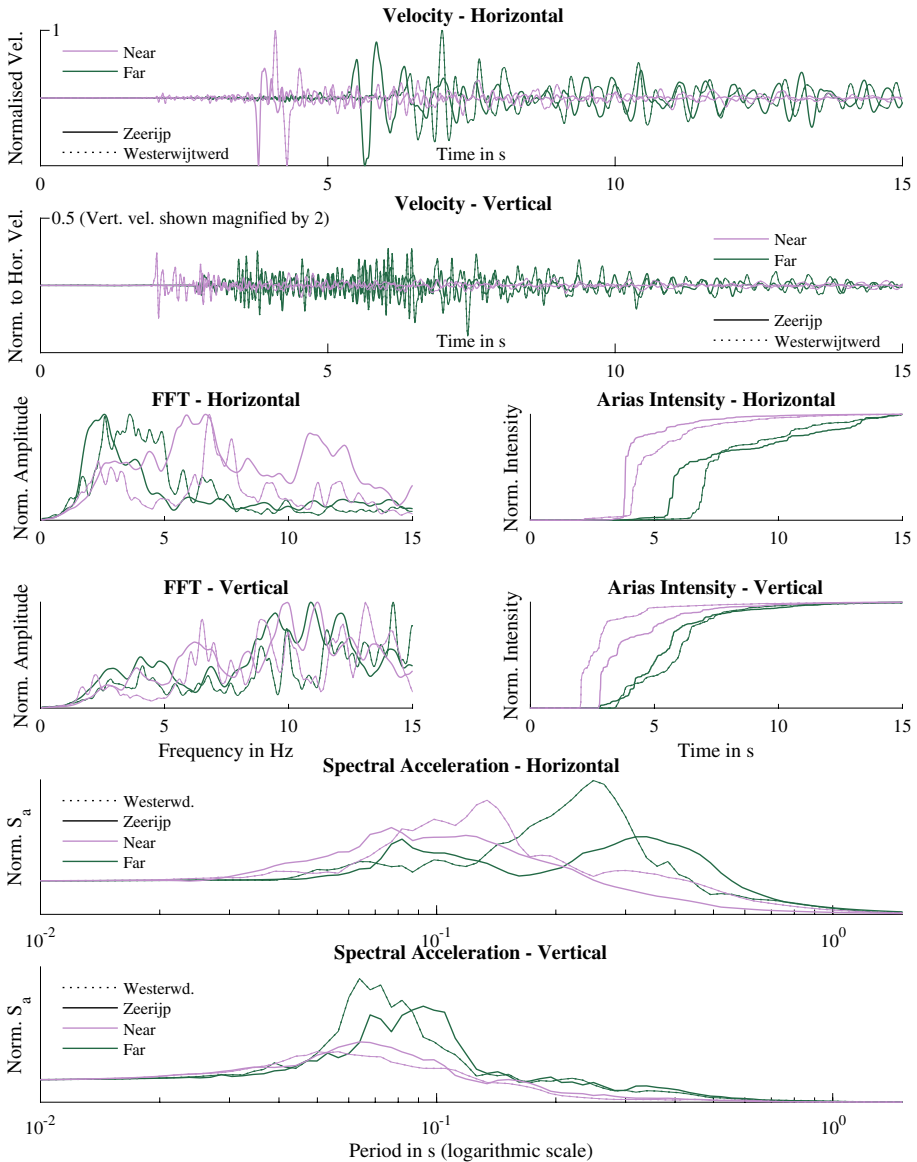
**Fig. 4** Comparison between records of the Zeerijp and Westerwijtwerd earthquakes. For each event two time-series have been selected: recorded at relatively near and far stations; see Table 5. Records are normalised to the horizontal peak ground velocity for comparison purposes

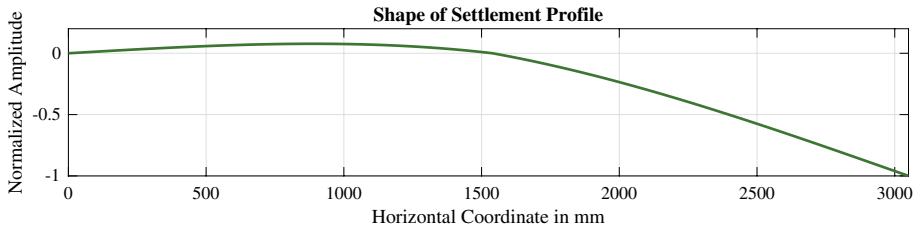
**Fig. 5** Normalised profile of the settlement displacement applied to the base of extrapolation models with pre-damage

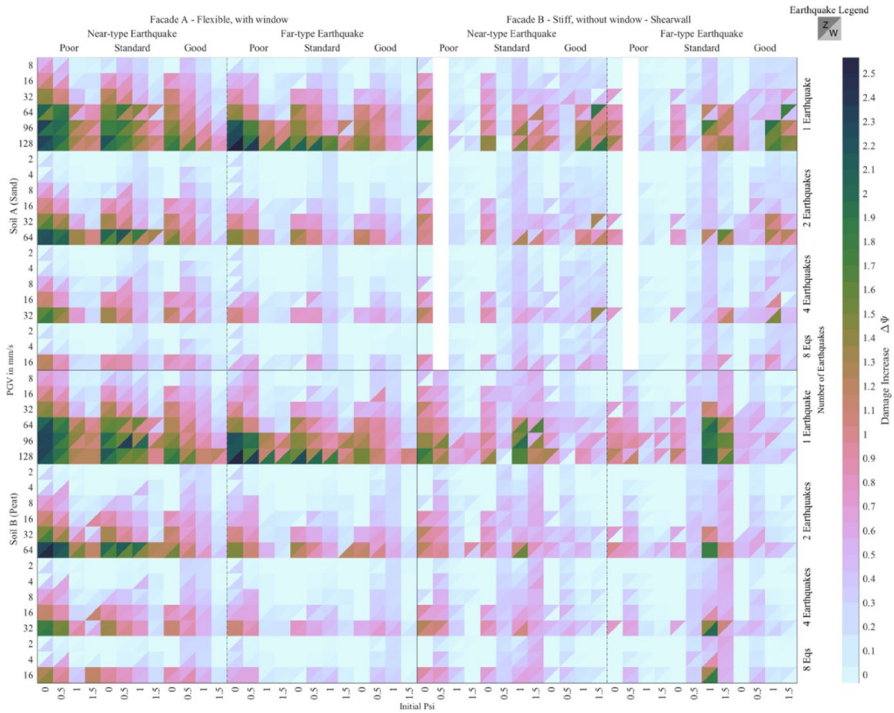
**Fig. 6** Overview of results from the modelled scenarios for the four records of the earthquakes of Zeerijp and Westerwijtwerd measured and expressed as the increase in damage,  $\Delta\Psi$ . The darker triangles correspond to the larger increases in damage in respect to the initial damage ( $\Psi_0$ )

The trends observed in the multitude of analyses run to produce Fig. 6 can be captured in a regression model that incorporates the effect of every parameter varied and the relationship between the most relevant of these parameters. To avoid a ‘black box’ effect where an arbitrary model is fit precisely to the existing data points but may produce unexpected results outside of the domain of the data, a ‘reasoned model’ is employed where the relationship between the input parameters and damage can be understood. First, clear trends are gathered in the following order:

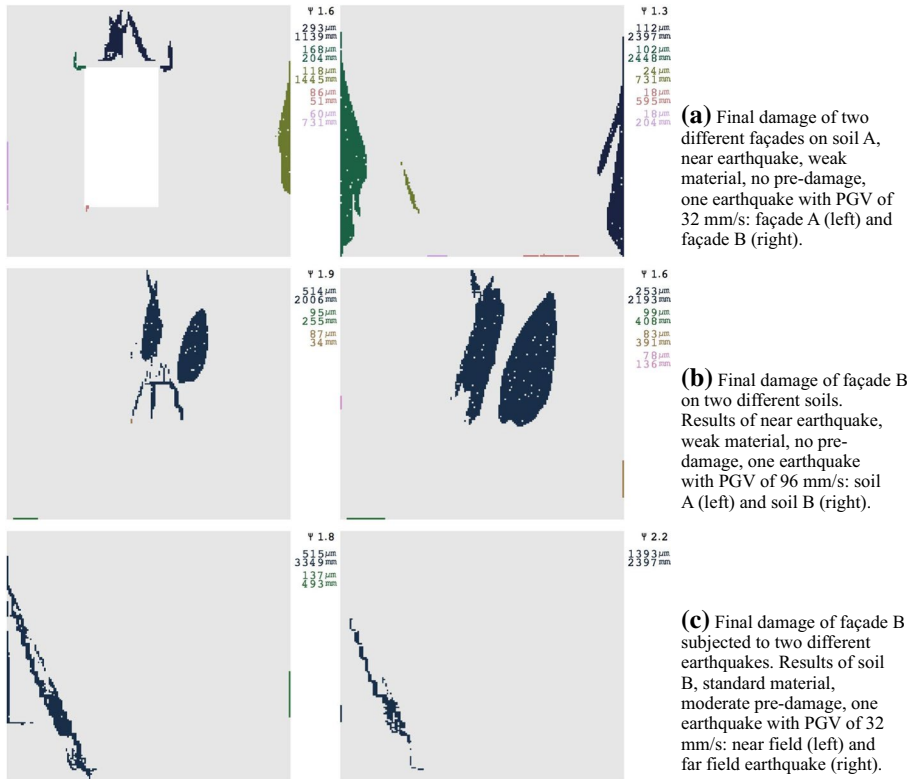
**Fig. 7** Hand-picked examples for comparison of the effect of the three binary variables: flexible or rigid wall type (top row), good or poor soil type (middle row), and near or far earthquake type, both for the Zeerijp event (bottom row)

higher stresses and damage in the walls. Figure 7b shows the virgin, rigid wall with weak material and subjected to a single, near earthquake (ZN) of 96 mm/s as PGV, analysed with two different soils. A similar crack pattern is detected for the two models, which depict diagonal shear cracking at the middle of the wall. Cracks in models with soil A appear more concentrated and wider than the smeared shear cracking of the one on the weaker soil B. In this case the difference in damage at the end of the protocol reaches about 20%.

For the earthquake type, near or far from the epicentre using the two records of the Zeerijp event, Fig. 7c presents the effect on façade B on soil B with standard material and moderate pre-damage. Both earthquake types are scaled to a PGV of 32 mm/s and a single motion is run. The results show a different crack propagation; while for the near-field motion the existing crack pattern grows mainly in length with some additional parallel lateral cracks, the far motion depicts mainly an increase in width without affecting much its length. This behaviour is frequently seen in façade B when the far record often produces higher damage. On the other hand, the flexible façade (A) appears more sensitive to the near motion. This observation is likely related to the different frequencies present in the two signals which interact in distinct manners with the two types of walls.

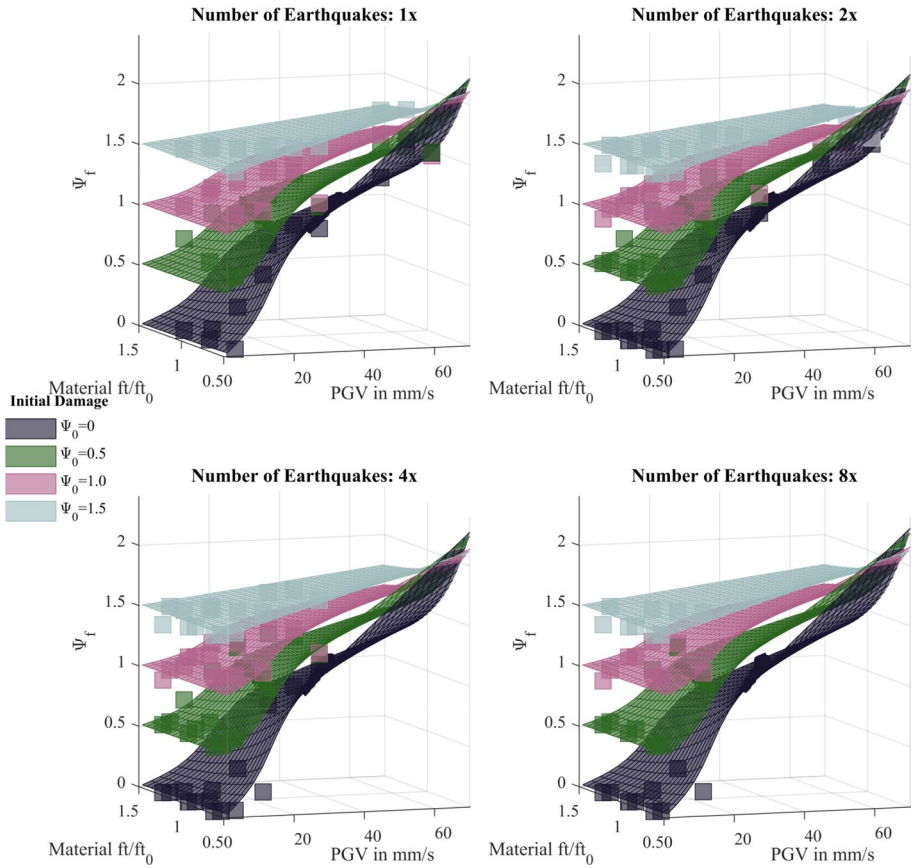
**Fig. 9** Example of the model shape and fit to the data points (squares) for the combination of soil A, façade A and far record of the Zeerijp event

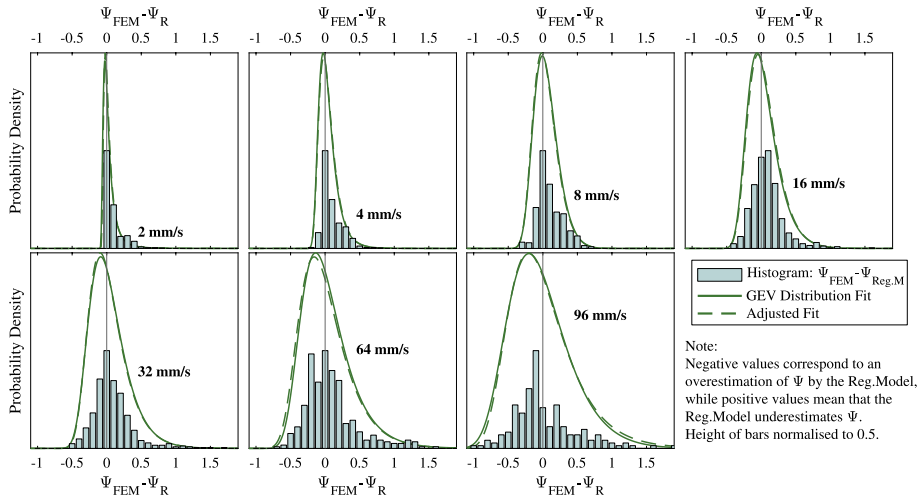
**Fig. 10** Residuals to the fit of the regression model segregated by PGV and Generalised Extreme Value (GEV) distribution fit for the uncertainty parameter

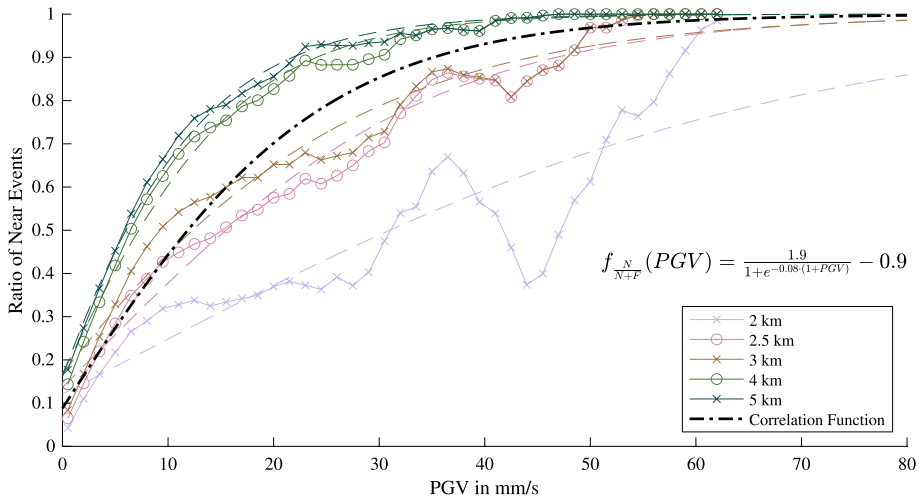
**Fig. 11** Correlation between PGV and near-type records from statistical, historical data. Low PGV values sometimes correspond to events with an epicentre located farther away, while PGV values above 10 mm/s always correspond to events originating less than 3 km away

between the PGV and whether an earthquake is near or far, with high values of PGV more likely to be caused by an event nearby. Secondly, the distribution of the epicentres in relation to the structures will also play a role in dictating whether earthquakes are distant or near. Therefore, a brief statistical study on historical data was conducted to characterise the type of earthquake and establish its correlation to the PGV. The events in the period between January of 1993 and December of 2019 with a magnitude of at least  $M_w \geq 1.5$  were observed and the PGV was computed throughout the region using ground motion prediction equations (GMPEs) as developed by Bommer et al. (2017); the PGV was sampled probabilistically. A simplified database with the number and location of masonry structures Arup (2018) was used to determine the distance and intensity of the seismic events in relation to the buildings in the region. A ratio between the near and far events, as categorised by a threshold varied between 2 and 5 km, was established for various PGV intervals; this is depicted in Fig. 11. This graphs shows how events with a local PGV greater than 40 mm/s for example, corresponded most of the times to events within a radius of 2 km; while events with a PGV smaller than 5 mm/s were much more likely to come from an event with a distant epicentre. As the threshold to distinguish between near and far events increases from 2 to 5 km, the likelihood of events being nearby reasonably increases. For a random event, this simulation employs a correlation function which establishes a 10% probability that the event is from a nearby source if the PGV is 1 mm/s and a 90% probability if the PGV is 35 mm/s. This function has been arbitrarily defined for any value of PGV based on the various thresholds plotted in Fig. 11.

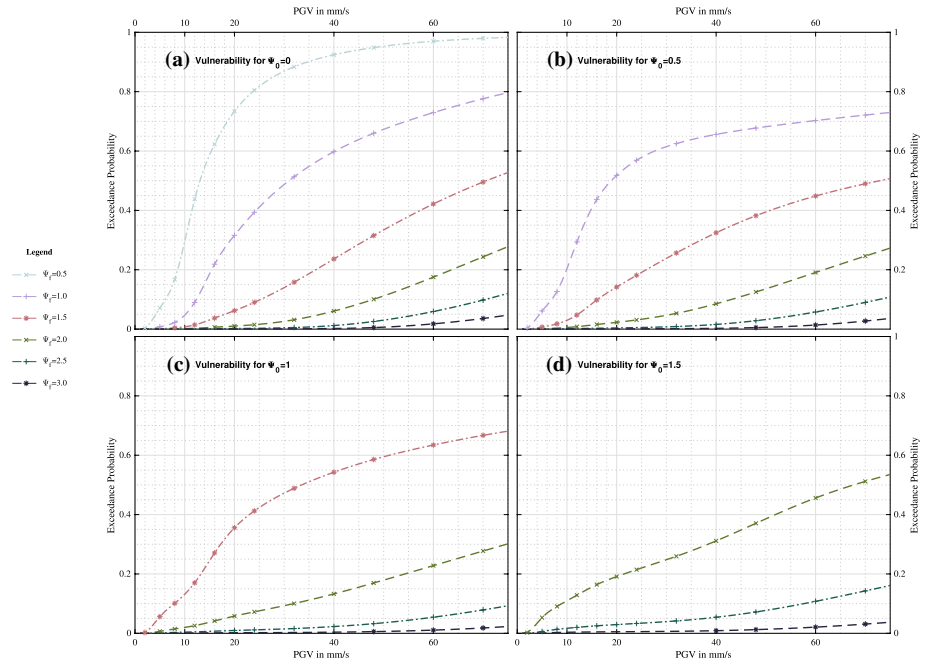
**Fig. 12** Vulnerability or fragility curves obtained from the MonteCarlo simulation for four different values of initial condition ( $\Psi_0$ ): **a**  $\Psi_0=0$ , no initial damage; **b**  $\Psi_0=0.5$ , damage invisible to the naked eye; **c**  $\Psi_0=1.0$ , barely visible damage with cracks around 0.1 mm in width; and **d**  $\Psi_0=1.5$ , clearly visible initial damage with cracks approximately 0.4 mm wide

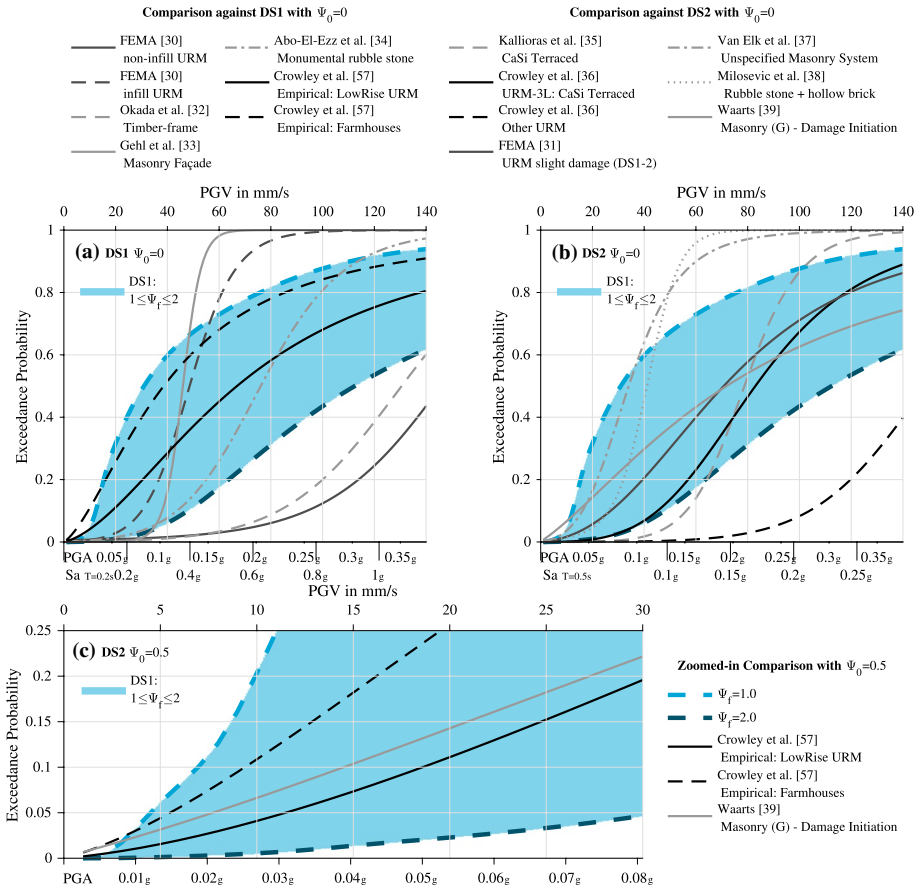
**Fig. 13** Comparison against other authors for  $\Psi_0=0$  and DS1 and DS2 (a, b), and (c) zoomed-in comparison of the fragility curves for imperceptible initial damage ( $\Psi_0=0.5$ ) against select curves for DS1 from literature

Additional literature for DS2, which should correspond to the end of DS1 given herein, is compared in Fig. 13b. These comparisons are relevant since a larger portion of the set also evaluates Groningen masonry. First, Kallioras et al. (2018) based their results on dynamic, large-scale tests representing calcium-silicate masonry terraced houses. Here, two differences are noted: firstly, this treats terraced houses which usually have a weak

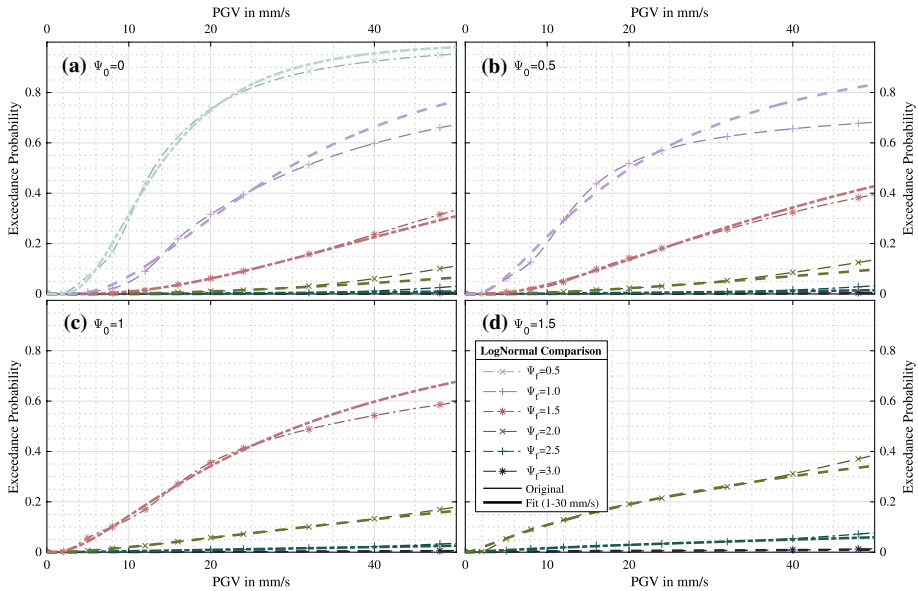
**Fig. 14** LogNormal fit to the fragility curves developed. The fit is enforced only for PGV < 30 mm/s
