FACADE TREATMENTS OF HISTORICAL BUILDINGS LIMITING THE RISKS

Rob R.P.J. van Hees

TNO Built Environment and Geosciences

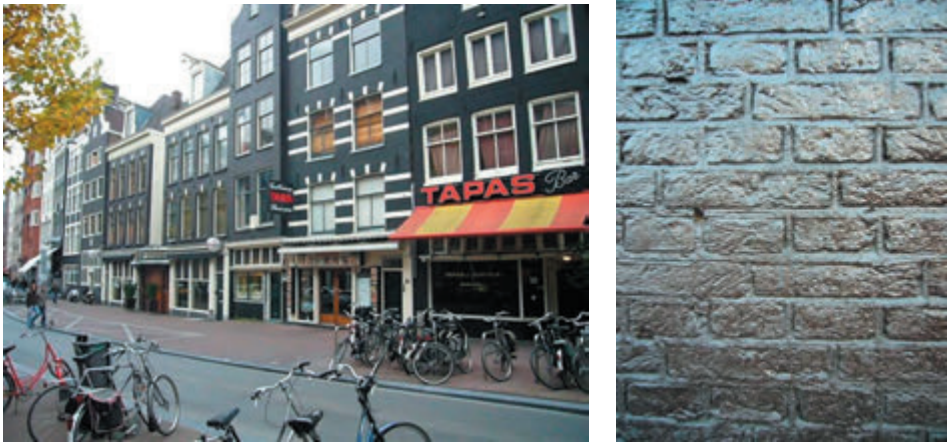
Figure 1: Historical 'protectives' on facades in Amsterdam. Use of linseed oil.
This kind of treatment was often applied from the beginning

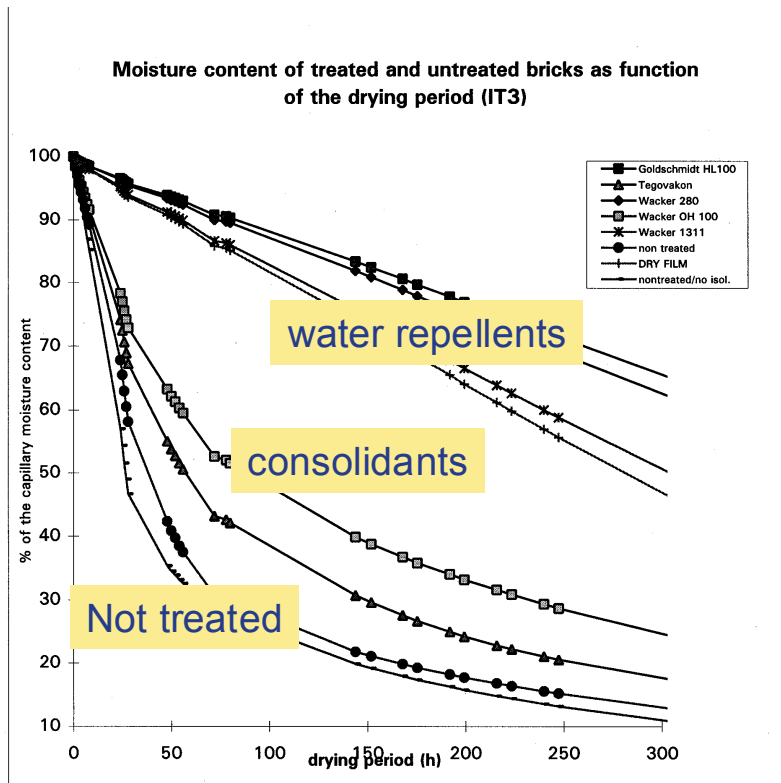
Figure 2: Drying behavior of treated (water repellents and consolidants) and not treated brick

The water repellent treatment can also contribute to limit the sulfate attack from environmental pollution. And finally a water repellent treatment can also have the aim of preventing microbiological growth and quick soiling after a cleaning operation. Water repellents may, even though the water vapor diffusion of the material is hardly altered, have a considerable influence on the drying behavior of the treated material and construction (Figure 2 and Van Hees 1998).

Consolidants are normally applied in a fluid state to allow penetration into the substrate. The filling of the pores has an effect on the drying behavior: drying of consolidated material is slower than the drying of the untreated one, but faster than in case the material would have been treated with a water repellent. Consolidants can not be applied successfully on materials showing delamination or scaling (Figure 3).

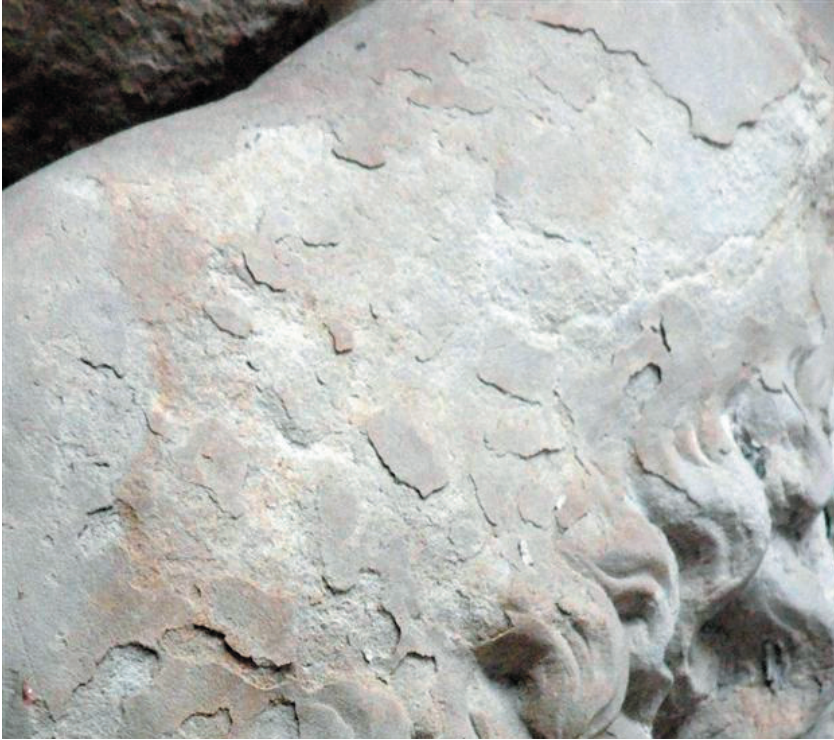
Figure 3: Detail of a natural stone showing scaling.
In this situation a consolidation treatment is not suitable

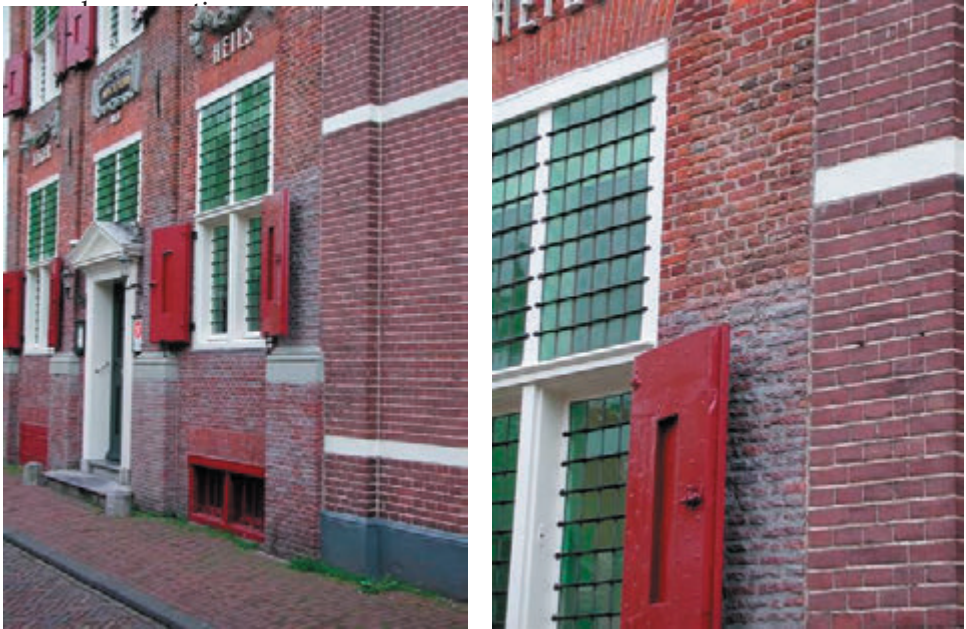
Figure 4: Clearly visible (transparent) antiraffiti coating in the lower part of the facade of a listed monument

In the case of anti-graffiti coatings, the effect on the aspect of the façade may be quite dramatical: a glossy aspect may result and sometimes the color will be clearly changed even in case of a transparent coating (Figure 4); the choice has to be made between the risks for the materials -due to graffiti and cleaning- on one hand and the possible negative effects like change in color and risks related to the effects of change in drying behavior on the other hand, as shown in figure 5.

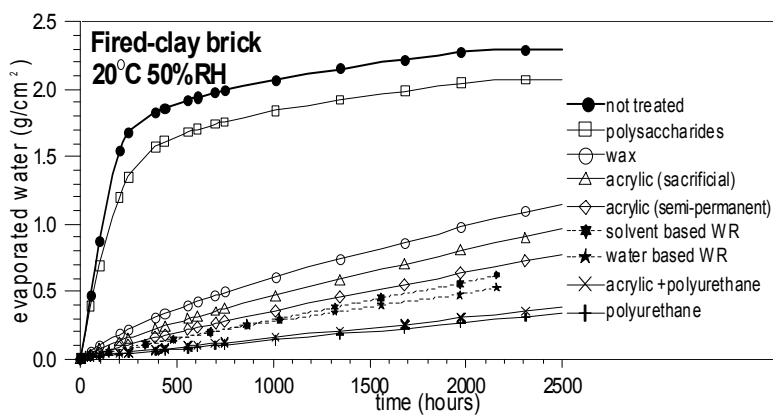
Figure 5: Drying behavior of treated (anti-graffiti coatings) compared with untreated brick

Also anti-graffiti coating may have a clear influence on the drying behavior (Figure 5 - Lubelli et al 2008).

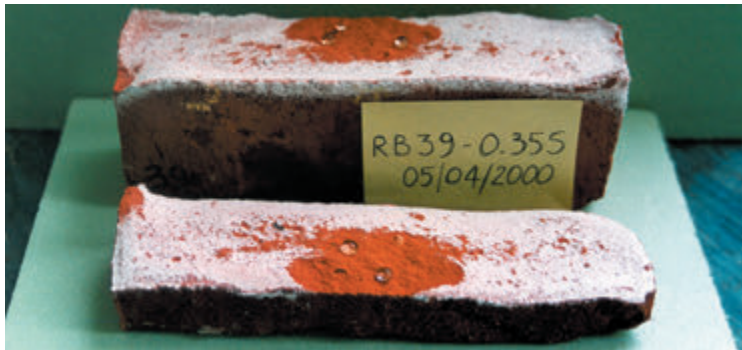
Figure 6: Spalling of a salt loaded brick treated with a water repellent

In case of water repellents, there is a certain risk for the historical materials, that is most outspoken in the presence of salts in the substrate (Figure 6). Further, a distinct change in drying behavior will occur (Figure 6).
