AN INTEGRAL APPROACH FOR THE ASSESSMENT OF TIMBER PILE FOUNDATIONS

Jan Willem van de Kuilen^{1,2}, Olga Beketova-Hummel³, Giorgio Pagella⁴, Geert Ravenshorst⁵, Wolfgang Gard⁶

ABSTRACT: Timber pile foundations are widespread in many areas around Europe and North-America. Especially in areas with weak soils, timber pile foundations have been a very good and economic solution. However, aging of the foundations can become a problem, as physical, biological and/or chemical degradation may occur over time. Now, that foundations can be up to 500 years in cities like Venice, Amsterdam, Hamburg, Boston and many others, questions arise about the reliability and which assessment methods can be used in order to estimate the current load carrying capacity and their residual service life. Residual service life is depending both on the time-to-failure behaviour of wood, as well as, the dead and live loads on the piles below buildings, quay walls and bridges. The approach taken integrates degradation models with a reaction kinetics based damage model. For wood that remains consistently below the waterline, the combination of bacterial degradation and long term loading is considered the most impo

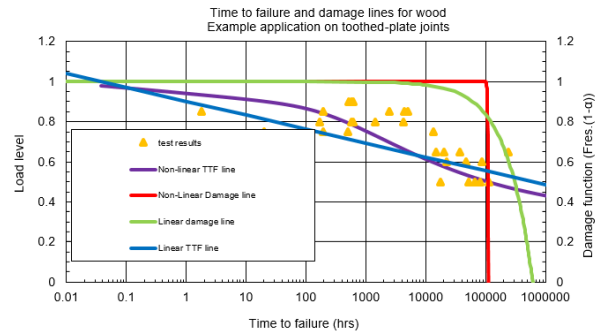
Figure 1: Indicative Time-To-Failure and Damage development (actual strength at time t) for a linear and non-linear damage accumulation approach. Example based on [15]

and linear or non-linear damage functions can be used. A straightforward application of a linear approach, but extended with the effects of biological degradation as shown in [6]. However, for various reasons as indicated previously, a more advanced damage model is required and a non-linear damage development approach from [4], [5],[12],[13-16] seems more appropriate, see also Figure 1.

Assuming that the decayed part has zero strength ($\beta=0$) is a safe lower bound approach. If $\delta \rightarrow 0$, the load carrying capacity approaches 0, and the damage grows ever more rapidly. This results in a shift of time-to-failure and increased damage development lines as indicated in Figure 1. The approach taken can be further explained on hand of Figure 2. There, a typical examples of a decayed piles that show severe decay on the outside (primarily sapwood), but hardly or no decay on the inside (primarily heartwood). Because of the weak outside layer, the remained inner parts will have higher stiffness, and consequently attract a higher portion of the load. These higher loads, will result in higher stresses on the still healthy cross section, thus increasing the stress ratio σ/f_s , resulting in more damage per Δt . This process continues until the damage parameter α has reached 1 and the structure has failed. A complicating factor will be that the inner part of the heartwood, is juvenile wood, which also has lower stiffness compared to adult wood, and consequently the stress level is not constant over the healthy part of the cross section either.

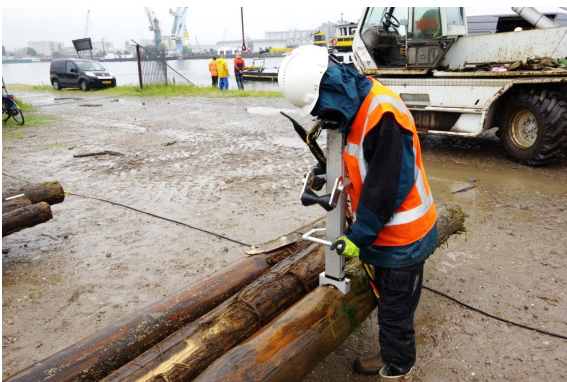
Figure 6: Microdrill in use on an excavated pile.

One of a few non-destructive and in-situ methods that is available for wood inspection is micro-drilling, such as IML-RESI PD. An IML-Resi for underwater use, is currently in a trial stage. In [17] an extensive analysis of microdrilling resistance and some of the pros and cons of the technology have been presented. The drill is equipped with a needle, which is injected through the cross section of the wooden trunk in question. As the needle passes through the material, the amount of energy needed to drive the needle through the medium is recorded/captured as drilling resistance. In case of IML-RESI PD, the needle is 3mm diameter at a tip and 1.5 mm diameter at its shaft. Resulting data is plotted as resistances vs distance, and shows a wave plot in which amplitude displacements coincide with changes in density and moisture content [19].

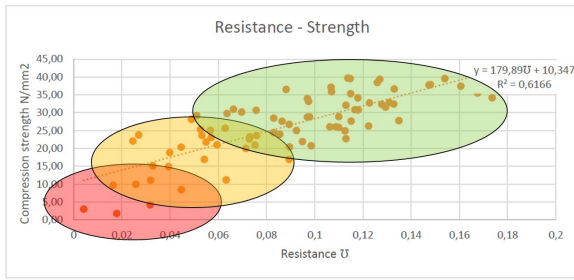
Figure 8: Relation between drill resistance parameter and compression strength of square specimens taken from excavated piles, modified from [21].

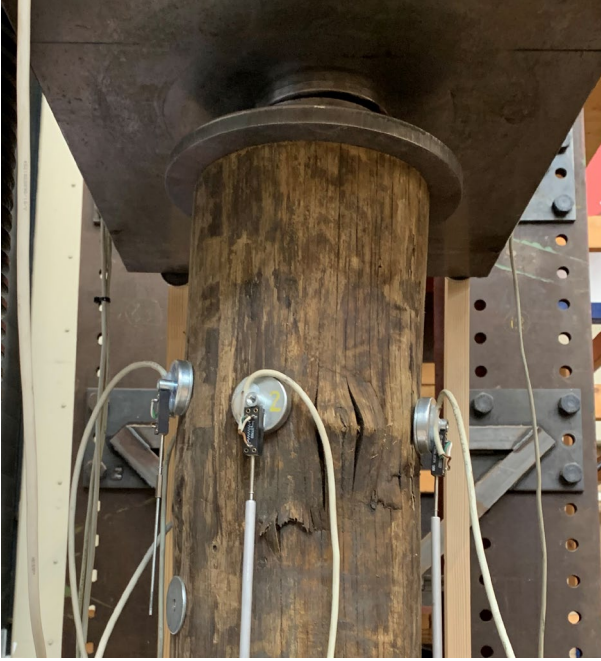
Figure 14: Failure in compression around knots
