## Conservation of windows and glazing

# 5 – Conservation of windows and glazing

Uta Pottgiesser & Susanne Rexroth

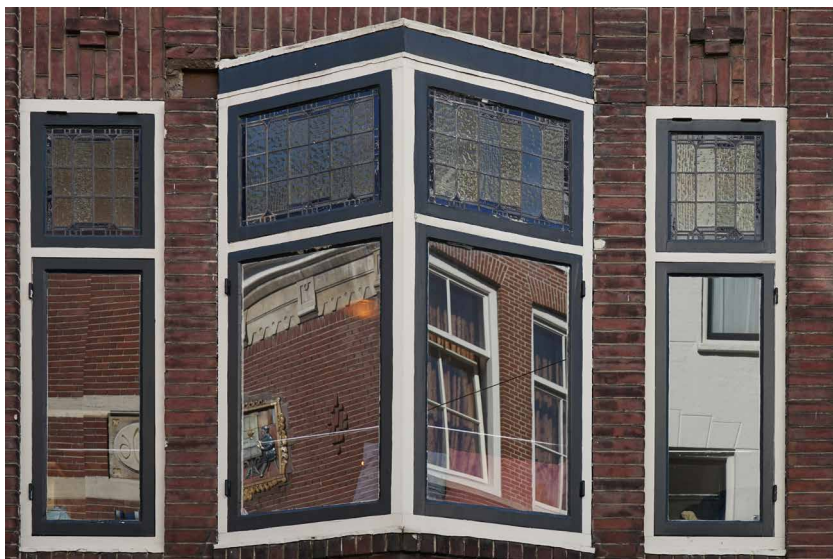
FIG. 5.1 Historic glazing / Photo: M. Olmeda

Hereafter, the most common types of glass are briefly illustrated and their fabrication process explained (Wigginton, 1996 and Schittich et al., 2021). When found in monuments, the types of glass from the past should be identified and analysed and, if possible, protected [FIG. 5.1].

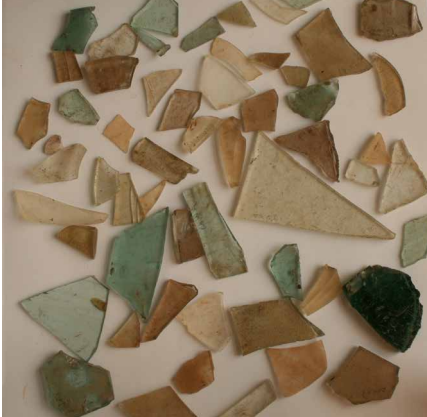
FIG. 5.2 Roman glass from the German site of Haselburg / Photo: [https://de.wikipedia.org/wiki/Datei:Haselburg\\_Glas.jpg](https://de.wikipedia.org/wiki/Datei:Haselburg_Glas.jpg) 2007, accessed Aug. 2021

*Crown Glass (400 CE onwards):* to make crown glass, a bubble of glass is transferred from the blowpipe to a pontil iron and after perforating the glass balloon, is spun at high speed so that the centrifugal force causes it to flatten into a round 'crown'. The central piece, the 'bull's eye' was often used for cheaper (domestic) windows. Crown glass was one of the most common processes for making window glass in Europe until the 19<sup>th</sup> century [FIGS. 5.2/5.3/5.4].

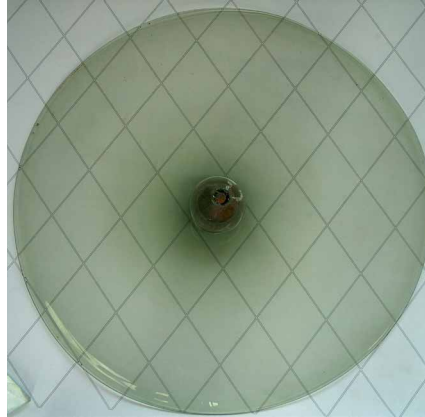
FIG. 5.3 The term 'bull's eye' refers to the thicker centre area of crown glass around the pontil mark / Photo: RCE

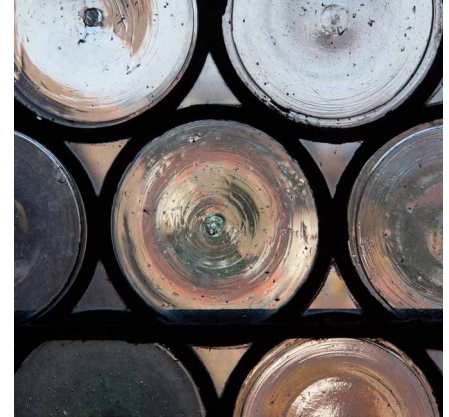
FIG. 5.4 Crown glass was one of the most common glass types until 19<sup>th</sup> century / Photo: pixabay.com

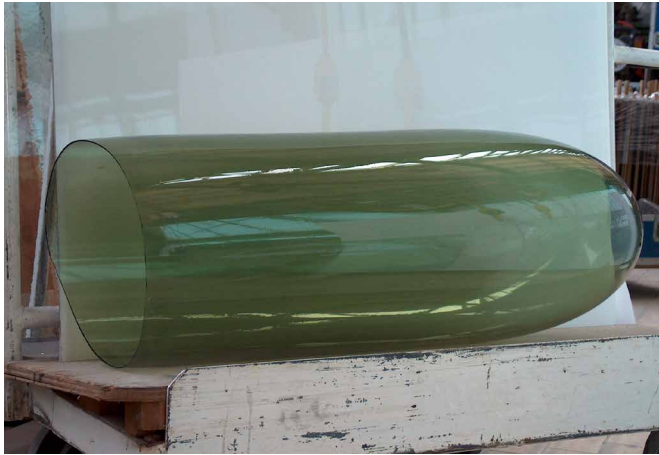
FIG. 5.5 Cylinder glass was another common glass types until 19<sup>th</sup> century / Photo: RCE

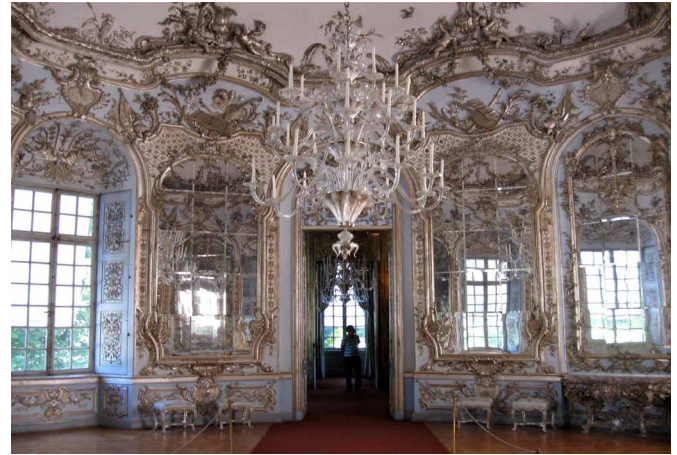
FIG. 5.7 Amalienburg hall of mirrors at Parc Nymphenburg (Munich) built in 1739 / Photo: [https://en.wikipedia.org/wiki/Amalienburg#/media/File:Amalienburg\\_Spiegelsaal-1.jpg](https://en.wikipedia.org/wiki/Amalienburg#/media/File:Amalienburg_Spiegelsaal-1.jpg), accessed Aug. 2021

*Polished Plate Glass (1665 CE onwards):* made by first pouring molten glass on to a table and rolling it until flat, then grinding and polishing it into a plate. Advancements in the process led to feeding the molten glass through continuous rollers, grinders and polishers. Plate sheet glass is no longer produced commercially in most European countries. As splendor had become a fundamental requirement, a whole new branch of industry could develop: the large scale production of polished plate glass. To get perfect flat and smooth panes, the cast glass has to be polished. This is a very time consuming and elaborate process. Glass has to cool slowly or it will crack due to internal stress. This very expensive glass type was for long only used for very specific buildings (both for windows and mirrors). Being almost undistinguishable from the best quality of modern industrially made float glass, it was also used for big shop windows into the 20<sup>th</sup> century [FIG. 5.7].

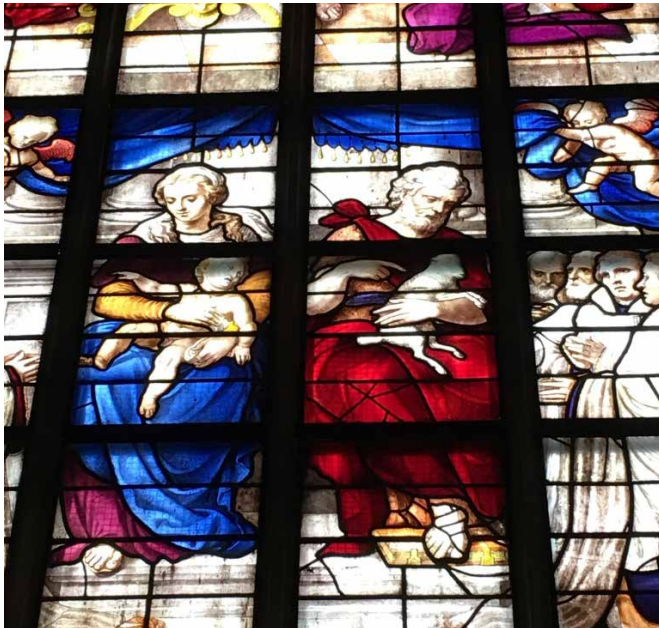
FIG. 5.6 16<sup>th</sup> century leaded glass in St. John's cathedral Gouda / Photo: S. Naldini

*Stained glass (1080 CE onwards):* coloured and painted glass not only adds light but also beauty to medieval churches. Setting glass in (strong yet malleable) lead required skilled craftsmen. Lead as matrix for glass pieces however was already known to the Romans [FIG. 5.6].

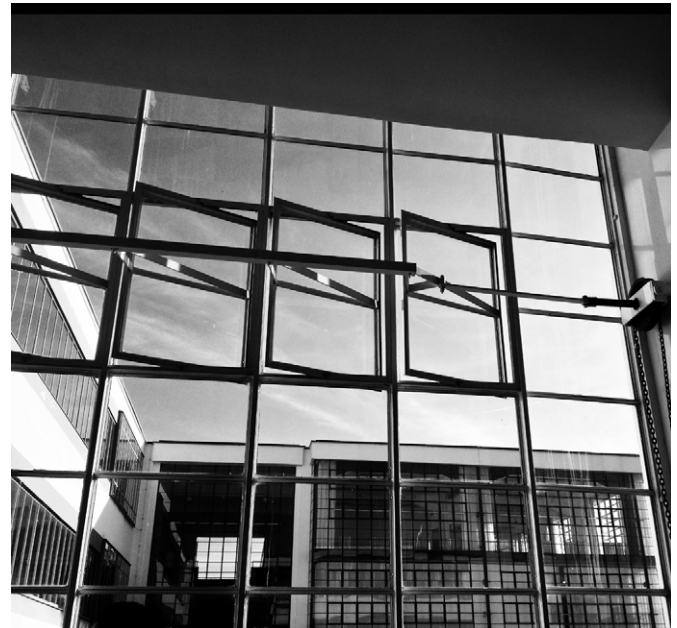
FIG. 5.8 Bauhaus Dessau, staircase, office and workshop glazings were originally using polished plate glass to achieve a precise and industrial look / Photo: pixy.org

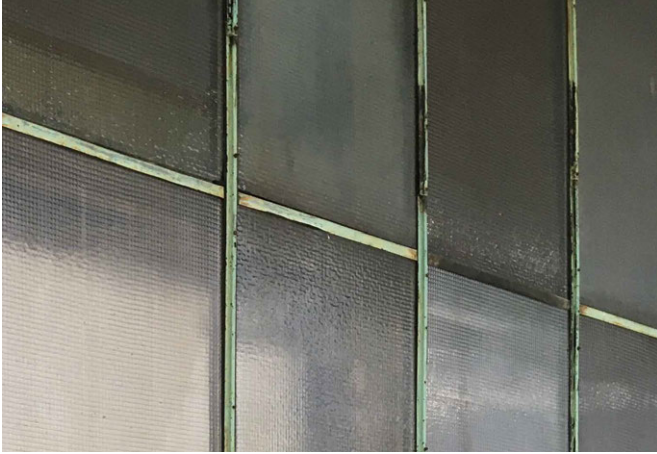
FIG. 5.9 Wire mesh glass, Lochal Tilburg / Photo: W.J. Quist

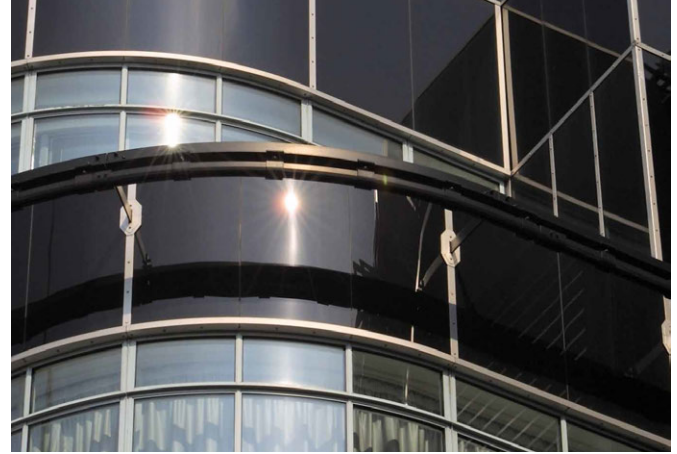
FIG. 5.10 Vitrolite spandrels at former Daily Express building by Ellis and Clark, 1932, London / Photo: [https://en.wikipedia.org/wiki/Daily\\_Express\\_Building,\\_London#/media/File:Express\\_Building.jpg](https://en.wikipedia.org/wiki/Daily_Express_Building,_London#/media/File:Express_Building.jpg), accessed Aug. 2021

*Pigmented Structural Glass (1900 onwards):* is a high-strength, coloured glass developed in 1900 in the United States by adding fluorides into the molten glass, which made the glass opaque. It was widely used in interiors, for signs and partitions and as facade cladding in the first half of the 20<sup>th</sup> century. Manufactured first in white, black or beige and later in a variety of colors, in flat panels or curved, it could be opaque or translucent, with a wide range of finishes: carved, cut, inlaid, laminated, sandblasted and textured. It was produced until the early 1960s in the US and until later in the UK and Europe. It was most commonly known under its trademarked name ‘Vitrolite’, but it was also sold as ‘Argentine’, ‘Carrara glass’, ‘Glastone’, ‘Marbrunite’, ‘Nuralite’, ‘Opalite’ or ‘Sani Onyx’ or as ‘Detopakglas’ in Germany [FIG. 5.10].

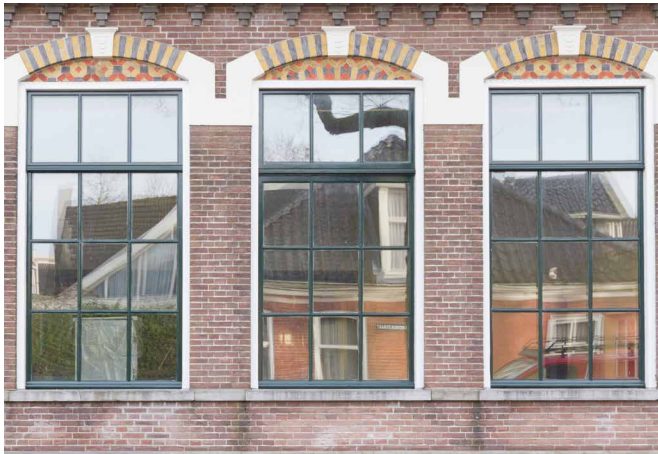
FIG. 5.17 Wooden window with muntins (glazing bars) connecting small glass panes / Photo: RCE

*Muntins or glazing bars:* were used to join the smaller glass panes to form a window [FIG. 5.17]. The fine wooden (or metal) bars were grooved on both sides to hold the glass pane and were inserted into each other without glue. The thicker frame pieces were grooved on one side and connected with the bars. Wooden connections were used at the frame corner joints. Thus, window frames were not inherently stiff and the system had the disadvantage that broken glass panes could only be replaced if the window was disassembled. This type of glazing, already used in England, was introduced in the Netherlands and continental Europe at the end of the 17<sup>th</sup> century and continued to be used to combine small sized glass panes until the middle of the 19<sup>th</sup> century.

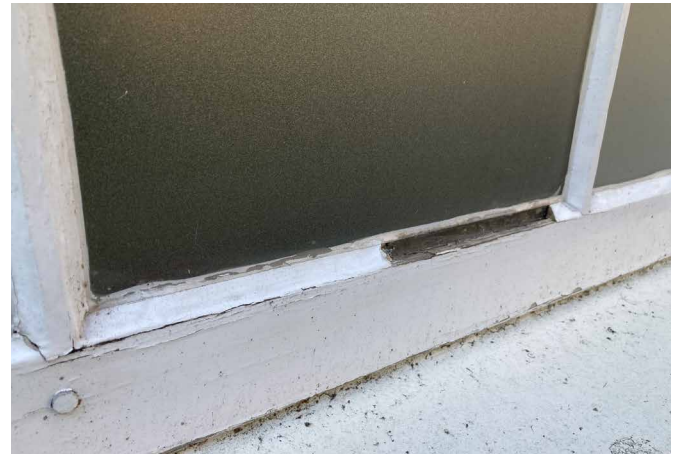
FIG. 5.18 Putty in wooden windowframe (in need of repair) / Photo: W. J. Quist

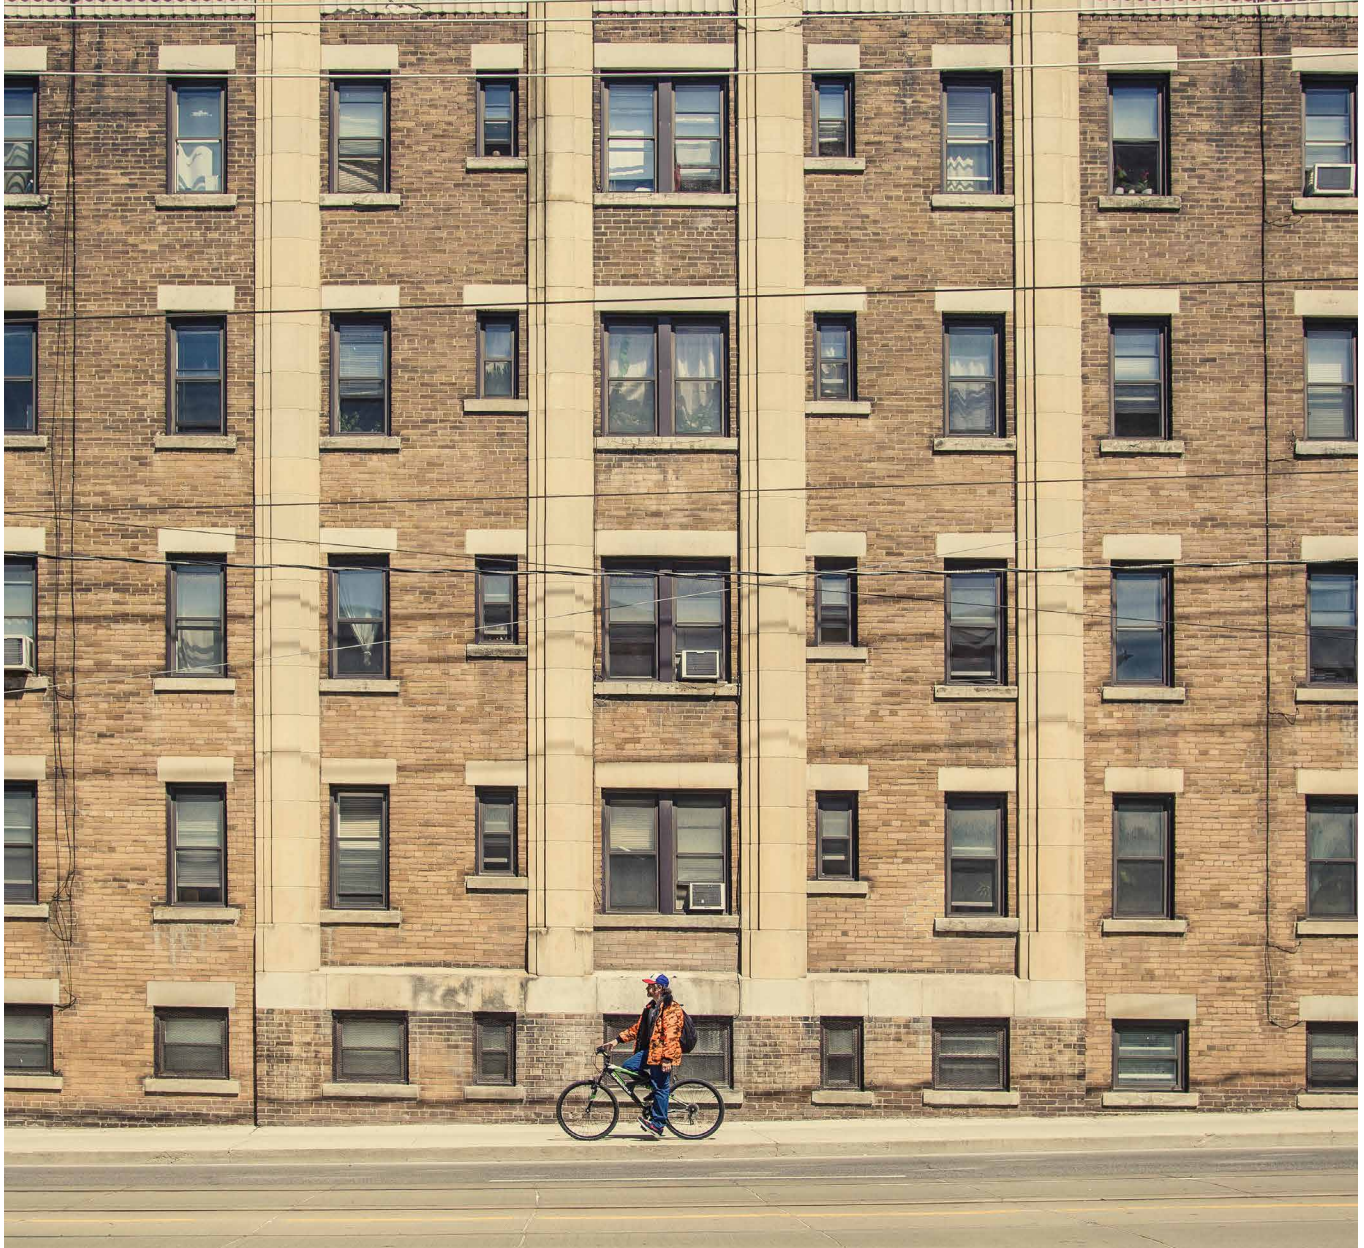
FIG. 5.19 Wooden frames were the most common material for residential buildings until mid 20<sup>th</sup> century. From early 20<sup>th</sup> century onwards larger glass panes were used in residential architecture / Photo: pxhere.com

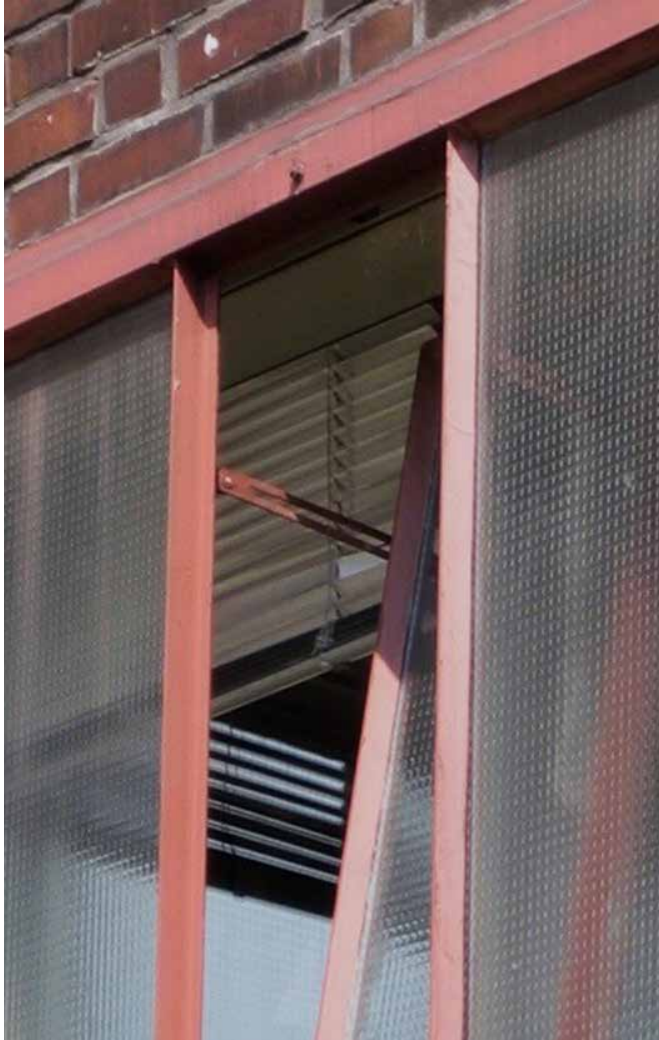
FIG. 5.21 Metal framed windows were used in industrial architecture since 18<sup>th</sup> century, and became standard in 20<sup>th</sup> century with mostly patterned or wired glass, Zollverein Coalmine, 1932 / Photo: U. Pottgiesser

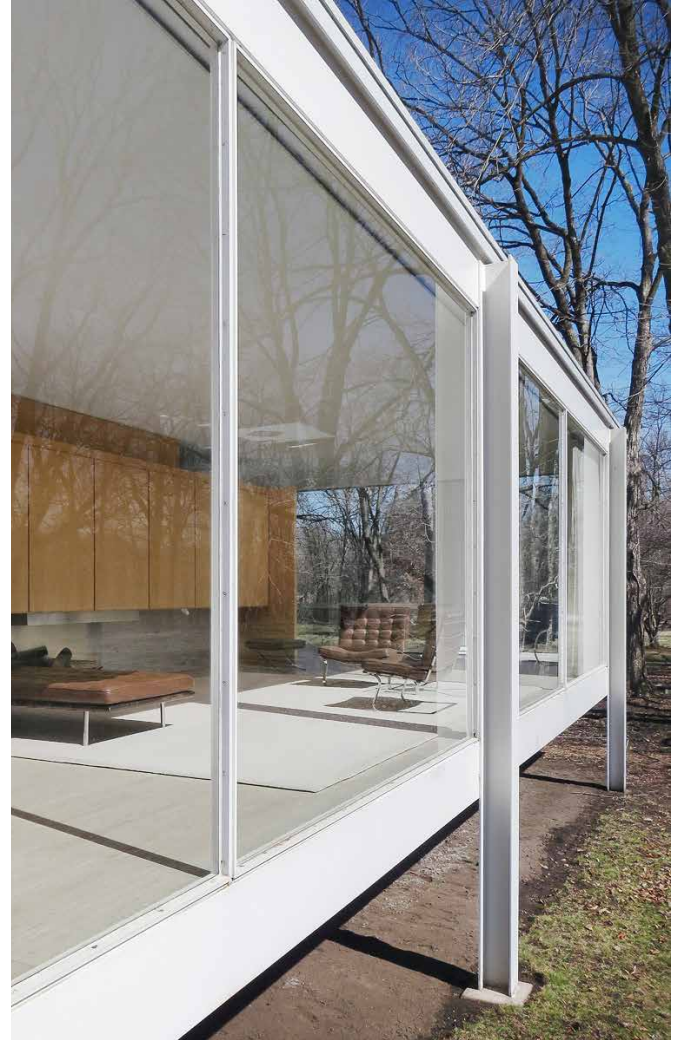
FIG. 5.22 Large metal framed windows were introduced to residential architecture in early 20<sup>th</sup> century, and became famous with buildings like the Farnsworth House, 1951 / Photo: A. Ayón

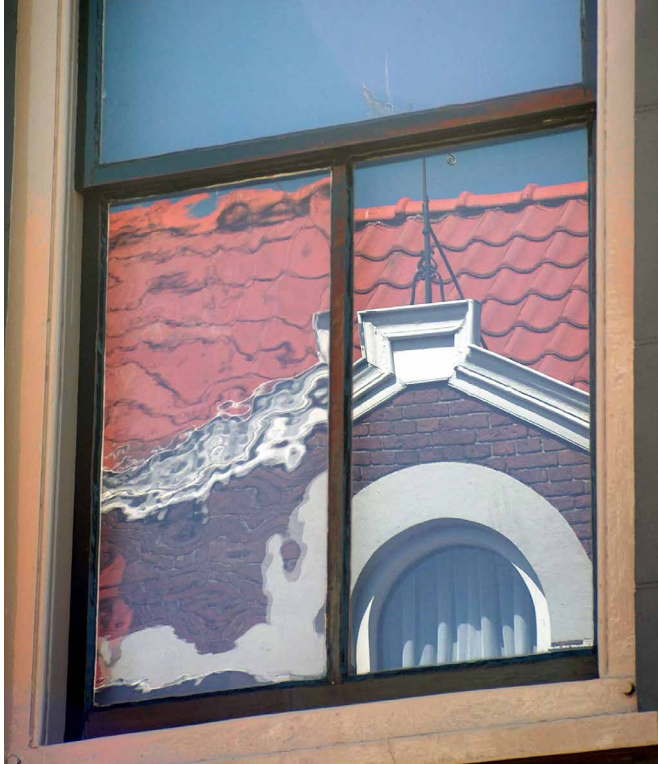
FIG. 5.26 Window with a historic irregular glass surface left and a new flat float glass surface right / Photo: H. v.d. Ven

Today it is common to replace historical glass with float glass. The use of float glass as replacement for original drawn or plate glass may require some compromises to be adopted. Aside from the visual differences between the products, there are limitations to the sizes available for today's float glass sheets which may pose additional challenges for reglazing interventions at modern buildings that require large sizes (Ayón, 2019) [FIGS. 5.26/5.27].

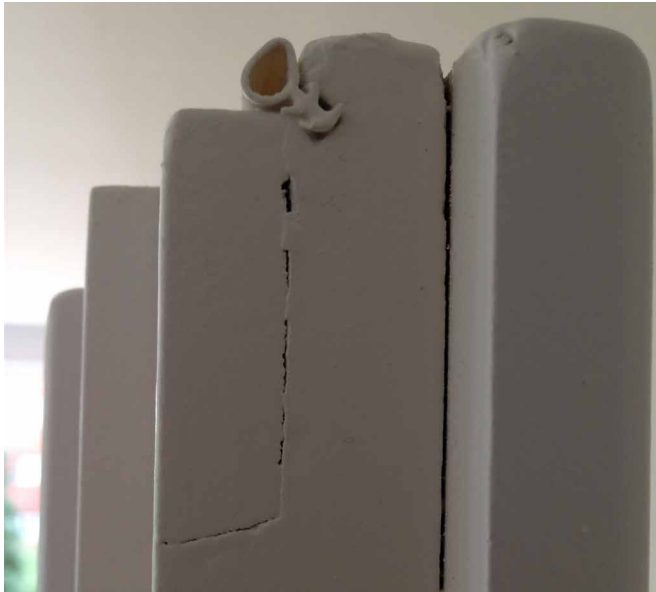
FIG. 5.28 Sash frame with new sealing: a) Image and b) schematic drawing / Photo: S. Rexroth

A common and less invasive measure for restoring and slightly upgrading wooden windows is first of all a carpentry overhaul that can be applied to single, composite or box windows. The windows are entirely closable and serviceable and a silicone tube profile seals the window sash (or in the inner window sash in case of compound and box windows) against draughts. This reduces ventilation heat losses. Draught leaks are usually caused by warped sash frames of which the

rebates no longer close evenly. To remedy this, they should first be reworked by craftsmen. Gaping irregularities can be closed flexibly by installing concealed crimp seals in the frame rebate of the sash frame, which also improves sound insulation [FIG. 5.28]. It is important that the seal is loose enough to close the existing gaps on the one hand, and on the other hand that the closing function is not impaired, e.g. by bulging. It should be recognized, however, that the improvement in tightness and heat loss reduction may be accompanied by a reduction in the hygienically required air exchange.

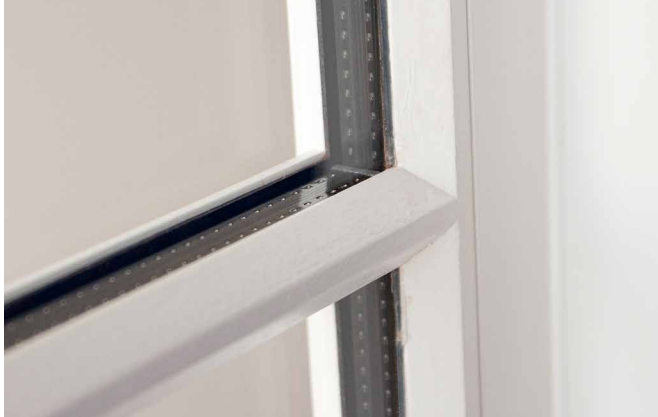
FIG. 5.33 Attached glazing bars are used when the existing structural bars are not wide or deep enough to accommodate double glazing

If new glass panes are installed, special attention must be paid to the glazing bars. They are usually placed on the glass panes as so-called superimposed Viennese bars ('Wiener Sprosse'), a spacer is mounted in the space between the panes [FIG. 5.33].

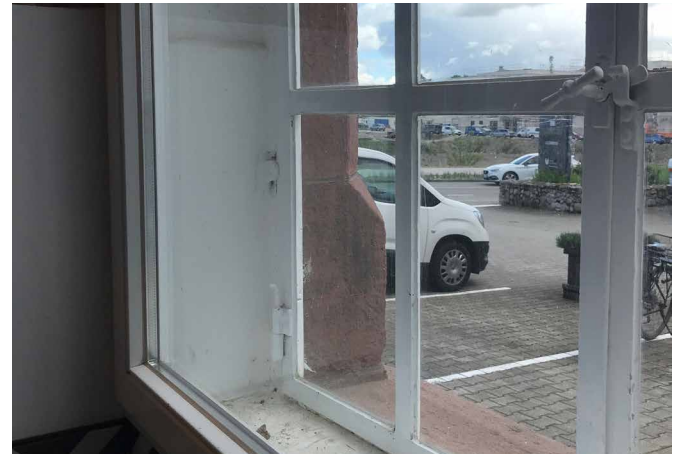
FIG. 5.37 a) Single steel windows with new secondary wood-framed glazing at the interior and b) scheme / Photo: S. Rexroth

Adding a secondary insulated glazed window to the outside or inside of the single window turns the single window into a double window [FIG. 5.37]. With a larger distance between the frames, it can be considered as a type of the energetically favourable and historically widespread box window.

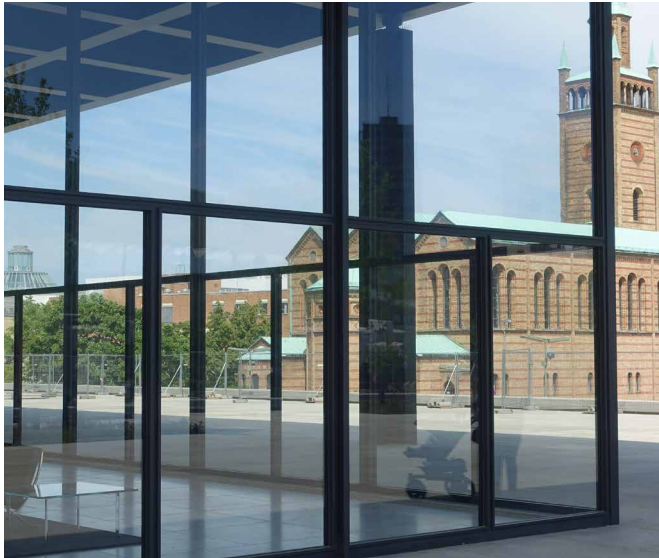
FIG. 5.39 New National Gallery, Berlin: original glazing (above) and three variants for the rehabilitation. In order to avoid glass breakage in the future, a double-thick laminated safety glass (2 x 12 mm) was used (second variant from above). The other two variants would have distorted the appearance of the construction too much. / Photo: F. May

A currently prominent example for the handling of such demanding window types is the renovation of the Neue Nationalgalerie (New National Gallery) in Berlin. The facade construction, which was not thermally separated, in conjunction with the relatively high humidity during exhibition operation, led to a high level of condensation from outside temperatures below 4° C. In order to minimize condensation, a detailed feasibility study was carried out at the beginning of the preliminary planning phase to investigate the use of double-glazed insulating glass. After weighing up the arguments relating to the preservation of monuments and technical aspects, David Chipperfield Architects however made the decision in favour of single glazing in a thermally non-separated construction [FIGS. 5.39/5.40], as this was the best way to preserve the appearance of the high-ranking monument (Bauwelt, 2021).

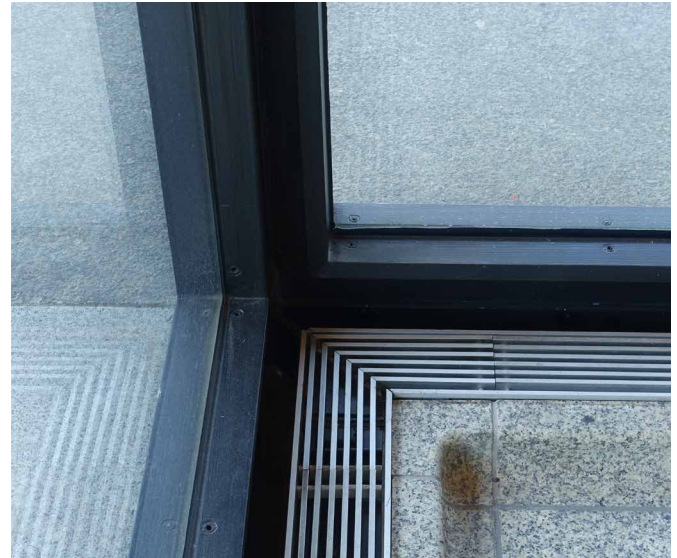
FIG. 5.40 New National Gallery, Berlin: New facade with a single glazing in a thermally non-separated construction / Photo: F. May
