<i>Project number</i>	C31B67
<i>File reference</i>	C31B67WP1-14
<i>Date</i>	February 18, 2018
<i>Corresponding author</i>	Samira Jafari (s.jafari@tudelft.nl)

TU Delft Large-Scale Testing Campaign 2016

MATERIAL CHARACTERISATION OF EXISTING MASONRY FOR URM ABACUS

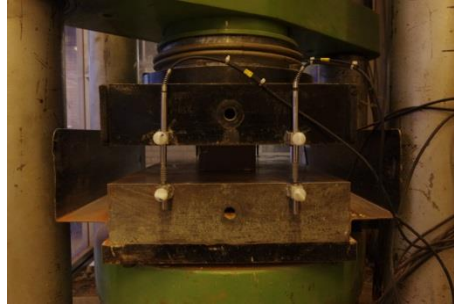
Figure 1 – Compressive test on a single brick.

To reach the failure load within 2 min [7], the rate of the jack displacement was set as follows: 0.03 mm/s for solid clay brick, 0.02 mm/s for perforated clay brick and 0.015 mm/s for CS brick.

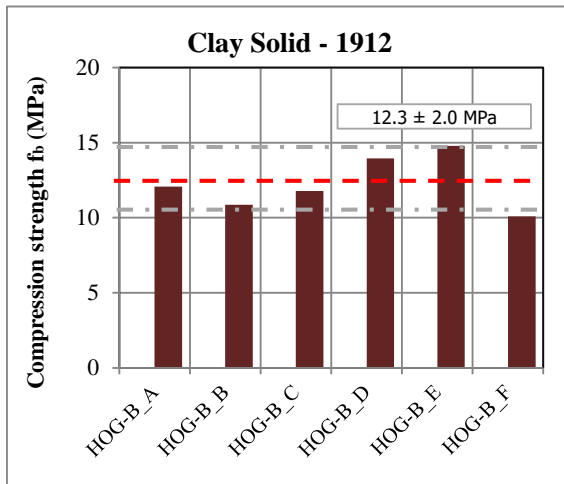
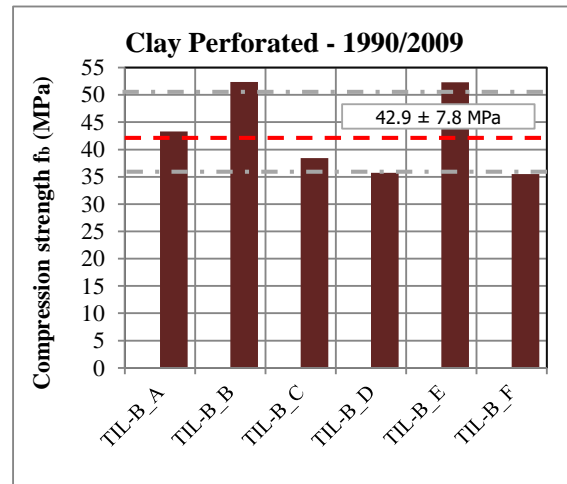
Figure 3 – Histogram representation of the normalised compressive strength of clay bricks: (a) solid clay bricks used before 1920; (b) perforated clay bricks used after 1945.

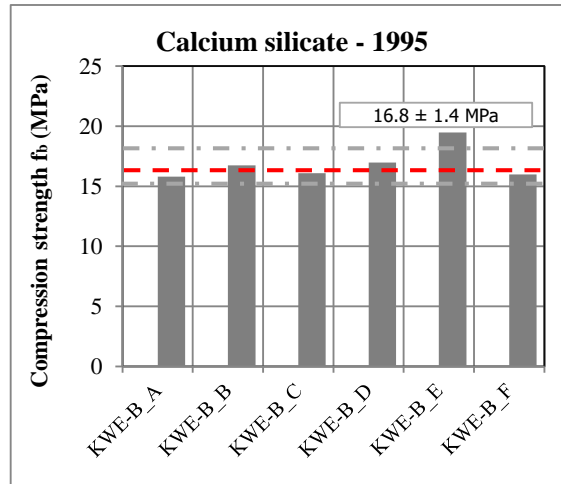
Figure 4 – Histogram representation of the normalised compressive strength of CS bricks used after 1985.

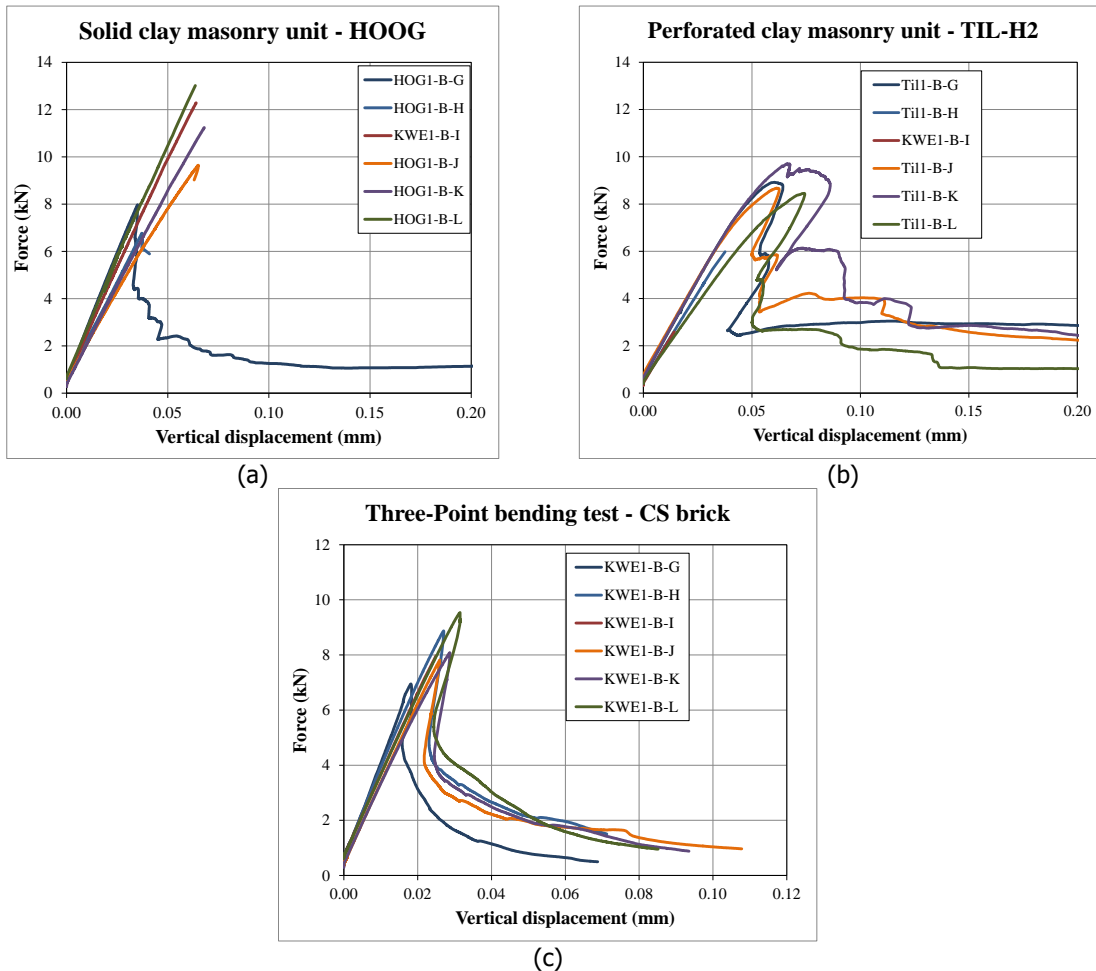
Figure 6 - Force-vertical displacements curves (LVDTs readings) of three-point bending test on masonry unit: (a) solid clay brick; (b) perforated clay brick; (c) calcium silicate brick.

Figure 6 shows the displacement-force diagram for the three different masonry units. The solid clay bricks showed a linear behaviour up to the peak followed by a brittle failure. The perforated clay bricks and CS bricks showed linear behaviour approximately until 90% of the peak load followed by a post-peak exponential softening.

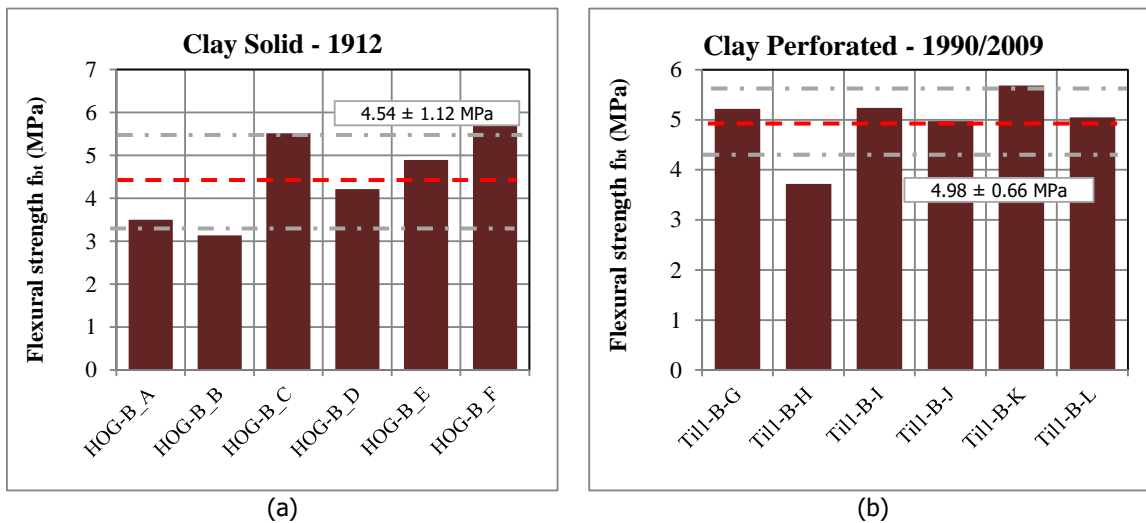
Figure 7 – Histogram representation of the flexural strength of clay bricks: (a) solid clay bricks used before 1920; (b) perforated clay bricks used after 1945.

Table 6 and Table 7 list the density, flexural strength and the Young's modulus of the clay bricks and CS bricks, respectively. The results of flexural strength in terms of histogram are shown in Figure 7 and Figure 8. The perforated clay brick and calcium silicate bricks showed a low variation in strength with an average flexural strength of 5.0 and 3.2 MPa, respectively. A higher variation of flexural strength for the solid clay brick was observed.

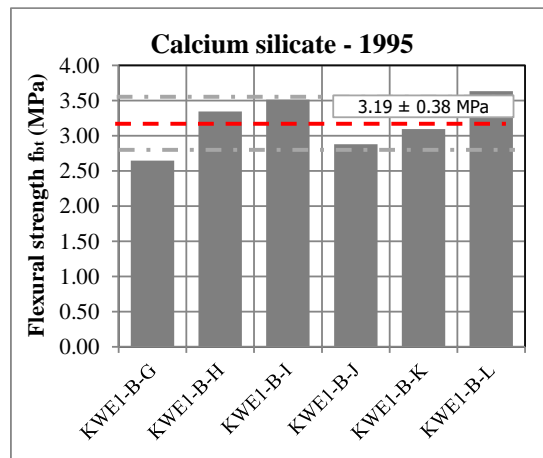
Figure 8 – Histogram representation of the flexural strength of CS bricks used after 1985.

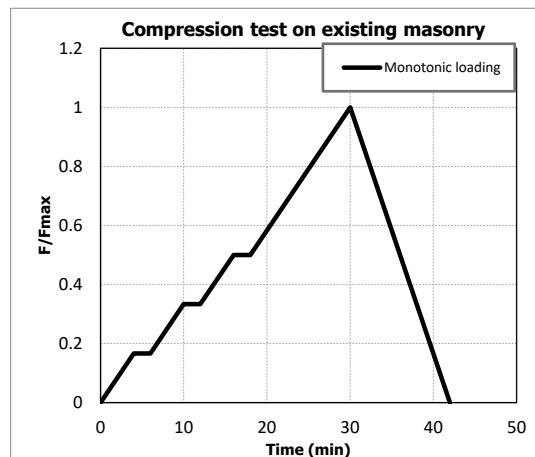
Figure 12 – Monotonic loading scheme for compression test on existing masonry specimen.

For the two vertical and horizontal configurations, three specimens were tested by applying a *monotonic loading* as prescribed by the EN 1052-1:1998 [9] (Figure 12). Half of the expected maximum compression force was applied in three equal steps and was kept constant for 2 ± 1 min. Afterwards, the maximum stress was reached monotonically. Subsequently, the test was continued to explore the post-peak behaviour. The load was applied with a rate of 0.003 mm/s to reach the peak stress in 15 to 30 min. The deformation and the force were registered, including the post-peak softening regime.

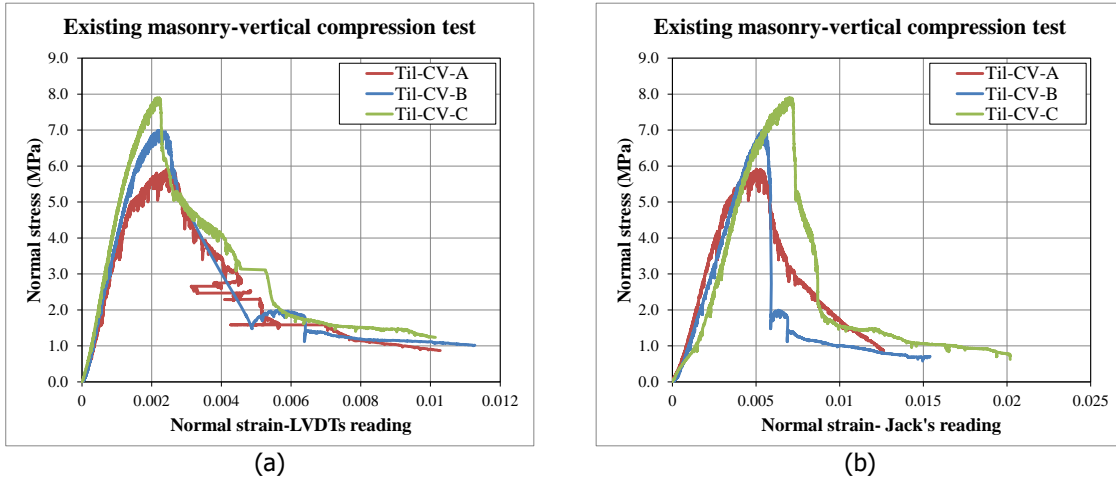
Figure 14 – Vertical compression tests on CS brick masonry specimens used after 1985 (TIL-H1-CV): (a) normal strain obtained by LVDT’s reading; (b) normal strain obtained by jack’s reading.

Figure 14 and Figure 15 show the stress-strain diagram for the CS brick masonry specimens tested under the vertical (TIL-H1-CV) and the horizontal (TIL-H1-CH) configuration, respectively. The graphs refer to the normal direction that is defined as the one parallel to the loading direction. For both configurations, the stress-strain relationship in the normal direction presents a similar trend. The pre-peak stage was characterised by linear-elastic followed by an hardening behaviour until the peak. After the peak stress was reached, a linear softening behaviour was observed for both configurations.

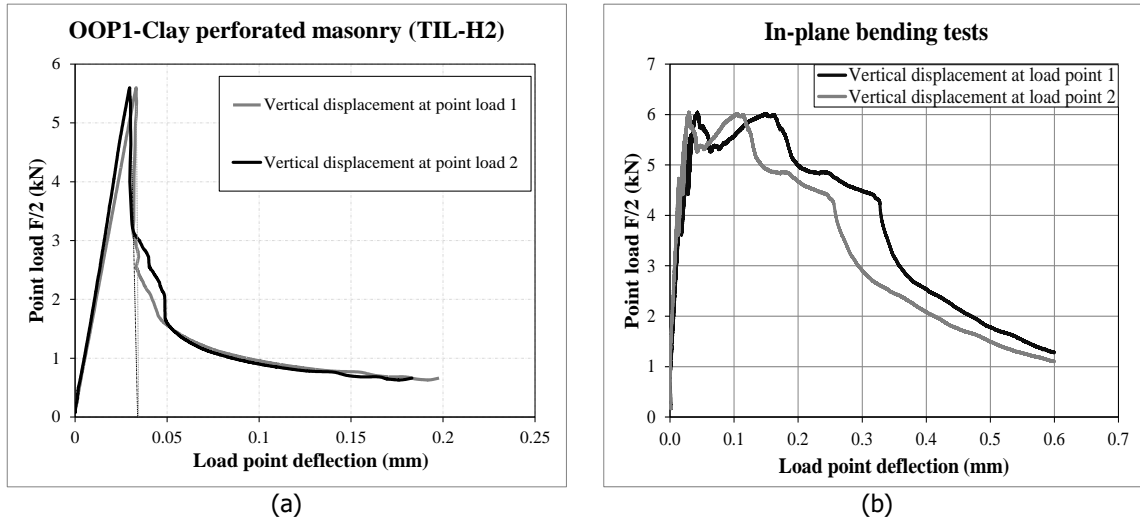
Figure 22 – Force versus deflection curve at loading point used to calculate the fracture energy: (a) out-of-plane bending; (b) in-plane bending.

Figure 22 shows the force versus deflection curve at the loading point used to calculate the fracture energy. In some case, especially for the out-of-plane tests, a plateau was found in the post-peak phase, which might be attributed to the weight of the specimen, formation of mixed cracks propagated along multiple joints and constraining of the specimen after a certain deformation. In this case, the stress-strain relationship adopted for the estimation of the fracture energy was modified by considering a linear approximation of the curve after the peak load. The slope of the post-peak curve calculated between the maximum load and approximately 10% reduction in the maximum load was used as a basis to approximate the post-peak phase (Figure 22a).

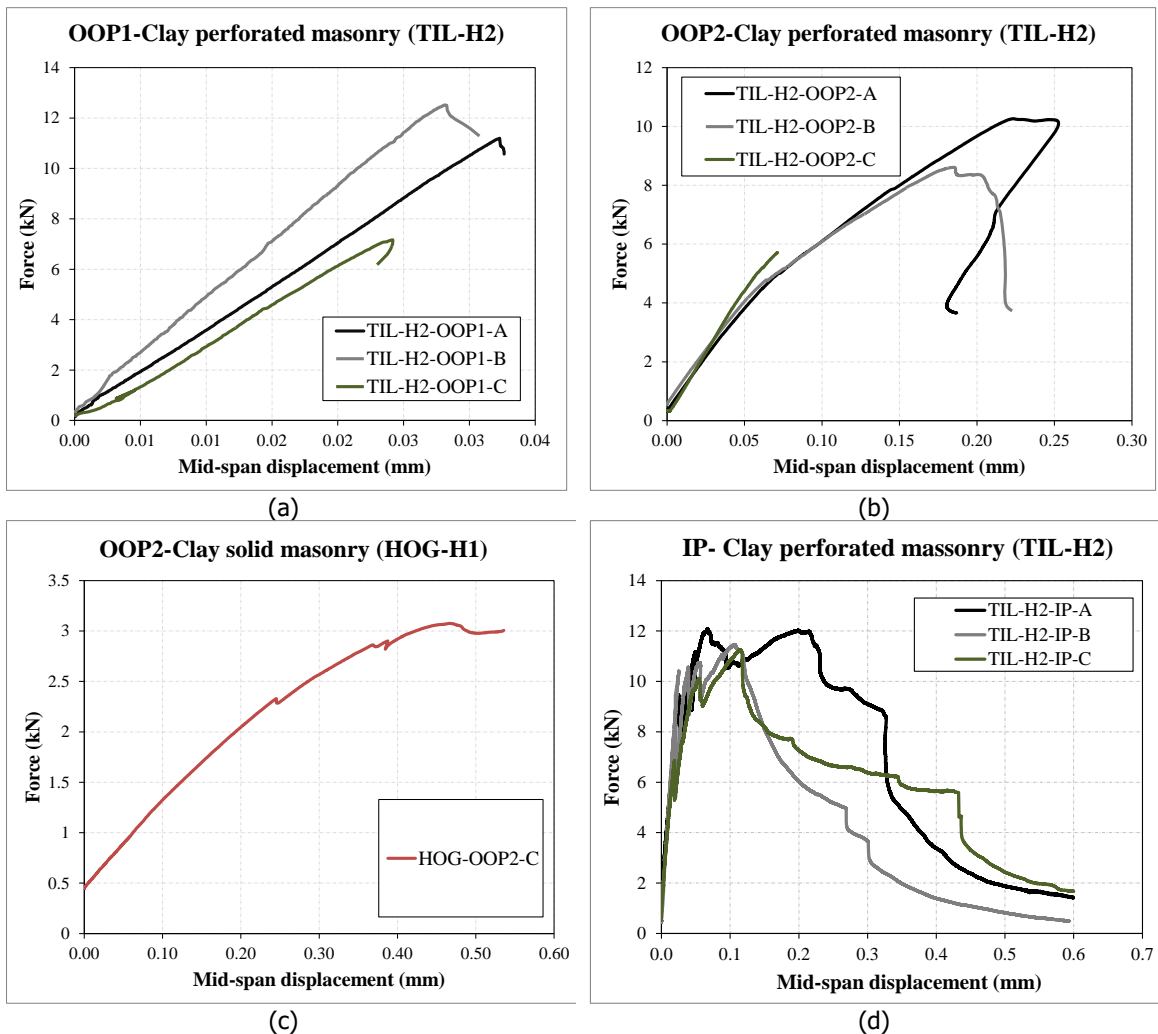
Figure 23 – Force-displacement curve for existing masonry subjected to: (a) vertical out-of-plane bending test on clay perforated masonry (TIL-H2); (b) horizontal out-of-plane bending test on clay perforated masonry (TIL-H2); (c) horizontal out-of-plane bending test on clay solid masonry (HOG-H); (d) in-plane bending on clay perforated masonry (TIL-H2).

Figure 23 shows the force-displacement curve for existing masonry specimens subjected to bending tests. In the case, the installation of a central LVDT was not possible the mid-span displacement has been calculated from the readings of the other LVDTs, by applying a linear interpolation. A post-peak softening behaviour could be observed for almost all the tested specimens.

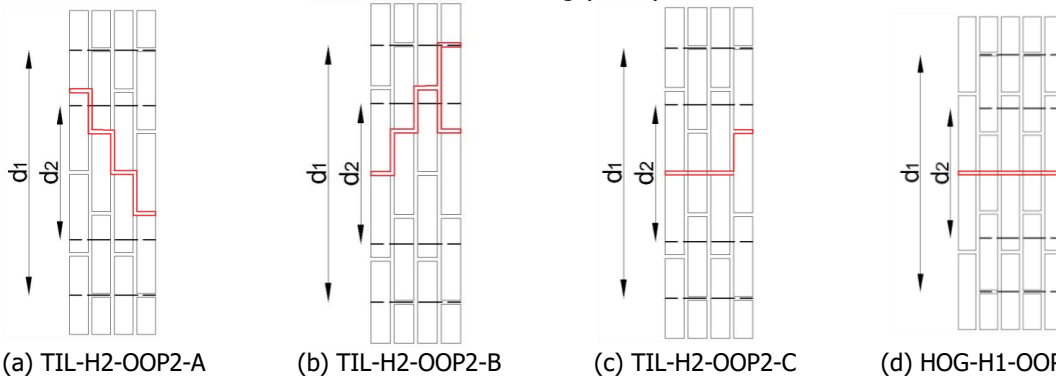
Figure 25 - Crack pattern of specimens subjected to horizontal out-of-plane bending: (a)-(c) perforated clay brick masonry (TIL-H2); (d) solid clay brick masonry (HOG-H1).

In the case of horizontal out-of-plane bending tests, two failure modes were observed as follows (Figure 25):

- Alternating crack running through the head joints and bed joints (TIL-H2-OOP2-A to C).
- Vertical crack in the middle of the sample starting from the mortar and developed upward (HOG-H1-OOP2-C)

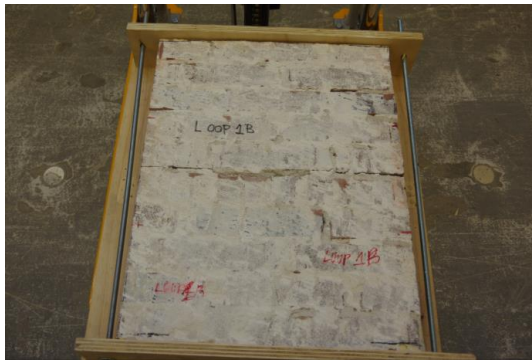
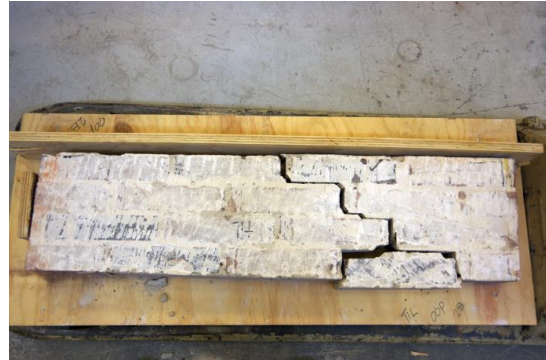
Figure 27 – Crack pattern of existing masonry specimens subjected to four-point bending tests: (a) vertical out-of-plane bending; (b) horizontal out-of-plane bending; (c) in-plane bending.

The crack patterns of specimens for the bending tests are shown in Figure 24 to Figure 27.

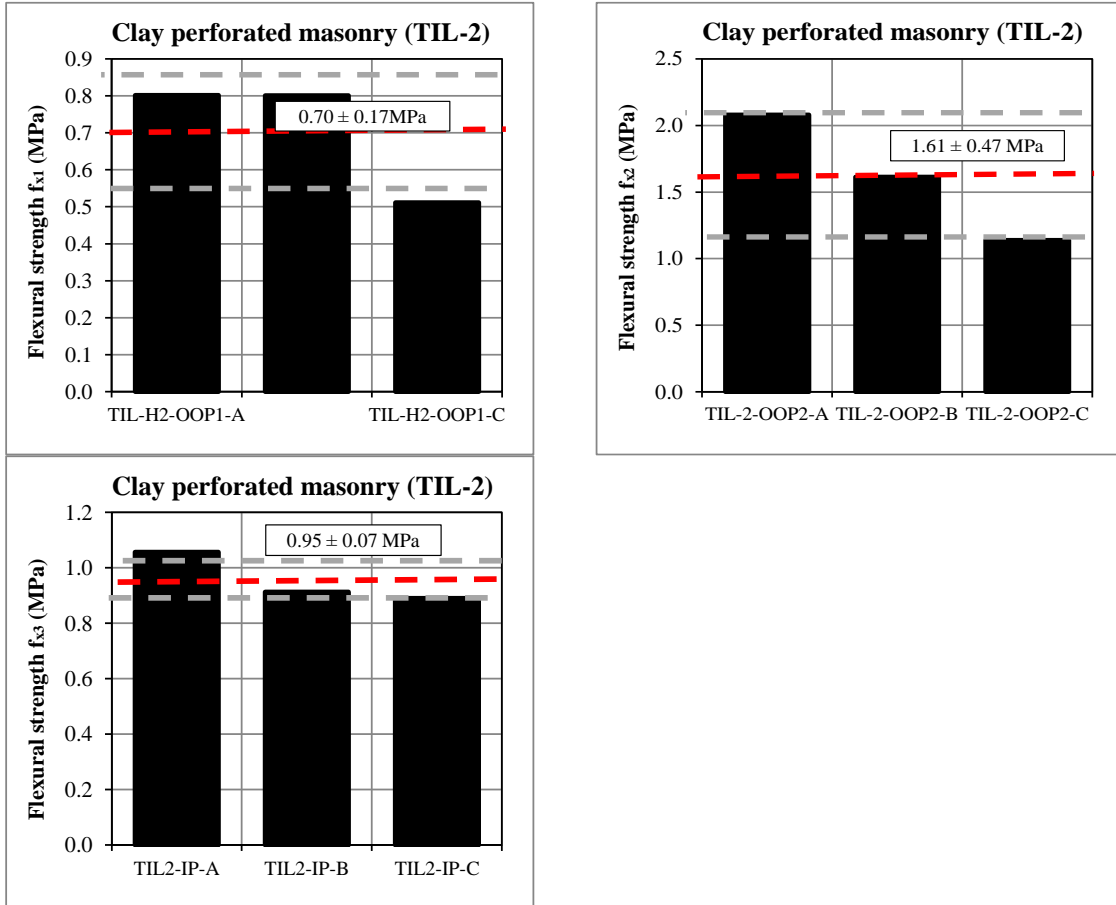
Figure 28 – Bending properties of perforated clay brick masonry specimens constructed after 1945 (TIL-H2): histogram representation.

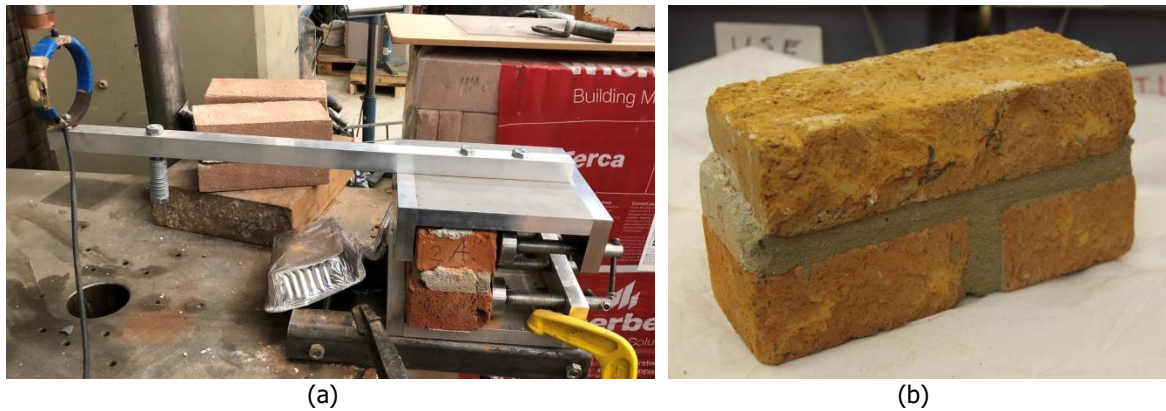
Figure 29 – Bond wrench tests: (a) improved set-up; (b) sawn-cut couplet specimens.

The improved test set-up is used in this campaign as shown in Figure 29a. The specimen is rigidly held by a support frame that holds the specimen in accordance with EN 1052-5:2005 [14]. A clamp attached to a lever is placed on top of the masonry unit. The lever is used to apply a bending moment to the brick-mortar interface. The load is applied by a jack operated manually and a load cell attached to the jack measures the applied force. Therefore, the improved set-up provides the possibility for recording the applied load continuously.

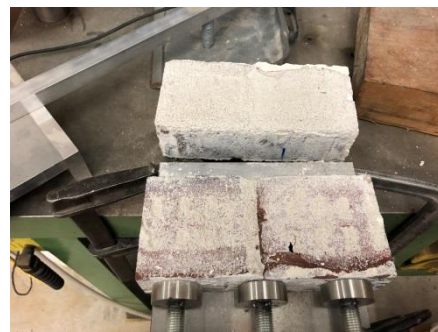
Figure 32 – Observed failure mechanisms: (a) solid clay brick masonry with joint's repointing (HOG-H1); (b) perforated clay brick masonry (TIL-H2).

Figure 31 reports the classification of the type of failures [14], while Figure 32 shows the observed failure mechanisms.

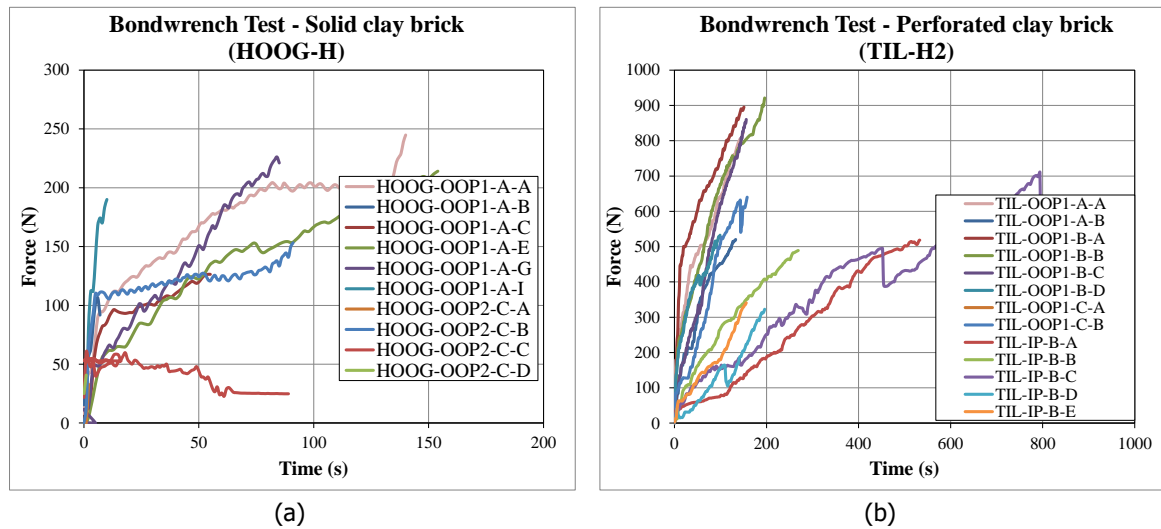
Figure 33 – Time versus force (F_1) applied by manually controlled jack: (a) solid clay brick masonry constructed before 1920 (HOG-H1); (b) perforated clay brick masonry (TIL-H2) constructed after 1945.

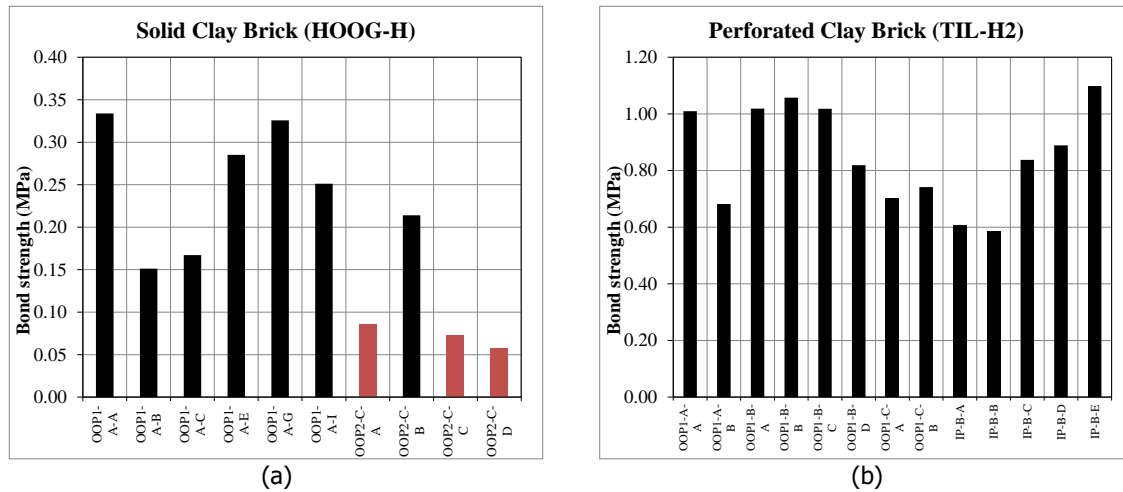
Figure 34 – Bond strength values of clay brick masonry: histogram representation: (a) solid clay brick masonry constructed before 1920 (HOG-H1); (b) perforated clay brick masonry constructed after 1945 (TIL-H2). In red excluded values.

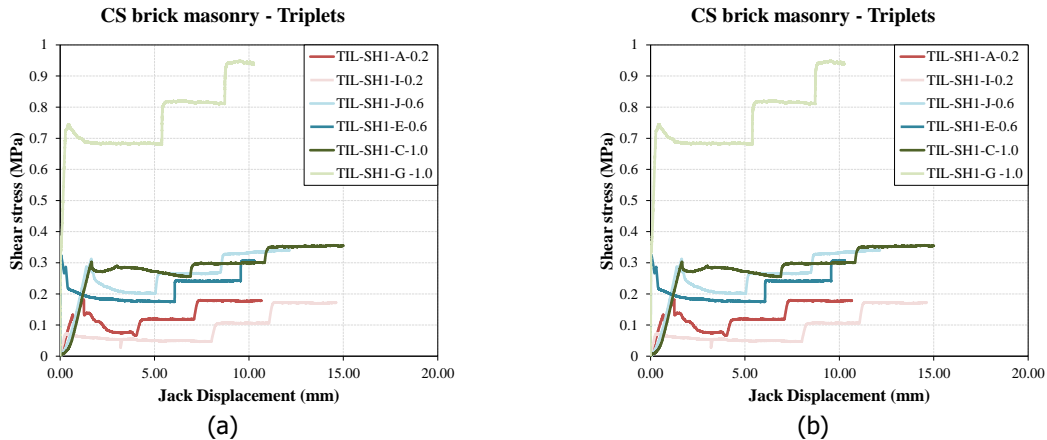
Figure 37 – Shear stress versus relative displacement of the central brick for CS brick triplets (TIL-H1): (a) Jack' readings; (b) LVDT's readings.

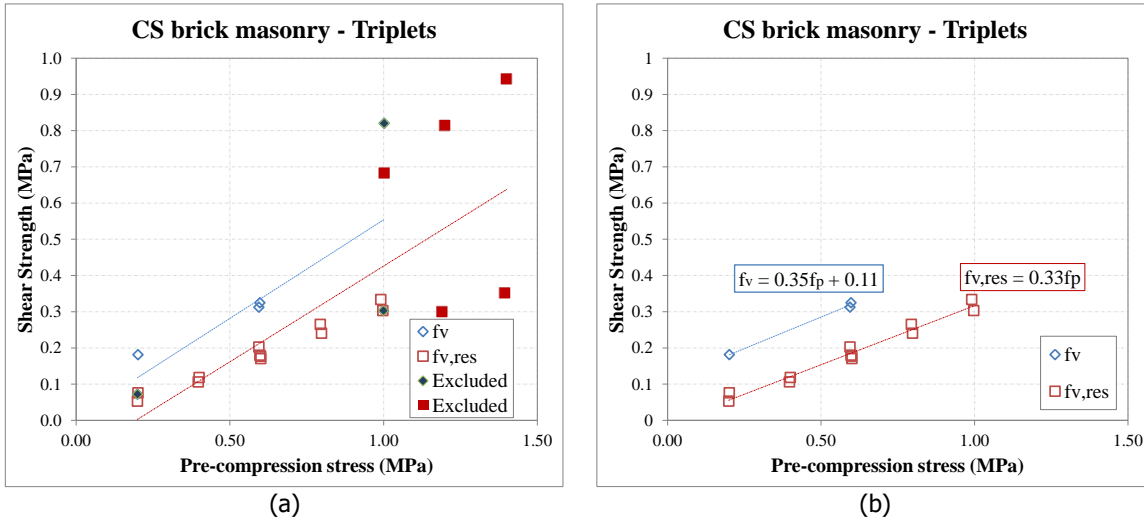
Figure 38 – Shear strength versus pre-compression stress for CS brick masonry triplets (TIL-H1): (a) all the results with indication of excluded data; (b) data considered for determining the shear properties.

The results of all the tests were plotted in a pre-compressive stress versus shear strength diagram. Considering a linear regression of data, the initial shear strength f_{v0} and the coefficient of friction μ can be found such as the intercept with the vertical axis and the gradient of the line, respectively. The angle of internal friction α was determined as the angle between the regression line and the horizontal axis.

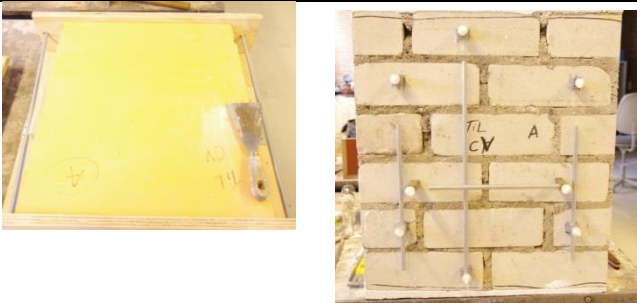
<p>Specimen arrived in good condition. Sample was covered with plaster. After removal of plaster the sample was subjected to vertical compressive load</p>
TIL-CV-B

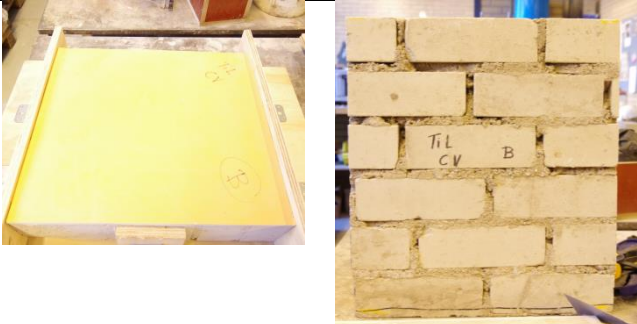
<p>Specimen arrived in good condition. Sample was covered with plaster. After removal of plaster the sample was subjected to vertical compressive load</p>
TIL-CV-C

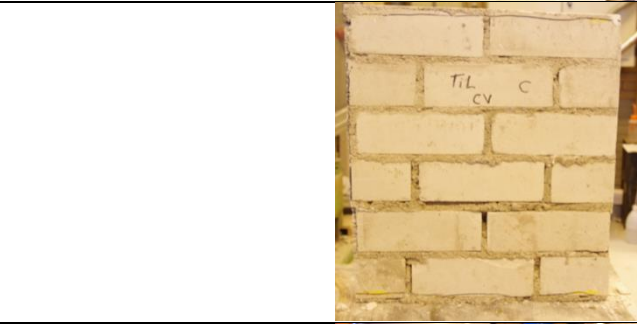
<p>Specimen arrived in good condition. Sample was covered with plaster. After removal of plaster the sample was subjected to vertical compressive load</p>
TIL-CH-A

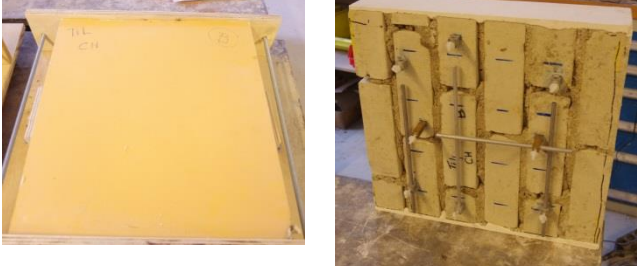
<p>Specimen arrived in good condition. Sample was covered with plaster. After removal of plaster the sample was subjected to horizontal compressive load</p>

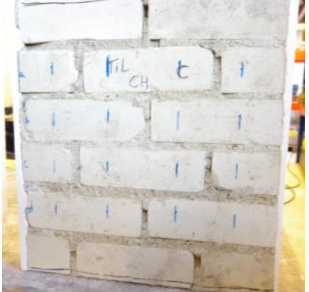
<p>TIL-CH-C</p>

<p>Specimen arrived in good condition. Sample was covered with plaster. After removal of plaster the sample was subjected to horizontal compressive load</p>
<p>TIL-SH1-A</p>

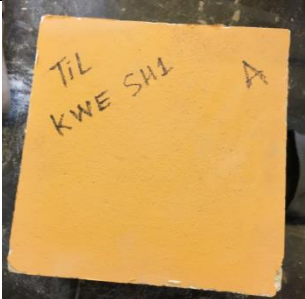
<p>Specimen arrived in good condition. Sample was covered with plaster. Partial disintegration of sample during preparation</p>
<p>TIL-SH1-B</p>

Tests were performed only on CS brick masonry specimens. The description of status of the CS brick masonry triplets can be found in Appendix A. The specimens were delivered with a layer of plaster. During the removal of plaster and handling, some of the specimens were disintegrated. As a result, only 6 out of 10 specimens were tested, as shown in Figure 36. Among the tested specimens, 3 out of 6 specimens showed damage in both one bed and head joint (TIL-SH1-A and TIL-SH1-J, Figure 36) or only in one bed joint (TIL-SH1-C, Figure 36).

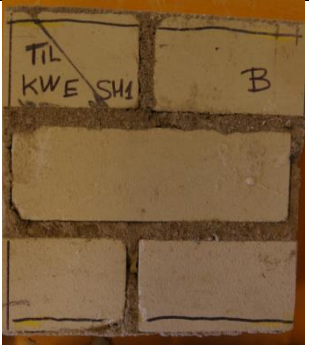
<p>Specimen arrived in good conditions. Sample was covered with plaster. Partial disintegration of sample during preparation.</p>
<p>TIL-SH1-C</p>

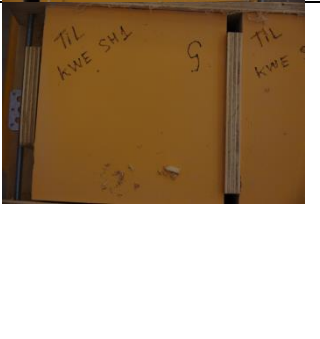
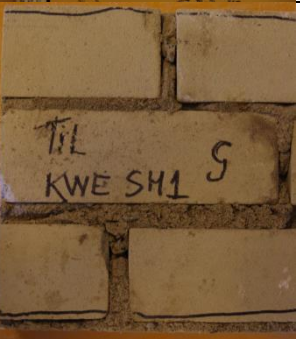
<p>Specimen arrived in good condition. Sample was covered with plaster. After removal the sample was subjected to shear-compression load.</p>
<p>TIL-SH1-H</p>

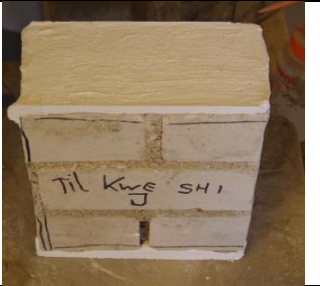
<p>Specimen arrived in good condition. Sample was covered with plaster.</p>
<p>TIL-OOP1-A</p>

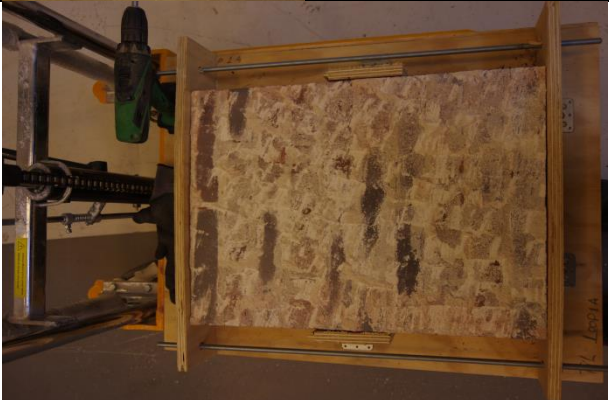
<p>Specimen arrived in good condition. Vertical out of plane bending test was performed.</p>

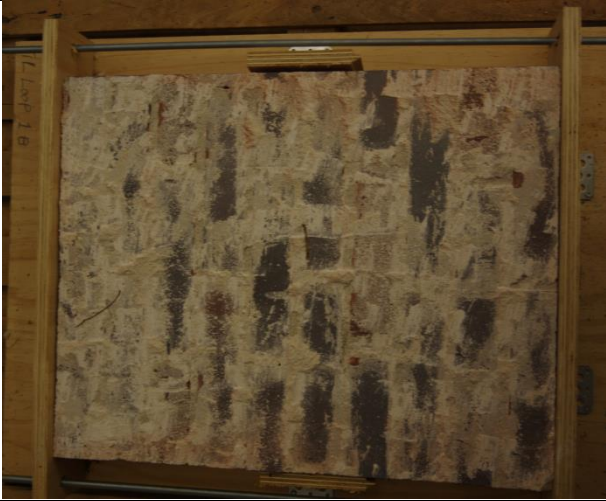
<p>TIL- OOP1-B</p>

<p>Specimen arrived in good conditions. Vertical out of plane bending test was performed.</p>
<p>TIL- OOP1-C</p>	 	<p>Specimen arrived in good conditions. Vertical out of plane bending test was performed.</p>
<p>TIL- OOP2-A</p>	 	<p>Specimen arrived in good conditions. Horizontal out of plane bending test was performed.</p>
<p>TIL- OOP2-B</p>	 	<p>Specimen arrived in good conditions. Horizontal out of plane bending test was performed.</p>
<p>TIL- OOP2-C</p>	 	<p>Specimen arrived in good conditions. Horizontal out of plane bending test was performed.</p>

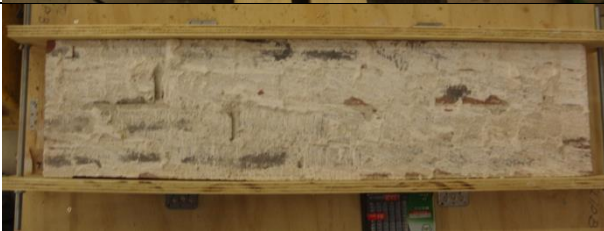
<p>Specimen arrived in good conditions. In-plane bending test was performed.</p>
<p>TIL-IP-C</p>

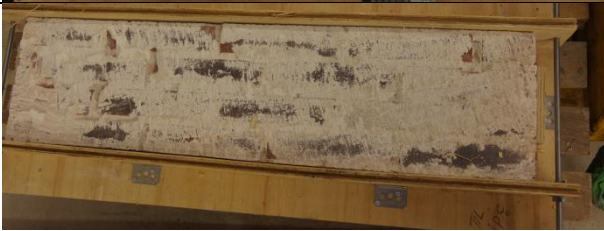
<p>Specimen arrived in good conditions. In-plane bending test was performed.</p>
<p>HOG1-OOP1-A</p>
