Mechanical strength characterization of recovered azobé timber boards for reuse

Case Studies in Construction Materials

Timber sheet pile
Deterioration
Reuse
Bank protection
Residual bending strength

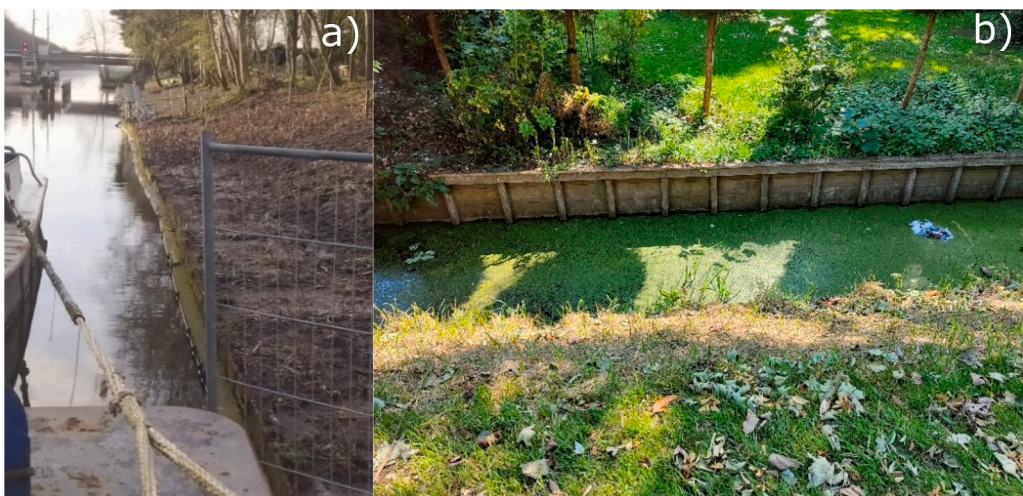
Fig. 1. a) Existing azobé sheet pile nearing end of service life b) Horizontal wooden elements protecting bank of the canal.

horizontal sheet members (Fig. 1). Hundreds of kilometers of timber sheet piles are reaching the end of design service life or are in need of maintenance and intervention. In comparison to used timber piles for which detailed methodologies are currently being developed to study their current condition [2], very little is known about the current condition of timber sheet pile wall boards.

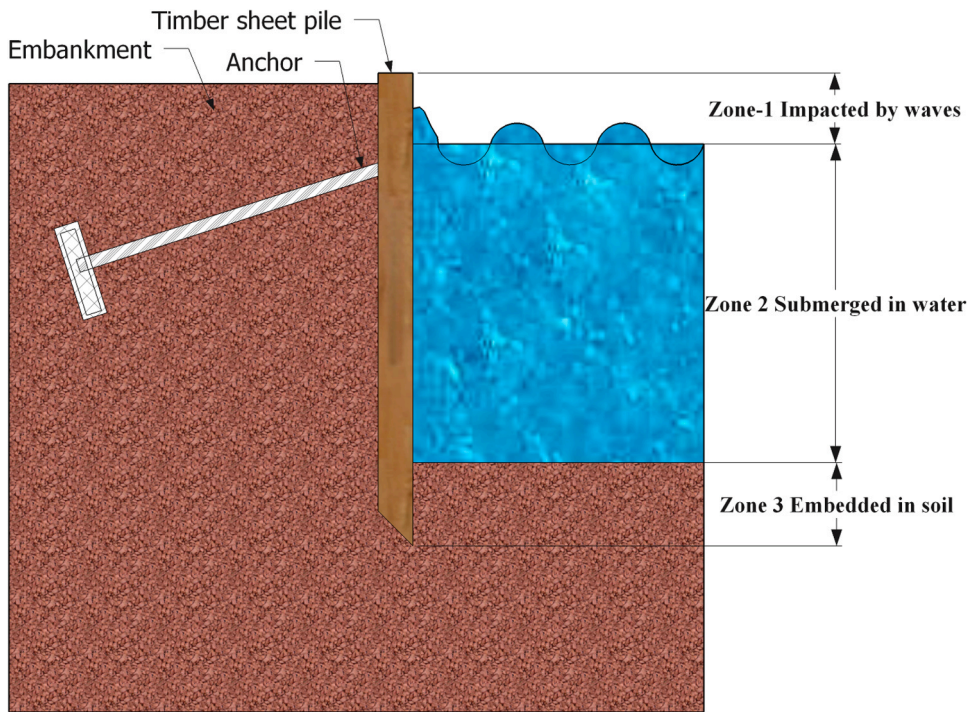
Fig. 2. Different zones in a timber sheet pile in service (modified from Nowak et al. [7] and Van de Kuilen and Van Der Linden [8]).

Timber sheet piles, similar to other hydraulic structures made of timber such as lock gates, and fenders are exposed to harsh conditions such as drying out, mechanical and wave impact (Gard and Van de Kuilen [6]). These conditions could result in deterioration, which necessitates the need for monitoring of such structures. The extent of deterioration might vary along the length of sheet pile (top of the sheet pile to embedment), vary with respect to the face of the sheet pile (open water side or earth side). Three different sections can be identified in a typical sheet pile (a) section which is completely embedded in the ground and below the waterline (anaerobic), (b) section which has one face completely in water on one side and earth on other side, (c) section which was subjected to air-water-soil environment [7], see (Fig. 2). While, it could be reasonably assumed that the top part of the sheet pile where an air-water-soil interface exist could be more prone to biological deterioration due to favorable circumstances, the parts completely submerged in water are less prone to attack by biological agents. Similarly, the earth face of the sheet pile is less susceptible to mechanical deterioration such as wave impact compared to the face on the water side.

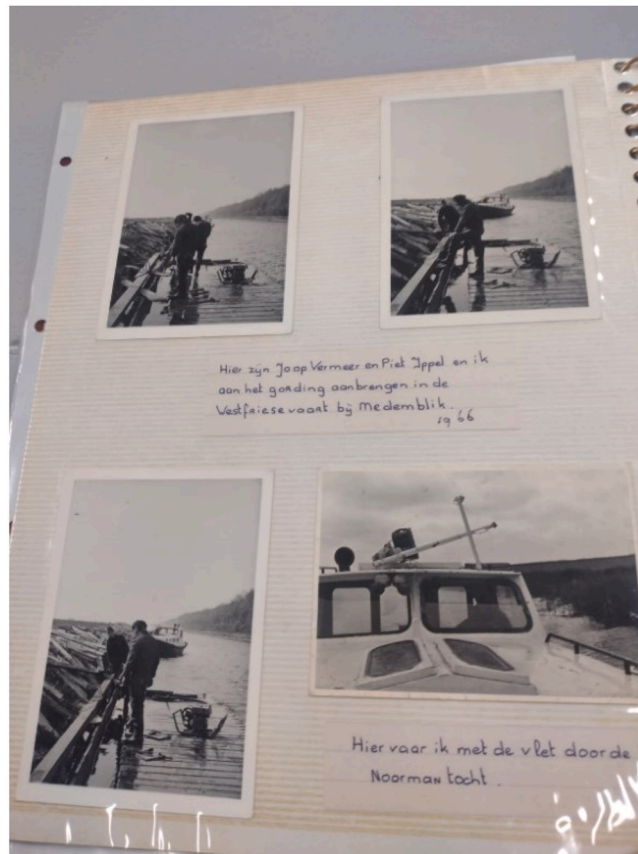
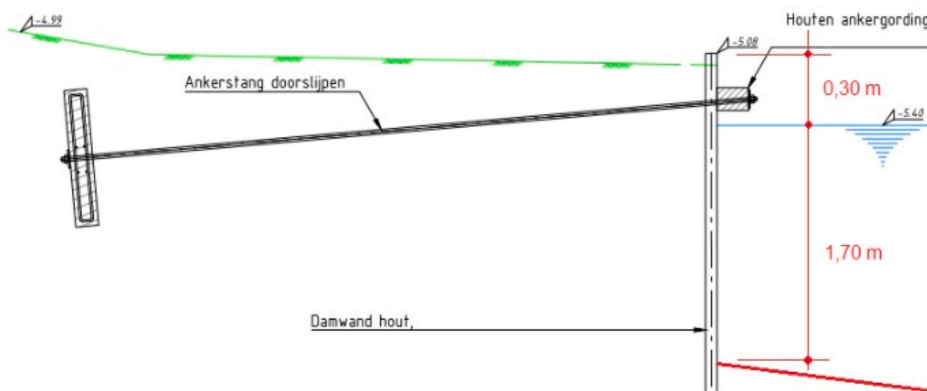
Fig. 3. From archives: a) Picture of installation of azobé timber sheet piles in 1966 b) Installation design of the sheet pile. Courtesy: Province of Noord-Holland.

For the current study, timber sheet piles of azobé which were installed in 1966 in Medemblik, Province of Noord-Holland, the Netherlands were obtained (Fig. 3). The sheets were retrieved in early 2022. This study is aimed at characterizing the current state of these azobé sheet piles, using both destructive and non-destructive techniques. The results are aimed to support practicing engineers in planning maintenance or replacements measures.

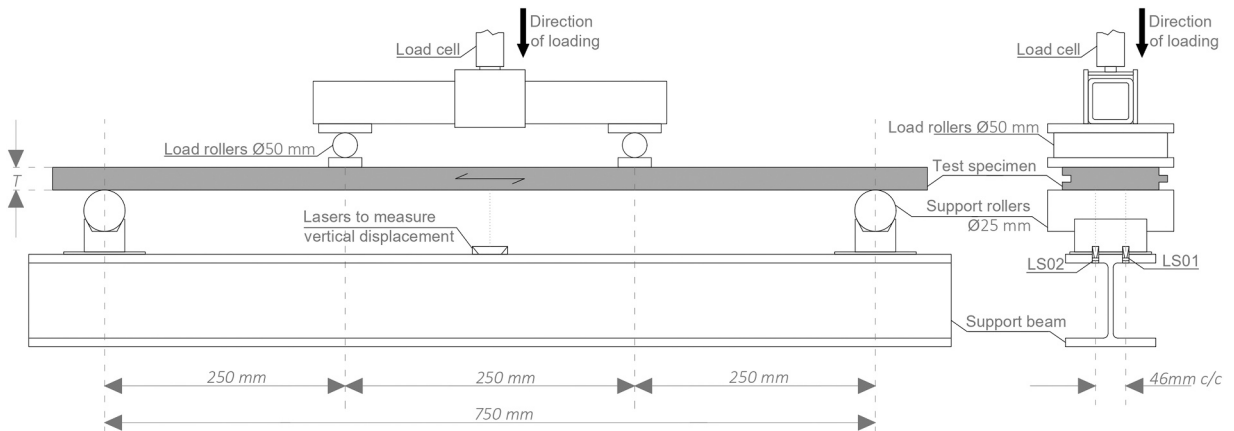
Fig. 5. Four point bending setup for $MOE_{s,g}$ measurements.

Four point flat wise-bending tests were conducted on 152 specimens to determine $MOE_{s,g}$ and bending strength (MOR). It was decided to conduct the four point bending tests in four different configurations based on the face of the specimen subjected to loading (earth side or water side) and location of the specimen with respect to the total sheet pile (top part or bottom part), see Table 3. For $MOE_{s,g}$ the deflection is measured on the board at mid span relative to the roller supports. Two lasers displacement sensors (LS01 and LS02) placed below the level of the supports at mid span record the vertical displacement of the downward facing surface of the board with an accuracy of 0.001 mm

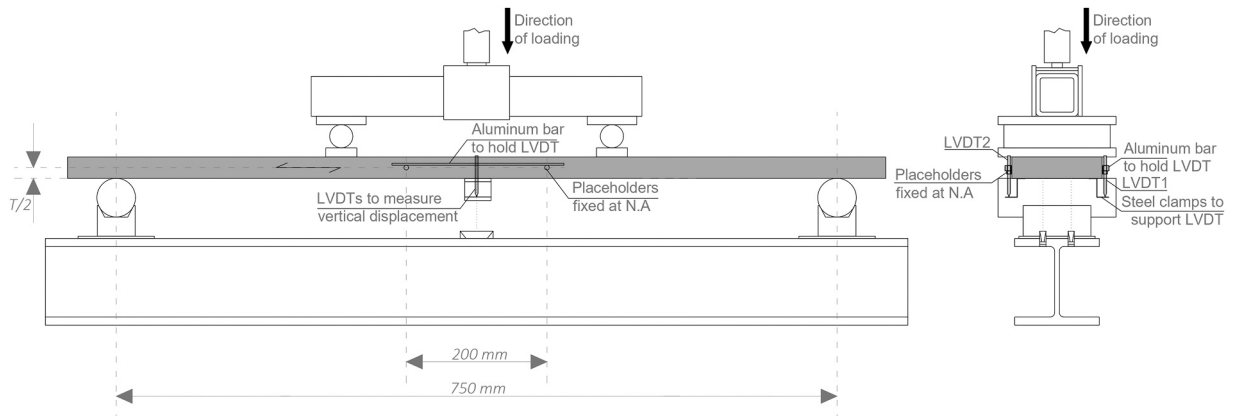
**Fig. 6.** Four point bending setup for $MOE_{s,1}$ measurements.

In order to estimate the $MOE_{s,l}$, the deflection within the point loads where constant moment occurs is measured. As specified in EN 408 [18] the central distance between the points of measurements of the displacement had to be kept 5 times the thickness of the specimen tested and was taken as 200 mm. The measurements are taken at limited part of the test piece using a LVDT to estimate $MOE_{s,l}$ see Fig. 6.

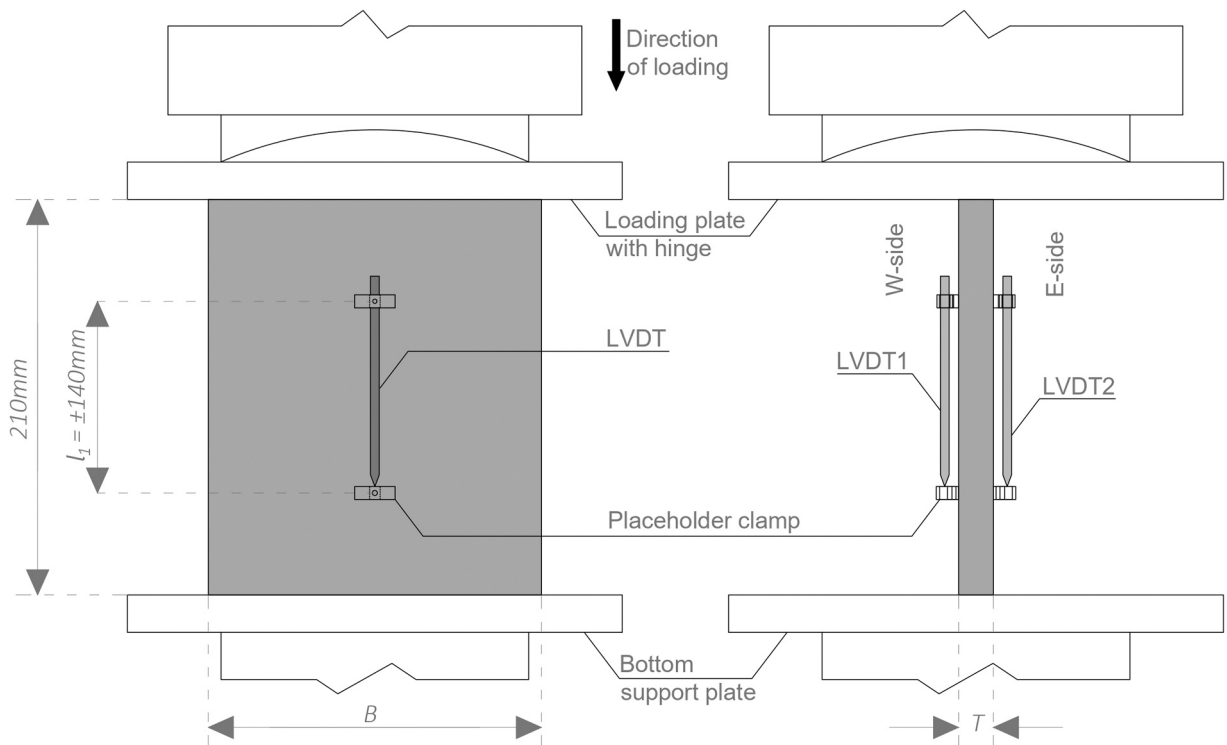
**Fig. 7.** Compression test setup.

Specimens with a length of 210 mm, which is approximately 6 times the smallest cross-sectional dimension were cut from 20 boards for testing specimens in compression. In addition to the vertical displacement measurements being recorded by the load cell based on its own movement, two LVDTs were placed on either surface of the specimen as shown in Fig. 7. Each LVDT was fixed to the board using two brass clamps that were fixed to the specimen using screws at a distance of at least 140 mm, which is 4 times the thickness of the thinnest specimen (EN 408 [18]). The loading rate was maintained at 0.01 mm/s according to EN 408 [18].

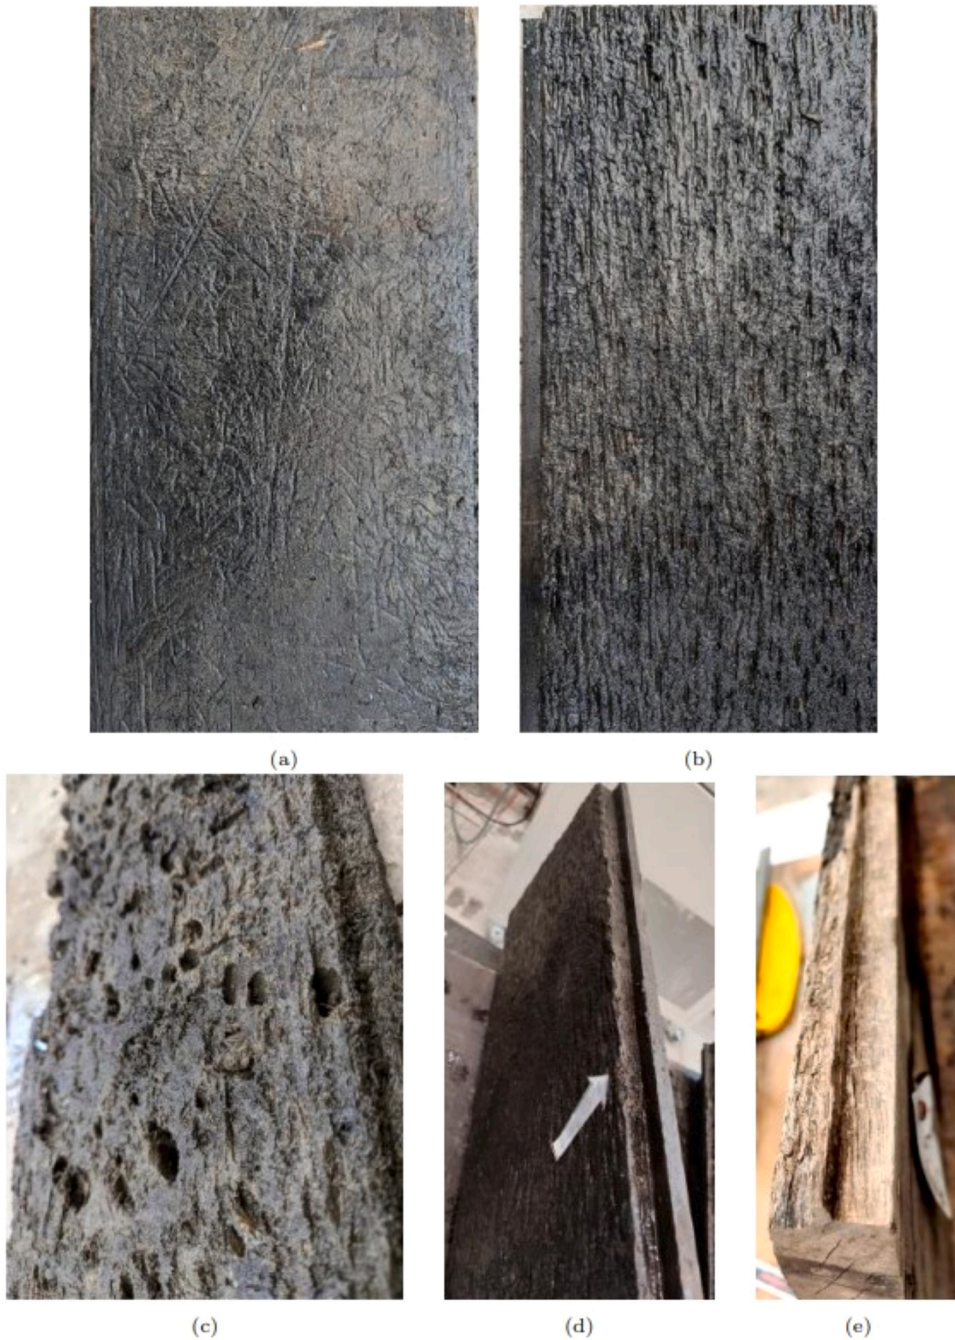
Fig. 9. Deterioration observed on the recovered azobé boards a)Earth side b)Shallow stripes observed on water side c)Severe water side deterioration d)Water side deterioration of the groove e)Water side deterioration of the tongue.

Deterioration stripes were observed in all the boards on the water facing side with varying degree (Fig. 9 b). Tongue and groove was found to be intact and had shallow stripes in 18 percent of the tested boards. Highest number of sheets were assigned to VDS 2, 45 %, indicating that majority of the boards had only moderate deterioration (Table 4). Deterioration holes showing a pattern like that of *Teredo navalis* (shipworm) passing through the full thickness was present in a minority (6 %) of the tested boards and thus assigned to VDS score 4 (Fig. 9 c)). In general, the groove edges that were facing the water side were thin and had undergone deterioration or in worst case absent. The tongue was rectangular and about 2 mm thinner compared to the size of groove.

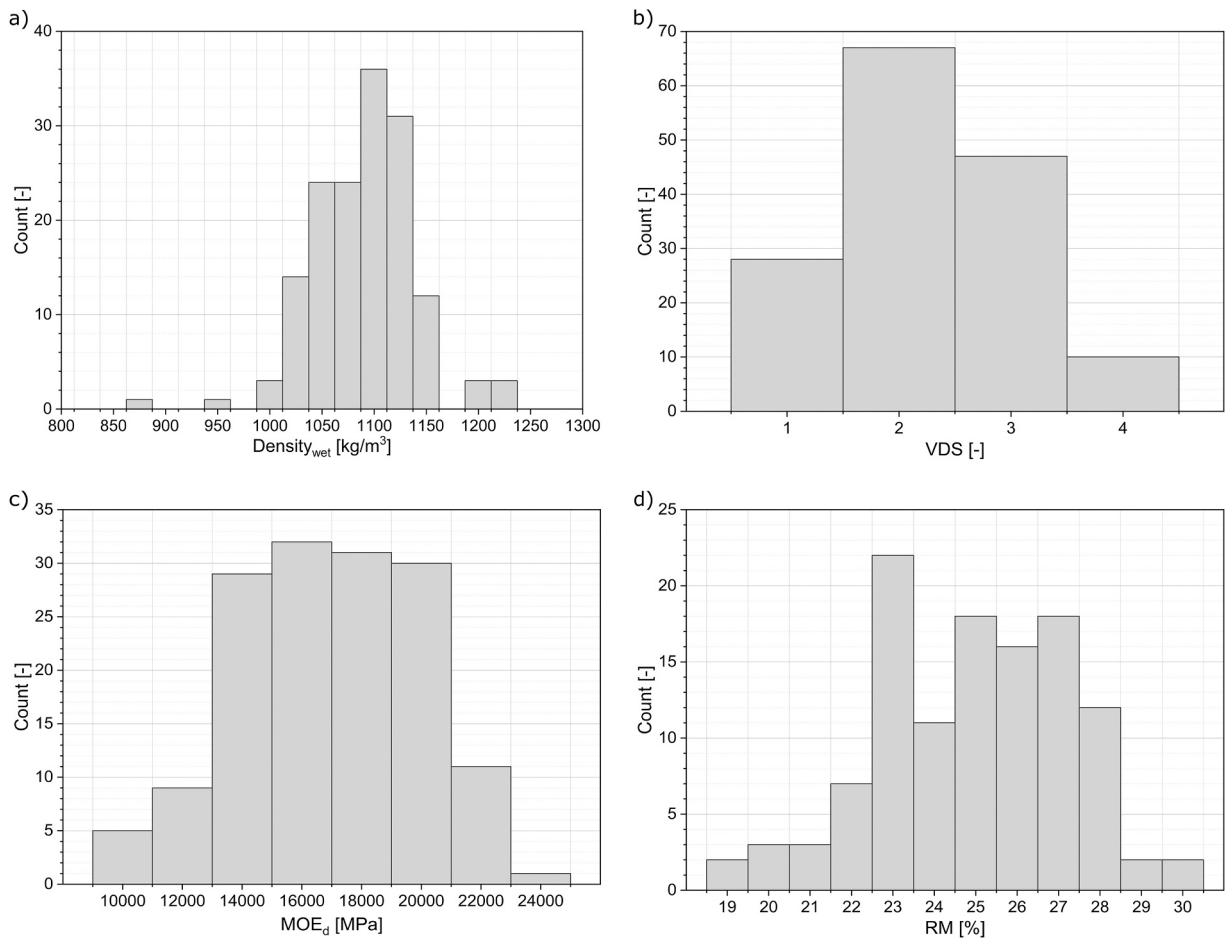
Fig. 10. Distribution of non-destructive measurements a) Wet density, b) Visual deterioration score, c) Dynamic modulus of elasticity, d) Resistance measure according to Eq. 3.

An average MOE_d in wet state of the full population of 152 boards tested was 16800 MPa with 17.9 % CoV. The penetration drilling measurements showed no discerning pattern when compared to the visual deterioration score assigned. No clear pattern was also observed on RPD measurements along the board or from either side of the board. This points towards the lack of potential of the use of RPD measurements for the type of deterioration observed in this study. Distribution of non-destructive parameters measured are shown in Fig. 10.

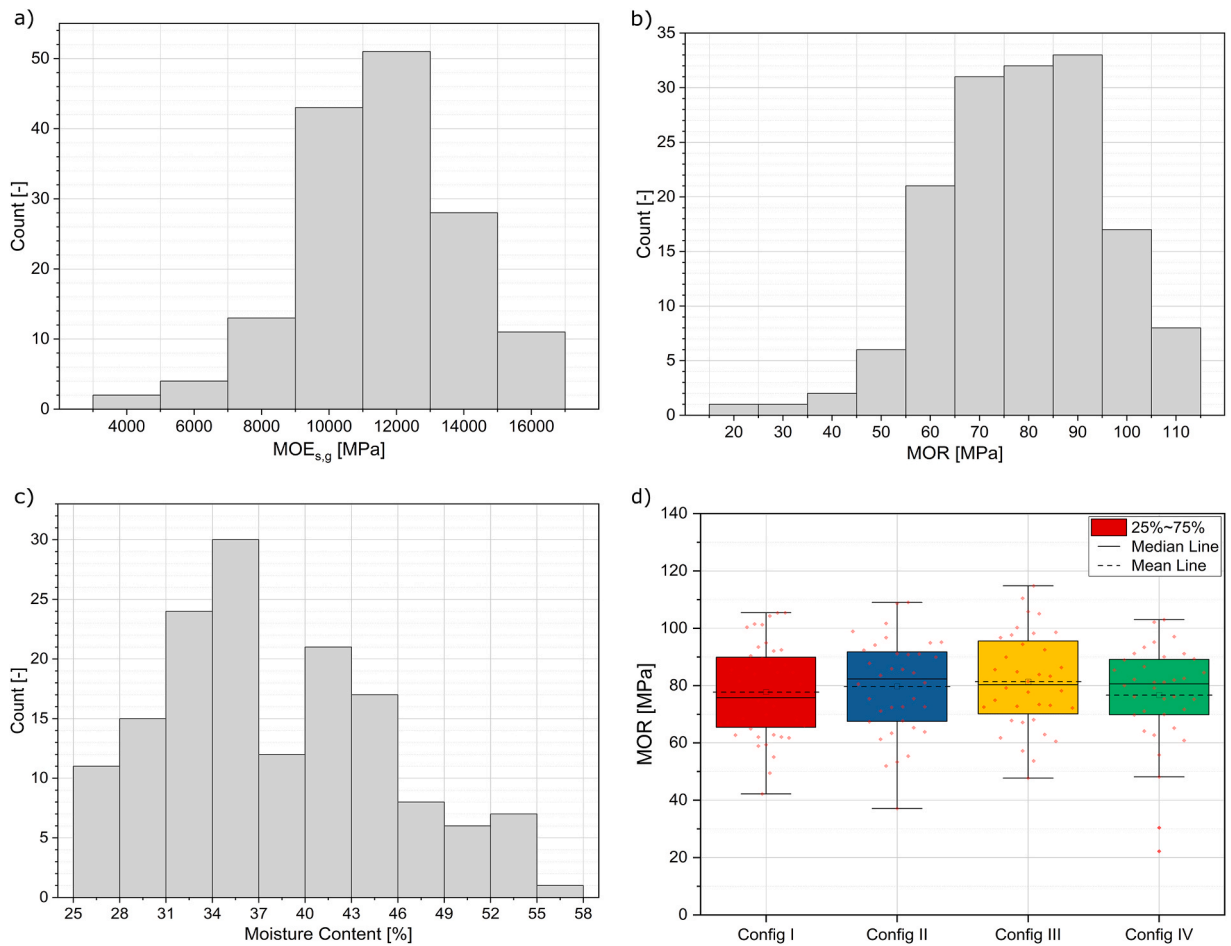
Fig. 11. Distribution of destructive strength parameters a) MOE_{s,g} b) MOR c) Moisture content d) MOR of four configurations tested.

Eight boards were tested for determining $MOE_{s,l}$, the average local modulus of elasticity was 11750 MPa with coefficient of variance 22.4 %. Twenty samples from the sheet piles were tested in compression and an average compression strength of 46 MPa was obtained. The average modulus of elasticity in compression was determined to be 13300 MPa. Distribution of destructive parameters are shown in Fig. 11.

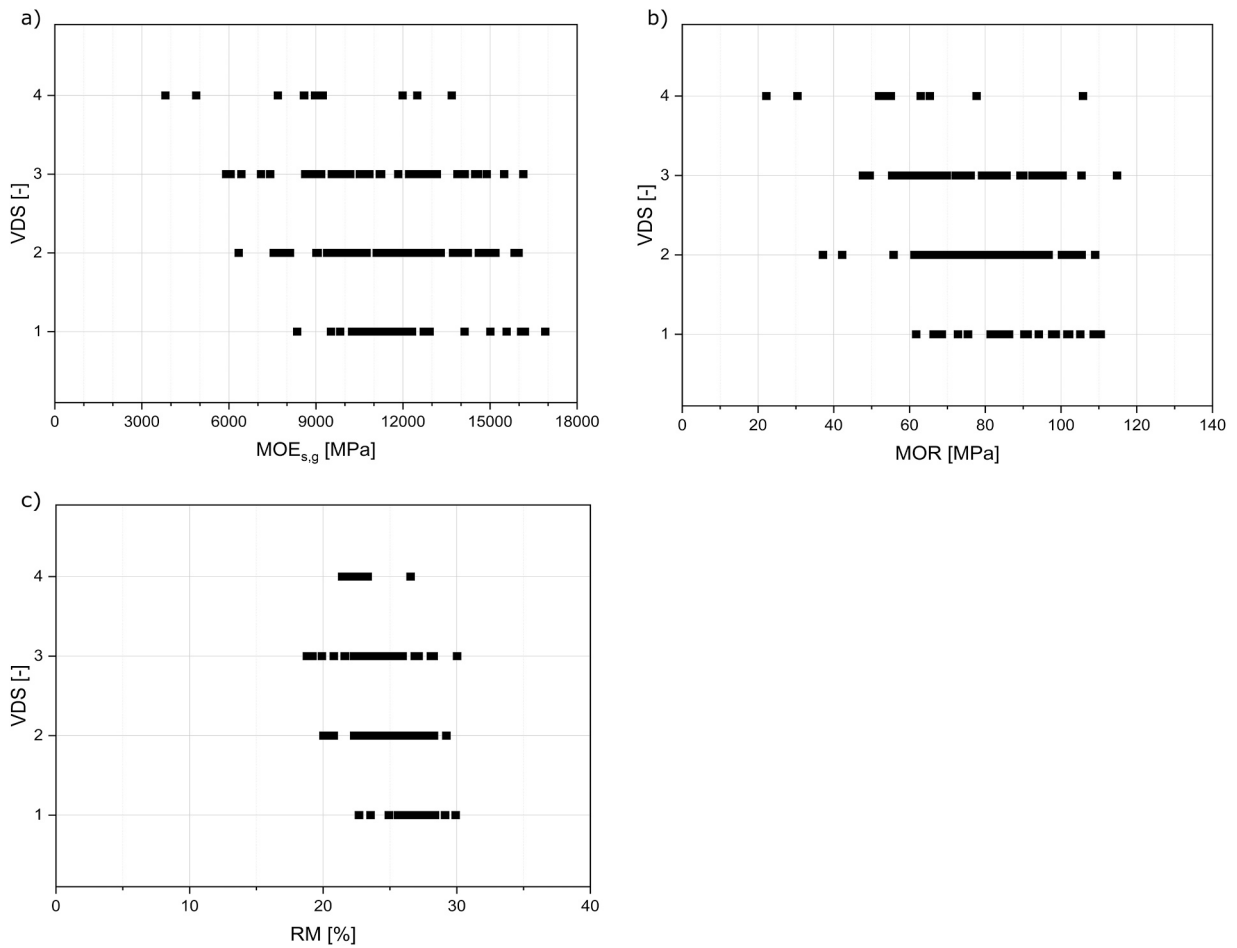
Fig. 12. Relationship between VDS and a) MOE_{s,g} b) MOR c) RM.

A slight general trend of decrease in VDS (from VDS 1 to VDS 4) with respect to decrease in $MOE_{s,g}$ and MOR was observed (Fig. 12). Due to the generic nature of the observation and narrow range of VDS, the methodology used in this study can be used only as a preliminary indicator for the strength of the boards.

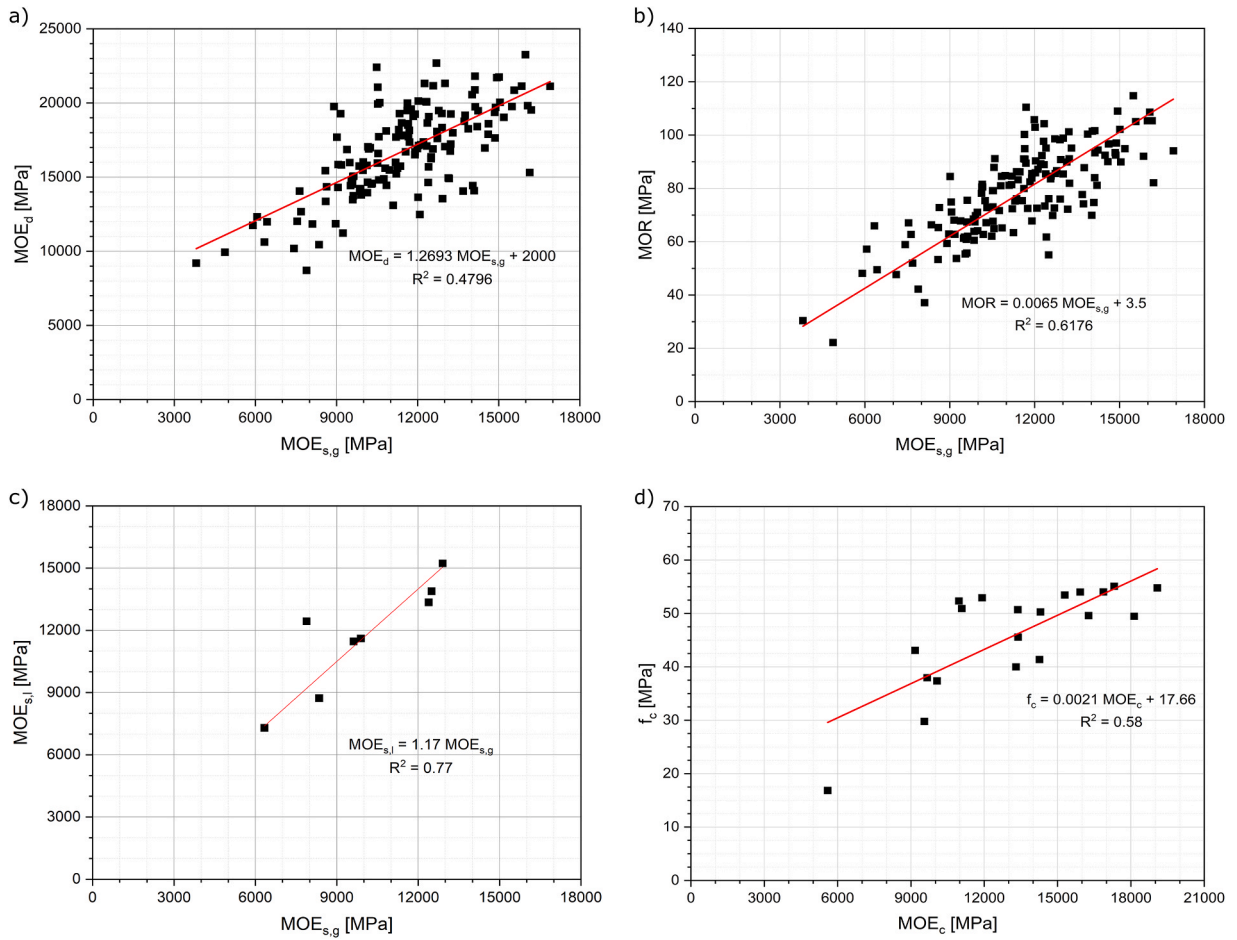
Fig. 13. Relationship between: a) MOE_d vs MOE_{s,g} b) MOR vs MOE_{s,g} c) MOE_{s,l} vs MOE_{s,g} d) f_c vs MOE_c.

MOE_d was correlated to $MOE_{s,g}$ by $MOE_{dyn} = 1.2693 MOE_{s,g} + 2000$ with an R^2 of 0.47. Drilling resistance measurements (RM) was not correlated with any of the mechanical test results of $MOE_{s,g}$ and MOR. Majority (>50 %) of the resistance measures fell in between 22 % and 28 %. $MOE_{s,g}$ was positively and strongly ($R^2=0.61$) correlated with MOR by $MOR = 0.0065 MOE_{s,g} + 3.5$. The relationship between local $MOE_{s,l}$ and $MOE_{s,g}$ was found to be $MOE_{s,l} = 1.17 MOE_{s,g}$, with $R^2 = 0.77$, see Fig. 13.

The compressive strength shows good correlation with modulus of elasticity in compression MOE_c as $f_c = 0.0022 MOE_c + 17.66$, with $R^2 = 0.58$, see Fig. 13. Compressive strength also shows strong correlation with $MOR_{s,l}$, $f_c = 0.56 MOR_{s,l}$ with $R^2 = 0.76$. The compression strength parameters, MOE_c ($R^2 = 0.33$) and f_c ($R^2 = 0.53$) showed better correlation with RPD measurements than bending parameters.

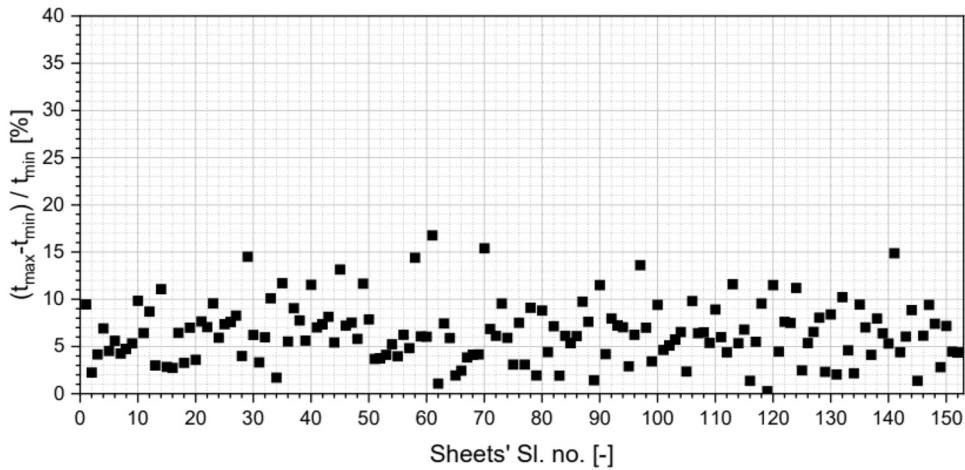
Fig. 14. Percentage difference between maximum and minimum thickness of individual boards.

The variations in I_{cal} and I_{act} would result in a strength and stiffness overestimation between 6 % and 9 %. The thickness of the boards varied throughout the length. Additionally, these differences in thickness, though not locally taken into account, are included in the bending strength and stiffness calculated by considering the average thickness of each board. The variation in thickness can also be considered as an indication of quantity of the deterioration the board has undergone. Assuming, the thickest section measured for an individual board represents intact thickness, the maximum % of variation in thickness due to deterioration was below 18 %. (Fig. 14).

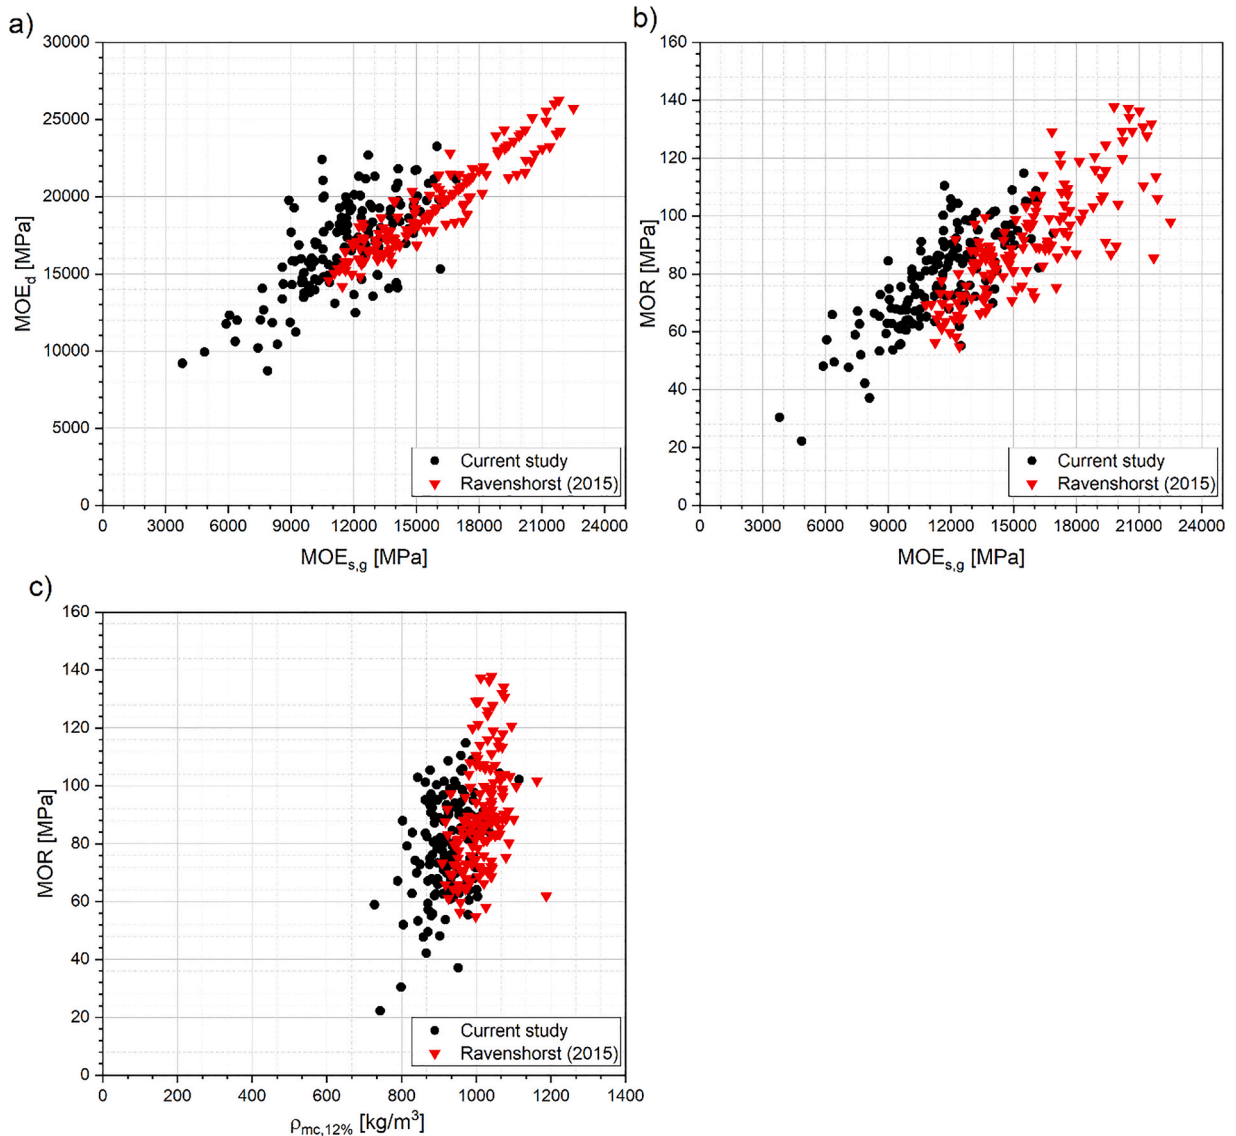
**Fig. 15.** Comparison of strength parameters between the current study and Ravenshorst [28]. a) MOE_d vs MOE_{s,g} b) MOR vs MOE_{s,g} c) MOR vs $\rho_{mc12\%}$.

In order to compare the general trend among strength parameters of the boards in this study with fresh azobe boards tested by Ravenshorst [28], MOE_{s,g}, MOE_d, MOR and density for both studies were plotted, Fig. 15. It can be observed that the cloud of data from Ravenshorst [28] and this study follow a similar general trend for MOE_d vs MOE_{s,g} Fig. (15, a)). However, it can be also observed that density of tested boards in this study are lower than that reported by Ravenshorst [28] for new boards. Given that no information is available about the quality of the boards used in this study during installation five decades back, the lower density at 12 % moisture content ($\rho_{mc12\%}$) and superficial deterioration observed, points towards a general lower intrinsic quality of the boards. Again, it has to be noted that the surface of the boards was not planed and the density measurements are based on average values of dimensions measured.
